Modeling the Deepwater Horizon blowout using STAMP

Rolf-Arne Haugen Syvertsen

Master of Science in Product Design and Manufacturing

Submission date: June 2012

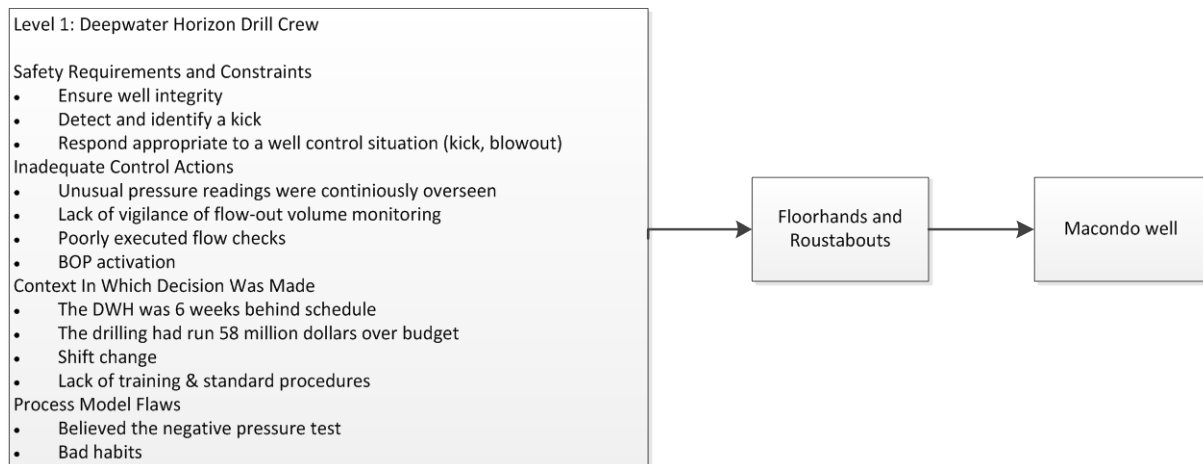
Figure 4. 2: DWH drill crew level analysis.

The crew on the rig didn't fully understand the magnitude of the blowout and had routed the gas influx to the diverter and coupled this with the mud-gas separator. This coupling was not necessary, but for environmental concerns and economical concerns it is not desirable to dump drilling mud overboard (Drilling, 2011). Given the magnitude of the influx coming to the rig the mud-gas separator did not have the capacity to handle the blowout. In accordance with (API, 2006) the diverter was correctly engaged and the valves were open, but since the crew was feeding the flow through the mud-gas separator it got overrun by the blowout.

As the mud gas separator was failing a gas cloud started gathering on the rig. The first explosion was at 9:49 p.m. and the drill crew now tried to close in the well. There is no evidence that the rig crew activated the shear ram in the BOP prior to the first explosion (Drilling, 2011). Figure 4.2 depicts the result of the causal analysis of the drill crew.

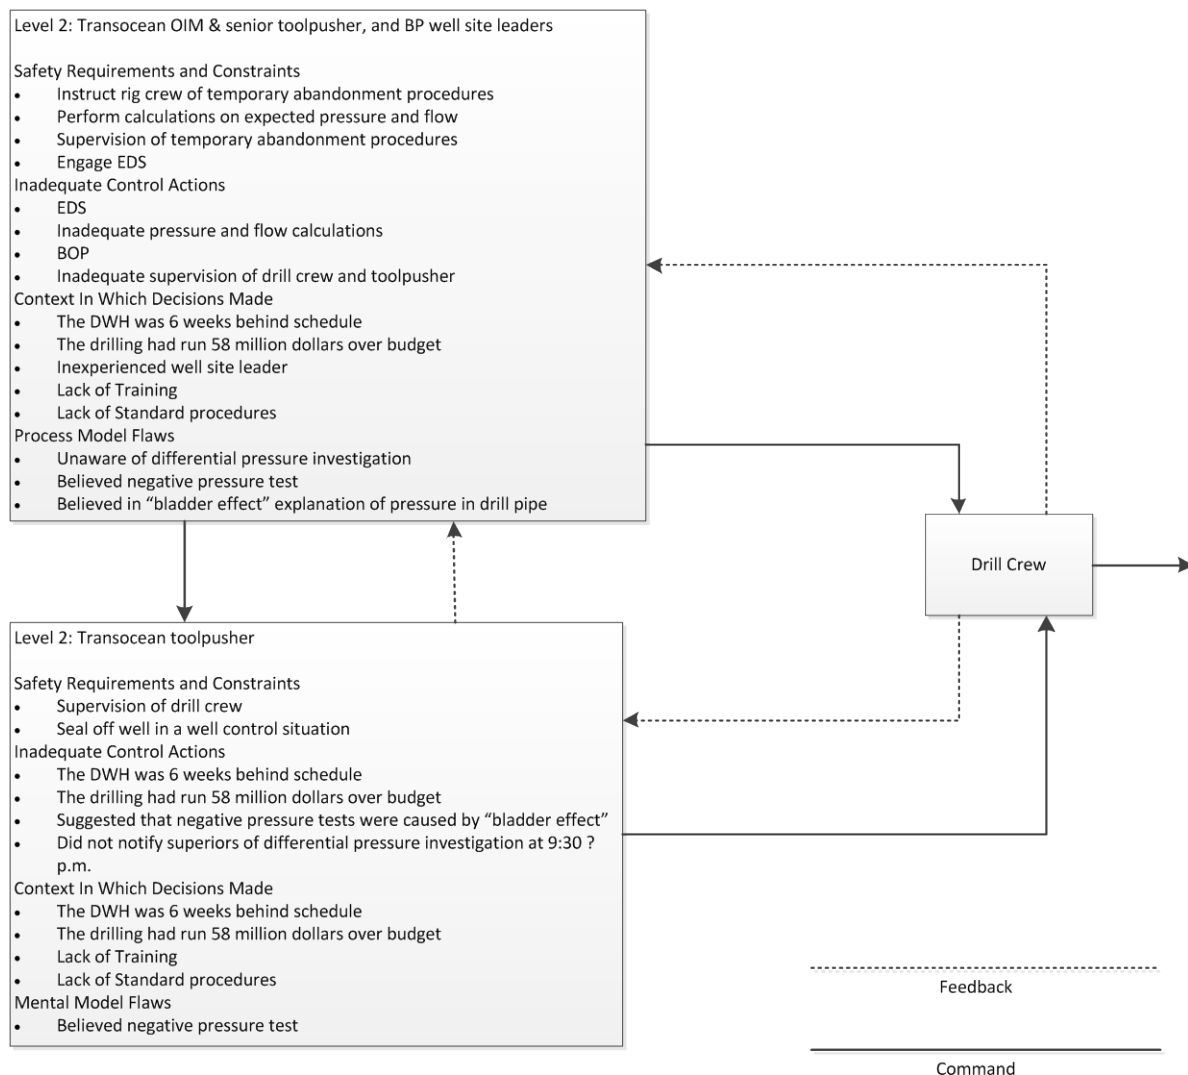
Figure 4. 3: Operations Management level analysis.

Toolpusher Anderson whom followed the driller and assistant drillers the closest during the temporary abandonment was the one who decided to stop the pumps and investigate the differential pressure at 9:30 p.m. He did however never notify any of his superiors of this investigation. As he had the chance to close the well at this point the investigators have deemed his actions severely lacking (Drilling, 2011). The events that followed, after the investigation was started, were covered in the causal analysis of the drillers.

The senior toolpusher was called at 9:45 p.m., as mud was overflowing the rig, by an assistant driller from the drill shack, claiming that toolpusher Anderson was sealing in the well, but they needed the senior toolpushers help (Drilling, 2011). According to toolpusher Anderson's statement after the accident he had activated the lower annular preventer at 9:41 p.m., but Transocean later admitted that it was the upper annular preventer that had been activated at this time. As described in the casual analysis of the lower level there where confusions as to whether or not the annular preventers were tightened or the variable bore ram was activated. The datalog however shows that at 9:47 p.m. the pressure increased dramatically to 5700 psi, which may have indicated that the well was shut in (Drilling, 2011). Despite these efforts the first explosion at 9:49 p.m. was a fact. The OIM was at the time of the first explosion in the shower unaware of the problems prior to the explosion (Drilling, 2011). After the first explosion he found his way to the bridge and ordered EDS at 9:56 p.m. (Drilling, 2011). The EDS however failed, and what followed is beyond the scope of this thesis. Figure 4.3 depicts the results from the Operations Management level.

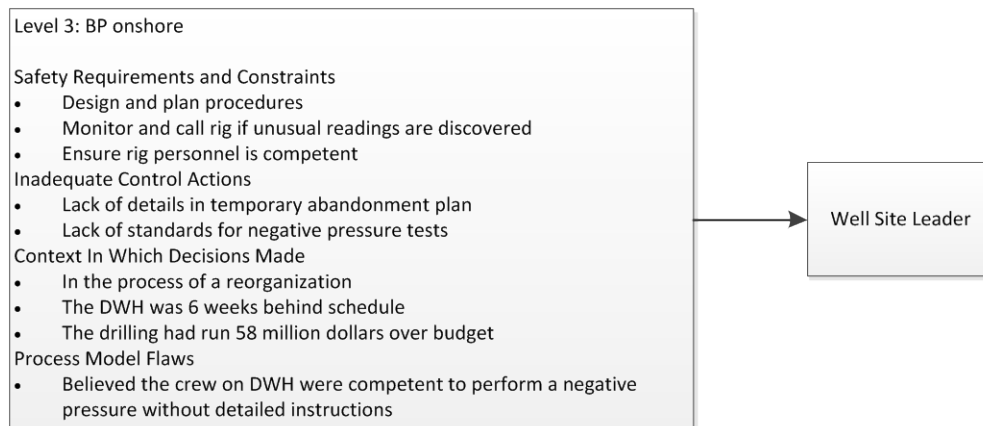
Figure 4. 5: Company level analysis.

Well site leader Vidrine talked with BP onshore at 9 p.m. which is the only record of communication between onshore and offshore personnel regarding the negative pressure test after it had been started (and finished) (Drilling, 2011). Vidrine called for information on the upcoming surface plug to be set in the well, not much of the conversations contents is known, but it is believed that Vidrine most likely did not mention any difficulties or signs of distress, since nothing was changed after this point (Drilling, 2011).

Finally an important part of BP's safety requirements at this level was to ensure that its personnel were competent enough to work with the complex tasks of deepwater drilling. Relying on well site leader Kaluza and Vidrine was clearly not good judgment of BP, during a crucial stage of the drilling operations at Macondo. Figure 4.5 represents the results from the causal analysis of the company level.

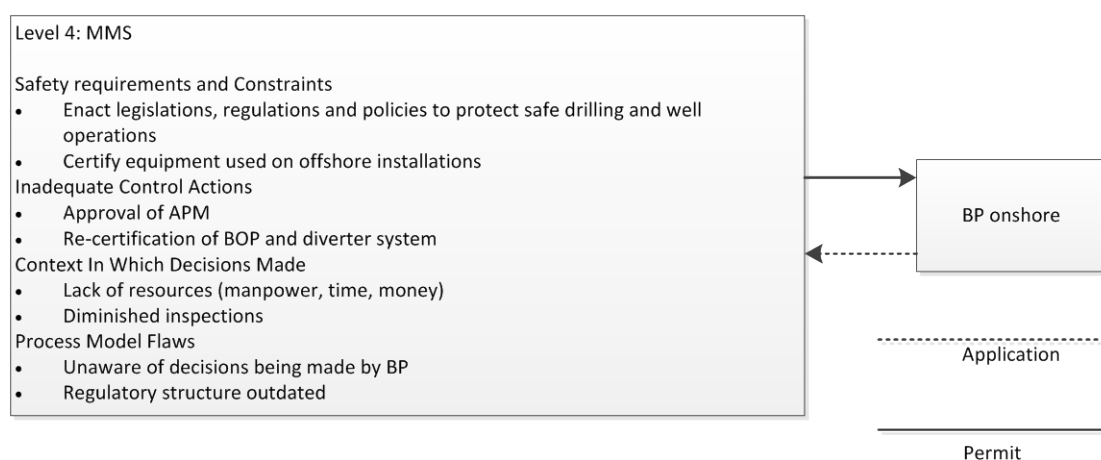
Figure 4. 6: Government regulatory agency level analysis.

Given these circumstances it was very important that MMS performed inspections and certifications which ensured that the equipment used in the drilling operations was safe. An oversight in an inspection on the DWH rig on April 1st 2010 had led MMS not to discover any noncompliance or problems that would have forced a stop in the operations on DWH (Drilling, 2011). This oversight was that neither the BOP or diverter system had been recertified since 2000 (Drilling, 2011). MMS's policies required re-certification every 3 to 5 years (Drilling, 2011). This oversight may have been critical since the BOP failed to seal the well when the well blew out. Figure 4.6 represents the government regulatory agency level, which is the highest level analyzed.

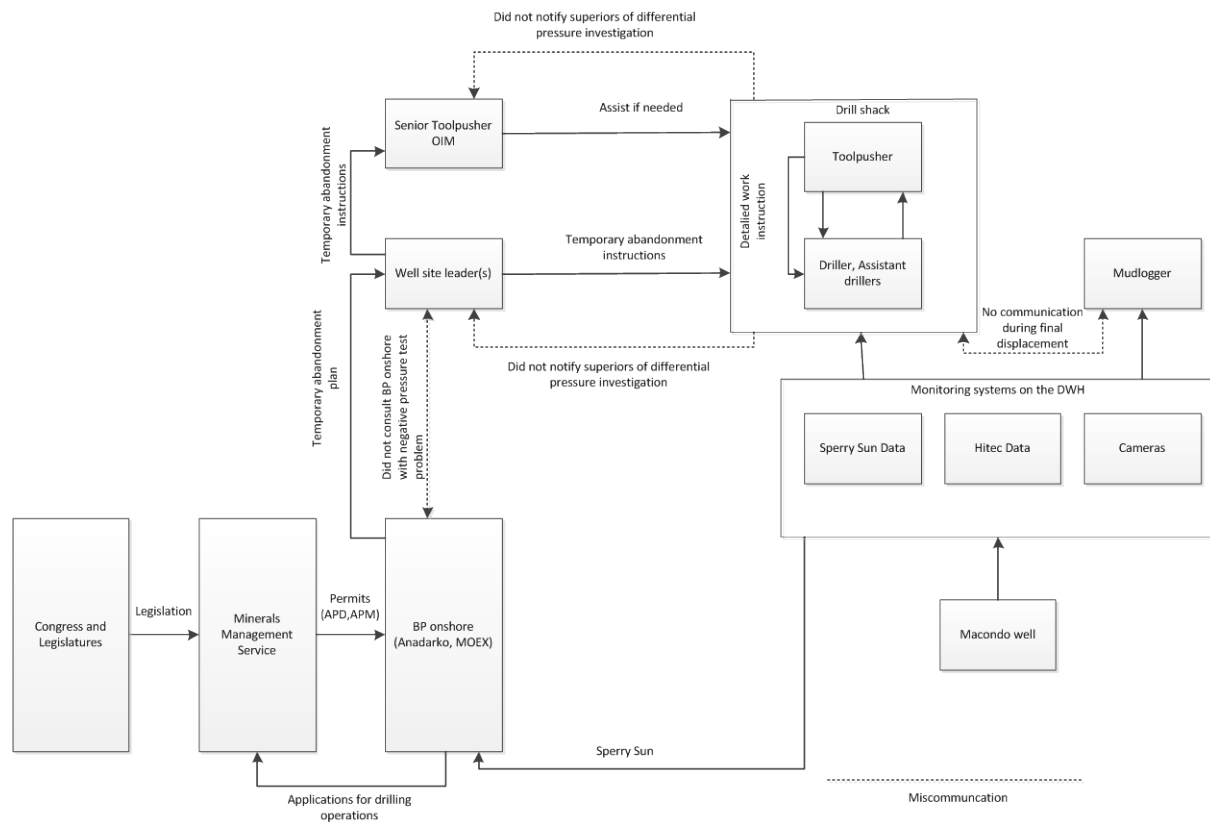
Figure 4. 7: Communication within the safety control structure at Macondo.

Step 7 is the last step of CAST used in this thesis. Here the coordination and communication between the components in the safety control structure have been assembled, based on the results from steps 5 and 6, together in Figure 4.7.

Arrows going from the top or bottom of the boxes represent communication, feedback. Arrows going into the left side of a box represents controls. Figure 4.7 focuses on the miscommunication between the parties during the temporary abandonment process, and therefore the communication arrows are limited to that.
