# FLOOD HANDLING AND EMERGENCY ACTION PLANNING FOR DAMS

By Grethe Holm Midttømme

A dissertation submitted to  
the Faculty of Engineering Science and Technology,  
the Norwegian University of Science and Technology,  
in partial fulfilment of the requirements for the degree of  
Doctor Engineer.

Trondheim, Norway, April 2002  
IVB Report B2-2002-4

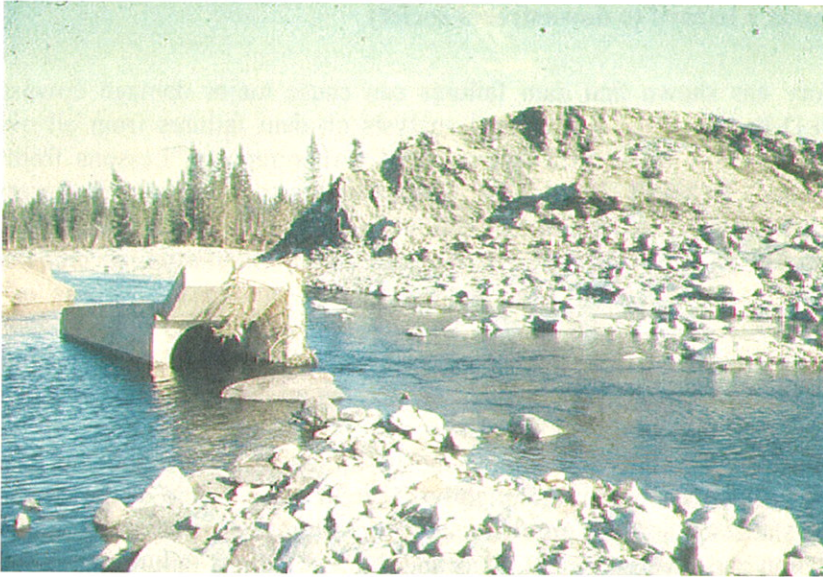
**Figure 1.2 Roppa Dam after failure (photo: Department of Hydraulic and Environmental Engineering, NTNU)**

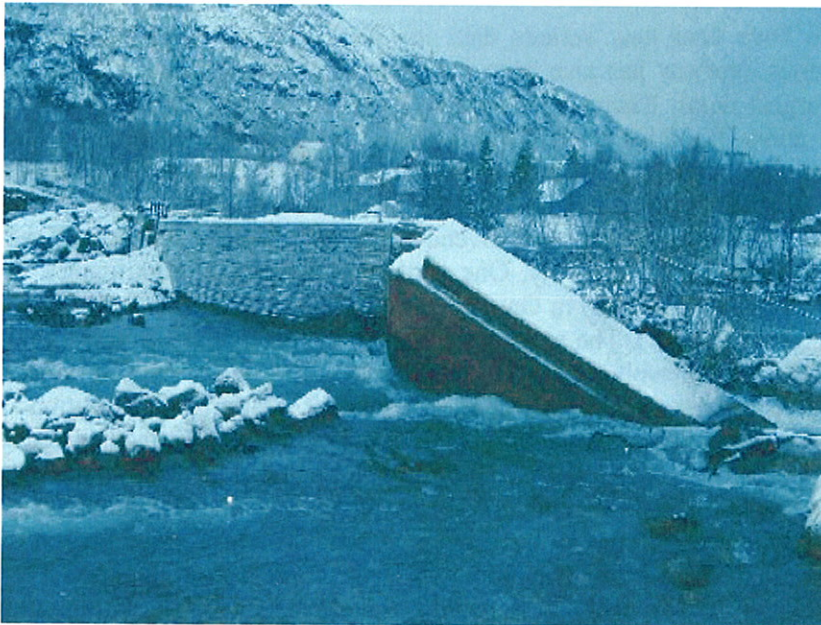
**Figure 1.3 Failure of Nervatn Dam, Blokken River, 11 January 2002 (Pedersen 2002)**

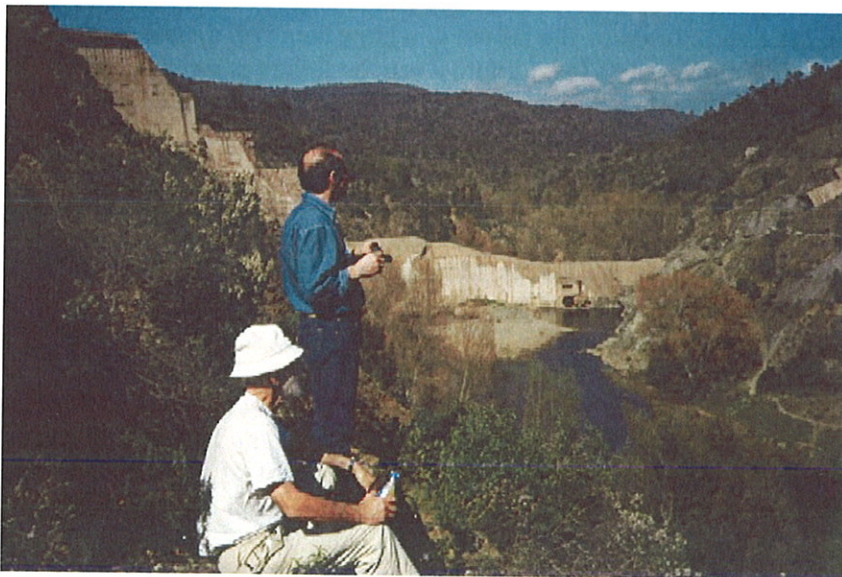
**Figure 2.2** Remnants of the Malpasset Dam, 42 years after failure (photo: R. Midttømme)

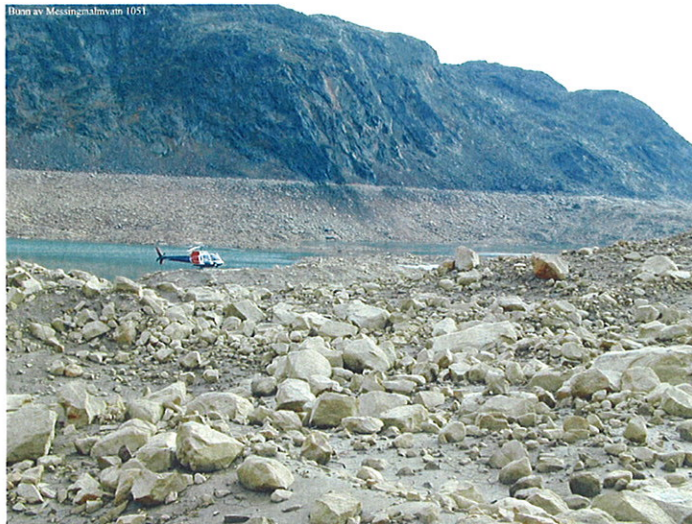
**Figure 2.9** Emptied lake after jökulhlaup at Blåmannsisen Glacier (Engeset 2001).

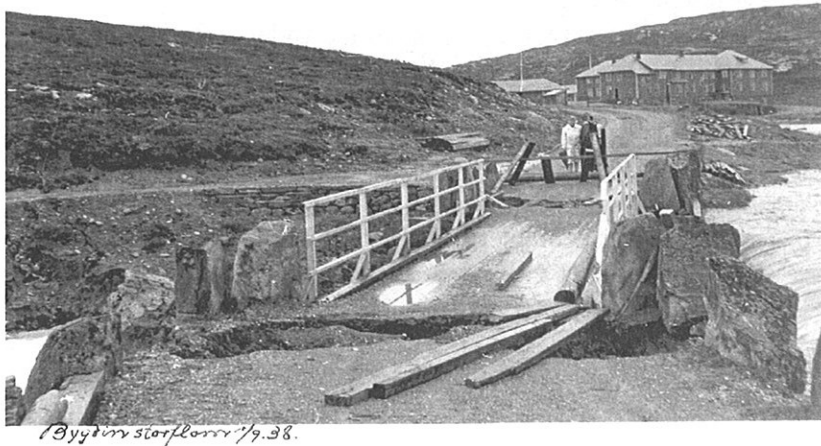
**Figure 5.8** Damage to southern road bridge downstream of Bygdin (photo: GLB)

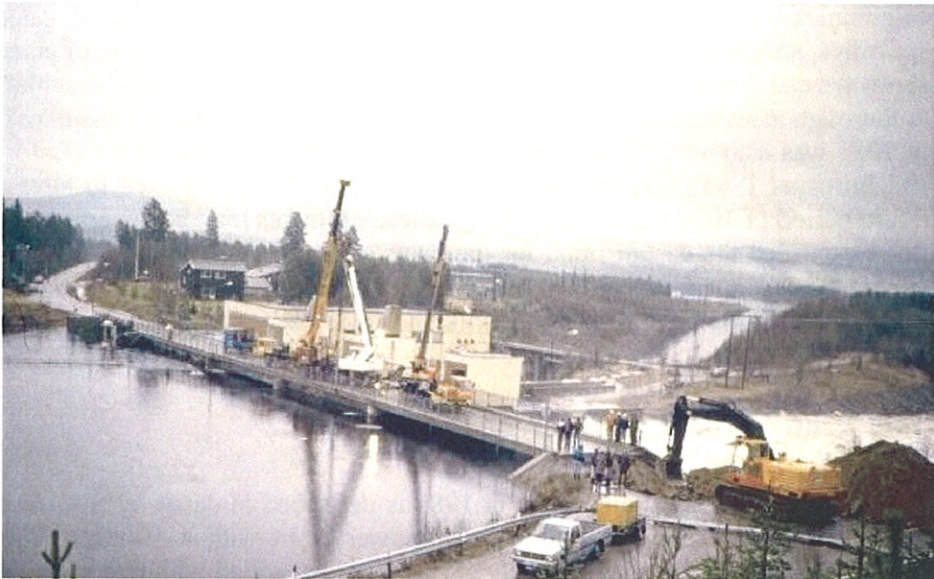
The dam owner tried to obtain mobile cranes to lift the gate, which was difficult as Friday 9 May was the day after Ascension Day, a public holiday in Norway, and many people were off work. Finally, three 20-ton mobile cranes arrived, but in the interim water had risen above the radial gate and it was not possible to fasten wires or hooks to the gates. It was concluded that controlled blasting of a part of the embankment dam would be the best option in order to minimize the effects of the flood. The army was contacted to assist in lowering the water level by controlled blasting of the crest of the western embankment (Figure 5.10).

**Figure 5.10 Preparations for blasting of western embankment during the 1986 flood at Lutufallet (photo: O.J.Olberg)**

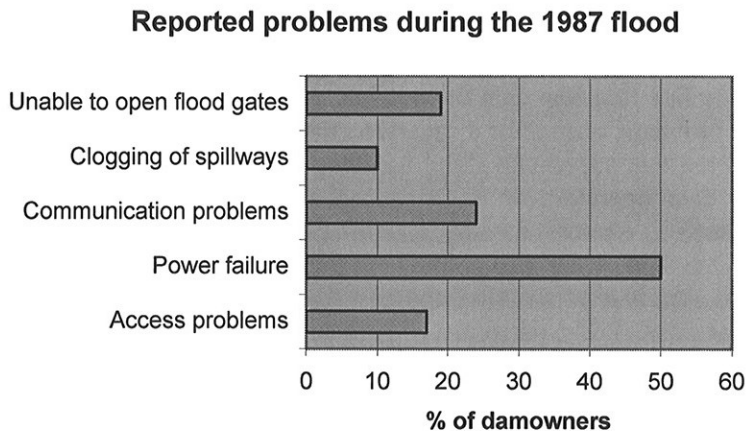
NVE made an inquiry into flood related problems after the situation had calmed down. The results from the inquiry are reported by Svendsen (1989). Sixty-four dam owners, representing 365 dams, responded to the inquiry, and an overview of typical problems encountered is given in Figure 5.12. Access roads were impassable due to inundation, erosion, fallen trees and landslides. In some cases dam owners were able to pass with 4WD cars or by driving or walking long distances along alternative routes (such as small local roads used for forestry). Power failure was caused by broken transmission lines, and in some cases, by clogging of intake trash racks causing production to stop. Major problems were avoided to a great extent due to the fact that most gated spillways were already opened. Many dam owners were also equipped with an auxiliary power supply from diesel units or had the opportunity to manually operate the gates. However, auxiliary power proved to be unreliable and manual operation of gates was slow and required a real trial of strength.

**Figure 5.12 Typical problems reported during 1987-flood**

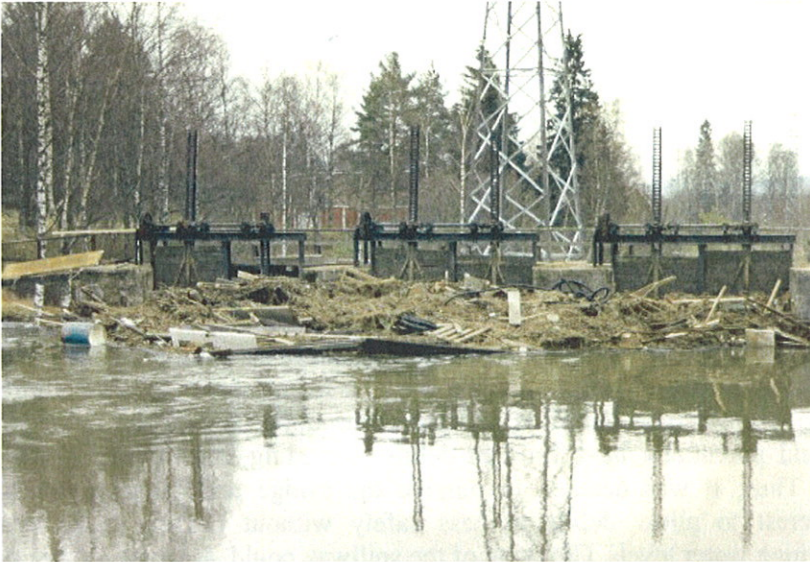
**Figure 5.13 Debris at small intake dam, 1987 (photo: V.N.Svendsen)**

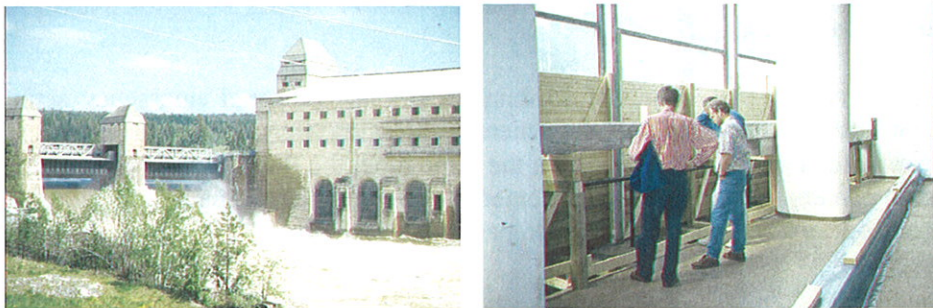
**Figure 5.16** Solbergfoss Dam and powerplant - protection of machine hall against high tailwater level, 6 June 1995,  $Q \approx 3500 \text{ m}^3/\text{s}$

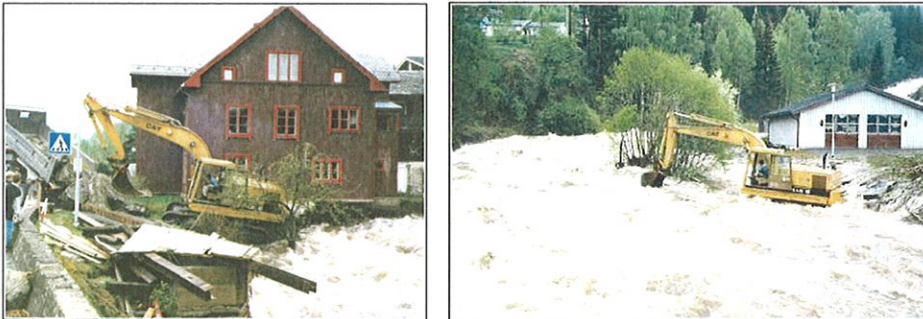
**Figure 5.19 Attempts to protect Fonstad (left) and Moksa power plant (right) on 1 June 1995 (photo: MGE)**

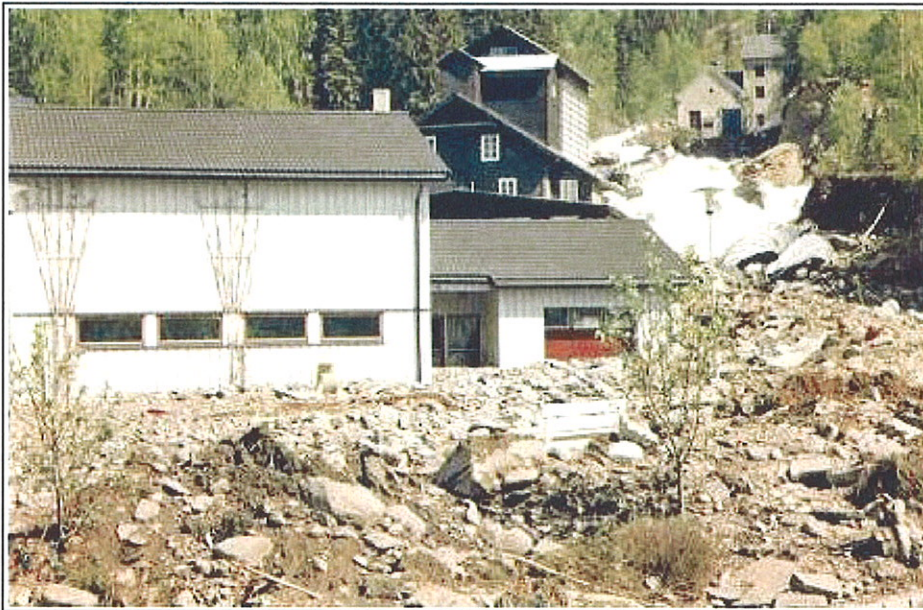
**Figure 5.20 Moksa power plant, Stavheim mill and Moksa 1, with the new river course between Stavheim and Moksa 1 (photo: MGE)**

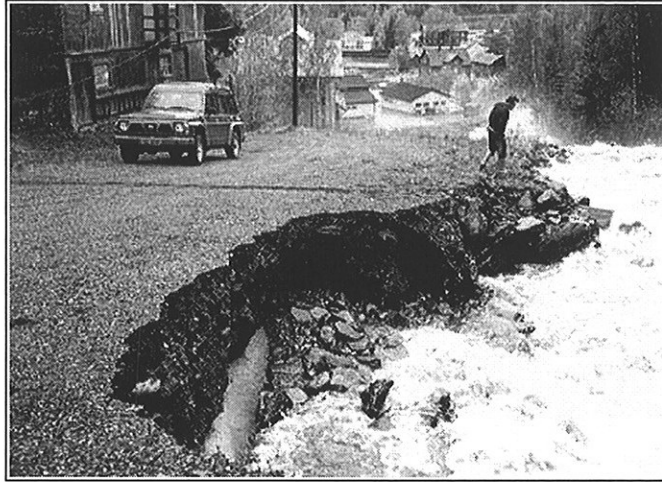
Figure B-1 The mechanical engineer inspecting the river banks close to Moksa 1 (the old power plant) on 1 June 1995 – notice erosion around the pipeline (photo: MGE)

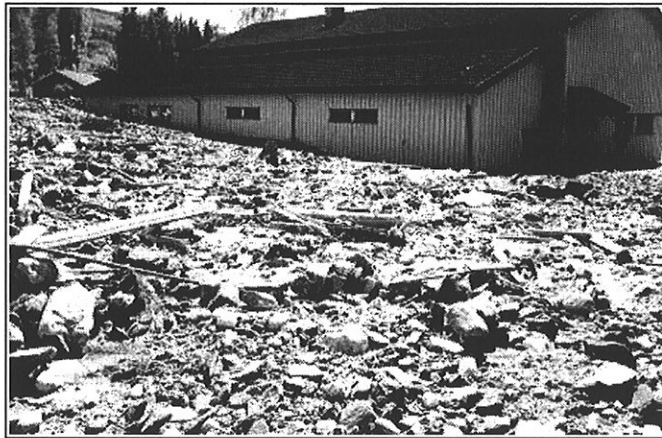
Figure B-2 Deposits upstream of Moksa power plant after the flood (photo: MGE)

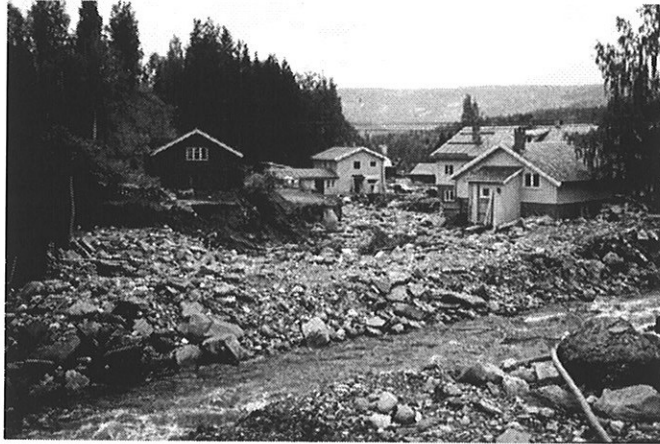
Figure B-3 Damages caused by the flood – downstream reach of the new river course

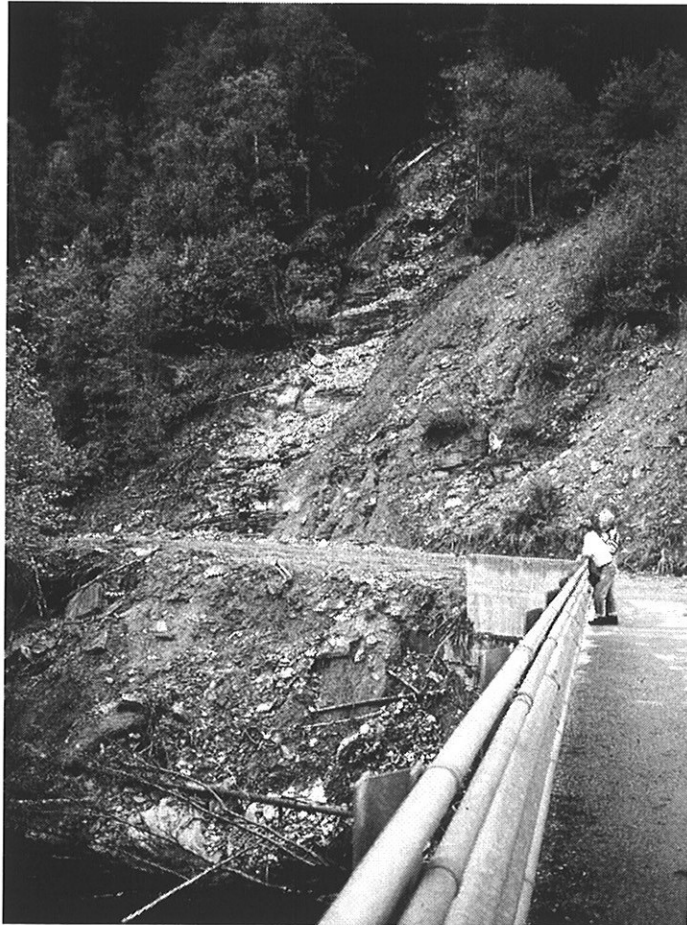
Figure B-7 Slides in the upstream end of Vinkelfallet Reservoir

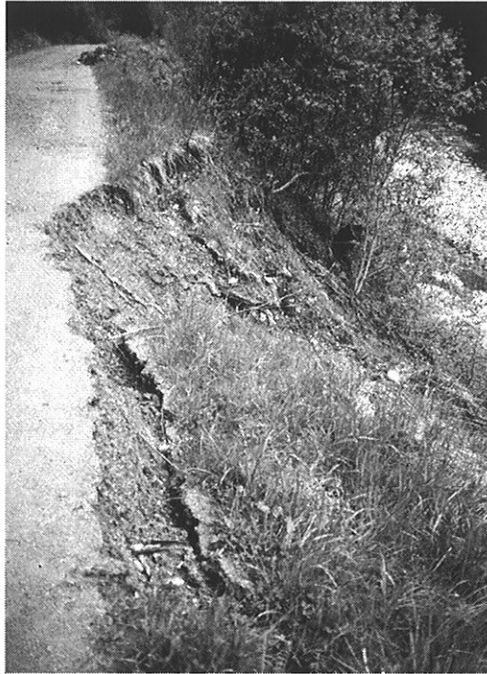
Figure B-8 Slides between the road and the reservoir at Vinkelfallet

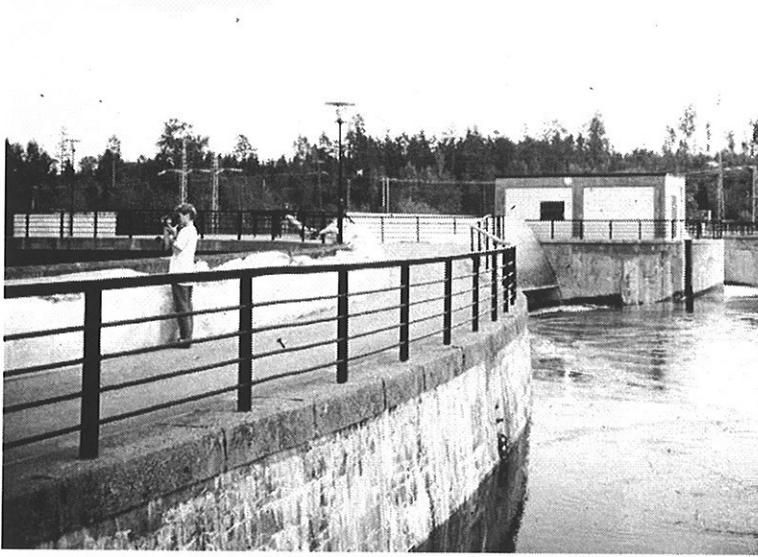
Figure B-10 Heightening of dam crest at Vamma Dam by means of sand bags (photo: H. Midttømme)

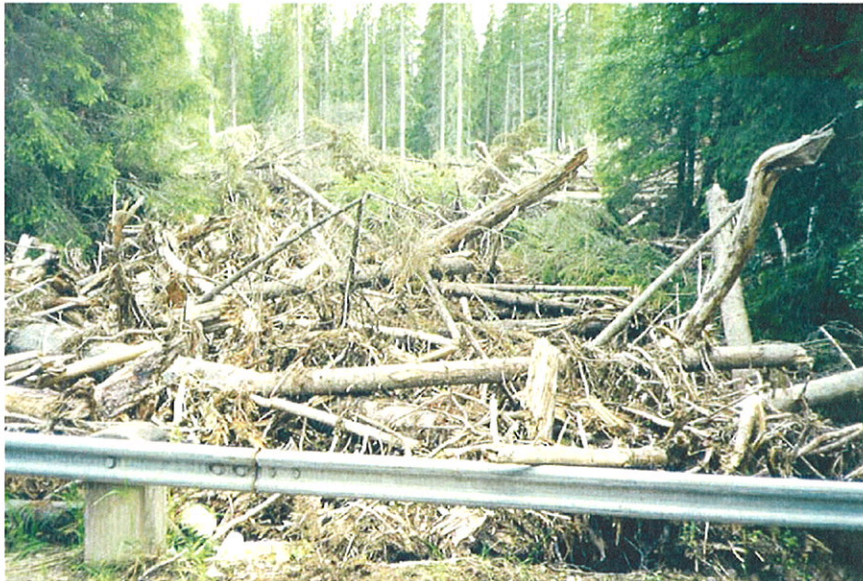
Figure C-4 Looking upstream from the Stora Göljån culvert. Accumulated debris in the old river course

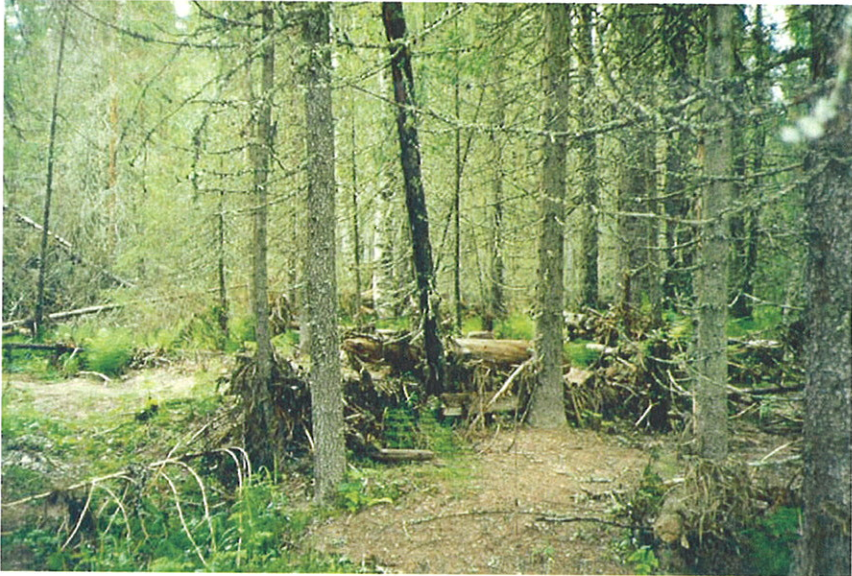
Figure C-5 Debris in the alluvial fan

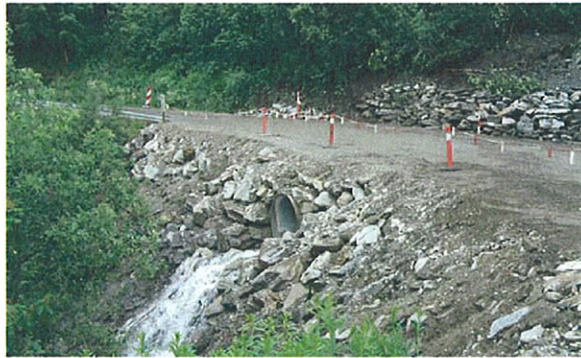
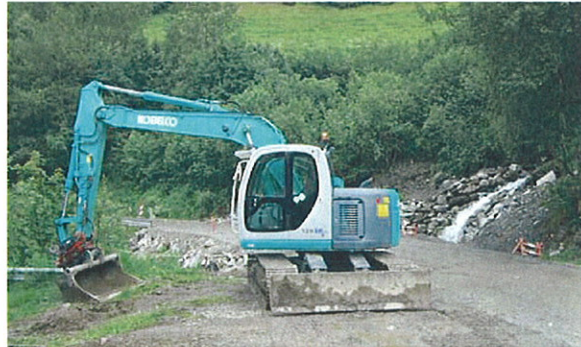
Figure D-11 Repair work on the main road from Vinstra to Skåbu (Olstappen) after erosion damage from flood in a small tributary to Vinstra River, August 2000
