Permanent effect of a cryogenic spill on fracture properties of structural steels

2015 IOP Conf. Ser.: Mater. Sci. Eng. 102 012004

H Keseler¹, I Westermann¹, S Y Kandukuri², J O Nøkleby², B Holmedal¹

Abstract. Fracture analysis of a standard construction steel platform deck, which had been exposed to a liquid nitrogen spill, showed that the brittle fracture started at a flaw in the weld as a consequence of low-temperature embrittlement and thermal stresses experienced by the material. In the present study, the permanent effect of a cryogenic spill on the fracture properties of carbon steels has been investigated. Charpy V-notch impact testing was carried out at 0 °C using specimens, from the platform deck material. The average impact energy appeared to be below requirements only for transverse specimens. No pre-existing damage was found when examining the fracture surfaces and cross sections in the scanning electron microscope. Specimens of the platform deck material and a DOMEX S355 MCD carbon steel were tensile tested immersed in liquid nitrogen. Both steels showed a considerable increase in yield- and fracture strength and a large increase in the Lüders strain compared to the

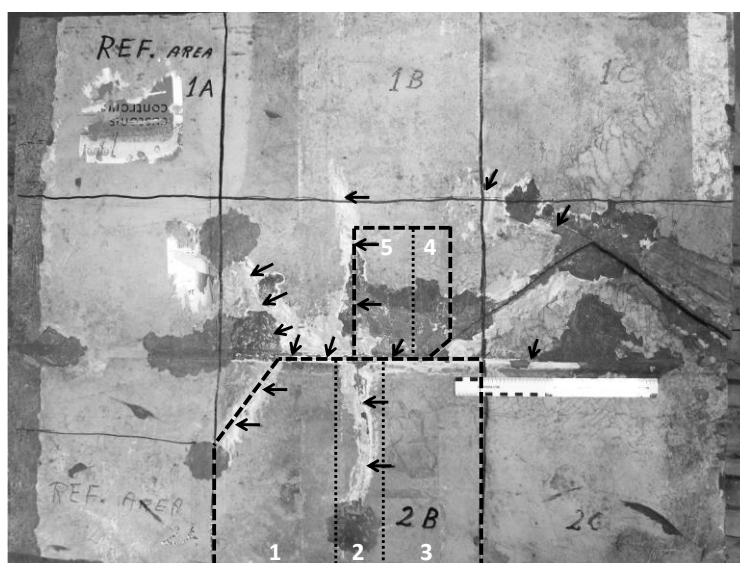
Figure 1 shows an overview of the original damaged platform material that was received by DNV in 2011. The arrows indicate the extension of the secondary cracks, which were assumed to have propagated from brittle areas and arrested when reaching more ductile material. The two plates that were used in the present study are outlined with dashed lines. These plates were further divided into smaller sections as indicated with dotted lines and numbered 1 to 5. The platform material was painted, and the paint had cracked in certain areas. This was assumed to be caused by differences in the thermal contraction between the paint and the underlying material during the liquid nitrogen exposure. The areas where the paint cracking was observed were expected to have been cooled to lower temperatures. Areas indicating cryogenic exposure will further on be referred to as exposed areas, whereas those with no paint cracking will be referred to as non-exposed.

Figure 1. An overview of the platform material received by DNV. The two pieces used in this study is highlighted with dashed lines. Further subdivision is shown with dotted lines and the pieces are marked with numbers 1-5. The arrows indicate the extension of the crack formation.

From the results of this work, it is believed that a cryogenic spill can permanently damage the fracture properties of carbon steel. Therefore, the standard repair procedure after such incidents, which is to only remove the visibly damaged material, may be insufficient. Microcracks or sulphide related damage may be present in apparently undamaged material and can reduce the impact energy in these regions.

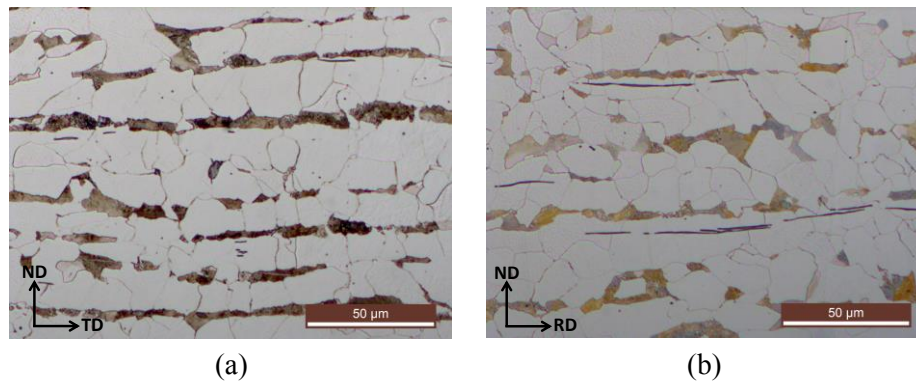
The light optical images in Figure 2 show the microstructure of the platform material. In (a) the microstructure from a non-exposed area in a plane perpendicular to the rolling direction, and (b) for a cryogenic exposed material in a plane parallel to the rolling direction. In both cases the microstructure consists of ferrite and elongated pearlite and contains long manganese sulphide inclusions elongated in the rolling direction; cf. Figure 2(b). No obvious differences between the two microstructures could be observed of the exposed and non-exposed areas of the plate.

Figure 2. The microstructure of (a) material from a non-exposed area in a plane perpendicular to the rolling direction, and (b) from cryogenic exposed material in a plane parallel to the rolling direction.

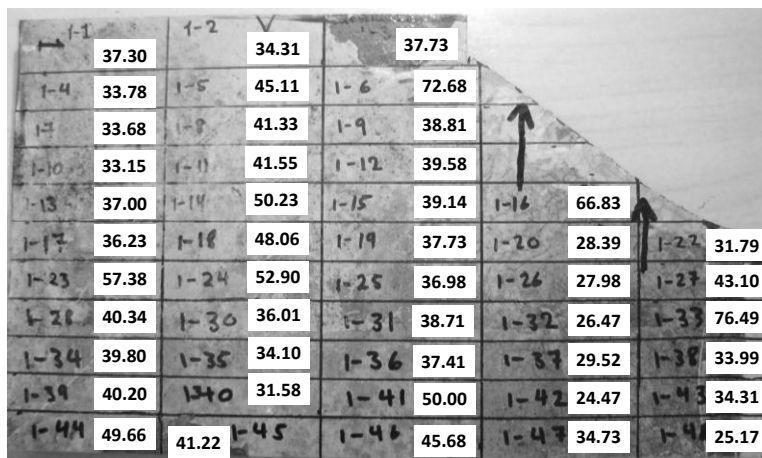
Figure 3 shows the numbering and position of the transverse Charpy specimens taken from section 1 of the plate in Figure 1. The Charpy impact energy for the given specimen is marked in the white boxes. The average value of the measured impact energies was 38.68 J. However, large variations are observed within the plate, with a maximum value of 76.49 J and a minimum of 24.47 J.

Figure 3. The sectioning of plate 1 into transverse Charpy specimens and their corresponding impact toughness values, given in Joules [J], at 0 °C.

The specified Charpy V-notch impact energy of NV E36 steel at -40 °C is 34 J in the longitudinal direction and 24 J in the transverse direction [6]. These values are given as minimum values and the real impact values of the material are expected to be significantly higher. In this work the impact test were performed at 0 °C. As a rule of thumb, the impact energy increases by 1 Joule for 1 °C increase in temperature. At 0 °C this leads to required impact energies of approximately 74 J and 64 J in the longitudinal and transverse direction, respectively. According to the standard [7] the minimum requirement should be met by the average of three test pieces. It can be accepted if one individual value is below the specified value, provided that it is not less than 70 % of this value.

The longitudinal Charpy specimens are well within the requirement, whereas the transverse specimens are far too low in impact energy. A rather large variation in impact energy is observed. The reason for this might be random variations caused by microstructural inhomogeneities through the material. However, it could also be a consequence of stress relief occurring in the region close to the main crack.

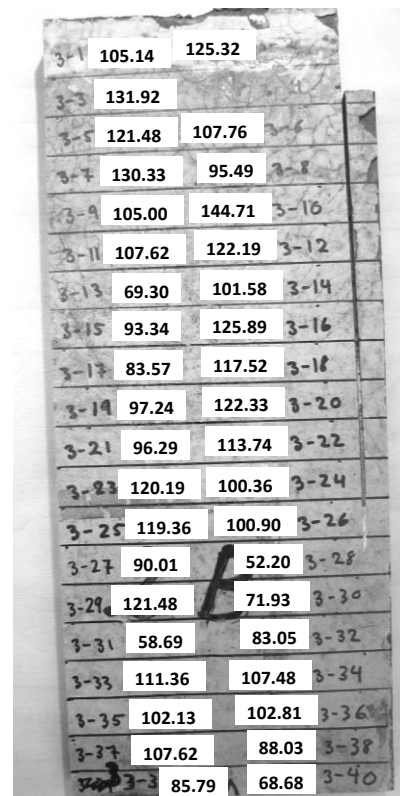
Similarly, Figure 4 shows the position and numbering of the longitudinal Charpy specimens taken from section 3, where the Charpy impact energy is marked for each specimen. In the longitudinal direction, the Charpy impact values are in general higher with an average value of 102.83 J, but also here large variations are found in the energy, ranging between 52.20 J and 144.71 J

Figure 4. The sectioning of plate 3 into longitudinal Charpy specimens and their corresponding impact toughness values, given in Joules [J], at 0 °C.

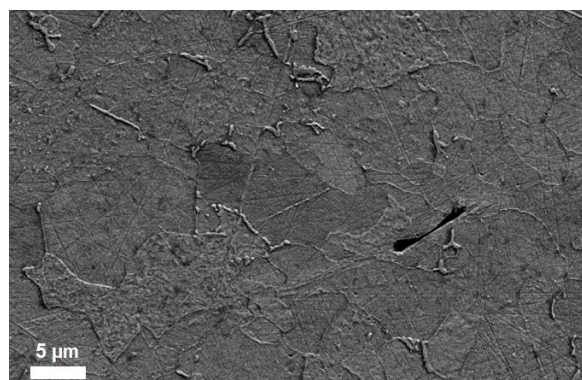
SEM investigations of the longitudinal cross section of a DOMEX S355 MCD sample that only had been exposed to liquid nitrogen at a force of 6500 N revealed a few microcracks as shown in Figure 7. Some of the cracks were located at grain boundaries, but mostly they appeared in the grain interior. For comparison the longitudinal cross section of an untreated specimen was investigated, and no microcracks were found in this material.

Figure 7. Microcracks observed in the DOMEX S355 subjected to 6500 N under cryogenic conditions.

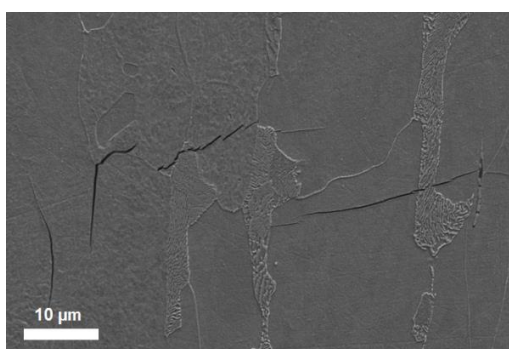
Figure 8 shows two types of microcracks that were found in the NV E36 material tested at -196°C . Figure 8(a) shows a type of microcrack which was only found at small distances from the fracture surface. These cracks were mainly oriented parallel to fracture surface. Another type of microcrack found in the longitudinal cross section is shown in Figure 8(b). These cracks were always directed along the rolling direction and are associated with elongated manganese sulphides.

Figure 8. Two types of microcracks observed in the RD-ND plane in the NV E36. (a) microcracks near the fracture surface and (b) cracks associated with MnS.

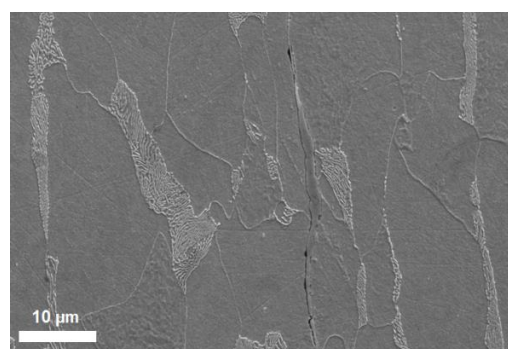
(b)

Such cracks were observed to occur through the entire test region of the tensile specimen, and the extent of these cracks could be through several ferrite grain boundaries. The reason for the formation of the sulphide related cracks is believed to be a combination of the low temperature and the high stresses in the material. Brooksbank and Andrews [8] showed that MnS inclusions have a linear thermal expansion coefficient that is higher than for steel ($18 \times 10^{-6} \text{ }^{\circ}\text{C}^{-1}$ vs. $12 \times 10^{-6} \text{ }^{\circ}\text{C}^{-1}$). This means that when the material is cooled, the MnS inclusions will contract at a higher rate than the steel. The result can be decohesion, and possibly also void formation at the inclusion-matrix interface.
