The susceptibility of grade 70 anchor chain steel to HISC

Knut Ove Dahle

Materials Technology

Submission date: July 2011

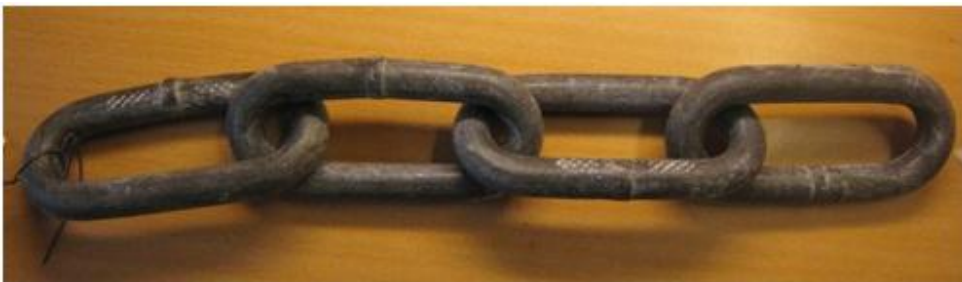
Figure 13. The link of the fractured chain steel as-delivered.

The second examined chain quality in this project work is of an unknown origin. Unknown factures include how long the chain was in use prior to failing and were it was manufactured. The rings were unmarked and had no identification numbers or marking. The chain was said to be of grade 70, the same strength class as the sandblasted chain. Unfortunately, this could not be verified by any documentation. Its microstructure, hardness and tensile curve will be tested later in this report. The impact strength of the material will be found by the charpy test. The four rings of the fractured chain link were delivered as seen in Figure 13.

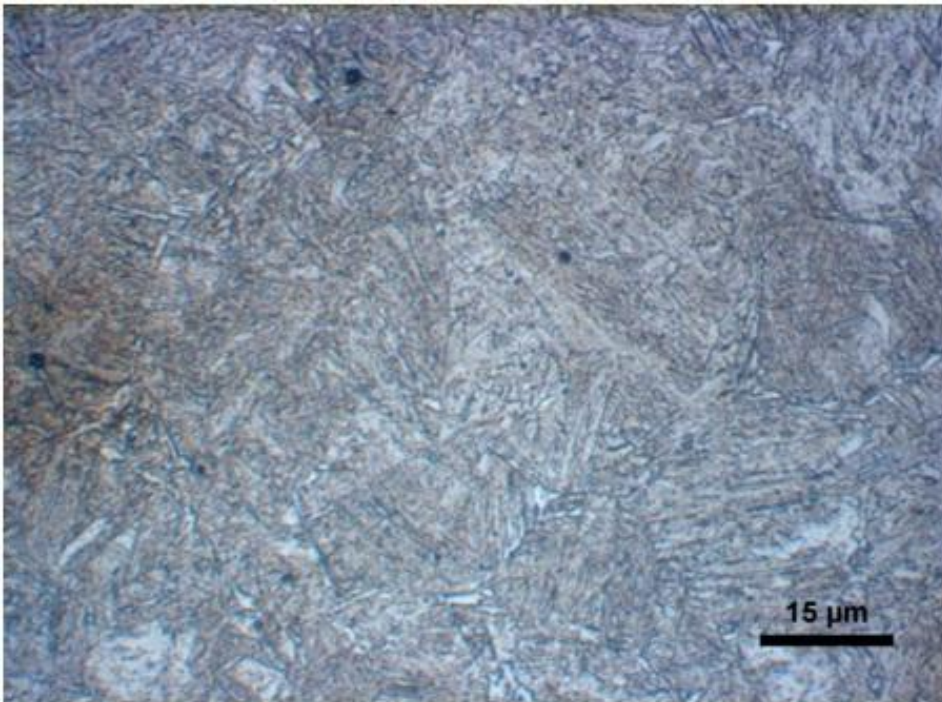
Figure 26. Microstructure of the fractured anchor chain. Magnification is given by the scale bar.

The image of the microstructure in Figure 26, from the fractured anchor chain, resembles a tempered martensite structure. Here ferrite and carbides are barely resolved. Characteristic for martensite structure is the lath or needle shapes on the surface. The image was taken from the center of the hardness sample 4.T.a.

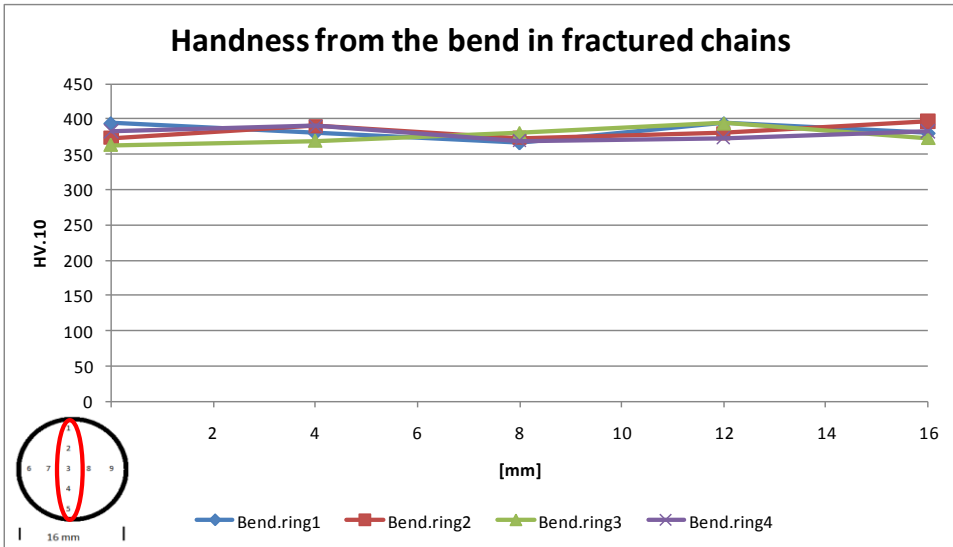
Figure 27. Longitudinal hardness profile from the bend of the fractured anchor chain.

The average hardness of fractured anchor chain was 381 ± 8 HV with 10kp load. This corresponds to an average indentation diameter of $221\mu\text{m}$. The hardness of the sandblasted chain was previously found to be 367 ± 12 HV [1].

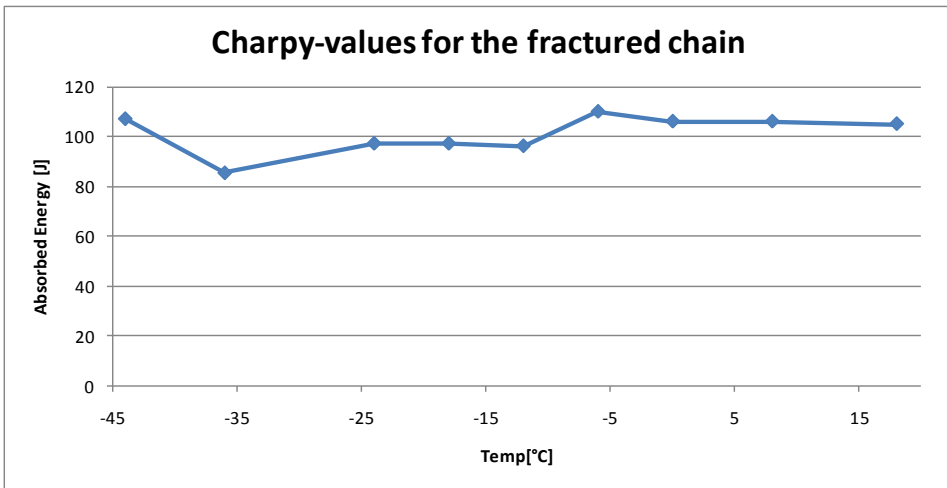
Figure 28. Charpy values for the fractured chain steel.

The impact energies for the fractured chain steel over temperature are given in Figure 28. The transition temperature between brittle and ductile fracture for the fractured chain was not found for the test temperatures used in the experiment.

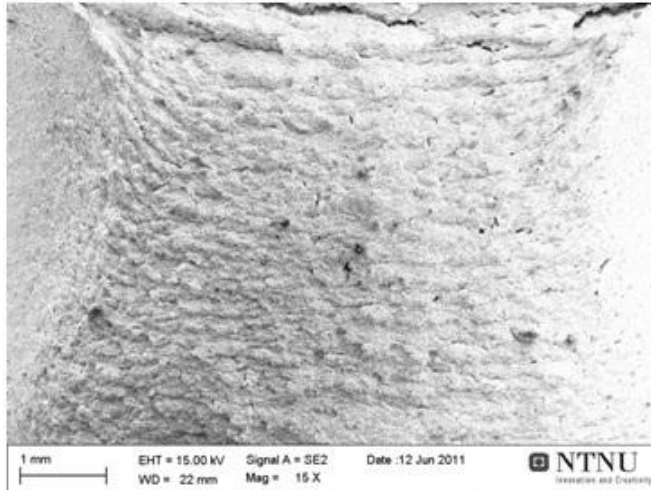
Figure 29. Fracture surface of charpy specimen 1 at 15x magnification.

Figure 29 show the fractography of charpy specimen 1 at 500x magnification. Figure 30 shows the same sample at a magnification of 1000x.

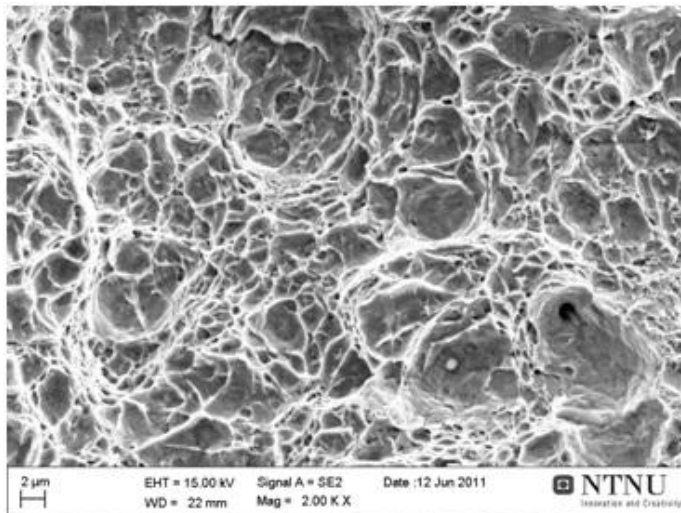
Figure 30. Fracture surface of charpy specimen 1 at 2000x magnification.

The fracture surface is marked with dimples which are a sign of a ductile fracture. Specimen 9, tested at -44°C , was also examined. Figure 31 and Figure 32 below shows the topography of the sample at 500x and 1000x magnification respectively.

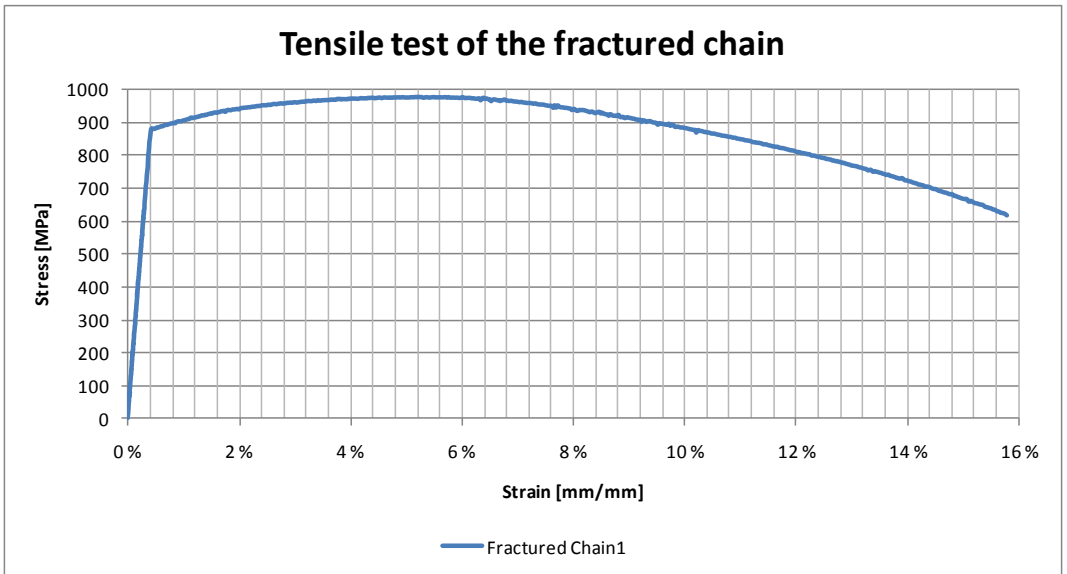
Figure 33. Stress- strain curve of the fractured chain steel.

The tensile test of the fractured chain revealed that its yield strength was 140MPa lower than that of the sandblasted chain. It was considered possible that the fracture chain were weaker than they should have been and that the reason it failed in-service was due to overload.

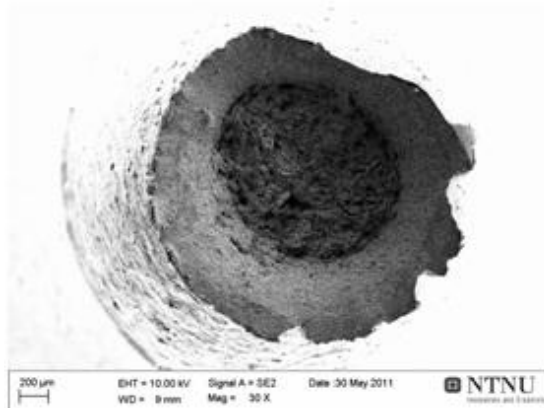
a) Macro photo of *CorTest25.s(galv)* at 30x.

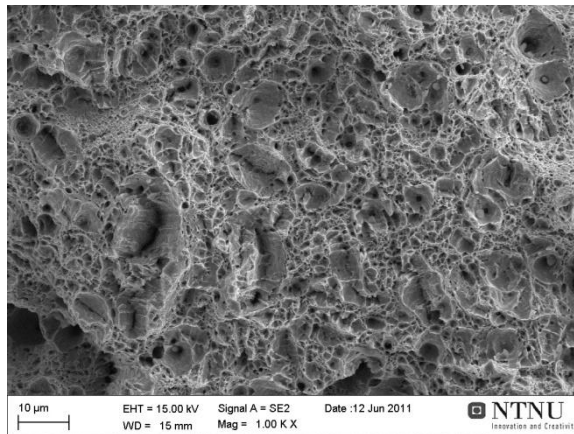
b) Center of specimen *CorTest25.s(galv)* at 1000x
