## Long-term Influence of Concrete Surface and Crack Orientation on Self-healing and Ingress in Cracks – Field Observations

This paper presents results from investigations on the long-term influence of concrete surface and crack orientation on ingress in cracks. Five reinforced concrete structures from Norway exposed to either de-icing salts or seawater have been investigated. Concrete cores were taken with and without cracks from surfaces with vertical and horizontal orientation. Carbonation in cracks was found on all de-iced structures, and a crack on a completely horizontal surface appeared to facilitate chloride ingress. Ingress of substances from seawater was found in all cracks from marine exposure. However, the impact of cracks on chloride ingress was unclear. Horizontal cracks on vertical surfaces appeared to facilitate self-healing.

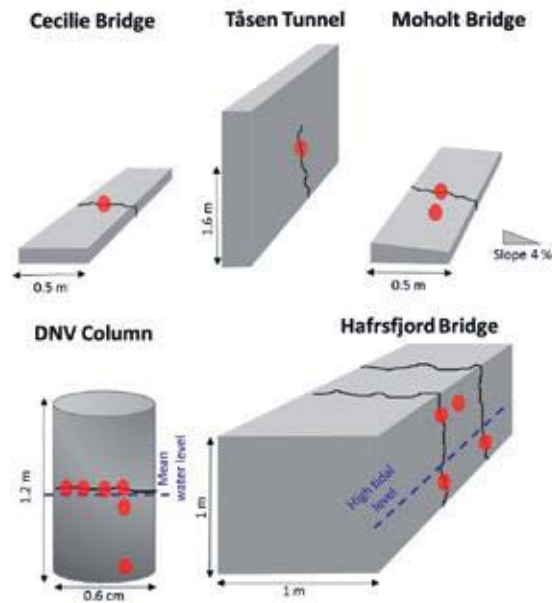
Figure 2 illustrates the investigated structural parts showing the different orientation of the investigated concrete surfaces and the orientation of the investigated cracks. The red circles indicate locations of coring. Concrete cores were taken from horizontal and vertical surfaces. The edge beam from Cecilie Bridge was the only completely horizontal surface of all investigated structural parts. The edge beam from Moholt Bridge had a slope of about 4 %. From Tåsen Tunnel, the DNV column and the foundation of Hafrsfjord Bridge, cores were taken on vertical surfaces.

Figure 2 - Illustration of the investigated structural parts showing the concrete surface and crack orientation. Locations where cores were taken are illustrated in red.

While the Tåsen Tunnel and Hafrsfjord Bridge had vertical cracks, the DNV column had a crack with horizontal orientation. Except for the DNV column, it is expected that the investigated cracks are due to early drying shrinkage or thermal restraint. The investigated crack from the DNV column derives from dynamic loading [15]. None of the structures allowed cores to be taken from different surfaces or crack orientations.

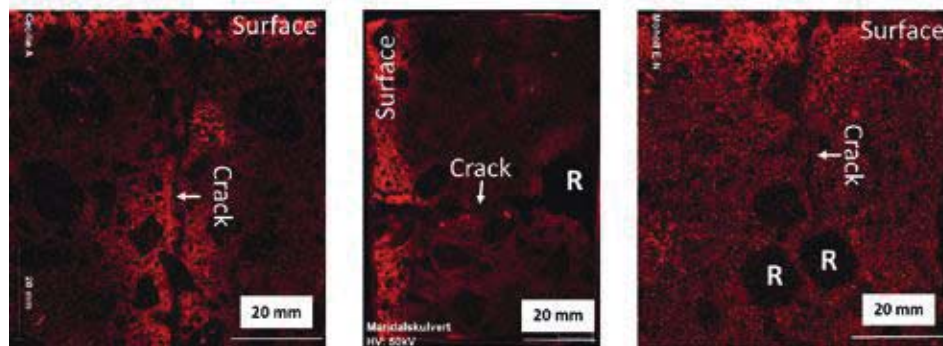
Figure 3 shows the  $\mu$ -XRF chlorine maps of concrete cores taken from Cecilie Bridge, Tåsen Tunnel and Moholt Bridge. The surface crack width of the cracks was 0.45 mm for Cecilie Bridge and Tåsen Tunnel and 0.55 mm for Moholt Bridge. Figure 3 (left) shows the chloride ingress in the cracked concrete core from Cecilie Bridge. An even chloride ingress over the whole width of the concrete core is visible within the first 10 mm. Besides that, chloride ingress is visible along the crack. Chloride ingress from the crack surface into the concrete was observed over the full length of the core, i.e. 100 mm. In contrast to this, the concrete cores from Tåsen Tunnel (Figure 3 middle) and Moholt Bridge (Figure 3 right) did not show an impact of the crack on the chloride ingress.

In the core from Tåsen Tunnel, somewhat higher chlorine intensities were observed around the steel-concrete interface compared to the bulk of the concrete. A possible explanation could be micro-cracking in the steel-concrete interface facilitating the accumulation of chloride. The surface crack width was similar in the core from Cecilie Bridge and Tåsen Tunnel. However, the core from Cecilie Bridge was taken from a horizontal surface, while a crack from a vertical surface was investigated in Tåsen Tunnel. The time of direct exposure is generally longer on a horizontal surface, which can explain the higher ingress into the crack observed in Cecilie Bridge.

In the core from the Moholt Bridge, there seems to be a very low level of chloride ingress in the concrete surface. The measured intensities in the surface near region are not much higher than in

In cores drilled above reinforcement from Moholt Bridge and Tåsen Tunnel general corrosion was found on the surface of the steel in contact with carbonated concrete. However, the extent of corrosion was limited. Carbonation in cracks was observed in all cores taken from de-iced structures regardless of the surface crack width. Figure 4 shows the corrosion imprint in the steel-concrete interface, general corrosion on the reinforcement and the carbonation of the crack surface from the concrete core taken from Moholt Bridge. The example shown is from the concrete core with limited chloride ingress presented in Figure 3 (right).

Figure 3 -  $\mu$ -XRF chlorine maps of concrete cores from de-iced structures. Left: Core C\_0.45D from the Cecilie Bridge; Middle: Core T\_0.45D from the Tåsen Tunnel; Right: Core M\_0.55D from the Moholt Bridge. The orientation of the cores represents the surface orientation in the field. R = reinforcement

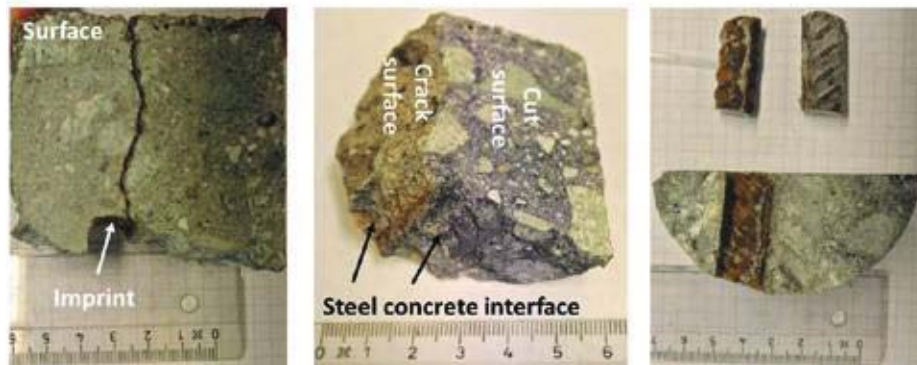
Figure 4 - Concrete core M\_0.55D from the Moholt Bridge. Left: Cut concrete core; Middle: Carbonated crack surface and steel-concrete interface of the corroded rebar Right: General corrosion on the upper surface of the reinforcement and corrosion imprint in the steel-concrete interface for the reinforcement beneath the crack.

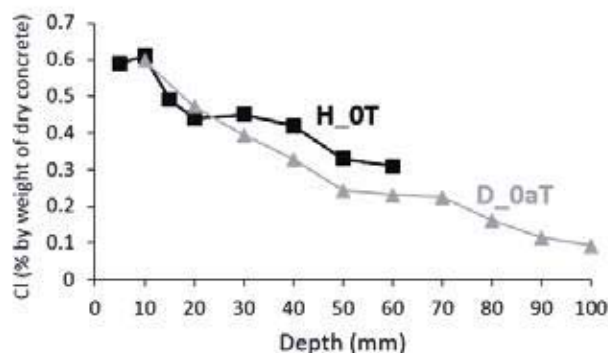
For the marine exposed structures, quantitative chloride profiles of reference cores without crack were taken.  $\mu$ -XRF mapping was performed on concrete cores with and without cracks. Figure 5 shows the chloride profiles of a core from the 33-year-old DNV column (D\_0aT) and the 50-year-old Hafstrsford Bridge (H\_0T). The chloride profiles look similar with about 0.6 % Cl by weight of concrete in the outer 10 mm of the concrete cores.

Figure 5 - Quantitative chloride profiles of cores H\_0T and D\_0aT from Hafstrsford Bridge and the DNV column, respectively. Both cores were without crack and from the tidal zone.

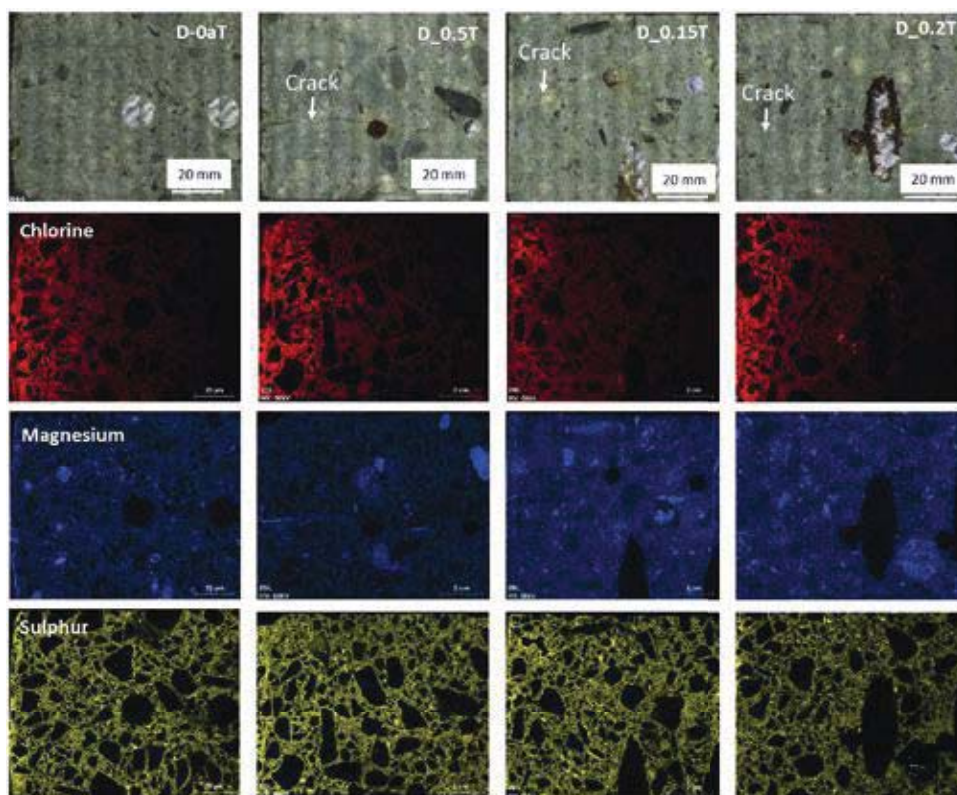
Figure 6 shows the chlorine, magnesium and sulphur maps of four concrete cores from the DNV column. The first core to the left is the reference core with no crack. All four concrete cores show an even chloride ingress from the concrete surfaces. Compared to the reference core there is no apparent deeper chloride ingress in the cracked cores. In the crack of core D\_0.5T, magnesium is visible within the first 20 mm. In cores D\_0.15T and D\_0.2T, the cracks are difficult to see due their small size and the extensive self-healing observed in these cracks. Magnesium and calcium rich products were found in all cracks, which is typical for self-healing of concrete exposed to seawater [9, 11]. Right after cutting and after cleaning the reinforcement with acid, no corrosion was observed. During storage, corrosion developed on the cut steel surfaces in the concrete cores. Corrosion was especially observed on the outer reinforcement, which can be explained by a higher chloride content in this area. Further details on the investigations performed on the DNV column are given in [14].

Figure 6 - Chlorine, magnesium and sulphur maps from cores from the DNV column. **Left:** Core D\_0aT without crack from the tidal zone; **Middle left:** Core D\_0.5T, surface crack width 0.5 mm; **Middle right:** Core D\_0.15, surface crack width 0.15 mm; **Right:** Core D\_0.2, surface crack width 0.2 mm. The cracked concrete cores were located about 0.2 m higher than the reference concrete core without crack. The indicated cracks are partly healed.

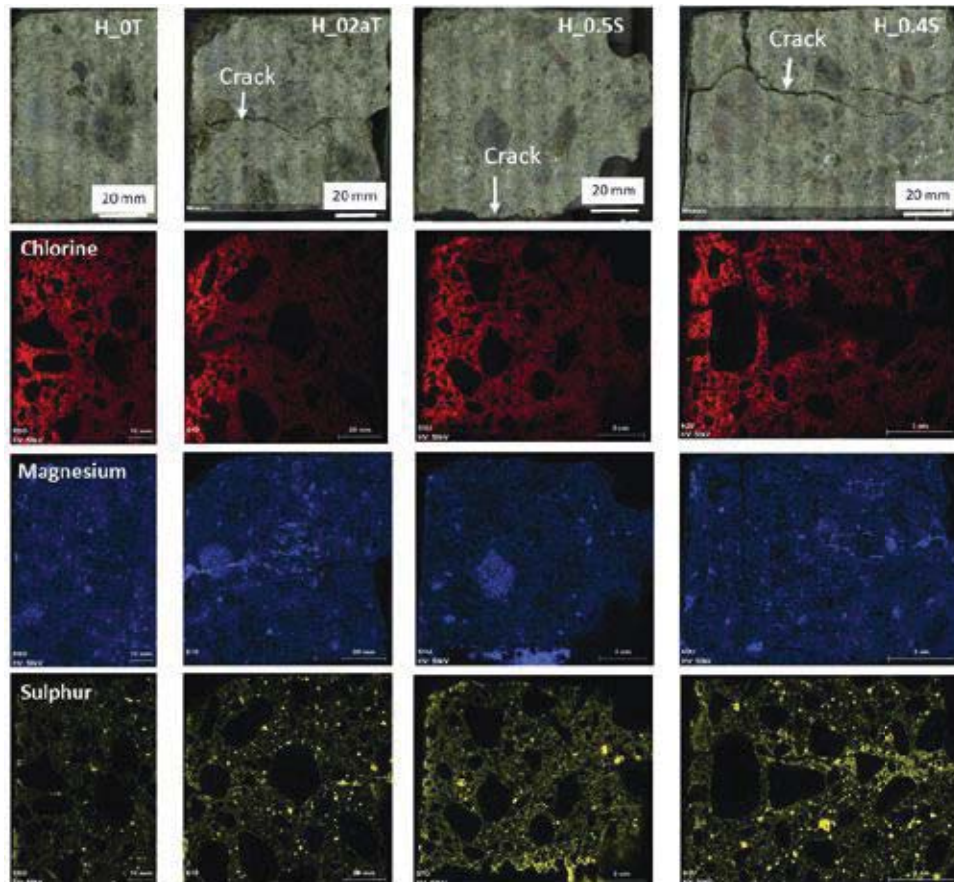
Figure 7 shows the chlorine, magnesium and sulphur maps of four concrete cores from Hafslund Bridge from the tidal and splash zone. The first core to the left is the reference core with no crack. In the field, it was observed that the crack mouth was sealed in the tidal zone. The same cracks but higher up (splash zone) had an open crack mouth. When the concrete cores were extracted, the crack surfaces did not show signs of self-healing, independently of exposure. Most cores fell apart along the crack surface and had to be taped together for  $\mu$ -XRF analysis. The cracks of the concrete cores shown in Figure 7 appear therefore larger than the original size. The sealing of the crack mouths in the tidal zone might be explained by leaching from the cement paste followed by precipitation. Although, no self-healing was observed, magnesium precipitation on the crack surfaces was detected with  $\mu$ -XRF in all cores. Furthermore, ingress of sulphate through the cracks is clearly visible from the sulphate maps. While magnesium seems to precipitate on the crack surfaces, sulphur appears to diffuse into the concrete. Magnesium and sulphate were detected as deep as 100 mm in core H\_0.4S. The very light spots in the sulphur maps are pores, and are also visible in the calcium mapping. This could be explained by potential precipitation of gypsum on the pore walls. Despite, the clear ingress of seawater into the cracks, an impact of the cracks on chloride ingress was not detectable.

Figure 7 - Chlorine, magnesium and sulphur maps from cores from the Hafrsfjord Bridge. **Left:** Core H\_0T without crack from the tidal zone; **Middle left:** Core H\_0.2aT, surface crack width 0.2 mm, from the tidal zone at the same height as core H\_0T; **Middle right:** Core H\_0.5S, surface crack width 0.5 mm from the splash zone; **Right:** Core H\_0.4S, surface crack width 0.4 mm, from the splash zone.

Two cores from Hafrsfjord Bridge (H\_0T and H\_0.5S) were drilled through reinforcement, one off crack and one on crack. Both the uncracked reference core (H\_0T) and the cracked core (H\_0.5S) did not show signs of reinforcement corrosion. Compared to the other investigated structures, the cover depth at the foundations of Hafrsfjord Bridge was higher with about 90 mm.

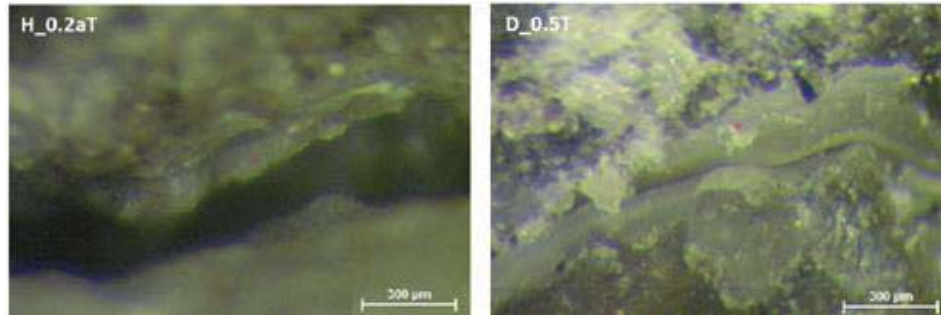
As mentioned before, magnesium precipitation was observed inside cracks for both, the DNV column and Hafrsfjord Bridge. However, self-healing was only observed in cores taken from the DNV column. Figure 8 shows a close up picture of the crack in core H\_0.2aT from Hafrsfjord Bridge and core D\_0.5T from the DNV column. In core H\_0.2aT we can see an open crack with some precipitation on the crack surface. In core D\_0.5T we can see a layer of products closing the crack. In both cases, the phases were rich in calcium and magnesium.

Figure 8 - Left: Open, not self-healed crack of core H\_0.2aT from the Hafrsfjord Bridge; Right: Closed, self-healed crack of core D\_0.5T from the DNV column.

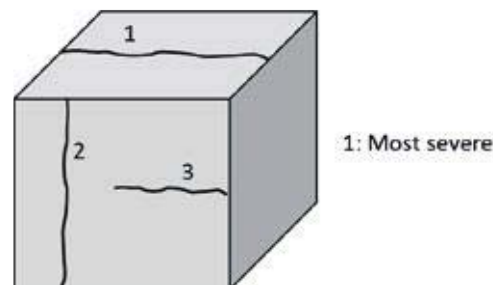
Figure 9 illustrates the observed long-term influence of concrete surface and crack orientation on ingress in cracks. A crack on a horizontal top surface (1) appears to represent the most severe condition with regard to ingress. This supports the guidelines given in the *fib* model code for service life design (MC-SLD) [3]. A crack on a vertical surface is less severe. The potential for self-healing of a crack in marine exposure seems to be facilitated with a horizontal crack, i.e. vertical cracks (2) appears more severe than horizontal cracks (3).

Figure 9 - Illustration of the observed long-term influence of concrete surface and crack orientation on ingress in cracks.
