Long-term performance of cathodic protection (CP) of marine bridge, inspection of Sortlandsbrua 27 years after CP installation

An investigation of performance and damages on the installation.

Master's thesis in Experience-based Part-time Master programme Road and Railway Engineering
Supervisor: Mette Rica Geiker
May 2019

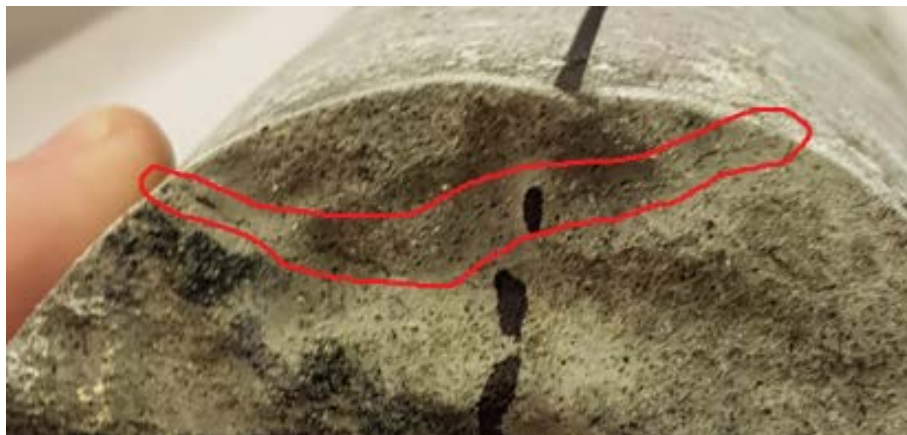
Figure 4-15 Core M6 with a crack

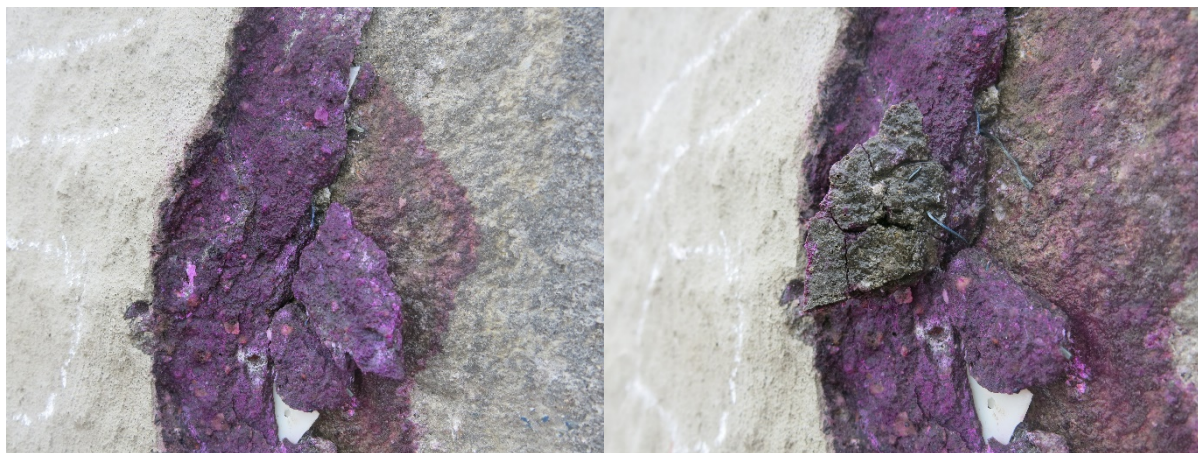
Figure 5-2 Delaminated area sprayed with phenolphthalein.

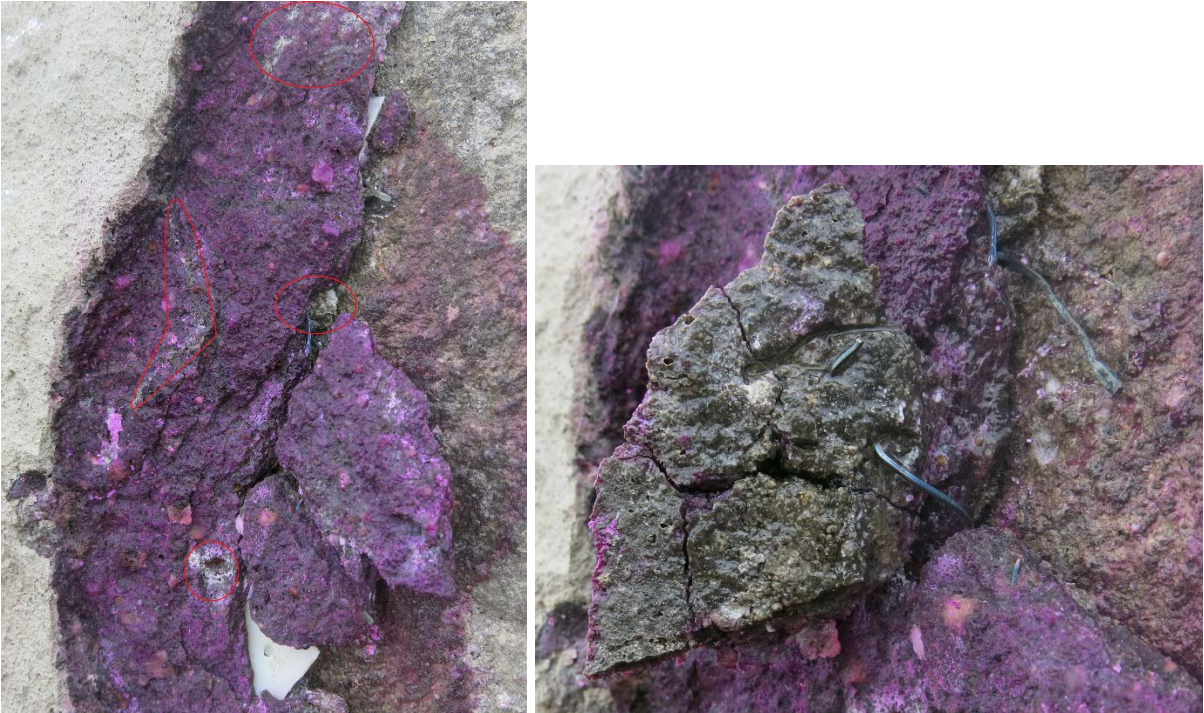
Figure 5-3 Highlighted acidic areas of the mortar from the freshly broken surface.

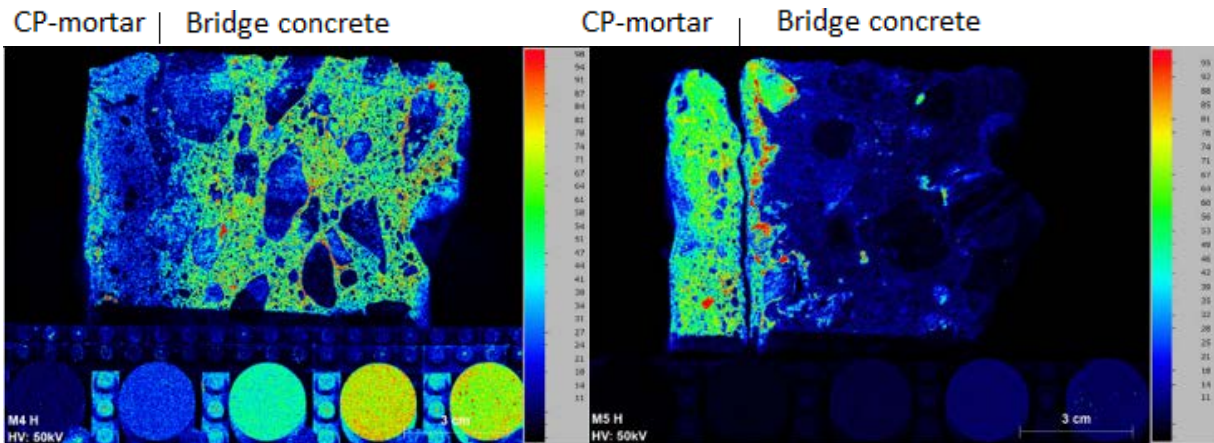
Figure 5-16 Core M4 and M5 with different levels of chloride ingress

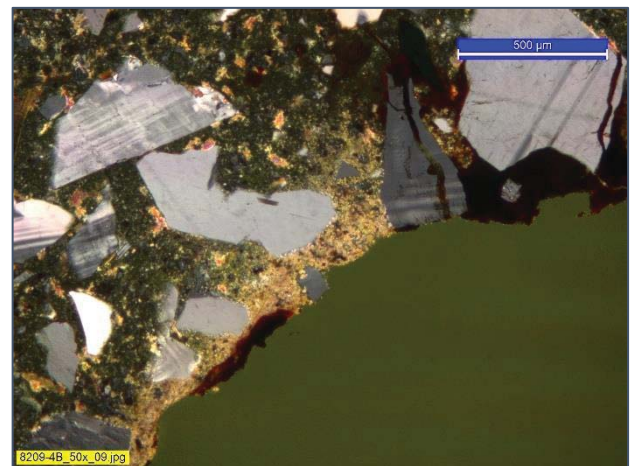
Bottom of section -B with rust lining imprint after rebar. Carbonated paste is seen along the imprint as well as along the fracture zone.

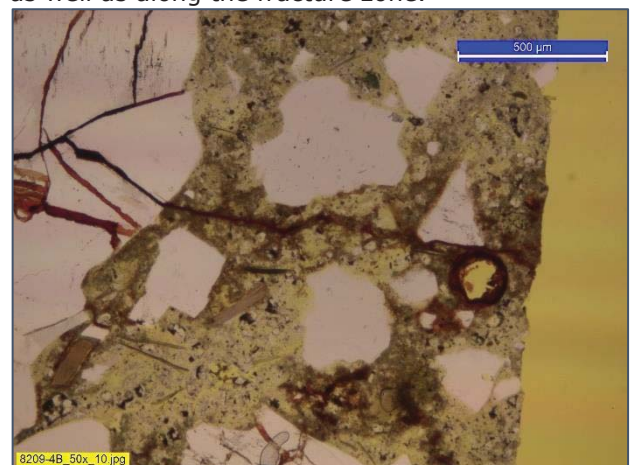
Cracks close to the rebar is more or less filled with rust. The paste in this area appears somewhat leached.

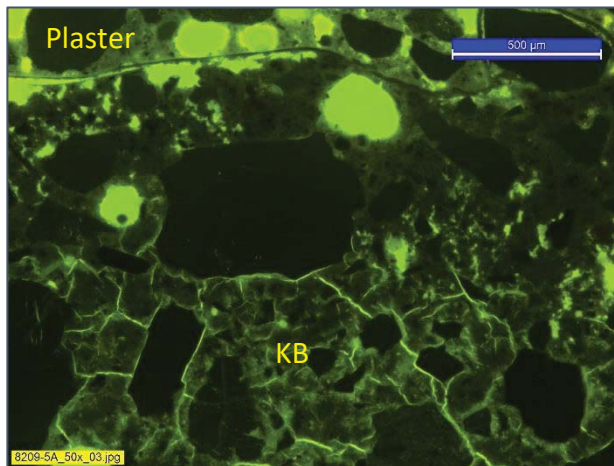
Interface between relative porous plaster and dense KB mortar. The KB paste contains a very high number of micro-cracks. Surface is dense.

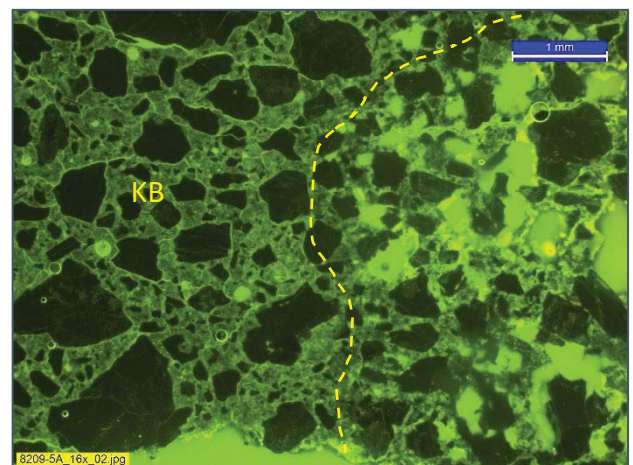
Porous area in the KB mortar (to the right), positioned near an anode. The dense paste is cracked.

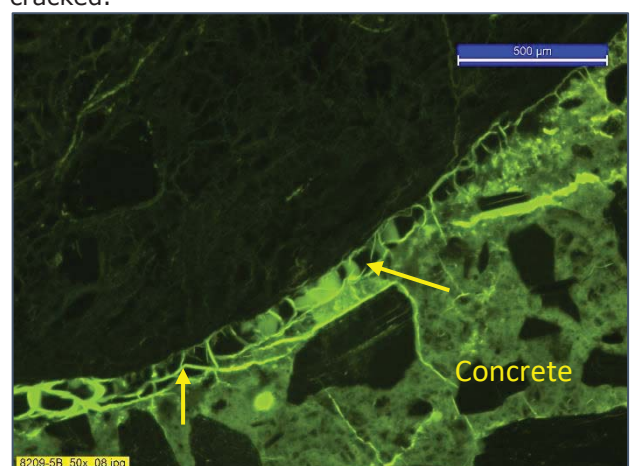
Several cracks near an corroded rebar in the bottom of the core is filled with alkali silica gel. Her gel is present around an gneissic aggregate.
