Comparative analysis of protective coating on Scandinavian road bridges

Bachelor's project in FTHINGMAT and FTHINGOG

May 2020

Group IMA-B-13
Karsten Tranborg Eriksen
Henrik Rødal Ler
Kristian Ringheim Moe

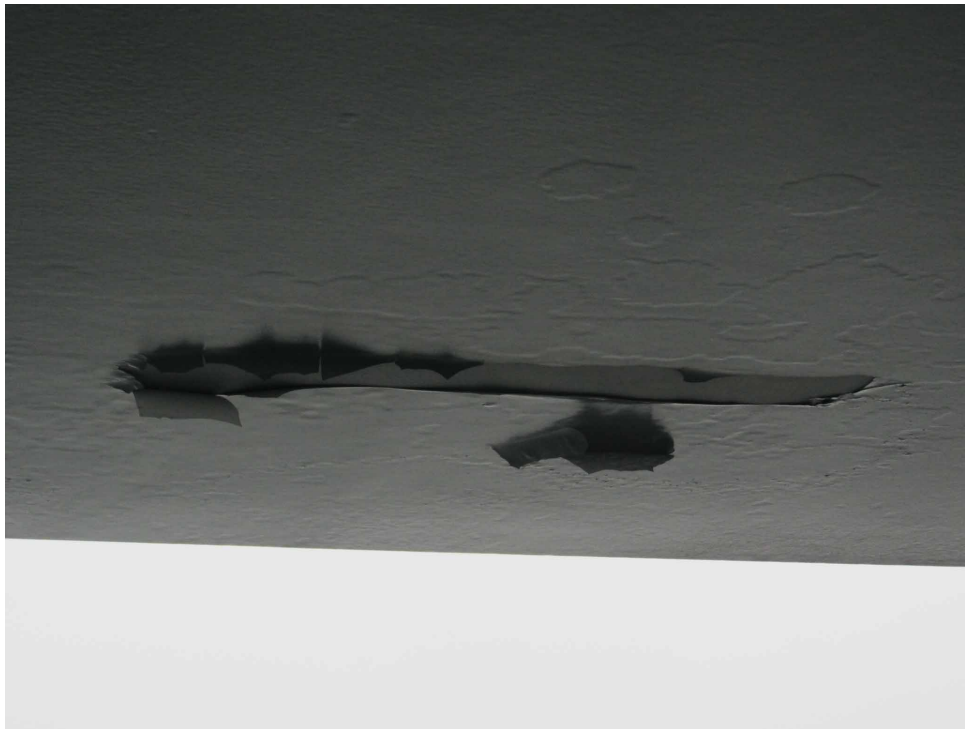
Figure 5.1: Example of the coating (IOZ) on a bridge assessed as good. Few areas of this kind of top coat flaking is accepted

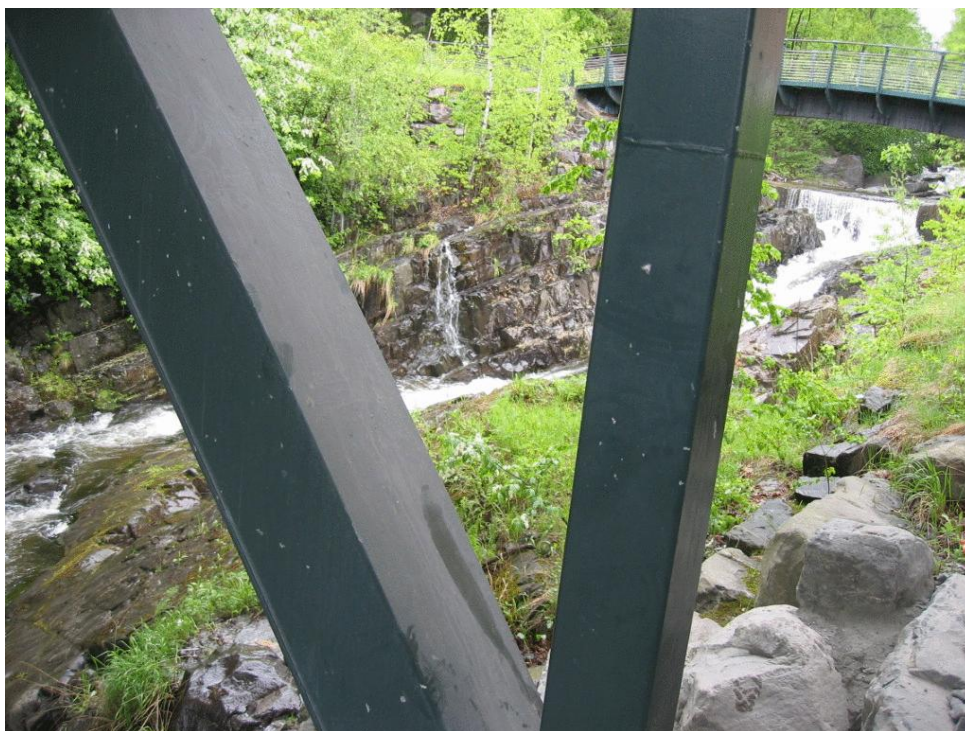
Figure 5.2: Example of the coating of a bridge assessed as fair. Pinhole application errors with zinc oxide visible over large areas can make the bridge assessed as fair

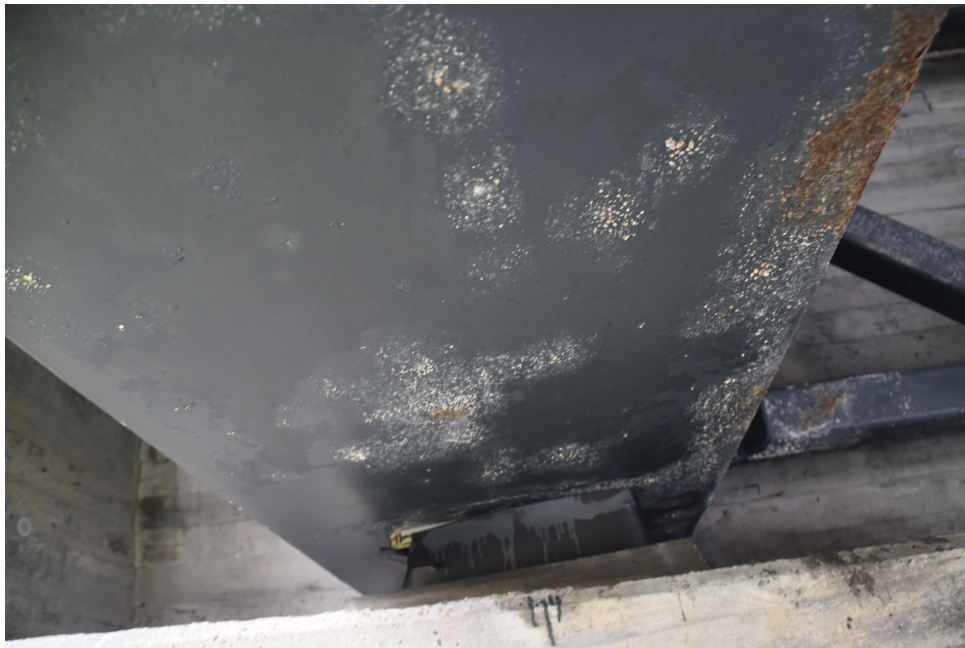
Figure 5.3: Example of the condition of a bridge assessed as poor. Widespread areas of visible ferric corrosion through the coating

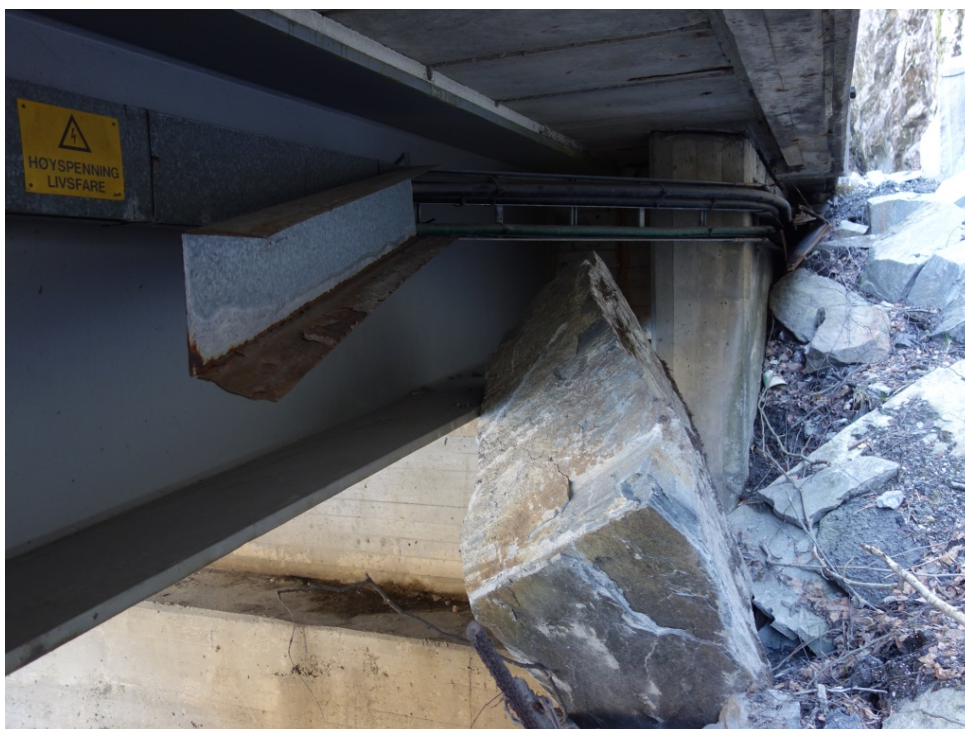
Some bridges bore marks of damages from contact with other objects. A couple of bridges had impact damage from either trailer trucks or boats, scraping away substantial areas of coating. One bridge in Western Norway had rock- and landslides on it resulting in a boulder resting on the bearing construction as seen in figure 5.4. Such damages were not taken into consideration when assessing the coating condition.

Figure 5.4: Boulder on bridge beam

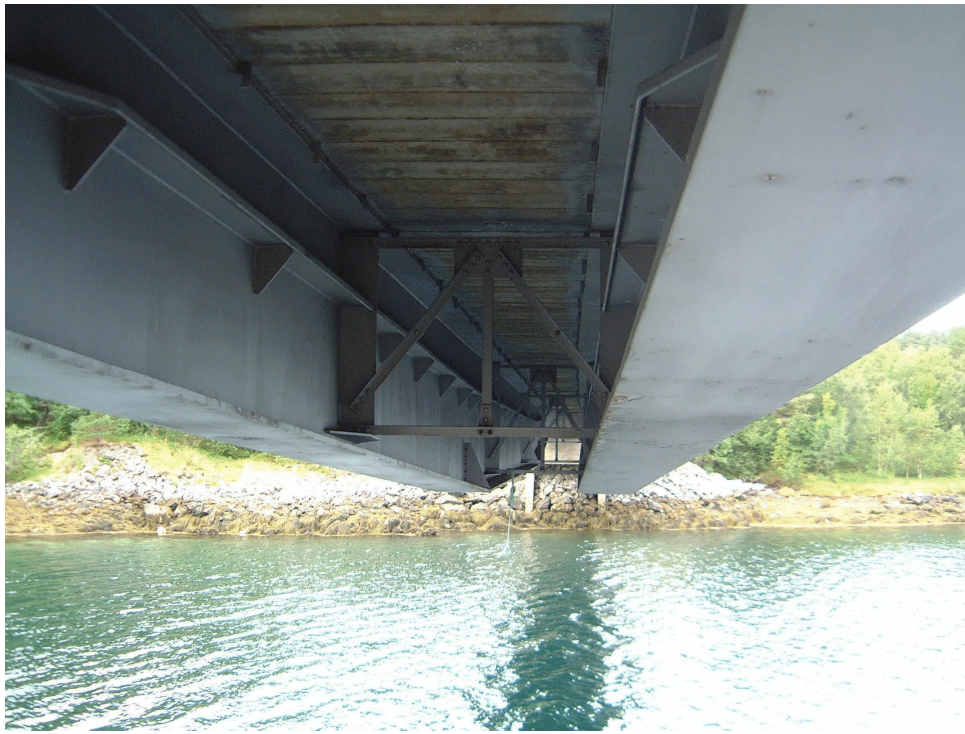
Hestvik bridge is interesting to note due to preventative maintenance. The bridge seemed to be in fair condition in 2007, which is illustrated in figure 5.5. The reasoning behind the painting was to stop corrosion early as some white rust had been observed and the bridge is in a very aggressive environment. The maintenance contract for this bridge also covered multiple other bridges of different sizes, which Hestvik and Bangsund were of the longer ones. The company responsible for the paint job claimed the price they charged was 155 EUR/m², which made the jobs on the larger bridges very profitable, but also that they lost money on smaller bridges with the same price. This points towards the project starting costs, involving project planning and mobilizing of equipment and personnel. These costs don't scale much with the size of the bridge and becomes a smaller fraction of the maintenance cost when the relevant bridge is longer.

Figure 5.5: Hestvik bridge in 2007. Together with some pictures of rusty bolts this would be considered fair by this thesis standards

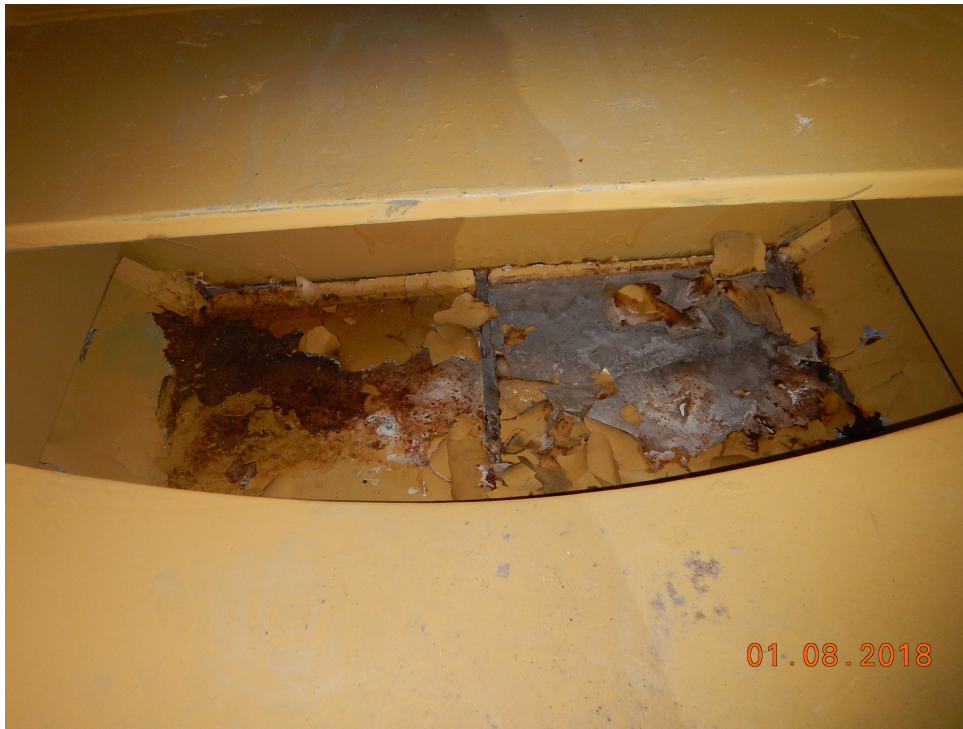
More Swedish bridges than Norwegian showed corrosion traps under examination, which if avoided could increase the lifetime of the coating. A corrosion trap found on a Swedish bridge is shown in figure 5.6. The presence of these reduces the lifetime of the coating and construction significantly. 39% of the Swedish bridges were repaired, compared to 19% of the Norwegian bridges studied here and by Knudsen et al.

Figure 5.6: Corrosion trap on a Swedish bridge
