# Review on the Major Failure Cases of Unlined Pressure Shafts/Tunnels of Norwegian Hydropower Projects

Dr. Krishna Kantha Panthi and Er. Chhatra Bahadur Basnet

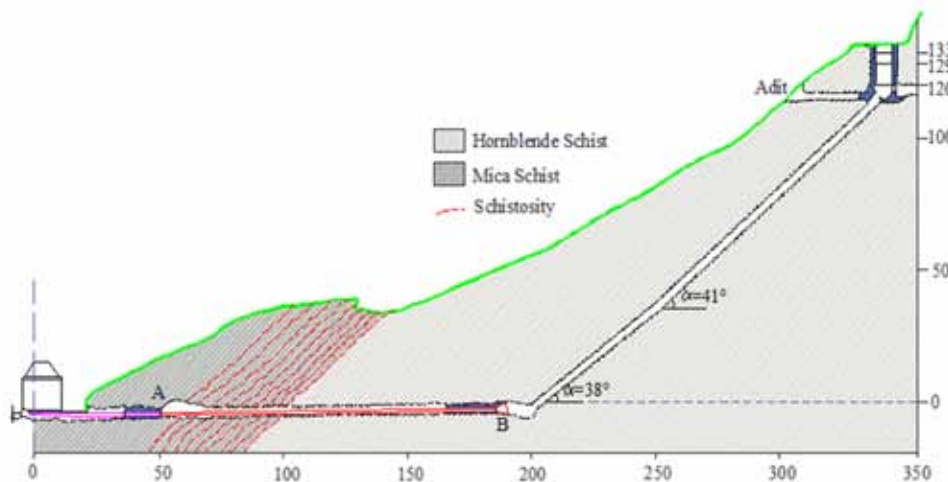
As indicated in Figure 3, the main rock types in the project were registered as hornblende schist and mica schist. The schist had foliation strike NW-SE with dip of about 50° SW (Vogt, 1922). The unlined

The observed leakage at one particular location at surface was about 300 l/s. As a remedial measure, reinforced concrete lining with a minimum thickness of 50 cm was carried out covering 60 m more pressure tunnel. Second water filling was made, however, after two months of power plant operation, rapid increase in leakages was observed once again at the surface. The waterway system was drained again and inspection was carried out. Many open cracks with an opening of

up to 20 cm were found in reinforced concrete lining between chainage 70 m to 79 m covering both tunnel walls near the spring line. Selmer-Olsen (1969) interpreted this incident in such a way that the rock mass over the tunnel had been lifted during first cracking and then deformed downward after water way was drained. Finally, decision was made to extend penstock all the way up to the bottom of the inclined pressure

Figure 3: The Herlandsfoss hydroelectric project, in operation since 1919 (Redrawn from Vogt, 1922)

Initially, the steel penstock pipe was installed to cover only the first 50 m long section from the turbine. A concrete plug was installed at the cone section as shown in Figure 3. Vogt (1922) reported that water inflow was observed from chainage 92 m to 94 m during construction. Concrete lining was used as mitigation measure at this tunnel stretch and rest of the 150m horizontal pressure tunnel was kept unlined all the way up to the bottom of the shaft (Figure 3). A minor leakage was observed at the outer part of pressure tunnel during first water filling with a static water head reaching 123 m. After five hours of full hydrostatic pressure, considerable amount of water leaked from the upstream of the cone area and leakage channel reached all the way to the surface over the 50 m chainage. The waterway system was drained and inspection was carried out. It was observed that considerable amount of inflow was coming back at chainage 98 m. This demonstrated on the extent of hydraulic splitting occurred in the tunnel after water filling. This splitting led to extend existing joints in the rock mass and also new fractures were developed along the spring line of unlined pressure tunnel over

shaft up to the point B as indicated in Figure 3. The third water filling was a complete success with no significant water leakage registered and this project become the first unlined pressure shaft of Norway.

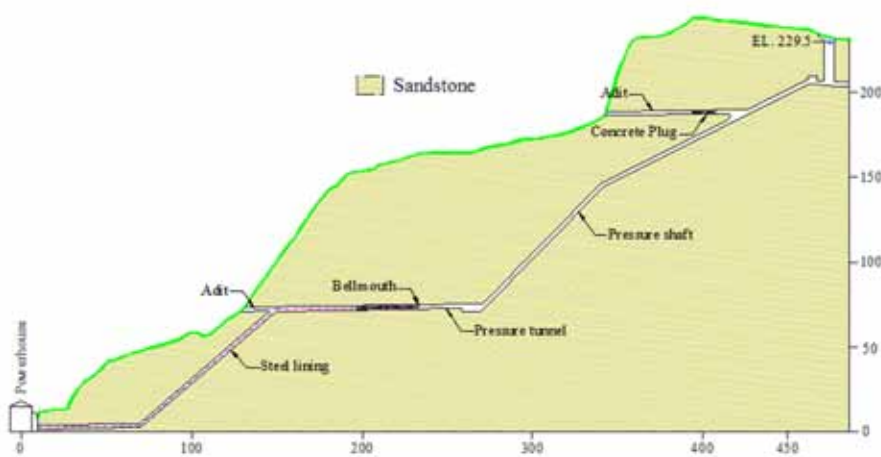
Figure 4: The pressure tunnels and shafts arrangement at Svelgen hydropower project (Redrawn from Vogt, 1922)

Since the fine grained sandstone has in general low degree of porosity, the leakage risk was always through the joint system; from both gently dipping bedding joints and steeply dipping cross-joints. During excavation, very little inflow in both tunnels and shafts was registered. Test water filling was carried out until the elevation of 223 masl. The pressure tunnels and shafts were filled in four hours period and rest of the headrace tunnel was filled in 5 days period. To check the leakage through the unlined waterway system, inlet gate was closed for two days and water level was sinked to 160 masl from the maximum elevation of 223 masl (Vogt, 1922). Water loss from the waterway system was calculated to about 70 l/s. A short part of the pressure tunnel was concrete lined and cement grouted. After then the waterway system functioned normal and no as such failure reported.

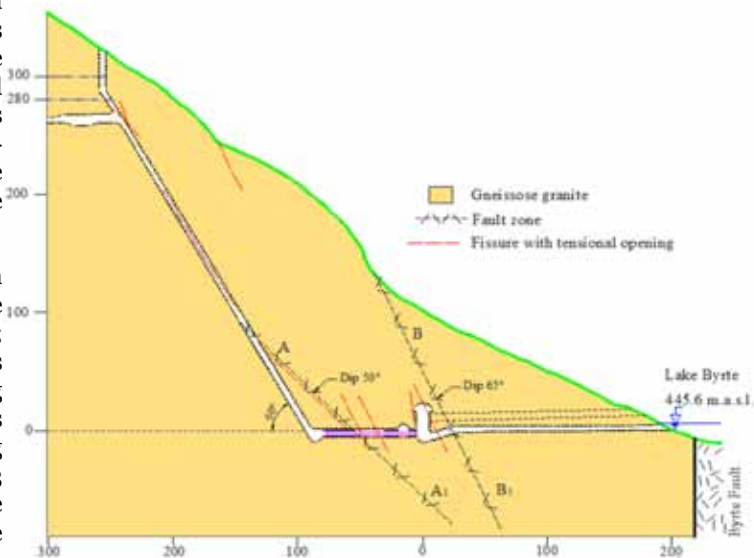
Byrte project is situated in Tokke commune in Telemark county of Norway. It was built in 1968 with 20 MW installed capacity. The project has low pressure headrace tunnel, surge shaft, unlined pressure shaft (600 inclination), about 80 m long steel lined horizontal tunnel, underground powerhouse and about 200m long tailrace tunnel. The project was designed with a design discharge of 8 m<sup>3</sup>/sec and with maximum gross head of 295 m. Main rock type in the project is granitic gneiss. The rock mass consists several systems of joint sets dipping between 550 and 700, and minor faults with strike approximately parallel to the valley side slope (Selmer-Olsen, 1969). There is also a wide clay-filled fault at Byrte Lake, which is called 'Byrte Fault' (Figure 5).

Figure 5: The unlined shaft and underground powerhouse arrangement at Byrte hydropower project (Redrawn from Selmer-Olsen, 1969)

According to Selmer-Olsen (1969) the clay filled fault zone AA1 (Figure 5) consisting weak rock mass did not managed to sustain the hydrostatic head acting on it and hydraulic splitting occurred along this zone. Ultimately, opening of the fault followed hydraulic splitting in the pre-existing joints in the rock mass leading to the leakage at the underground power station as well as leakage along the surface topography following fault zone BB1. Finally, the whole shaft was steel lined (Buen, 1984) as permanent solution.

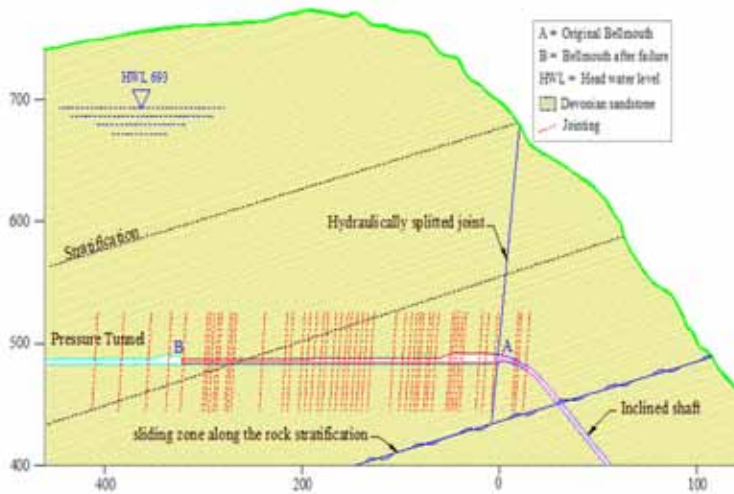
Figure 6: Section through pressure tunnel of Askåra power plant (Redrawn from Bergh-Christensen, 1975)

In the first stage of project construction at about 173 m chainage (Figure 6), considerable water inflow into the tunnel was registered and it was sealed with cement grouting. This inflow indicated possibility of leakage from the pressure tunnel during operation. Initially the pressure tunnel was kept unlined up to the point A in Figure 6. The first water filling was carried out in the waterway system achieving full hydrostatic head of 690 m. The filling process was gradual until the unlined pressure tunnel reached to a hydrostatic pressure of 194 m and filling of remaining part was fairly quick. Leakage was observed at the western valley slope of the mountain topography immediately after the water filling was completed. The next day, large leakage of about 1.0 m<sup>3</sup>/sec was registered on the same place indicating complete failure at the downstream end of the unlined pressure tunnel. The waterway system was drained and inspection was carried out. During inspection it was observed that the cross joints were opened by about 3-4cm between the tunnel section A and B (Figure 6). The opening in the joints clearly demonstrated the occurrence of hydraulic splitting. Finally, steel lining was extended up to point B. After this modification, the power plant is being operated successfully.

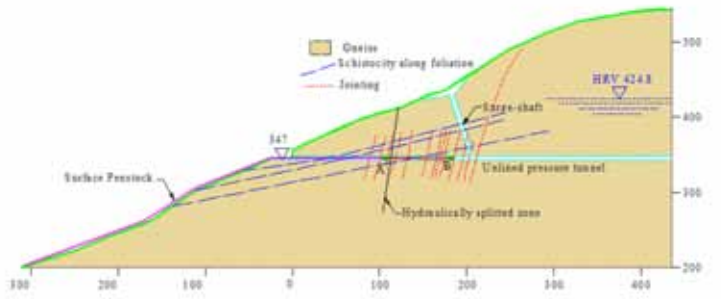
Initially, the penstock cone was placed at about 100 m from the tunnel portal at point A as shown in Figure 7. Three of the exposed steeply dipping cross joints upstream of the cone area were found to be open and these joints were filled with plumb concrete as a remedial measure during construction. The filling of the waterway system was carried out. Shortly after the water filling with the maximum static water head of 72 m at point A, small leakage was observed downstream of the cone plug. As a surprise, after four days of operation, large leakage was registered at the bottom of the valley slope just above the power station. The power plant was closed immediately. After 30 minutes of stoppage the water level reduced by 23 m. This reduced water level indicates a leakage of approximately 1.2 m<sup>3</sup>/sec. Tunnel inspection was carried out after the drainage. It was observed that the pre-existing joints immediately upstream of concrete plug were opened by approximately 20 mm in walls and 53 mm in the floor (Valstad, 1981). The opening in the joints clearly indicated that there had been hydraulic splitting, which led to the shift of valley side. As a remedial measure, the penstock pipe was extended further by about 80 m to point B (Figure 7). The water way system was filled once again with

Figure 7: Geological details of the outer end of Bjerka unlined pressure tunnel (Redrawn from Valstad, 1981)

care and well planned monitoring. The filling was successful and no significant leakage was registered.

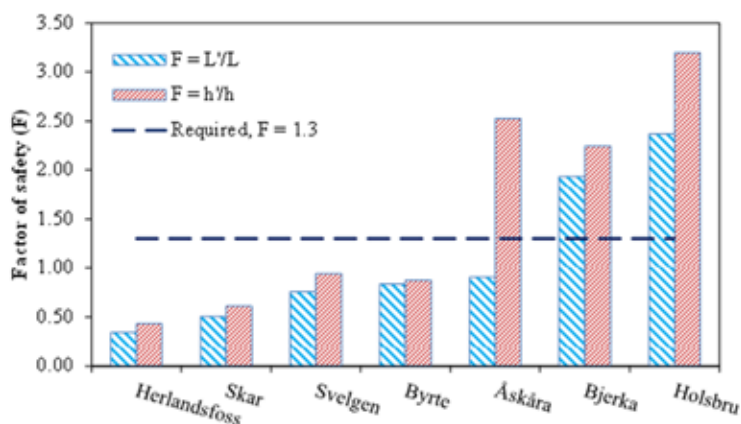
As can be seen in Table 3, the factor of safety was found to be less than 1.3 as specified by Benson (1989) for both vertical rock cover and shortest distance from the valley side slope for projects Herlandsfoss, Skar, Svelgen and Byrte. Even though, the factor of safety for vertical rock cover is fulfilled, there exists

Figure 8: Factor of safety against vertical cover and valley side distance.

insufficient shortest distance from the side slope for Åskåra Project (Figure 8). It is, therefore, obvious that leakage occurred through these pressure shafts and tunnels are mainly due to hydraulic splitting. The leakage occurred at Bjerka seems more linked to the pre-existing open joints. The detail assessments

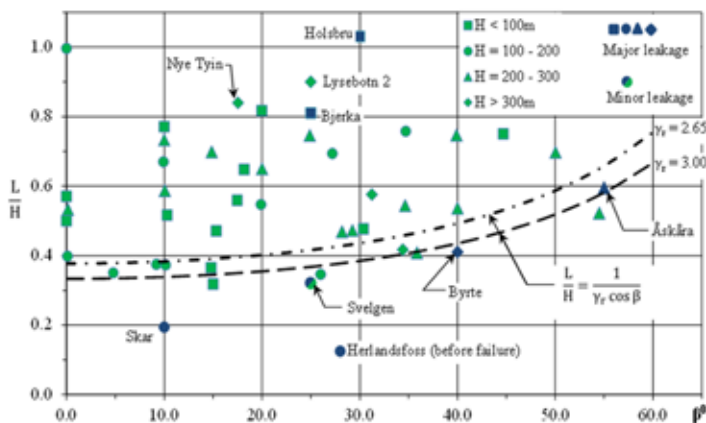
Figure 9: Unlined pressure shafts/tunnels in valley side with various inclinations,  $\beta$ . Updated from Broch (1982).

Five cases not fulfilling the design criterion for shortest distance were included in a chart presented by Broch (1982) (Figure 9). As can be seen, all projects are well below two dotted lines excluding Bjerka and Holsbru projects, which fulfilled the criterion but still substantial leakage occurred.
