Creative Construction Conference 2017, CCC 2017, 19-22 June 2017, Primosten, Croatia

## Climate adaptation of school buildings through MOM – a case study

Steinar Grynning<sup>a</sup> \*, Jørn Emil Gaarder<sup>a</sup>, Jardar Lohne<sup>b</sup>

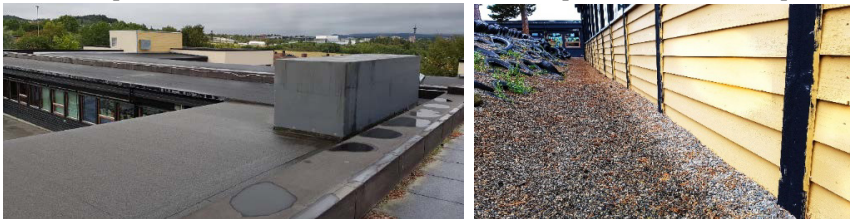
The roof of building A is in good condition. However, some ventilation ducts creates runoff problems. The ducts leads to clogging of the runoff, as shown in Figure 1 (left). The roof cladding shows signs of wear and should be replaced. Parts of the cladding was replaced in conjunction with the installing of the district heating.

The wooden cladding of building A facing the playground is a source of much manual maintenance work. Needles from surrounding trees together with gravel from the playground is clogging the ventilation aperture under the cladding as shown in Figure 1 (right). Thus, the airing of these parts of the facade is poor and may lead to moisture-damages in these parts. In addition to this, the terrain is sloping towards the facade causing heightened moisture strains due to poor rainwater runoff abilities. However, improvements of this is planned to be carried out.

Figure 1. (left) The casings for ventilation ducts and technical pipes. (right) The clogged ventilation aperture of the wooden cladding in parts of building A.
