## In situ evaluation of a timber structure using a drilling resistance device. Case study: Kjøpmannsgata 27, Trondheim (Norway)

# *In situ* evaluation of a timber structure using a drilling resistance device. Case study: Kjøpmannsgata 27, Trondheim (Norway)

F. Frontini\*

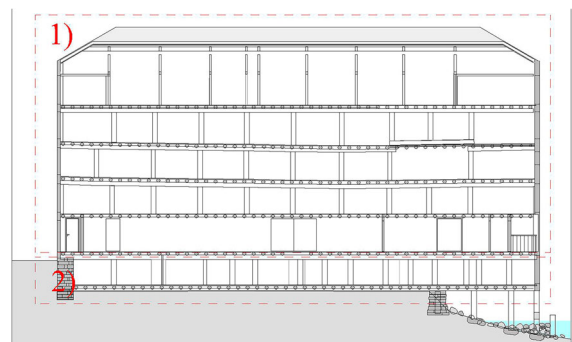
4 Main areas of investigation

Following the methodology of Frontini, Siem and Nilsen (2015), the subsequent visual inspection identified two main areas for investigation: the basement and the upper floors (Fig. 4).

On the upper floors, the timber elements are sound, and no efflorescence or wet areas were detected. The measured moisture content was below 23% in all of the timber members, and few elements were missing or had been removed, especially in the knee bracings. The part of the building with the most decay is therefore the basement, where the majority of the foundation beams are rotten (Riggio *et al.* 2014).

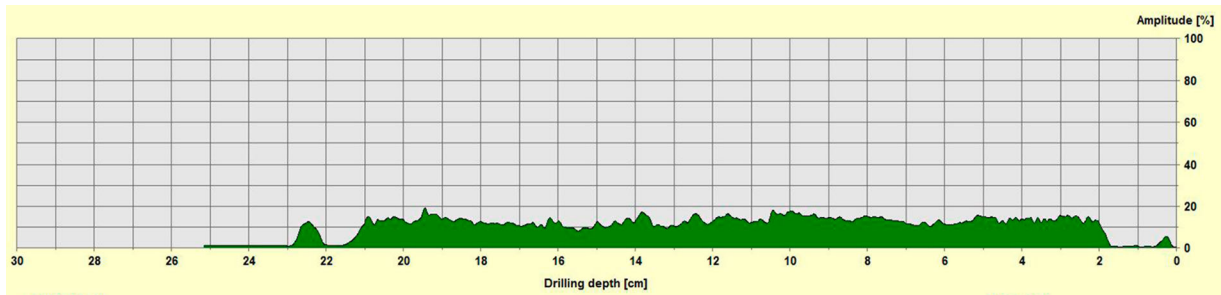
8 Drilling resistance graph for Column 0-B3

The results indicate that the wood within the columns and beams of the basement is in good condition and there is no evidence of decay or cross-section loss. None of the columns had exceeded their strength limit or displayed any signs of damage or decay. A typical graph from a drilling resistance test of a column is shown in Fig. 8; it is clear that the resistance is normal and continuous throughout the cross-section. A small crack was detected close to the surface, but this was judged as insignificant with respect to the strength and stability of the element.

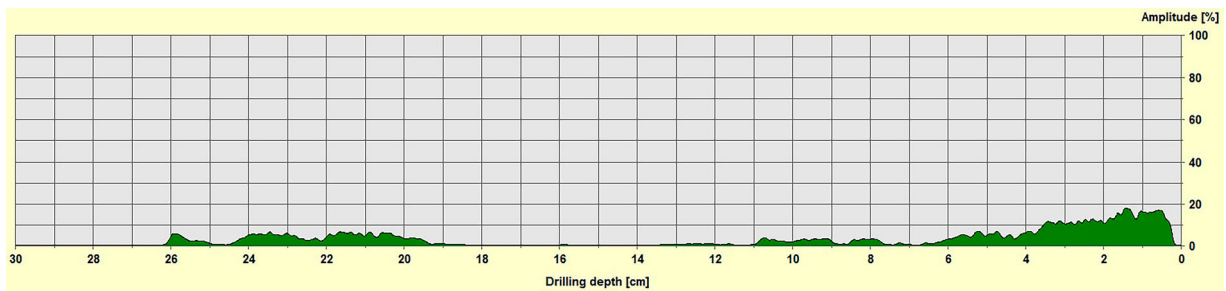
9 Drilling resistance graph for foundation beam 0H4-0H5

Figure 9 shows an example of a graph from a drilling resistance test of a foundation beam. In this particular

beam, more than 40% of the cross-section shows low or no resistance at all and the area adjacent to one of the surfaces is also rotten.

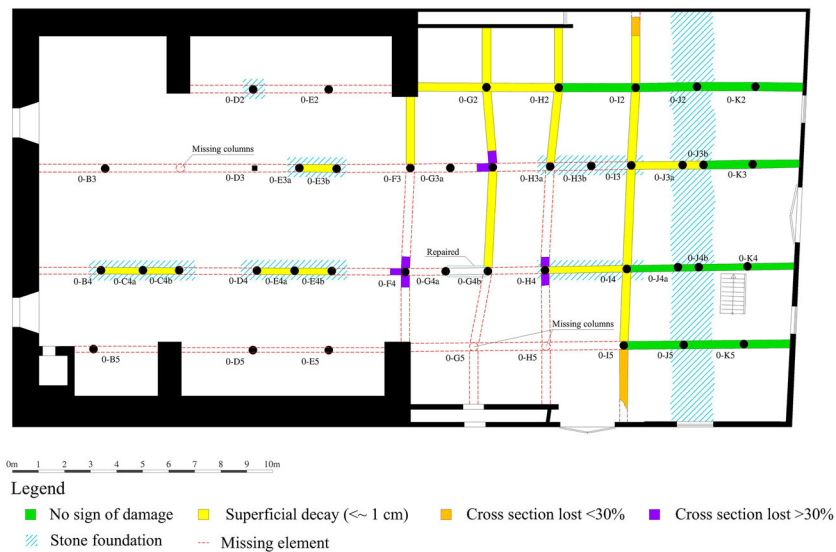
10 Map showing condition of the foundation beams

cracking, superficial and internal decay, and fungal growth due to the humid environment. The visual inspection formed the basis of the study and identified the main damaged zones for further investigation, which in this case were located in the basement. These areas were then examined using drilling resistance measurements to detect the above-mentioned defects. According to the tests, the condition of the columns and beams in the basement were good although they had a very high moisture content (see Table 1). The foundation beams were in the worst condition and they affect the load-bearing capacity of the entire structure. The results of the drilling resistance tests were used to create a map of the undamaged members in the basement structure, see Fig. 10.

It is clear from this map that there is no sign of damage or superficial decay in the elements on the east side of the structure where the timber is in a more favourable environment with the potential for it to dry. In the central part of the basement, the beams have superficial decay or a small cross-section loss (<30%). Some of these beams are still weight-bearing even though they are in urgent need of repair. The beams on the west side of the building are in the worst condition and the results of the drilling resistance tests indicate that most of the surviving beams have high levels of cross-section loss. A high percentage of the original beams are missing in this area and as a result some columns are now resting on the ground (Table 2). This map highlights the elements which require replacement; the elements in green will be saved, while the others need to be replaced with new beams. It will also be necessary to design a membrane to separate the foundation beams from the ground to reduce moisture levels.
