Pitting on Carbon Cathodes in Aluminium Electrolysis Cells

Samuel Senanu¹, Tor Grande² and Arne Petter Ratvik³

Uneven cathode wear is one of the key challenges for the lifetime of aluminium electrolysis cells. Here we report on autopsy of several potlinings with focus on the surface morphology of the carbon cathodes. The surface morphology of the spent potlinings was characterized by measuring the profile by a laser interferometer, X-ray computed tomography and microscopy. The surface pitting of the cathodes resembles wide shallow pitting corrosion of metals. The characteristic size of the pittings is determined and compared to the size of the large aggregates constituting the cathode materials. No correlation between the characteristic size of the pitting and the aggregate size is observed. Based on the present findings, aggregate detachment is ruled out as a contributing mechanism to cathode wear.

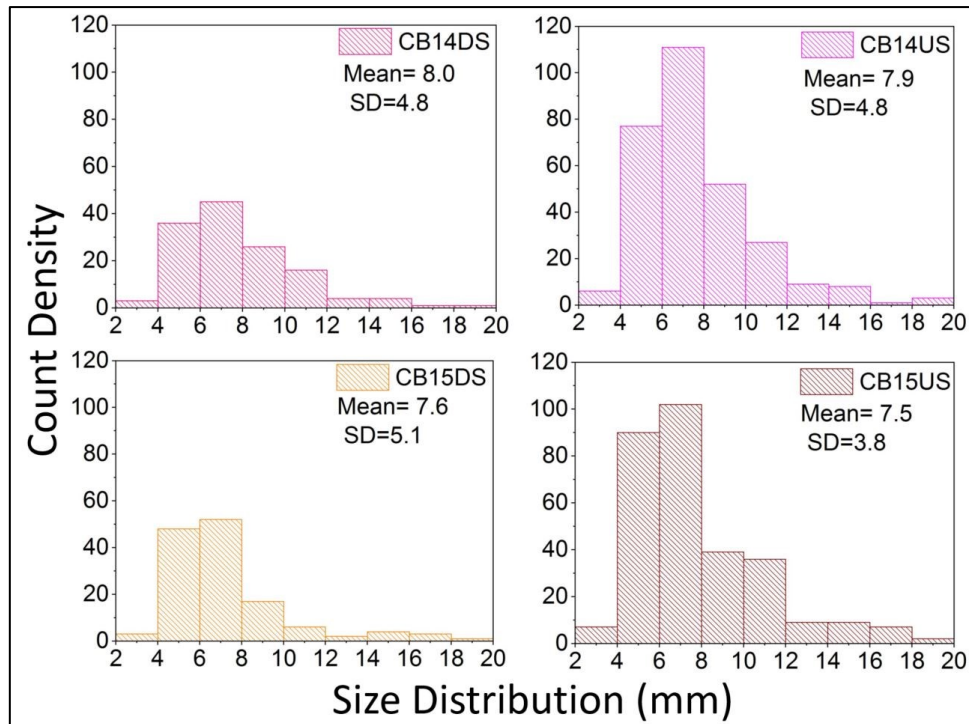
Figure 3. Histogram showing the count density and size distribution of pitting on the upstream and downstream ends of 2 carbon cathode blocks (cathode blocks 14 and 15) from pot 5.

In order to verify the particle detachment mechanism, the average grain sizes of the carbon aggregates and the average sizes of the pittings were determined. Figure 3 shows the size distribution of the pittings observed from the autopsy of pot 5. The average grain sizes of the carbon aggregates were also determined by analysing the CT images of the autopsy samples as shown in Figure 7 using the linear intercept methods. Comparing the average sizes of pittings to the average grain sizes of the carbon aggregates did not yield any correlation. This observation does not support grain detachments as the main mechanism for the observed pitting.

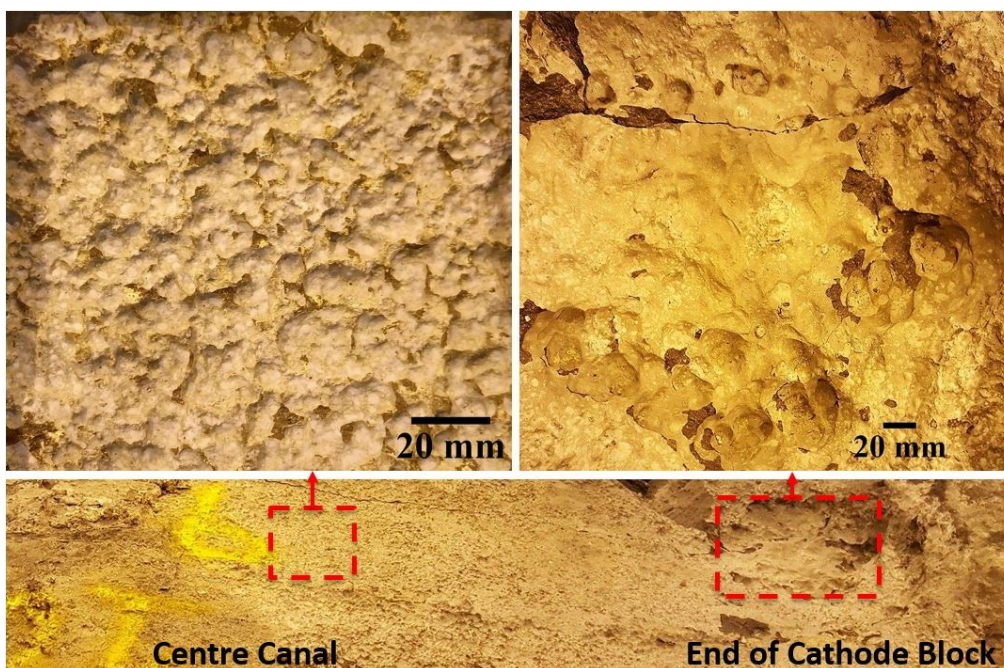
Figure 4. Photograph of a spent potlining with graphitic cathode block (pot 6057) showing pitting all over the surface. Highlighted images show the differences in pitting sizes between the centre and side of the cathode block.

The varying sizes of the pitting on the graphitic cathode blocks with respect to the centre canal and the ends of the cathode blocks as shown by Figure 4 may be explained by the combination of high current densities and faster transport rates. The high current densities at the ends of the cathode block will lead to an increase in the electrochemical formation of aluminium carbide. The high current densities will also induce high electromagnetic movements in the metal and bath leading to an increase in the dissolution and transport of aluminium carbide at the cathode block ends as compared to the centre canals [6, 10]. For the graphitized cathode blocks, the high degree of pitting at the ends as compared to the centre with almost no pittings may also be because of the high current density and the induced high movements in metal and bath and thus higher dissolution and transport of aluminium carbide.

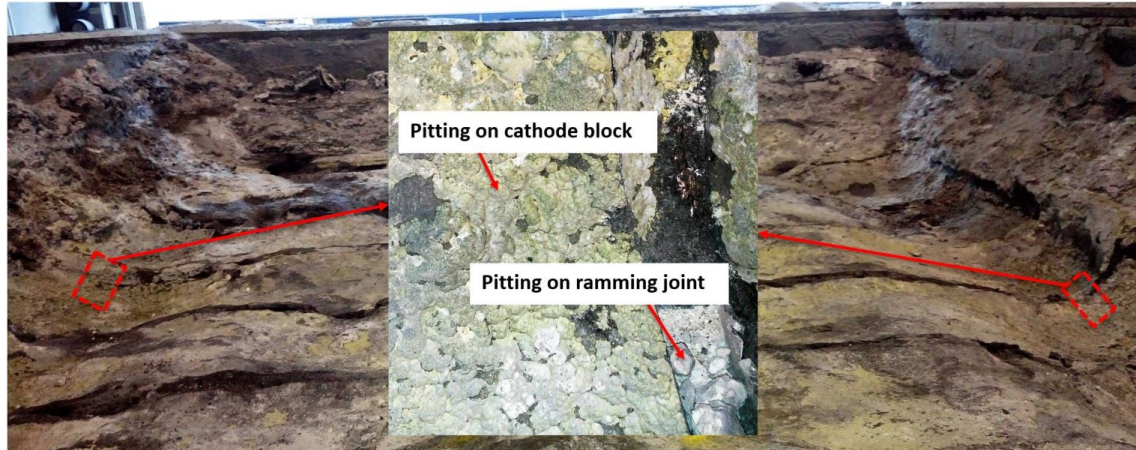
Pitting was also observed on the ramming joints between the cathode blocks at the locations with highest degree of pitting as shown in Figure 5. One of the spent potlinings (pot 5) that was investigated had a tapout through a pothole on one of the carbon blocks. A closer investigation of the location surrounding the pothole revealed a very high degree of pitting. Figure 6 is a picture showing the tapout hole in the cathode block.

Figure 5. Photograph of a section of a spent potlining with a graphitized cathode block (pot 1) showing pitting mostly at ends of cathode block. The insert image shows the pitting mainly observed at the ends of the cathode blocks and ramming joints.

All the autopsies conducted demonstrate the presence of pitting on the carbon cathode surface irrespective of the type of carbon material or grade of the carbon cathode block. Figure 5 is a picture showing pitting on both the cathode block and ramming joints. This suggests that pitting is essential for the carbon cathode wear mechanism. There is, however, a difference in the amount of pitting observed on the graphitized and graphitic cathode blocks. While the graphitized cathode blocks showed distinct pitting mainly at the ends of the cathode blocks, the graphitic cathode blocks show pitting almost all over the carbon cathode surface. The images in Figures 2 and 4 show these differences. The appearance of pitting all over the graphitic cathode blocks is assumed to be due to their relatively high porous nature as compared to the graphitized cathodes, resulting in a relatively higher electrical resistivity that contributes to a more even current distribution over the cathode.
