Downhole errors

Master's thesis in MTPETR Supervisor: Pål Skalle June 2019

Norwegian University of Science and Technology Faculty of Engineering Department of Geoscience and Petroleum

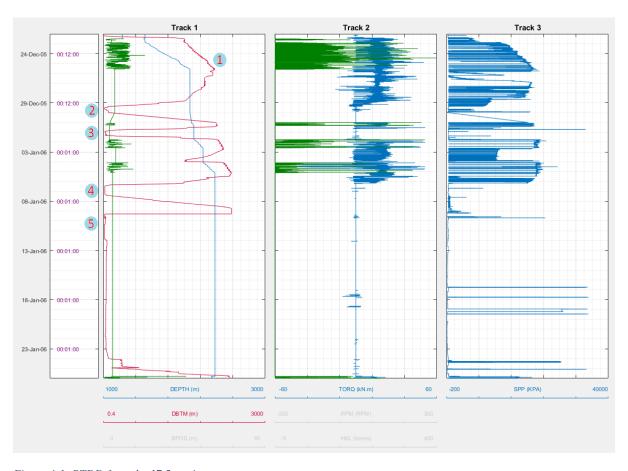
Figure 4-1; RTDD from the 17,5 section

From the data we can see where most of the NPT occurred. The red line (Figure 2-1 Track 1) represents the depth of the bit at any given time, while the blue line represents the total depth the well has achieved. During the first run the PowerDrive, responsible for maintaining directional control, failed. Communication was later established, and it was decided to continue drilling. At point ((1) Figure 4-1 Track 1 (1)) the bit started behaving

erratically and it became stuck. It became hard to maintain the circulation of mud in the hole. It was a decided to Pull out of hole (POOH) (Figure 4-1 Track 1(2)). This was more difficult than anticipated and was only possible by backreaming most of the well. A bad mud mix had caused coagulation in the well and made drilling almost impossible. They used the opportunity to repair the BHA, perform a BOP test and circulate the well clean of residue from the bad mix. Drilling operations continued, but they were soon forced to POOH again due to another failure on the PowerDrive (Figure 4-1 Track 1(3)).

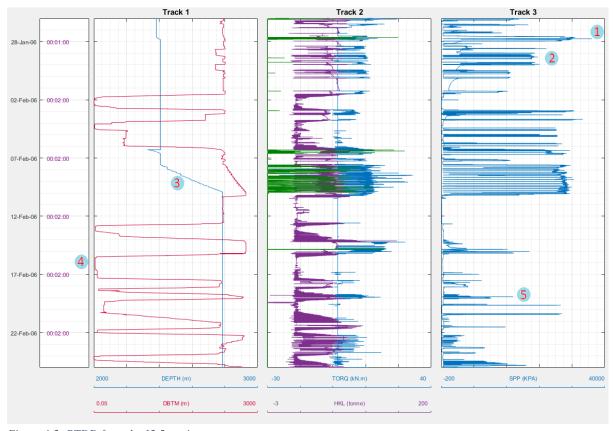
Figure~4-2;~RTDD~from~the~12,5~section

Early in the 12 ½" section the well was about to enter a high-pressure zone. In expectance to this the SPP (Surface pump pressure) was steadily increased. This caused the Effective Circulation Density (ECD) to reach a pressure above the expected high-pressure zone before it was encountered. In (Figure 4-2) the blue line in Track 3 represents the SPP. From the data we can see the jump in pressure at January the 28th (Figure 4-2 Track 3(1)).

The increased ECD caused Loss of circulation (LOS) to the formation. The pressure dropped and 10m^3 mud was lost to the formation before a stable Bottom hole Pressure (BHP) was established. Two attempts at sealing the formation followed by two failed LOT's were then performed. The well was subsequently killed by displacing cement into the loss zones. The increased SPP we can observe at this time (Figure 4-2 Track 3(2)) is caused by the attempts at sealing the loss zone, performing Leak of tests (LOT's) and finally displacing the kill mud.

Because of the heavy loss zones, it was decided to implement Measure While Drilling (MWD) and use Managed Pressure drilling (MPD). To do this it was also necessary to use a Positive Displacement motor (PDM) to prevent the string from rotating while drilling the run (Figure 4-2 Track1(3)).

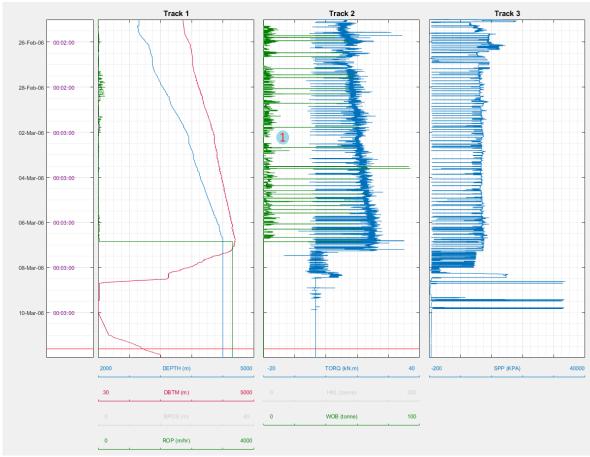
Figure 4-3; RTDD from the 8 ½" section

At 4109mMD, only 300m for target depth, the PowerDrive failed. Drilling did continue since the pathing of the well matched that of the planed wellpath before the tool failed and it continued to drill straight. The section was therefore completed in a single run.

Upon reaching target depth and completing the 8 ½" section of the well, the setting of the 7" casing began. Problems were experienced early with establishing returns. A previously unidentified loss zone was discovered in the connection shoe to the previous 9 5/8" liner. Equipment not available on the platform needed to be ordered to seal the loss zones. Because of the sealing procedure several runs regarding cement squeezing and new LOT's had to be performed. The cleanup runs after theses operations were not enough, and complicated later operations. New obstructions in the well were created that lead to miss-runs, and new cement squeezing had to be performed.

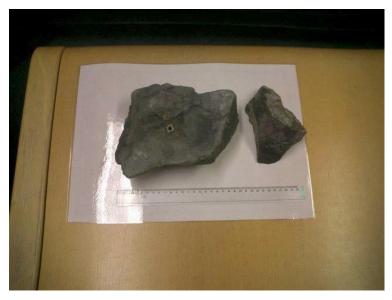
In the 17 ½" section a specific mud was used to prevent bit balling. It was however not approved since it contained an oil-based polymer, and the well was only approved for water-based mud. The polymer was therefore substituted with another. This resulted in a mud mix that coagulated. Large cuttings came on the shakers, and the BHA had to be back reamed from 1814 to 135 m inside the 20" casing. The back reaming lasted 96 hours, and the BHA came out "encapsulated" in sticky cuttings. We can observe in (Figure 4-3 Track 2) that the torque required to POOH at times was equal torque that was needed during drilling. This illustrates the difficulty experienced when POOH.

Figure 4-4; "Cuttings" found on the BHA during clean-up

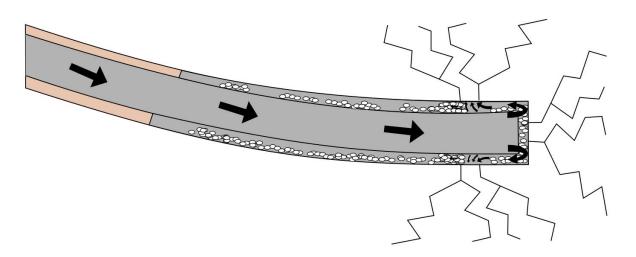
In the 17 ½", 12 ¼" and 8 ½" section they experienced problems squeezing the cement below the previous cashing shoe. This later led to Loss of circulation. In all the sections it was concluded that the reason for the subpar cement job was improper hole cleaning. After cement squeeze in the 12 ¼" section, proper circulation of the hole was not performed. It was made clear that EOW rapport that other wells passing through the same formations also had problems regarding insufficient cleaning after a cement job. Even so the cleanup job was unsatisfactory.

Figure 4-6; The presence of particles in the anulus caused a bad cement job th

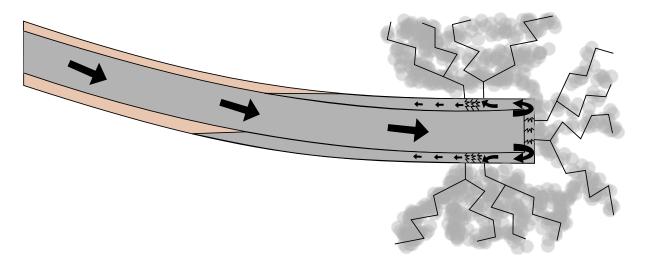
2. A subpar cement job could not withstand the pressure buildup and caused fractures in the formation. This is similar to how natural losses occur with one difference; before the drilling fluids can reach the natural wall in the well, the cement needs to be bypassed. The FIT discovered an unreliable seal created by the sub-par cement job, and the presence of micro anulus in the cement. Luckily this was discovered and repaired before drilling continued.

Figure 4-7; The figure illustrates how the fluids penetrates the cement through the micro annulus and enters the formation. This figure represents attempts at filling the micro annulus with cement.

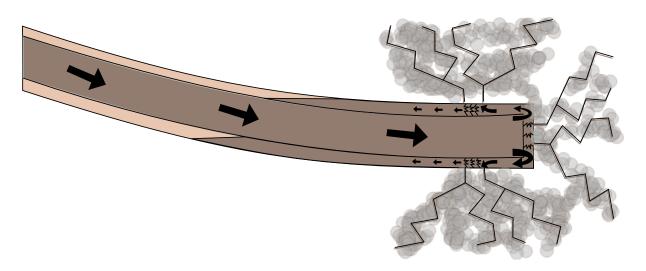
In the 17 ½" section a Leak of test (LOT) was performed in the casing shoe. Probably due to a poor cement job the formation integrity test (FIT) leaked of at a much lower pressure than was expected (Figure 4-5). Since the leak of pressure was so low, it was expected the pressure had leaked off into micro annulus in the cement and fractured the formation shallower than the shoe depth. It was then decided to perform a new cement squeeze to seal the micro annulus. It took two attempts before reaching sufficient pressure on the FIT.

Figure 4-8; Formation integrity test. After the microanalyses were filled with cement, the pressure was increased in the anulus to test if the formation was strong enough to withstand the required pressure.
