Rock cut slope excavated for Settling basins of Seti Khola Hydropower Project

Krishna Kanta Panthi

Chhatra Bahadur Basnet

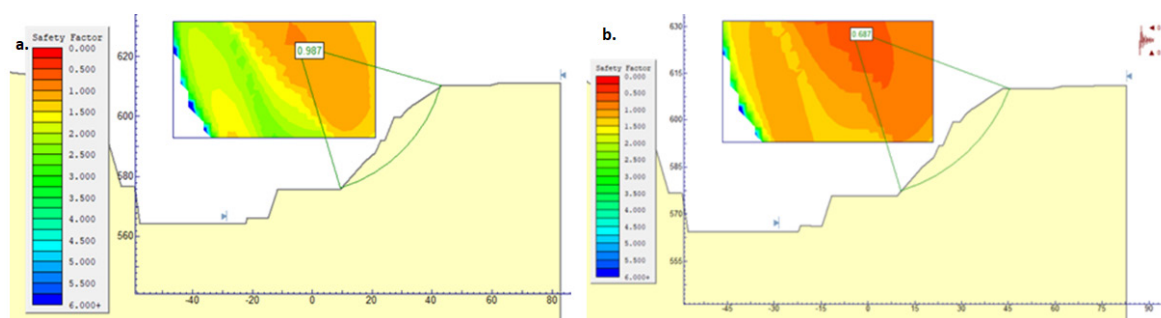
A comprehensive analysis using SLIDE indicated that the original slope was critically equilibrium at the banks of the Seti River. Figure 4 shows the stability condition at the cut slope after excavations for both normal and seismic loading conditions. As can be seen in the figure the cut slope is at critical stage with FoS below one at normal loading condition and at failed state at seismic loading condition.

Figure 4. Achieved factor of safeties before support measure. a. At normal, b. At seismic loading conditions.
