# Permanent Effect of a Cryogenic Spill on Fracture Properties of Carbon Steel

**Hanne Keseler**

Chemical Engineering and Biotechnology

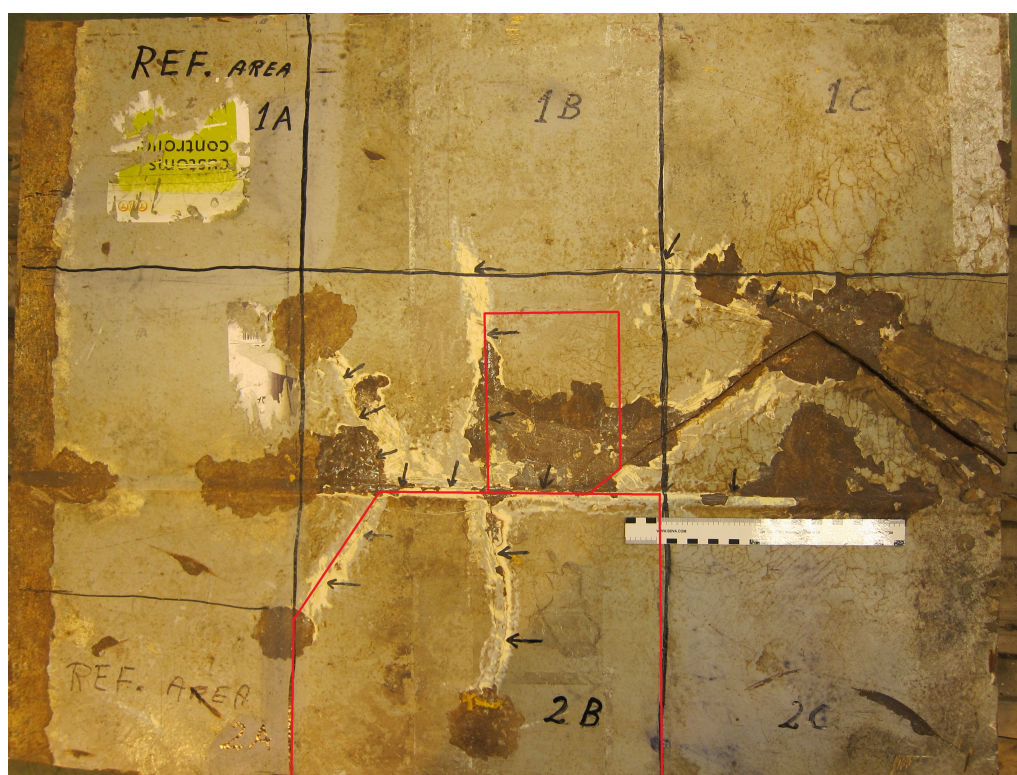
**Figure 3.1:** Overview of the platform material received by DNV GL. The two pieces which were used for the present experiments, are outlined in red

As seen in Figures 3.1, 3.2 and 3.3, the paint had cracked in certain areas. This was assumed to be caused by differences in the thermal contraction between the paint and the underlying material during the liquid nitrogen exposure. Which areas of the plate had been cooled to lower temperatures during the cryogenic spill, was indicated by cracks in the paint. In addition, the secondary cracks in the plate were believed to have propagated from brittle exposed areas and stopped when reaching more ductile material. Areas indicating cryogenic exposure will in this report be referred to as exposed areas, while those where no evidence of cryogenic exposure can be seen at the macroscopic level will be referred to as non-exposed areas.

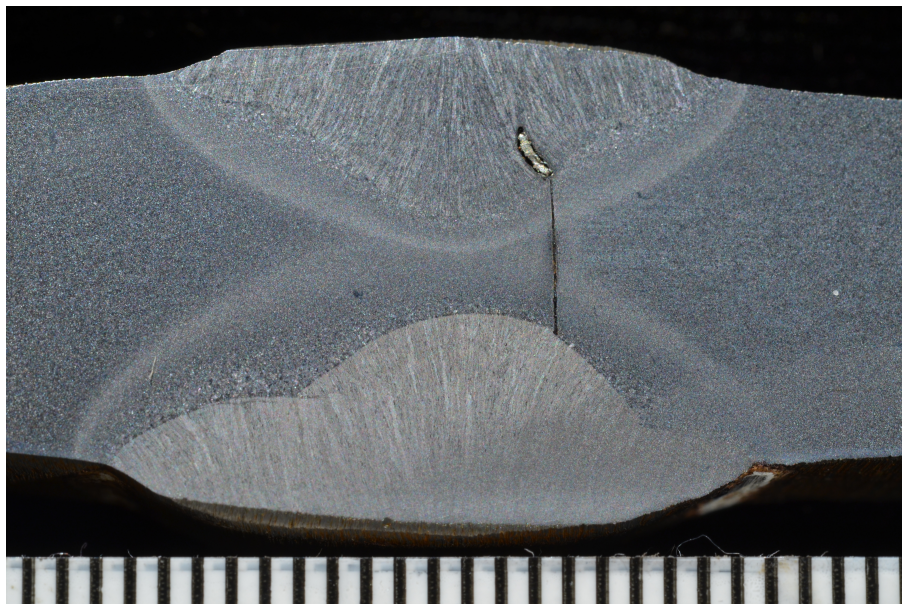
A macrograph of the weld taken by DNV GL, is shown in Figure 4.4. The image shows a flaw in the weld which may have initiated cracking during the liquid nitrogen exposure. It can be seen that the weld is off-center, which is expected to make it weaker and more susceptible to cracking. The main crack in the steel plate, may have started at the flaw in the weld when the material was subjected to thermal stresses and low temperature embrittlement. The crack could then propagate easily along the weld, which was off-center and therefore especially weak.

**Figure 4.4:** *Macrograph of the weld, taken by DNV GL*

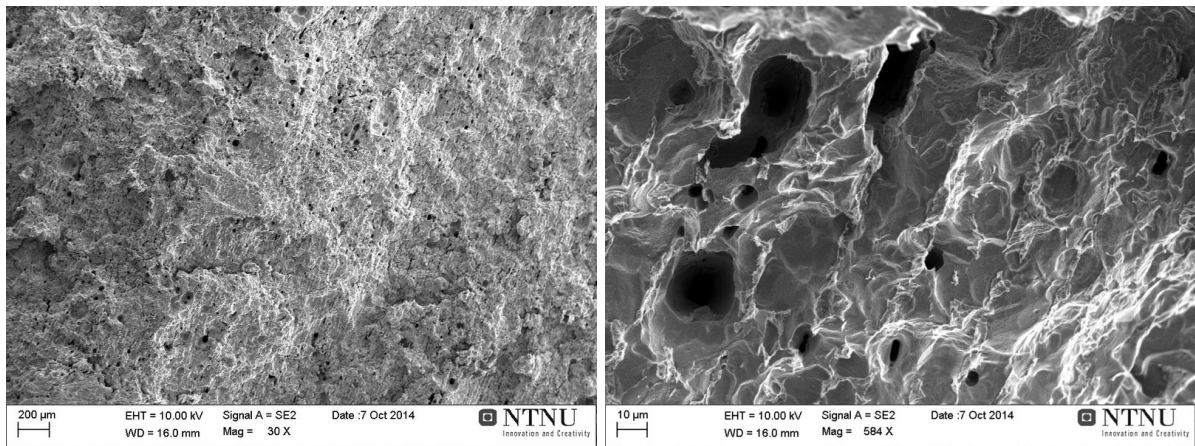
A low magnification image of the fracture surface of specimen 2-5 is shown in Figure 4.5a. Many pores of different depth and shape can be seen in the surface. The pores give the fracture surface the appearance of being ductile. However, when increasing the magnification the surface appears quite featureless, as shown in Figure 4.5b. The figure shows pores, as well as traces of cementite lamellae from the elongated pearlite grains, which have become visible at the surface due to the etching. This type of appearance could also be observed in certain areas of the fracture surface of most of the other specimens, but was most prominent in the first eight specimens. It is believed that the regions showing this fracture feature have been severely effected by etching and corrosion. Figure 4.6 shows a SEM image of the an other area of the fracture surface of specimen 2-5. Some pores and elongated pearlite grains can be seen also here. In addition, several cracks with different orientation are located in the fracture surface. This appearance was observed only in some smaller areas of the fracture surface of this specimen.

**Figure 4.5:** SEM images of the fracture surface of specimen 2-5

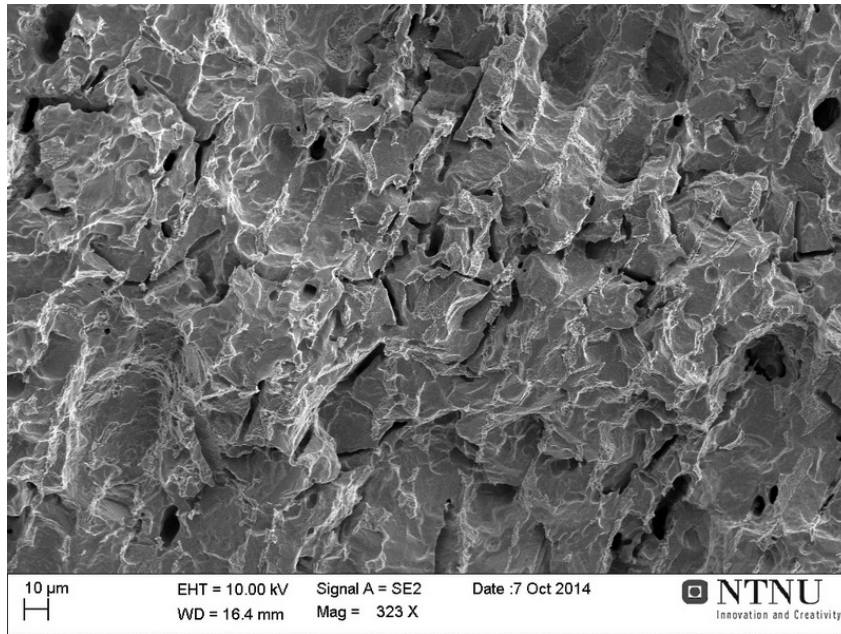
**Figure 4.6:** SEM image of the fracture surface of specimen 2-5, at 323× magnification

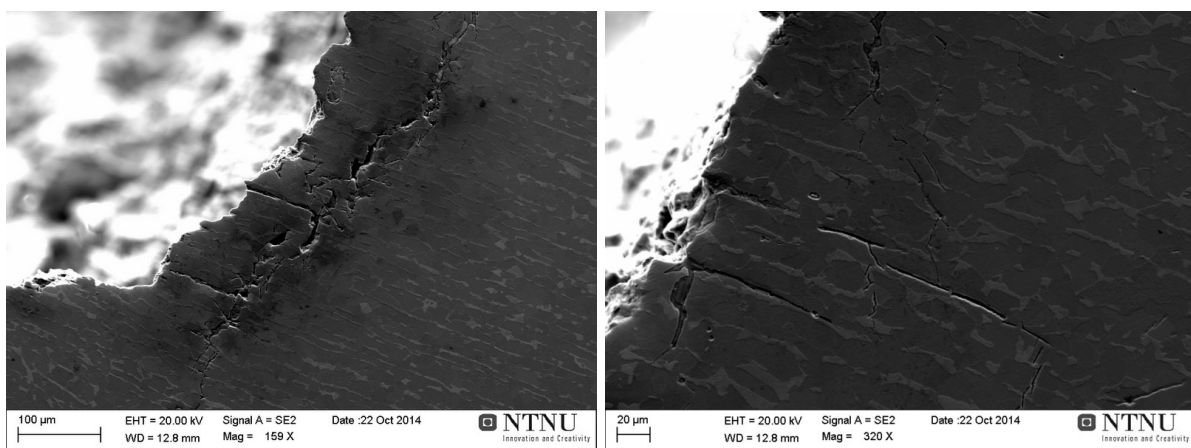
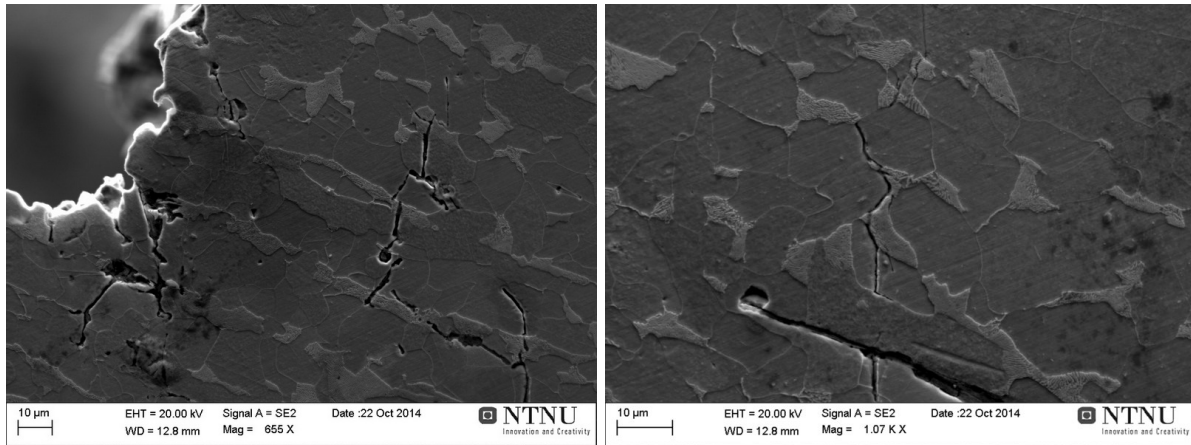
Figures 4.7 and 4.8, show the fracture surface of specimen 2-6 from the side. The rolling direction is perpendicular to the fracture surface, as can be observed by the elongation of the pearlite grains in this direction. Many secondary cracks were observed, indicating a brittle fracture mode. Several microcracks were also found beneath the fracture surface. However, these cracks were only found at short distances, up to approximately 0,3 mm, from the fracture surface. It can be observed that some of the microcracks are aligned transverse to the rolling direction, like the majority of the cracks in Figure 4.7a, while others are aligned in the longitudinal direction, like most of the cracks in Figure 4.7b. In addition, both transgranular and intergranular cracks can be observed by studying the images in Figure 4.8. The cracks in Figure 4.8a propagate directly through both pearlite and ferrite grains, while a crack following the grain boundaries can be seen in Figure 4.8b.

**Figure 4.7:** Fracture surface of specimen 2-6 viewed from the side. The rolling direction is perpendicular to the fracture surface.

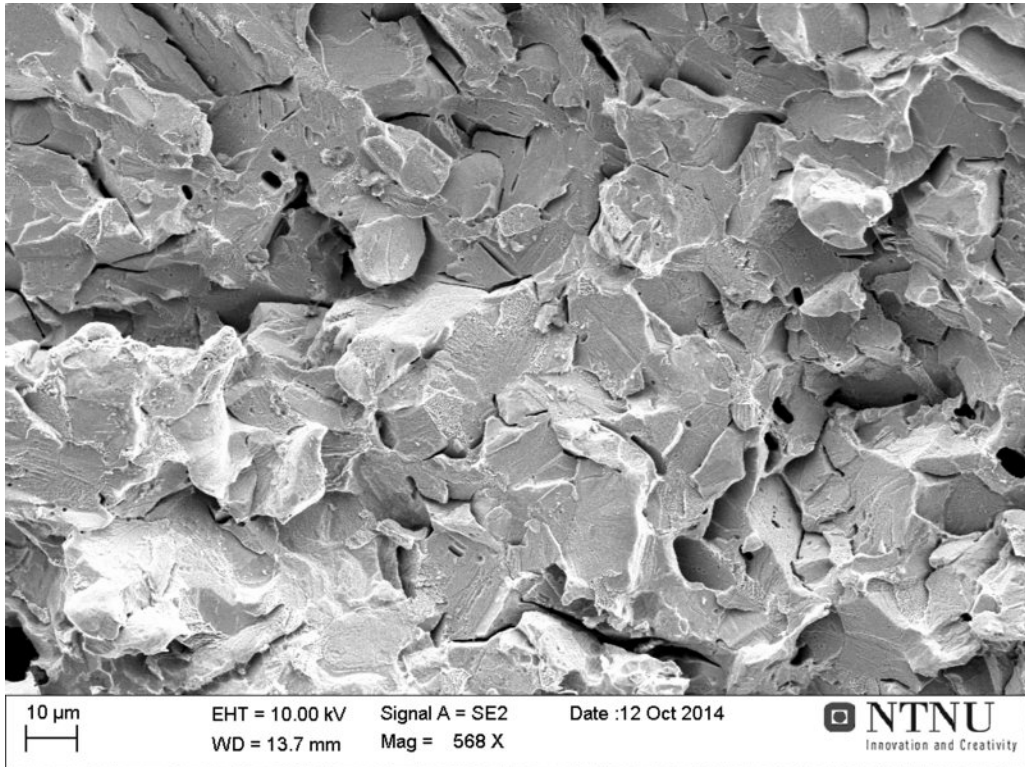
**Figure 4.9:** SEM image of the fracture surface of specimen 2-8 at 568 X magnification

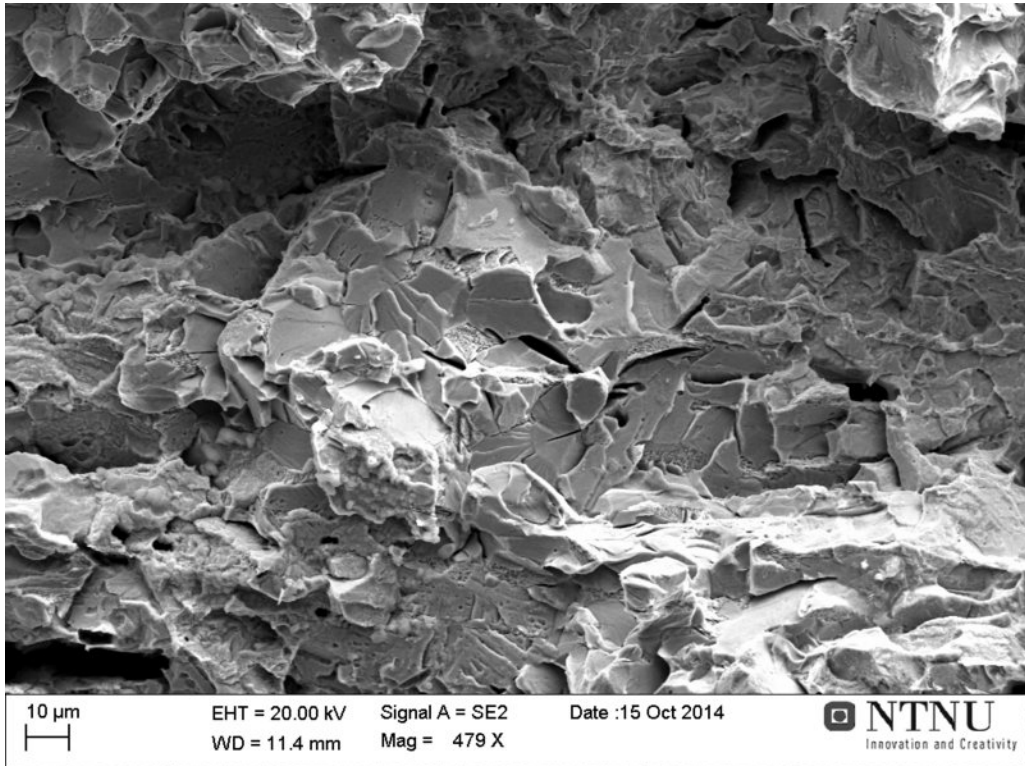
**Figure 4.10:** SEM image of the fracture surface of specimen 2-14, at 479 X magnification

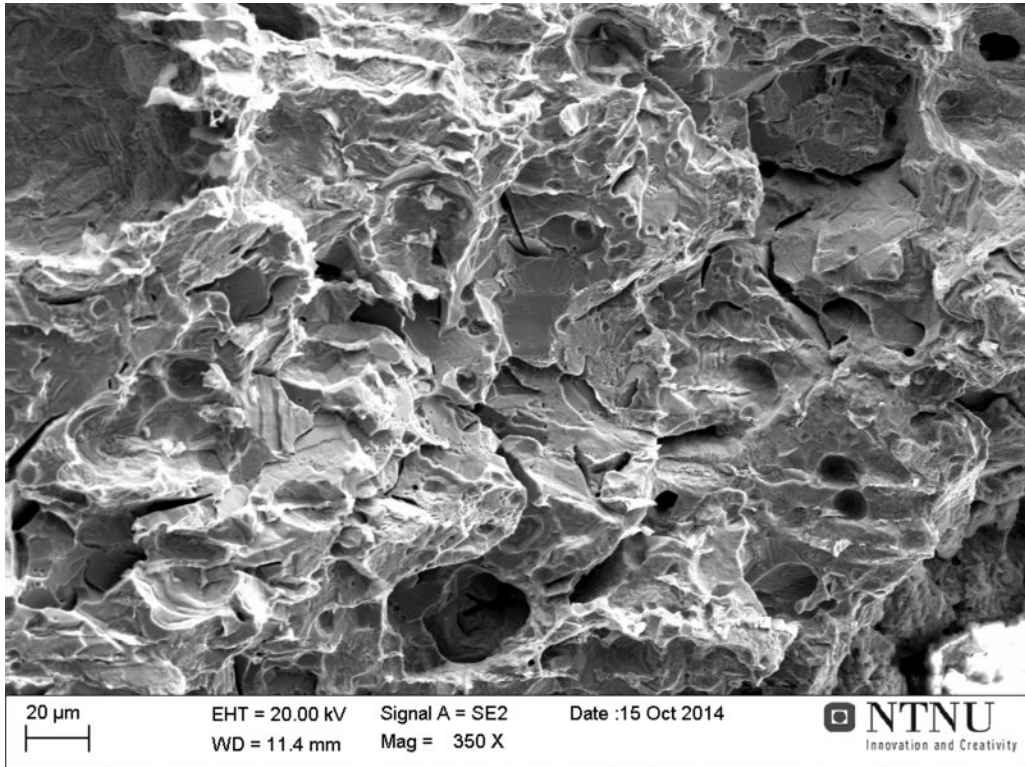
Figure 4.11: SEM image of the fracture surface of specimen 2-16, at 350 X magnification

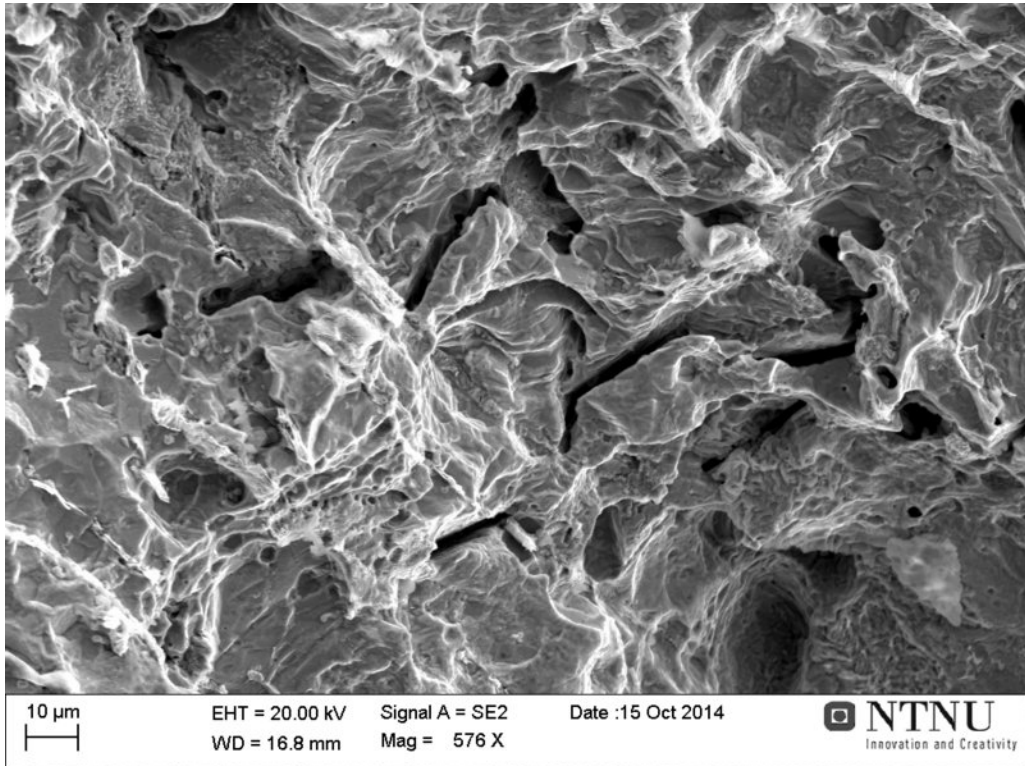
Figure 4.12 shows an image of the fracture surface of specimen 2-20. Also here, surface cracks are observed. Pores of different sizes and depths can also be seen in the image, as well as some elongated pearlite grains. While the surface cracks may indicate that some transgranular brittle fracture features were present, no flat regions could be observed. The dimples may be traces of ductile fracture or caused by etching or rusting.

Figure 4.12: SEM image of the fracture surface of specimen 2-20, at 576 X magnification

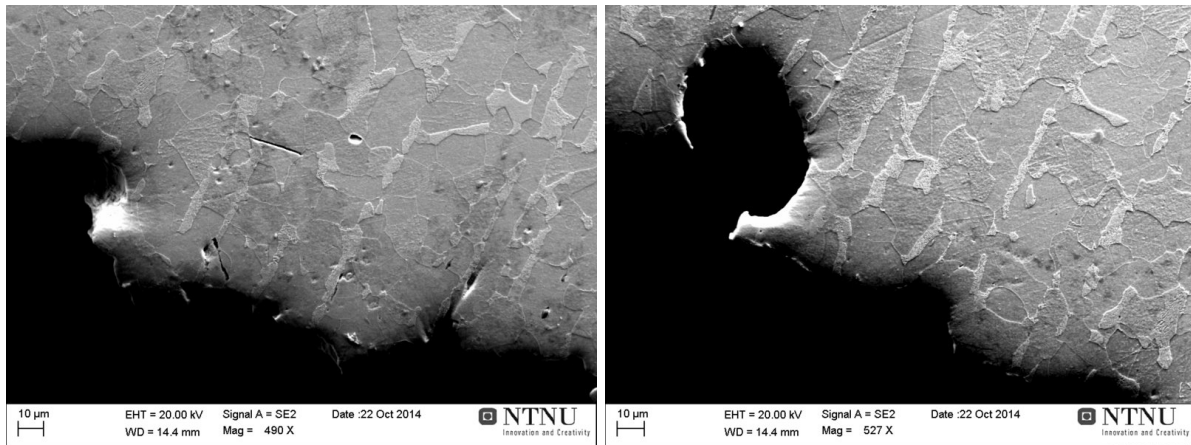
The images in Figure 4.13 show the fracture surface of specimen 2-19 from the side. Little secondary cracking and microcracking beneath the fracture surface could be seen. Only a few cracks could be observed, as shown in Figure 4.13a. This indicates that the fracture mode in this region, which is close to where the crack stopped, was mainly ductile.

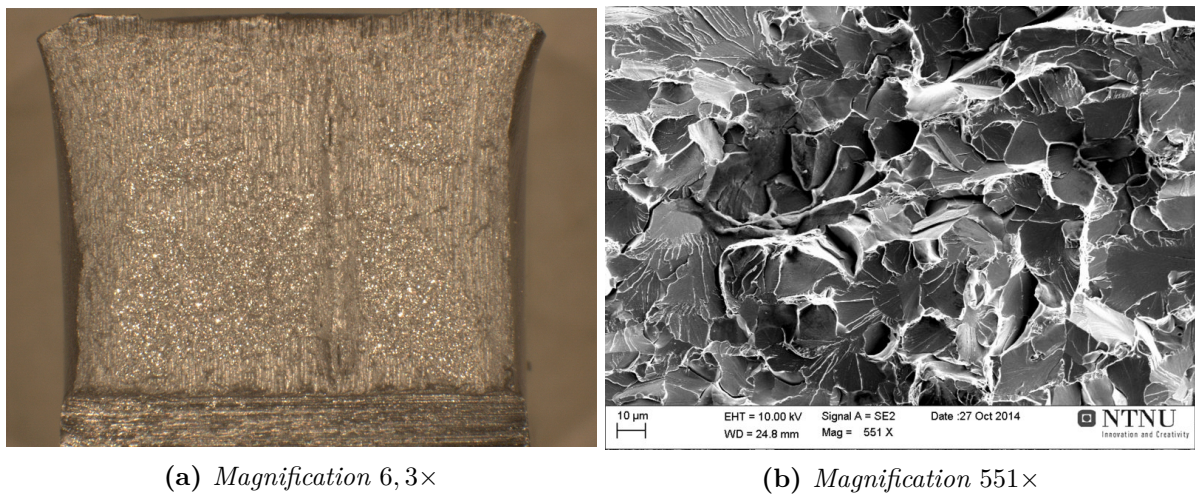
**Figure 4.20:** Fracture surface of specimen 1-32, with a Charpy impact value of 26,47 J

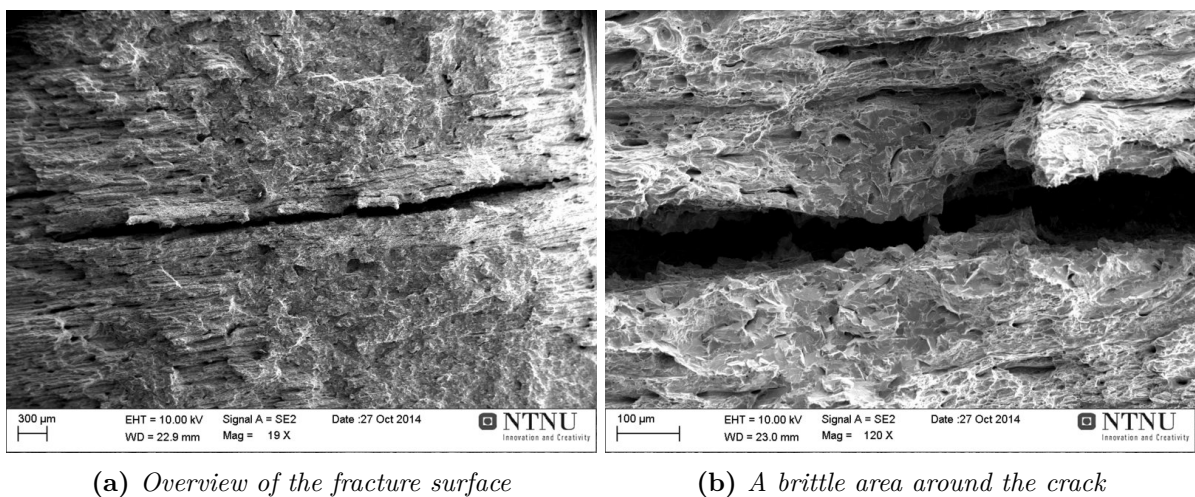
**Figure 4.21:** SEM images of the fracture surface of specimen 1-32, with a Charpy impact value of 36,01 J. Fracture propagation direction is from the right to the left

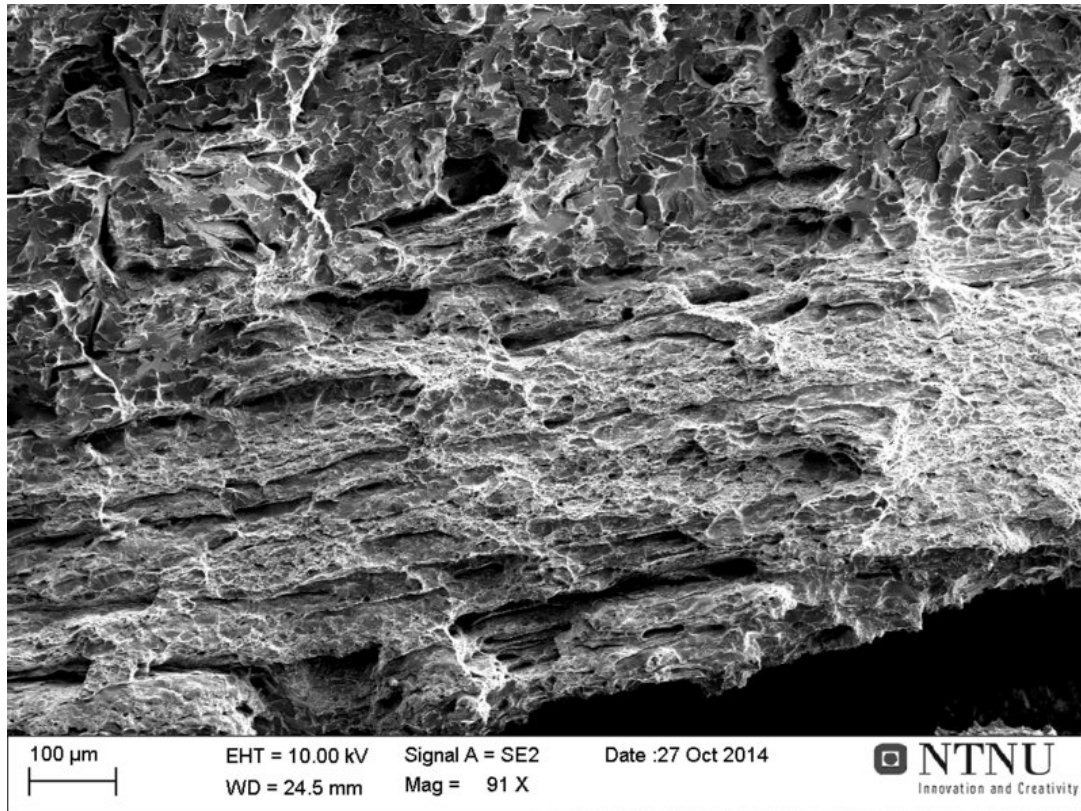
**Figure 4.22:** SEM image of specimen 1-32, with a Charpy impact value of 36,01 J

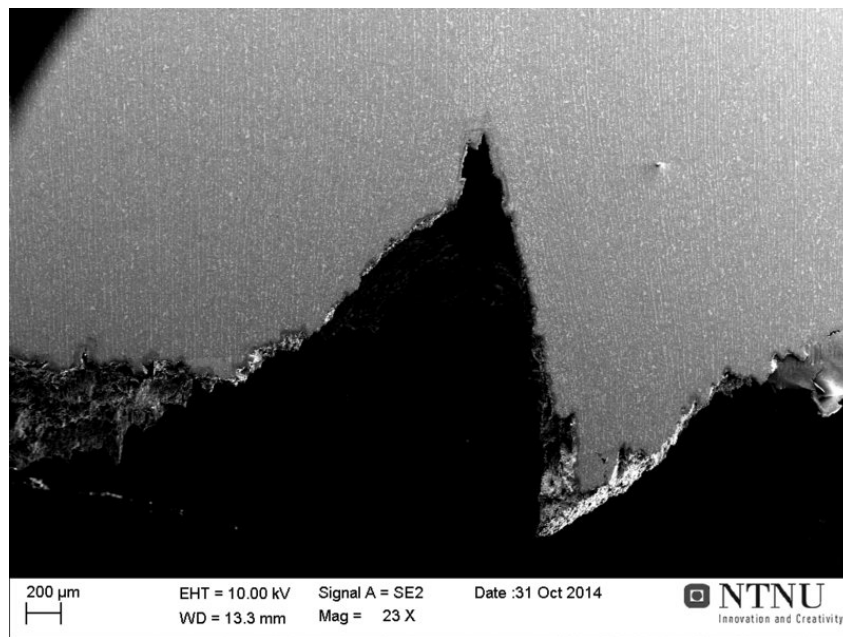
**Figure 4.28:** Fracture surface of specimen 3-34 viewed from the side. The rolling direction is perpendicular to the fracture surface

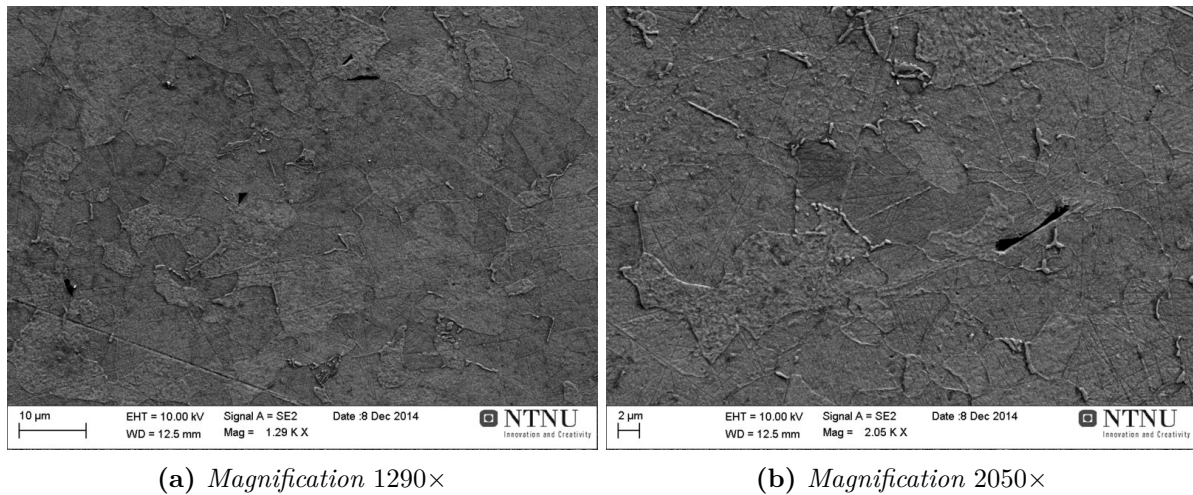
**Figure 4.43:** SEM images from the longitudinal cross section of a S355 specimen which had been held 10 min at a tensile force of 6500 N at  $-196^{\circ}\text{C}$ .
