Norwegian University of  
Science and Technology

# Influence of Cracks on Chloride Ingress and Reinforcement Corrosion

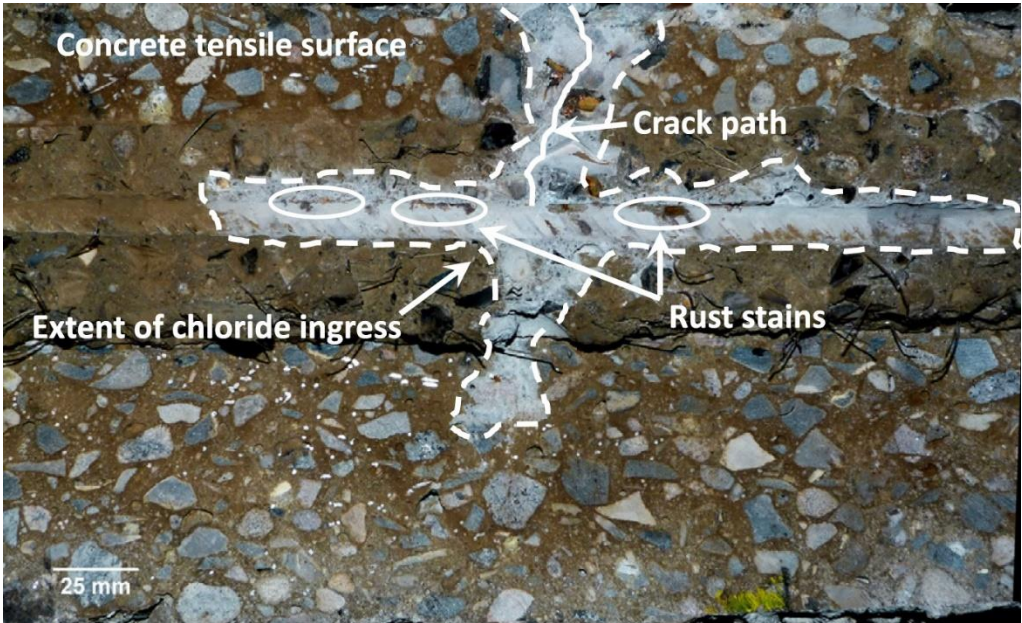
Figure 2.1 Extent of chloride ingress (broken line), crack path (solid line) and rust stains (circled areas) from a laboratory investigation. (Michel et al. 2013)

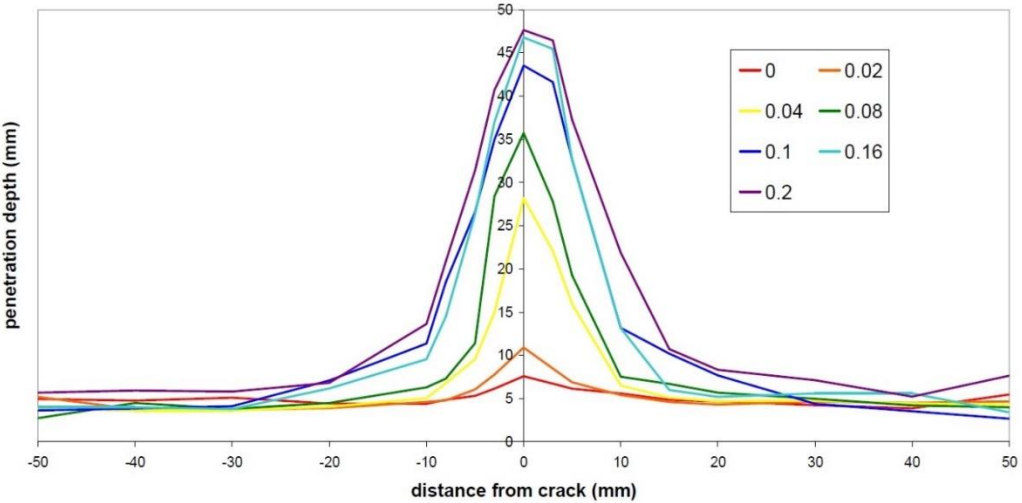
Figure 2.2 Chloride penetration depth for varying crack widths. Cracks were made using Brazilian splitting test. (Audenaert et al. 2009)

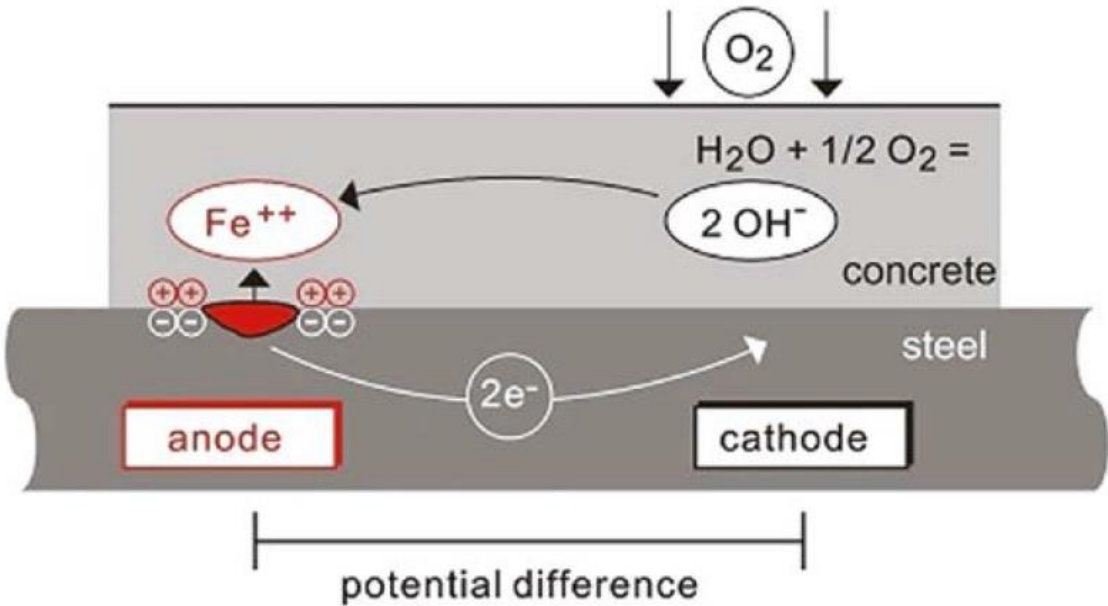
Figure 2.3 Principle of reinforcement corrosion with availability of oxygen. (Proceq SA 2016)

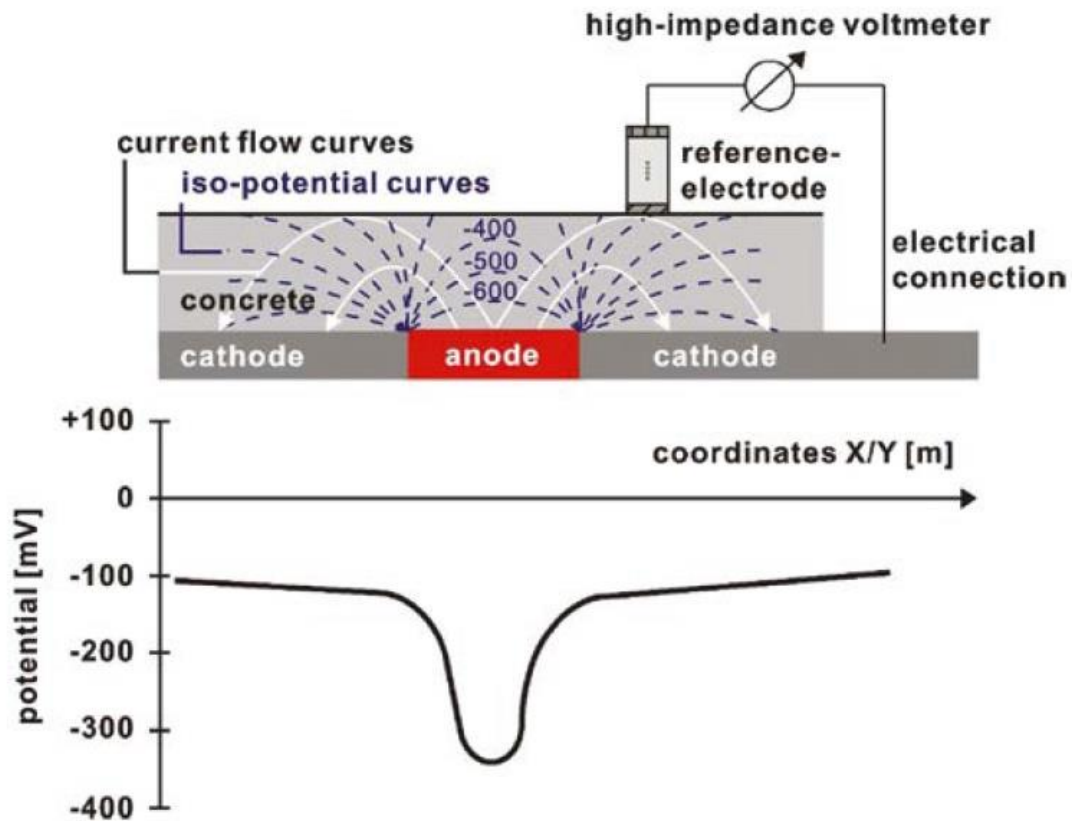
Figure 2.4 Principle of half-cell potential measurements. (Proceq SA 2016)

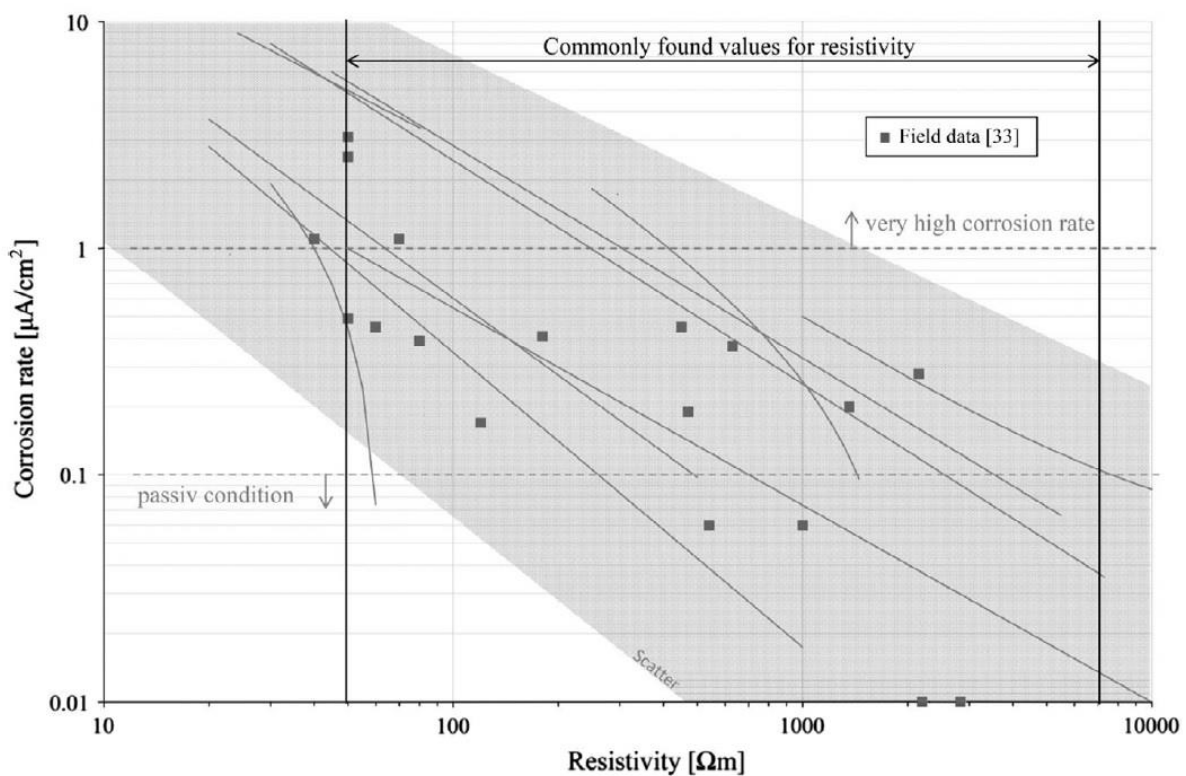
Figure 2.5 A graph on what corrosion rate to expect from different resistivity values. (Hornbostel et al. 2013)

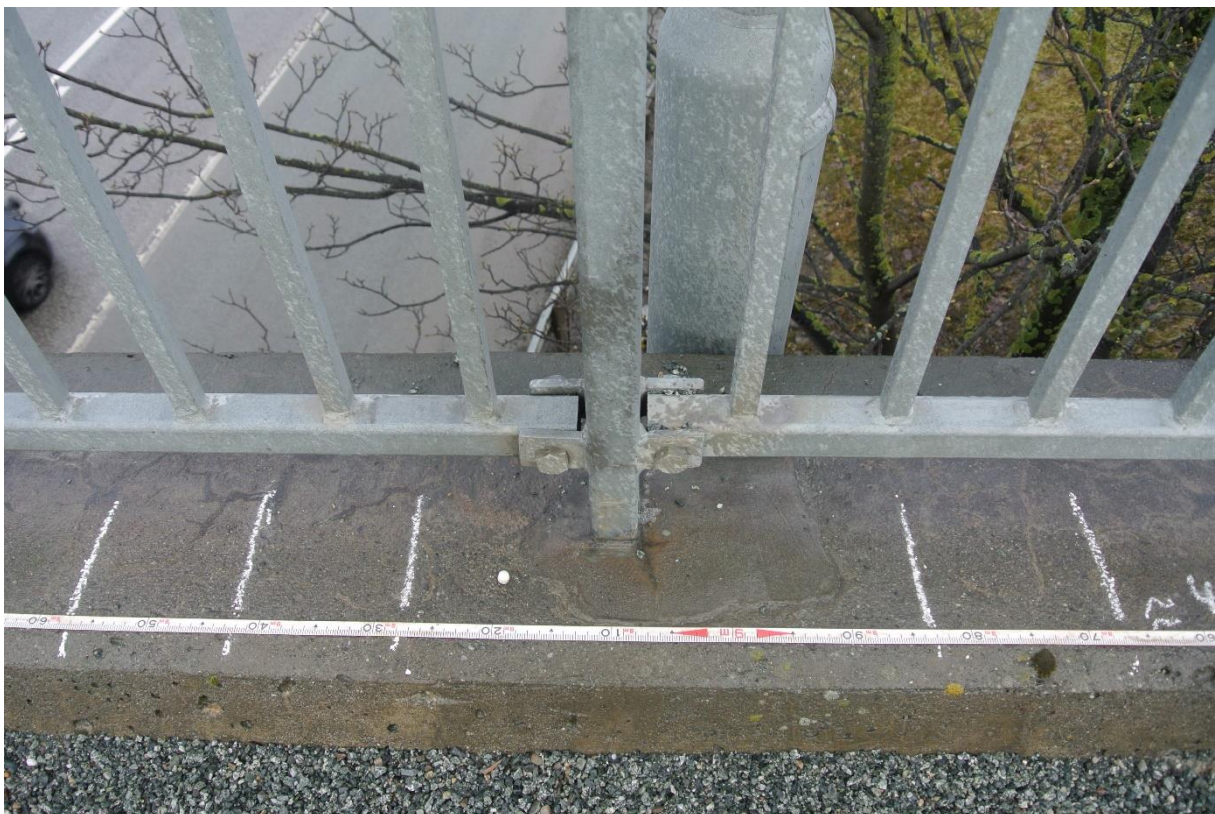
*Figure 3.5 Fence post on Moholt bridge, extra concrete seem to be added around the post.*

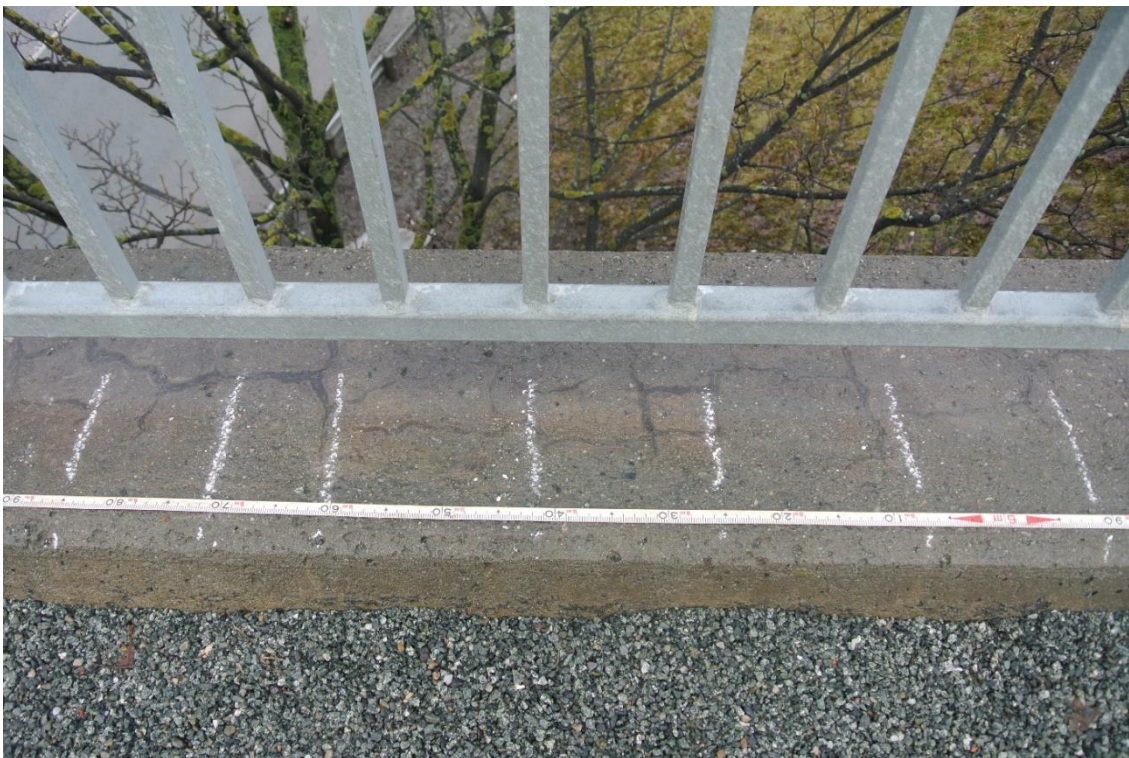
Figure 4.2 Another picture of the axis, the stirrups are marked. In this picture point 6.61 m is located, that is where later core B was drilled from. At 6.61 m the tiny 0.15 mm singular crack is hard to see, even on a close up picture. The cracks with a darker color is the map pattern type of cracks.

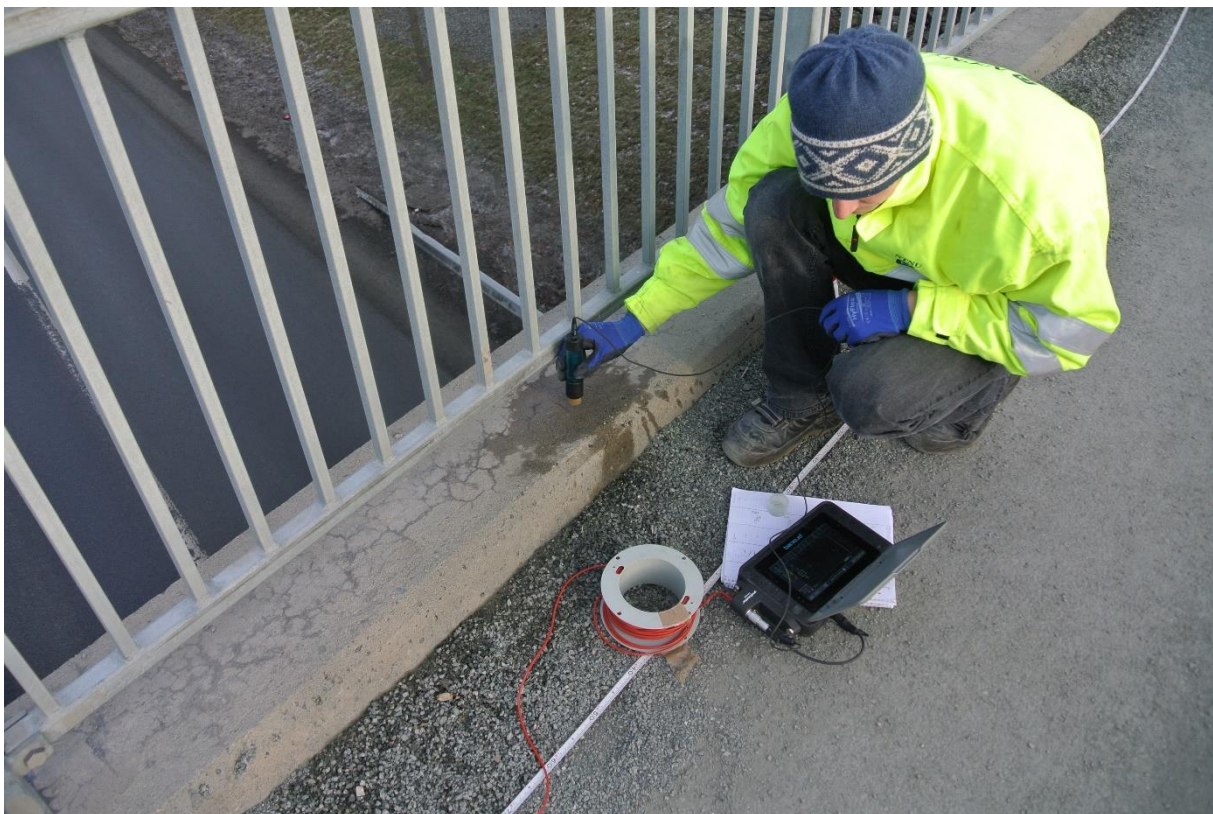
Figure 4.3 Measuring half-cell potential with the Profometer, here the Cu/CuSO<sub>4</sub> rod is used in combination with the Proceq Profometer.

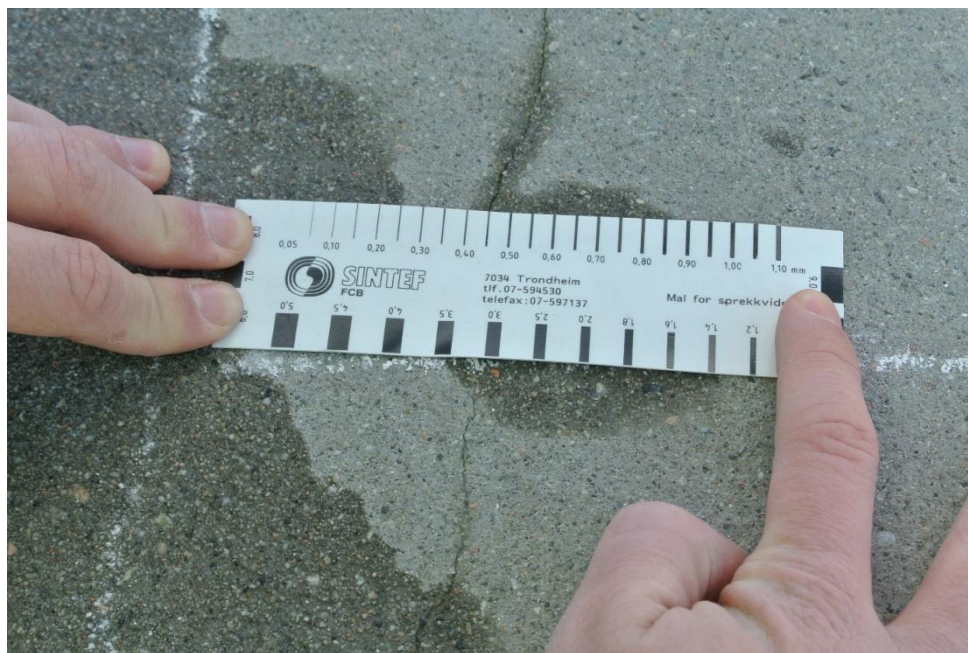
Figure 4.6 Measuring crack width where core A from Cecilie Bridge later was drilled.

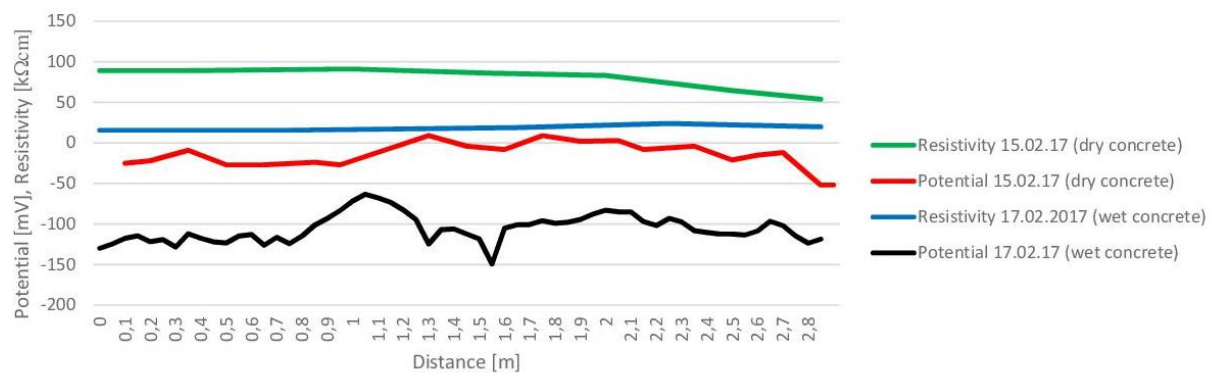
Figure 5.1 half-cell and resistivity measurements done on wet (17.02.17) and dry (15.02.17) concrete for the first 3 meters of Moholt Bridge. X-axis represent distance from point 0, given in meters. Point 0 is at the east end of the bridge, as shown in Figure 4.1

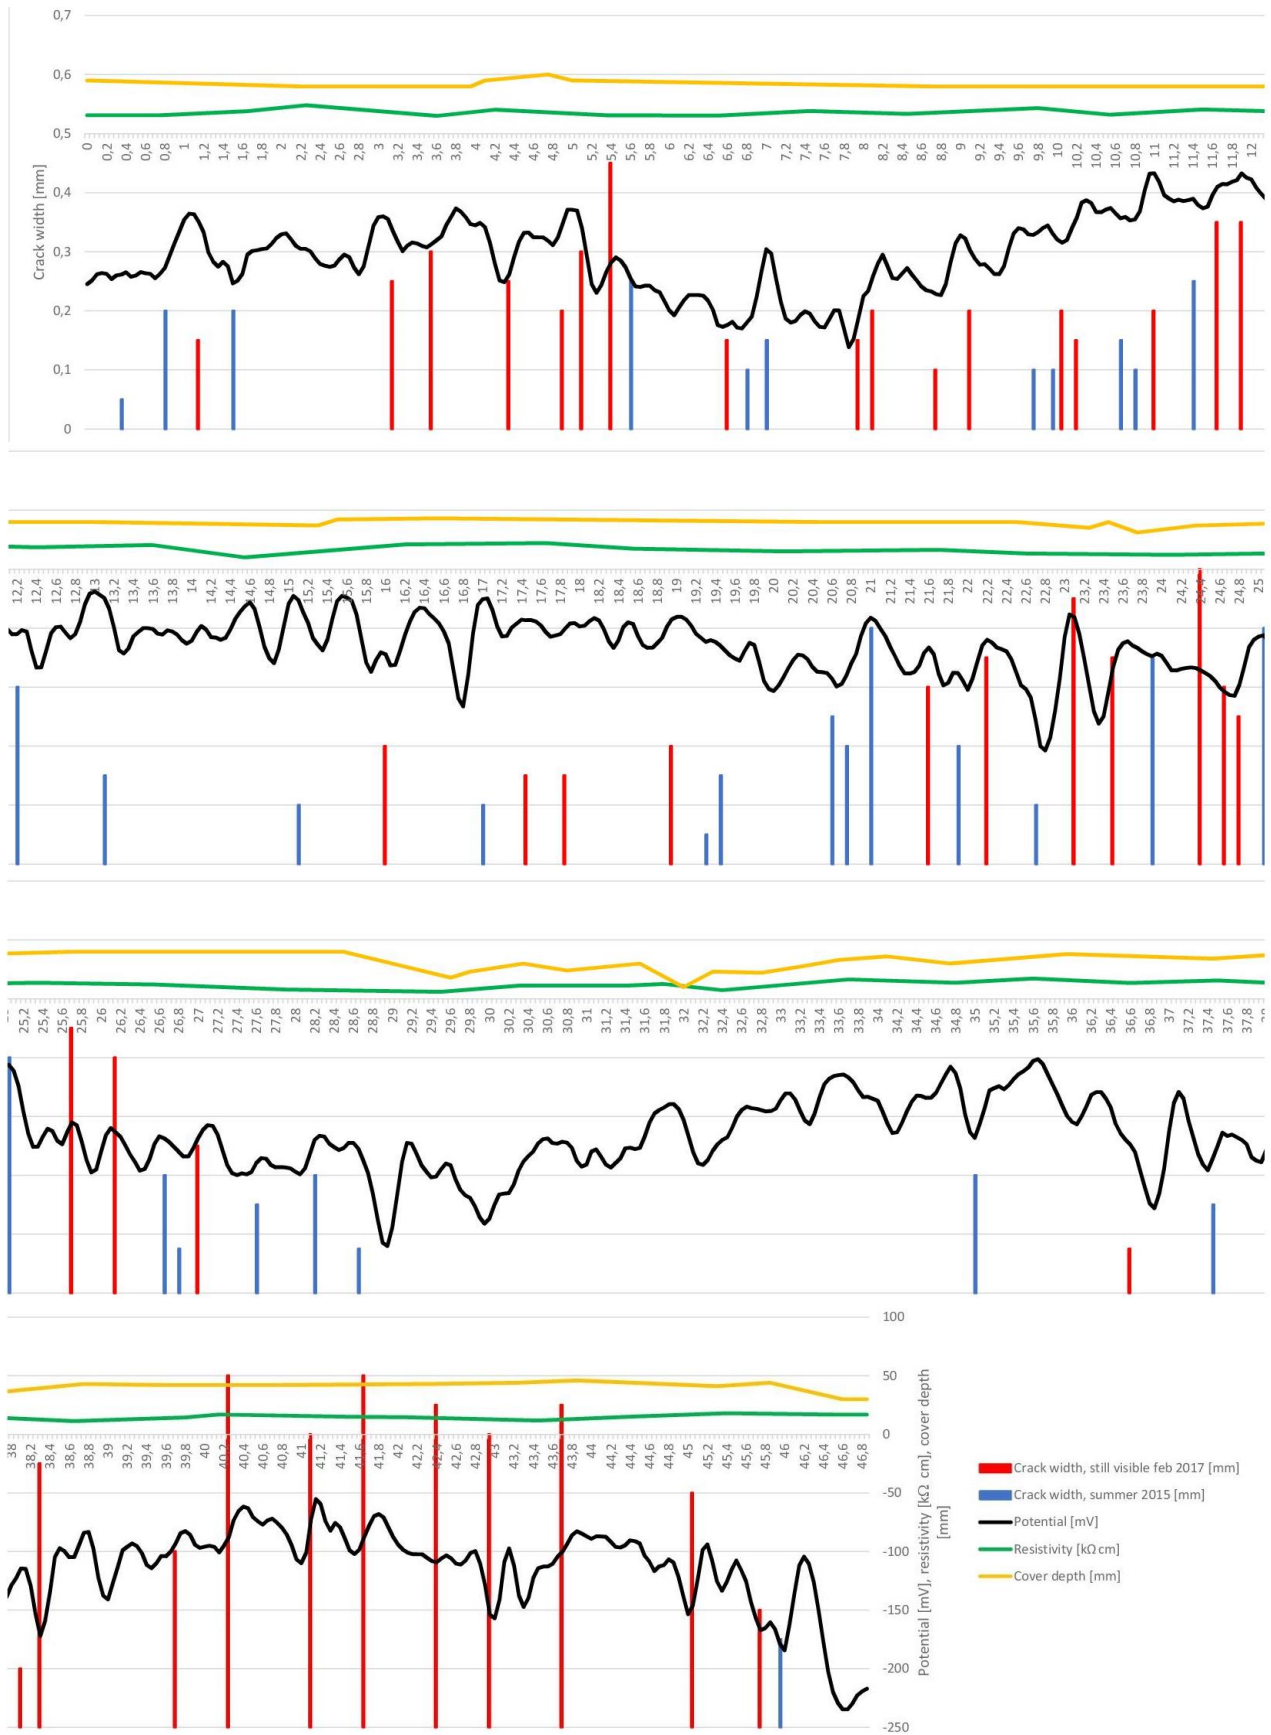
Figure 5.2 Complete measurements from Moholt Bridge, half-cell potential, concrete resistivity, cover depth and crack width together. The x-axis starts with 0 m at the joint on the east side and ends at 46.85 m at the joint on the west side of the bridge. The reference electrode is a Cu/CuSO<sub>4</sub>.

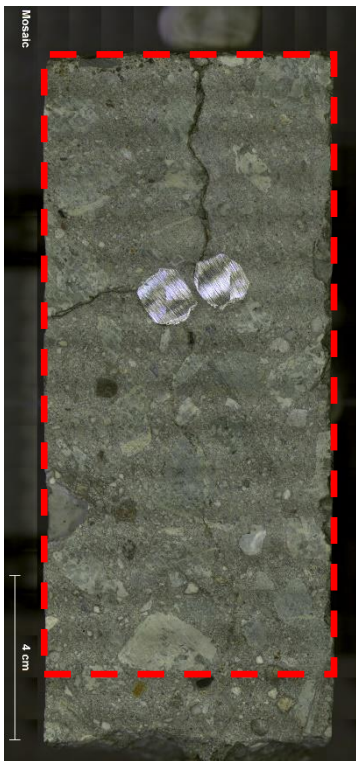
Figure 5.8 Mosaic picture of core E, Moholt Bridge. Exposed concrete surface is on the top.

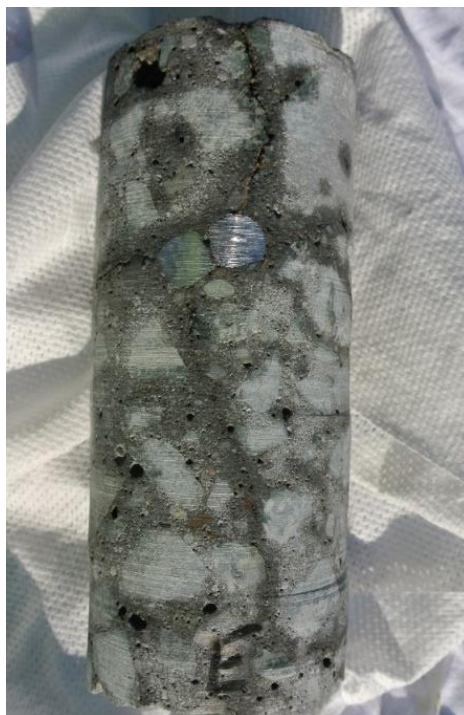
*Figure 6.1 A picture of core E, Moholt Bridge. It is oriented so that the surface is on top in this picture. This picture is taken right after the core was drilled and therefore it had recently been exposed to a lot of water needed to cool the drilling equipment.*

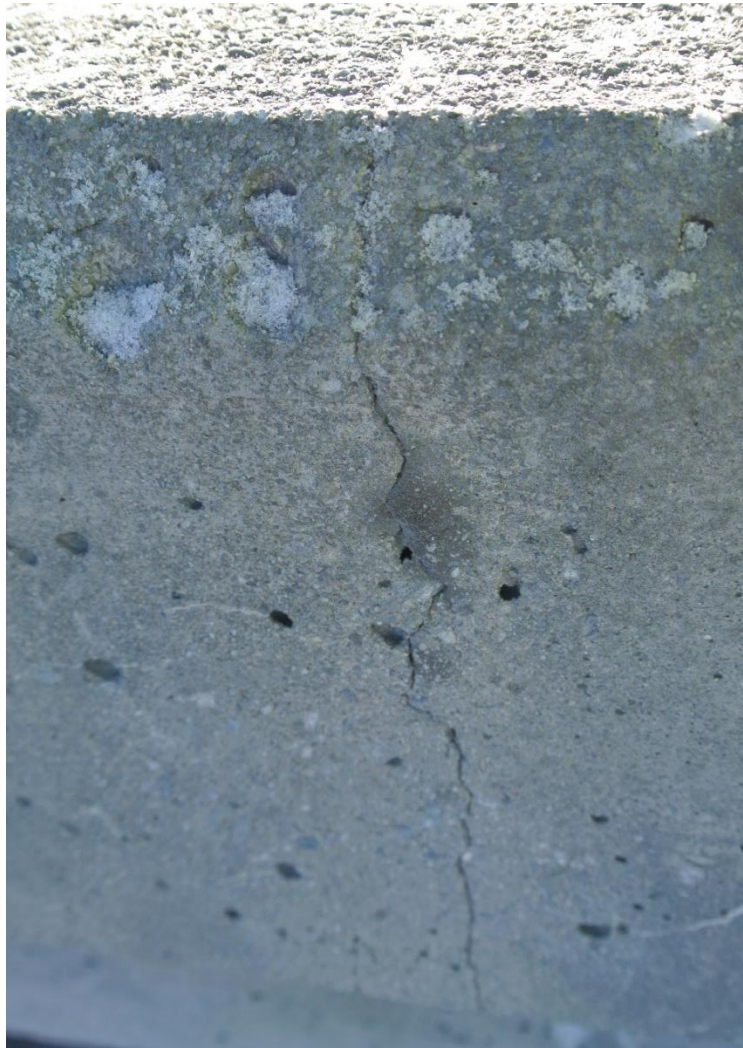
*Figure 6.2 One of the singular cracks. This picture is from the outer side of the edge beam. This crack extends on the top surface to where core E was drilled.*

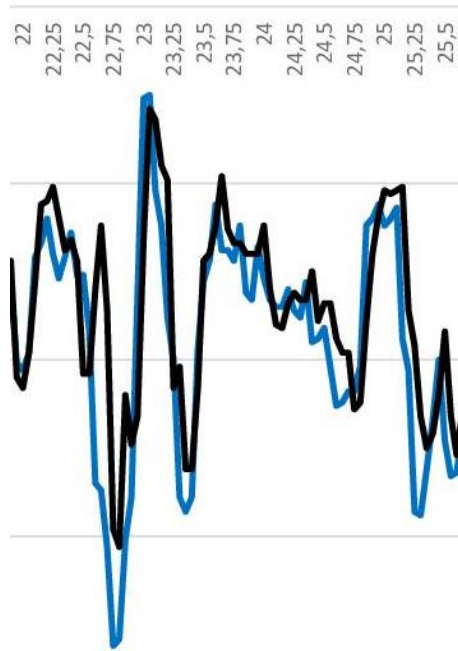
Figure 6.3 Half-cell potential values at Moholt Bridge from 22.0 m - 25.5 m.

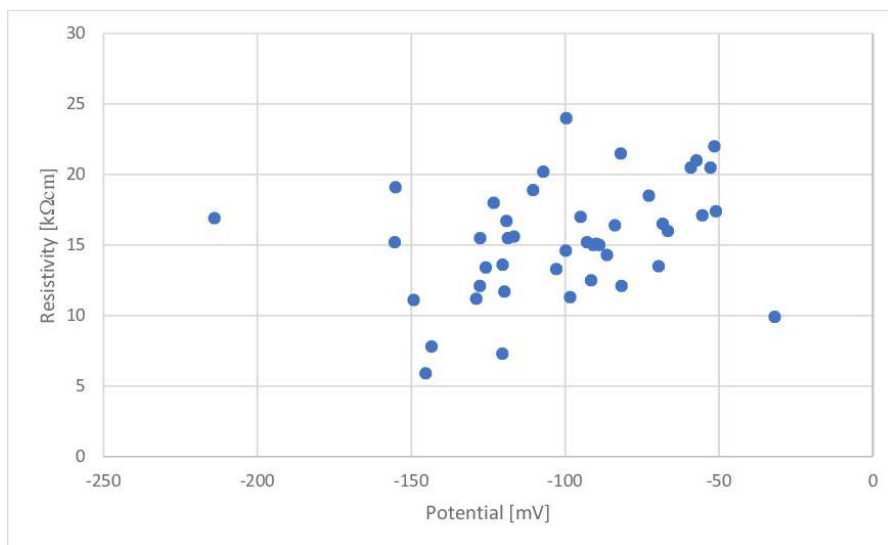
Figure 6.4 Resistivity versus half-cell potential from Moholt Bridge

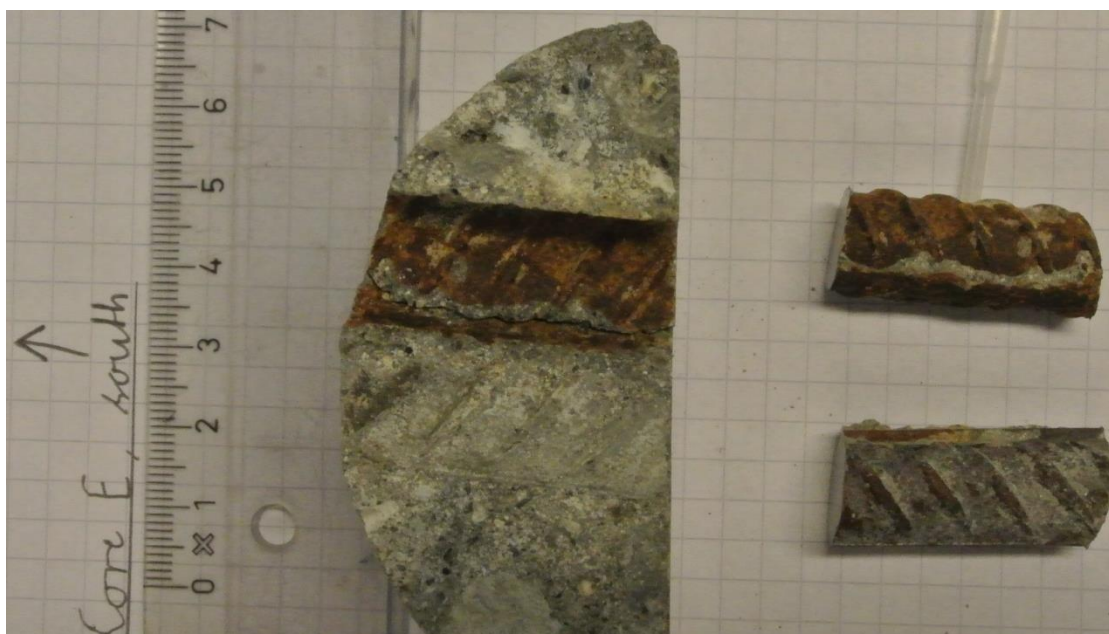
Figure 6.5 Excavating the reinforcement from core E, Moholt Bridge

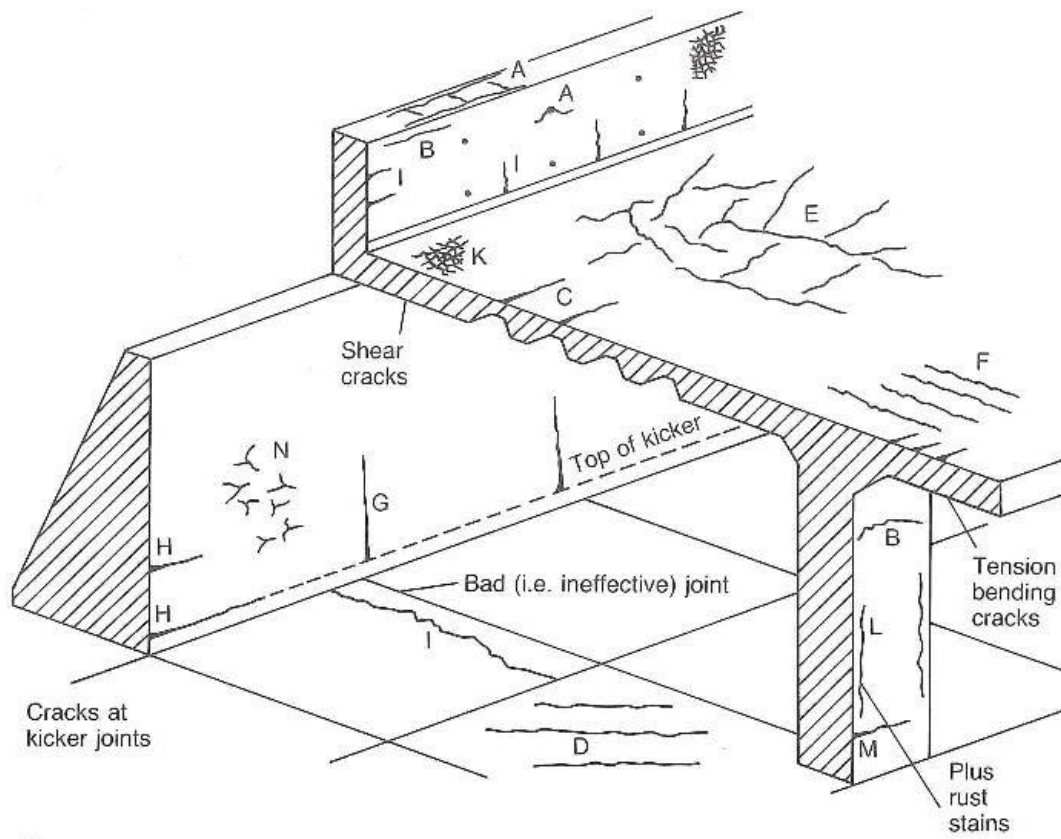
Figure 10.10 Picture describing different cracks on a structure, letters refer to Table 10.1

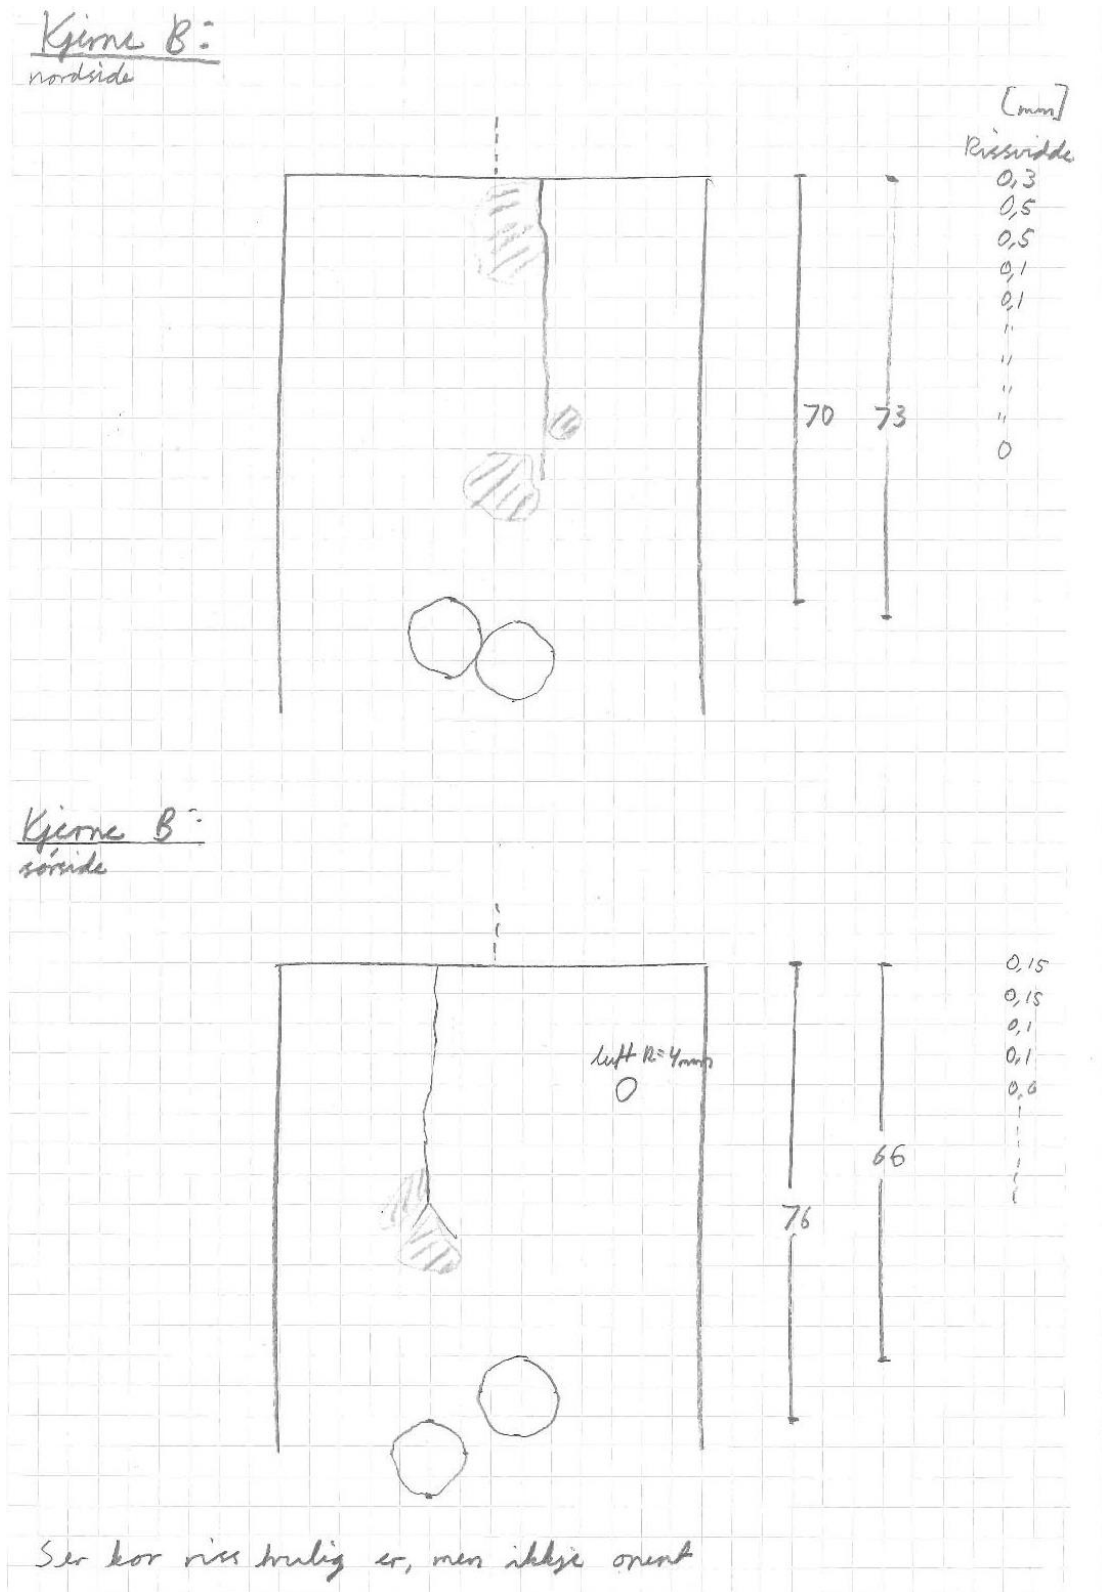
Figure 10.11 Drawing of core B with point of interest and detailed crack width.

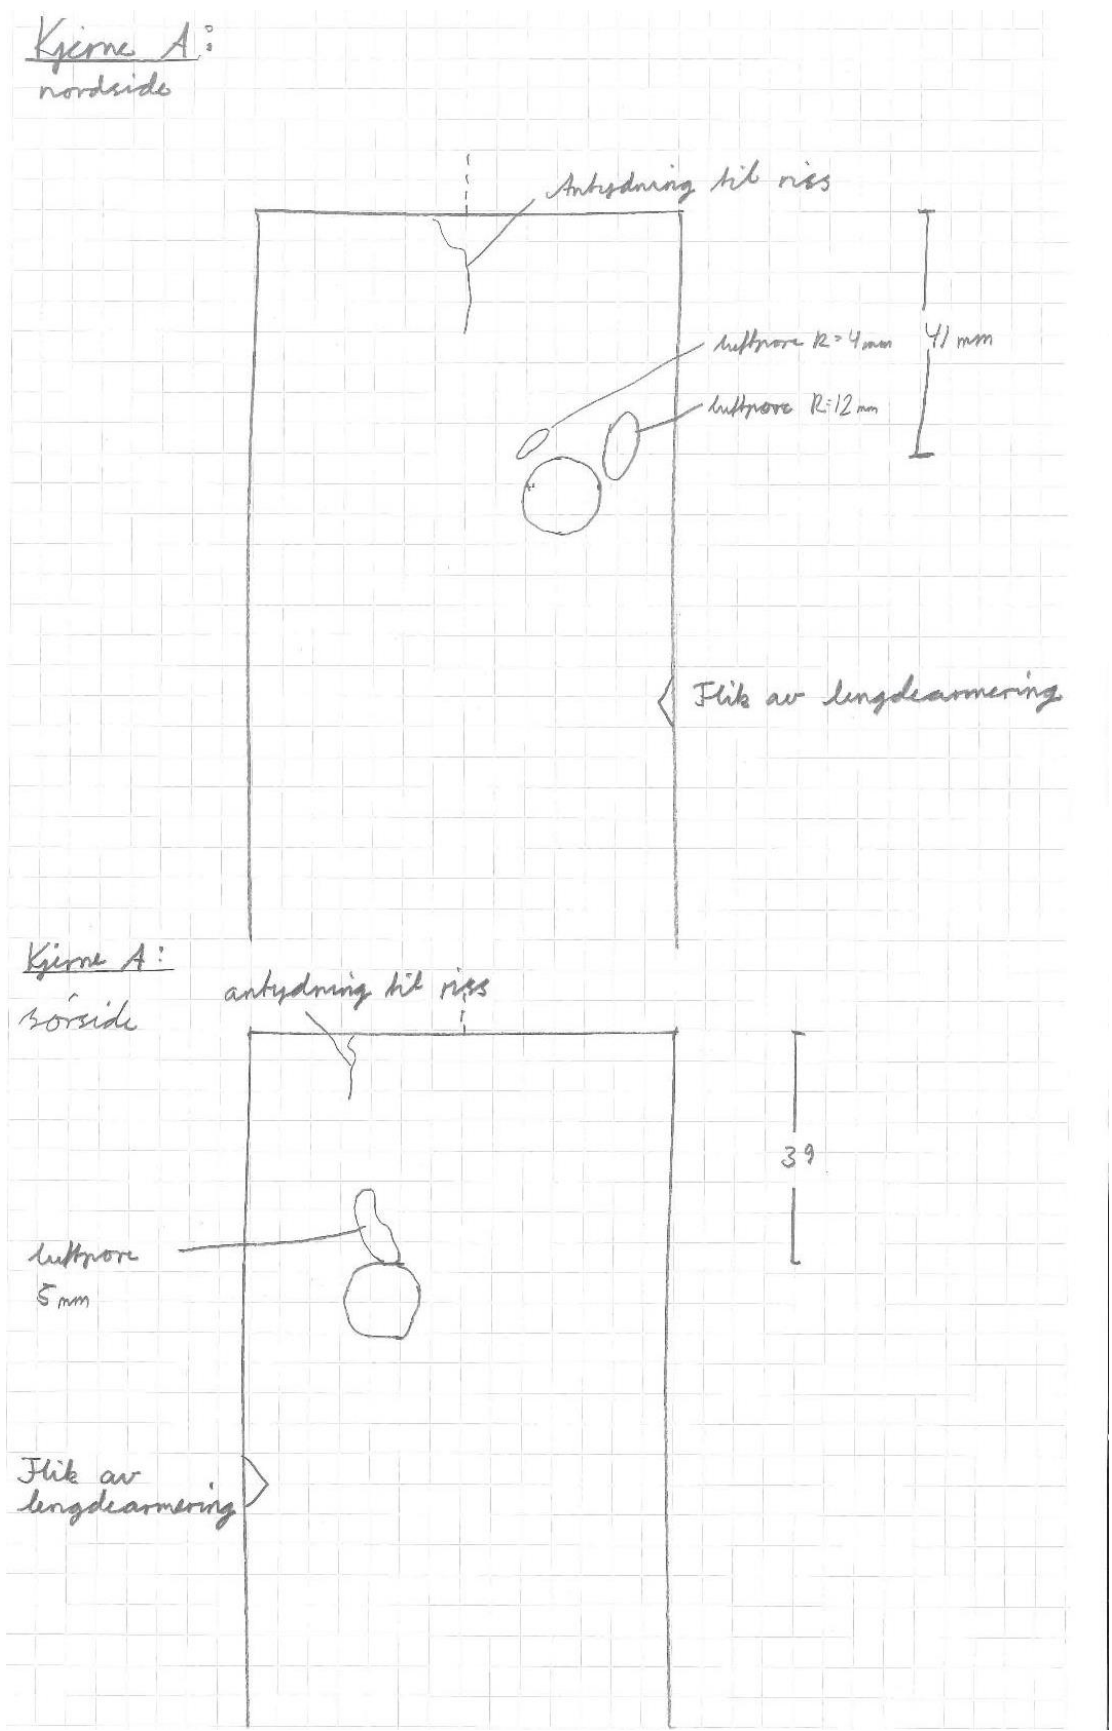
Figure 10.12 Drawing of core A with point of interest and detailed crack width.

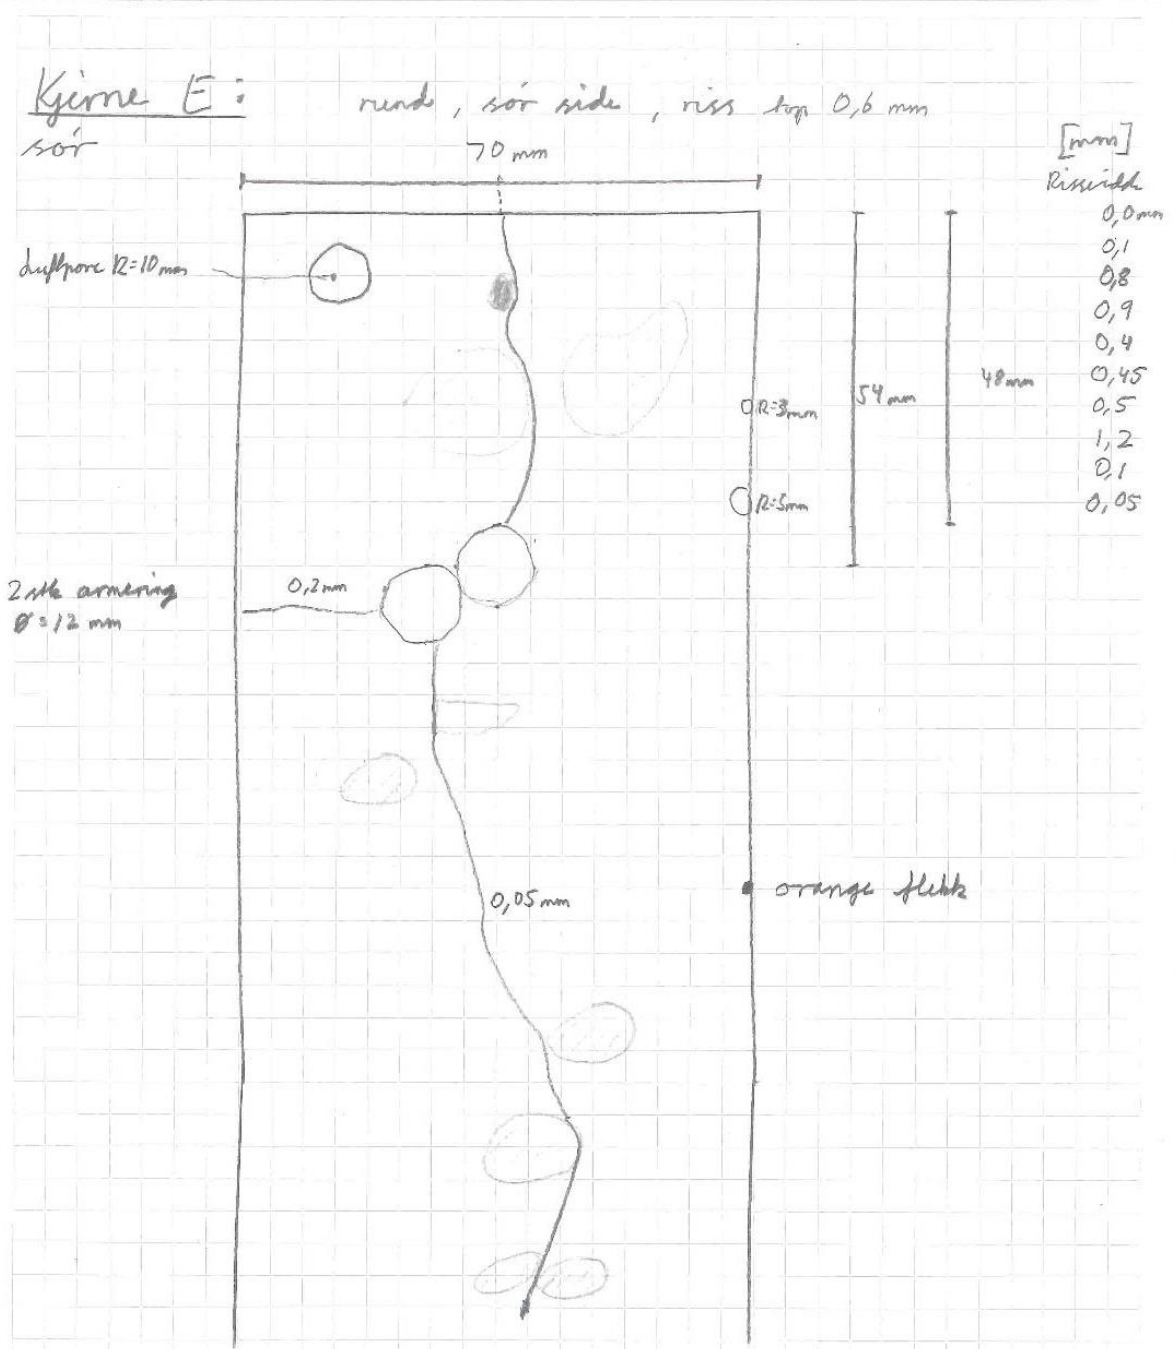
Riss går rundt tilslag, følger kantene til tilslag  
 Riss under armering er rypelig, men egentlig ikke åpen  
 Riss til venstre for armering er åpen  
 Det er områder / vertikale streker som fører uten riss  
 til høyre for armering og, men ikke rypelig riss.  
 Også områder beholdt til begge sider under armering  
 Fleire små luftporer

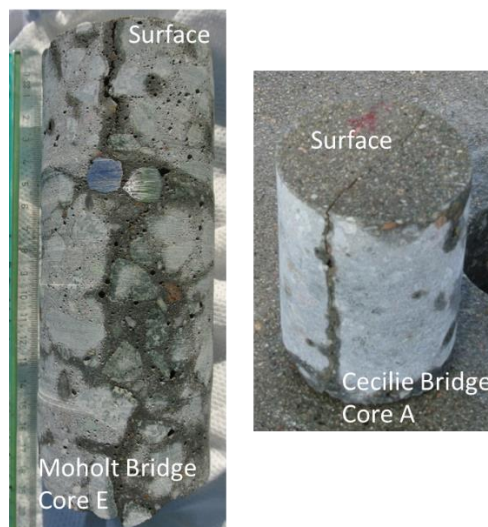
Figure 10.15: Concrete cores E and A extracted from Moholt Bridge (Left; Crack width 0.55 mm, cover 50 mm) and Cecilie Bridge (right; Crack width 0.45 mm). Picture: Andreas Rygg

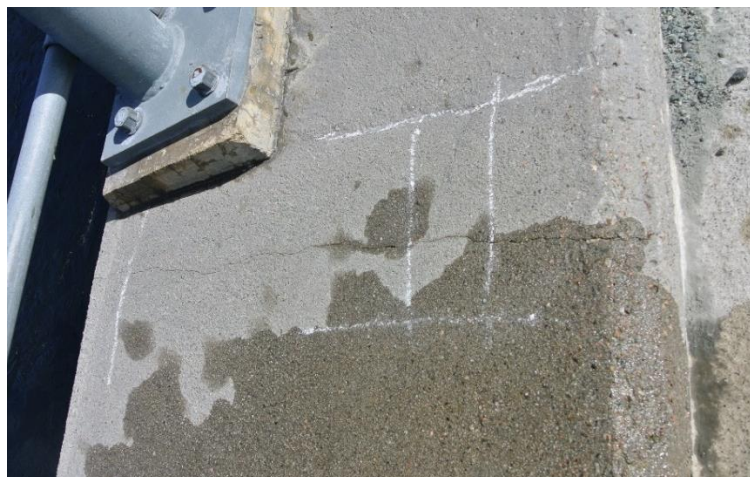
Figure 10.16: Investigated singular crack through the edge beam on Cecilie Bridge (Crack width 0.45 mm). Picture: Andreas Rygg

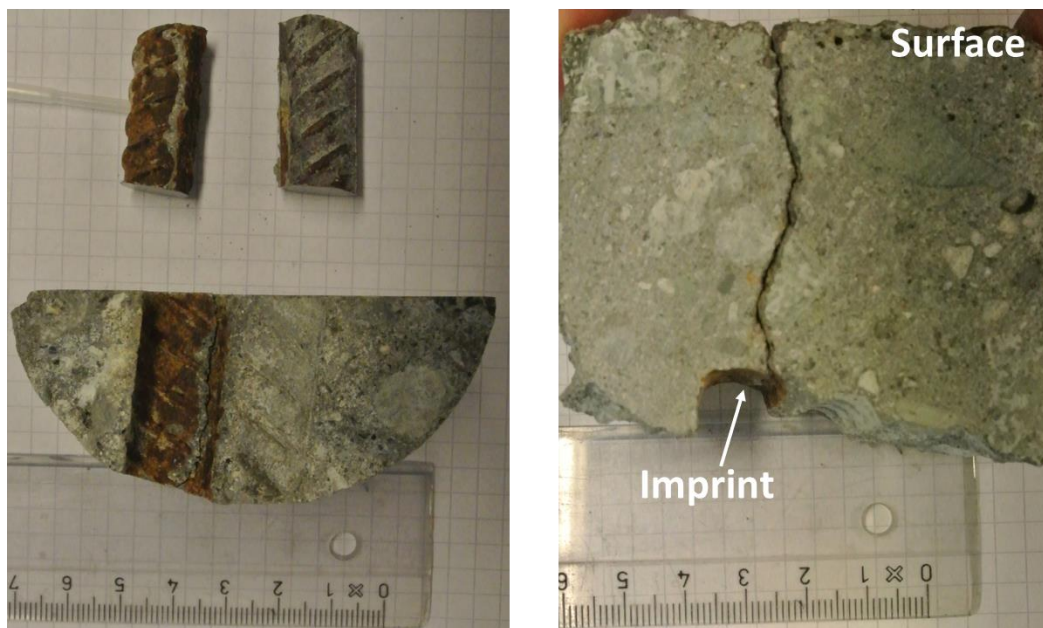
Figure 10.17: Extraction of reinforcement from the Core E from Moholt Bridge. Stirrups located left and right to the crack and imprint of corrosion products in the steel-concrete-interface facing upwards (left). Cut surface showing the crack and imprint of corrosion products in the steel-concrete-interface of the left stirrup facing upwards (right). Picture: Andreas Rygg

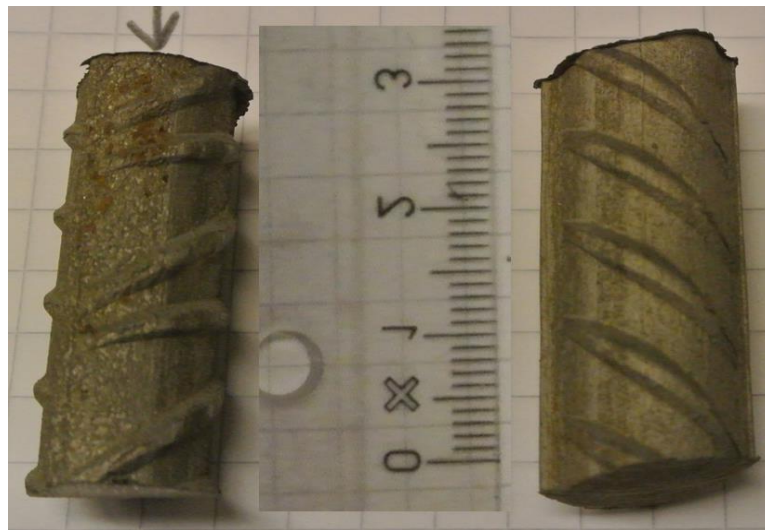
*Figure 10.18: Extracted reinforcement from Core E from Moholt Bridge. Mostly Corroded stirrup located left to the crack (left), less corroded stirrup located right to the crack (right). Picture: Andreas Rygg*

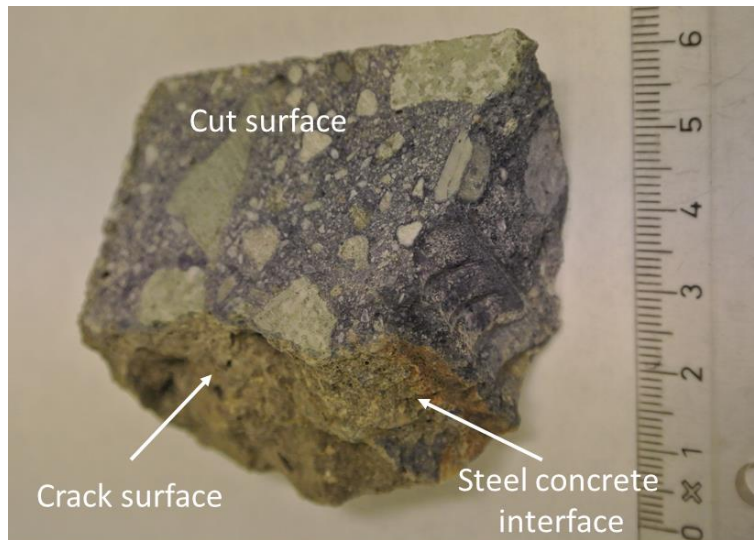
Figure 10.19: Carbonation on crack surface and cut surface of Core E from Moholt Bridge. Picture: Andreas Rygg

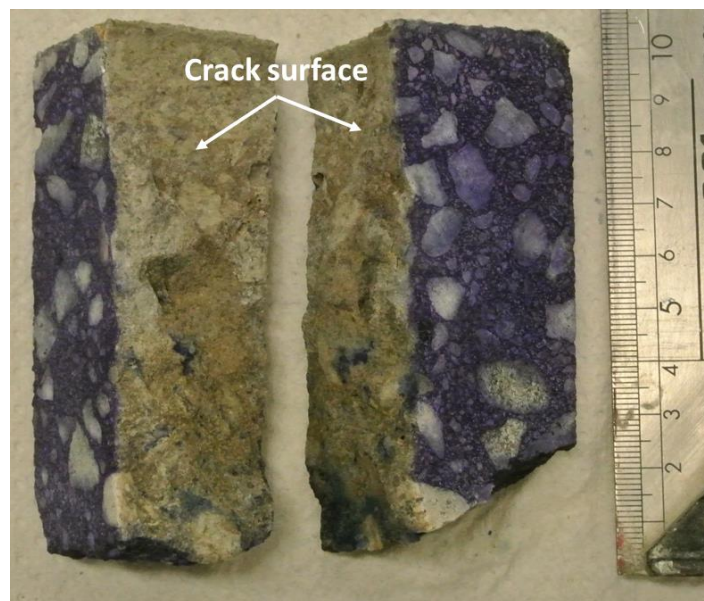
Figure 10.20: Carbonation on crack surface and cut surface of Core A from Cecilie Bridge. Picture: Andreas Rygg
