The Story of a Steep River: Causes and Effects of the Flash Flood on 24 July 2017 in Western Norway

Abstract: Flash floods can cause great geomorphological changes in ephemeral fluvial systems and result in particularly severe damages for the unprepared population exposed to it. The flash flood in the Storelva river in Utvik (western Norway) on 24 July 2017 was witnessed and documented. This study assessed the causes and effects of the 2017 flood and provides valuable information for the calibration and validation of future modelling studies. The flooded area at peak discharge, maximum wetted and dry areas during the entire event, critical points and main flow paths were reconstructed using on-site and post-event (i) visual documentation, such as photographs and videos, and (ii) aerial surveying, such as orthophotographs and laser scanning, of the lowermost reach. The steep longitudinal slope together with the loose material forming the valley and riverbed contributed to a large amount of sediment transport during this extreme event. Steep rivers such as the Storelva river have very short response times to extreme hydrologic conditions, which calls for exhaustive monitoring and da

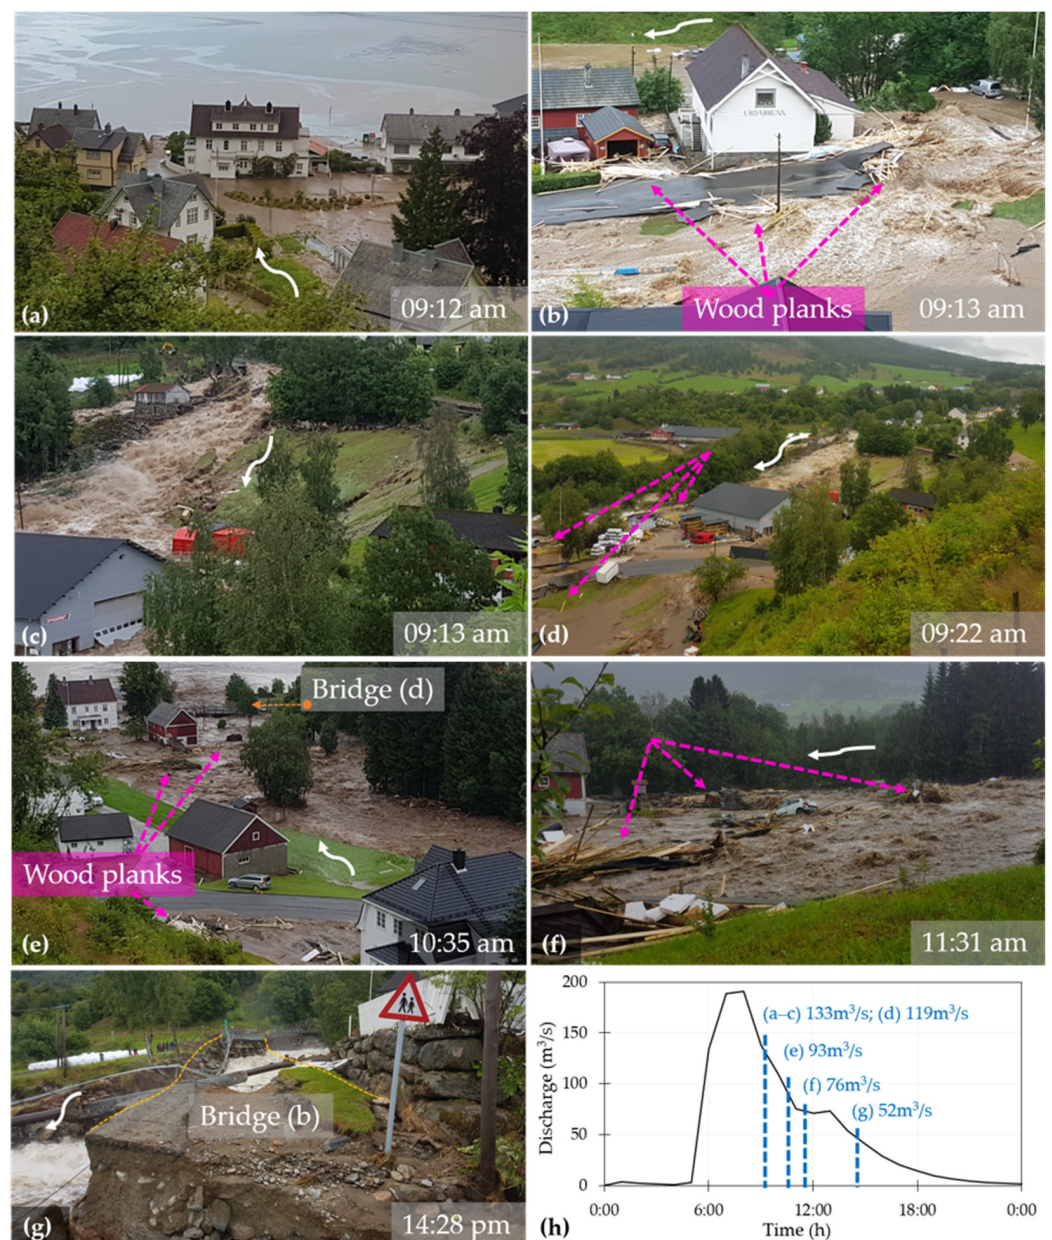
Figure 4. Examples of visual documentation of the flash flood in the Storelva river in Utvik on 24 July 2017 ((a–g), photographed by O. Bruland after Q_{peak}), sorted temporally and referenced in the hydrograph with highest expectancy (h) from [8]. Flow direction indicated by white arrows.

downwards on the floodplain all the way westwards downstream (Figures 4 and 5c–f). This location seemed to be the most critical.

and left bank. Bridges (a), (c) and (d) were eroded away, and the road embankment by bridge (b) was eroded and damaged on the left bank (Figures 4 and 5). Moreover, the severe erosion generated a new river channel and several secondary flow paths during the flood (Figure 6), affecting most of the residential area exposed. Although the effects of such critical points were identified by on-site observations and visual documentation, the geomorphic causes of such critical points were identified when combining such observation with the erosion and deposition map. This study case stresses the importance of monitoring steep rivers and documenting flash flood events. The visual documentation during- and the laser scan post-event provided essential information on the morphologic processes during the flood event, improving our understanding of it and directing our focus to the core issue: the erosion, transport and deposition capacity of steep rivers during flash floods. The procedure followed in this study (Figure 2) was a preliminary attempt to develop a methodology to investigate the causes and effects of similar flash floods affecting steep rivers in other regions.

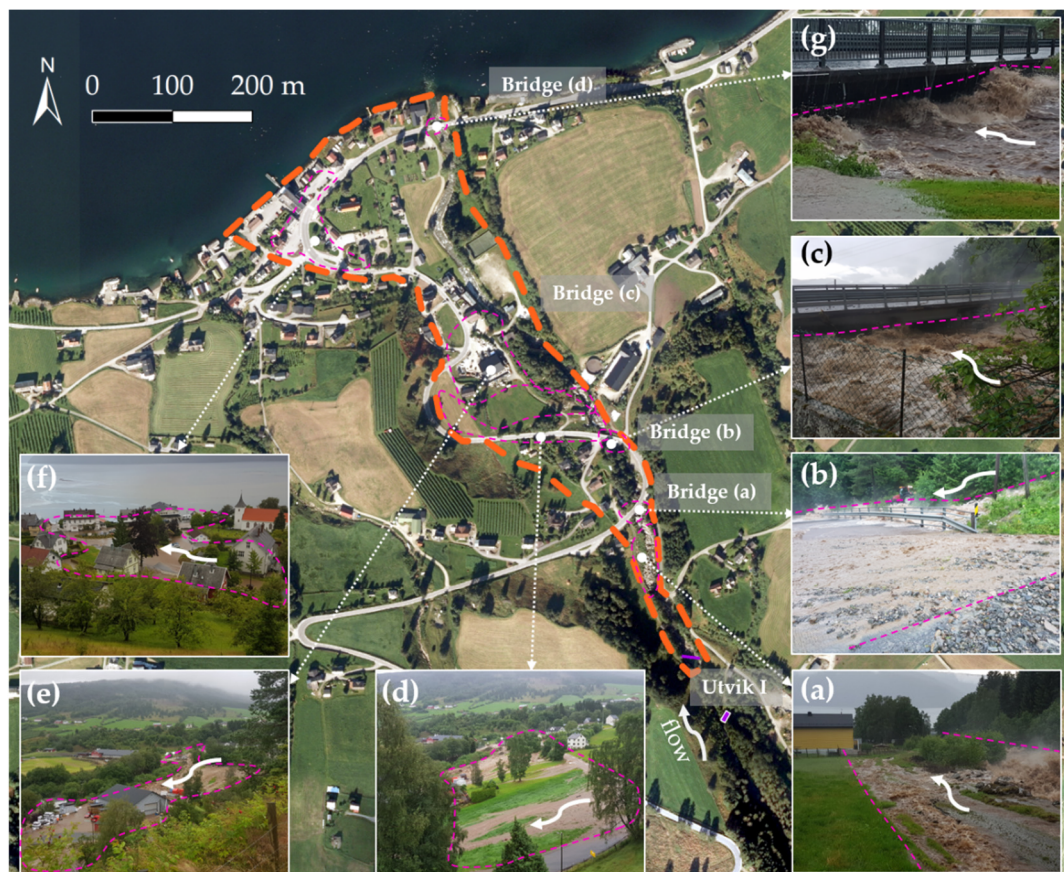
The observed flooded area, i.e., set of wetted and dry areas affected by the flood, in the area of interest was 101,552 m² (Figure 5, thick dashed orange polygon), including flooding near all four bridges (marked "a" to "d" streamwise) and in the lower areas of both sides of the floodplain, according to the documentation of the historical flood. Figure 5 shows examples of documentation of flooded areas and water levels (i.e., thin pink dashed marks in subfigures) during the peak of the hydrograph.

The uppermost bridge (Figure 5b, "bridge (a)"), which was severely damaged due to erosion processes enhanced by the flood, served as the main county road (Rv60 connected to road E39). The road by bridge (a) was washed away, interrupting the connection with neighboring villages southwards. This location seemed to be critical, as the water left the channel and made its way to (i) the left floodplain and the houses located in the upper reach (Figure 5a), as well as to (ii) the right floodplain due to failure on the right-hand side of the bridge (a) and guided by the road until bridge (b) (Figure 5b,c and lowermost right floodplain). A bit more downstream, by the bridge (b), the waterway between the piers of the bridge clogged, leading to a local rise of the water level. The riverbank was overtopped and consequently eroded, which resulted in the collapse of the flood protection wall along the river reach. Subsequently, the road embankment by bridge (b) broke down, guiding the water coming from upstream and overflowing bridge (b) to follow the road and continue

According to reports and testimonies (Table A1), it is believed that the water flowed following shortcuts in between the houses along the left floodplain. Moreover, a great amount of wood planks from the construction material shop located on the left bank were transported along the left floodplain all the way to the fjord (light colored clusters by the front row of houses marked by pink dashed arrows in Figures 1 and 4e) when the breakage by bridge (b) occurred and the road was eroded away. Witness testimonies suggest that on the right floodplain, near bridge (b), the owner of the property created a barrier with sacks and successfully blocked the water from taking a new direction and potentially eroding out a channel in the direction of his property. There was a very small bridge close to the construction material shop (Figure 5e, “bridge (c)”). This third bridge was completely eroded together with the left bank. The houses in the center of the village were affected and, to minimize the damage, an excavator was used to divert the water back to the original river channel between bridge (c) and the downstream channel kink. The efforts put on-site into reducing the flood damage did not prevent the collapse of the most downstream bridge by the fjord at 10:36 a.m. (Figures 4 and 5g, “bridge (d)”), leaving the village completely isolated by land [8].

Figure 5. Assessment of the flooded area at Q_{peak} (orange dashed polygon) using visual documentation of the event (e.g., pink dashed marks in subfigures). Photographs, sorted from upstream to downstream, were taken on 24 July 2017 between 7:30 a.m. and 9:00 a.m. (i.e., near Q_{peak}) by O. Bruland. Flow direction marked by white arrows. Dam crest and Utvik I mini-HPP in purple. Orthophoto from [16].

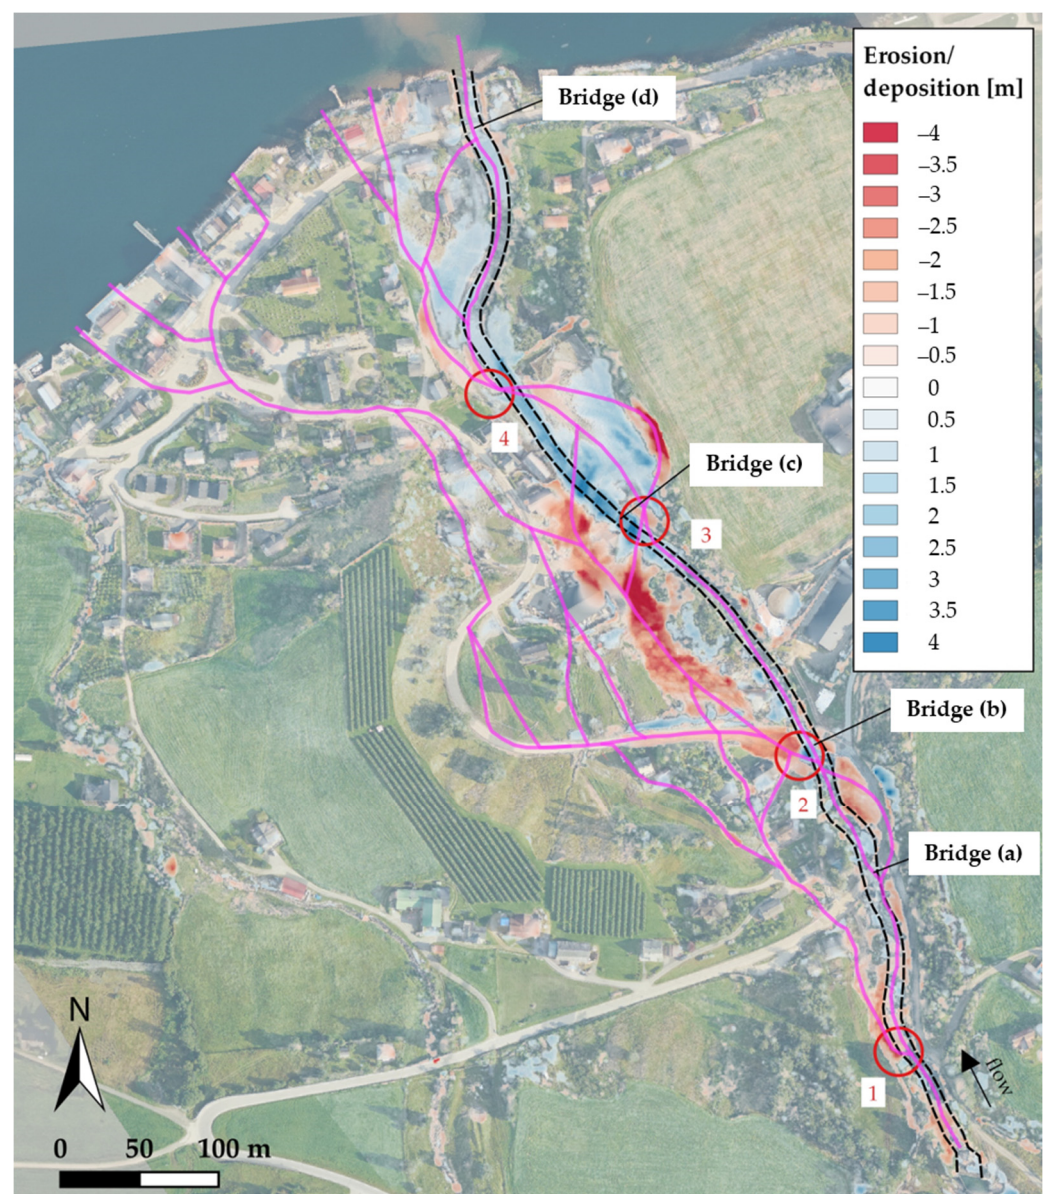
The erosion and deposition map (Figure 6) obtained from comparing DEMs, together with orthophotos and visual documentation and testimonies, resulted in the preferential flow paths (purple lines in Figure 6) and main critical points (red circles in Figure 6) for the maximum flooded area of the 2017 flood. From upstream to downstream of the area of interest, four critical points were identified: (i) upstream of bridge (a), (ii) by bridge (b), (iii) in the middle of the reach between bridges (b) and (c), (iv) downstream of bridge (c), and near the channel kink (locations 1 to 4 in Figure 6).

Figure 6. Flow paths and critical points on the erosion and deposition map obtained from pre- and post-flood LiDAR scans. Bridges are labeled (a–d); black dashed line represents the original river channel; red circles represent the critical points; purple lines represent flow paths during flood event. Post-event orthophoto from [15].

The erosion occurred mainly on the left floodplain. For instance, ca. 100 m upstream bridge (a), intensive erosion of the left bank resulted in water overflowing and originating a

new flow path (critical point 1) all the way to the main road crossing the village. Moreover, on the right bank between bridges (a) and (b), there was a short flow path that eroded ca. 2 m of material while following the bend of the road to bridge (b). As described in the previous section, the water followed the road from bridge (b) and found shortcuts across the village, reaching its core residential area and the fjord (purple lines in the farthest left floodplain). On the left bank by bridge (b), the road embankment breached (critical point 2) and created the new river channel out of the original one between bridges (b) and (c). The erosion in the new river channel reached the rock bed (i.e., erosion 1.5–5 m). The most critical location was the new channel created between critical points 2 and 3 because most of the water was diverted from the original river channel (black dashed lines in Figure 6) and part of the water flow was inclined towards the core residential area in the village, causing property damage. For instance, the construction material shop located in the left floodplain (Figure 5e) got damaged and wood planks were transported along the aforementioned new flow paths.

Due to a gentler longitudinal slope, the material eroded during the creation of the new river channel was deposited especially in the original river channel downstream of bridge (c), reaching deposition values between 2.5–4 m. The new flow direction (caused by the diversion of the water from the original channel in critical point 2) resulted in the new channel crossing the original one upstream of the bridge (c) (critical point 3). Then the new channel hit and eroded the steep slope in the right floodplain and, following the topography, bent back towards the village between critical points 3 and 4. The flow returned from the right floodplain to the left one by eroding its way across the original channel (critical point 4) and flooding several houses on the left floodplain before reaching the fjord.

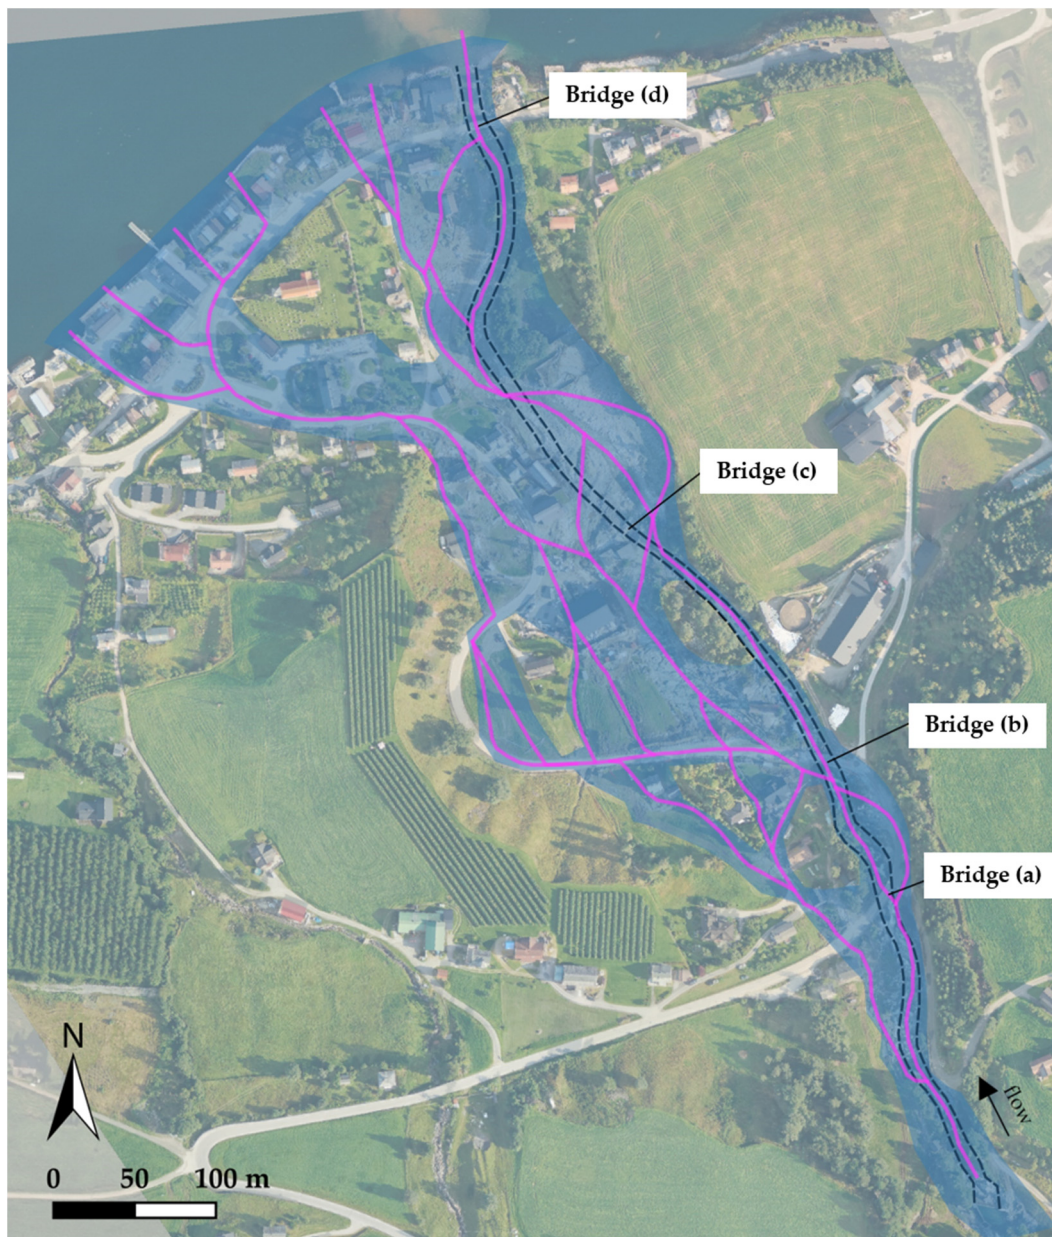
Figure 7. Maximum flooded area, i.e., wetted area in blue and dry areas as gaps in the blue area, throughout the 2017 flash flood. Bridges are labeled (a–d); flow paths (purple lines) as in Figure 6. Post-event orthophoto from [16].

As mentioned in Section 3.2, some of the discrepancies between field observations and estimated flood extension (i.e., maximum flooded area in Figure 7) were due to inherent uncertainties in the flood mapping process (e.g., inadequate data resolution, insufficient data available, or expertise and subjectivity of the user) and partial spatial and/or temporal coverage of the observations, as some locations were hardly accessible at the peak of the flood event (i.e., timestep used for the validation of control points; [27]). As most of the village was devastated, the damages caused by the 2017 event were promptly repaired, which concealed most of the marks left by the flood. Therefore, GPS measurements of such traces are not available. The uncertainty inherent to the hydrologic input data for this study case was addressed in previous studies (e.g., [8,28]), so we will limit to a short overview of the topographic input data.

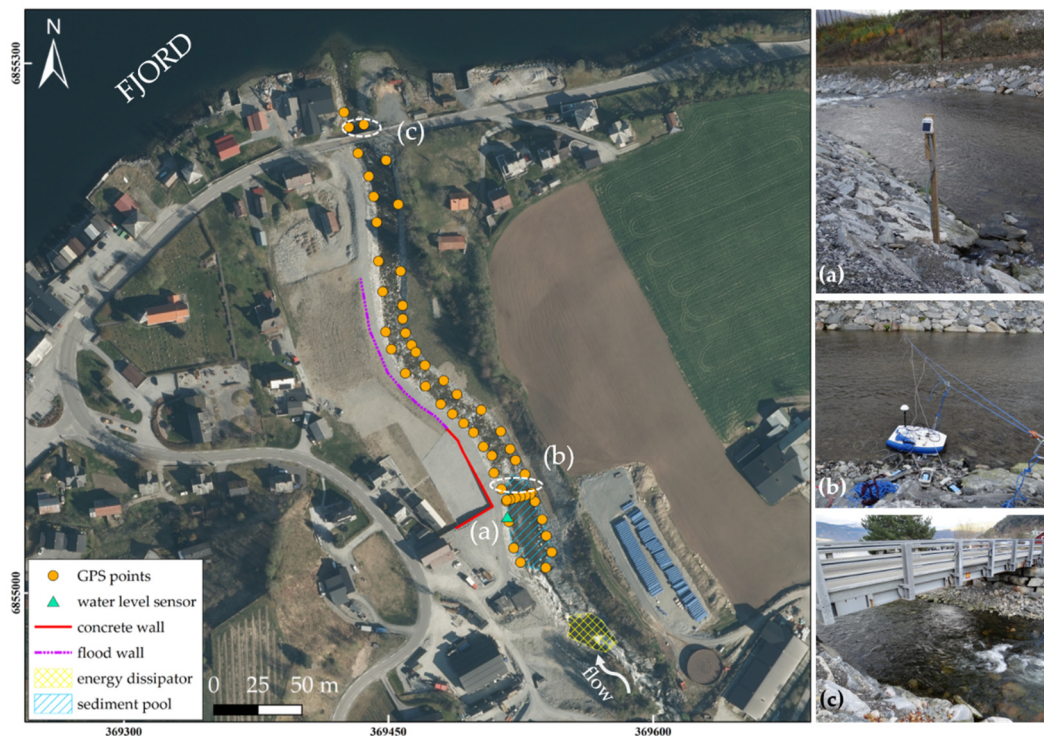
Figure 8. Flood protections and field survey in the restored the Storelva river in Utvik; (a) pressure transducer installed by the pool, (b) cross-section for discharge measurement with ADCP, (c) reconstructed bridge. Orthophoto in ETRS89, UTM33 [32]. Field photos taken by A. Moraru.

Recent field inspections allowed documenting the progress of post-disaster recovery and current state of the Storelva river. Besides the reconstruction of bridge (d) (Figure 8c), some of the safety measures implemented post-flood include concrete and flood walls on the left floodplain, access road on the left floodplain, partial channelization of the river downstream using riprap on both river banks, a sediment deposition pool and an energy dissipator upstream of the sediment pool [31] (Figure 8). Furthermore,
