# Maintaining well integrity during slot recovery operations

**Henrik Braune**

Earth Sciences and Petroleum Engineering

Submission date: May 2012

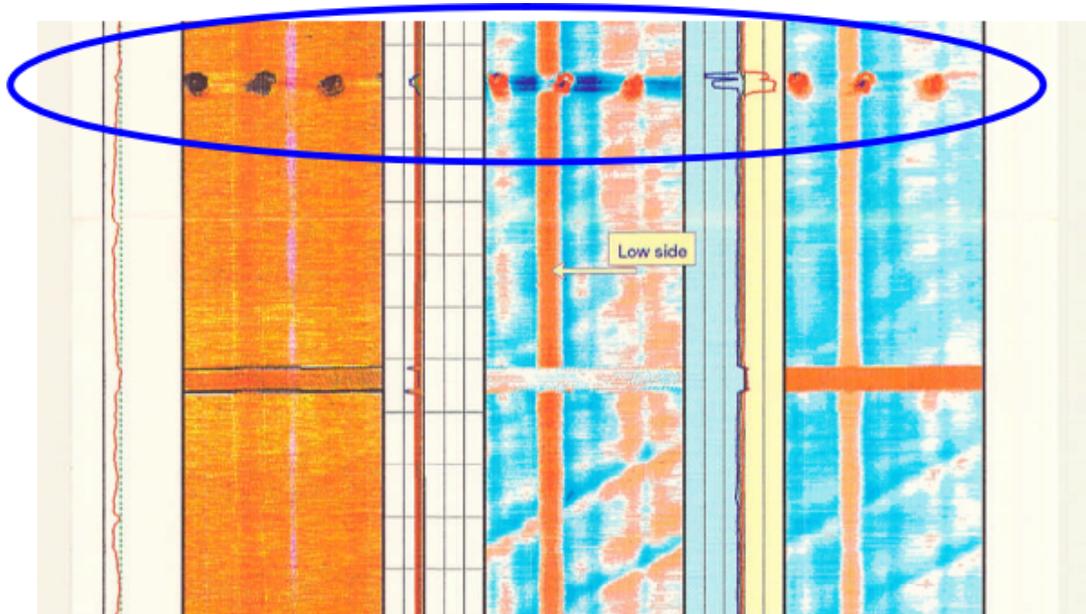
Figure 4.2: The figure shows the three holes created by the high-pressure washing tool. The image is created from a USIT/CBL log (Brattbakk et al., 2005).

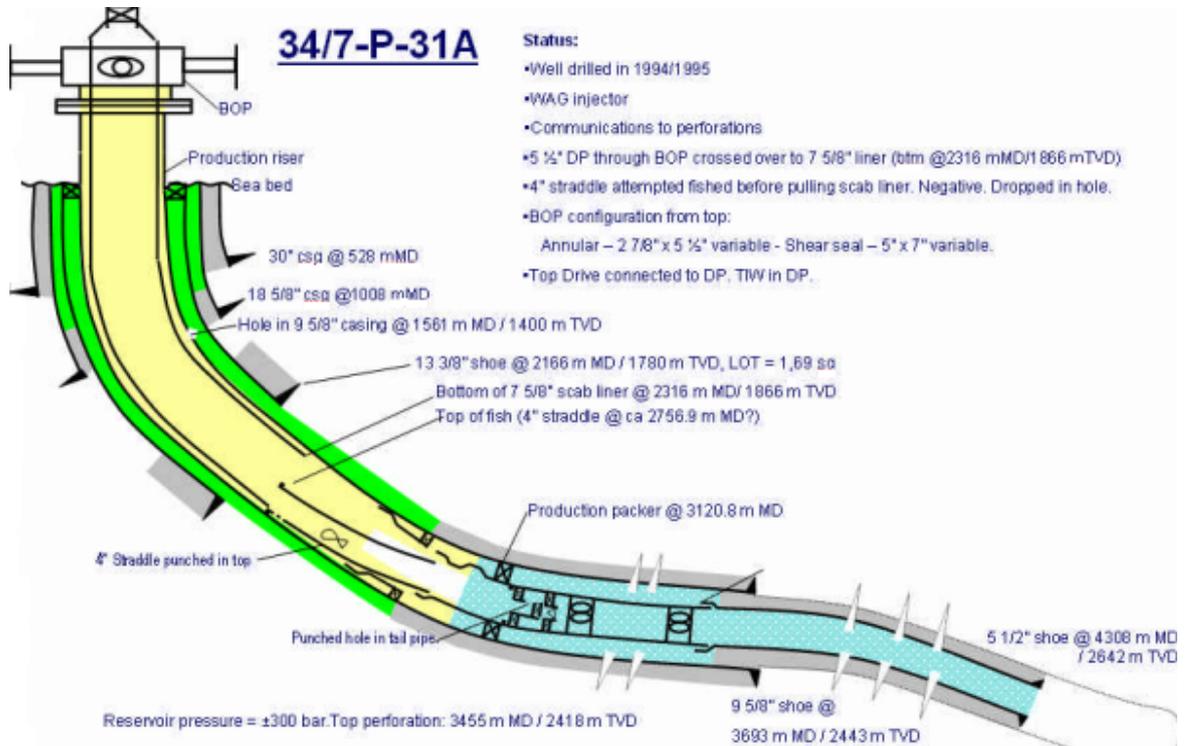
Figure 4.5: The figure shows status before the incident took place. The most notable things to observe is the punched hole in the tail pipe and the hole in 9 5/8" csg at 1561 m MD (Brattbakk et al., 2005).

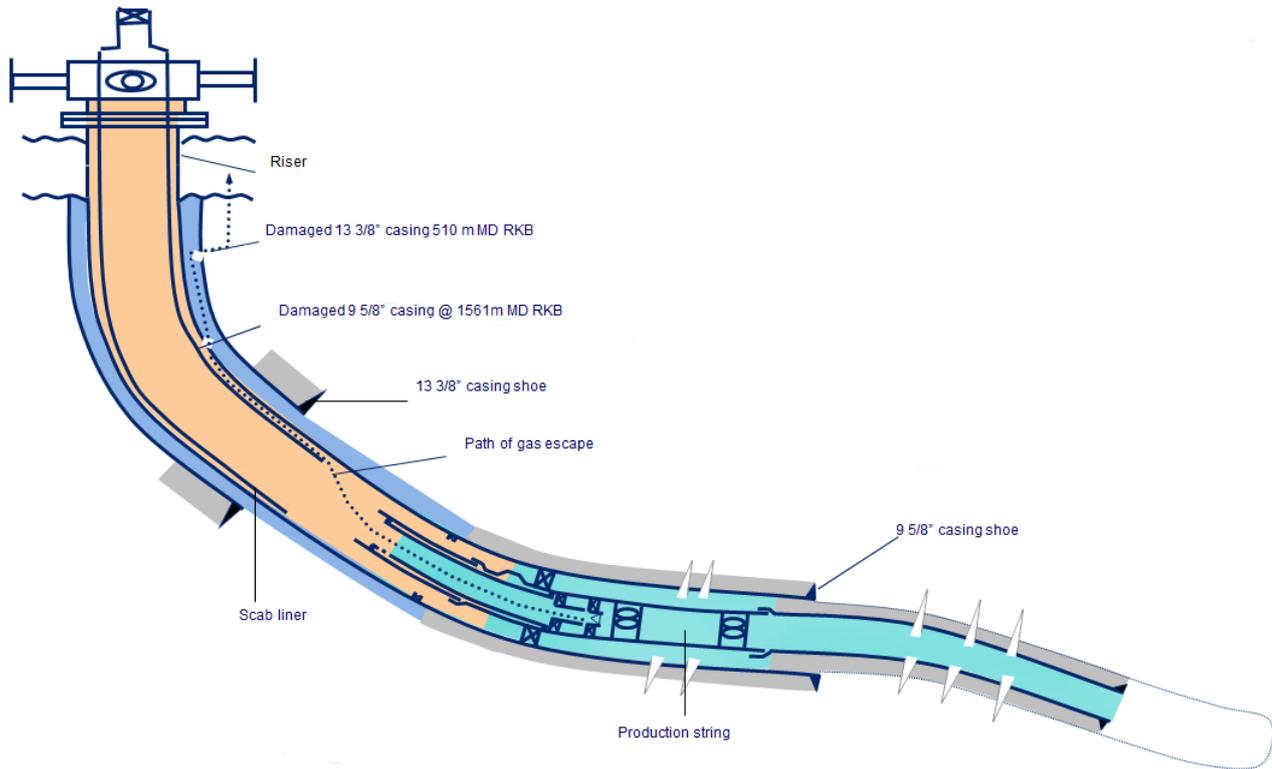
**Figure 4.6:** The figure shows how the gas escapes the wellbore through damaged parts of the casing (Petersen et al., 2006).

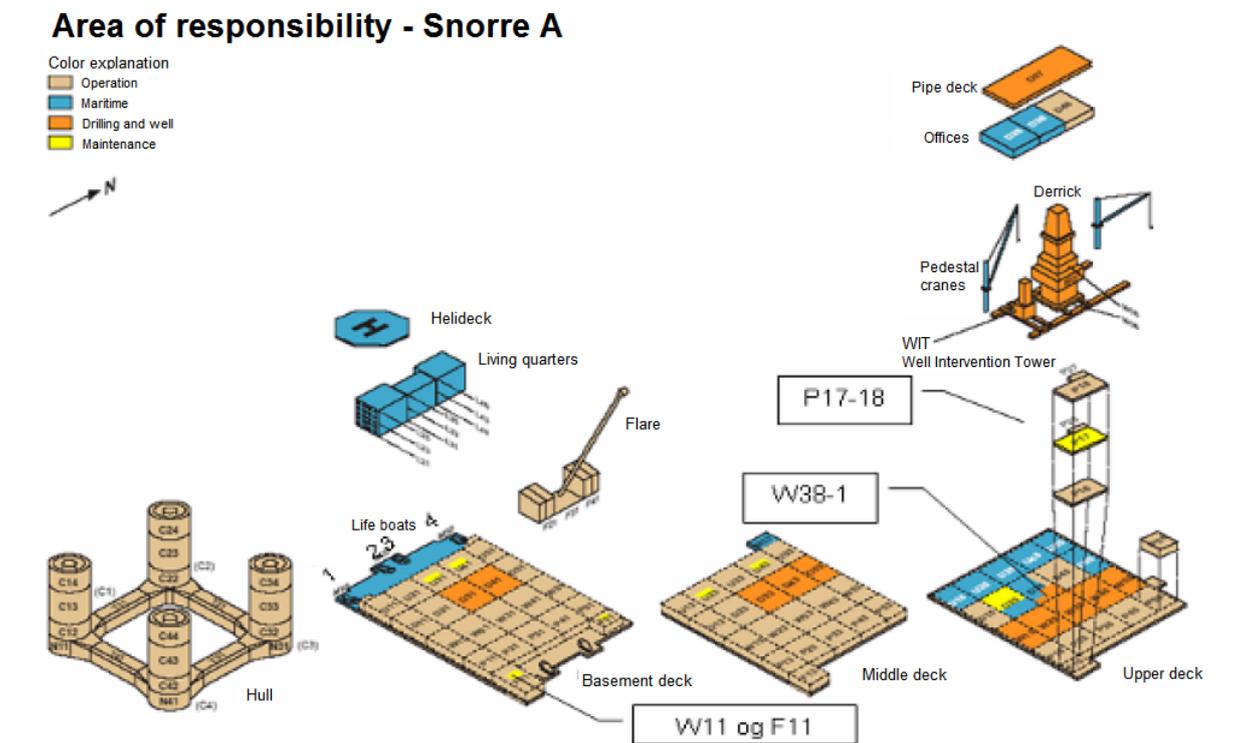
**Figure 4.7:** The figure shows different modules on the rig, highlighting the modules where gas was detected (Brattbakk et al., 2005).

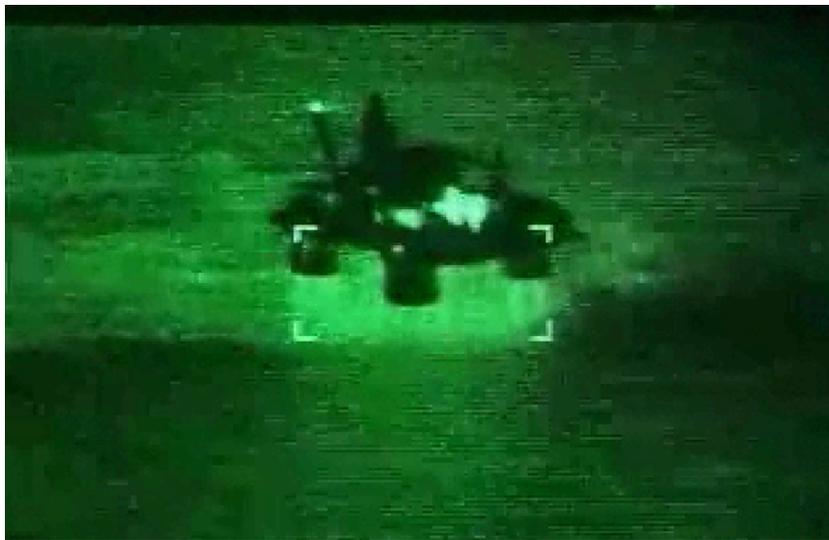
**Figure 4.9:** The picture taken by a night vision camera on board one of the helicopters approximately at 2 a.m. captures the heat of the gas underneath the rig (Statoil, 2005).

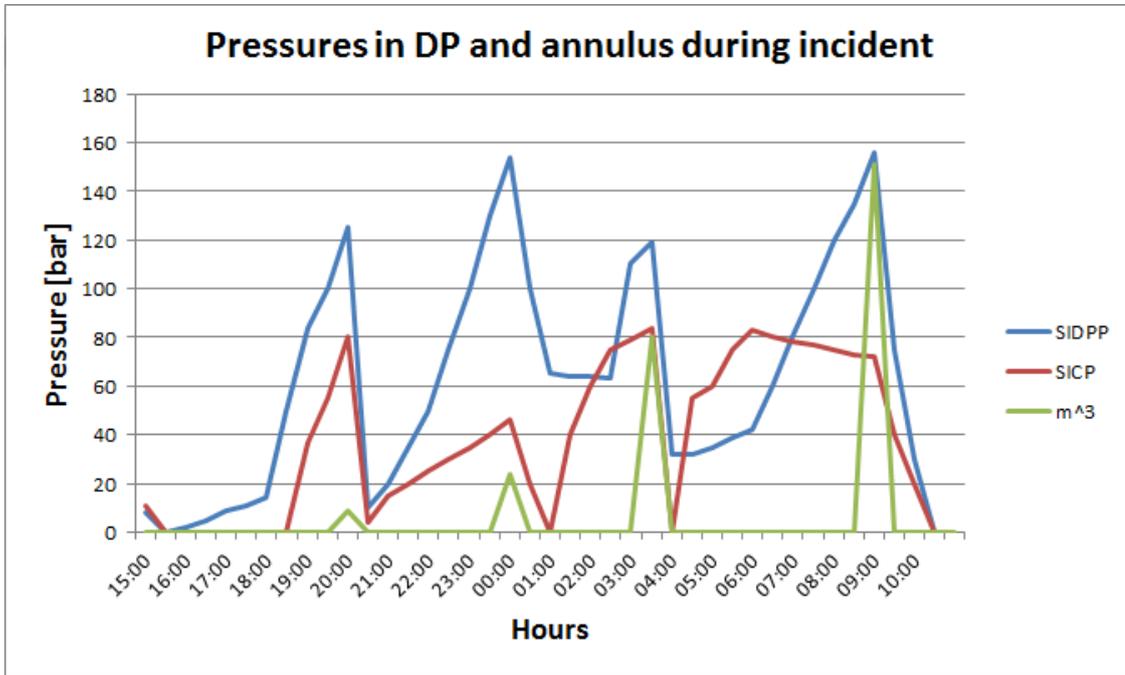
Figure 4.10: The graph shows how the SIDPP and SICP behaved during the incident. The green curve shows when mud was bullheaded into the formation.

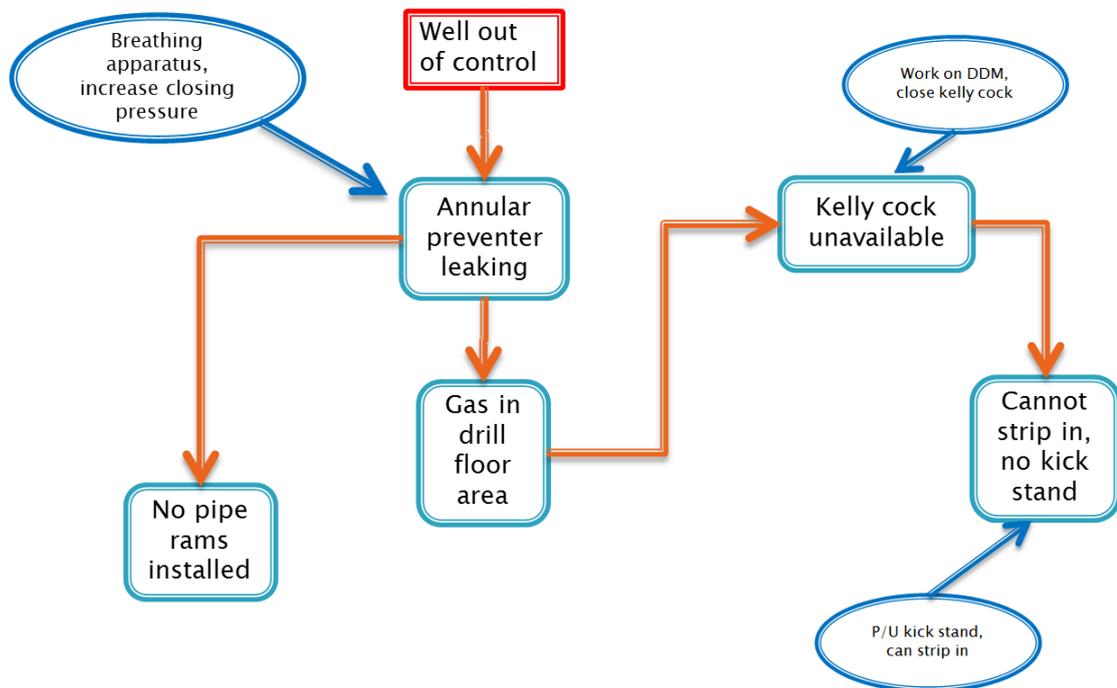
Figure 4.12: The schematic shows in a simple way the causes and consequences to the problems on the drill floor.

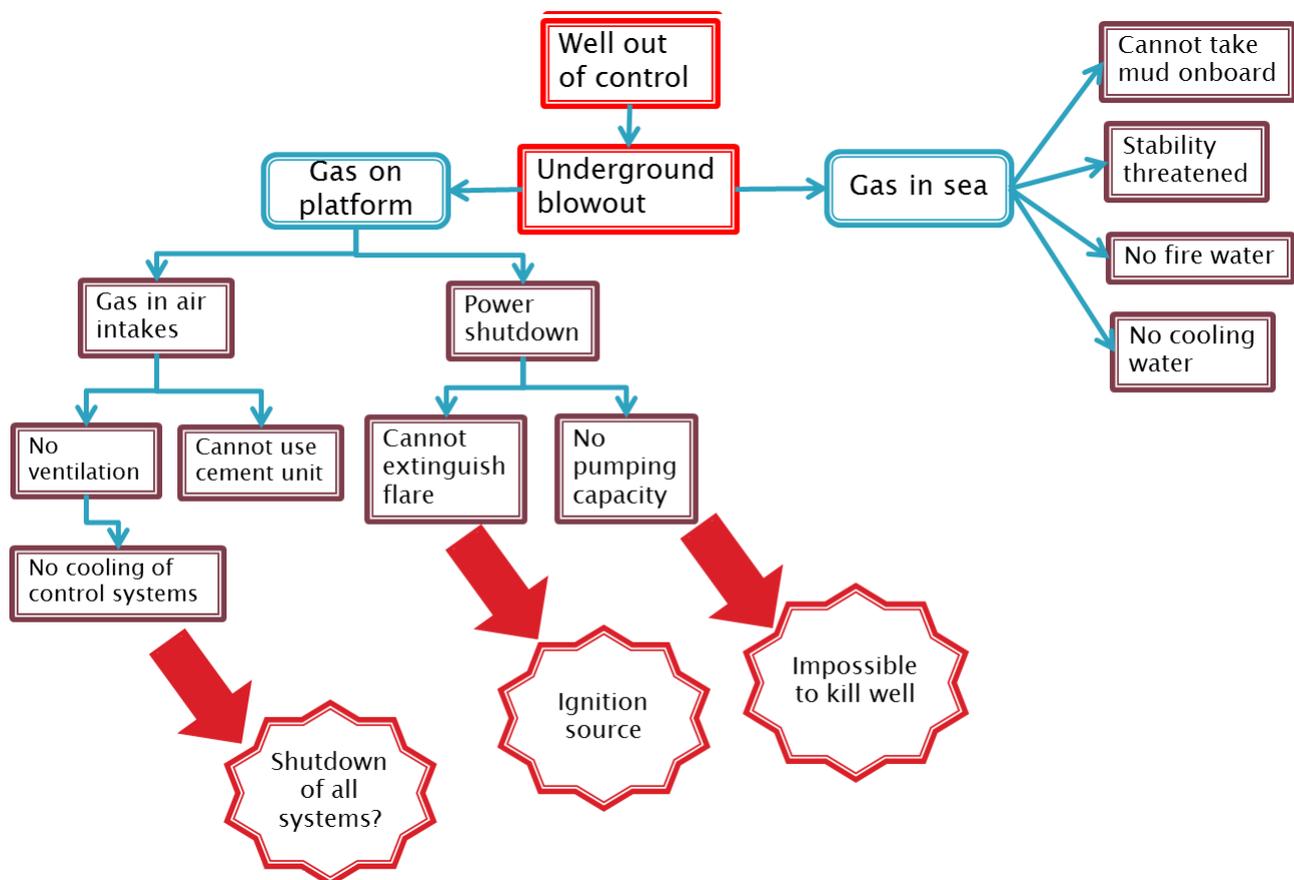
Figure 4.13: A slightly more complex schematic of how the problems developed on the rig itself, and how limited measures for the crew were.

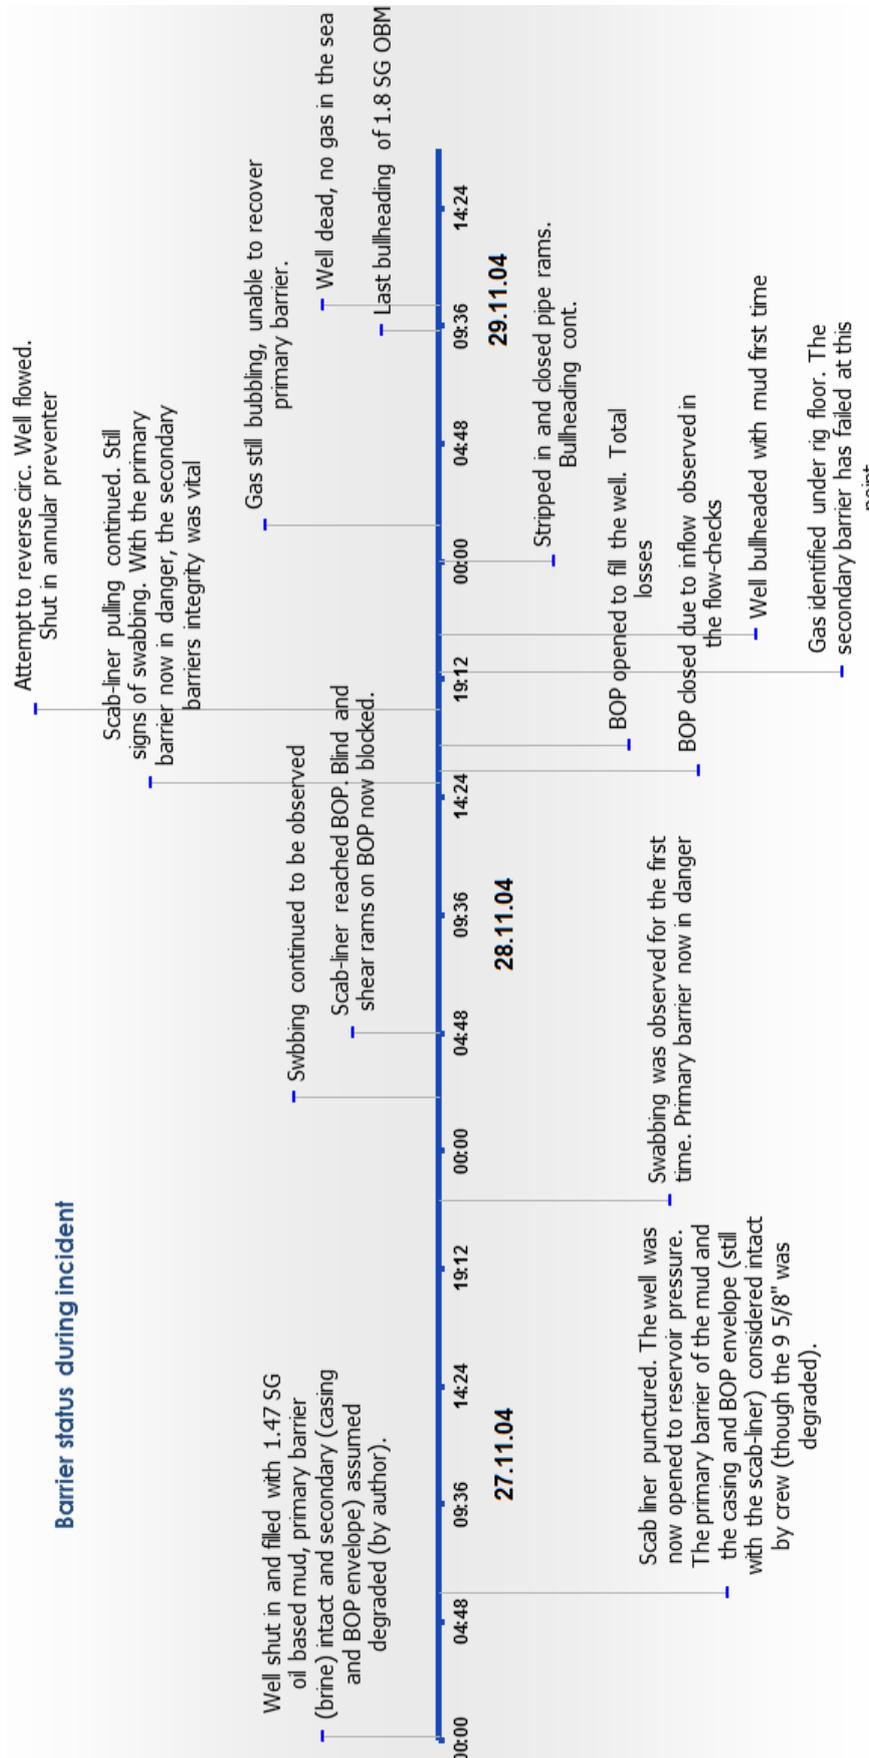
Figure 4.15: The figure shows a time line of the development in barrier status during the SNA incident.

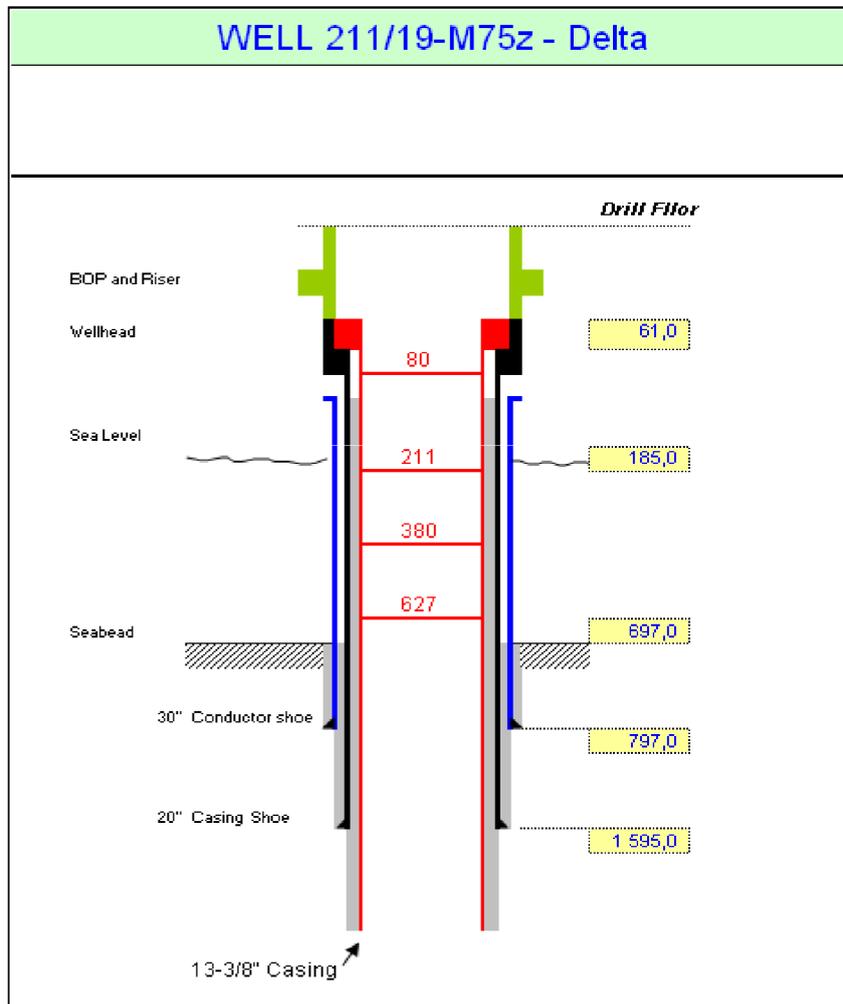
Figure 5.4: The figure illustrates in which area of the well the jarring took place when the 20" casing failed (between 80 and 211 ft). All depths are shown in feet (RevusEnergy, 2008).

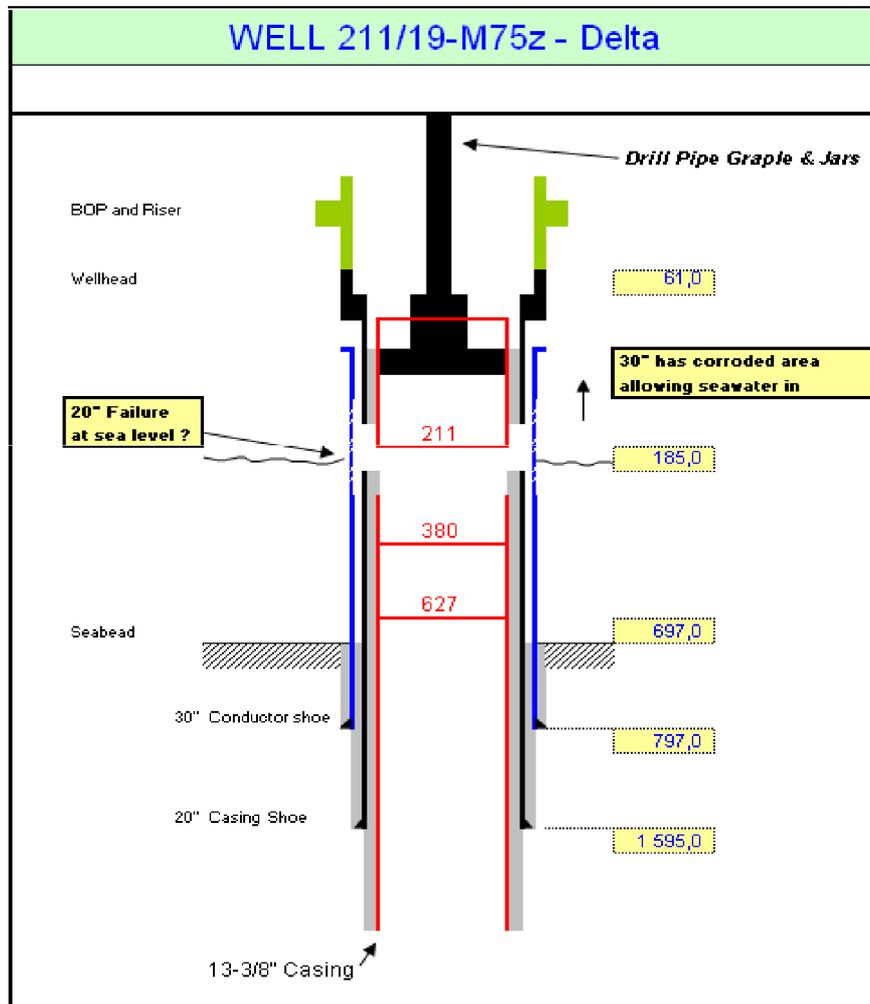
Figure 5.5: The figure illustrates where the 20" casing failed (around sea level). All depths are shown in feet (RevusEnergy, 2008).
