Fatigue of Smart Composite Metal Joints

Even Vardenær Lunder

Submission date: June 2013

**MASTER THESIS SPRING 2013
FOR
STUD. TECHN. EVEN VARDENÆR LUNDER**

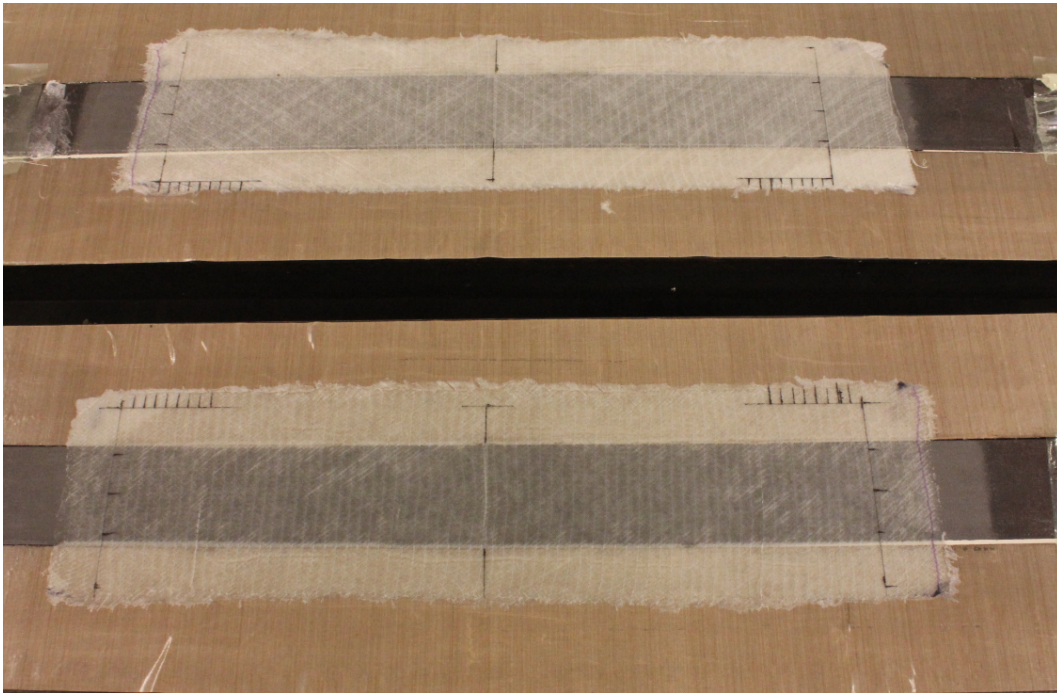
The picture in Figure 23 was taken during the production process. It shows the DB810 galvanic protection layer applied and cured to beam number 36 and 37. Beam 36 is in the top of the picture and beam 37 is in the bottom part of the picture. It can be observed that there is a larger amount of epoxy permeated in the galvanic protection adhering it to the steel for beam 37 than 36. The layer of beam 36 is not as transparent and looks less saturated with epoxy than the case of beam 37. A laminate has to be saturated with epoxy to ensure proper adhesion to the steel. A laminate not saturated will experience voids in the material, with air pockets making the material brittle and reducing the adhesion to the steel. This illustrates how the quality of a hand lay-up can differ.

Figure 23: Beam 36 in top part of picture, beam 37 in the bottom part.

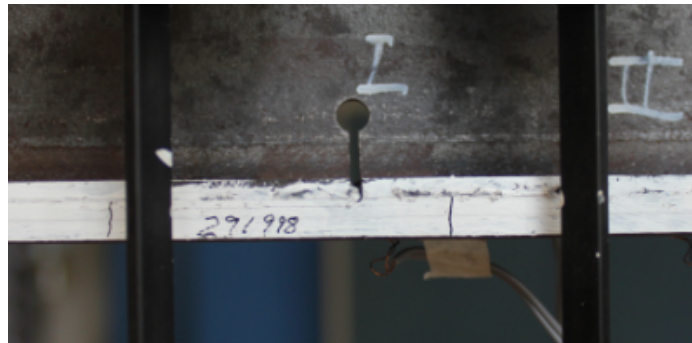
Figure 46: Damage propagation from center towards both ends. Front of beam 21.

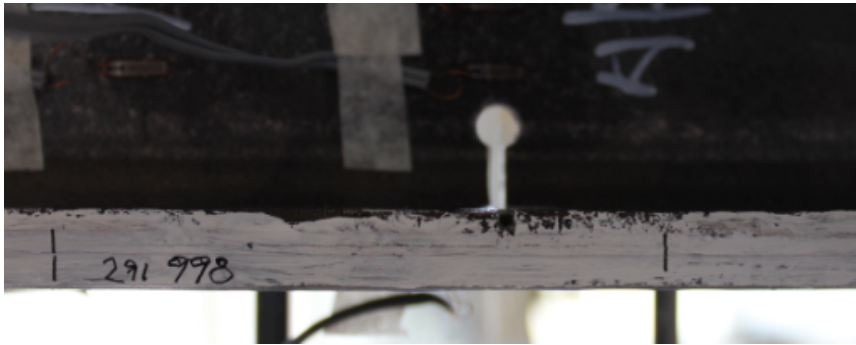
Figure 47: Damage propagation from center towards both ends. Back of beam 21.

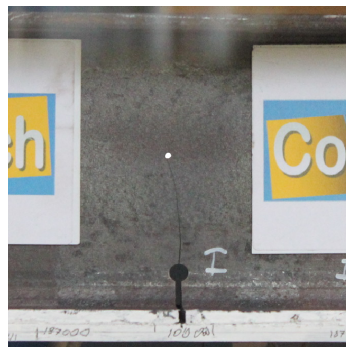
Prior to failure, a delamination in the top groups of UHMC plies occurred closest to the front from the right side of the beam. This delamination can be seen in the Figure 51. Some values for the measured crack length by visual inspection are presented in Table 8.

Figure 50: Crack propagation in the web, beam 22.

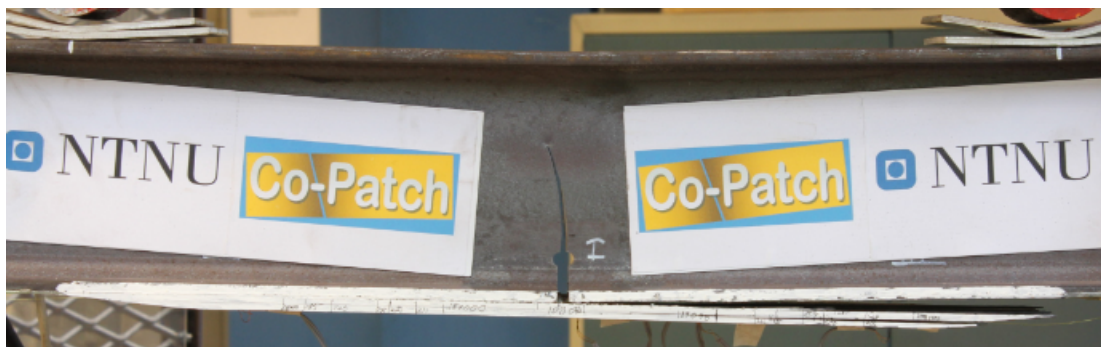
Figure 51: After failure, beam 22.

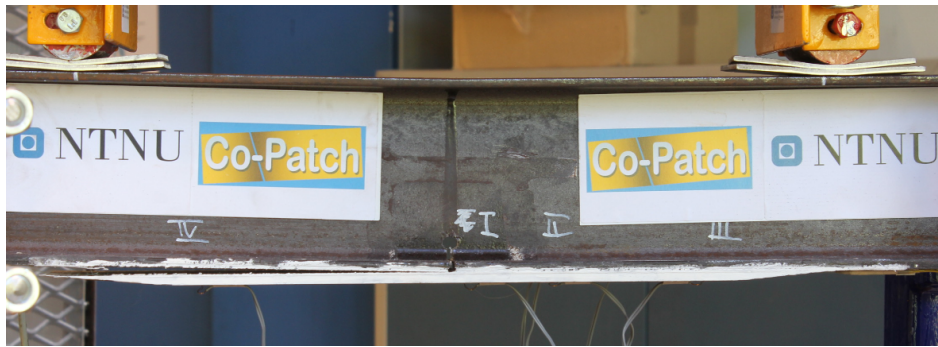
The strain in the top of the patch seen in Figure 57 increases and the curve close to center shifts a bit towards the ends up to 5000 cycles. The reason for these shifts of the strain curve is the damage that propagates from center in the adhesive layer. As the length of the optical fiber measuring strain here is about 280 mm of the patch length, the damage propagating from the left can not yet be detected. At 6500 cycles a decrease and shift in the strain curve towards the right is seen on top of the patch. The length of the damage from the left side has now reached the measuring range on the patch top. The left end does not transfer the same load and the strain on top of the patch decreases on the corresponding side. From Figure 56 it can be confirmed that the length of the damaged area has reached the range of the optical fiber on the patch top at 6500 cycles. The damage growth from the left end has reached the length on the x-axis of approximately -125 mm.

Figure 58: Beam 32 after failure. Debond and cohesive failure on the left side.

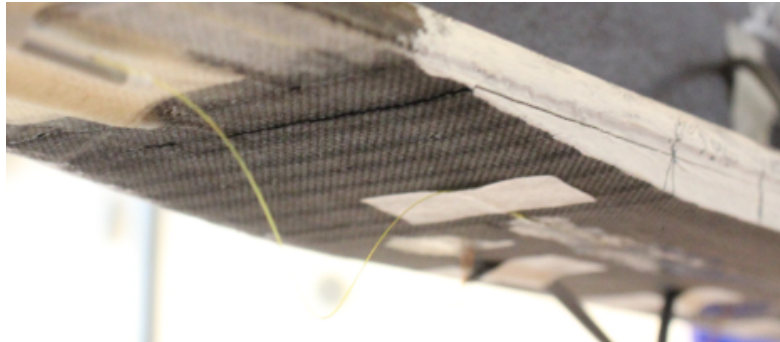
The lengths of the delamination at different cycles are presented in Table 9. These are measured on the back side of the beam at the initiation of the delamination towards center of the patch. Delamination eventually reached center of the beam as seen in Figure 63. Failure occurred along the right side of the patch as a combination of the delamination and cohesive damage in the adhesive layer from the center at 13650 cycles, see Figure 64.

Figure 61: Delamination from right side of the patch. Beam 33, seen from the back.

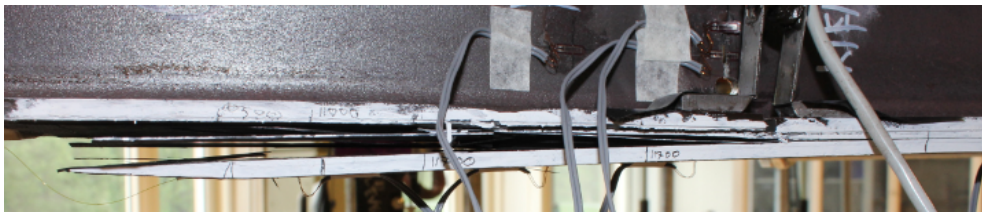
Figure 64: Failure of beam 33, seen from the back.

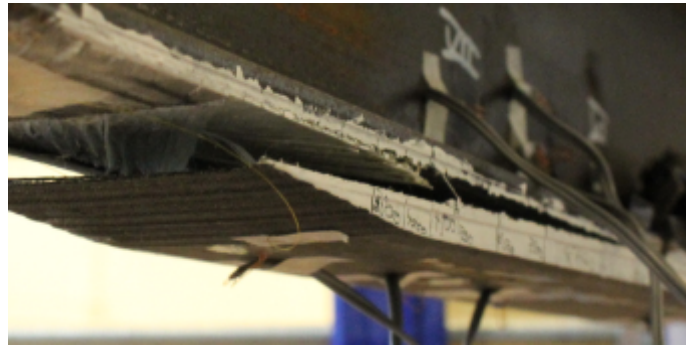
measurements and it did not give any results able to be analyzed after 4000 cycles. It was seen by visual inspection that damage propagated from center and from the right end of the patch. From Figure 65 it can be observed a decrease in the strain curve of the embedded fiber from the right side at 4000 cycles. This indicates a damage propagating in the adhesive layer from the right end of the patch. Cohesive failure in the right side occurred at 7966 cycles.

Figure 67: Failure of beam 34, seen from the back.

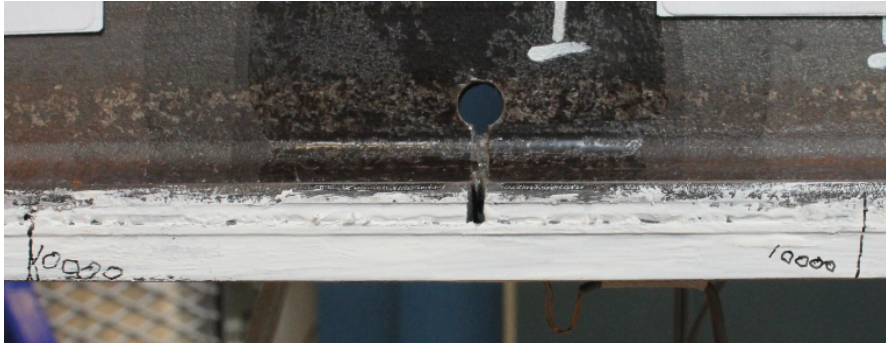
For beam 36 with the HMC material the damage propagation is of the same character as described for beam 32. In Figure 74 it is seen that the the damage propagation from center and towards the ends is close to equal for both sides. At 10 000 cycles the damage propagating from center was also detected by visual inspection of the beam. This was seen as cracks in the white paint along the steel and composite patch. This is shown in Figure 76. The lengths of these cracks were measured by visual inspection at different cycles and are reported in Table 10.

Figure 76: Damage propagation from center at 10 000 cycles. Beam 36.

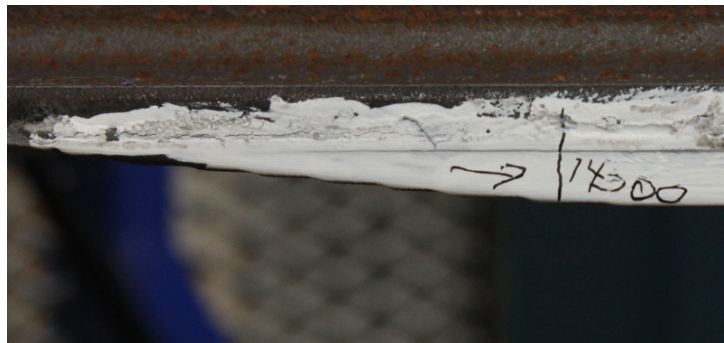
There is no damage propagation from the right end, but it can be detect from the measurements that damage is propagating in the adhesive layer from the left side. At 14700 cycles the damage propagating from the left end reaches the range of the optical fiber on top of the patch. In Figure 75 it is seen that the damaged area in the patch from the left end results in a shift in the the strain curve on top of the patch. The damage from the left end was detected by visual inspection at 14 000 cycles and the length of the crack was measured to be 45 mm, see Figure 77. The beam failed at 14 741 cycles in the left side of the patch and the failure mode was cohesive failure, see Figure 78.

Figure 77: Damage propagation from left at 14 700 cycles. Beam 36.

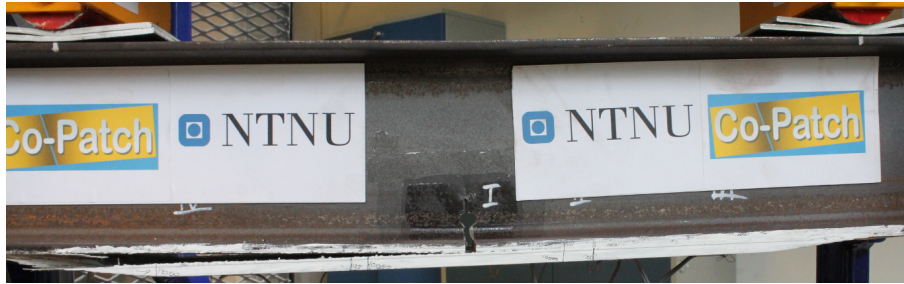
Figure 78: After failure, beam 36.

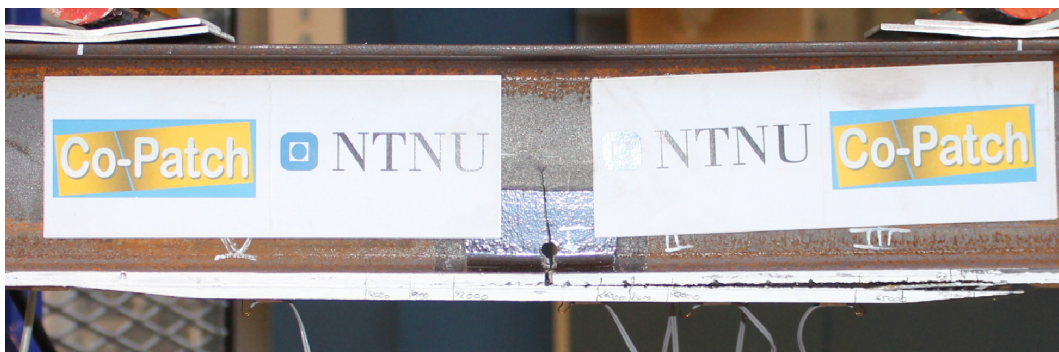
The beam also experienced the same crack propagation in the web as beam 21 and 22, see Figure 81.

Figure 81: After failure, beam 37.

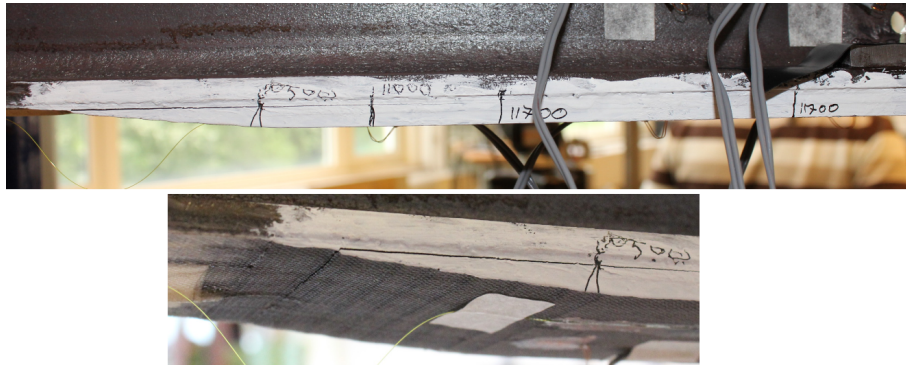
Figure 83: Damage propagation in the right side. Beam 33, seen from the back.

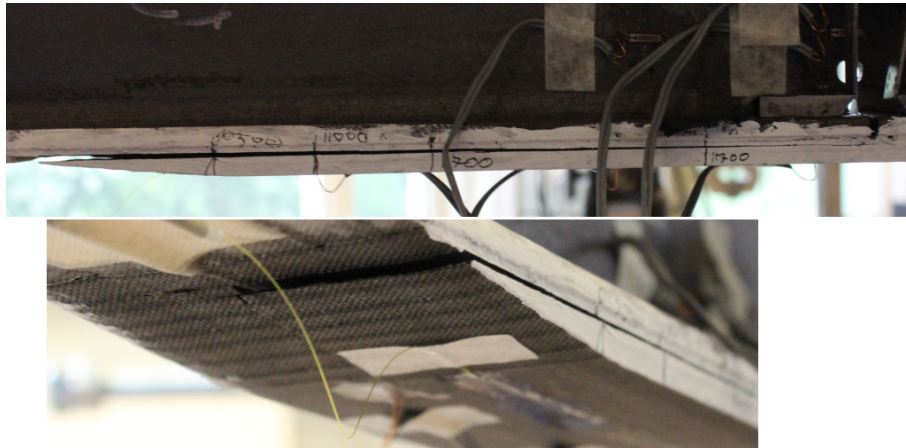
. At the back edge the delamination in the patch

Figure 85: Delamination from right side, beam 33. Seen from the back.

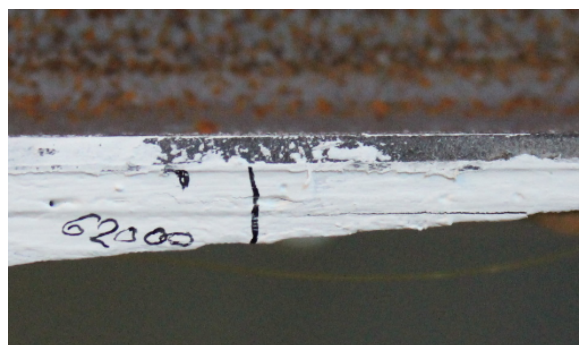
Figure 88: Damage propagating from the right end, beam 37. Seen from the front.

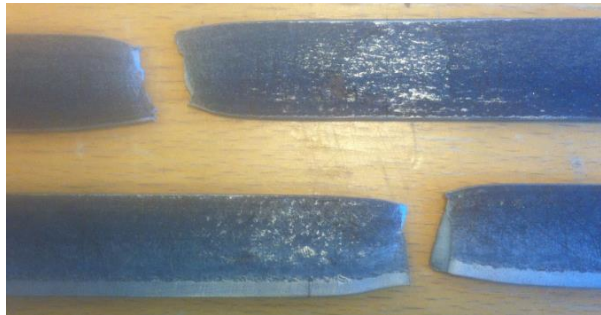
Figure 3-2: Rupture of specimen 4.2 (top) and 4.3 (bottom).
