RESEARCH ARTICLE | NOVEMBER 09 2023

Airtightness development in large timber buildings: Case study of a zero-emission building in Norway **FREE**

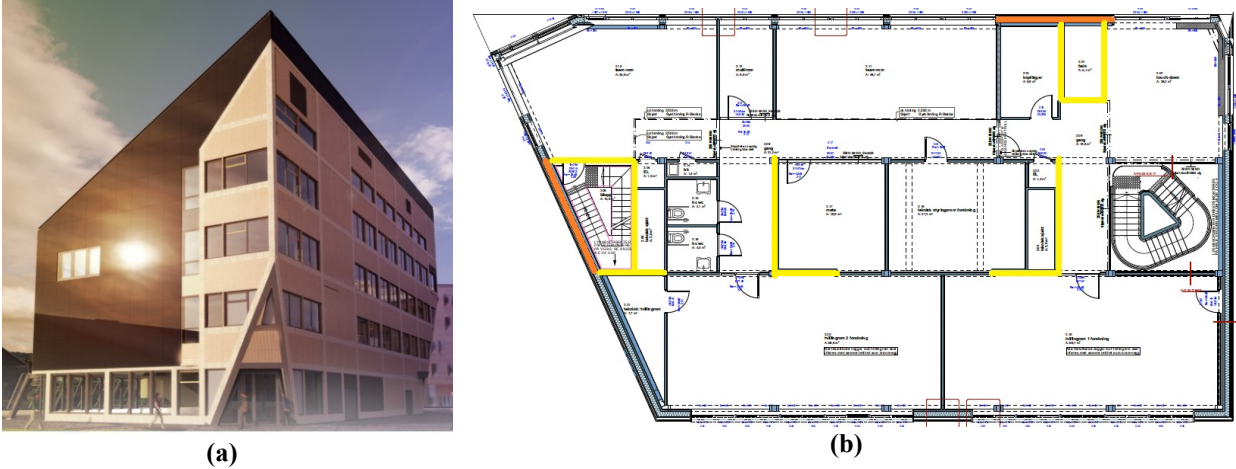
FIGURE 1. (a) Illustration of the ZEB Laboratory and (b) plan drawing of second floor showing external CLT-based walls illustrated in orange and internal CLT-based walls in yellow. Source: [8]

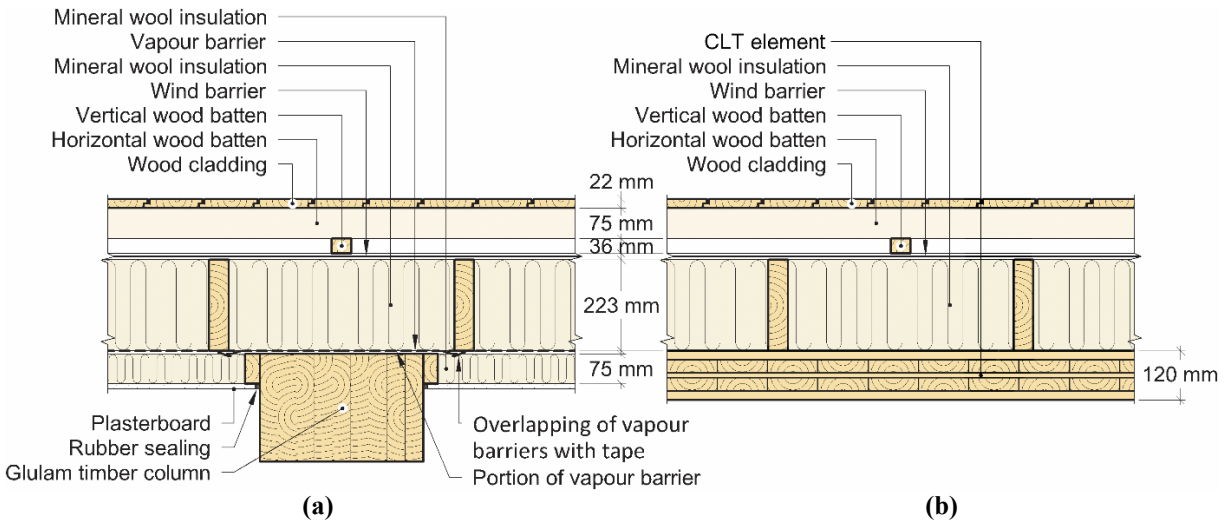
FIGURE 2. Horizontal section illustration of the two main types of external walls and sealing methods. (a) Insulated timber frame wall and (b) CLT-based wall.

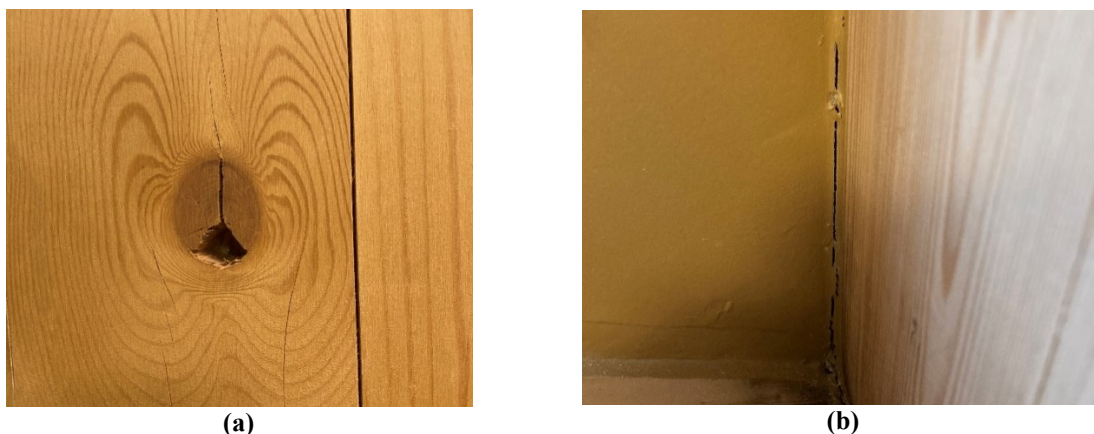
FIGURE 3. Knot hole in external CLT-element (a) and cracked sealing joint between CLT-element and external wall (b)
