# Deposit formation on cylinder liner surfaces in medium-speed engines

Øyvind Buhaug

Faculty of Engineering Science and Technology  
Norwegian University of Science and Technology

Trondheim, Sept 15, 2003

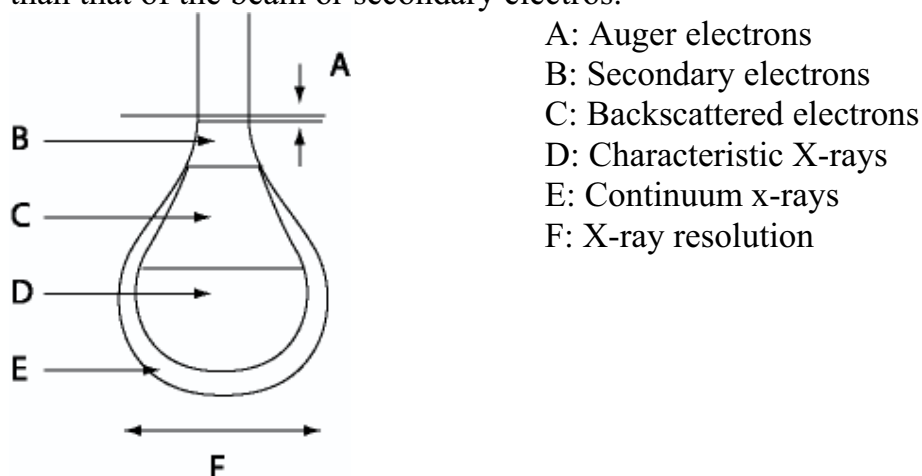
secondary electrons, and backscattered electrons can cause emission of secondary electrons as it exits the surface. Figure 3-1 illustrates the interaction between an electron beam and a sample. The electrons penetrate deep into the surface and are scattered. The electron and x-ray emissions due to the electron beam irradiation thus originate from a bulb shaped volume below the sample surface and the x-ray resolution is lower than that of the beam or secondary electrons.

Figure 3-1 *Electron beam interaction with sample surface*

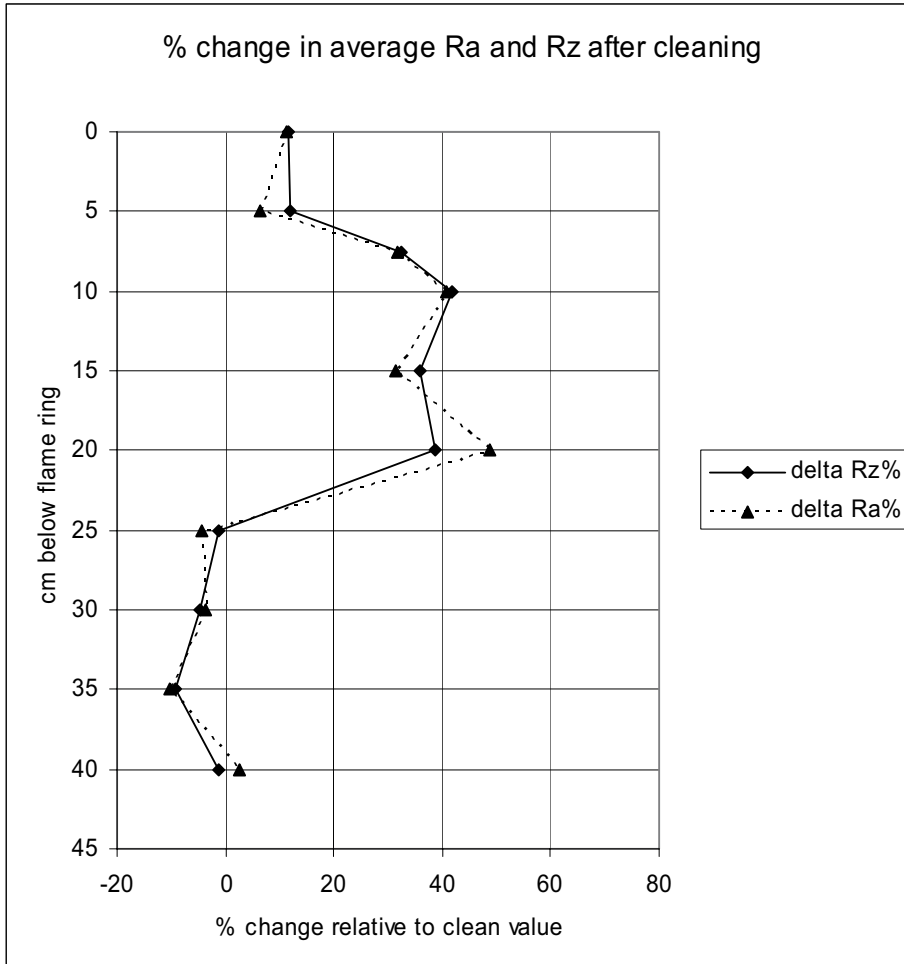
Figure 3-13 *Change in average surface roughness parameters after cleaning liner with acetic acid.*

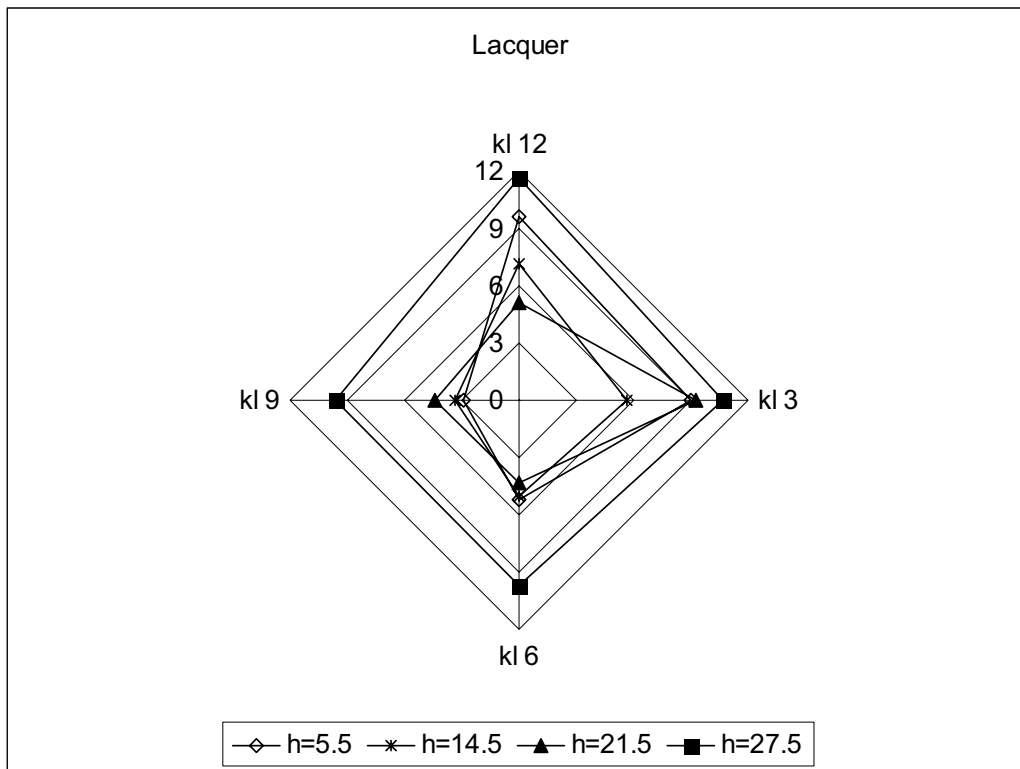
Figure 3-14 *Illustration of liner lacquer deposit pattern in engine A*

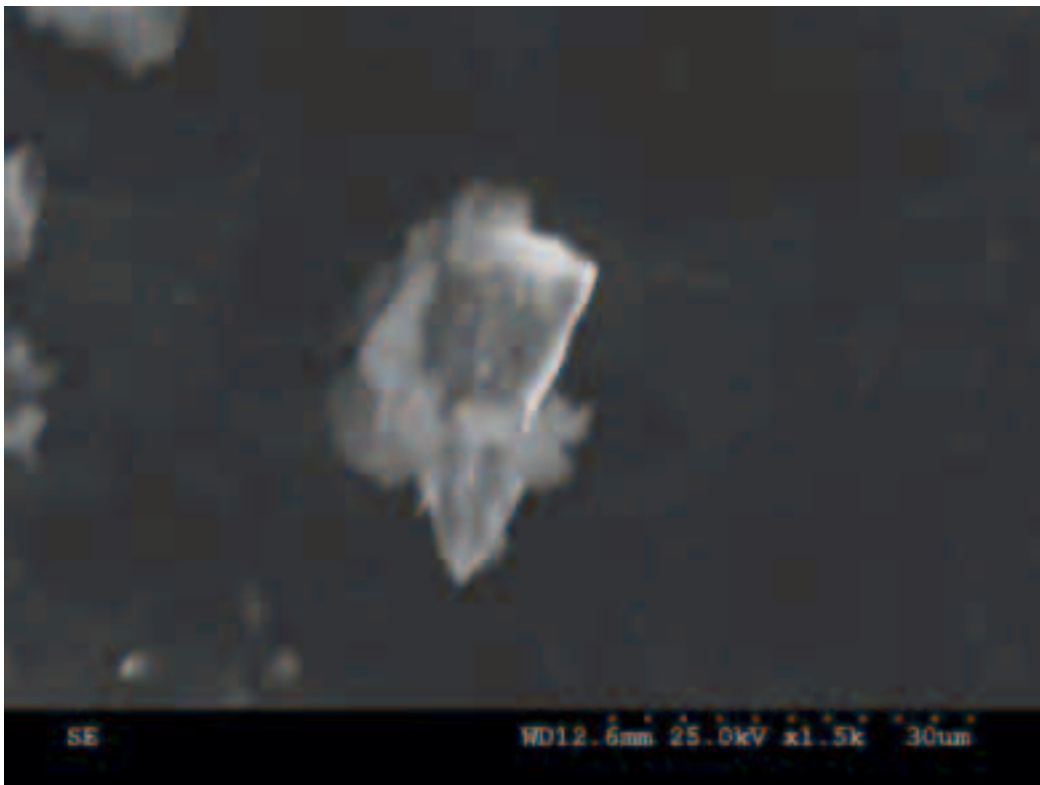
Figure 3-35 *Iron flake with deposit*

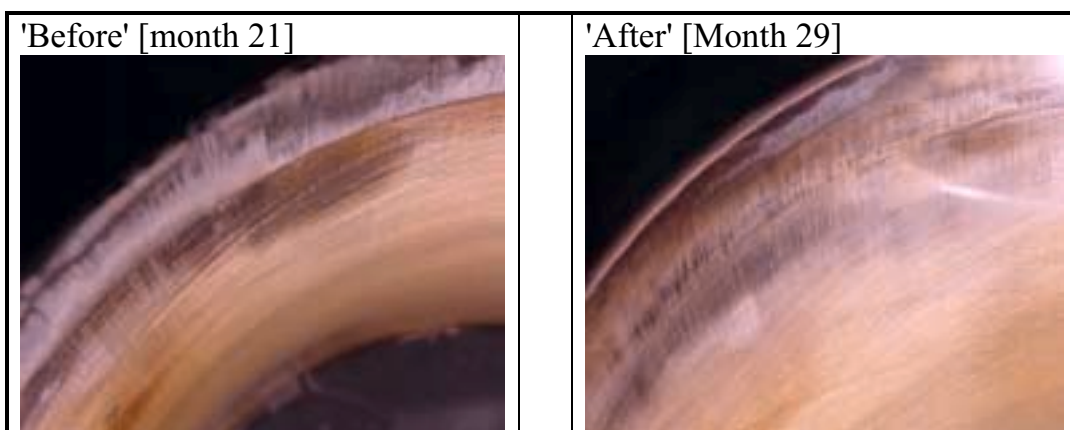
Figure 4-23 *Cylinder B5 before and after 8 months fuel additive treatment. Lacquerish deposits replace the soot above upper ring reversal.*

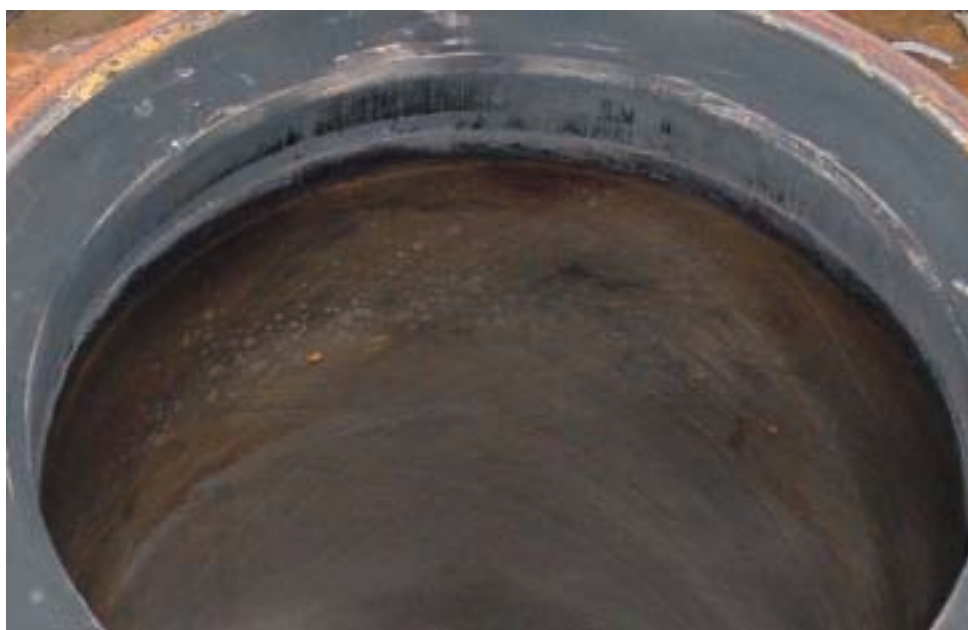
Figure 4-37 *Picture of the liner at inspection one*

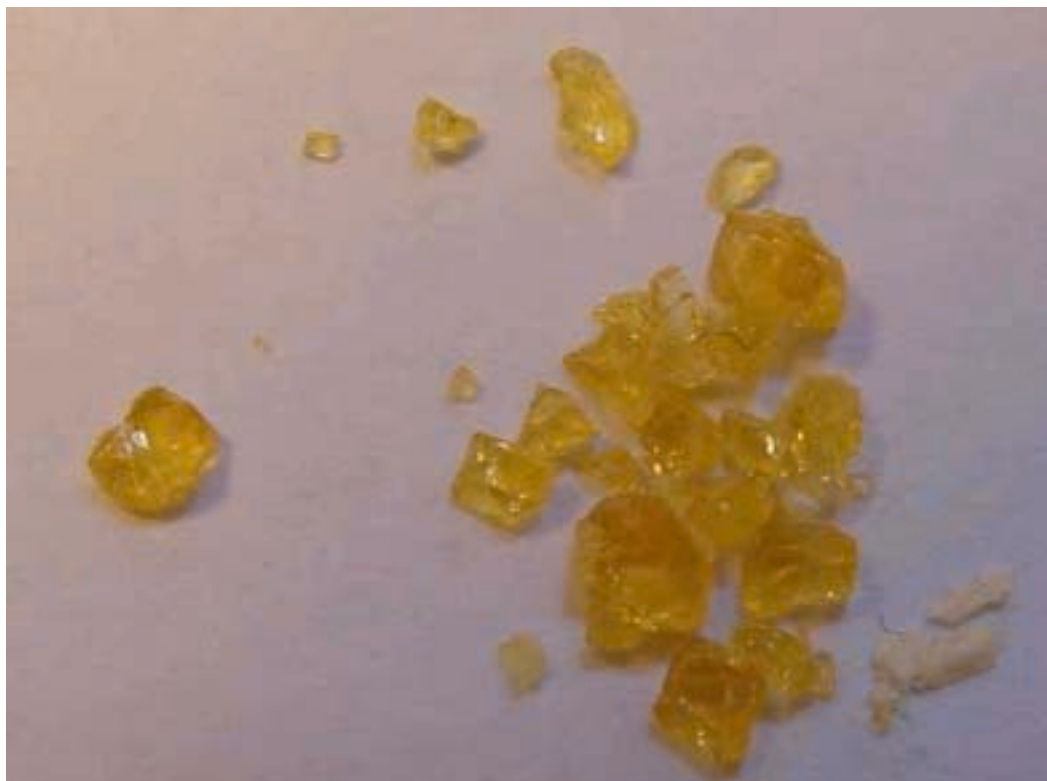
**Figure 1** Extracted calcium sulphonate
