# Durability of Vacuum Insulation Panels in Alkaline Environment

**Synne Christina Helgerud**

Norwegian University of Science and Technology  
Department of Civil and Transport Engineering

Report Title: <b>Durability of Vacuum Insulation Panels in Alkaline Environment</b>	Date: 28.05.2012 Number of pages of the article: 29 Number of pages incl. appendices: 50				
	<table border="1"> <tr> <td>Master Thesis</td> <td>X</td> <td>Project Work</td> <td></td> </tr> </table>	Master Thesis	X	Project Work	
Master Thesis	X	Project Work			
Name of MSc student: <b>Synne Christina Helgerud</b>					
Supervisor: <b>Bjørn Petter Jelle</b>

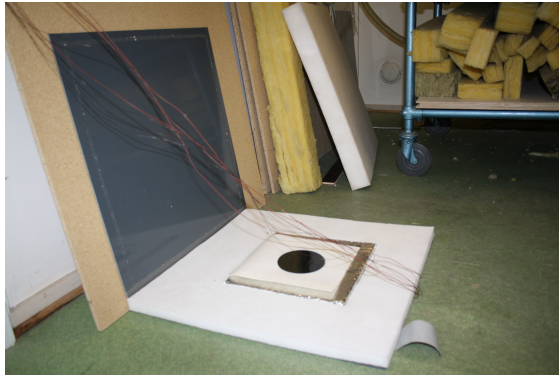
**Figure 3. The customized setup for smaller test pieces, used in the heat flow meter.**

A heat flow meter (HFM) apparatus was used to measure the change in thermal conductivity of the VIPs every three weeks during the 12-week testing period. Due to the limited size of the VIPs used in the experiment (250 mm x 250 mm), a customised setup for smaller test samples was applied, see Figure 3. The actual heat flow meters used were made of 1 mm thick, flexible, circular plate of polyurethane (PUR), with an outer diameter of 100 mm and a circular measuring area of 50 mm on each side of the specimen. To obtain stable conditions, with one constant warm side and one constant cold side, the whole metering area of the HFM apparatus (600 mm x 600 mm) had to be covered. Thus, the VIPs were placed in a frame of polyethersulfone (PES), see Figure 3. The measurements were performed in accordance with NS-EN 12667 (2001) and ISO 8301 (1991). A constant distance between the heating and cooling plates was used throughout the 12-week testing period, when the change of the thickness of the VIP panels proved to be insignificant.

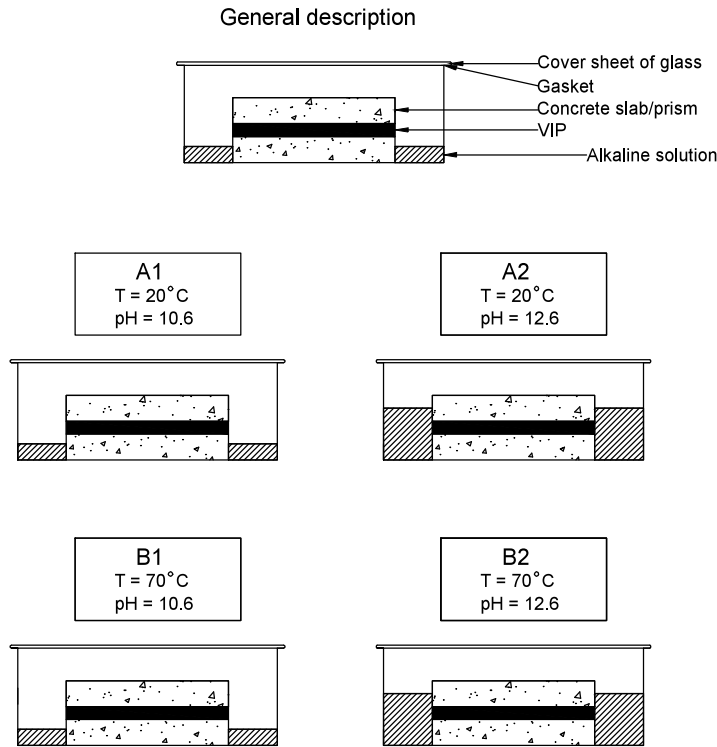
**Figure 4. Schematic setup of the different experiments.**

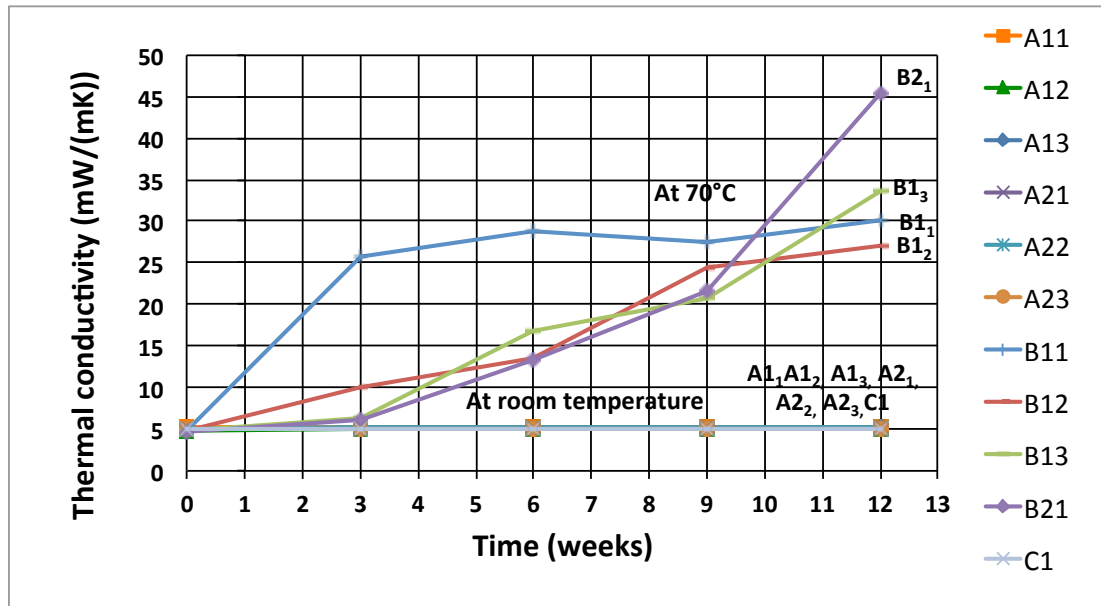
Figure 19. Thermal conductivity (mW/(mK)) versus time for the VIP experiments exposed to various degradation procedures. There is an obvious distinction between the A and C experiments at room temperature and the B experiments in the heating cabinet at 70°C.

Aluminium is not stable in any alkaline environment, but it was however assumed that the alkaline solution, (e.g. Ca(OH)<sub>2</sub> aqueous solution) with a pH-value of about 12.6 would degrade the VIPs to a greater extent than what the natural concrete water with a pH-value of 10.6 would do. Nevertheless, comparing the two different A experiments (A1 with pH = 10.6 and A2 with pH = 12.6) and the two different B experiment (B1 with pH = 10.6 and B2 with pH = 12.6) with each other, this proved not to happen after 12 weeks of testing, see Figure 19.

It is obvious that there is a distinction between the results from the panels aged at room temperature (A experiments) and the panels aged in the heating cabinet at 70°C (B experiments). The increase in thermal conductivity measured for the A experiments was relatively low compared to B experiments, and the overall performance of the A experiments was better than first expected. Thus, it may seem that the temperature have the greatest influence on the degradation of the thermal conductivity performance of the

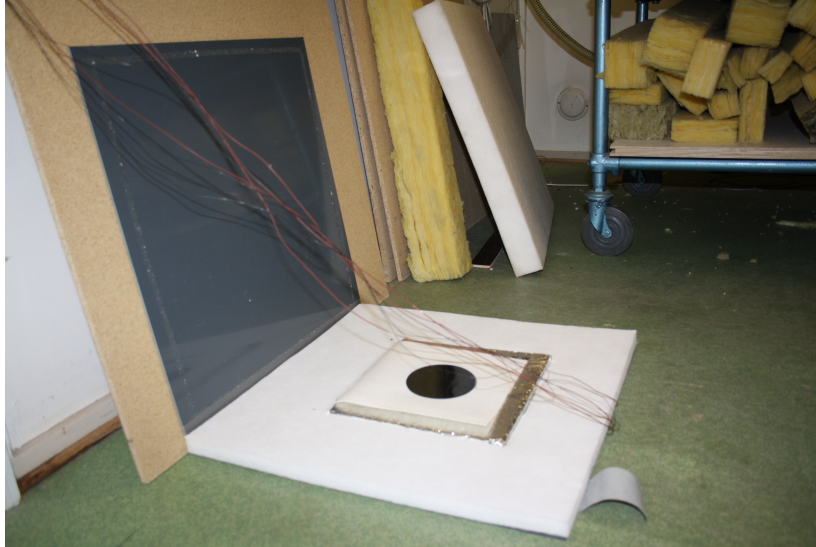
**Figure A2. The customised setup for smaller test pieces. The heat flow meter is the black, circular plate in the middle of the frame.**

setup for smaller test pieces was used. The HFMs used were of the type PU43T 0168 and 0169, made of 1 mm thick, flexible, circular plate of polyurethane, with an outer diameter of 100 mm and a circular measuring area of 50 mm on each side of the specimen. The setup is depicted in Figure A2.

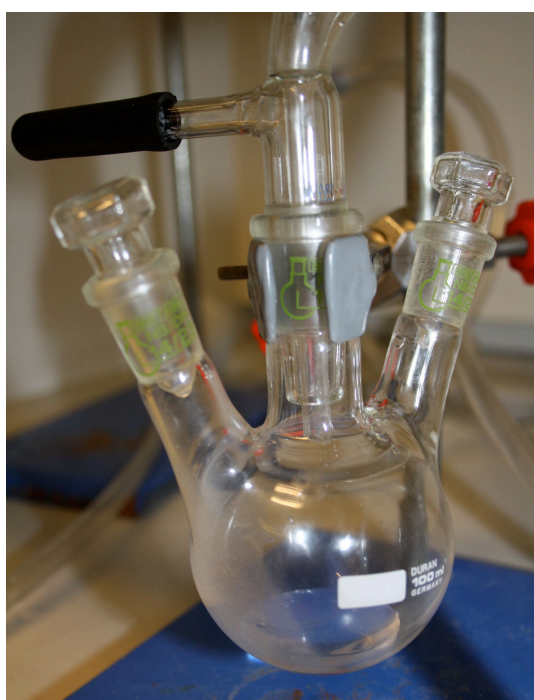
Figure B2. A close-up photo of the condensation.
