Norwegian University of
Science and Technology

Gas Turbine Optimum Operation

Synnøve Mangerud Flesland

Master of Science in Product Design and Manufacturing

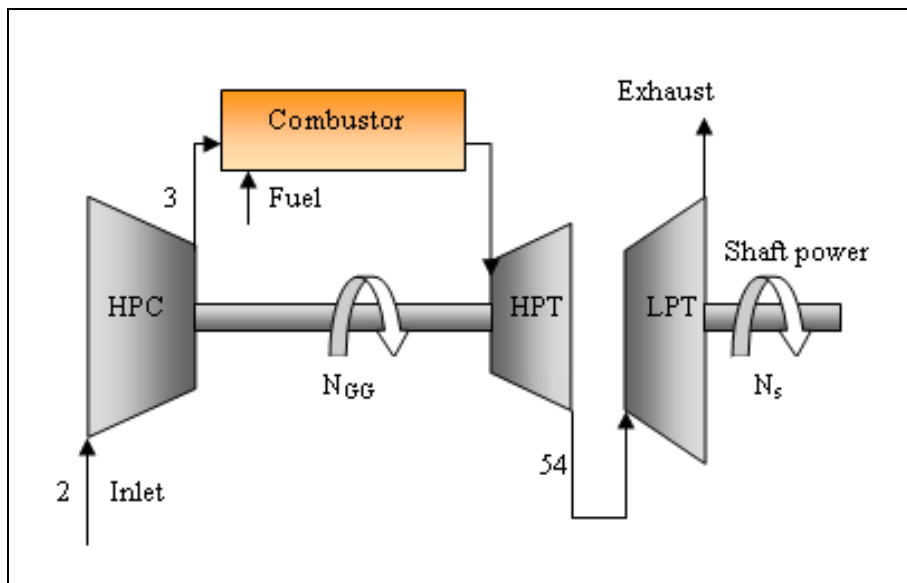
The compressor generates air at high pressure. The air is fed into the combustor chamber where the fuel is burned. The combustion products and excess air leaves the combustor at high pressure and temperature. The gas is further expanded in the high pressure turbine in order to run the compressor. The gas leaving the high pressure turbine still has high pressure and temperature, and is further expanded through the low pressure turbine (LPT). The power turbine is connected to the driven equipment which can be a compressor, a pump or a generator.

Figure 2-1: Two shafted gas turbine with sensor placement

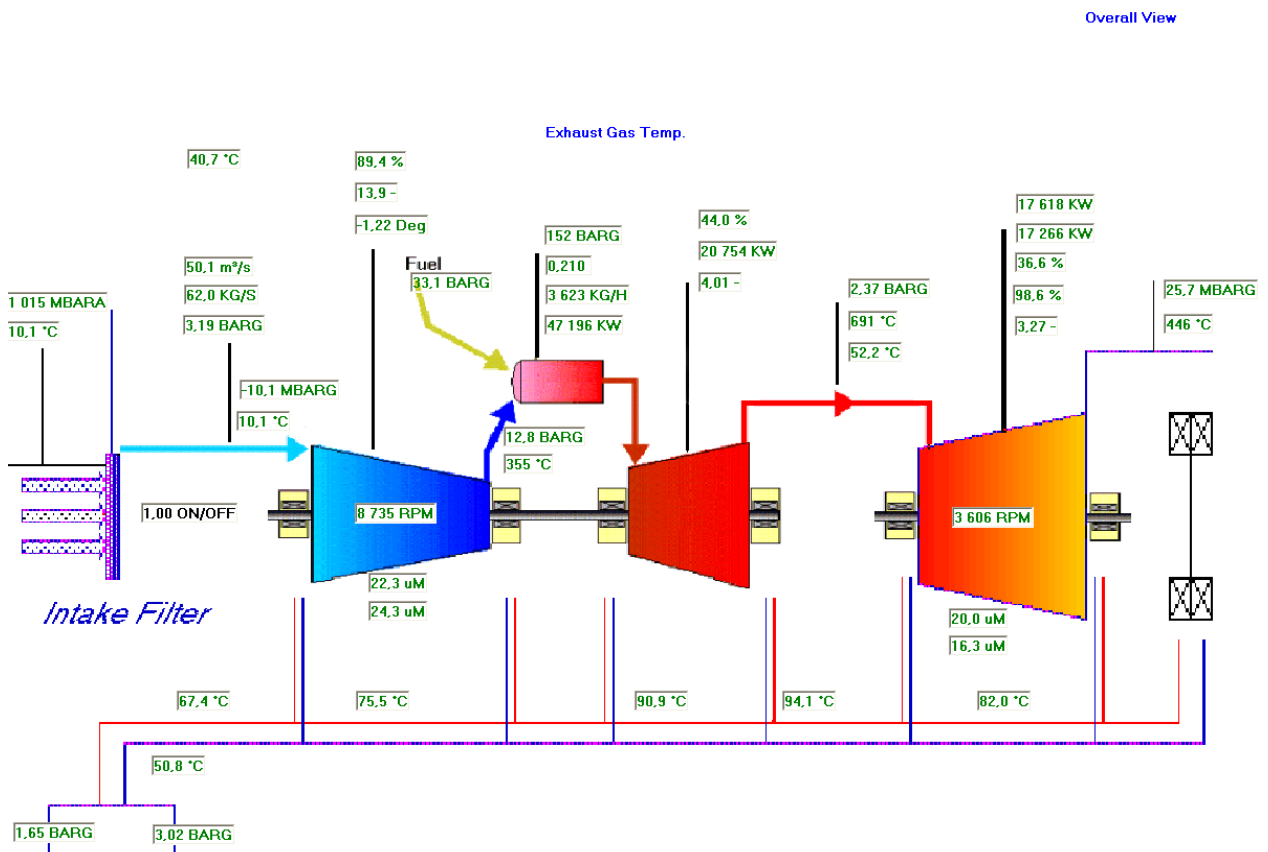
TurboWatch uses a console panel in order to organize the data from the specific plant. The console panel is a collection of individually monitored parameters and work as a graphical browser for monitoring the process. The main panel gives an overall view of all the different engines and a green or red light symbolize whether the engine is running or not. This gives the user a quick overview of the current situation at the plant and allows choosing the area of interest. Figure 6-1 shows the console panel for machine 1.

Figure 6-1: Console panel for machine 1

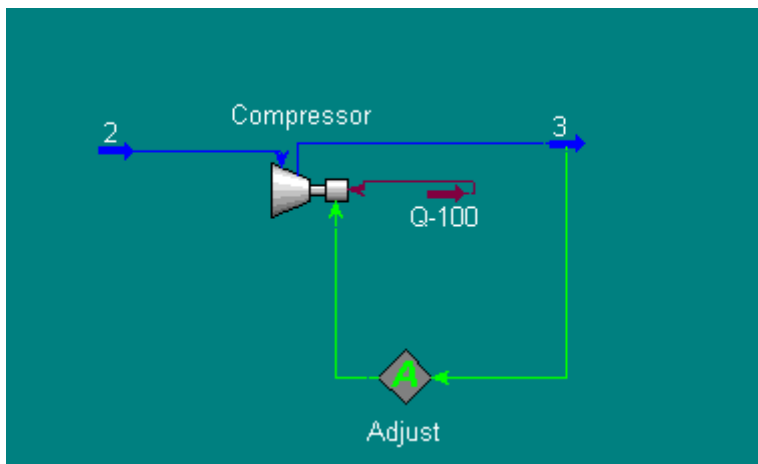
Figure 6-5: HYSYS compressor model

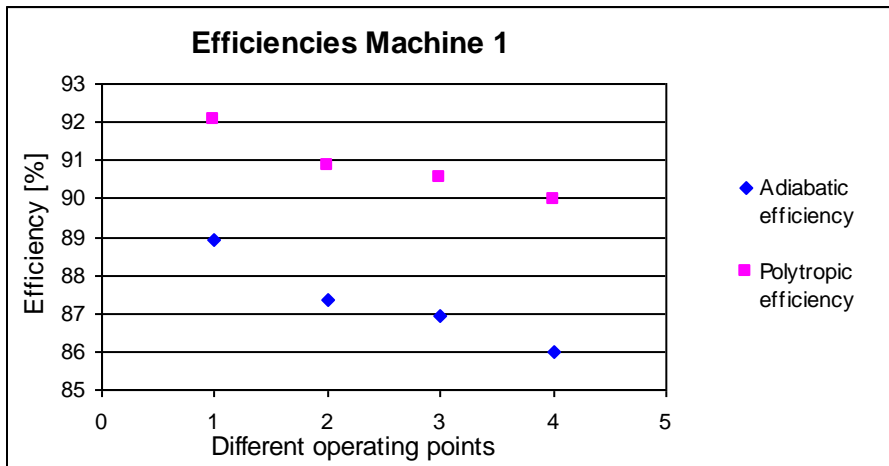
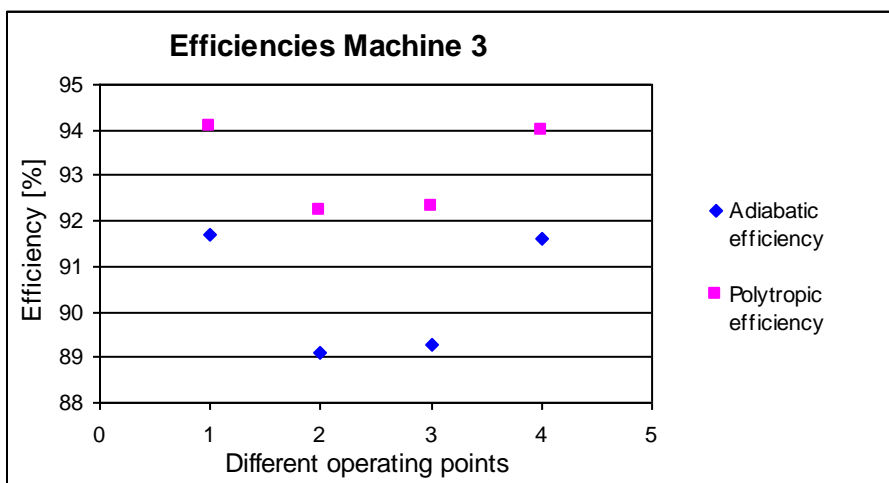
The two graphs clearly illustrates that the choice of efficiency does not affect the shape of the deterioration trend despite the great difference between polytropic and isentropic efficiency. This implies that the choice of efficiency is not critical when trying to reveal deterioration trends. The critical point seems to be that the choice of efficiency needs to be consistent throughout an analysis.

Figure 6-6: Comparison of efficiencies Machine 1

Figure 6-7: Comparison of efficiencies Machine 3

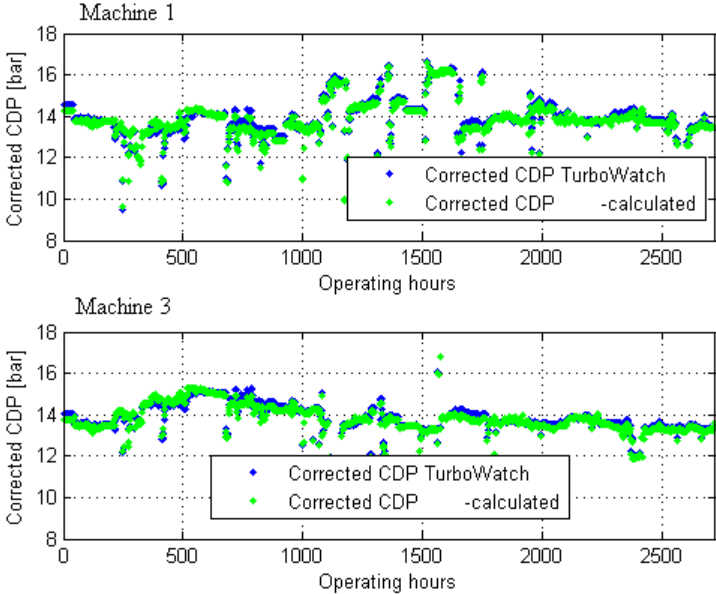
One general and one specific equation were available for corrected CDP. Calculations done with the two different equations for machine 1 and 3 are shown in figure 6-8 and 6-9. These values, when applying the specified and general equations, are plotted respectively against the values extracted from TurboWatch. It is interesting to note that these graphs imply that there are small deviations when using both the equations. It is therefore impossible to conclude which formula for corrected CDP is used in the software TurboWatch. The deviation is, however, quite small and it is therefore concluded that for further calculations in the present study the specified equation will be applied.

Figure 6-8: Comparison of corrected CDP when using the specified formula

Figure 6-9: Comparison of corrected CDP when using the general formula

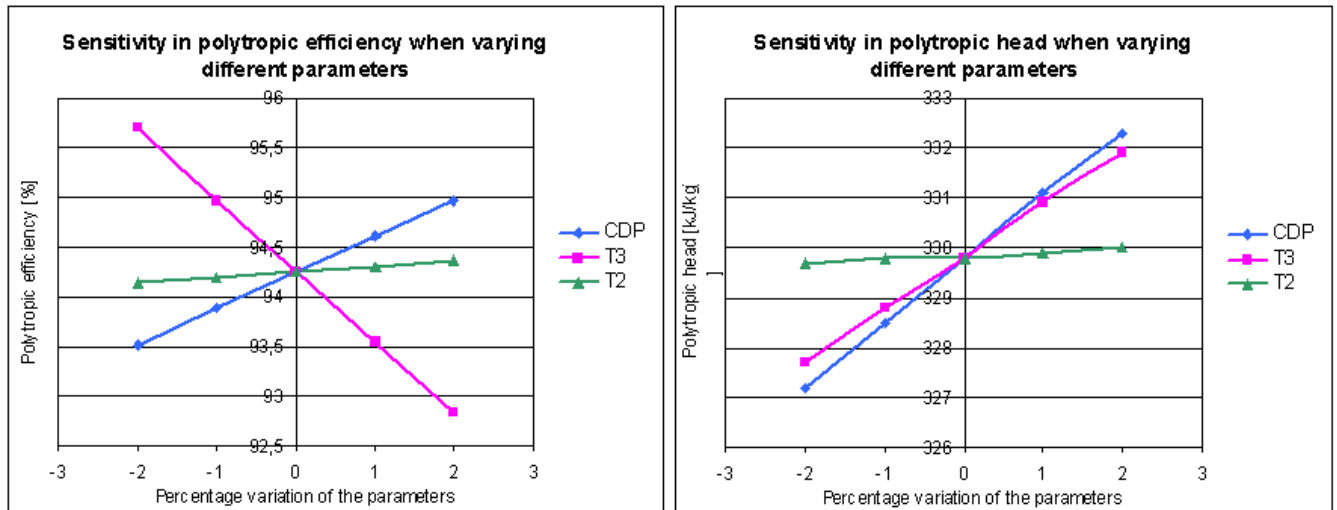
The change in polytropic efficiency when varying T3, T2 and CDP with 1 and 2 % is shown in figure 6-10. The graph clearly illustrates that polytropic compressor efficiency is mostly influenced by changes in T3. Changing T3 with $\pm 2\%$ results in a 3 % range in efficiency. Changes in both CDP and T3 lead to great variations in polytropic head. Changes in T2 had small affects on both the polytropic head and the efficiency.

Figure 6-10: Sensitivity in polytropic head and efficiency when varying certain parameters

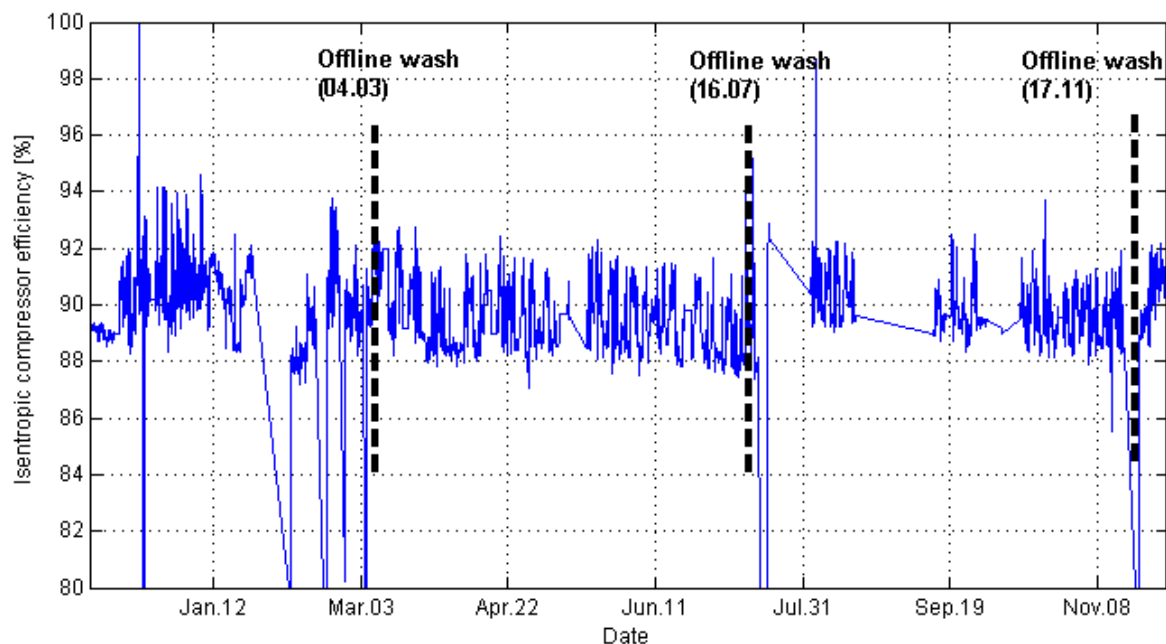
Figure 7-2: Compressor efficiency for Machine 3 – 01.12.09-01.12.10

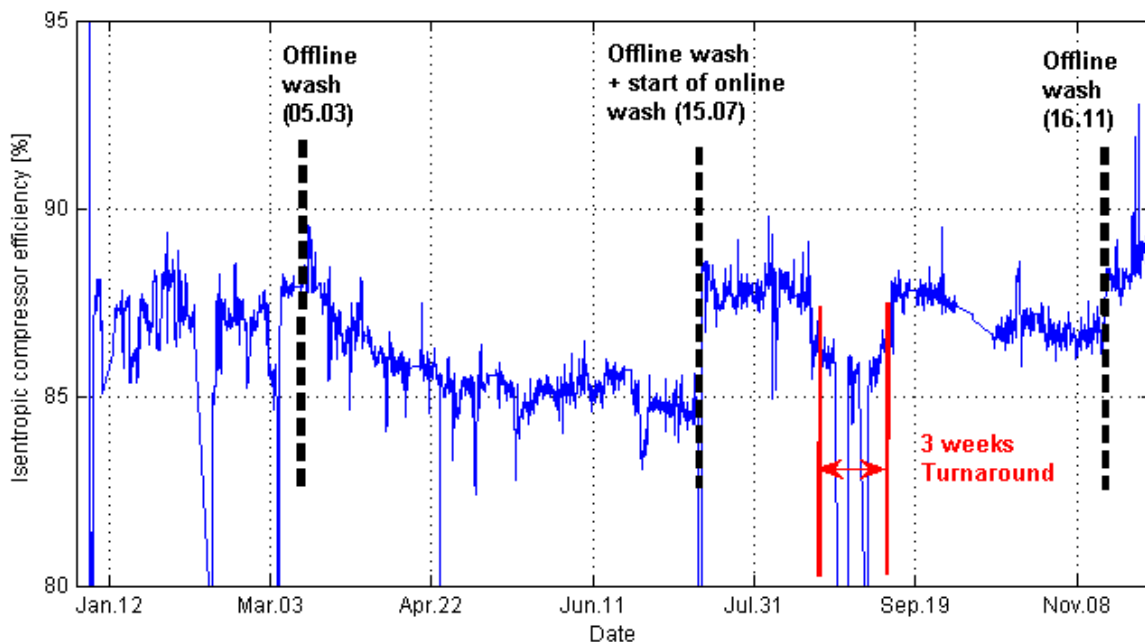
Figure 7-7: Compressor efficiency from 01.01.09-01.12.10

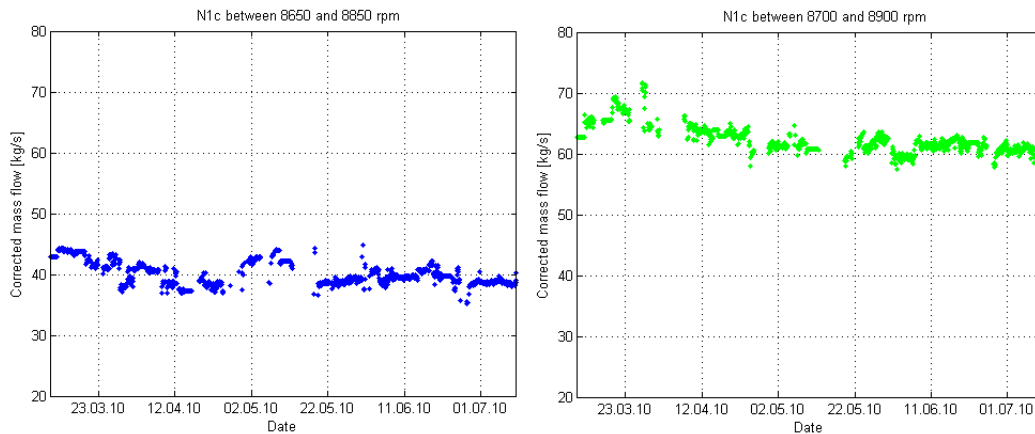
Machine 1: N1- 8650-8850 rpm, Machine 3: N1- 8700 and 8900 rpm

Figure 12-30: Corrected compressor airflow vs Date - Machine 1 (blue) and 3 (green)
