The Håkåneset rockslide, Tinnsjø

Stability analysis of a potentially rock slope
instability.

Inger Lise Sollie

Submission date: June 2014

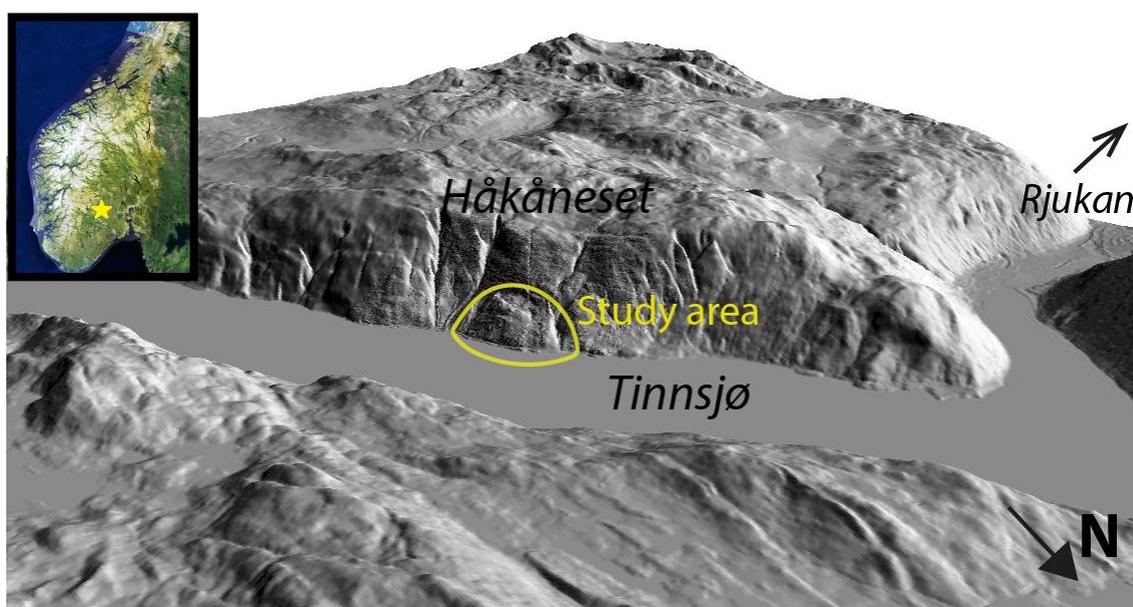
Figure 1: The unstable rock slope in this study is located at the foot of the Håkåneset Mountain, on a ENE facing slope along the shore of the lake Tinnsjø. This shaded relief model is derived from a 10x10 m resolutions DEM model.

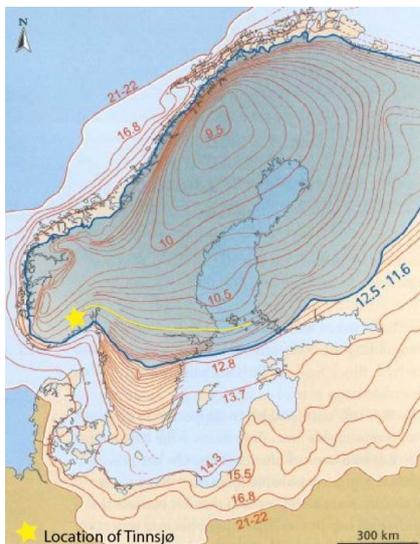
Figure 2: Map showing the stages of the retreat of the Scandinavian Ice Sheet. Ages for the various position of the ice margin are shown in thousands of calendar years. Tinnsjø (yellow star) was at the ice margin approximately 10 600 years ago (outlined with yellow line). The line marked "12.5-11.6" (blue) denotes the outer limit during the Younger Dryas stadial. (ed. after J. Kleman and A. Strømberg published by Ramberg (2008)).

formed deep U-shaped valleys. The deglaciation of the Scandinavian Ice Sheet started in the Old Dryas, about 18,000 years ago. Tinnsjø was at the ice margin approximately 10 600 years ago (Figure 2, Ramberg (2008)).

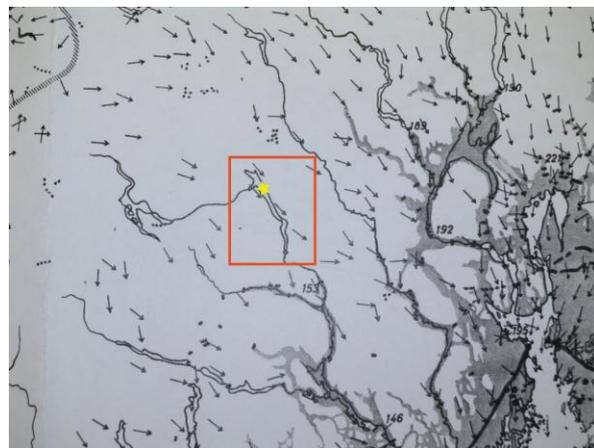
Figure 3: Extracted section of glacial map of Norway showing the main glacial movement (black arrows) in the area of the study area. The Håkåneset rockslide is located at the west shore of Tinnsjø, outlined in red. (Holtedahl and Andersen, 1960)

The orientation of Tinnsjø is parallel to the main glacial movement direction during the last glacial maximum in the area, Figure 3. In glacially eroded mountain setting valley profiles have extra deep submersions downstream meeting points of two or more valleys. In such areas the merging of several valley glaciers increases the erosion effect, causing deep thresholds (Jansen, 1986). Today these thresholds are filled with water and forming lakes such as Lake Tinnsjø, which is located south of five merging valleys. Tinnsjø is measured to be up to 460 m deep (<http://www.nve.no/>).

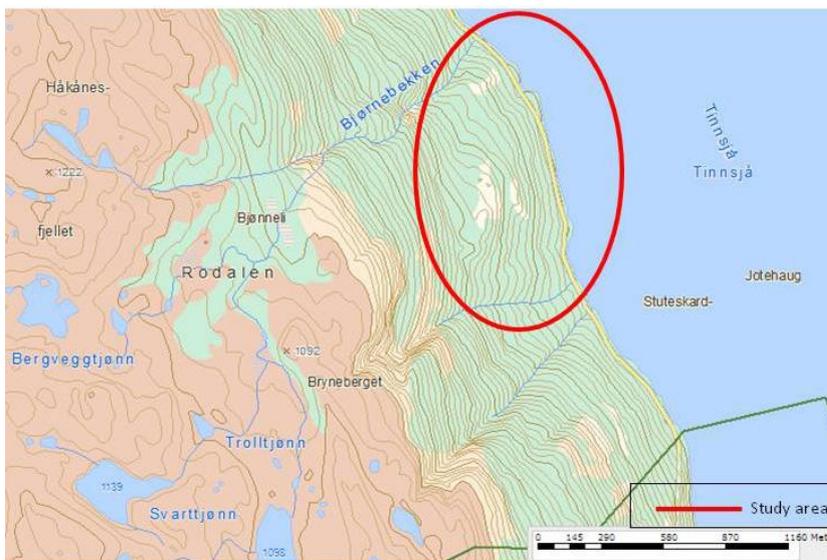
Figure 4: Extraction of hydrogeological map of the study area (atlas.nve.no). No particular conditions are reported within the limits of the study area.

To get an impression of the local hydrogeological conditions of the study area, the hydrogeological map of the Tinn sjø REGINE unit (no. 016.G42) was studied, see Figure 4. The Tinn sjø unit is a part of catchment of Skien ("Skienvassdraget"), and covers an surface area of 23.15 km². On average the seepage is 13.27 mill m³/yr based on measurements in the

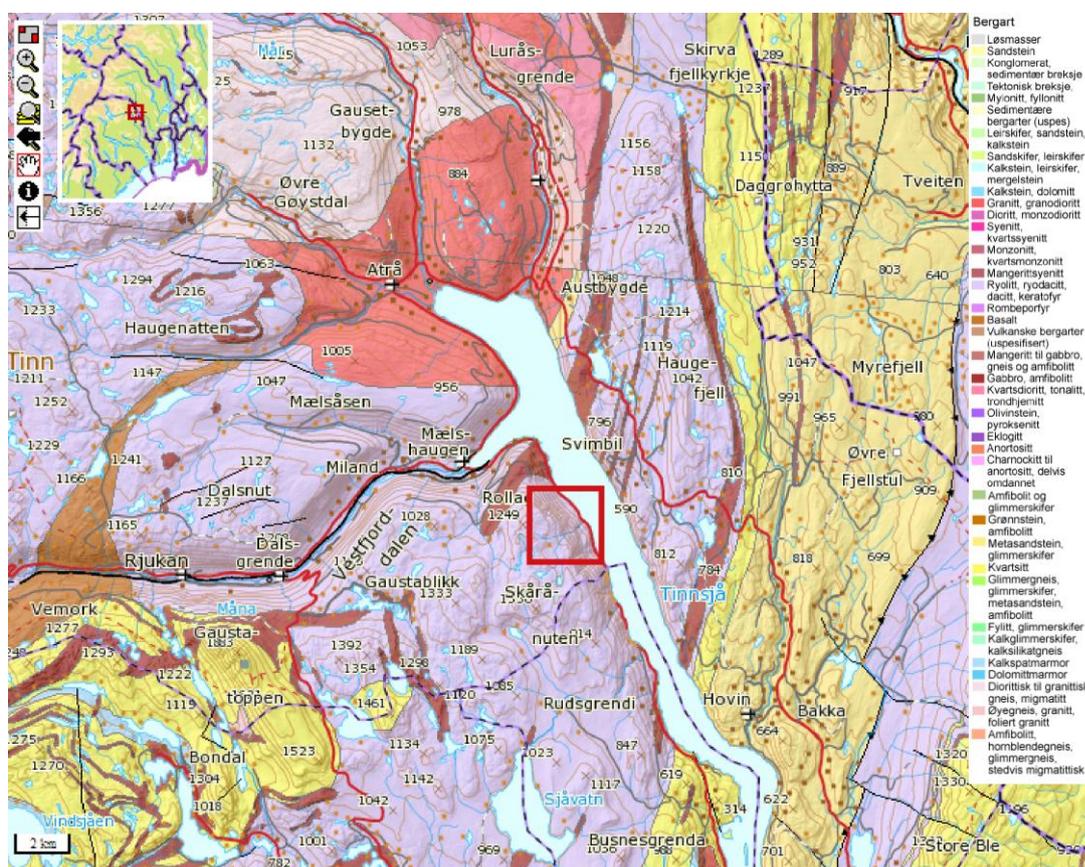
Figure 7: N250 map showing the regional main bedrock types around Tinnssjø. The study area (outlined with red the box) is located within a metarhyolitic/metamorphic tuff unit (geo.ngu.no).

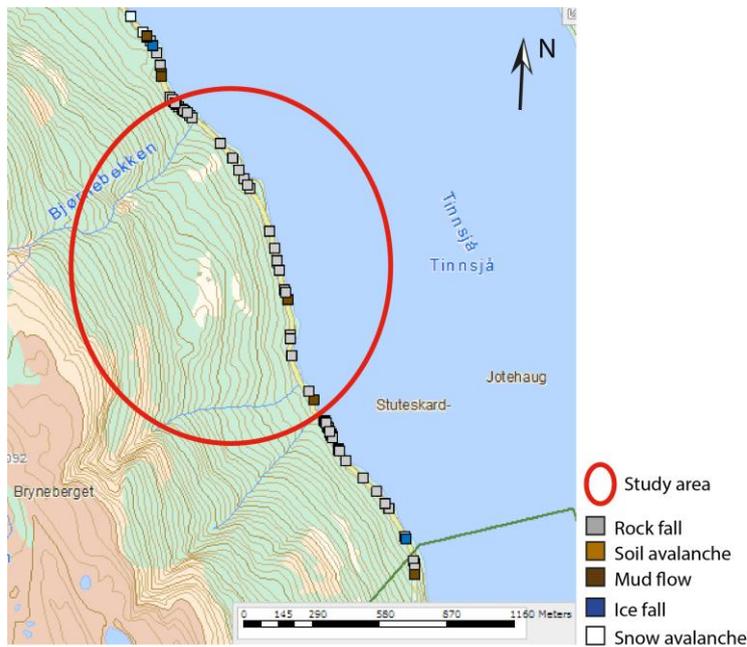
Figure 9: 35 historic rock fall events are recorded within the study area of the Håkåneset rockslide (www.nve.no).

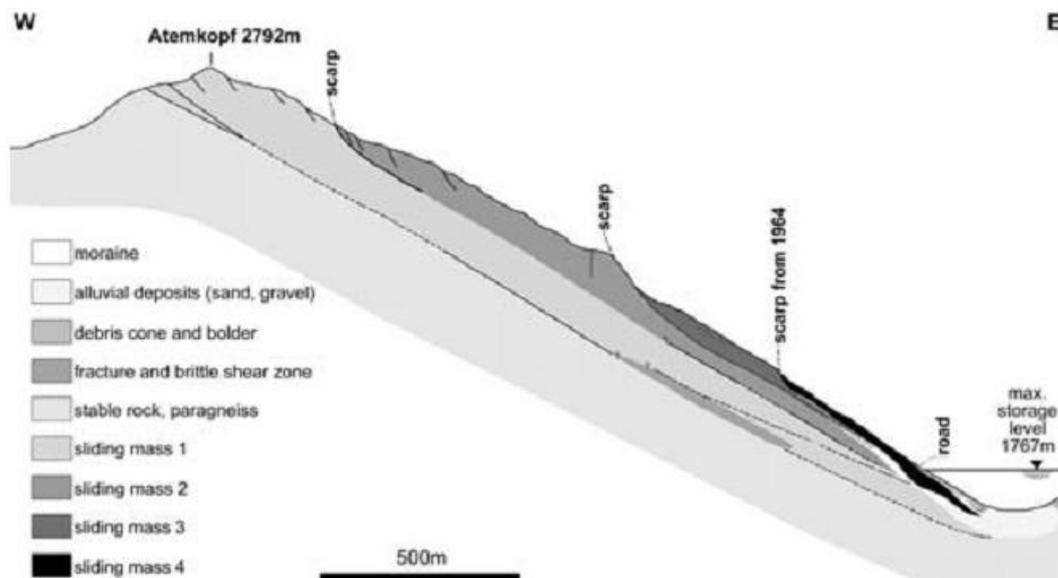
Figure 10: W-E geological cross section of the Hochmais–Atemkopf rockslide system (Schneider-Muntau and Zangerl, 2005).

Displacements in the range of 3 to 4 cm per year is recorded in the lower part of the slope and are mainly directed parallel down slopes, which suggests a translational sliding mechanism.

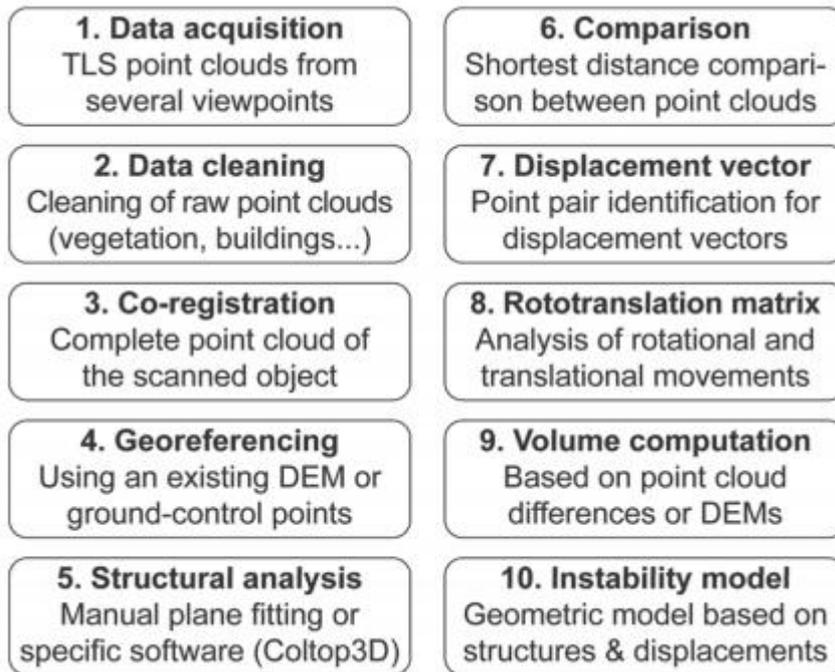
Figure 11: Flowchart for the acquisition, treatment and analysis of TLS data for structural analysis and deformation calculation. Step 1-5 applies for single acquisition and Step 6-10 require multi-temporal point cloud.

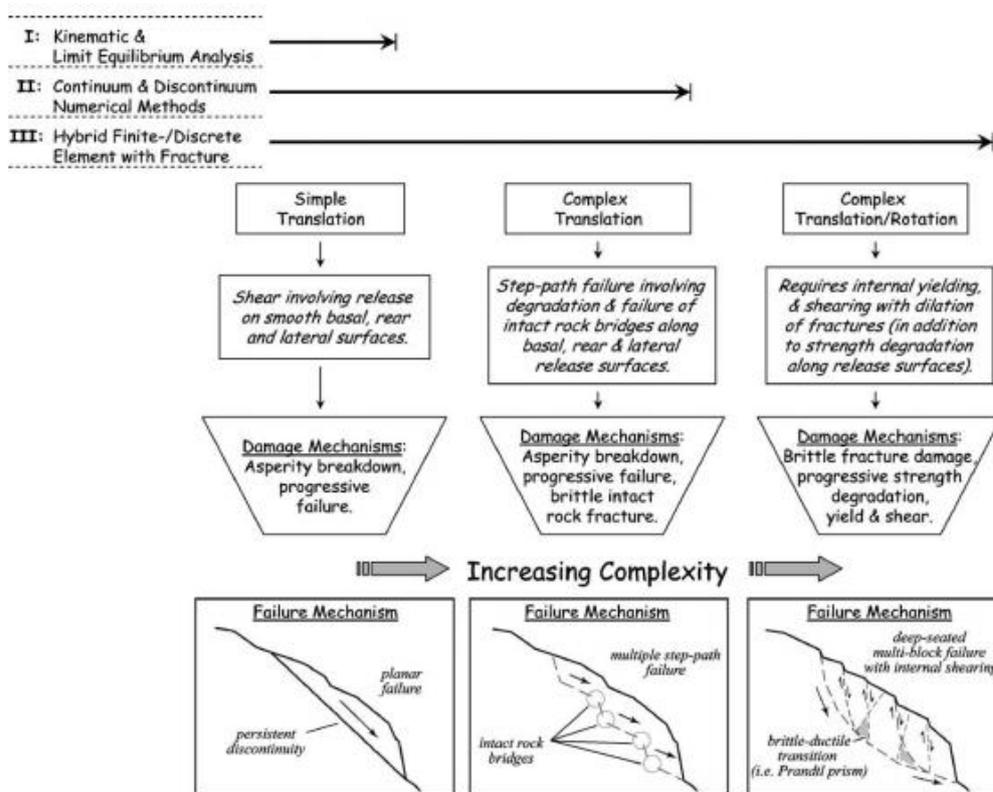
Figure 13: This figure gives recommendation for preferred slope stability analysis method based on the complexity of the assumed dominant failure mechanism forming a sliding surface (Stead et al., 2006)

The factors that are considered when choosing an analysis method for a rock slope analysis are mainly 1) the complexity of the geological conditions 2) time and costs. Stead et al. (2006) gives recommendations of preferred analysis method based on the complexity of the geological conditions, which are illustrated and described in Figure 13 and briefly described in the further text:

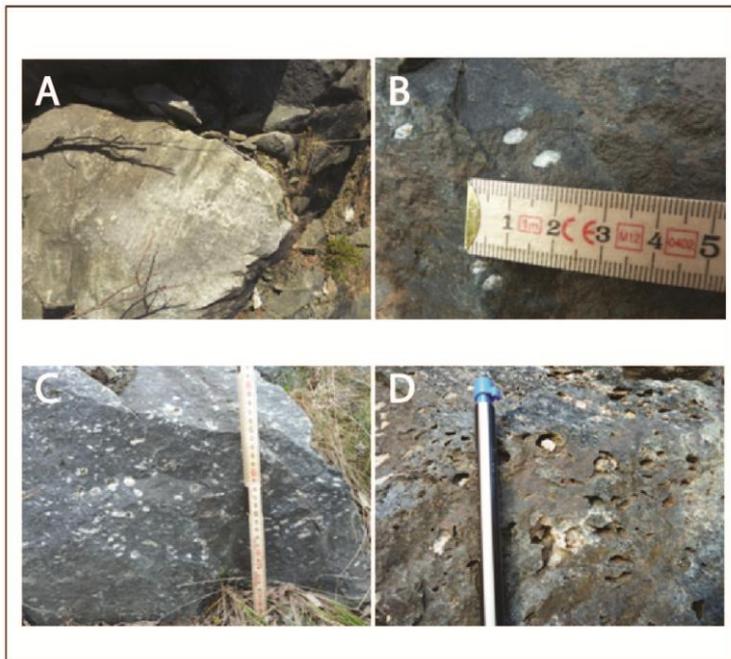
Figure 14: Some rock type characteristic observed in the area during field work. A) Gneissic rock with poorly developed schistose foliation. B) Metavolcanic ryholite with calcite (white) and brown FE-mineralized surface. C) Metarhyolite with quartz and calcite minerals. D) Porous ryholite with re-crystallized calcite and quartz in the pore holes.

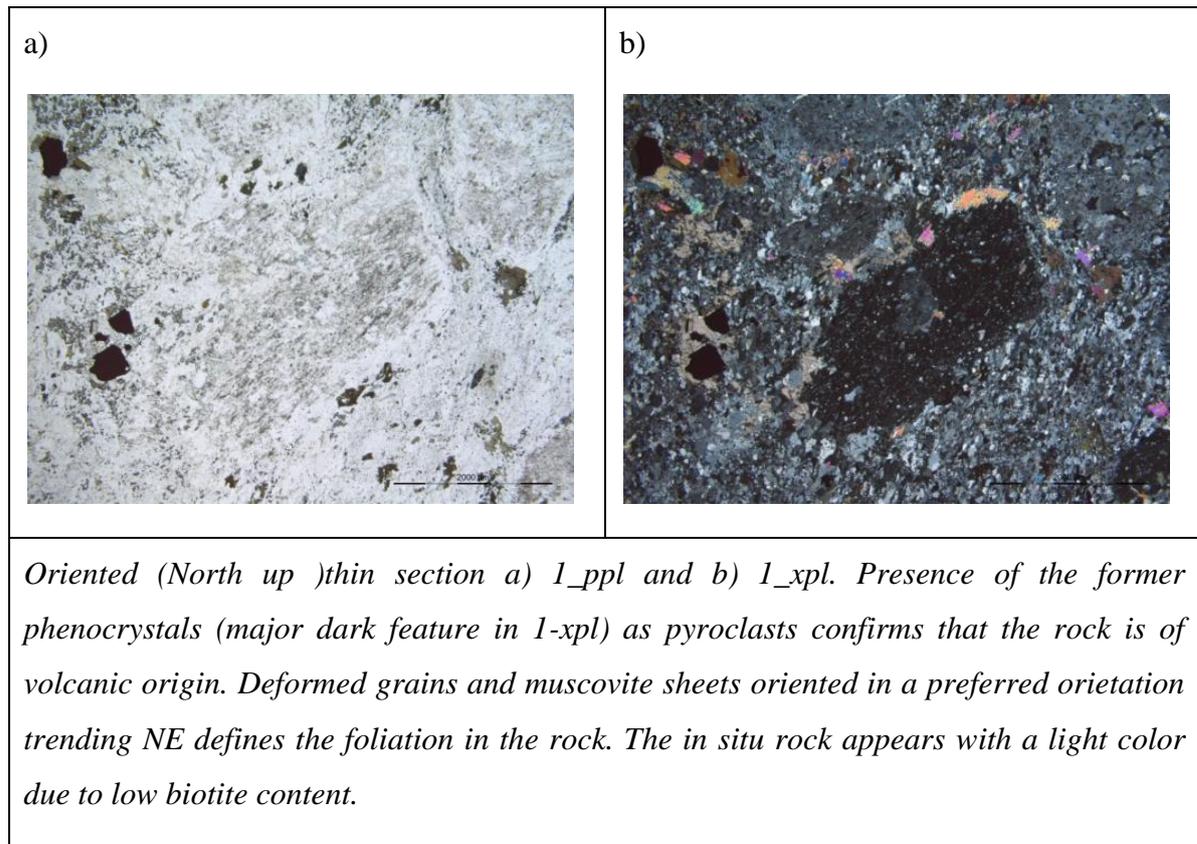
Figure 15: Oriented (North up) thin section #1 of the light colored in situ rock type within the Håkåneset instability.

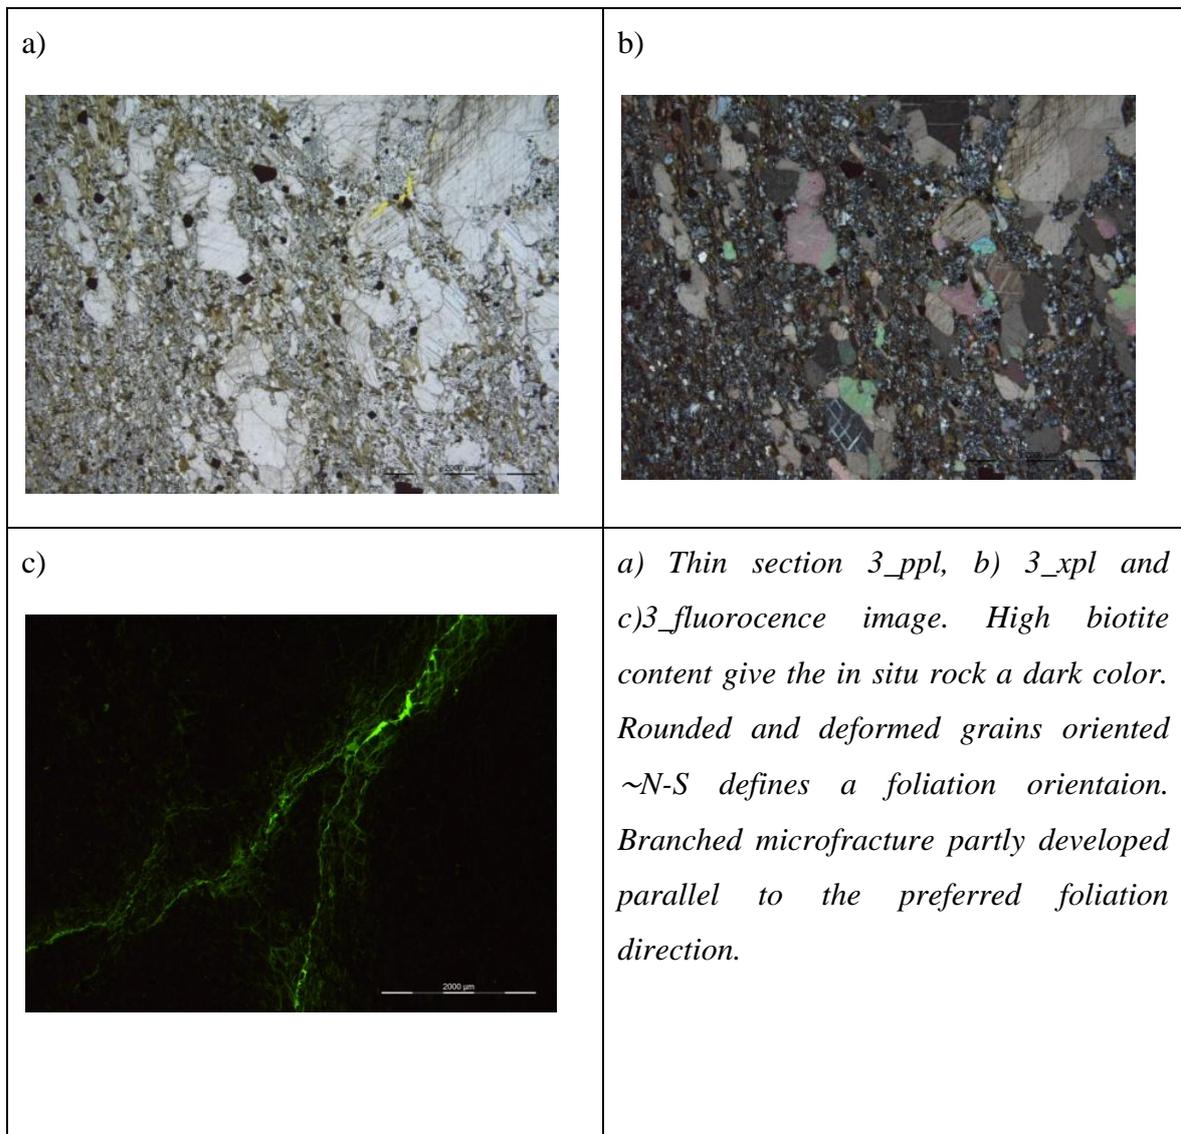
Figure 16: Oriented (North up) thin section #3 prepared from the dark colored situ rock within the Håkåneset instability.

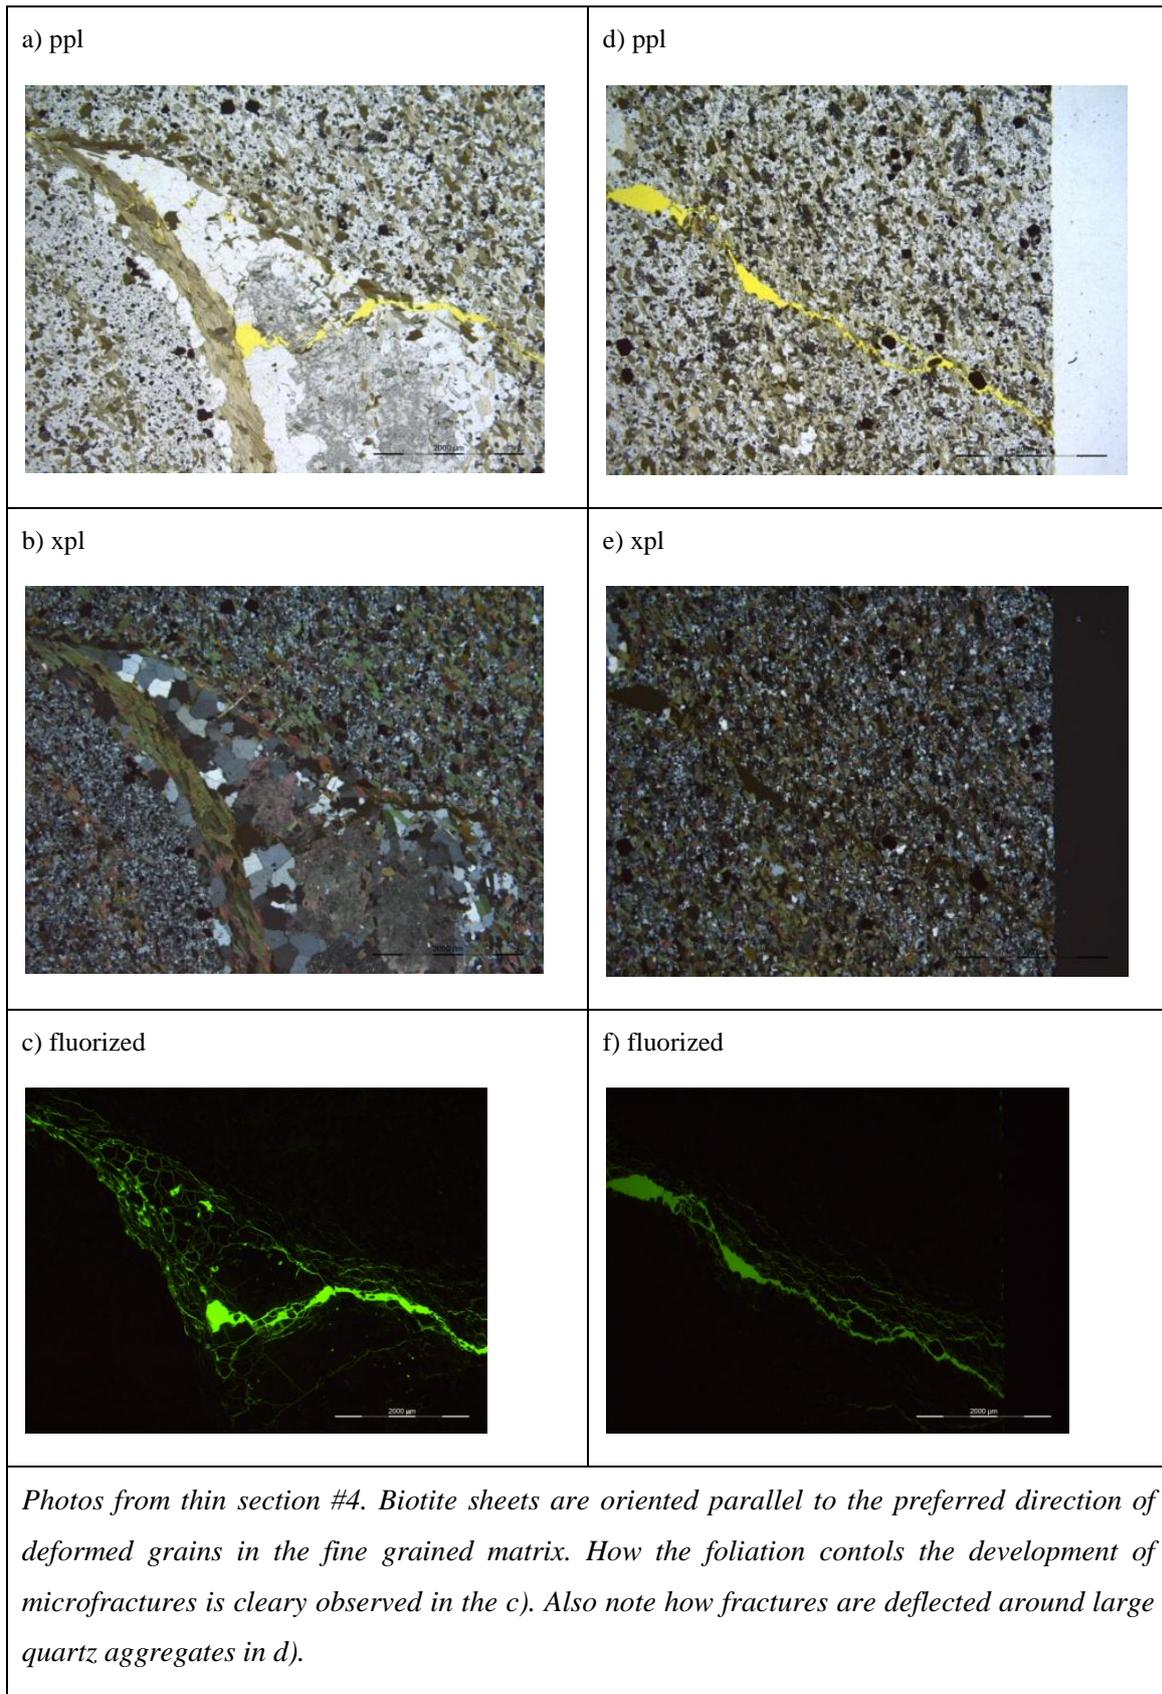
Figure 17: Thin section #4 (not oriented) of dark colored in situ rock sample within the Håkåneset instability.

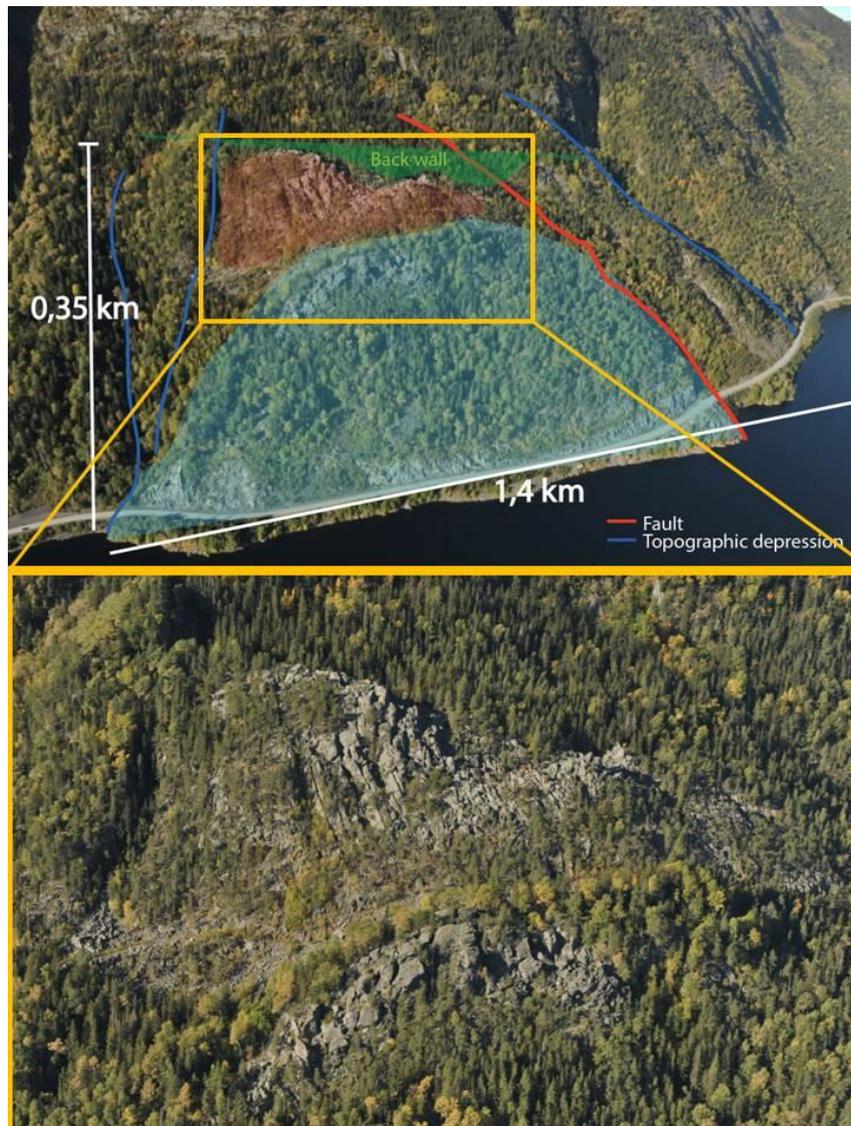
Figure 18: The rock mass at Håkåneset is heavily dissected by multiple joint sets that were mapped out during the project assignment. Structural domains (blue and red shaded area) and geological structures and geomorphology is described in Chapter 5.3. Photo: SVV, Audun Langelid

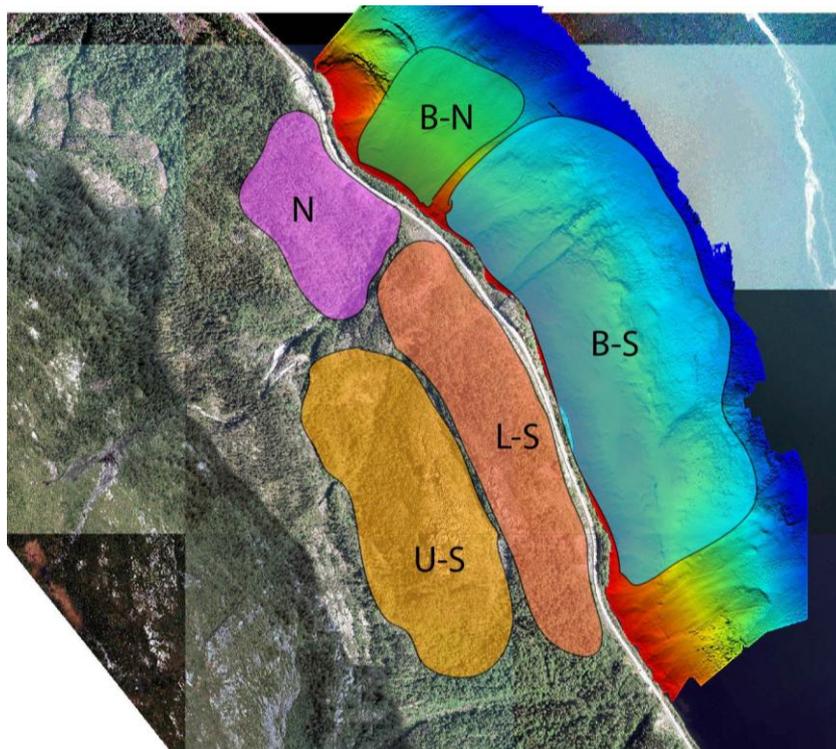
Figure 19: Defined structural domains for the study area: Subaerial domains are called North (N), Upper-South (U-S) and Lower-South (L-S), and are based on a systematic spatial variability in discontinuity orientations. Subaqueous domains are Bathymetric-North (B-N) and Bathymetric-South (B-S) and are divided based on geomorphological features that are visible on bathymetric images.

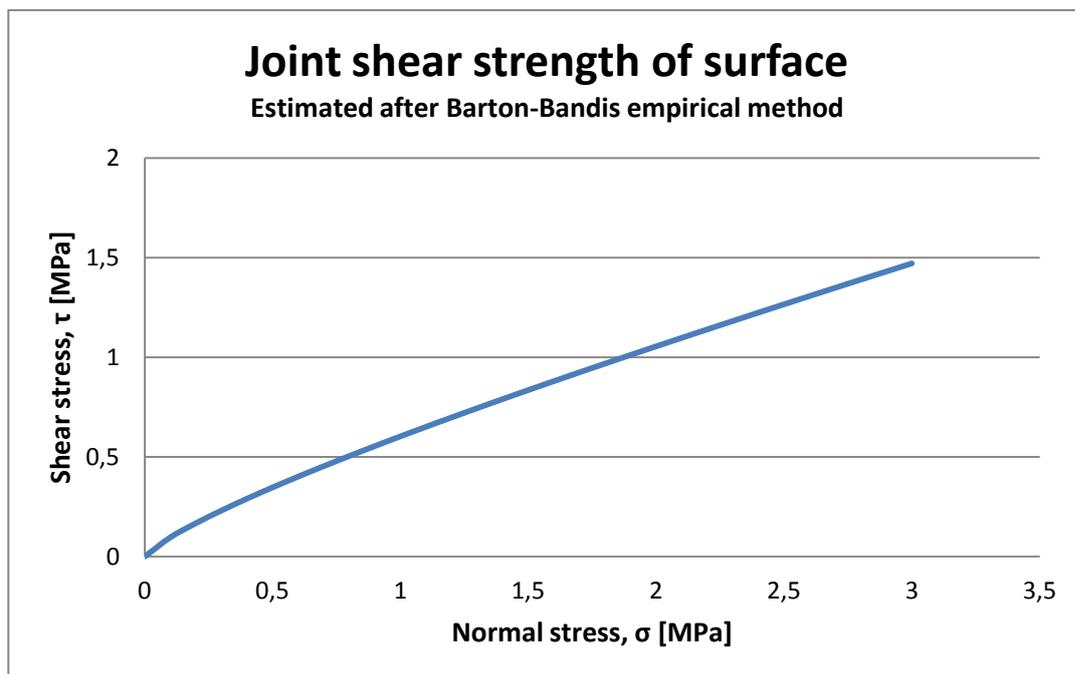
Figure 20: Estimated joint shear strength for the Håkåneset slope. The estimation is performed after the empirical method of Barton-Bandis, described in Grøneng and Nilsen (2009). Input values found in Table 4, Table 7 and Table 8

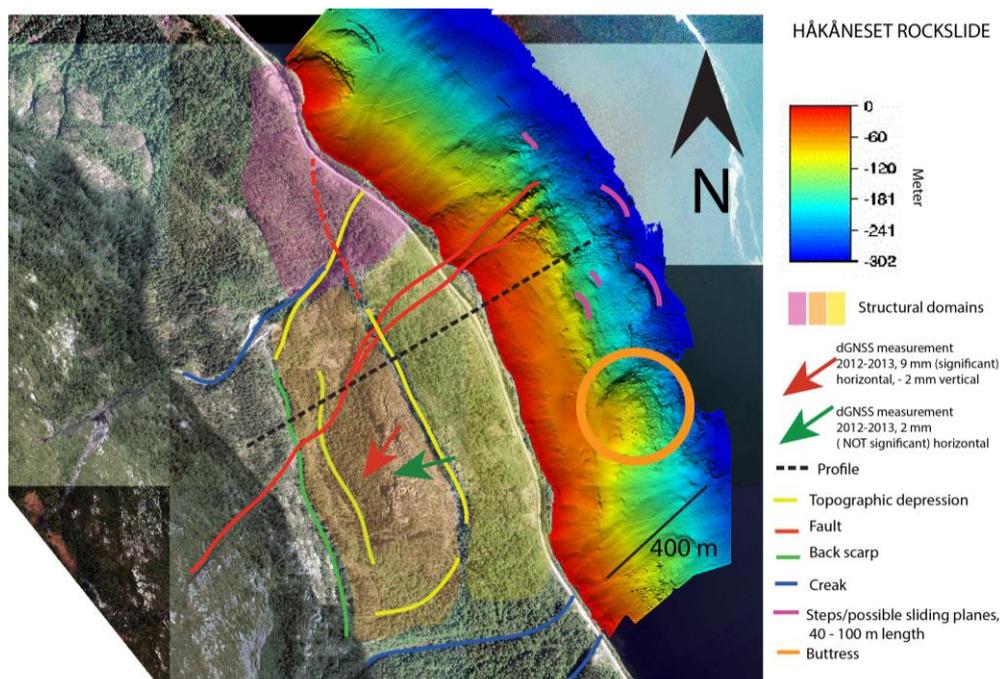
Figure 21: Important geomorphological features that are assumed to be affecting and controlling the stability of the slope. The three defined structural domains are highlighted and arrows show the direction of the measured movement in the slope by dGNSS (not in scale).

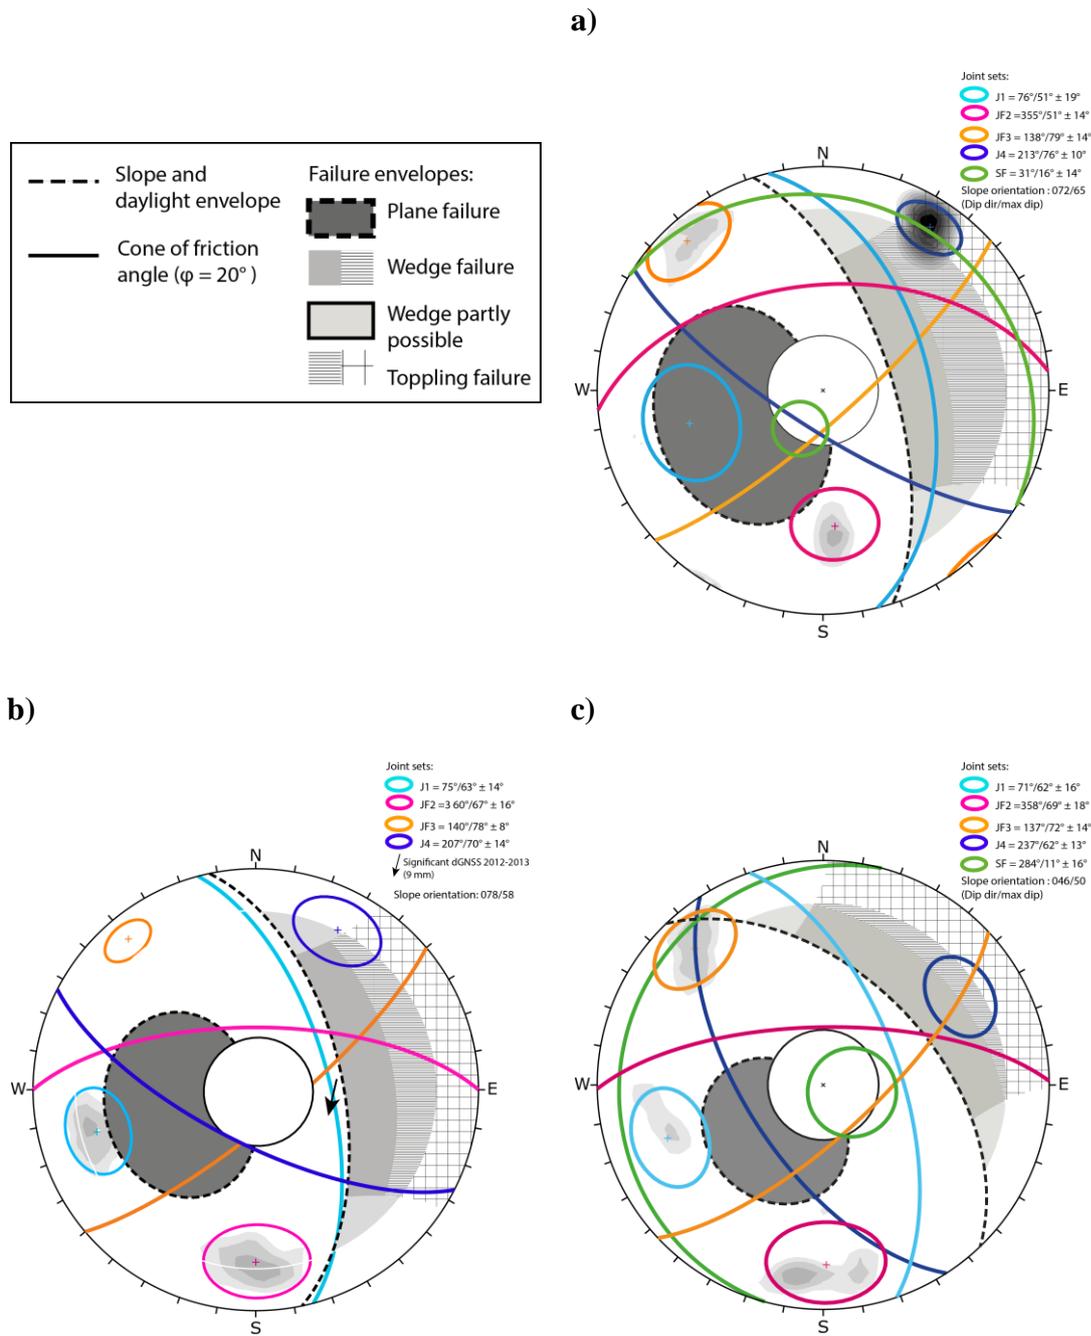
Figure 22: Kinematic feasibility test results for a) Lower-South (L-S) domain. b) Upper-South (U-S) domain. c) North (N) domain. The feasibility for planar, wedge and toppling failure are tested assuming maximum slope inclination. Guidelines given for the risk and hazard classification system provided by NGU (Hermanns et al., 2012b) are followed.

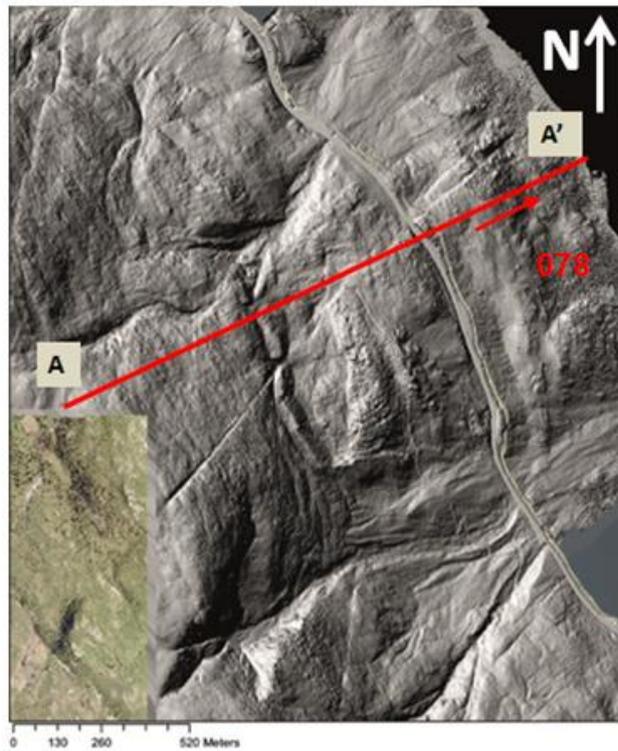
Figure 23: AA' is the trend of the cross section profile used to construct the Phase2 model. Profile constructed from 1m resolution DEM in Esri (2012)

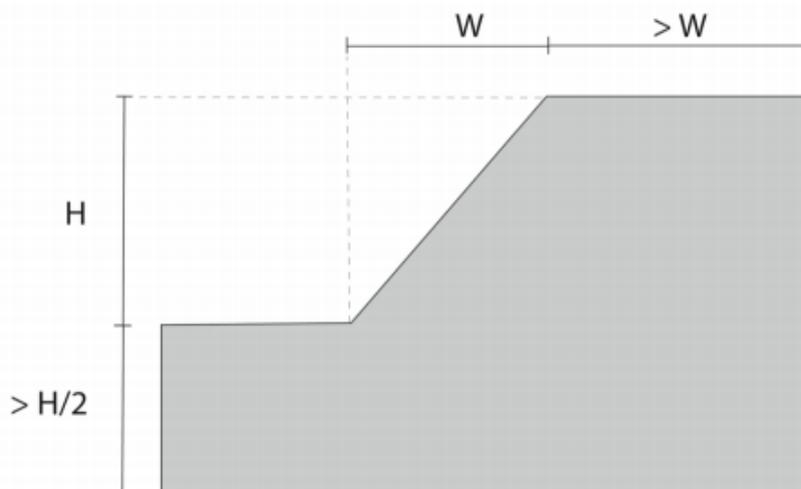
Figure 24: Recommended location of artificial far-field boundaries in a model for slope stability analysis given by (Wyllie and Mah, 2004)

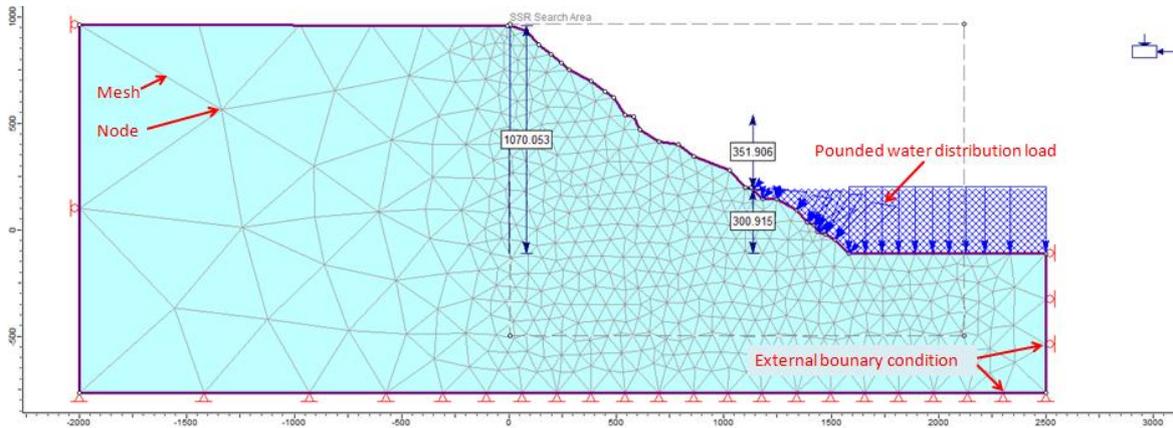
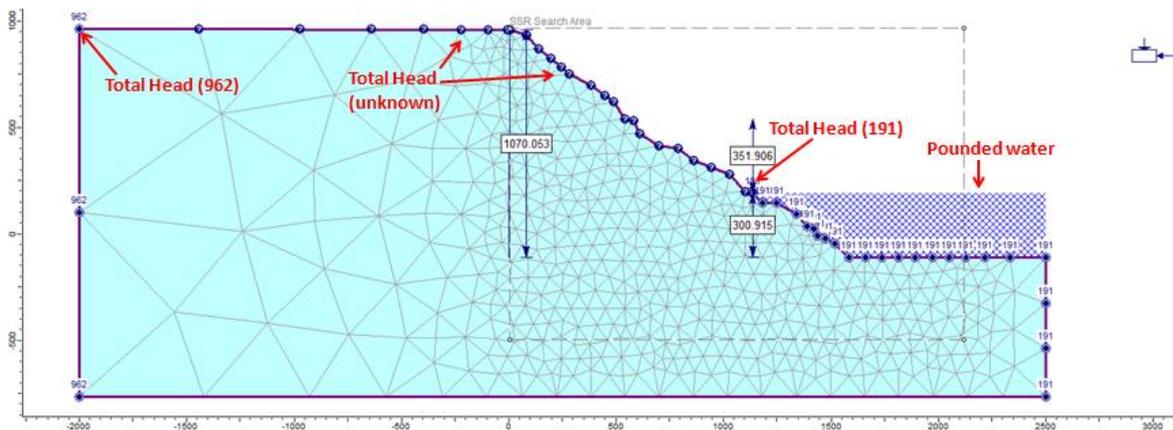
Figure 25: The Phase² model used for the stability analysis of the Håkåneset rockslide. The profile is constructed from the AA' profile in Figure 23

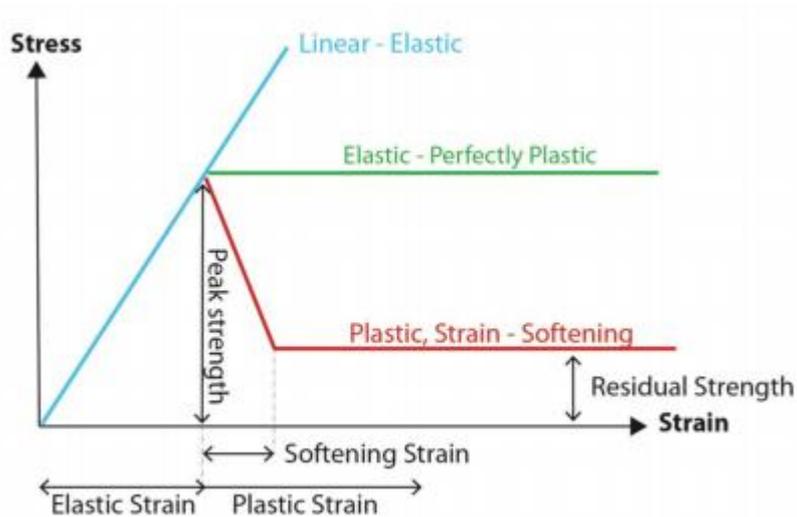
Figure 26: Stress-strain relations that represent the behavior of the rock mass when different material models are assumed. The residual strength relative to the peak strength describes the plastic strain-softening model of the material (ed. Hoek (2007)).

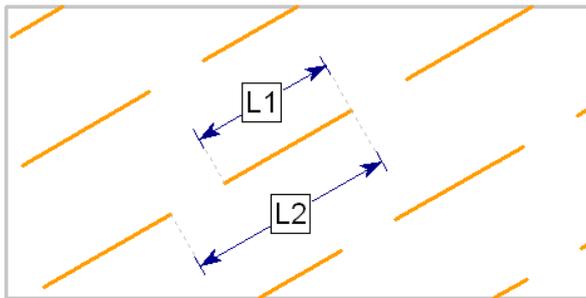
Figure 27: Length (L1) and persistence(L1/L2) of a joint after the definition used in the Phase2 model (Rocscience, 2014b).

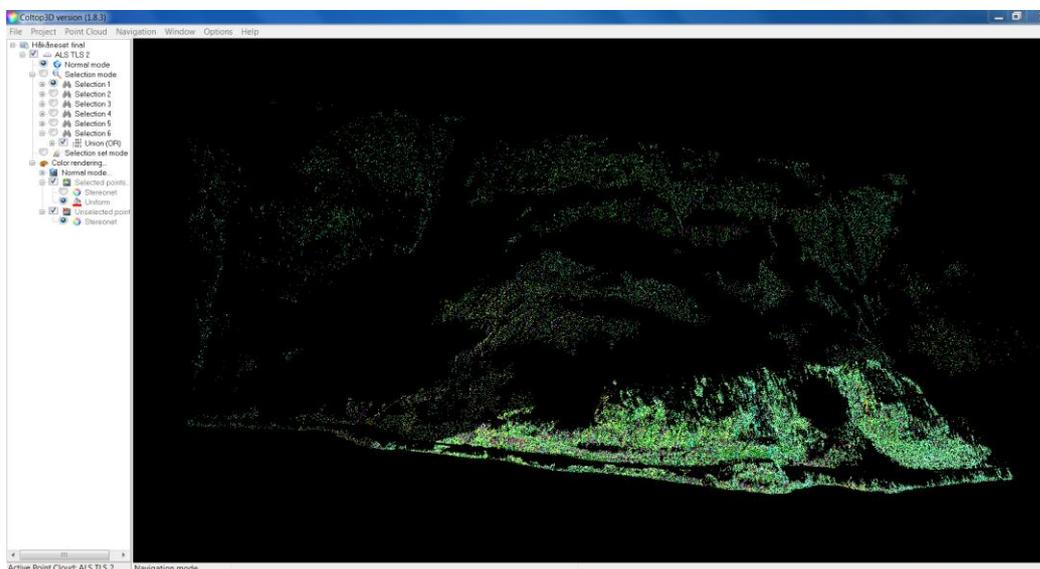
Figure 28: Print screen from the structural analyzing software COLTOP, showing the colored point cloud model of the study area at Håkåneset. The model is obtained by terrestrial laser scan from two directions in 2012.

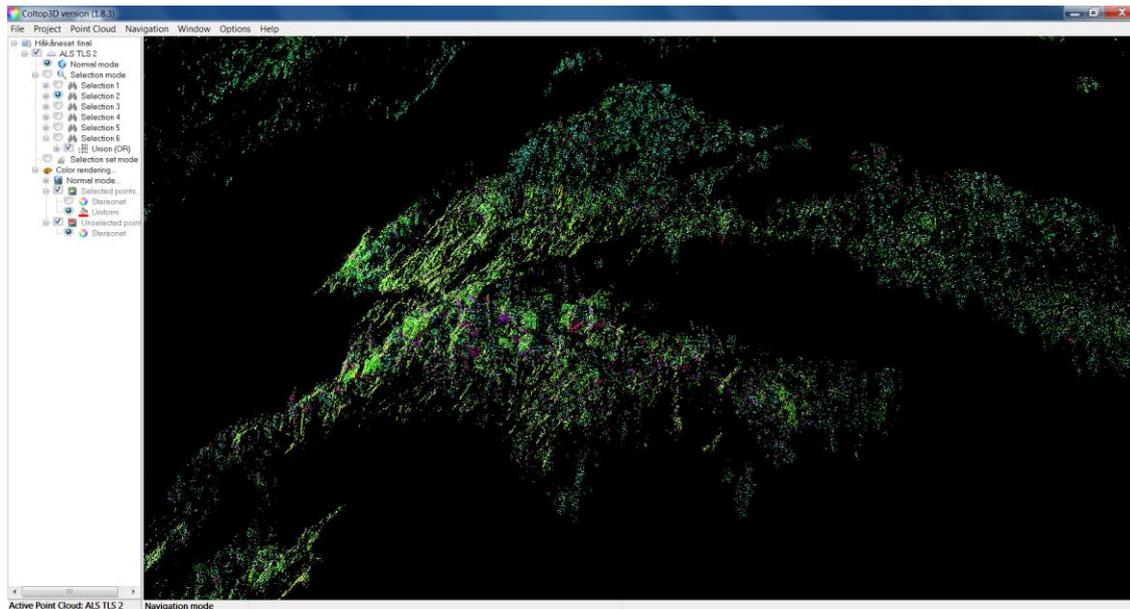
Figure 29: COLTOP displays exposed surfaces as areas with homogeneous color. The surfaces are interpreted to reflect the discontinuities that are present in the rock mass. Six color selections were defined and mapped out in the Håkåneset: turquoise, green, yellow/blue, light yellow/green, pink and purple.

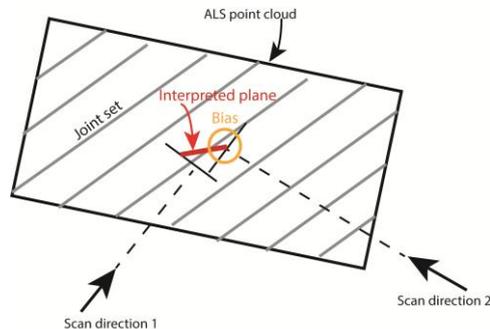
Figure 30: In Polyworks the colored surfaces are obtained by interpolation of a plane between two scan directions. This might cause a bias due to the scan direction This is likely to be the reason for the systematic difference between the field orientation measurements and the TLS orientations measurements of JF2 and JF3.

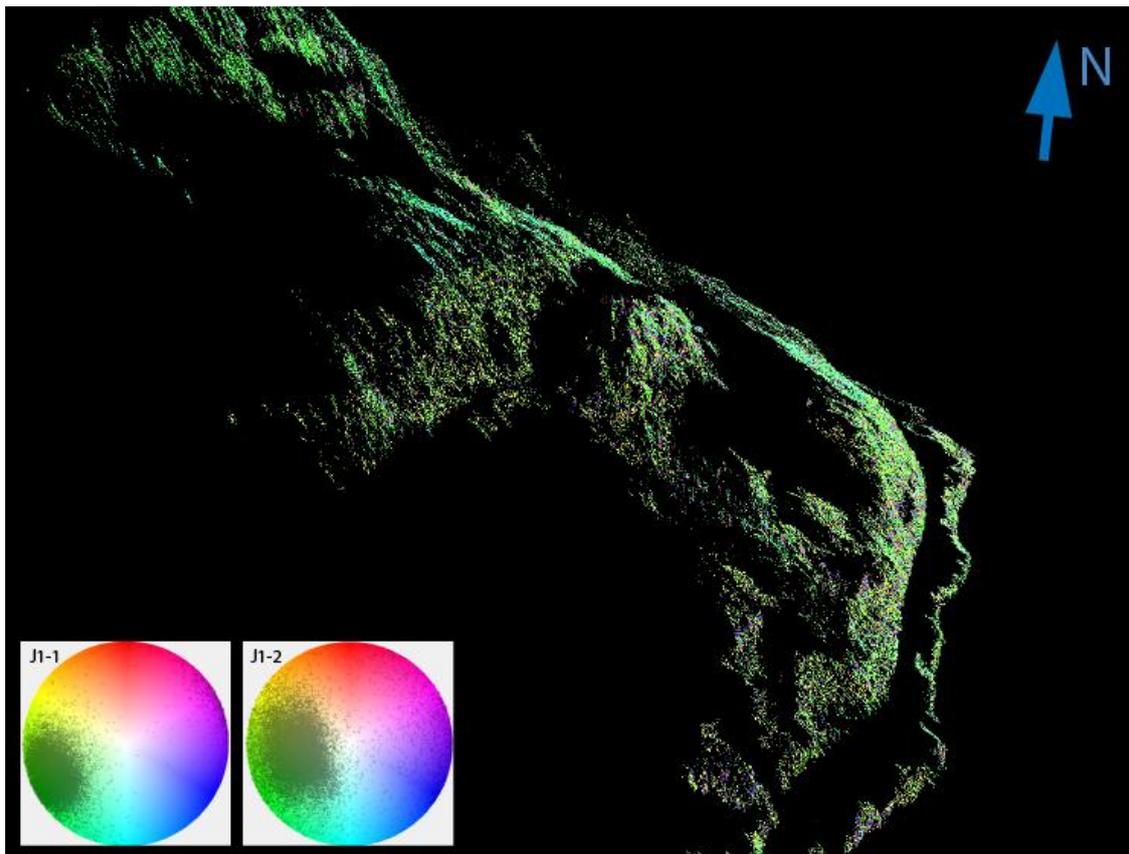
Figure 31: A systematic structural variability in the exfoliation joint set J1 is observed: the upper and central part is colored green and yellow, respectively, and the lower part is colored more light yellow. From the stereographic plots in the left corner this color trend indicate that the upper part of the slope is dominated by more steeply dipping surfaces than the lower part. The same trend was observed in the field mapped data in the project assignment.

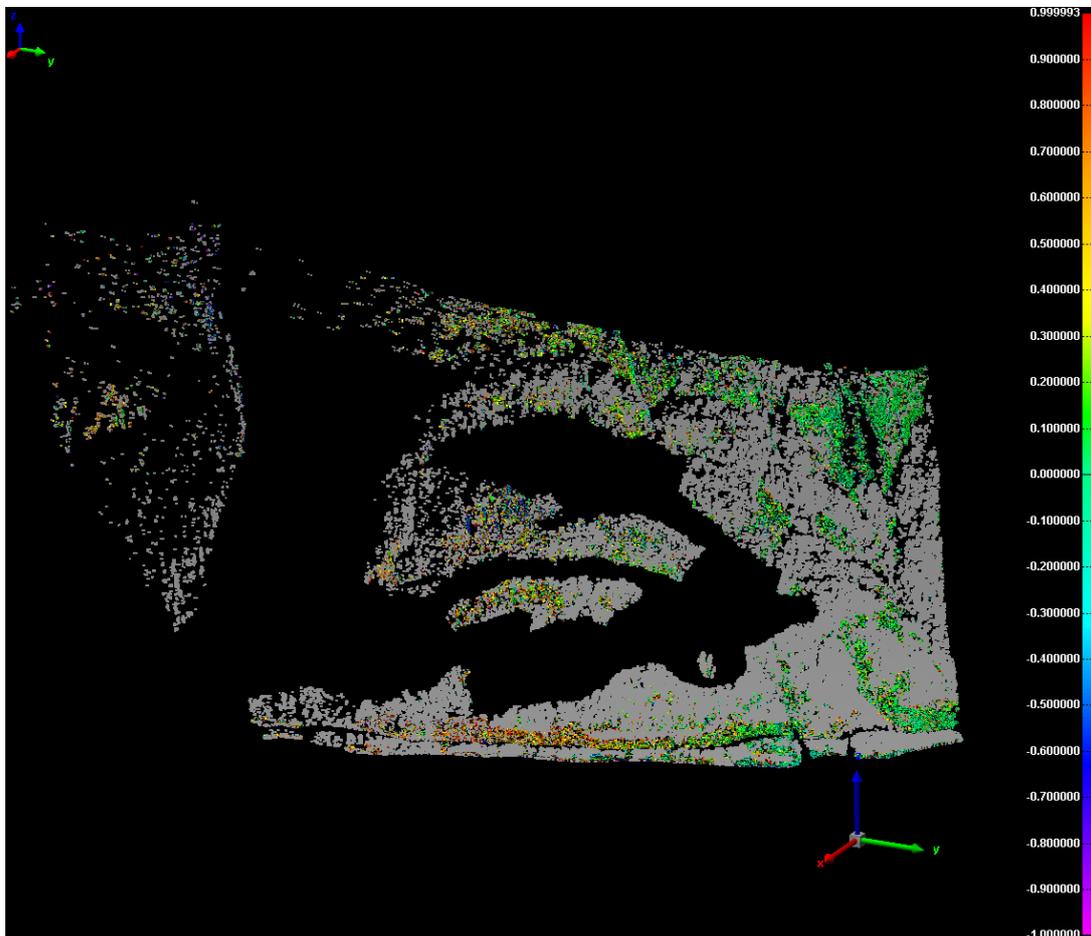
Figure 32: Output model from displacement analysis in IMInspect, Polyworks, by comparison of TLS-data models from 2012 and 2013. No critical displacement areas are revealed. Pronounced color cod
