The Håkåneset rockslide, Tinnsjø

Stability analysis of a potentially rock slope
instability.

Inger Lise Sollie

Submission date: June 2014

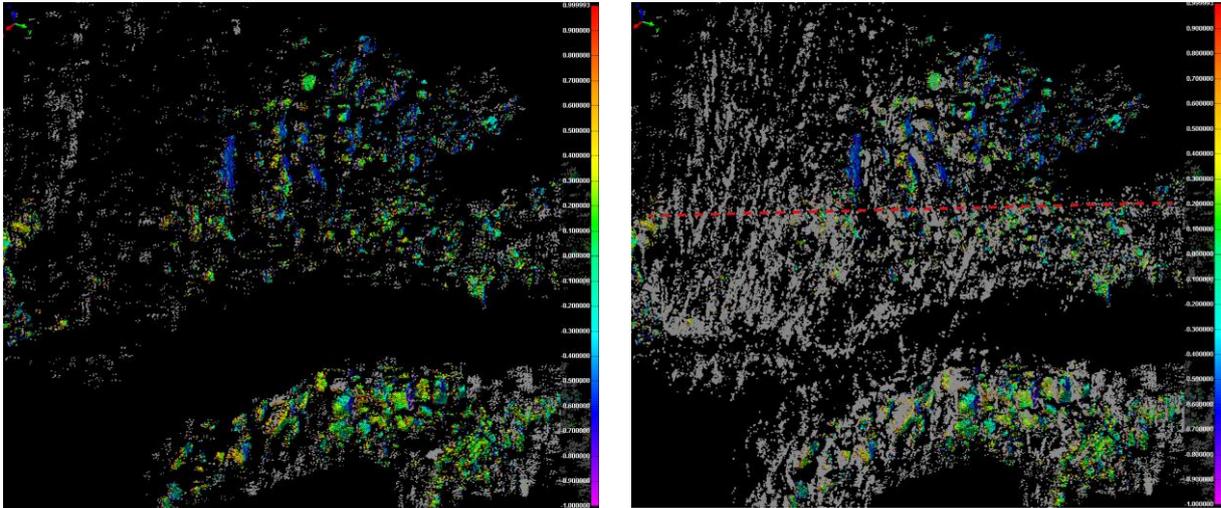
Figure 33: In the left figure both 2012 and 2013 data are displayed. In the right figure only 2013 data are visible. It is clear that the 2012 scan has a limit in the area, indicated with the red dotted line, that results in blue color (negative volumes). Thus, there is not sufficient evidence to conclude that there has been rock fall activity in the upper block area based on this analysis.

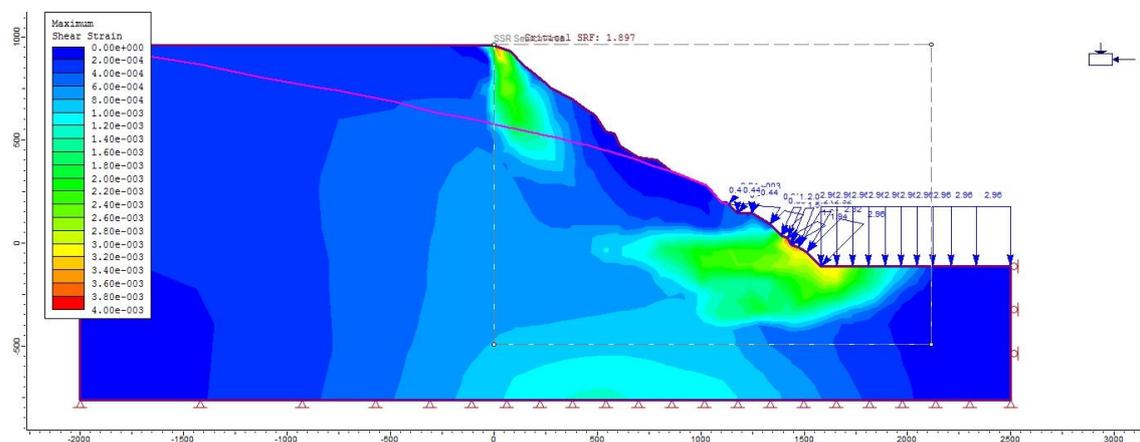
Figure 34: Maximum shear strain contours of Analysis 1.1. for isotropic permeability conditions and saturated permeability $K_s = 2.5 \times 10^{-8}$ the predicted groundwater table (purple line) is at surface for the area corresponding to the instability of this study. Critical SRF of 1.9 is obtained.

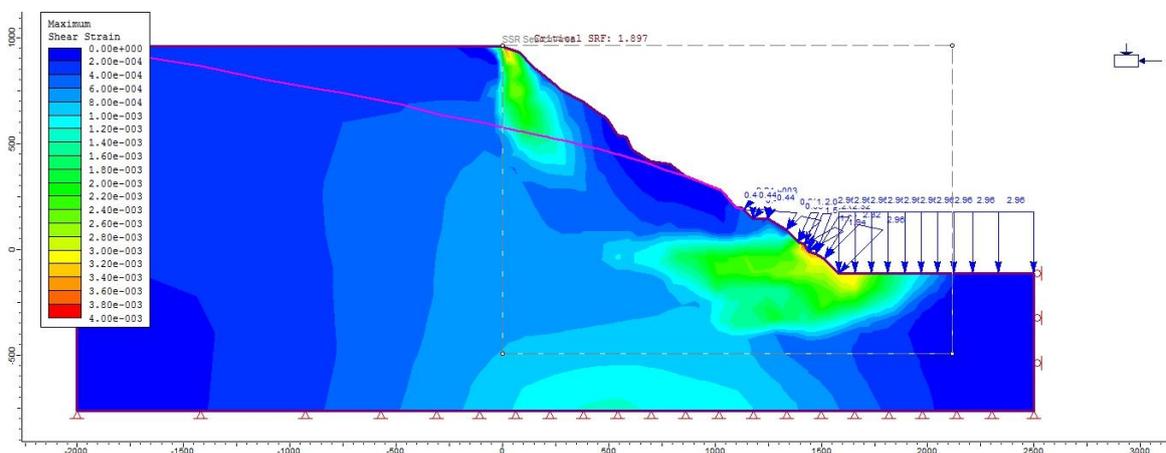
Figure 35: Maximum shear strain contours of Analysis 1.1 for isotropic permeability conditions and saturated permeability $K_s=1 \times 10^{-2}$. The predicted groundwater table (purple line) and CSRF are unchanged compared to Analysis 1.1_1.

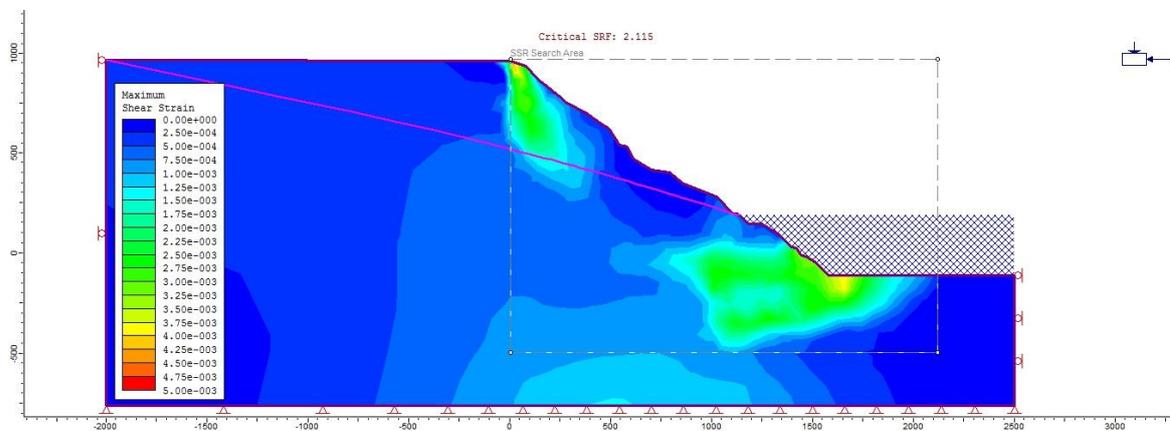
Figure 36: A subsurface groundwater table is predicted when an anisotropic permeability conditions with dominant vertical water flow is assumed. Vertical permeability defined as equal to $K_s = 5,0 \cdot 10^{-5}$ and horizontal permeability a factor of 0.001 to the vertical. CSRF of 2,1 is obtained.

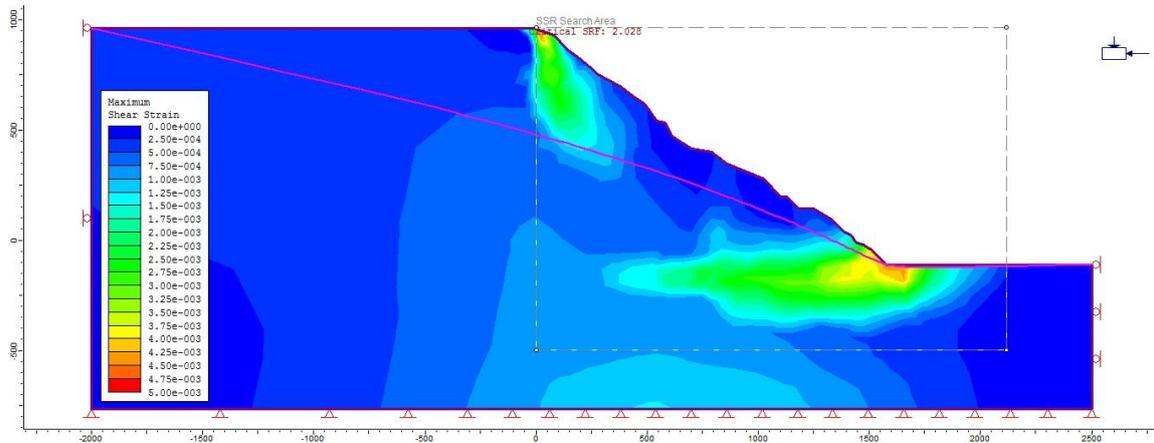
Figure 37: Maximum shear strain plot for a model without the lake water. Same model setting as in Analysis 1.1 with anisotropic conditions. CSRF value of 2.1 is obtained.

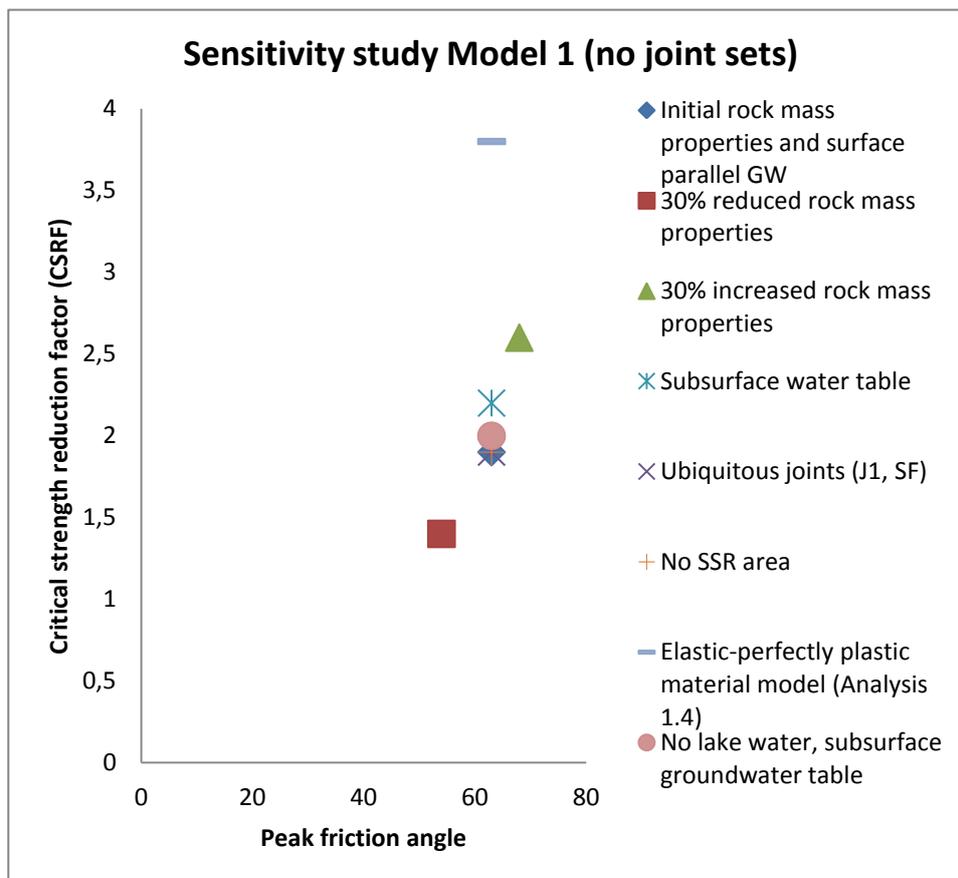
Figure 38: Summary of tested parameters with Model 1.

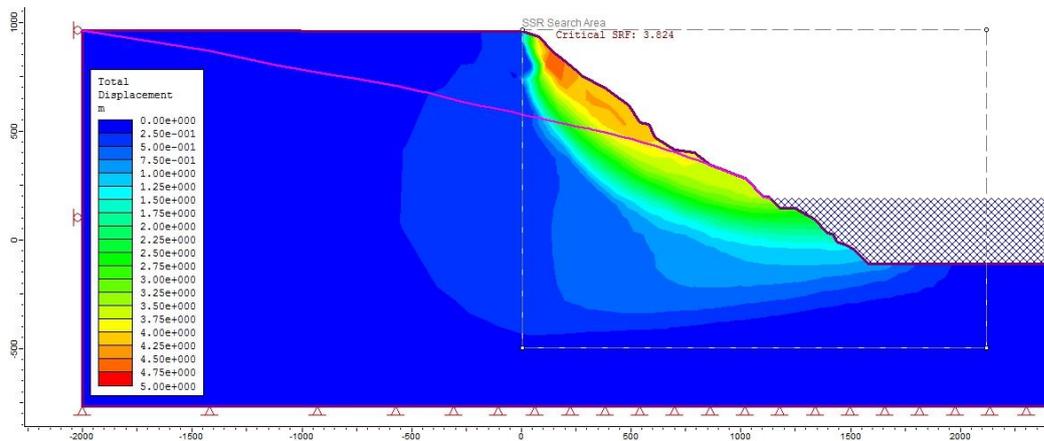
Figure 39: Elastic-perfectly plastic model setup. A) Maximum shear strain contours. B) Total displacement contours

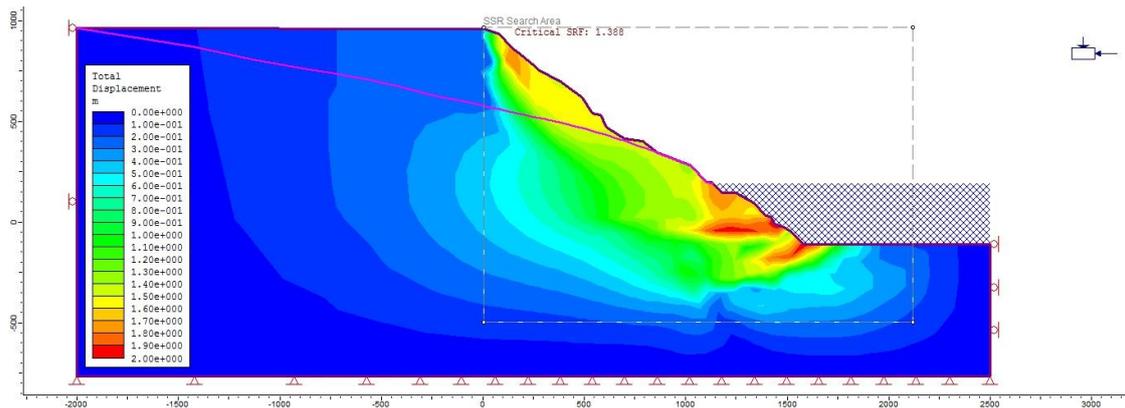
Figure 40: A) Maximum shear strain contour plot and B) Total displacement contour plot for 30%

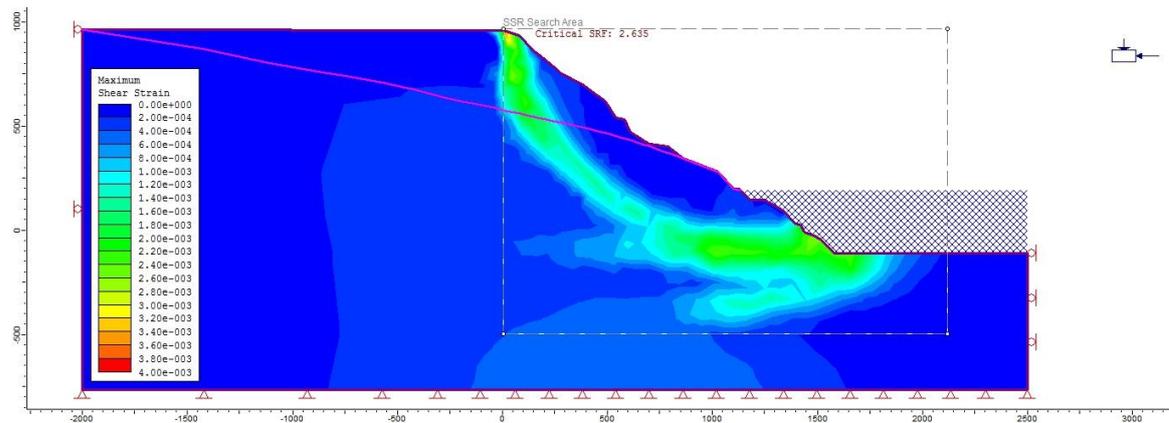
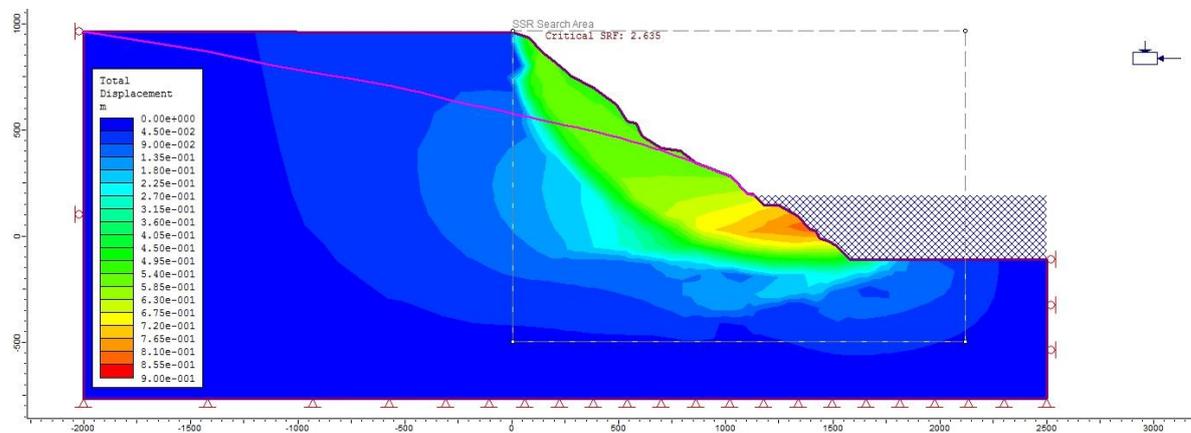
Figure 41: A) Maximum shear strain contour plot and b) Total displacement contour plot for 30% increased rock material properties (Analysis 1.5).

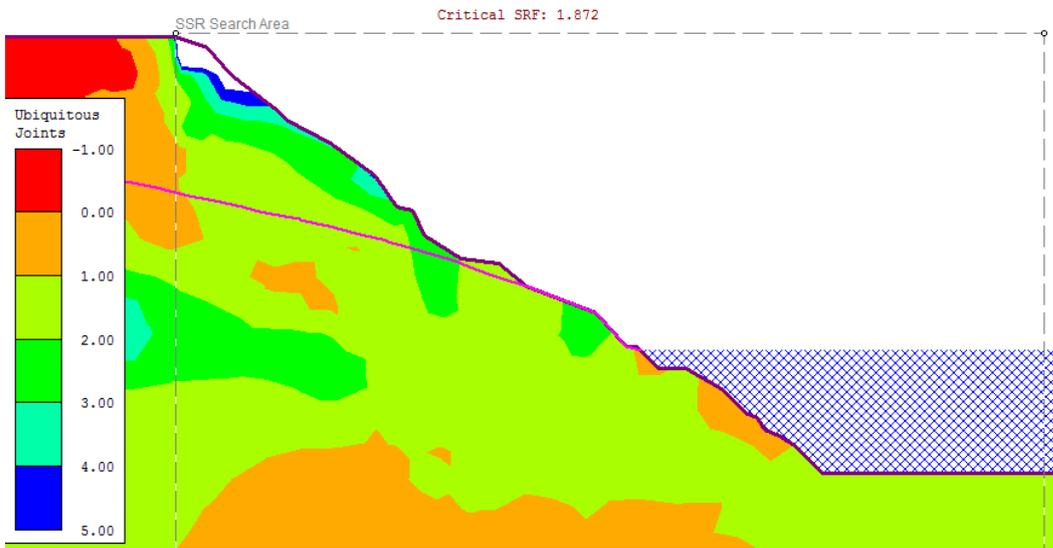
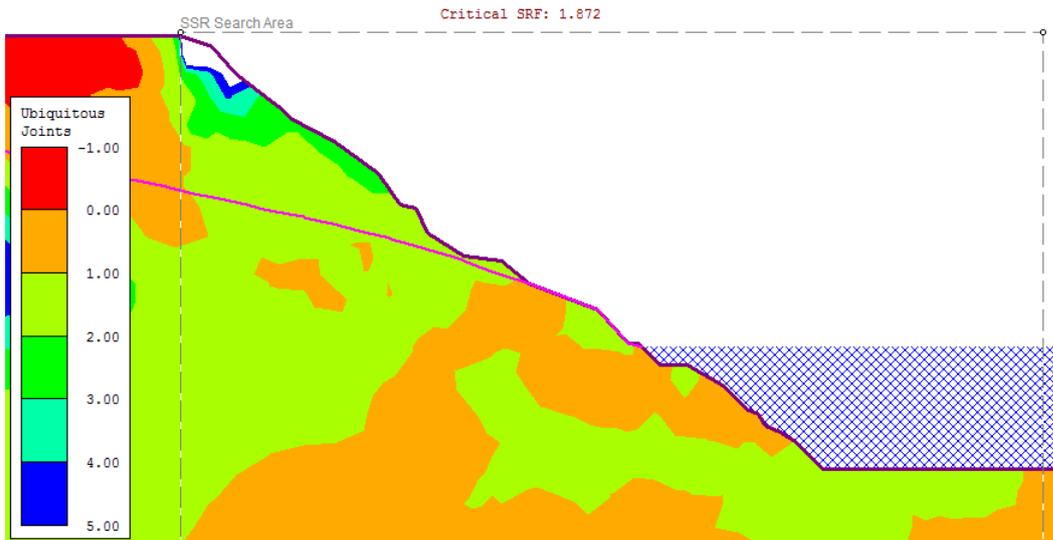
Figure 42: Strength Factor contour plots when A) J1 and B) J1 and SF are added as ubiquitous joints in Model 1. The area indicating critical conditions regarding failure (orange contour) increases from plot A) to B).

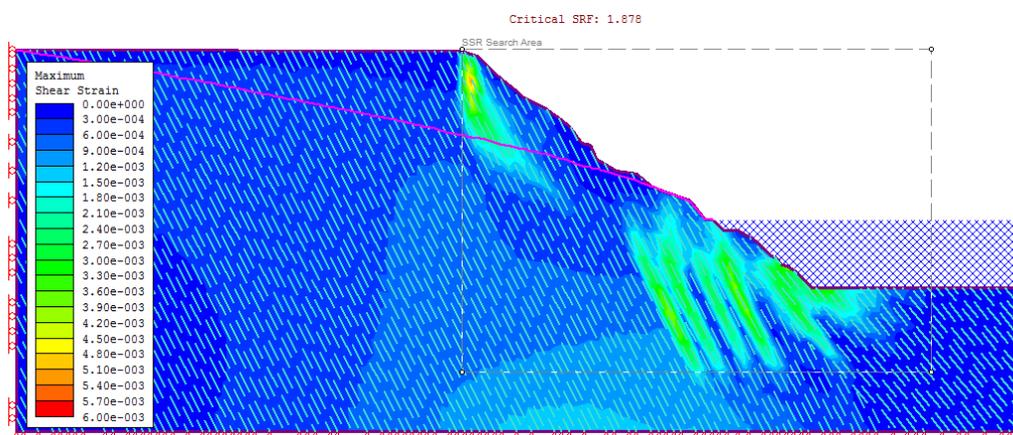
Figure 43: Maximum shear stain plot for Model 2 when initial values for rock mass and discontinuity strength are assumed. (CSRf = 1.9)

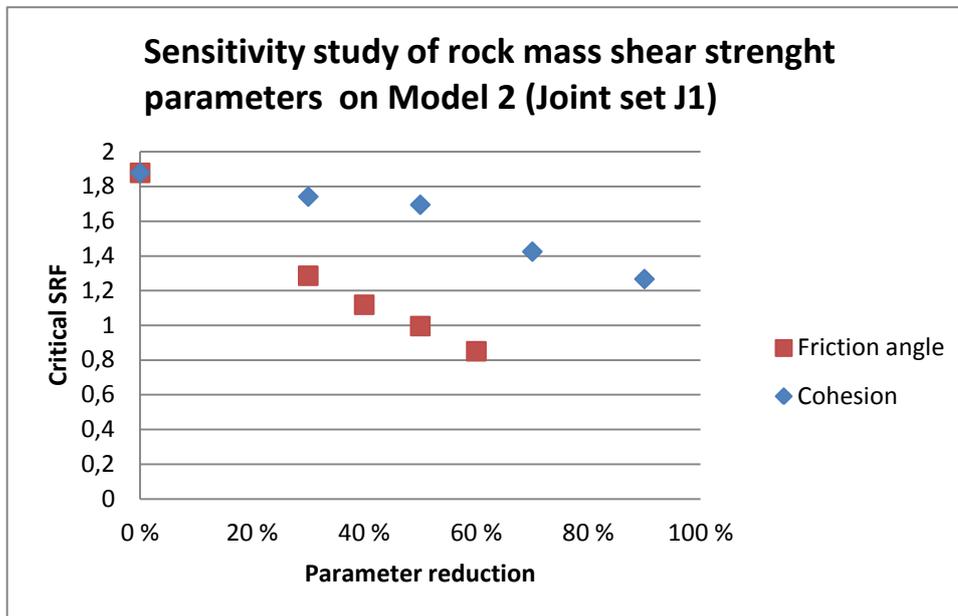
Figure 44: Result of parameter study of Model 2 by reducing friction angle and cohesion separately. CSRF appears as most sensitive to reduction in friction angle.

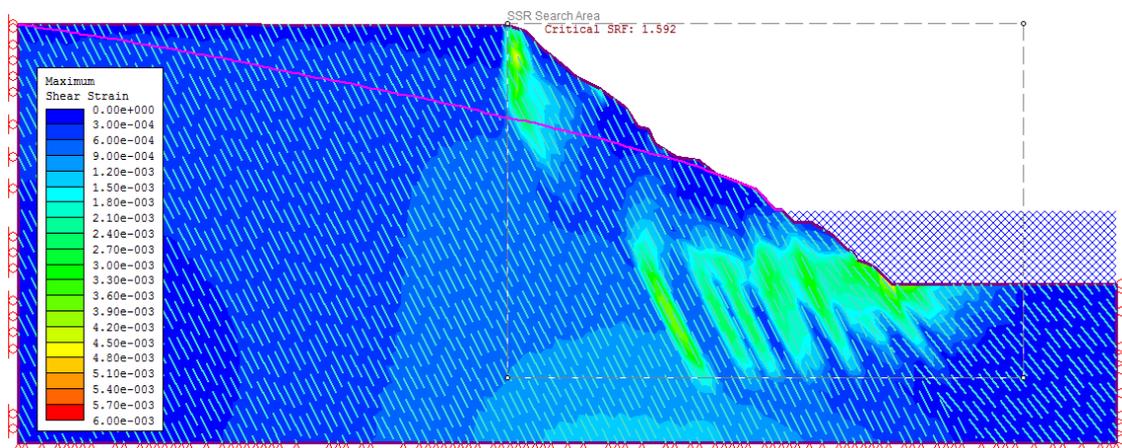
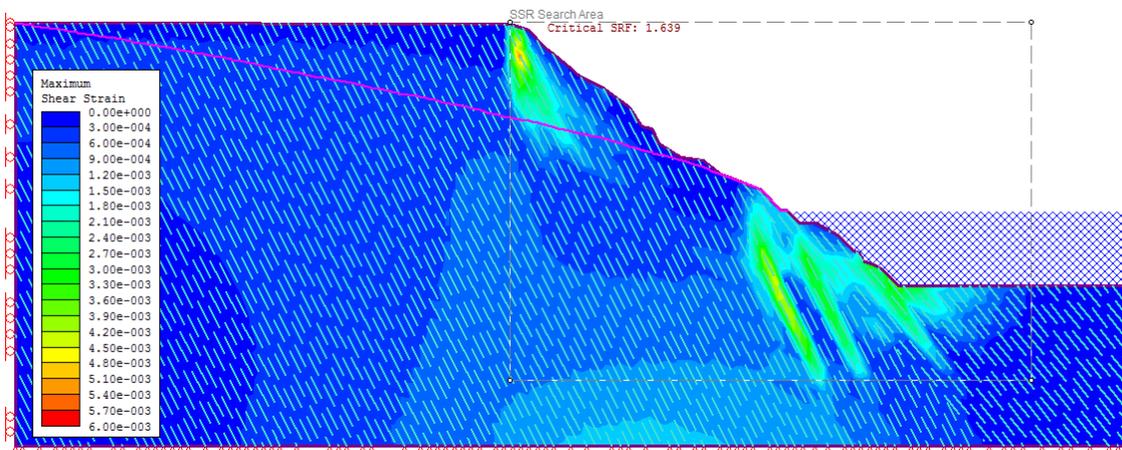
Figure 46: A) 48% reduced cohesion correspond to B) 12% reduced friction angle to obtain the same shear strength level and equal CSRF for both conditions. Even though the CSRF is equal, the strain concentration for the two conditions are significantly different.

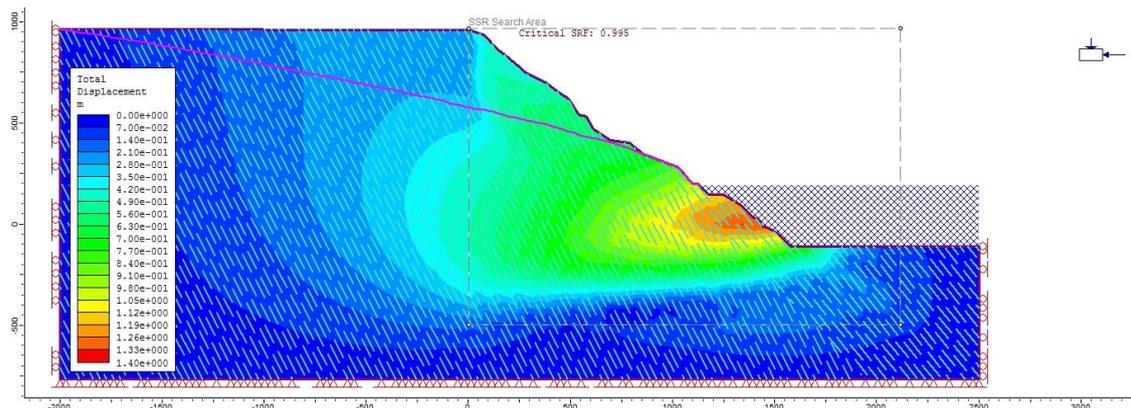
Figure 47: Model 2 with 50% reduced friction angle gives a safety factor of 1.0, which indicate unstable slope conditions. A) Maximum shear strain contour plot and B) Total displacement

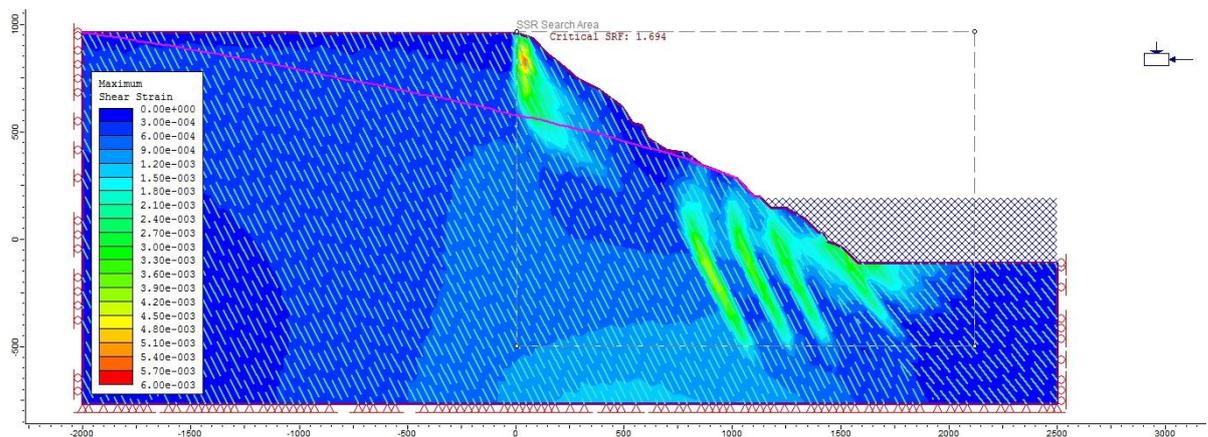
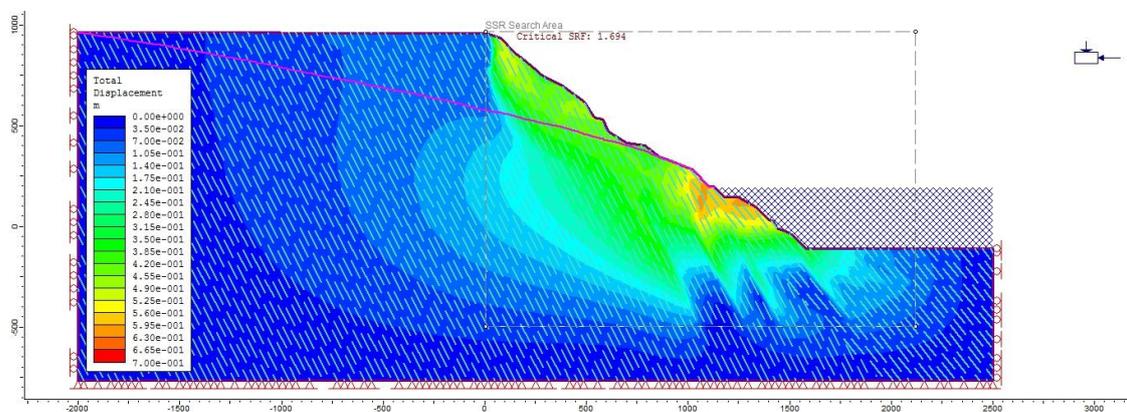
Figure 48: Model 2 with 50% reduced cohesion gives a safety factor of 1.7, which indicate stable slope conditions. A) Maximum shear strain contour plot and B) Total displacement contour plot. In this case the most active zone is indicated closer to lake surface level.

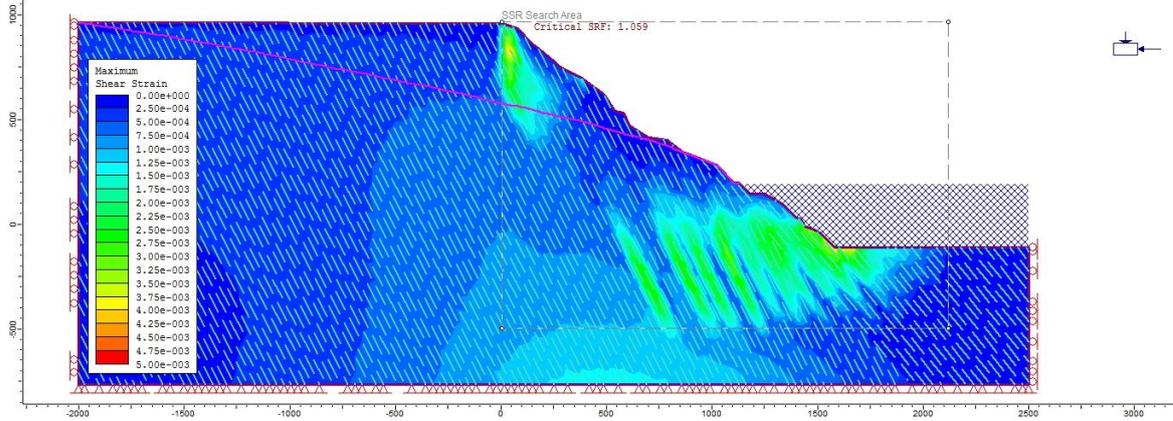
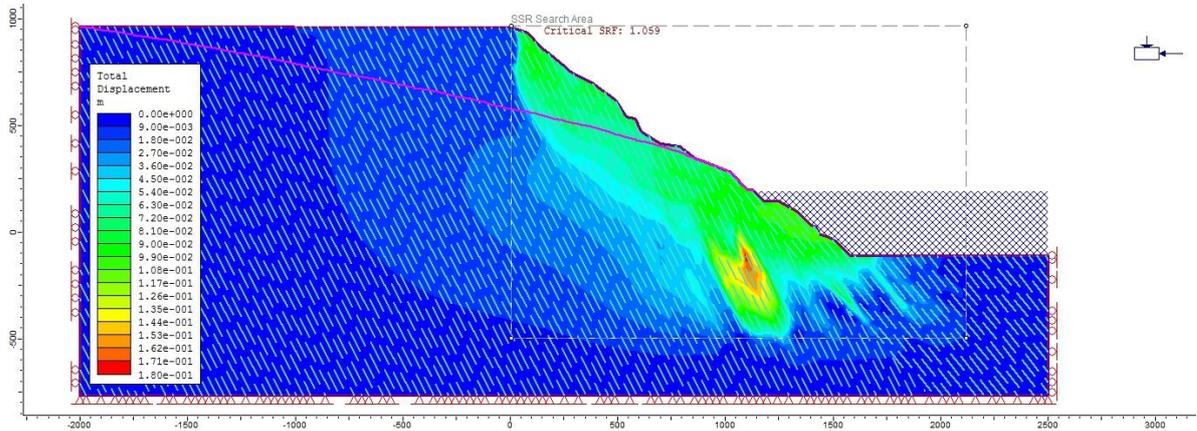
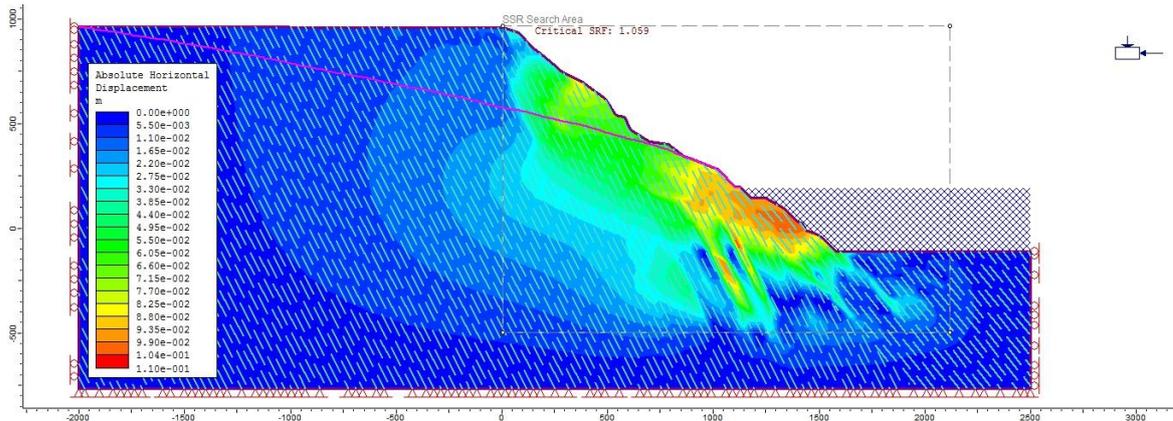
Figure 49: Analysis 2.12 on Model 2 assuming $(\phi_{peak}, \phi_{res})=(44, 29)$ (30% to initial) and $(c_{peak}, c_{res})=(0.75, 0.5)$ (50% to initial) (Table 11). A) Maximum shear strain. B) Total displacement relative

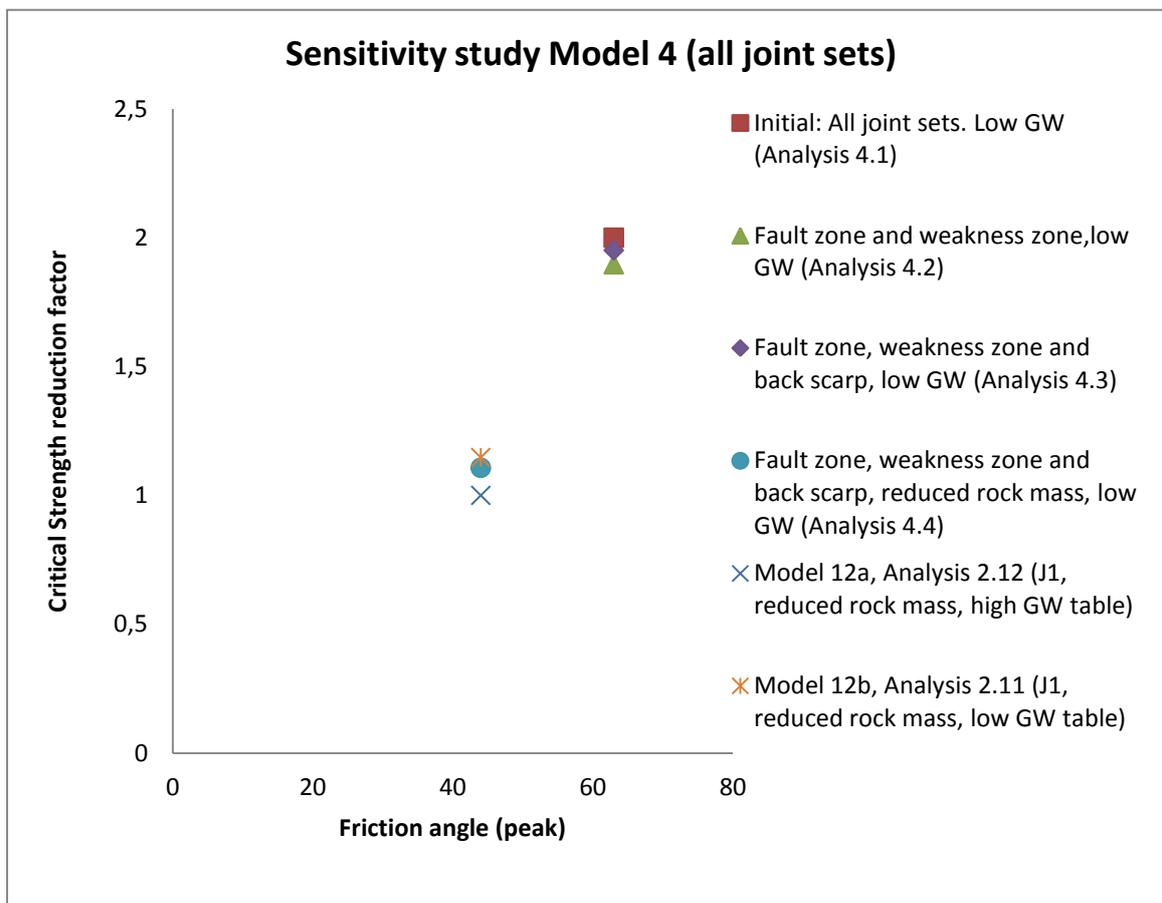
Figure 50: Sensitivity study of Model 4. Investigate the effect of adding mapped geological structures in the Model 4.

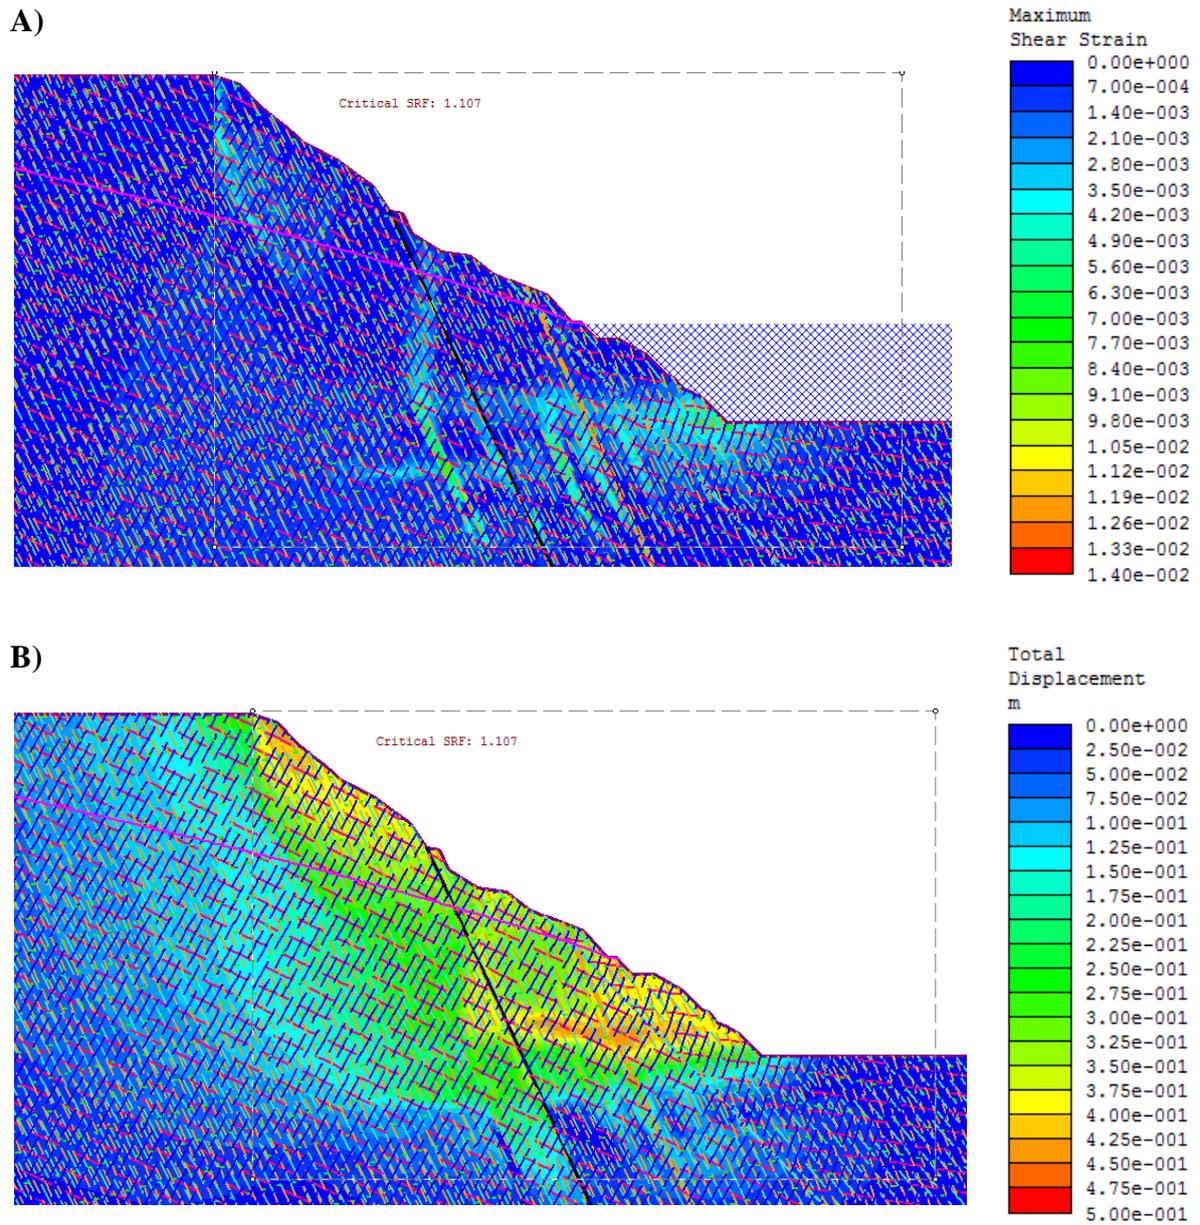
Figure 51: Subsection of Model 4. Analysis 4.4 is the most complex model constructed in this study and includes: All joint sets (J1, JF2, JF3, J4, SF), the back scarp, J1-fault zone, JF3-fault and the weakness zone that intersect the profile. When 30% reduced rock mass properties (peak $\phi = 44$, peak $c = 0,75$) and anisotropic permeability conditions are assumed the CSRF is calculated to 1.1.

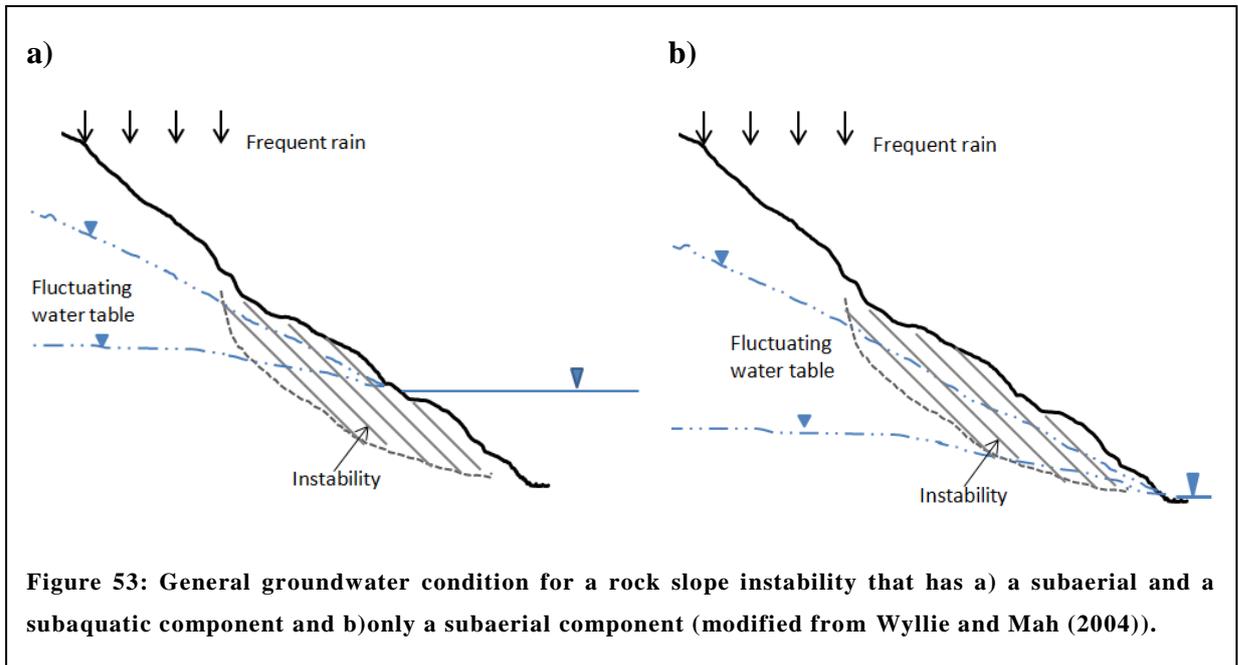
Figure 53: General groundwater condition for a rock slope instability that has a) a subaerial and a subaquatic component and b) only a subaerial component (modified from Wyllie and Mah (2004)).

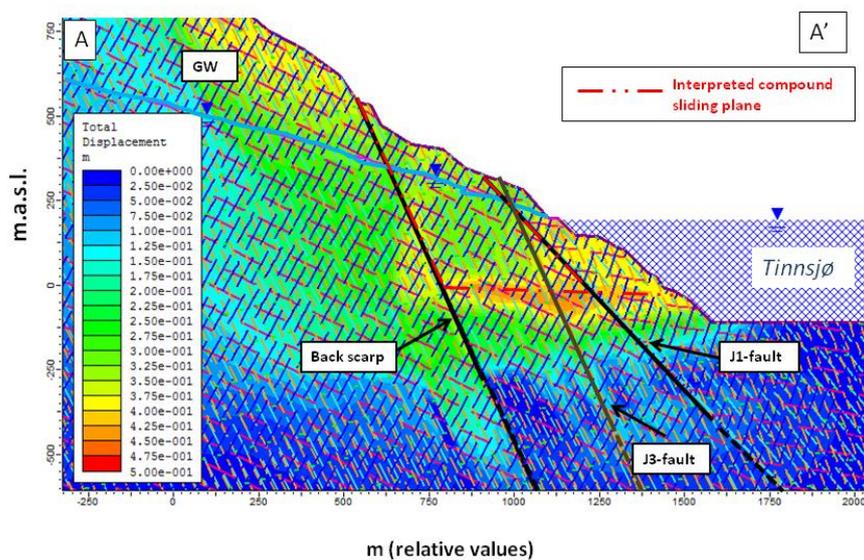
Figure 54: A) Maximum shear strain and B) Total displacement in Model 4, Analysis 4.4. A compound sliding surface is indicated (red dotted) by visual interpretation.
