# Micro Power Plant at Marangu Hotel, Kilimanjaro

Master of Science in Mechanical Engineering

Submission date: June 2014

EPT-M-2014-36

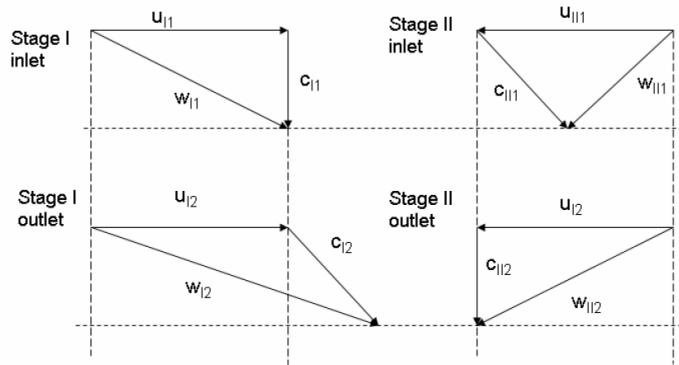
**Figure 3.3:** Velocity diagrams through stages I and II. (Haugli, 2010)

into mechanical energy to the shaft, leaving the exit water out of stage II with no rotation. This is shown in the velocity diagrams in Figure 3.

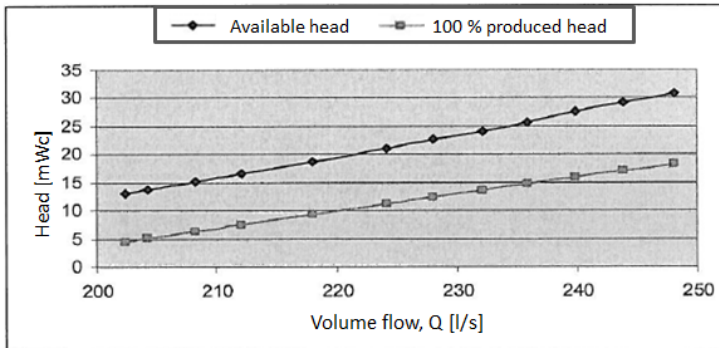
**Figure 3.4:** Head-discharge curve. (Lundekvam, 2006)

The graph in Figure 4 shows an unused capacity, and the efficiency curve in Figure 5 refer to a point of best efficiency with a higher flow than the design flow of 200 L/s. Lundekvam also points out that the head is almost twice that of the original design head.

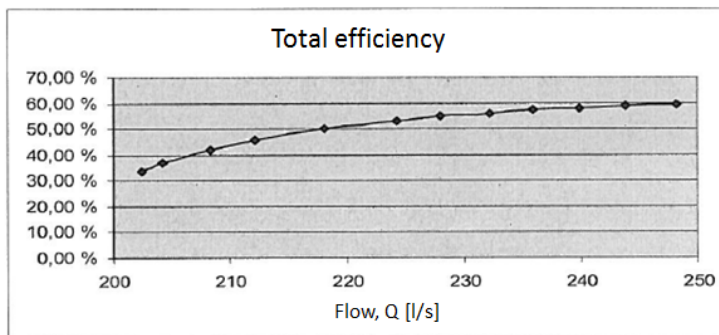
**Figure 3.5:** Total efficiency with ranging volume flow, Q. (Lundekvam, 2006)

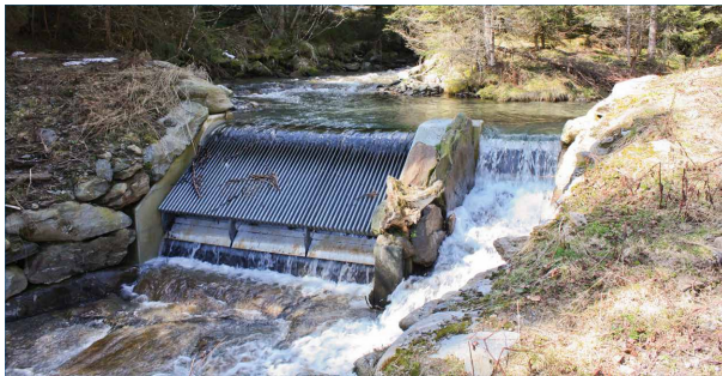
**Figure 3.7:** Coanda intake, 400 L/s. (Dahl, 2010b)

An alternative to the ordinary trash racks is the self-cleaning Coanda intake. This intake makes use of the Coanda effect of water deflecting from its regular path, to follow a concave surface. Use of Coanda screens is environmentally friendly and nearly maintenance free, as debris and rocks are swept over the screens, while clean water deflects through the screens and into a pipe inlet below. The screens has a bar clearance from 3 mm to 0.6 mm and will remove 70-80 % of sedimentation down to this size according to supplier Brødrene Dahl (Dahl, 2010b)

Screen design is custom-made to each site according to  $Q_{overflow}$ . This decides  $Q_{inlet}$  and  $Q_{bypass}$ . At small  $Q_{overflow}$  there will be no water to continue down the river. As water flows over the crest of the weir, it meets an acceleration plate to provide a smooth flow to the bars. The acceleration plate has an ogee shape fit to the free water surface.

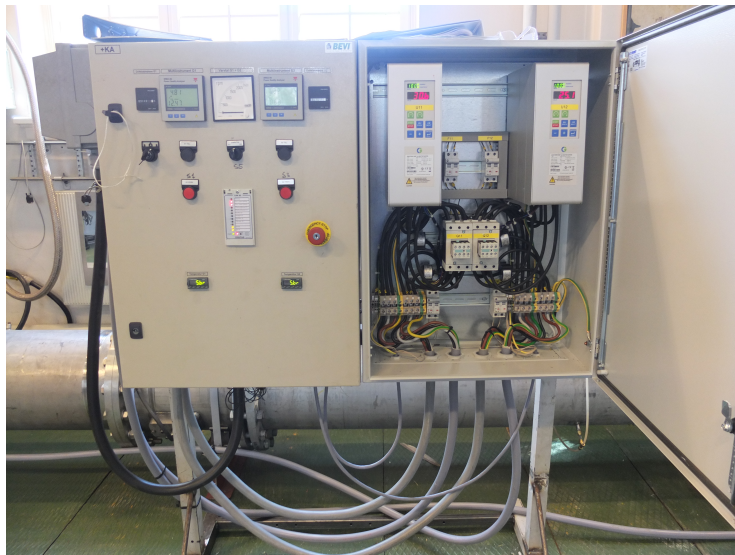
Figure 3.9: Cabinets for frequency controller and soft-start system. (Gjevik, 2014)

Electrical equipment should be located in a small building in safe distance from the river and at an easy accessible location. There are two cabinets: the multi-instrument with frequency control and soft-start system, as seen in Figure 9. These control and operate the turbine.

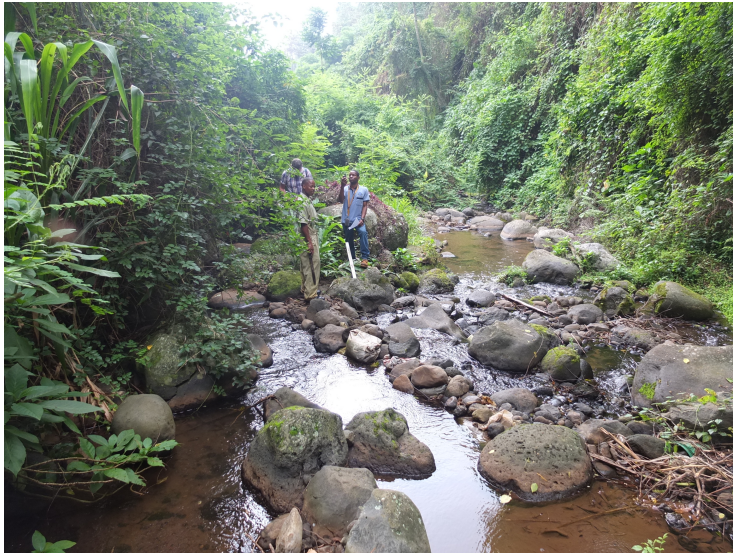
**Figure 4.4:** Intake and small dam from upstream.

The current intake is a simple side intake with no trash rack. A small dam has been made using rocks and bags of sand, diverting water to the channel from half of the river width. An estimated 12 L/s is provided from this intake while the installed turbine will require 200 L/s. The intake must be accordingly enlarged to secure the minimum flow of the turbine. Una had a quite low discharge at the time of fieldwork, as this was just prior to the rainy season. Flow is by visual determination estimated to be merely 200 L/s to 300 L/s. There had been some more rain than usual during the last months, however the river was said to be at low level, by the hotel owner (Brice-Bennett, 2014).

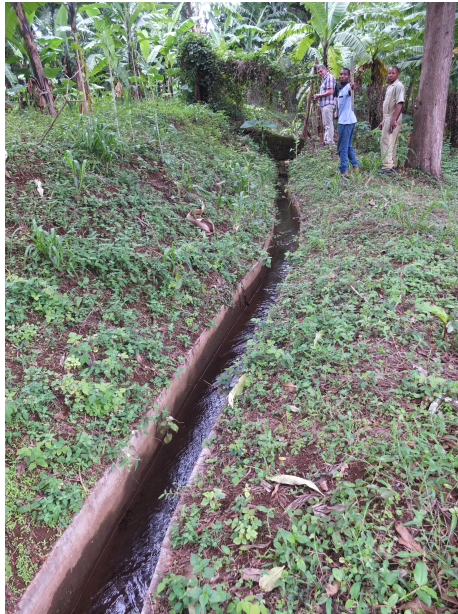
**Figure 4.5:** Walking along and tracking the channel.

Using a GPS, the channel was walked and mapped. A decent length was given from the GPS tracking, although the head difference was only approximated. This is due to the uncertainty of elevation measurements with GPS and the elevation measures that were found along the route gave an illogical range of results. Elevation along the existing channel, from intake to forebay site is therefore estimated to be about 6 m to 7 m over the course of 900 m channel. More details on the channel is found in Appendix .13. Head from intake down to the estimated forebay location is 7 m.

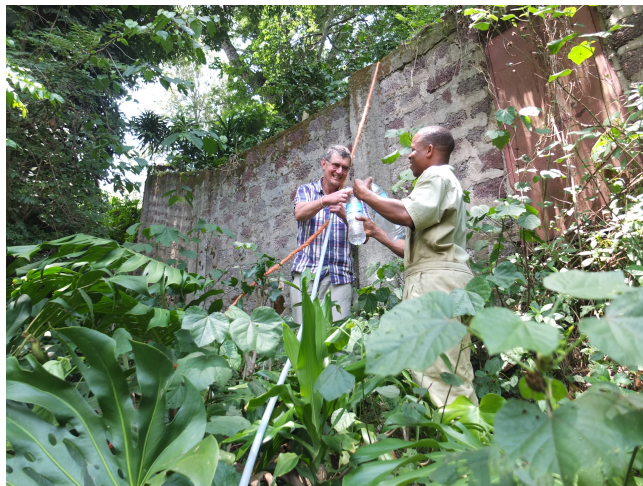
**Figure 4.6:** Filling the hose with water just below the hotel wall.

During the field work planning, it was decided that the head could be measured through the water pressure over a head difference. A clear garden hose, pressure cell and electrical manometer was brought and installed at the site. The terrain complicated the measurements and as the tube was finally filled with water the electronic manometer failed to show rational data, as seen in Appendix .13.

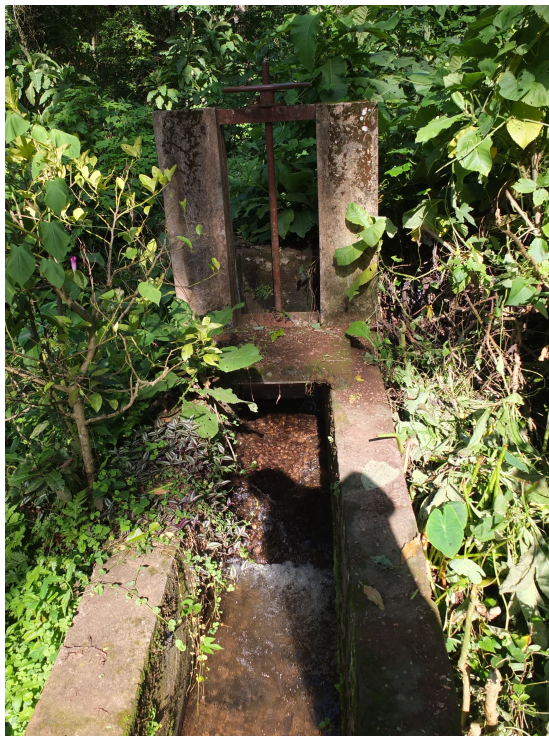
**Figure 4.7:** Channel and gate valve at turbine level.

An old channel and gate valve are visible down at the turbine level, transversely to the penstock. While the river is diverted 4 m out from the channel by a small, grass island, some water runs straight through the island, in the channel. The 0.5 m wide channel is considered as a possible foundation for the turbine. This could be of proper protection to the robust turbine and offer an easy solution of draft tube.

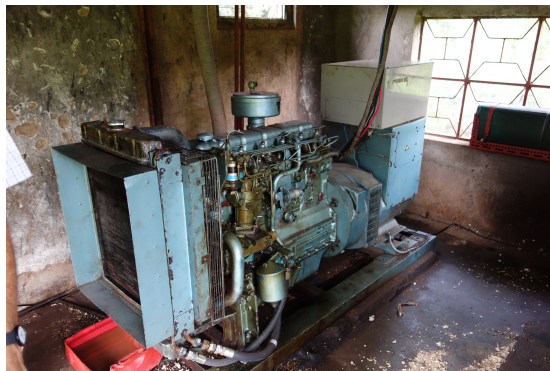
**Figure 4.12:** One of the three diesel generators.

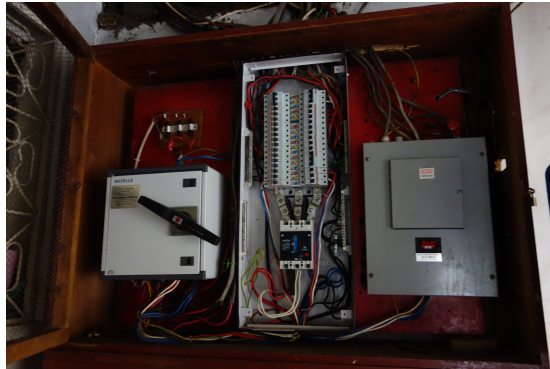
**Figure 4.13:** Main changeover switch.

Hotel electricity is distributed from a control panel by the office building. Here a changeover switch decides between the different input power source and receiving circuit branch. Changeover switches are also located by the generators, in order to decide the input coming up to the main control panel.

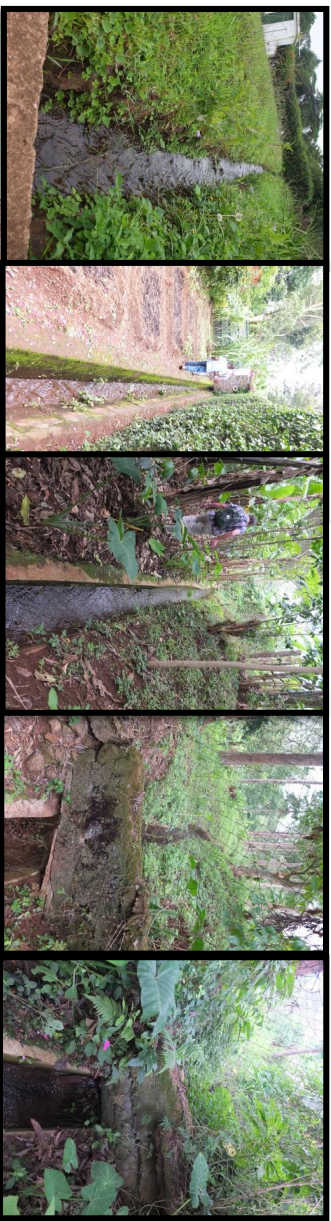
Length	What	Details
150 m	Pool, garden, campsite, house	Grass and earth channel, dammed water by a powerhouse
15 m	Garden of house, ends with a wall	Step of 10-15 cm, with a partly clogged trash rack
102 m	Long stretch on other side of wall, through a garden which ends with a fence	Step of 10 cm under the wall
32 m	Jungle forest on the other side of fence. Stops at new fence.	Step of 10 cm and a partly clogged trash rack
150 m	Through the garden of a school. Stops at new fence	Step of 10 cm and a partly clogged trash rack
80 m	Jungle forest. Stops at fence.	Concrete channel
400 m	Last stretch up to the intake along the	Concrete channel
929 m	<b>TOTAL</b>

The channel running through the hotel area, has its intake approximately 900 m upstream from the hotel, in the river Una. Water flows in the open air channel with a moderate inclination slope of 4-5 degrees and some jumps of 0.1 m. The average width is of 0.4 m and material of the channel changes from earth to concrete to rocks. At some locations there are no movement in the water and this might cause some challenge for design of the supply pipe. Running through gardens, schools and public paths, the pipes should be dug down in order to keep it secured and prevent vandalism.
