# Engineering geological assessment and structural comparison of the Vollan and Ivasnasen rock slopes at Sunndal, Norway

**Gudrun Majala Dreiås**

Submission date: November 2012

Norwegian University of Science and Technology  
Department of Geology and Mineral Resources Engineering

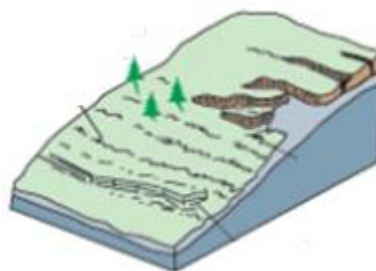
*Figure 10 Illustrates the creep mechanism (USGS, 2006).*

Creep (figure 10) is described as a “slow, steady, downward movement” of slope-forming soil or rock. The process is a continuous movement which proceeds at an average rate of less than a foot per decade, a deformation that continues under constant stress (Cruden and Varnes, 1996). It is a largely continuous process of deformation occurring below the elastic limit in response to prolonged stress, all deformation that is not wholly elastic. Movement is caused by shear stress sufficient to produce permanent deformation, but too small to produce shear failure. There are three types of creep, where one is seasonal and the movement is within the depth of soil are depended of the seasonal changes in soil moisture and soil temperature. The second one is continuous creeps, where shear stress continuously exceeds the strength of the material. The last, the third one is the progressive creep, where slopes are reaching the point of failure as

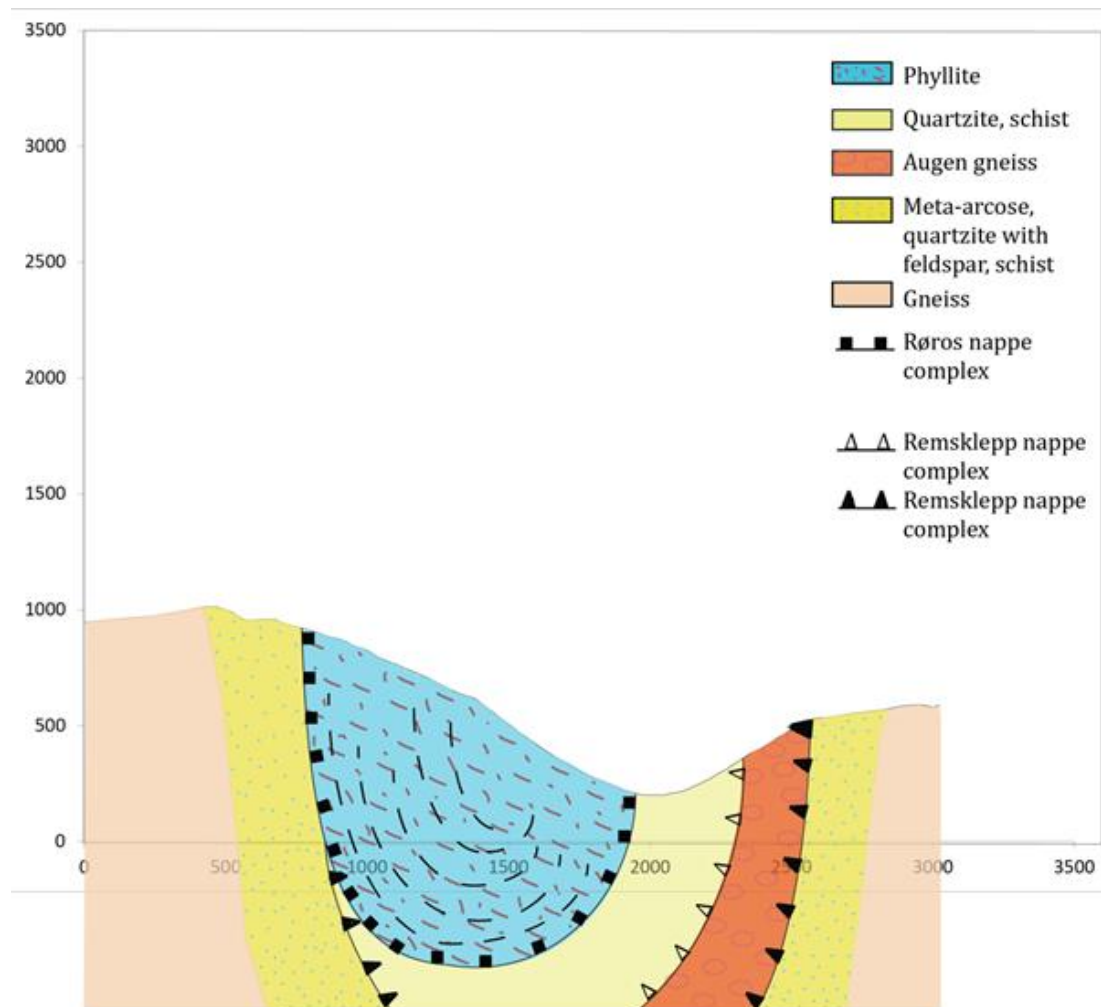
Figure 19 Geological profile from Vollan to Ivasnasen, based on fieldwork and available information from the NGU map "Røros & Sveg" (1989).

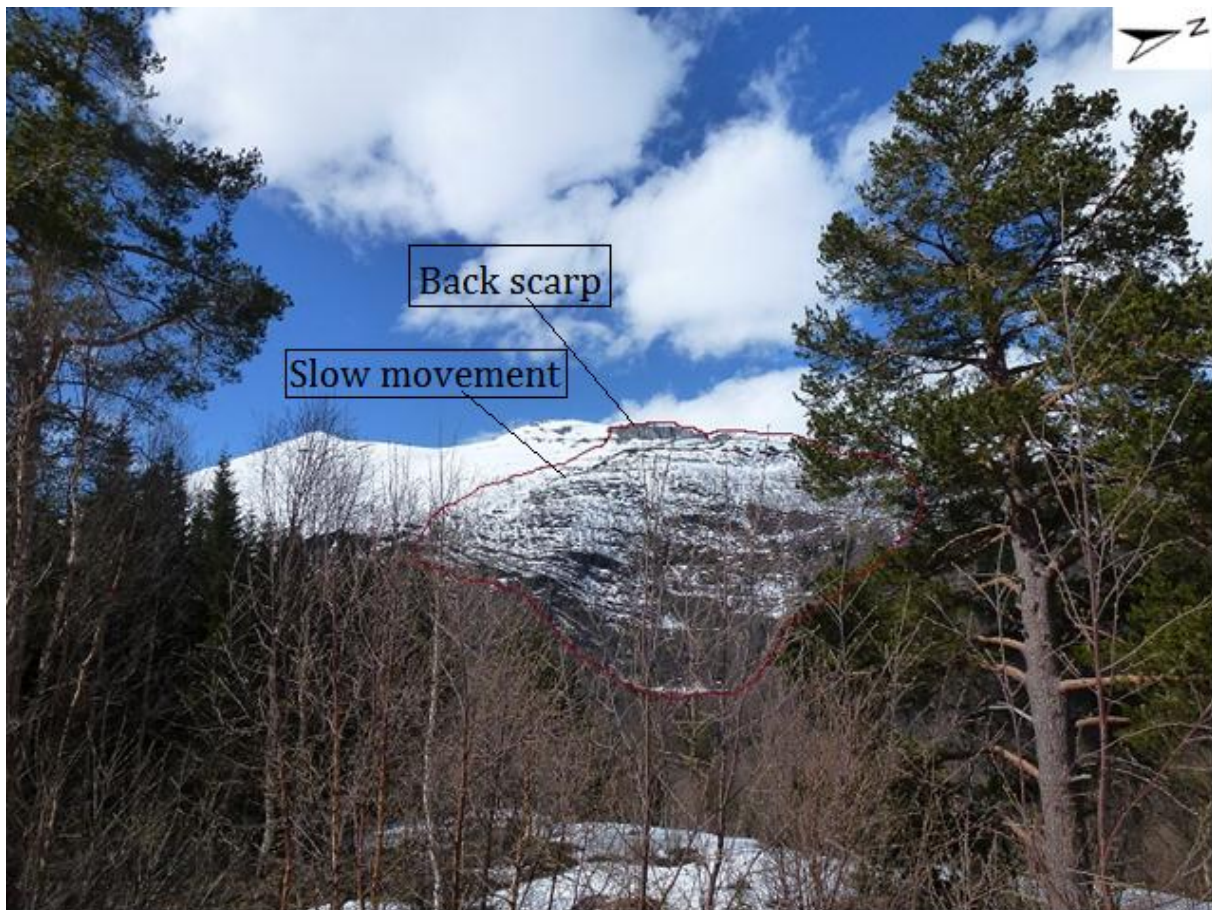
*Figure 23 Part of the study area at Volla. The entire slope cannot be seen, but the picture is shown to give an impression of the area. The slow movement process can partly be seen in the structures with snow covering. The back scarp is visible on the top of the mountain.*

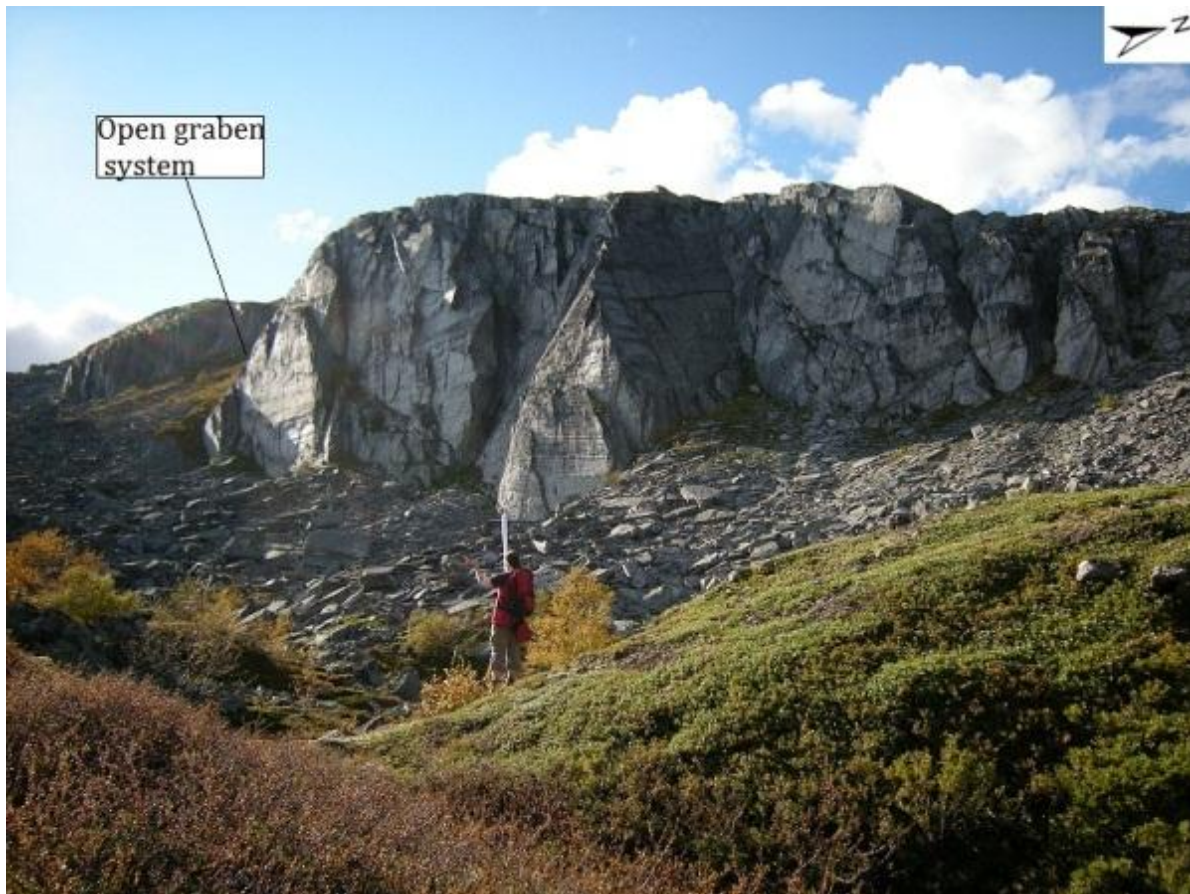
*Figure 24 Overview of the main backscarp at Vollan, can also see a big amount of deposits in front of the back scarp. The open graben system is marked in the picture.*

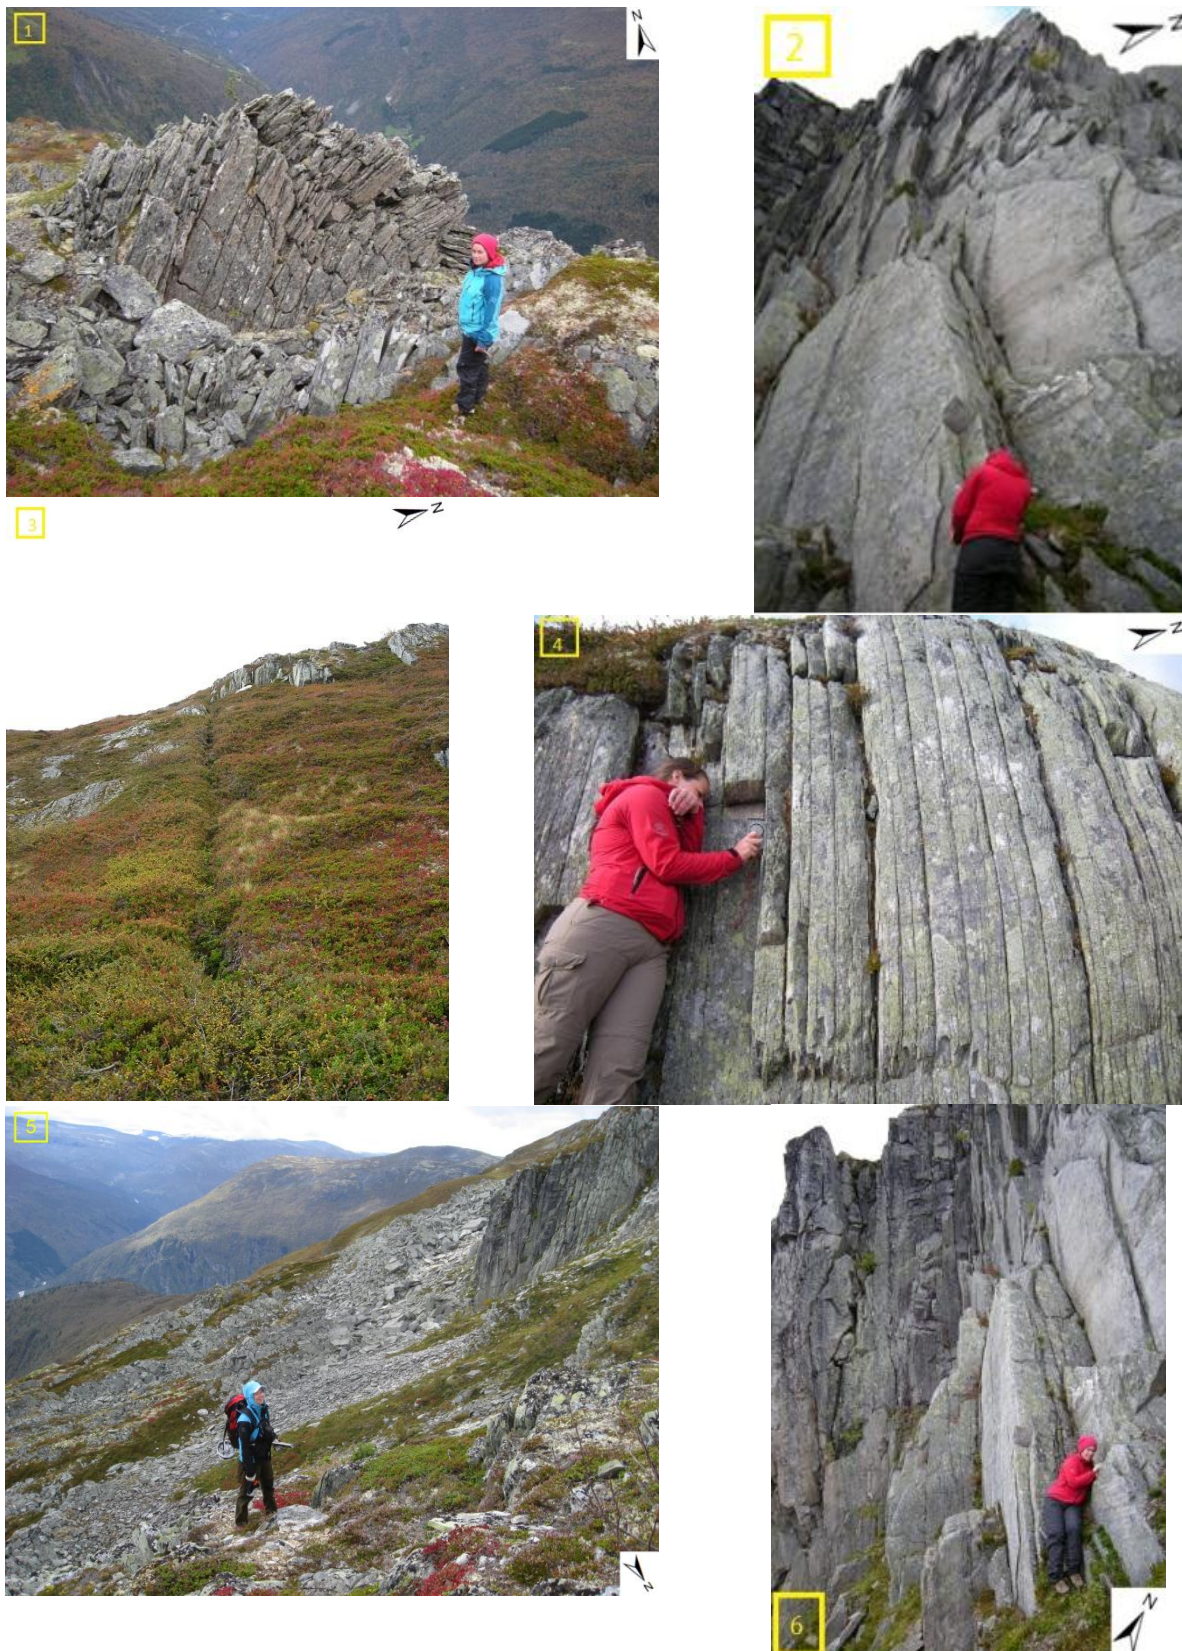
Figure 26 Different pictures taken of Vollan during fieldwork. 1) shows a really good illustration of the toppling failure that is in the area, and this is a mini-scale figure of this. 2) & 6) are taken from the back scarp, it shows clearly that it is really steep, fractured and contains massive quartzite. 3) shows a huge horizontal crack behind the back scarp. 4) is taken behind the back scarp, and the layers are quite thin here, but still quartzite. 5) partly overview of the area, back scarp to the right. Photo taken by the author and Yngvild S. Kvalvik.

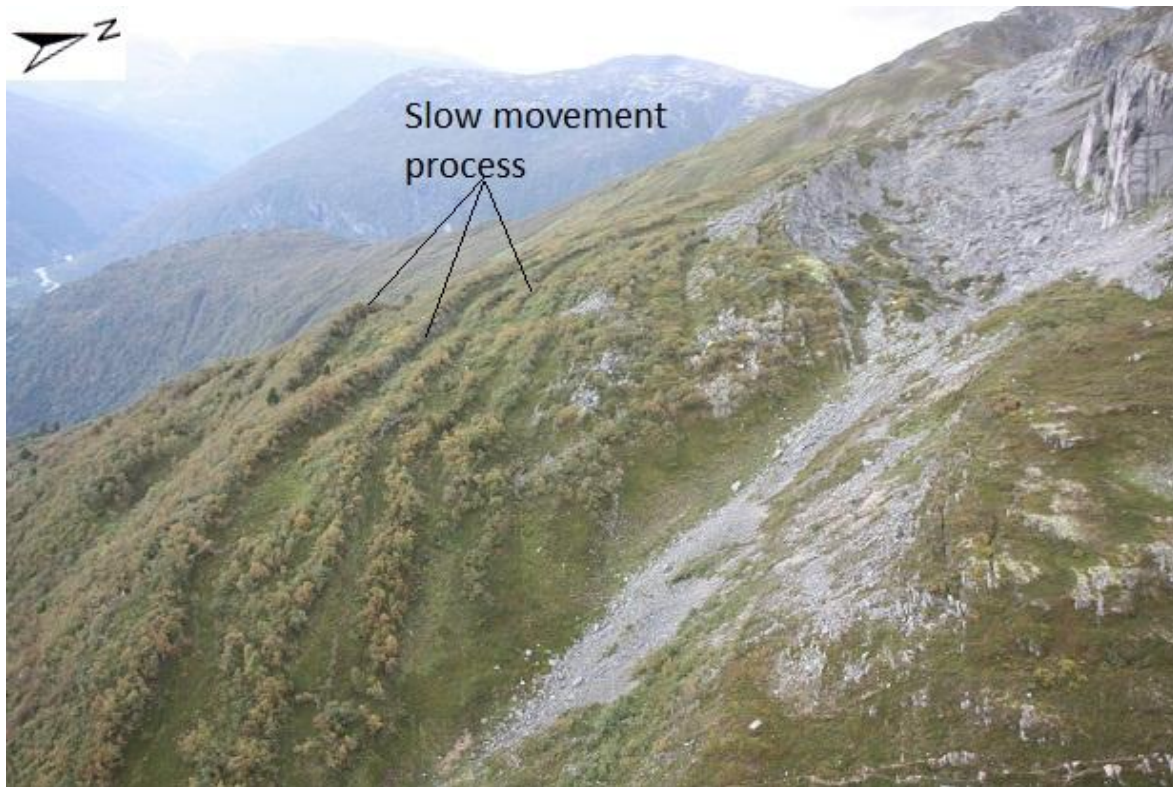
*Figure 27 The really slow movement process of the ground is really easy to see in the field and by orthophoto, this picture is taken by T. Oppikofer, NGU with helicopter in August 2011.*

Figure 27 show a picture of the slow movement process that is taking place at Vollan. The picture is taken by Thierry Oppikofer during a helicopter survey for NGU, August 2011. The slow movement process might be linked to a thrust fault. A lot of displacement has been picked up by the phyllite layer. The picture shows this as a possibility since it looks like all the layers have been displaced.

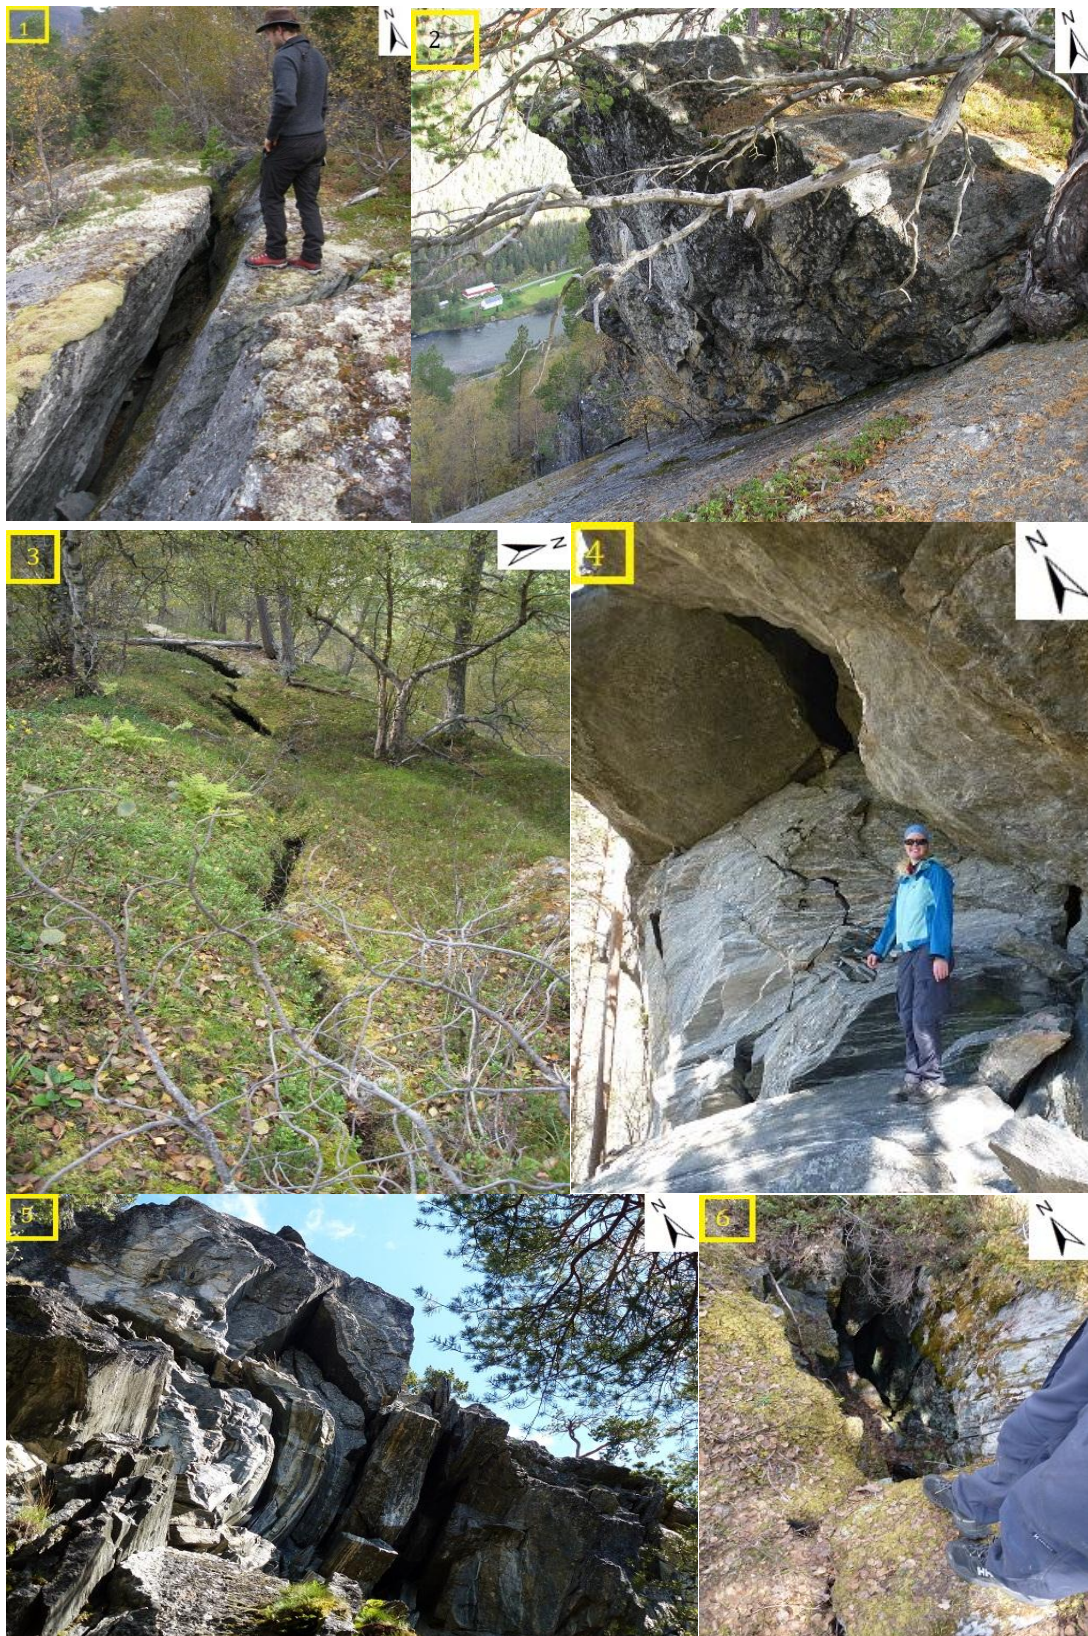
*Figure 33 Picture 1 and 2 and is from the historical rockslide, picture 3 is in the middle of the historical and the unstable part, and figure 4,5 and 6 is taken from the unstable part at Ivasnasen. They all shows sign of activity with huge cracks and deformations. Pictures taken by the author.*

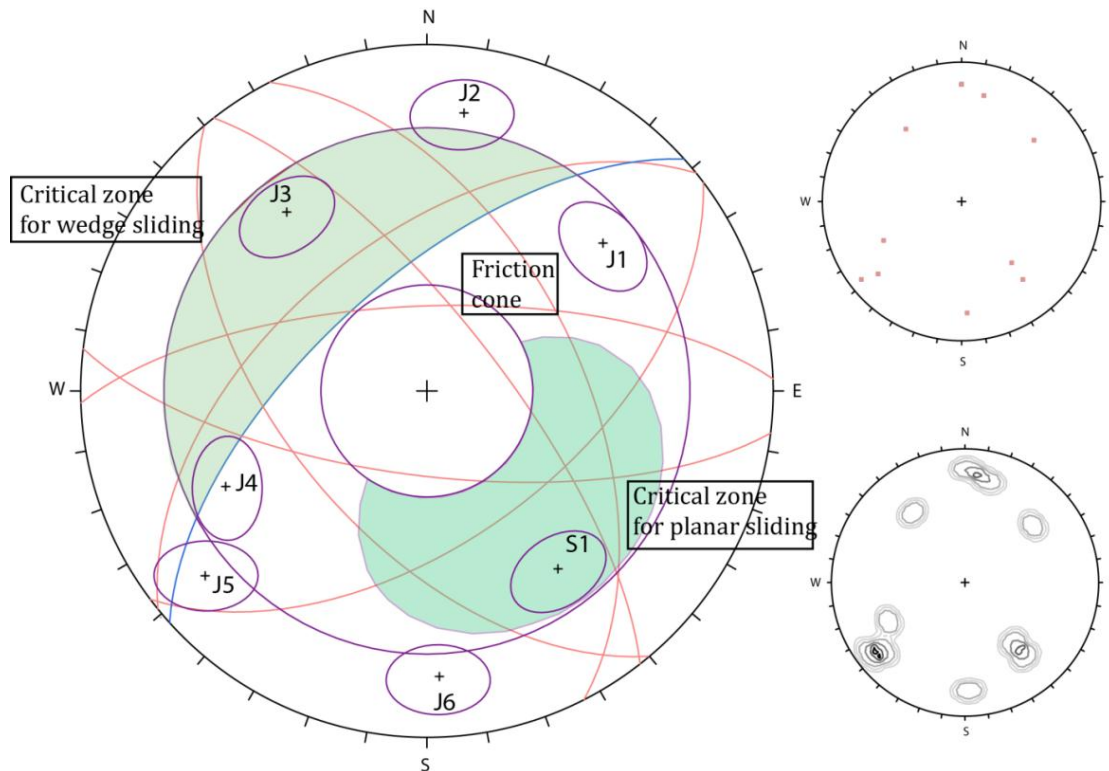
Figure 36 Kinematical analysis from LiDAR scans TLS 2010 and TLS 2011, shows possibilities for both planar and wedge sliding

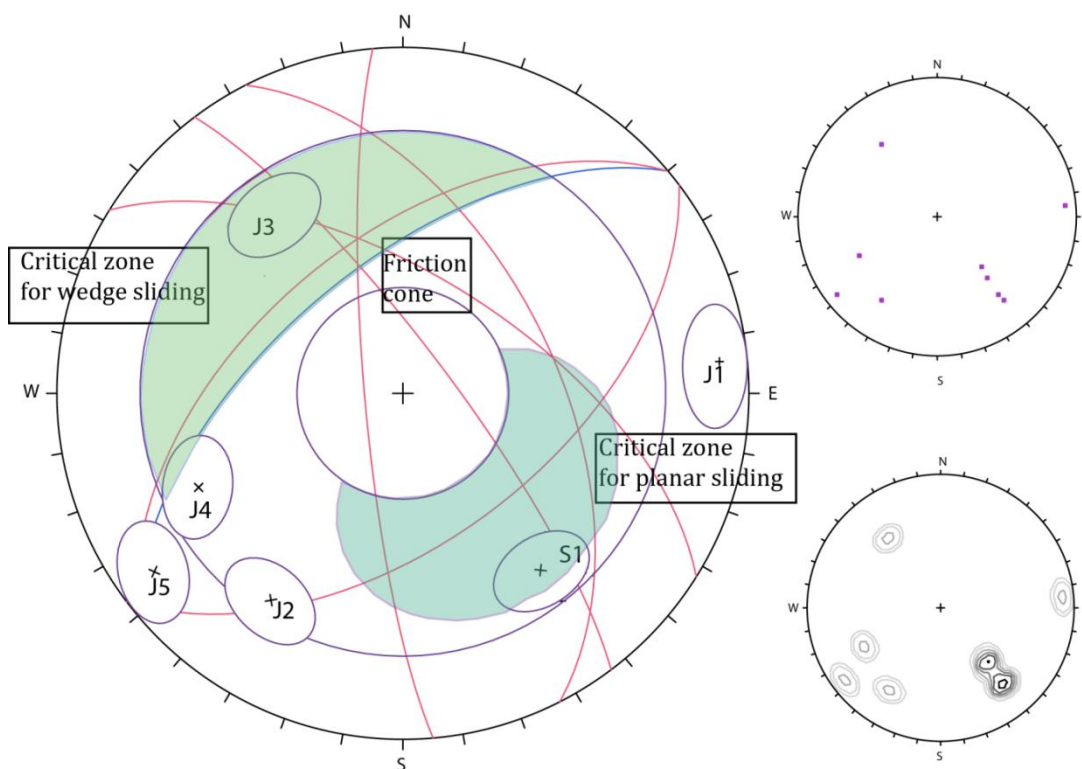
Figure 37 Kinematical analysis from LiDAR scans ALS 2011 and TLS 2010, shows possibilities for both planar and wedge sliding.

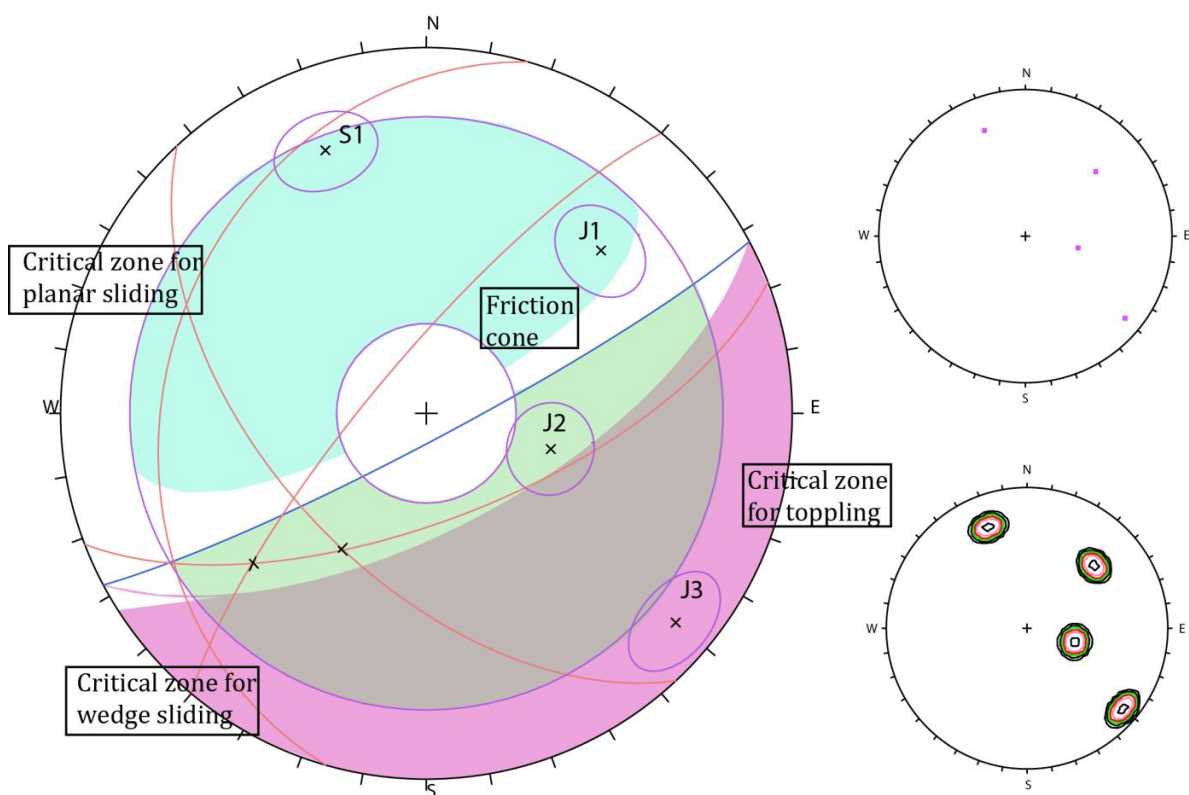
Figure 40 Kinematical analysis of the area around the cabin at Vollan. Possibilities for planar, toppling and wedge failure.

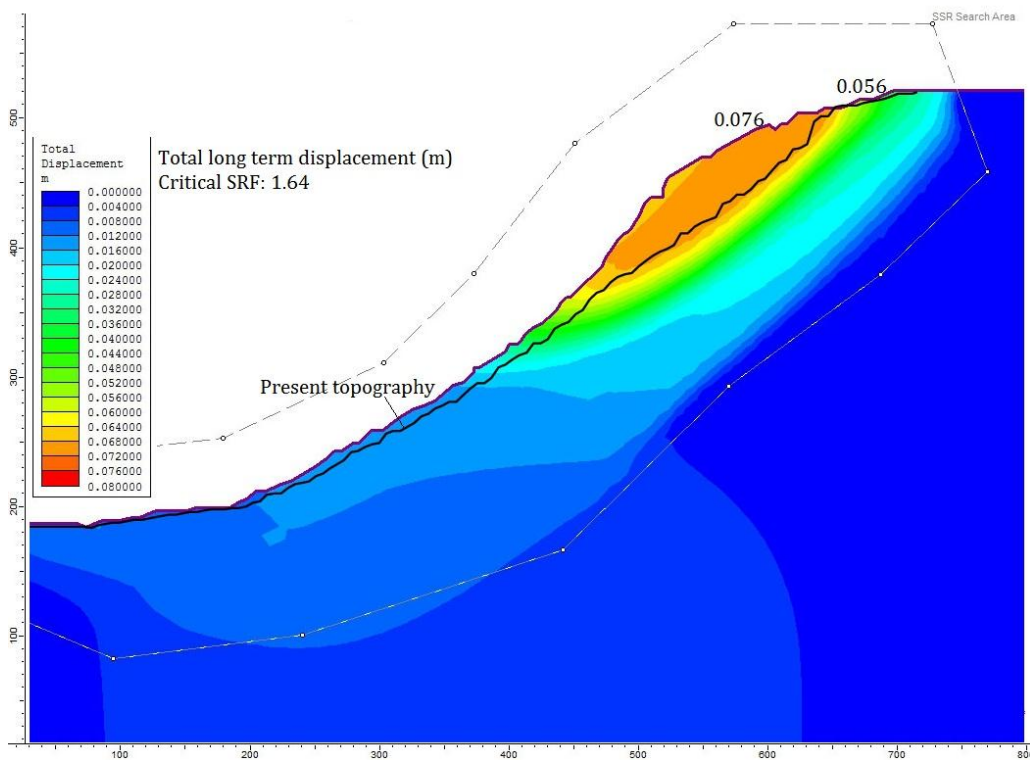
Figure 57 Total long term displacement historical rockslide, marked with present topography, critical SRF=1.64.

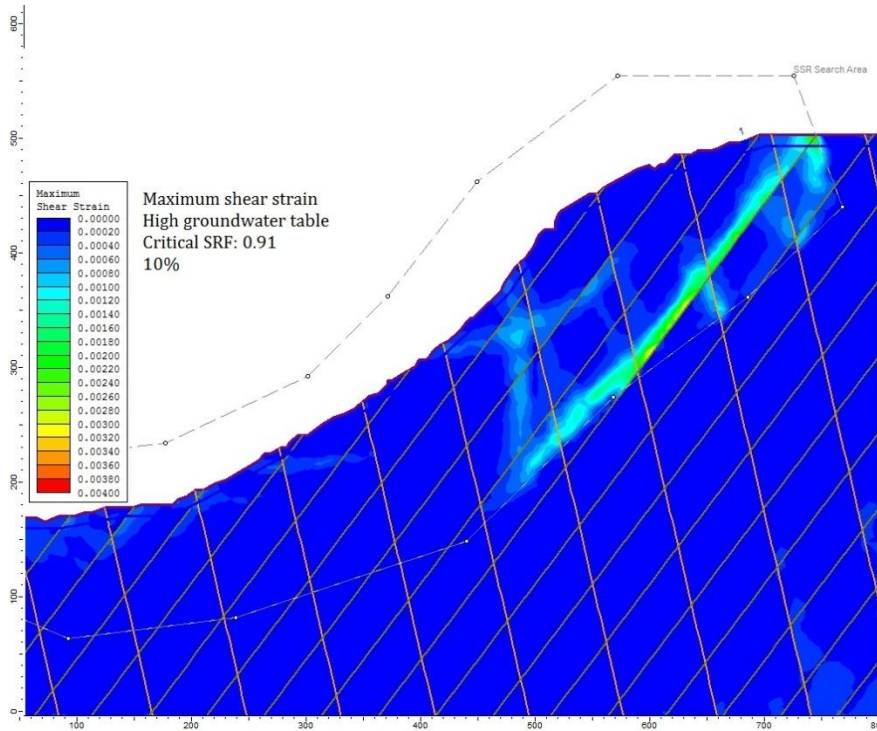
Figure 63 Maximum shear strain for the historical rockslide with high ground water table, critical SRF=0.91 with 10% reduction in residual values.
