Nonlinear and Time Dependent Analysis of a Concrete Bridge Suffering from Alkali-Silica Reaction

*A Case Study of the Elgeseter Bridge in
Trondheim.*

Civil and Environmental Engineering (2 year)

Submission date: June 2014

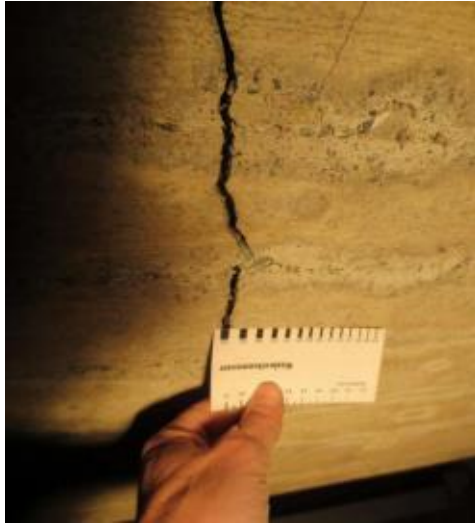
Figure 1. Crack (6 mm width) in internal beam of the bridge.

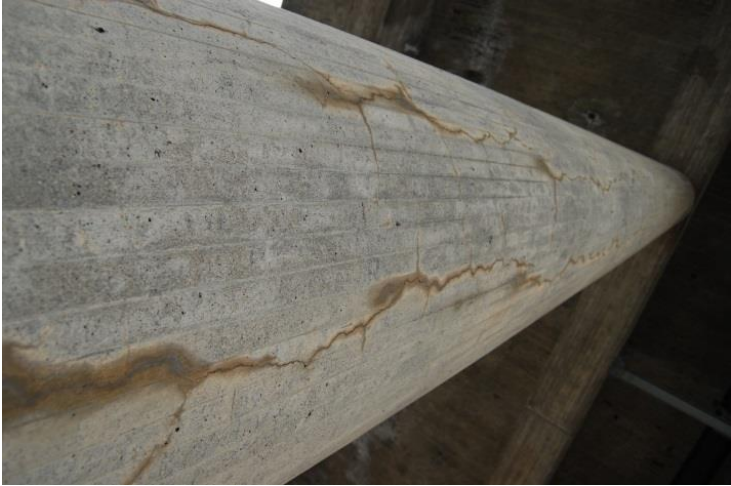
Figure 4. Corrosion of embedded reinforcement in column [fot. by Maciej Wisniewski & Krzysztof Wojslaw].

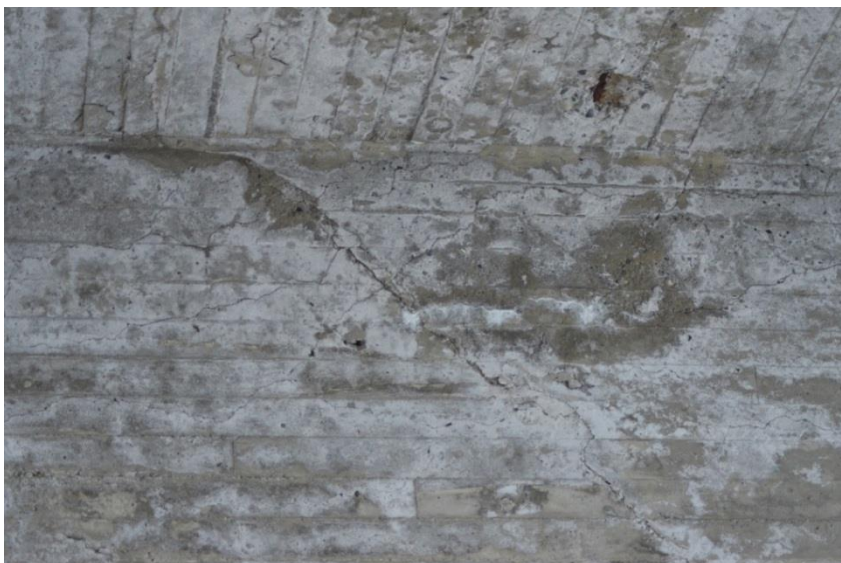
Figure 2.2. Map-cracking of a construction beam caused by ASR
[fot. by Maciej Wisniewski & Krzysztof Wojslaw].

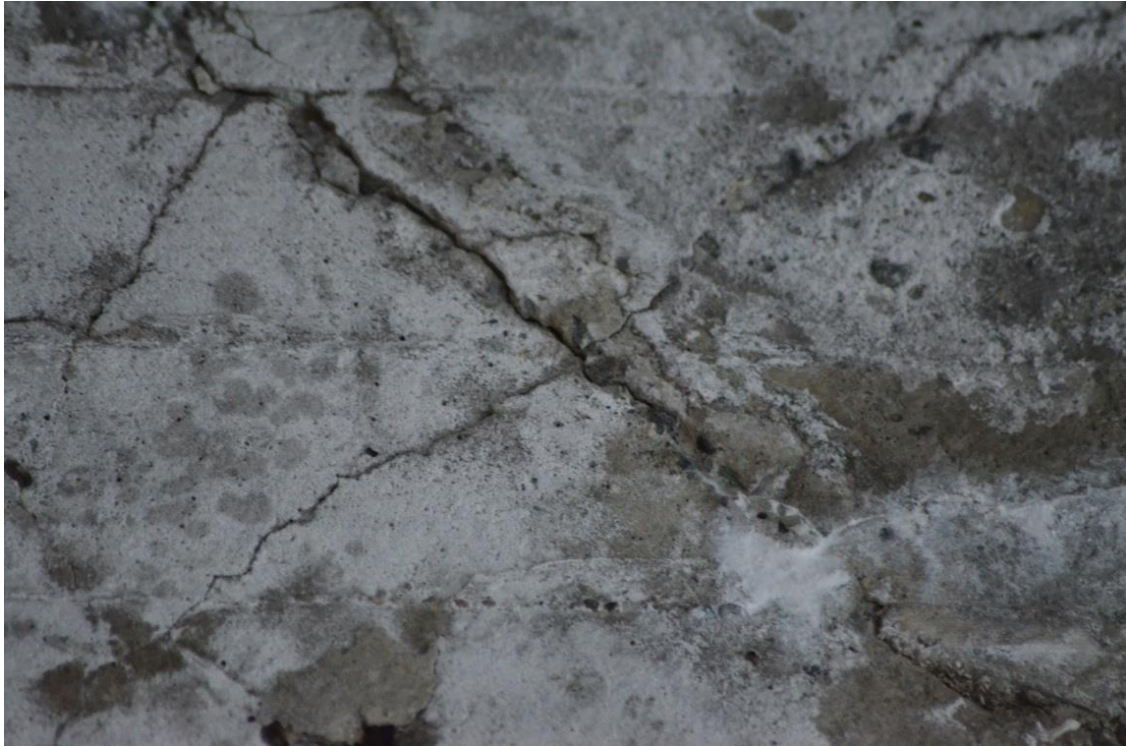
Figure 2.3. Map-cracking of a construction beam caused by ASR
[fot. by Maciej Wisniewski & Krzysztof Wojslaw].

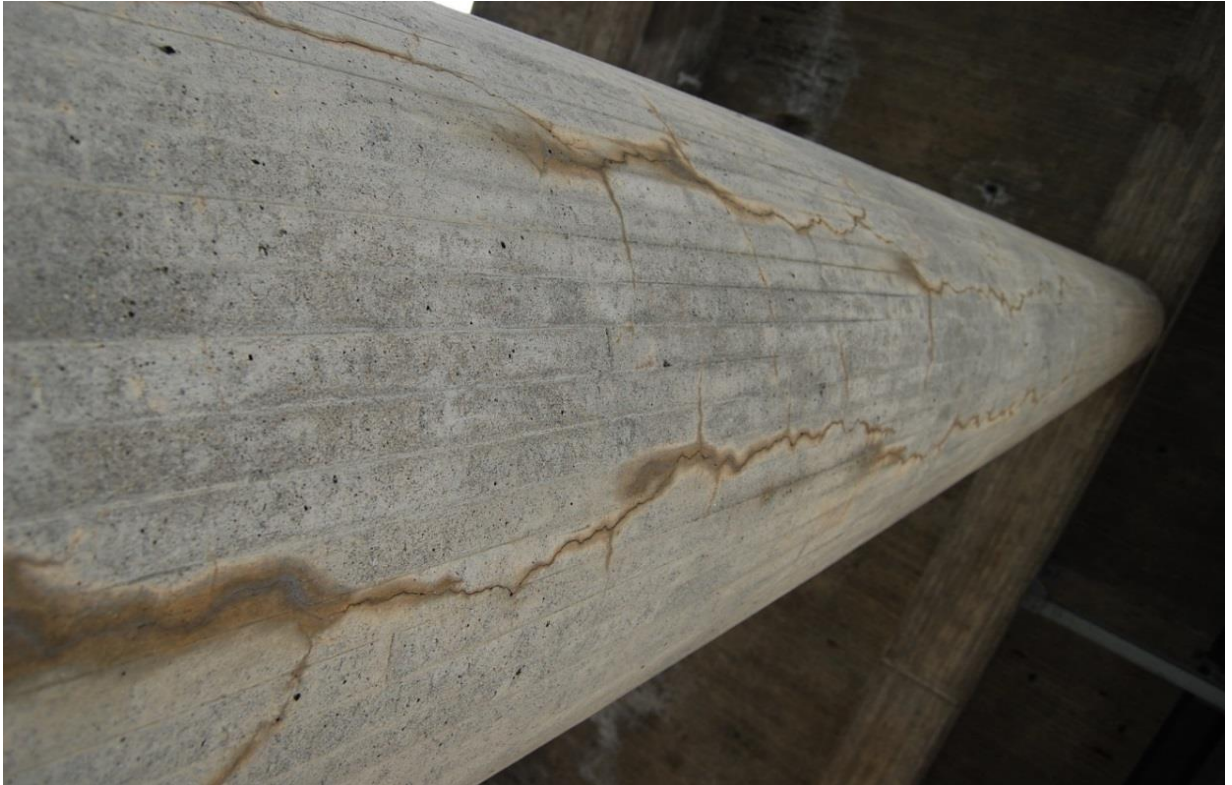
Cracking due to ASR provides elements of construction for oxidation and chloride ions from exposed for moisture from river water as well as from rain water and leads to rapidly penetrate the concrete cover and initiate corrosion of embedded reinforcement. One instance of corroded steel in column is shown in Figure 2.5.

Figure 2.5. Corrosion of embedded reinforcement in column [*fot. by Maciej Wisniewski & Krzysztof Wojslaw*].

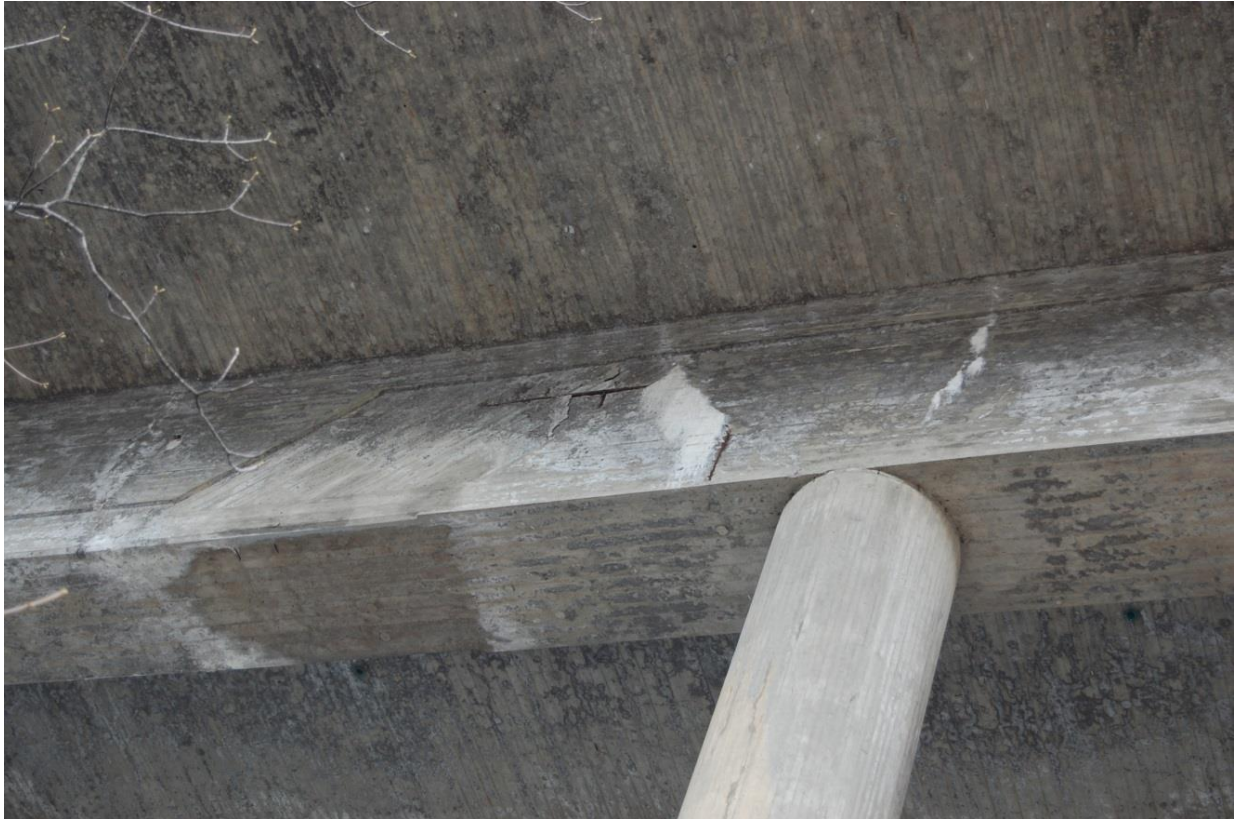
delayed and increases the cracking and expansion which is already contributed by ASR. On the figure 2.6 effects of ASR and DEF is shown.

Figure 2.6. Delayed ettringite formation effect [fot. by Maciej Wisniewski & Krzysztof Wojslaw].

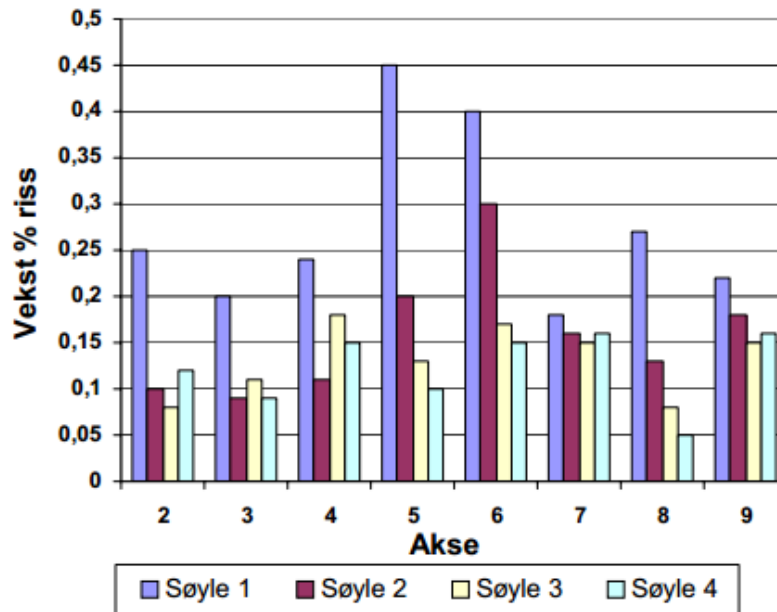
Figure 3.4 Shows expansion data for all the columns in Elgeseter Bridge. Note that the highest expansions occur in columns located in the most westerly row of columns (Column 1) and in the middle of the river (Zones 5 and 6).

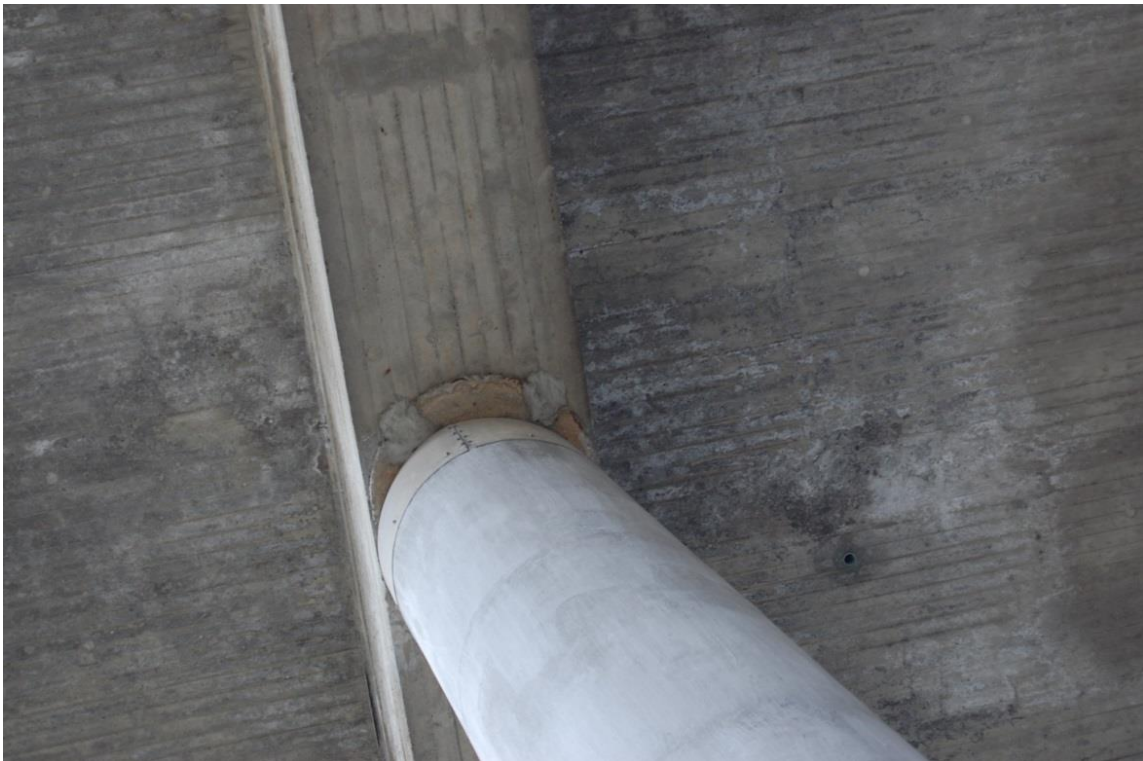
If this movement would be allowed to continue, there was a real risk that the columns will fail under tensile stress that will occur on one side. Hence, in 2003, the Road Directorate renovated all the northern columns in Zones 7, 8 and 9 on the bridge. The major repair work was to move columns back to a vertical position. A special steel construction was made to support the beam before demolishing the upper 1m of the column by mini-blasting. A Danish technique was used. The reinforcement was then cut and the column was moved back to a vertical position. Reinforcement was then welded back to the beam and the upper part of the column remolded with concrete.

Figure 3.5 shows the upper part of column 3 in Zone 7 where the concrete has been removed. Note that not all reinforcement was welded back due to rehabilitation[56]. [fot. by Maciej Wisniewski & Krzysztof Wojslaw].

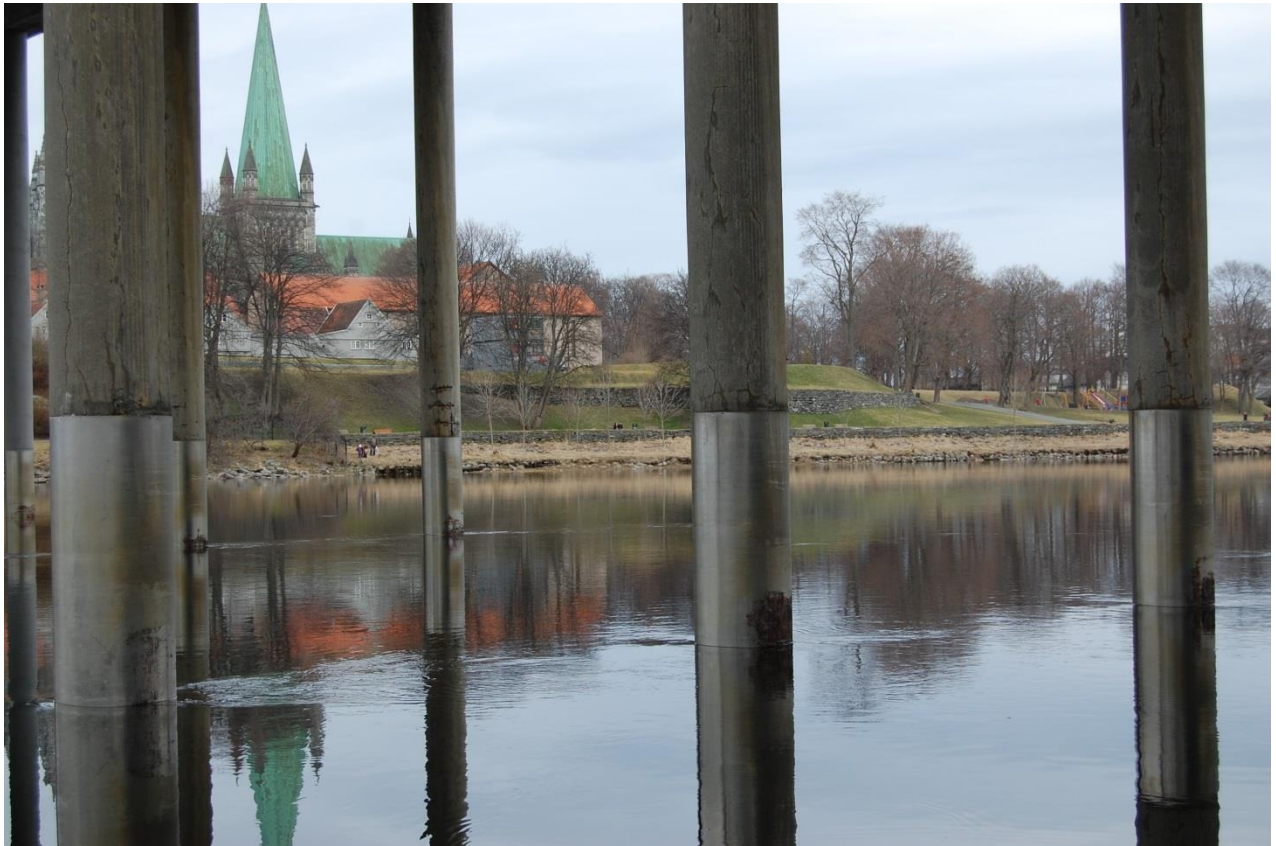
Figure 3.6 ASR in combination with corrosion of embedded reinforcement processes in zone 2-5. [fot. by Maciej Wisniewski & Krzysztof Wojslaw].

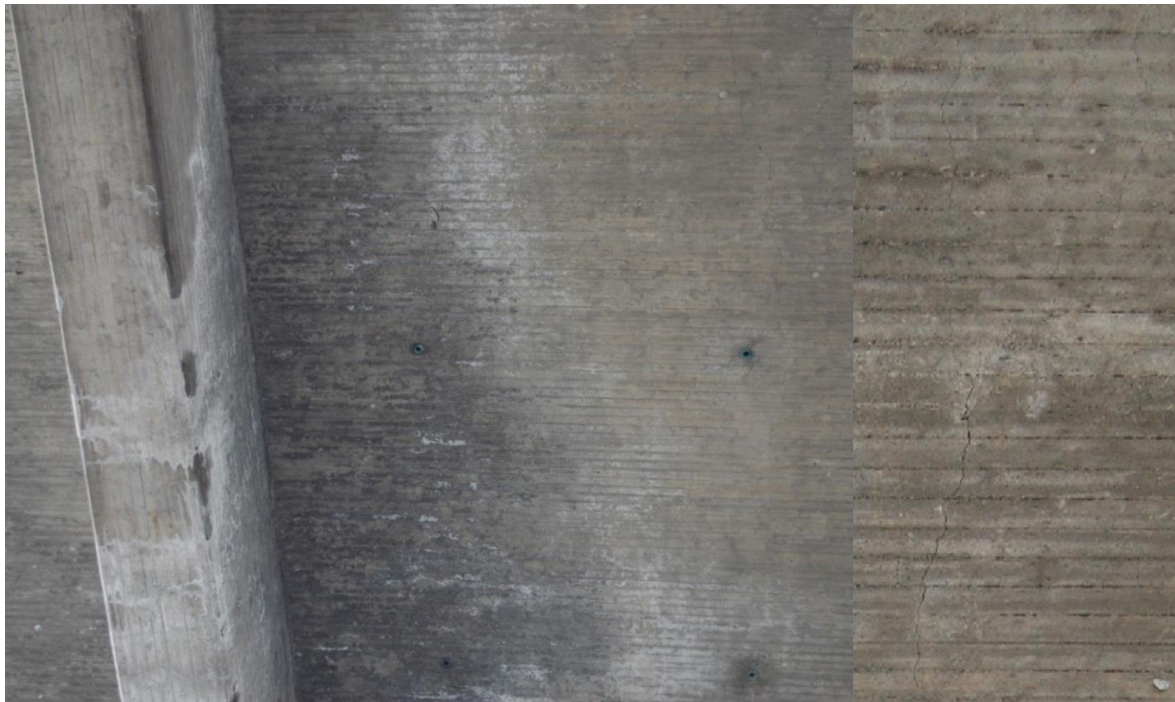
Another explanation can be based on the example that tensile concrete specimens with the same aggregate size show, as well known, that the tensile strength is lower along the casting direction. This suggests that the distribution of pores with various shapes and orientations determines both the direction with the weakest tensile strength and the preferred expansion direction. Before microcracking occurs, the swelling is nearly isotropic. Afterwards the gel expansion will induce the propagation of the cracks in the weakest zone (perpendicular to the casting direction), which will mutually influence the further swelling. In conclusion, anisotropic cracking resulting from anisotropic strength properties influences the anisotropic expansion. The same conclusion could be used to explain this case that the swelling redistribution in slab. In specimens subjected to uniaxial compressive loading or lateral constraining the imposed expansion is lower in the restrained direction. Once again the gel expansion induces the crack propagation in the direction which requires less energy dissipation. When the constraints are applied in the lateral direction the gel tends to expand along the longitudinal direction (Fig. 3.8)

Figure 3.8 Cracks in slab in zone 1 [fot. by Maciej Wisniewski & Krzysztof Wojslaw].

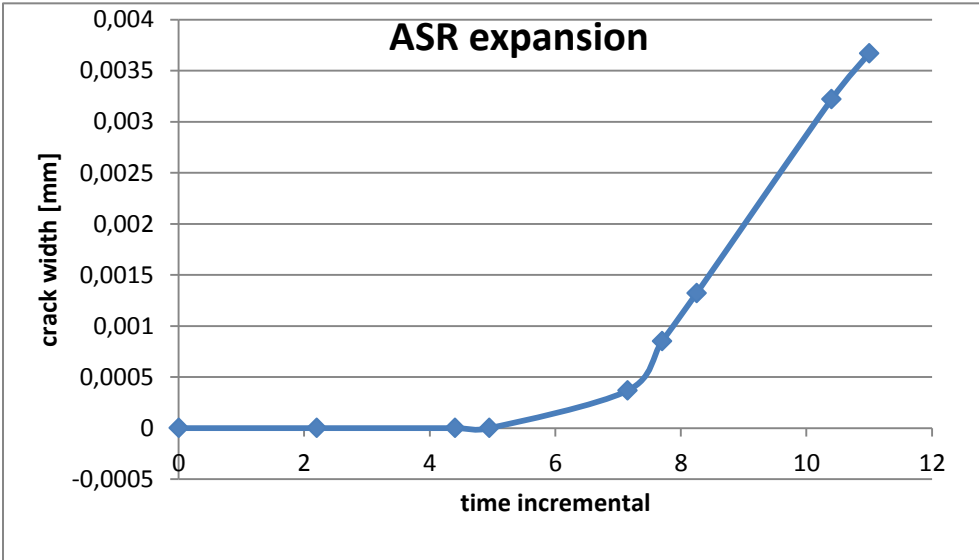
Figure 6.4 Graph shows relationship between ceack width and time.

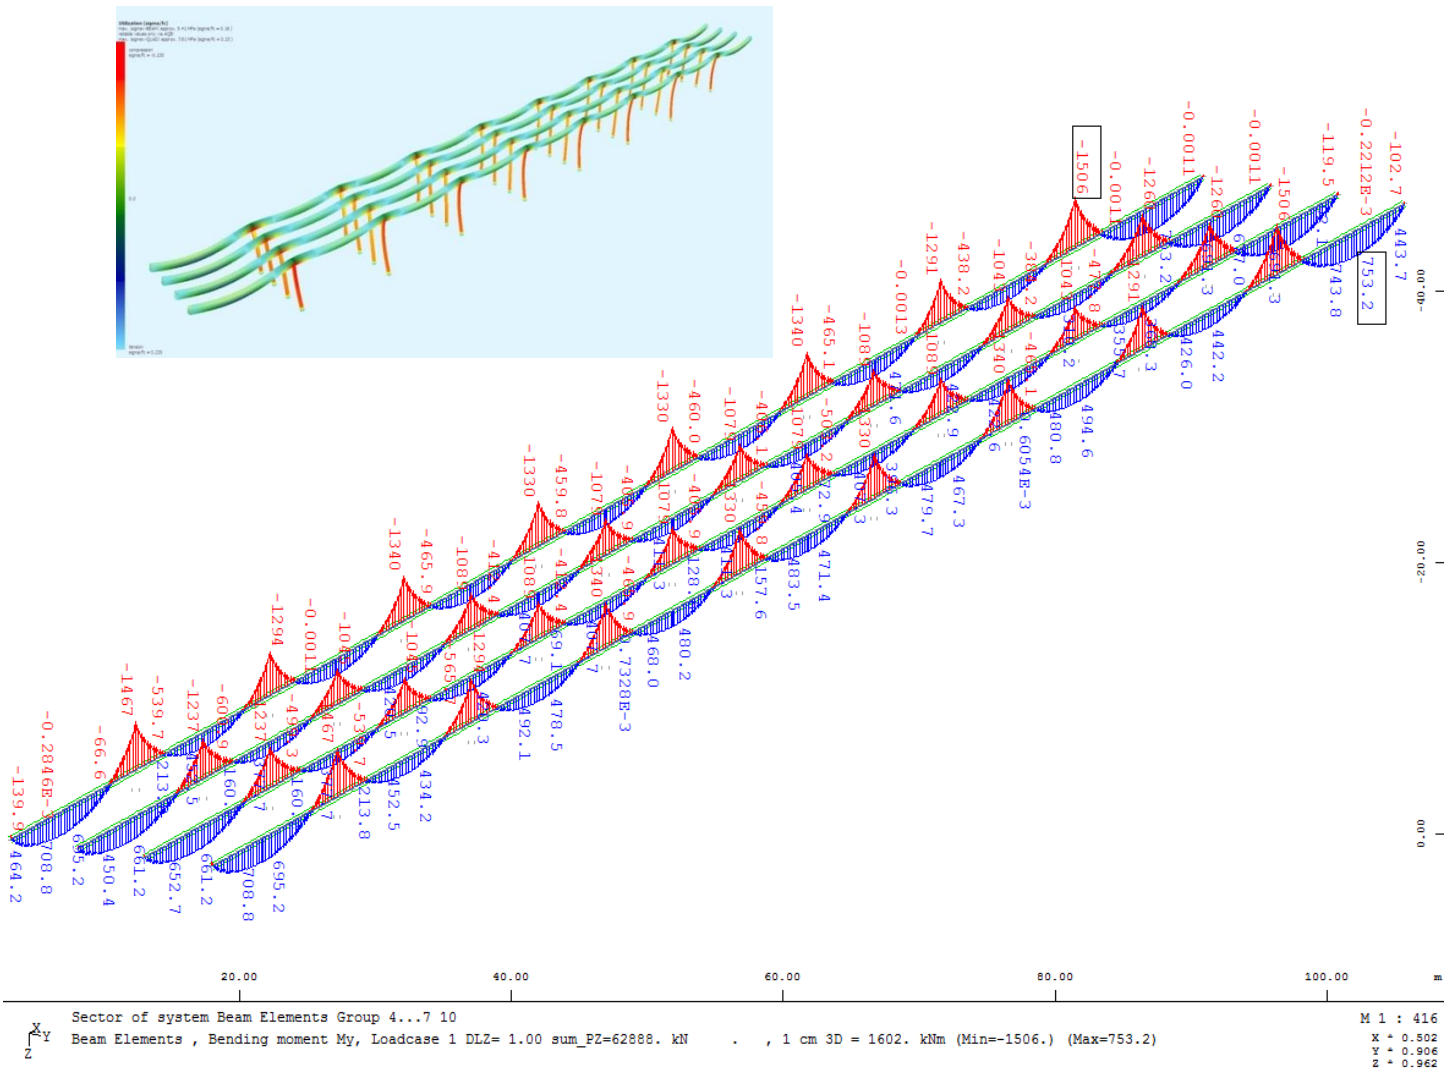
Figure 6.4 and Table 7 Longitudinal bridge bending moments redistribution for self-weight load case.

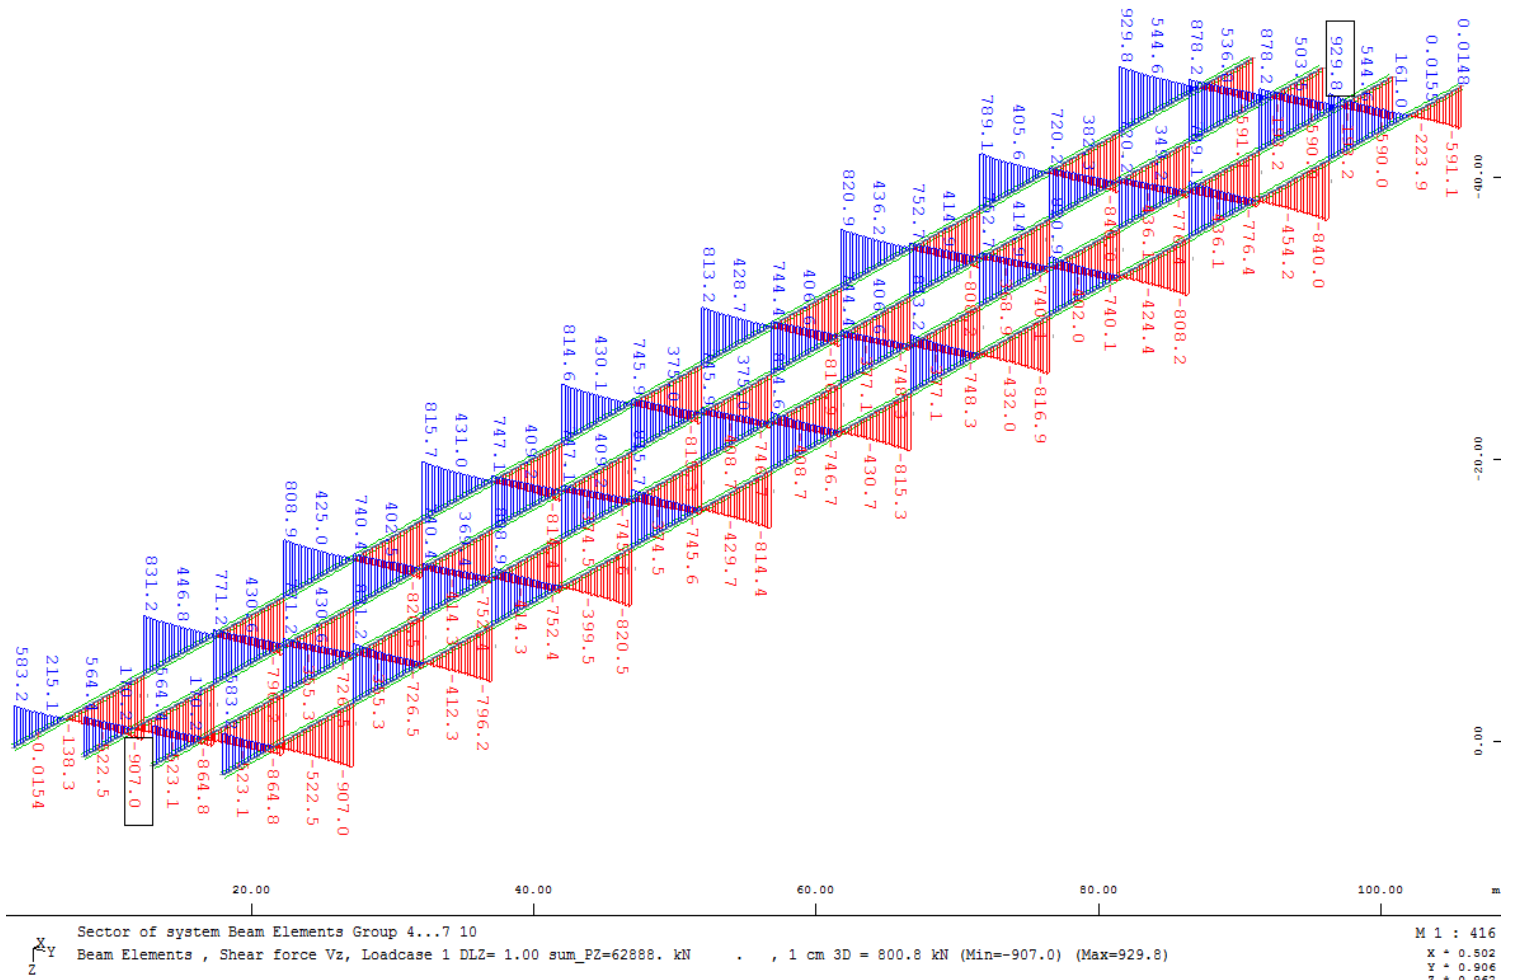
Figure 6.5 and Table 8 Longitudinal bridge shear force redistribution for self-weight load case.

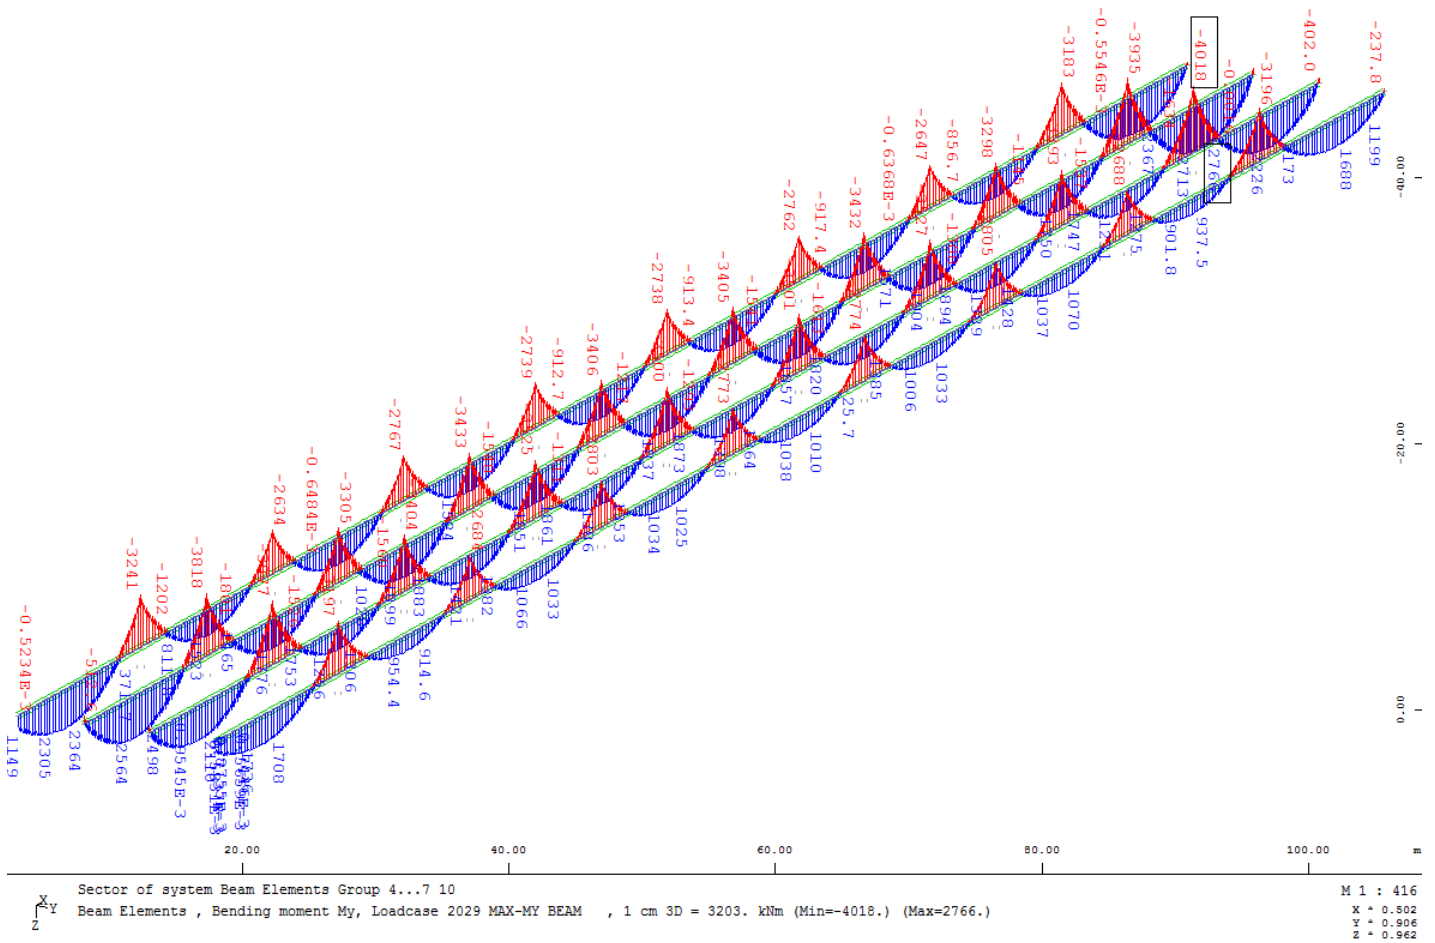
Figure 6.6 and **Table 9** Longitudinal bridge bending moments redistribution for The Ultimate Limit State Combination.

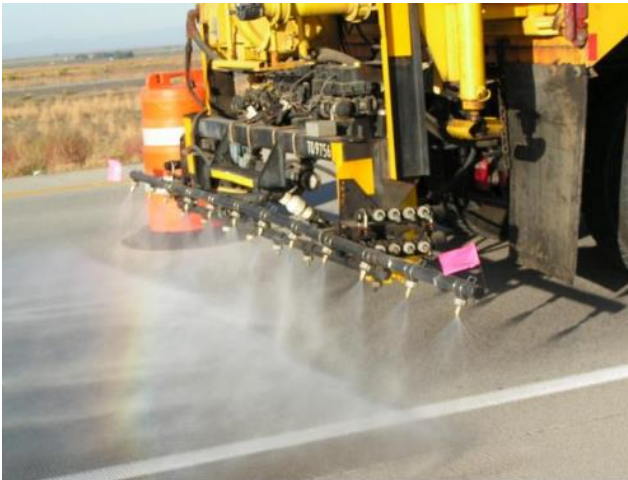
Figure 8.2 Photograph showing topical application of 30 percent-LiNO3 solution to concrete pavement.

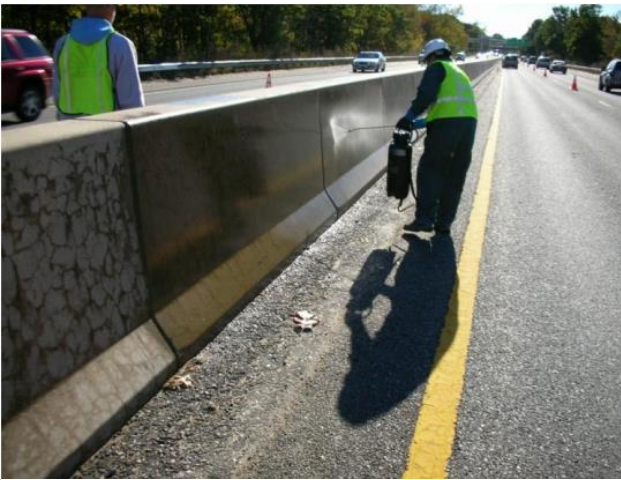
Figure 8.3 Photograph showing topical application of 40 percent-Silane Solution (solvent-based) to ASR-affected highway barrier.

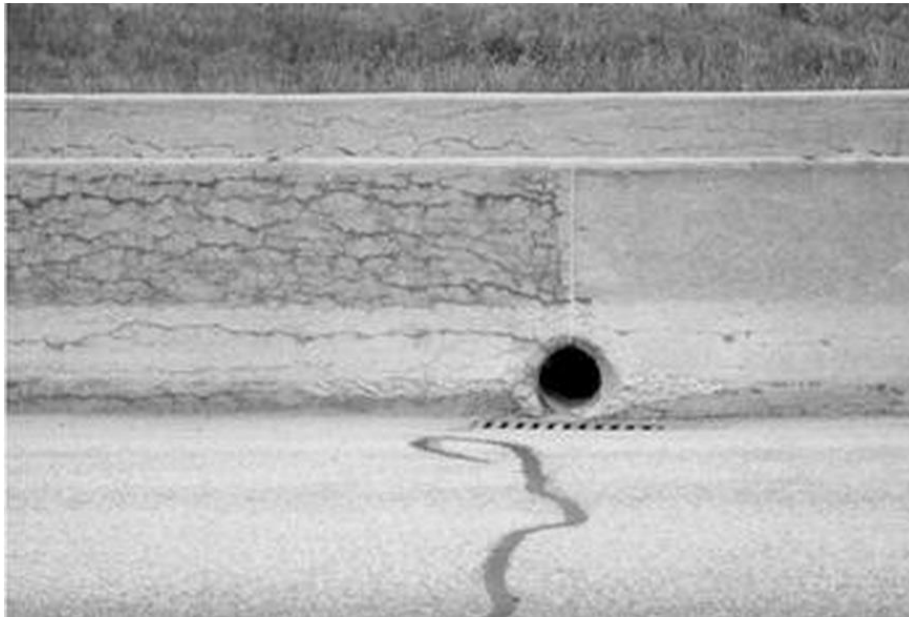
Figure 8.6 Barrier wall in Quebec-the section of the wall to the right of the picture has been treated with a silane sealer.

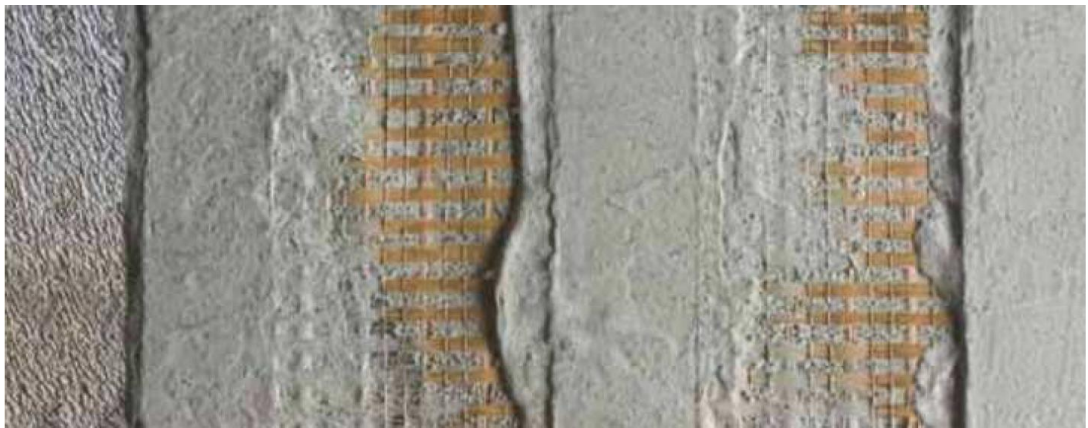
Figure 8.11 FRCM system with the PBO fiber on a cement matrix applied on the reinforced concrete element [70].

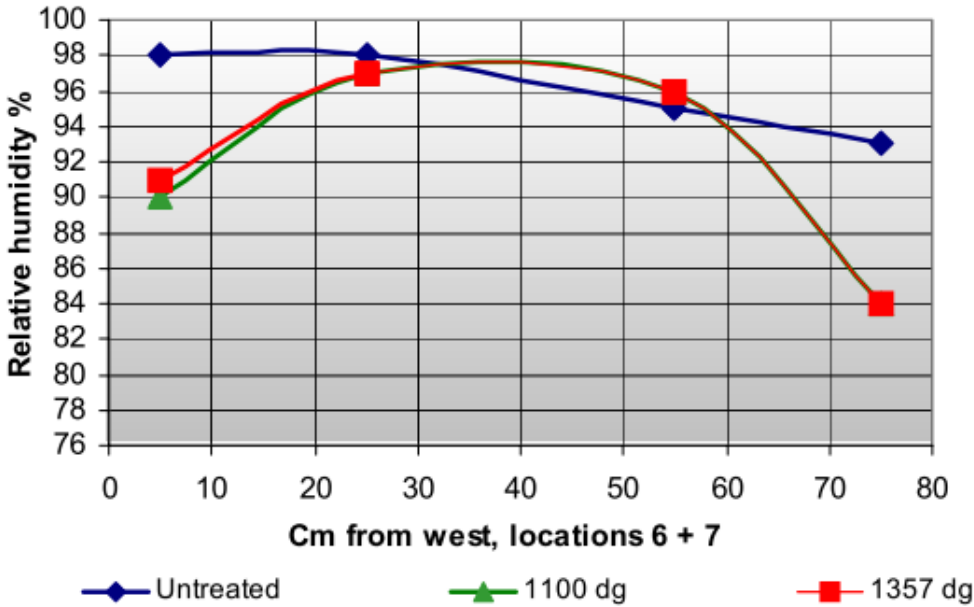
Fig. 9.3. Humidity profiles through column 1, Zone 9 about 1.5 m above ground level measurements before impregnation (untreated), 1100 and 1357 days, respectively. After application of silane type B.
