Alternating Current Corrosion of Steel in Seawater

Are Bergin

Materials Technology

Submission date: June 2015

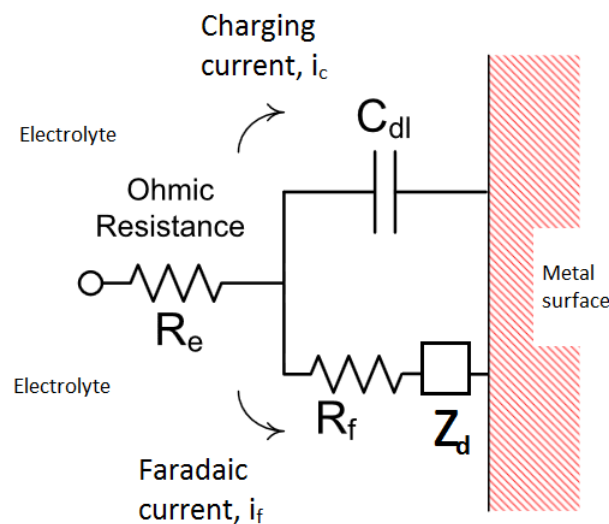
Figure 2-4: The equivalent electrical circuit that acts as a model for the interface between the metal surface and the surrounding electrolyte. Figure is adapted from literature [11].

The capacitance at the double layer (C_{dl}) arises due to charge redistribution at the interface, or from a dielectric oxide-film on the metal surface. It may act as a capacitor, and parts of any current that flow between electrolyte and the metal surface will cause charging or discharging (both will be i_c) of the double layer. R_f and Z_d on the other hand, are combined to an impedance called the polarization resistance. This resistance correlates to overpotential that is created by the concentration gradients of reactants and products, which are formed due to the flow of the Faradaic current, i_f . This current, dependent on its direction, causes oxidation of the metal surface and formation of other products due to oxidation [10, 12].

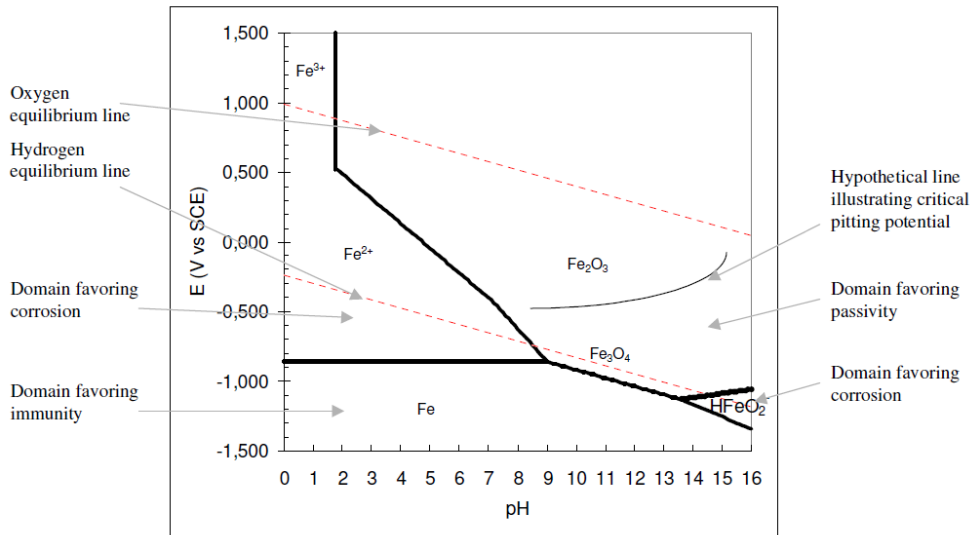
Figure 2-6: The Pourbaix diagram for iron/carbon steel in water. The active corrosion, immune and passive regions are indicated, as well as the critical pitting potential [21].

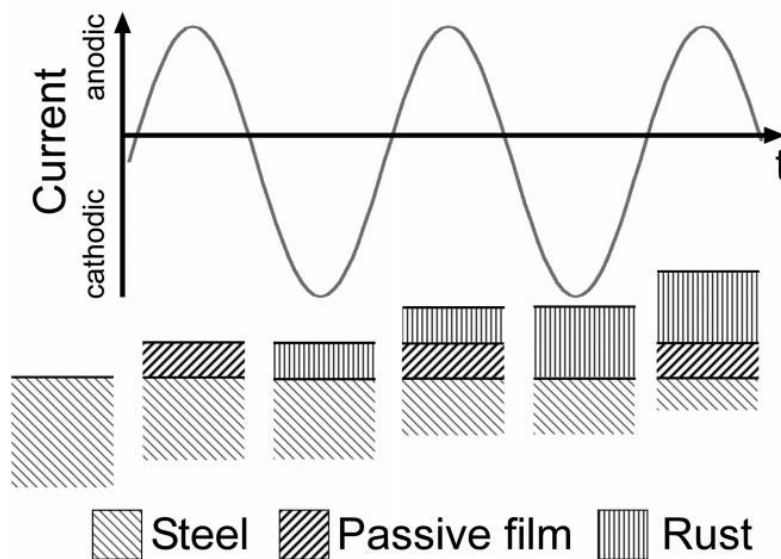
Figure 2-7: Schematic view of the AC corrosion mechanism when samples are under CP ($i_{DC} > 1A/m^2$), with graph and illustrations [33].

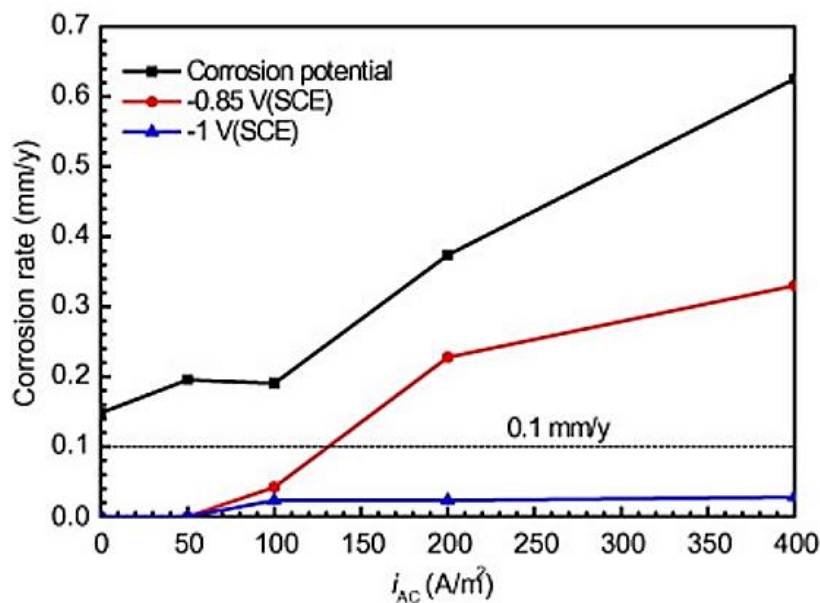
Figure 2-15: Corrosion rate as a function of applied i_{AC} under different CP-potentials. Determined by weight loss measurements of steel immersed in simulated soil solution [30].

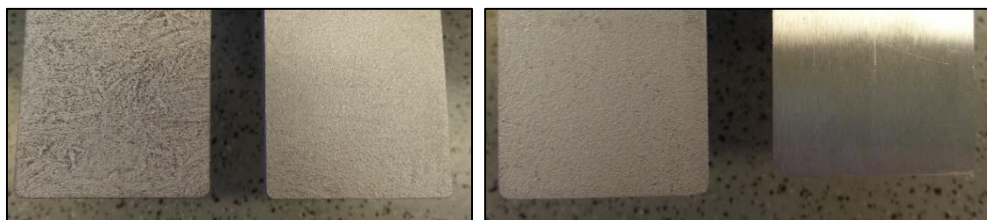
Figure 3-1: The first photo shows two 25Cr-samples, were the left one is prior to cleaning and the right one has been cleaned. The second photo shows the surface difference between some cleaned samples. The samples that was shiny, as the one to the far right was used for XRD and not weight loss measurements

The used samples were pretreated in different ways. The samples from X65 was freshly machined and either milled at NTNU's technical laboratory of materials and then grinded manually afterwards, or just milled. Grinding was done by using successively finer grade of SiC-papers (220-500-1000 grit size) at a standard grinding table with running water. It was necessary to clean the grinded samples according to ASTM-G1 after grinding, as they started to corrode in the presence water [45]. The samples of 316 and 25Cr were old samples from C. H. M Hagen and C. B. Esser's studies, which presumably had been polished by water to a grade finer than 1000 grit size. They had reacted during their storing at the workbench, and thus was cleaned according to ASTM-G1 as well [45]. Figure 3-1 shows two photos of samples from 25Cr; differences in surface pre- and post-cleaning and between cleaned samples.

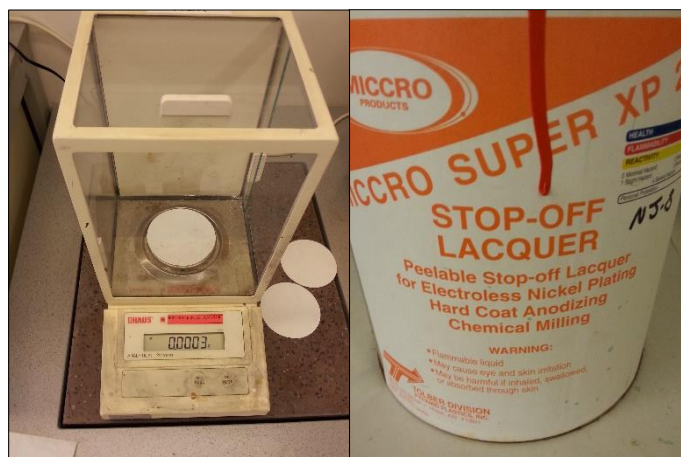
Figure 3-2: The left picture is of the standard analytical weight and the right picture is of the lacquer used to coat the samples.

Prior to testing, they were washed, dried, weighed and coated. Washing was done in the following order: distilled water, acetone and ethanol (96 %). The samples were dried using hot air from an electrical heat gun, weighed by a standard analytical weight (with an error of ± 1 mg) and coated with Micro Super XP 2000 Stop-Off Lacquer. The weight and the lacquer can be seen in Figure 3-2. The lacquer used was chosen due to its good protection against corrosion and easy removal.

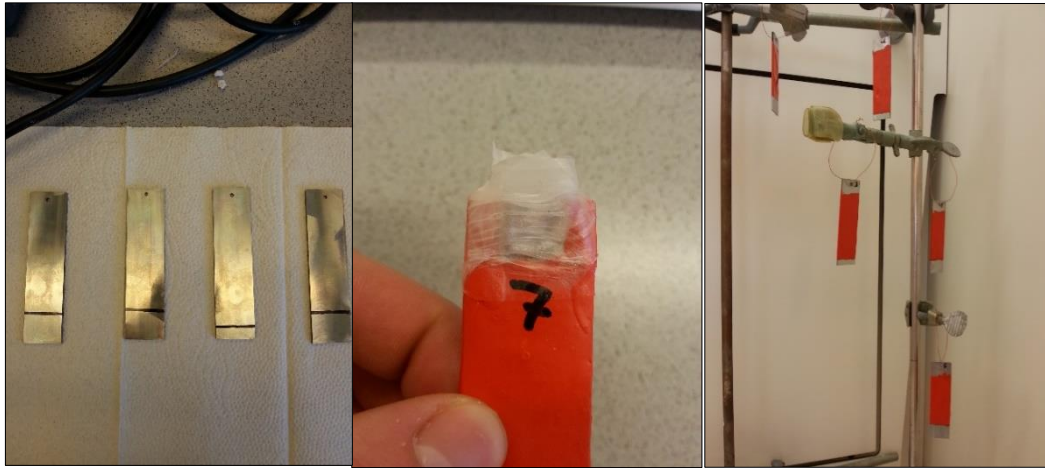
Figure 3-3: The left picture shows some samples before they were coated, and the difference in exposed area is visible. The picture in the middle shows how the sample top was covered to avoid unwanted corrosion. The right picture shows drying and storing of the samples after coating.

All the samples were coated twice, with approximately one day between each cycle and at least one day before immersion. As many samples often were coated at the same time, the samples were stored for days in the same manner as can be seen in Figure 3-3. To avoid corrosion around the clamp on the top of the samples during experiments, coating was applied tight around the clamp and the whole top was covered with laboratory-film as seen in Figure 3-3.

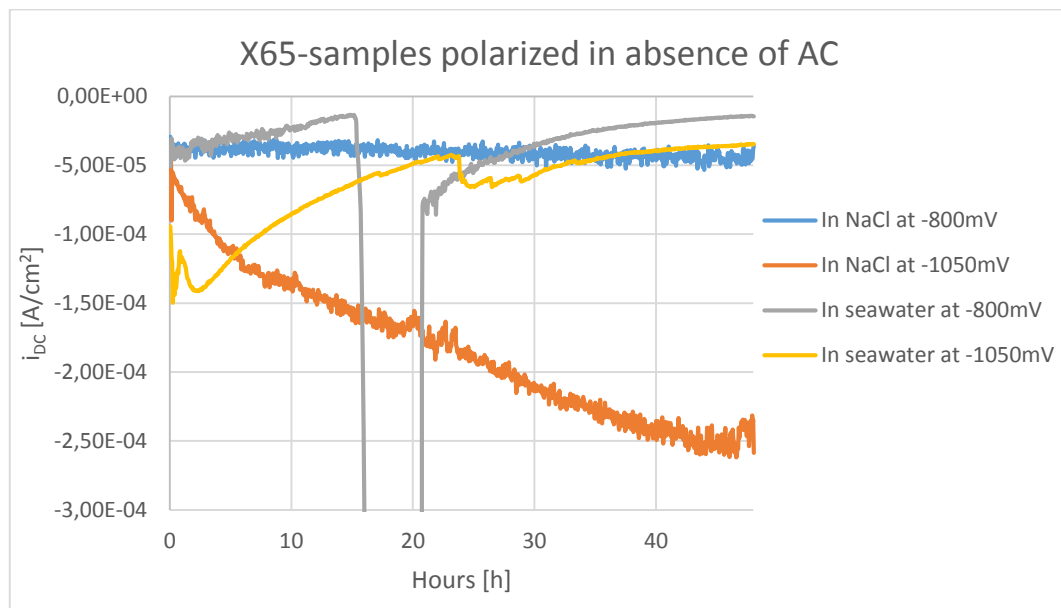
Figure 4-1: The recorded DC current density response as a function of time, with no AC applied. Samples are polarized at -800 and -1050 mV DC, in 3.5 % NaCl-solution and artificial seawater.

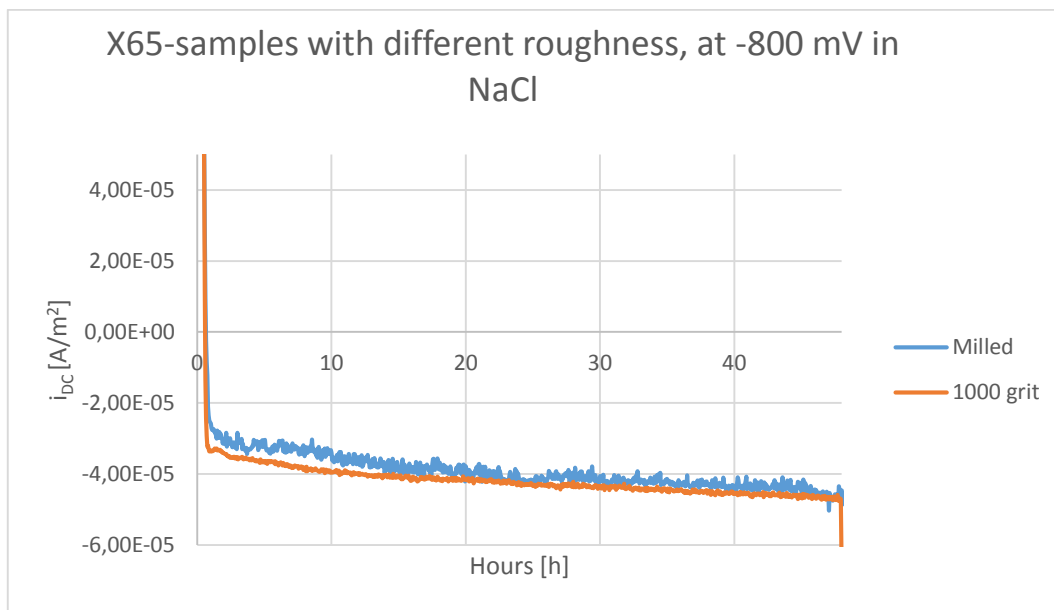
Figure 4-2: The recorded DC current density response as a function of time, with 500 A/m² AC applied. Samples are either milled or grinded at 1000 grit, and polarized at -800 mV DC in 3.5 % NaCl-solution.

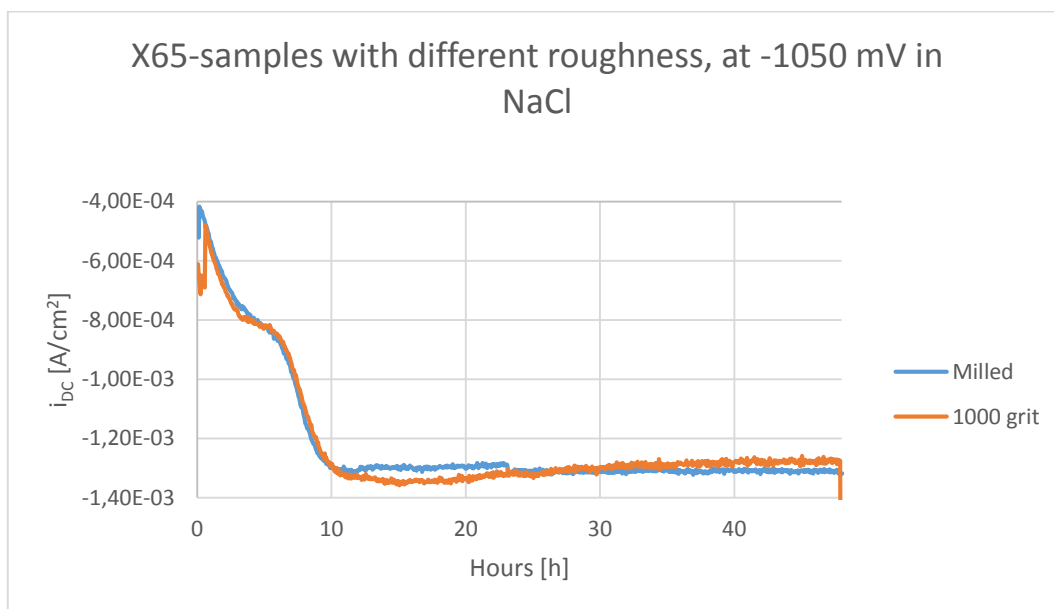
Figure 4-3: The recorded DC current density response as a function of time, with 500 A/m² AC applied. Samples are either milled or grinded at 1000 grit, and polarized at -1050 mV DC in 3.5 % NaCl-solution.

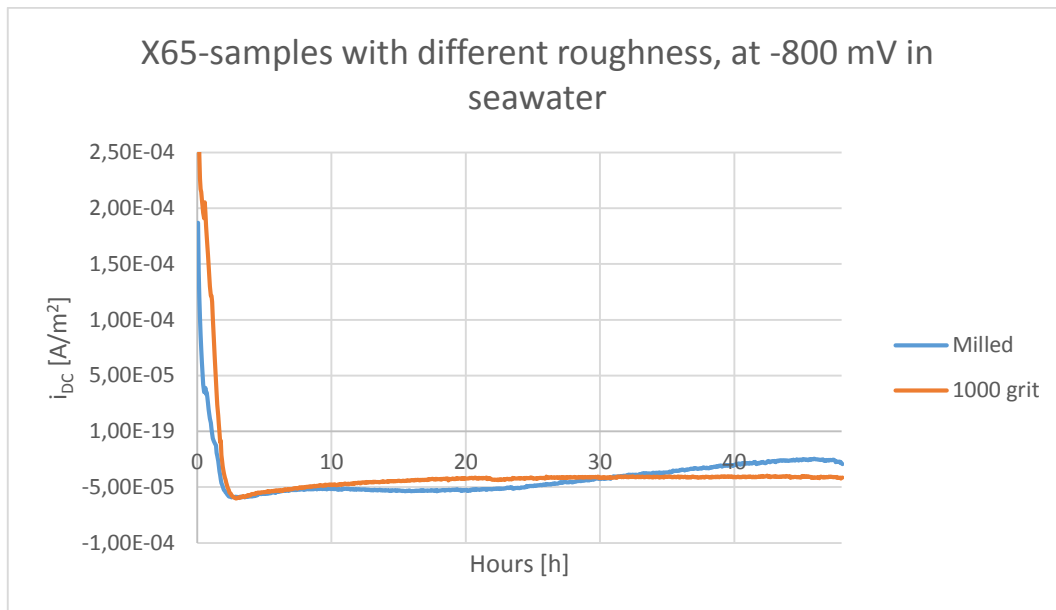
Figure 4-4: The recorded DC current density response as a function of time, with 500 A/m² AC applied. Samples are either milled or grinded at 1000 grit, and polarized at -800 mV DC in artificial seawater.

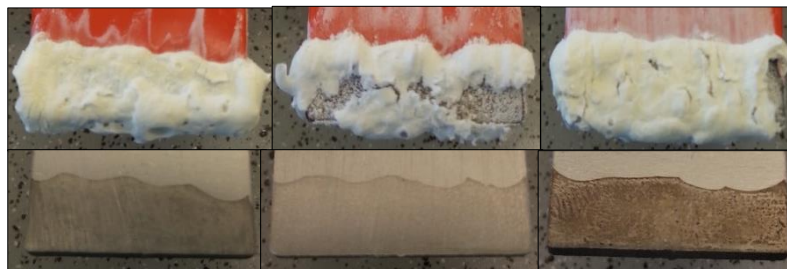
Figure 4-16: Pictures of 316-samples tested in artificial seawater at 1000 A/m² AC. The top pictures are prior to cleaning and the bottom ones are post cleaning. The left row was tested at -800 mV DC, the middle at -1050 mV DC and the right is the re-test of the middle one.

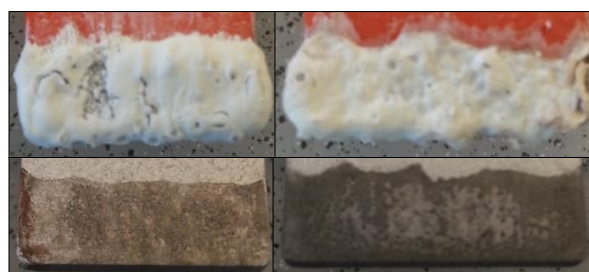
Figure 4-18: Pictures of 25Cr-samples tested in artificial seawater at 1000 A/m² AC. The top pictures are prior to cleaning and the bottom one is post cleaning. The pictures to the left are samples tested at -800 mV DC and the right at -1050 mV DC.

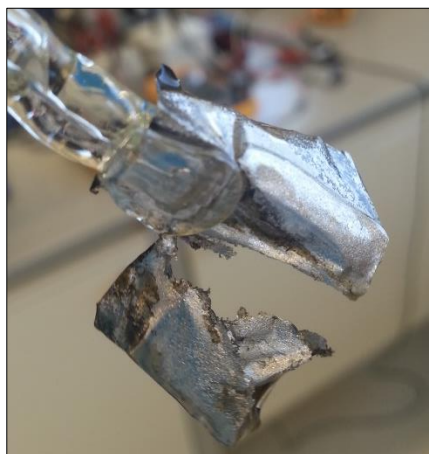
Figure 4-33: A photograph of the AC counter electrode that has started to dissolve.

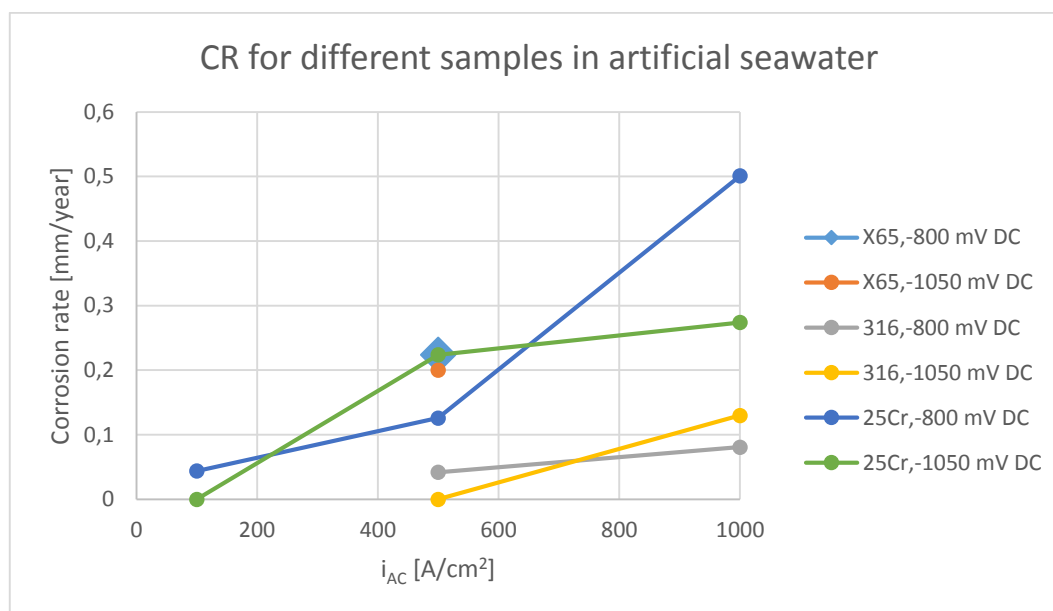
Figure 4-34: Calculated corrosion rate for all different-samples tested (at different ACs under -800 and -1050 mV DC) in artificial seawater. The CR-values are averaged for the experiments tested twice, but deviations are not included.
