Effect of Cathodic Polarization on the Susceptibility to Hydrogen Embrittlement in 5xxx, 6xxx and 7xxx Series Aluminium Alloys

Kjetil Fossland Veium

Submission date: June 2015

Norwegian University of Science and Technology
Department of Materials Science and Engineering

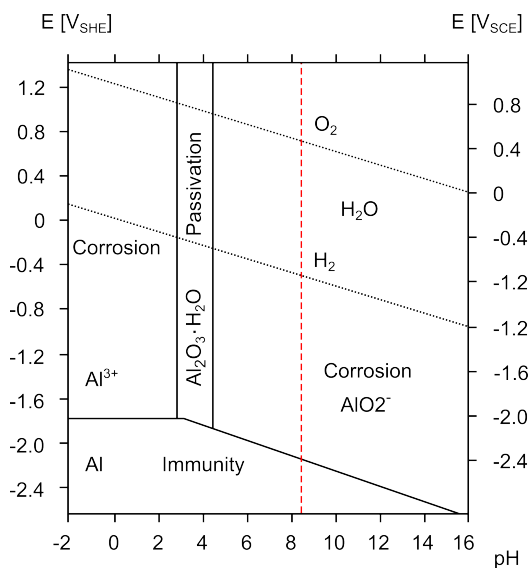
Figure 2.3: Pourbaix diagram for aluminium. Modified from [3].

Figure 2.3 shows the Pourbaix diagram for aluminium, where the red line indicate seawater conditions (pH 8.2). Apparently, aluminium seems to corrode when being exposed to seawater. However, alloying elements such as Mg and Mn are used to ensure passivation also in slightly alkaline environments. An experimental Pourbaix diagram for AA 5086 in a chloride solution is given in Figure 2.4. As it can be seen, the area passivity is extended to increased pH values due to the alloying elements.

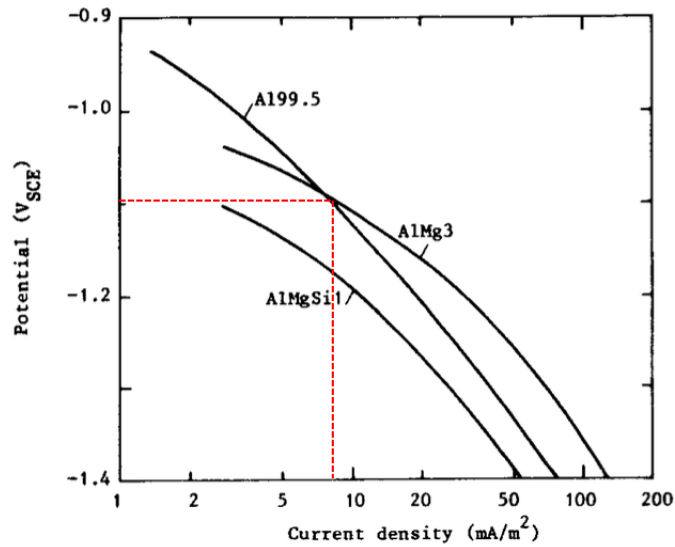
Figure 2.6: Cathodic polarization curves of aluminium alloys exposed to seawater under almost stagnant conditions. The dotted red line indicates the current density requirement for an AlMg3 alloy at an applied potential of $-1050 \text{ mV}_{\text{Ag/AgCl}}$ ($-1093 \text{ mV}_{\text{SCE}}$). Modified from [22].

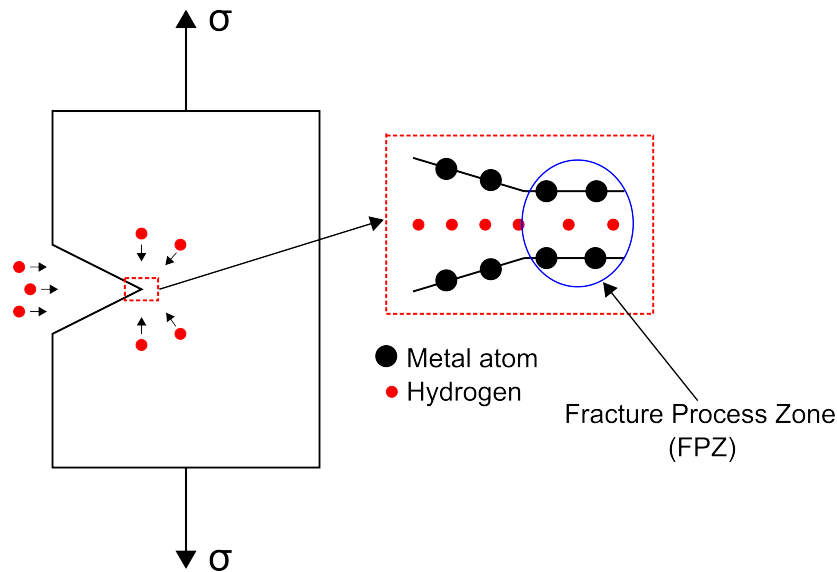
Figure 2.10: Illustration of the hydrogen enhanced decohesion (HEDE) mechanism. Hydrogen accumulates into areas of high stresses (*e.g.* a crack tip), and this causes a reduction in cohesive forces between the atoms and eventually crack propagation. Based on ideas from [28].

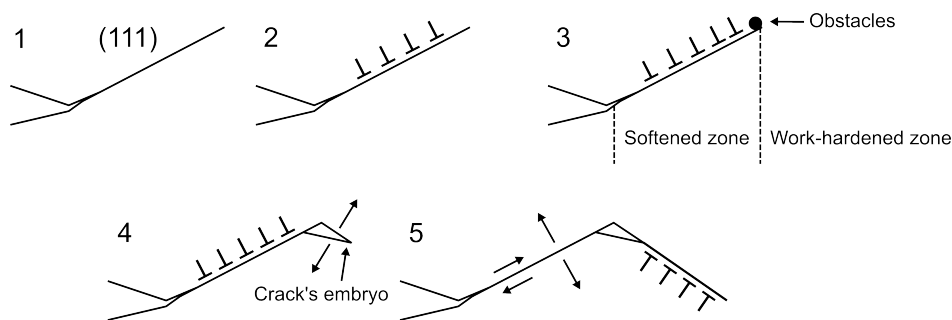
Figure 2.12: Illustration of the hydrogen enhanced local plasticity (HELP) mechanism. 1: activated slip plane in front of a crack tip, 2: increased dislocation mobility due to hydrogen, 3: pile up of dislocations, 4: microvoid formation, 5: crack propagation. Modified from [27].

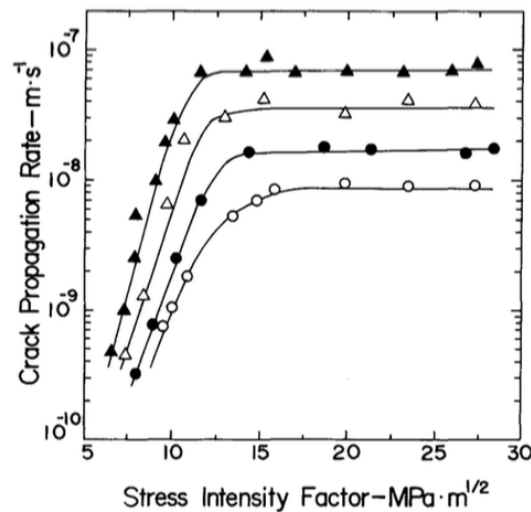
Figure 2.16: Stress corrosion crack propagation rate (v) vs applied stress intensity factor (K) for an Al-Zn-Mg (7xxx) alloy tested in a 3.5 wt% NaCl solution at 55 °C (black triangles), 45 °C (open triangles), 35 °C (black circles) and 25 °C (open circles) [42].

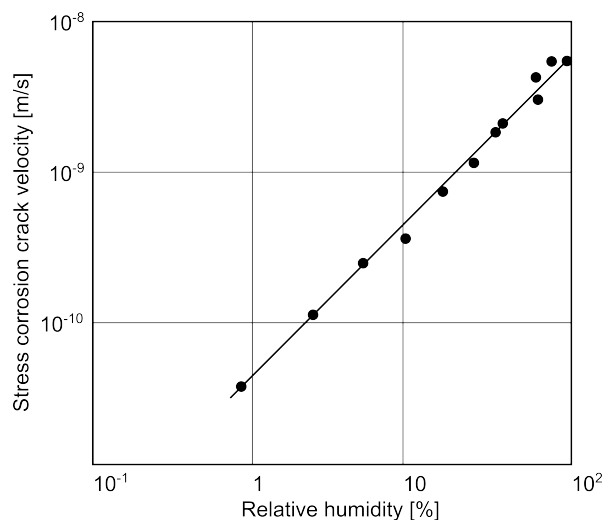
Figure 2.17: Effect of humidity on stress corrosion crack velocity in an Al-Zn-Mg (7xxx) alloy. A linear relationship is observed between the stress corrosion crack velocity and the humidity. Modified from [39].

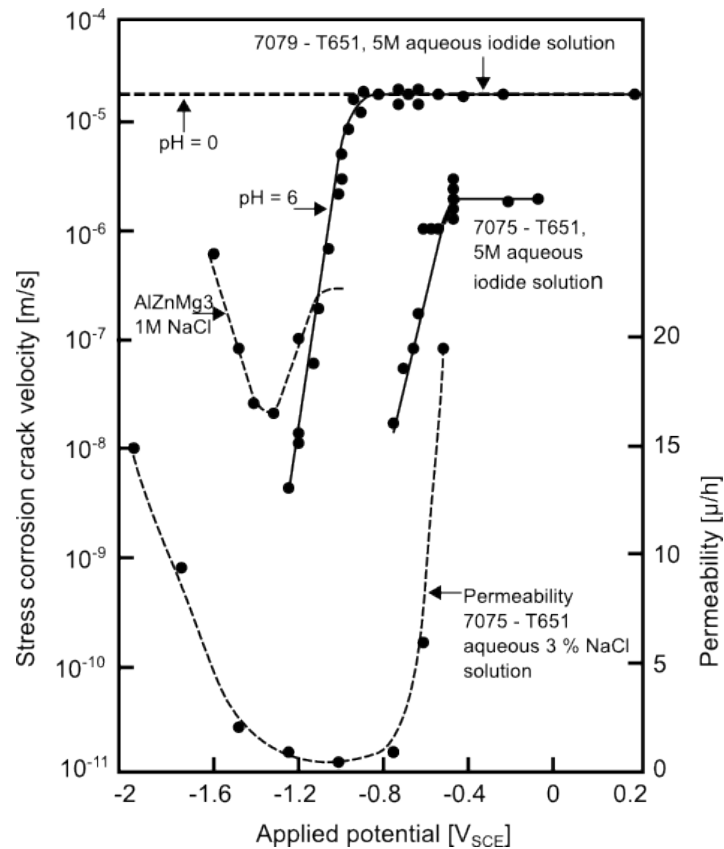
Figure 2.20: Effect of applied potential on hydrogen permeability (dotted lines) and stress corrosion crack velocity (solid lines) in different aluminium alloys. Modified from [32].

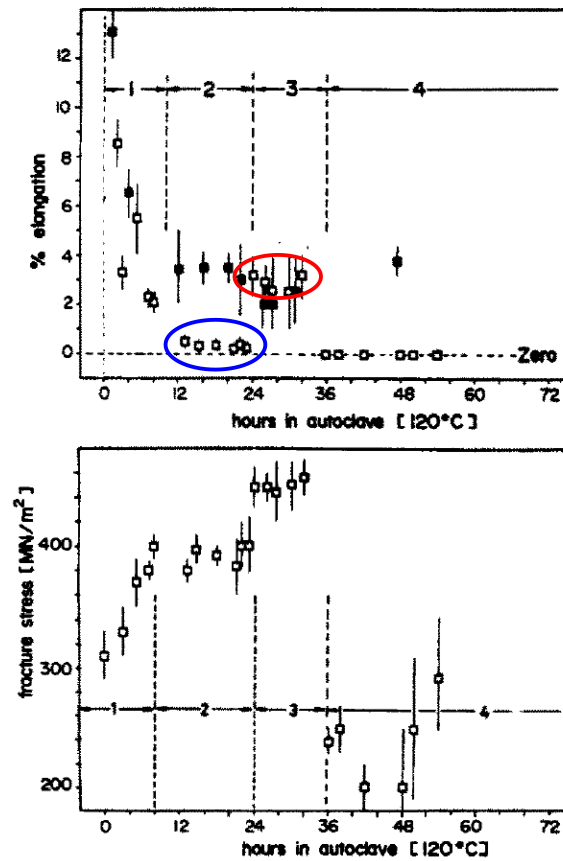
Figure 2.23: Results from embrittlement testing of an Al-Zn-Mg (7xxx) alloy for samples exposed to water vapour (open circles) and dry samples (filled circles). The upper diagram shows the variation in ductility as a function of exposure time and the lower diagram shows the variation in fracture stress as a function of exposure time. Recovery of ductility is observed between stage 2 (blue circle) and stage 3 (red circle). Modified from [59].

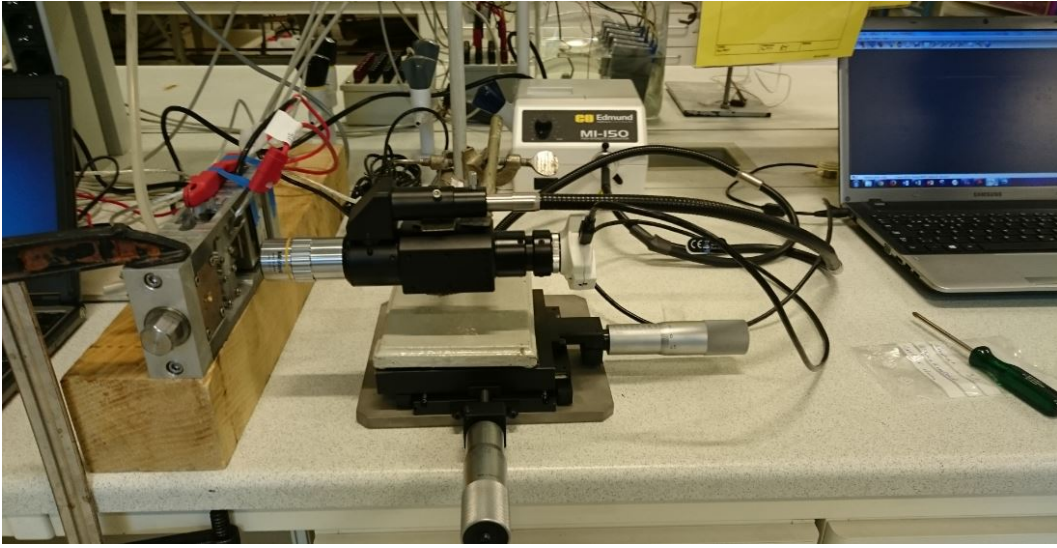
Figure 3.5: Experimental setup used for tensile testing with in situ cathodic polarization.

The tensile test equipment used were two ME-Meßsysteme GmbH load cells, each with a capacity equal to 1 Ton equivalent load. These were mounted to a desk by use of vices, and load was applied by hand using a wrench. Data was recorded by a connected computer with customized software. The test equipment used for tensile testing of samples in air is shown in Figure 3.3. Tensile testing with in situ cathodic polarization was performed by placing the samples in between a two-part electrolyte chamber as shown in Figure 3.4. The chamber was made of poly carbonate, and equipped with a glass window in front in order for images to be taken. Images were taken by the use of a Edmund Optics™ color camera mounted to a Mitutoyo™ video microscope. The microscope was equipped with a Mitutoyo™ objective providing 16 \times magnification. An overview image of the experimental setup used for tensile testing with in situ cathodic polarization is given in Figure 3.5.

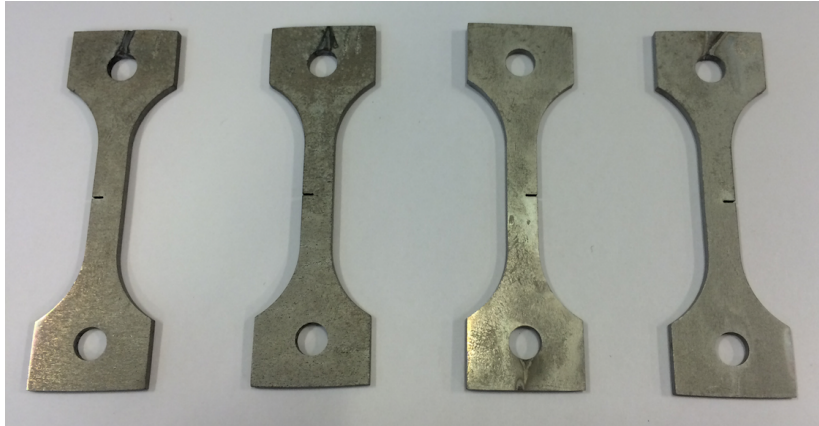
Figure 3.7: Image showing hydrogen pre-charged samples.

A selection of samples was hydrogen pre-charged prior to tensile testing. Precharging was performed to promote hydrogen uptake into the materials, which also can simulate the effect of CP after several years in service. The samples were submerged in a beaker filled with a 3.5 % NaCl solution and cathodically charged under potentiostatic conditions with an applied potential of $-1093 \text{ mV}_{\text{SCE}}$. A platinum wire was used as a counter electrode, and applied potential was supplied by a Bank ElektronikTM potentiostat and measured against a SCE. An image of the experimental setup is given in Figure 3.6. The temperature was kept at $80 \text{ }^\circ\text{C}$ in order to increase the hydrogen diffusion rate, and precharging was conducted over six days to ensure adequate hydrogen uptake. The samples were stored in a freezer until testing to avoid hydrogen outgassing. Figure 3.7 shows an image of hydrogen pre-charged samples.

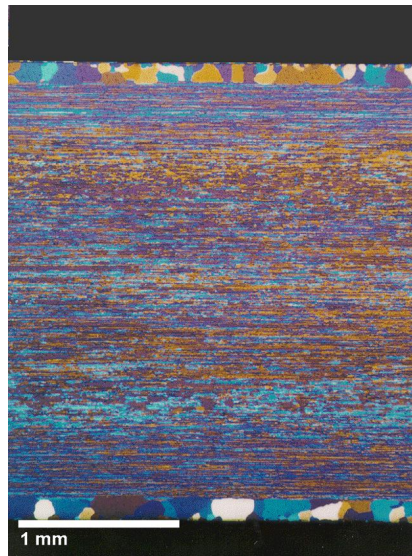
Figure 4.3: Optical micrographs showing (a) the microstructure of the AA 7108.50 base material, 7108B, perpendicular to direction of extrusion, and (b) the microstructure of a welded profile of EN AW 5083 H321, 5083BW, parallel to the direction of extrusion [72, 73].

Optical micrographs showing the microstructures of 7108B and 5083BW are presented in Figure 4.3. The microstructure of 7108B from Figure 4.3a is characterized by a fibrous bulk structure and with thin layers of recrystallized grains close to the extruded surfaces. From the micrograph of 5083BW in Figure 4.3b, it is difficult to define the microstructure since the image is taken parallel to the direction of extrusion. Nevertheless, the fusion zone consists of somewhat larger grains than the heat affected zone (HAZ).

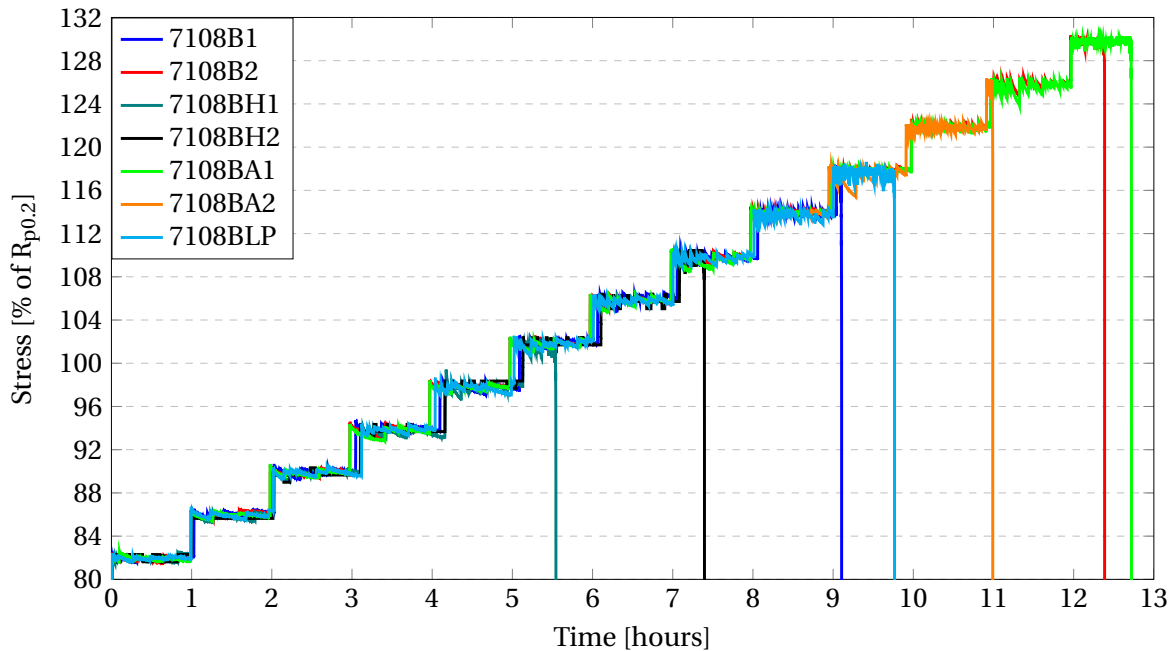
Figure 4.11: Plot showing tensile test results from the AA 7108.50 base material, 7108B, for not pre-charged samples (7108B1-2), hydrogen pre-charged samples (7108BH1-2), reference samples (7108BA1-2) and for the not pre-charged 7108BLP sample tested at $-1500 \text{ mV}_{\text{SCE}}$. Initial applied load was 82 % of $R_{p0.2}$.
