TMR4900 - Master Thesis

Analysis of the Big Orange XVIII and Ekofisk 2/4W collision in 2009

Erik Paulsen

Trondheim, 09.06.2011

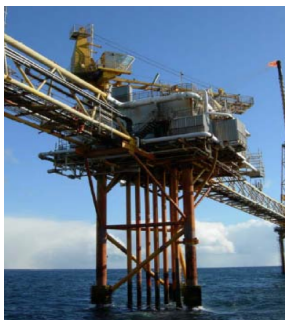
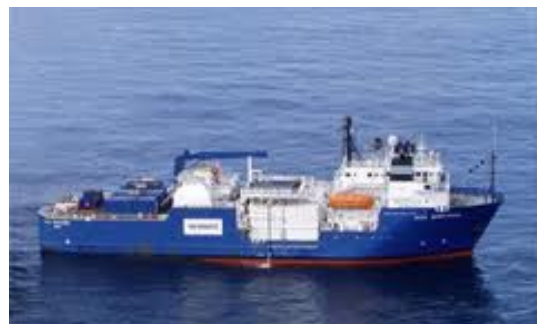
The platform Ekofisk 2/4-W was an unmanned water injection facility on the Ekofisk field, operated by Conoco Phillips. It was a three legged jacket structure, and was installed in 1972. It was mainly constructed as a bridge support, but was converted in 1989 when a water injection module was installed. As a part of the conversion, additional structural members were installed and other improvements done.

Figure 1.1: Ekofisk 2/4W and Big Orange XVIII

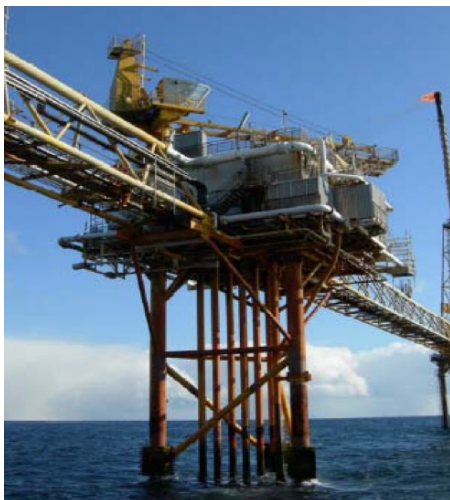
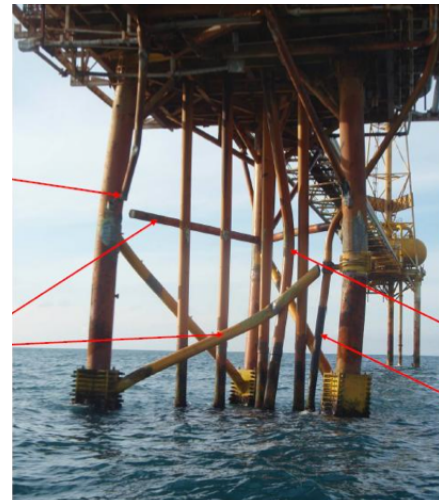
The Ekofisk installation was partly pushed out of position after the collision with BOXVIII, due to plastic damages to the structure. The maximum displacement under the collision was reported to be approximately two meters [Gjerstad, 2011]. Several braces were torn loose from the main load-bearing structure. The water injection riser for well W05 was severely bent, and some wellheads were dislocated. The conductors in the centre of 2/4W were dented.

Figure 2.2: Undamaged and damaged north face of Ekofisk 2/4W

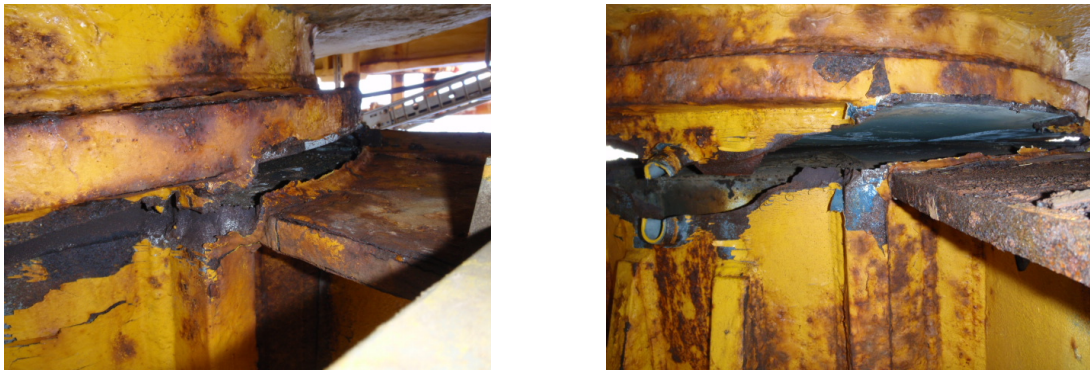
A local buckling was located on the southern leg near the cross-over to the pile. Cracks were discovered between the northwest and the northeast legs and the deck. The crack on the northwest leg near the topside was approximately half of the circumference. The crack on the northeast leg was approximately two thirds of the circumference. There were also some subsea damages to braces at levels $-2.5m$ and $-15m$ beneath the sea surface.

Figure 2.3: Crack in connections between leg and topside

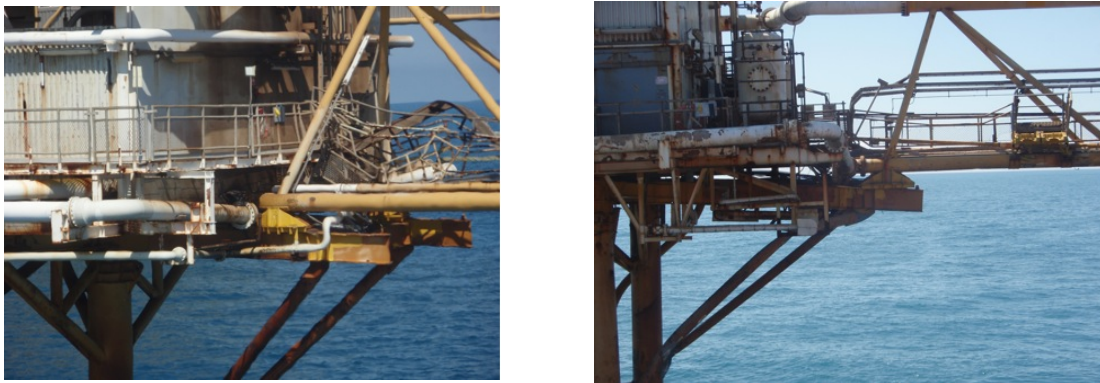
The bridge on the south side of 2/4W going to the south flare, illustrated in figure 2.4, was pushed into the topside and bearing structure. This caused damage to the bridge itself as well as to the bridge landing system.

Figure 2.4: Bridge landing. Left: south. Right: north

The north bridge landing, which connected the bridge with the rest of the Ekofisk structure, got some structural damage at the mid span under the collision. This was mainly due to interaction with the superstructure of BOXVIII.

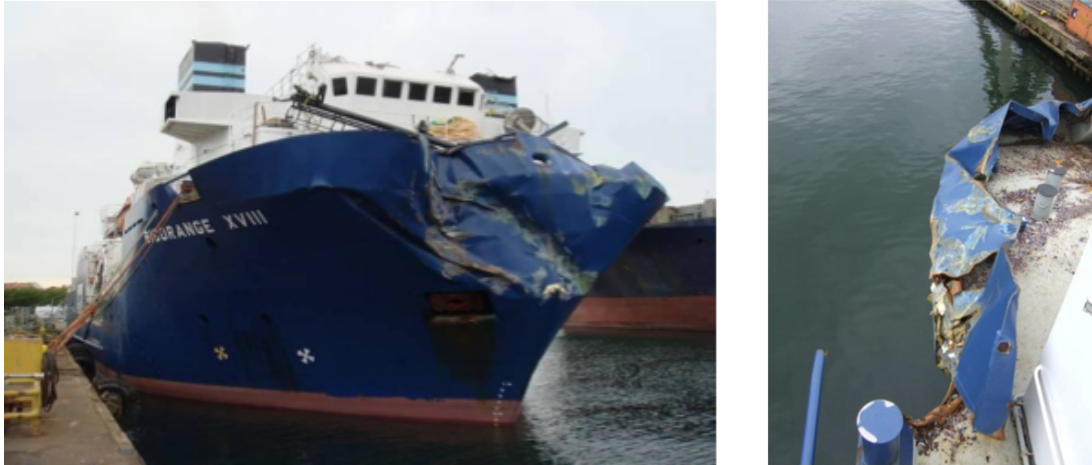
The bow of BOXVIII was pushed in approximately three meters when it collided with the north face of 2/4W. The equipment on the vessel which interacted with the north bridge was torn off under the collision. This made the vessel in-operational.

Figure 2.6: The damaged bow of Big Orange

In figure 2.6 and 2.7, marks of the jacket structure can be seen. The vessel collided with two of the jacket main legs. At starboard side in the connection point with the northwest leg and two of the jacket braces, and the northeast jacket leg at port side.

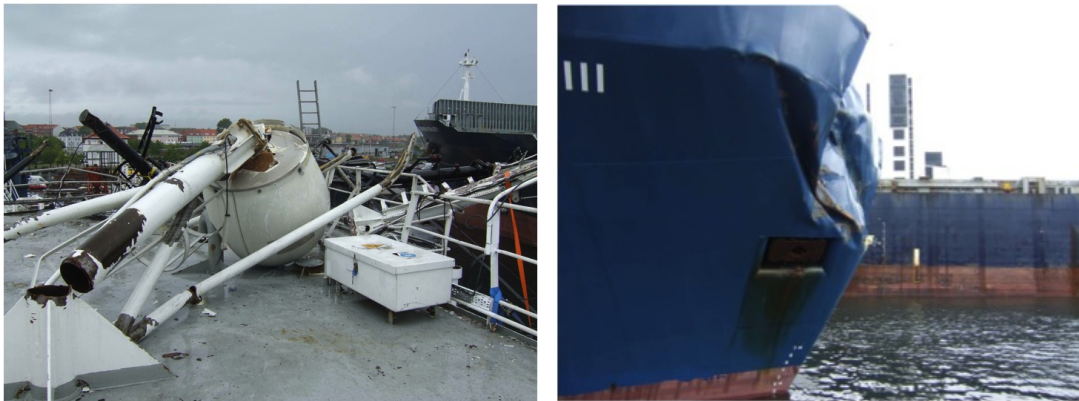
Figure 2.7: Left: Vessel equipment torn off. Right: Bow pushed in, from side

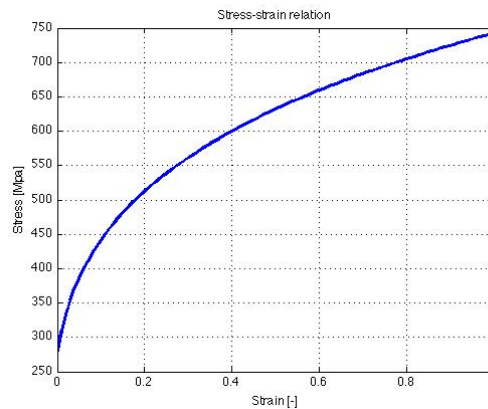
$$\varepsilon_o = \left(\frac{\sigma_Y}{K}\right)^{\frac{1}{n}} - \varepsilon_{plat} \quad (4.2)$$

Figure 4.9: Plastic stress-strain relations

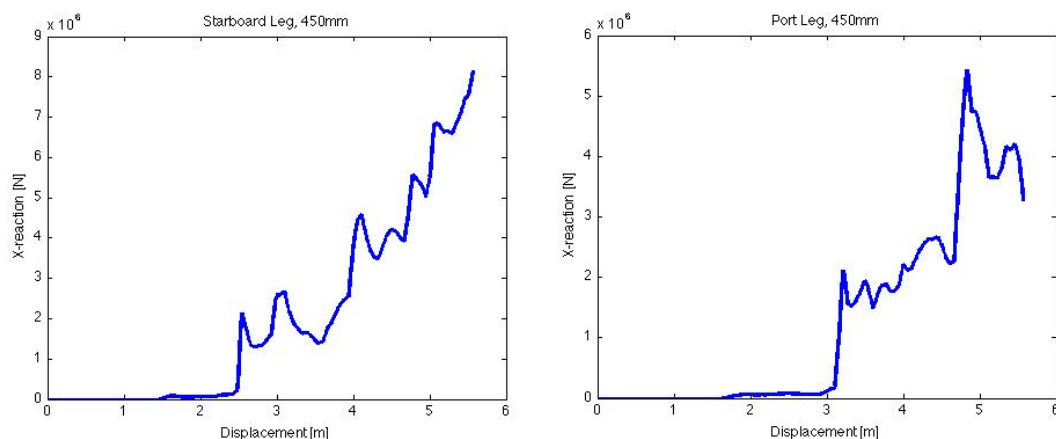
The ship hull plating on the starboard side had started to fold under the compression force from the northwest jacket leg. The diagonal brace left a mark in the BOXVIII bow which was similar to the document damage from the collision. The mark after the northeast leg at the port side of the vessel was also consistent with the reported damage. The load-deformation values from LS-DYNA were post-processed in Matlab to calculate the dissipated energy. The load-deformation curves from Matlab are given in figure 5.2. The Matlab code is given in appendix C.

Figure 5.2: Load-deformation curves from Matlab with 450mm mesh size. Left: Starboard leg. Right: Port leg

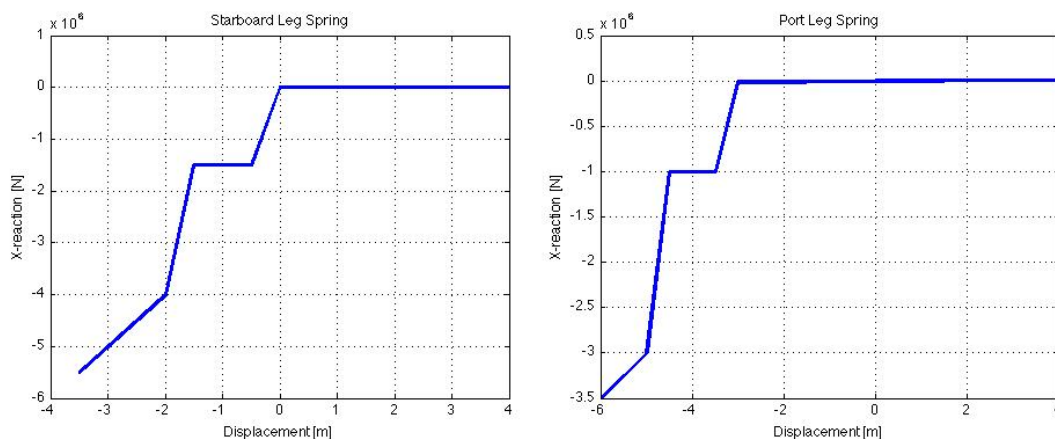
The load-deformation curves were to be used in USFOS as non-linear springs. The curves were based on the curves in figure 5.6, but were simplified with fewer points. The signs on the reaction force were reversed to comply with the input preference for USFOS. The zero displacement-point was moved to the point where first contact was made, i.e when the jacket structure collided with the bow.

Figure 5.7: Load-deformation curves implemented in USFOS

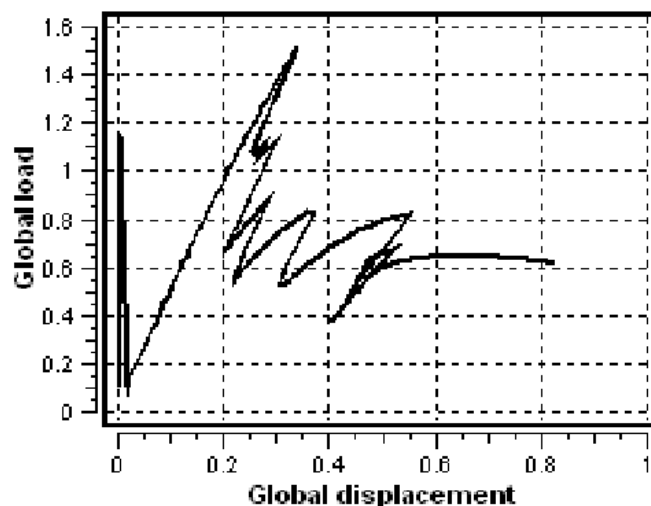
The first pushover analysis had north propagating waves. This was opposite of the collision direction which was from north. The load-displacement curve for the pushover analysis can be seen in the figure 6.1.

Figure 6.1: Load-displacement, pushover analysis in undamaged condition, north bound waves

failed. This stepwise increase and drop in the load level as braces fails is illustrated in figure 6.1. This is a typically load-displacement characteristic for this type of structure [Amdahl and Skallerud, 2002]. The structural response is illustrated in figure 6.2. The fringe range illustrates plastic utilization.

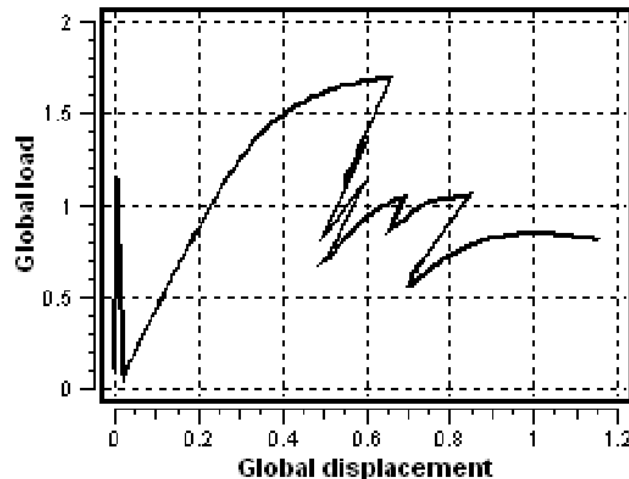
The load-displacement curve is illustrated in figure 6.3. The curve showed the same characteristics as the first pushover analysis, with repeating increases and drops in the load level. Both the load level and the global displacements before first load drop were somewhat higher than for the first pushover analysis.

Figure 6.3: Load- displacement, pushover analysis in undamaged condition, south bound waves

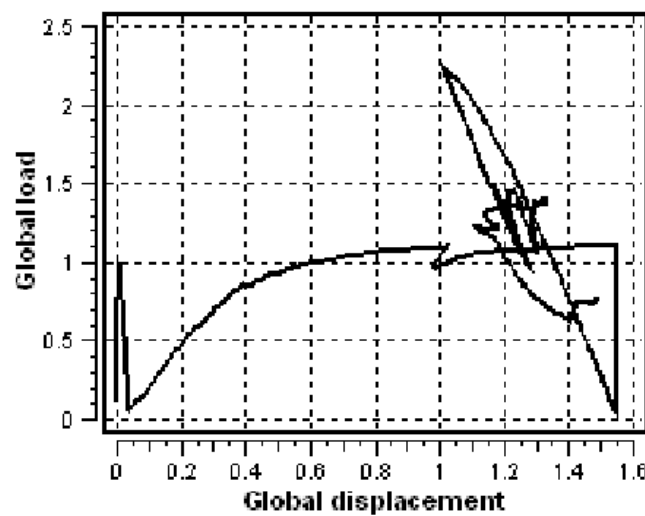
Figure 6.17: Force-displacement curve for pushover analysis in damaged condition. North bound waves

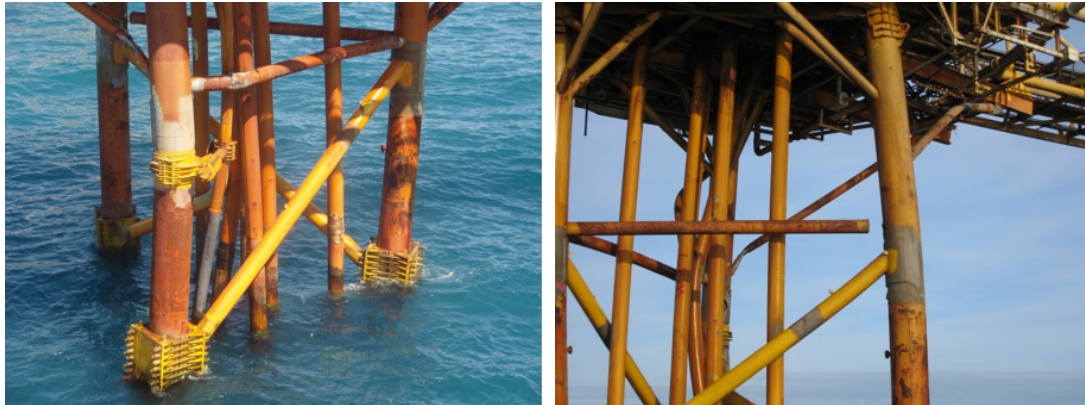
Figure 7.6: Comparison, braces above water

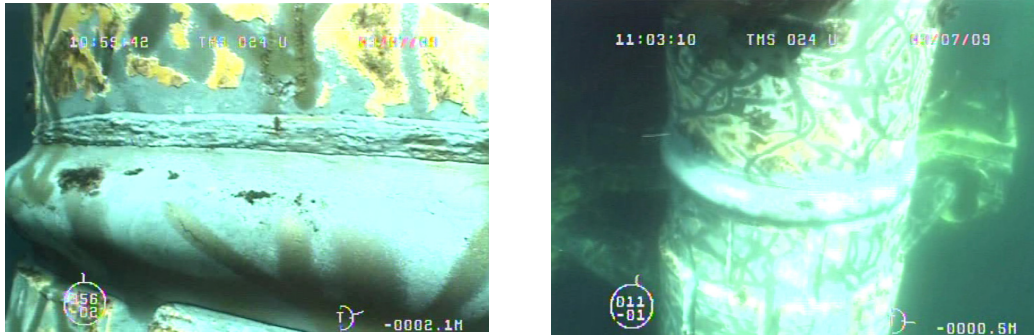
Figure 7.9: Buckling of splice joint at -2m
