Norwegian University of
Science and Technology

Wear of Carbon Refractory Materials in Silicon Furnaces

Materials Technology

Submission date: June 2016

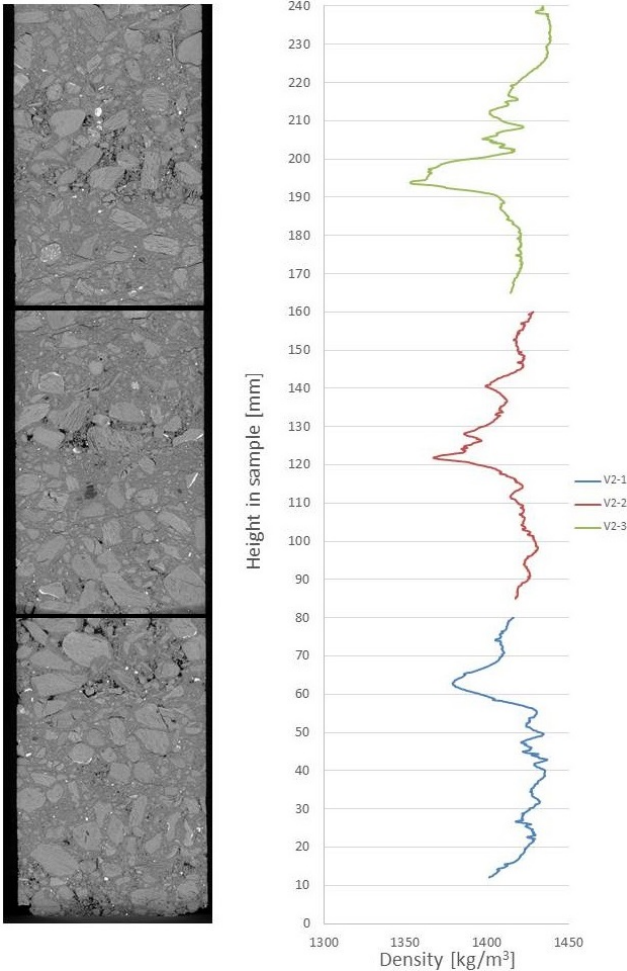
Figure 2.10: Orthogonal view of layered sample V2 in X-Z direction, and the average cross section density as a function of height.

CT investigations of the interior of each sample type showed that the preparation technique had influenced the internal morphology of the lining. By processing the images using the image processing program ImageJ, it was possible to obtain orthogonal views of the samples in X-Z and Y-Z direction. These images showed that while the samples prepared in the Fischer-Sandrammer had uniform density in height direction, the layered samples showed clear density variations depending on position relative to the ramming layers. This was confirmed by using ImageJ to calculate the average density of each cross section of the sample, and plotting the density as a function of height in the sample. Figure 2.10 shows the orthogonal view of a layered sample in X-Z direction on the left hand side, and the average cross section density as a function of height on the right.

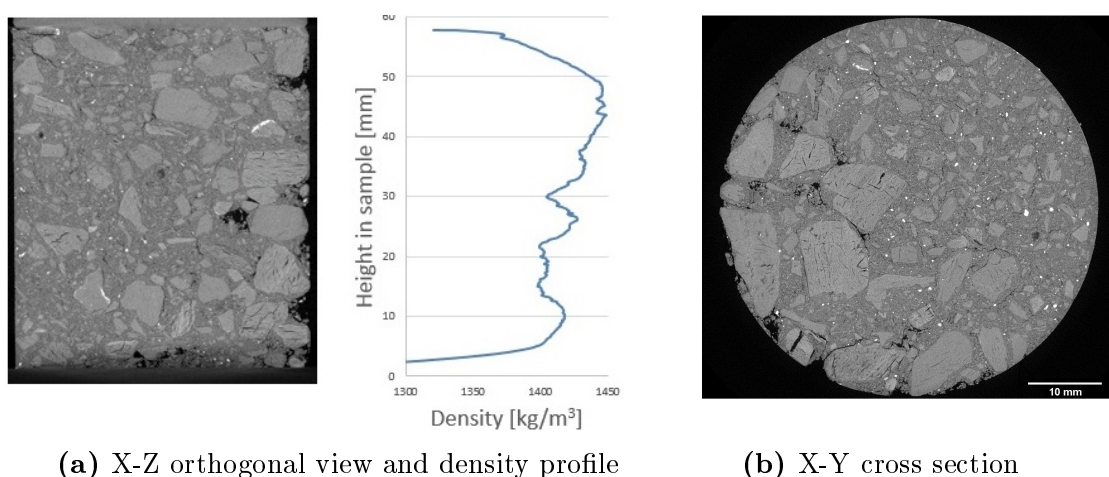
Figure 2.11: X-Z orthogonal view, average cross section densities and a X-Y cross section for solid sample FS1.

Figure 2.11 shows results obtained from CT scans of one of the solid, standard Fischer-Sandrammer samples. The left hand side of figure 2.11a shows the orthogonal view in the X-Z direction of sample FS1. The average density for each cross section was obtained using ImageJ, and the average density as a function of height is given in the right hand side of figure 2.11a. Inspection of these samples showed a much more even density distribution in across the height (Z-direction), but differences across the X-Y cross section. The porosity in one half of the sample proved to be larger than for the other half, which can be seen in figure 2.11b. This was assumed to be caused by segregation occurring as the paste was moved into the cylinders for sample preparation.

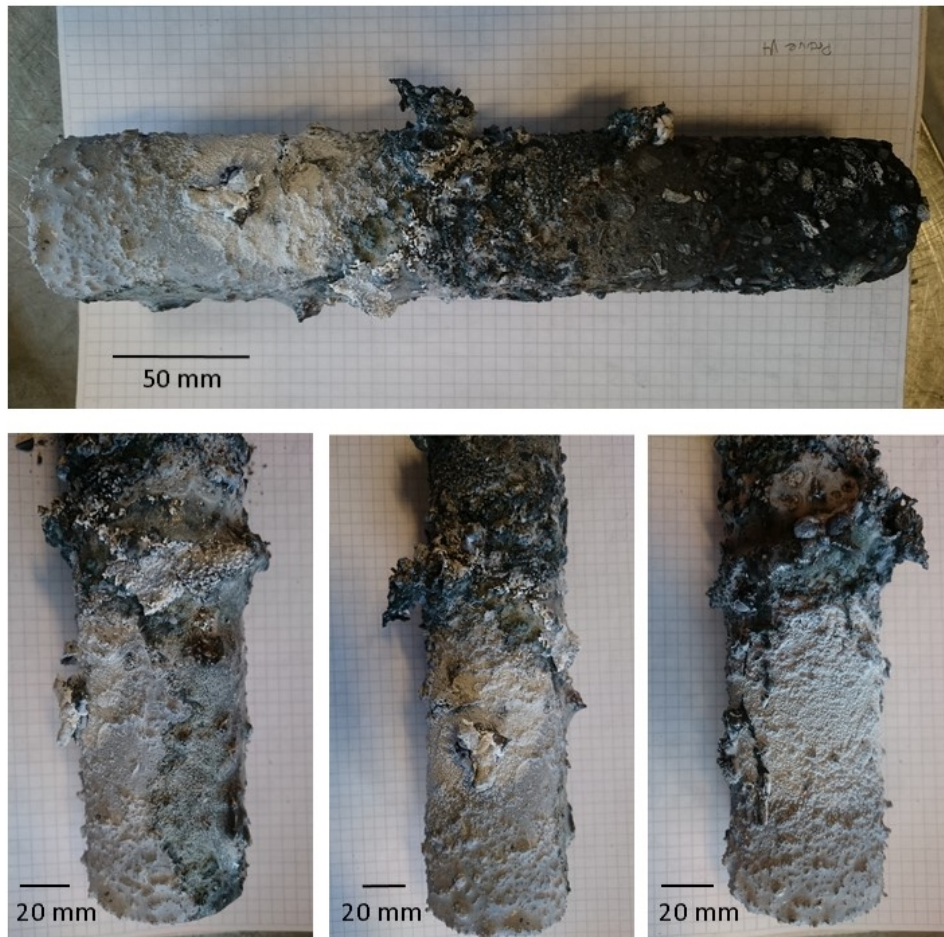
Figure 4.24: Visual inspection of sample V4 in different views, after exposure to silicon and slag in the induction furnace.
