Thermal Sprayed Aluminium for Subsea Heat Exchanger Surfaces

Effect of Temperature on Protection Current
Requirement and Calcareous Development

Subsea Technology

**MASTER THESIS SPRING 2014
FOR
STUD. TECHN. HÅVARD WILSON**

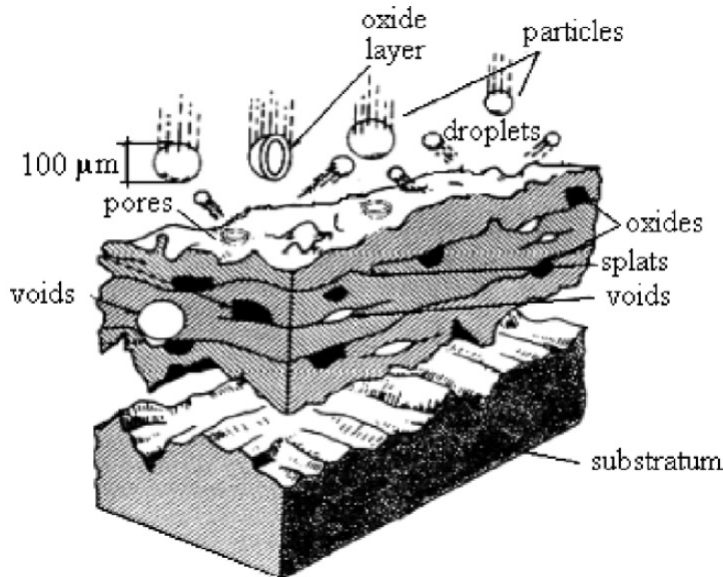
Figure 2.2: Schematic presentation of a thermally sprayed coating [3].

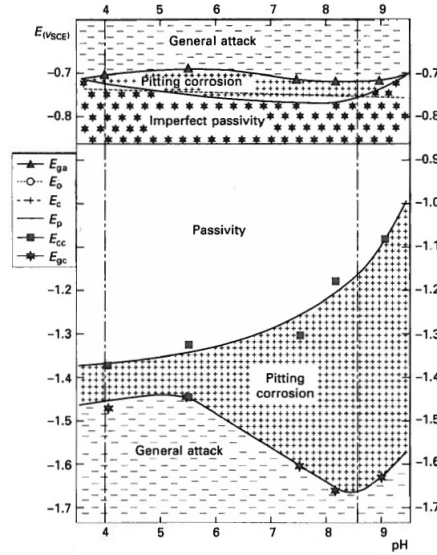
Figure 2.4: Experimental pourbaix diagram [30].

As can be seen in Figure 2.4, the aluminium alloy is passive in a much larger pH-range than the theoretical Pourbaix diagram indicates. This means that aluminium may

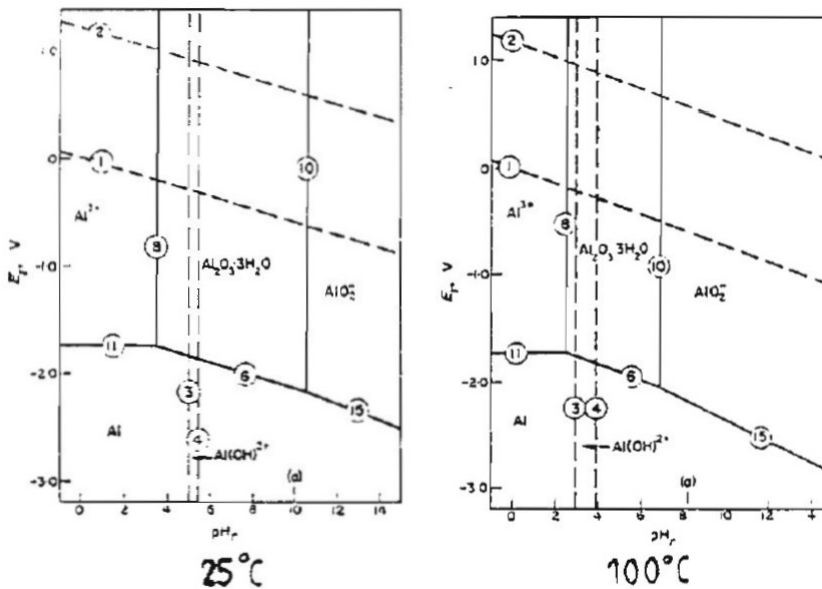
Figure 2.7: Theoretical Pourbaix diagram for Aluminium-water interaction at 25 and 100 °C. Adapted from [4].

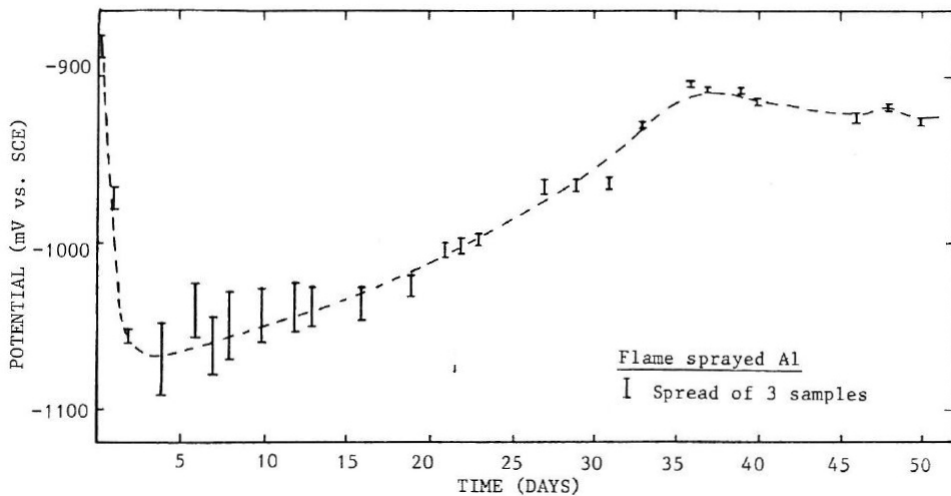
Figure 2.8: Corrosion potential of flame sprayed aluminium in seawater as a function of time [39].

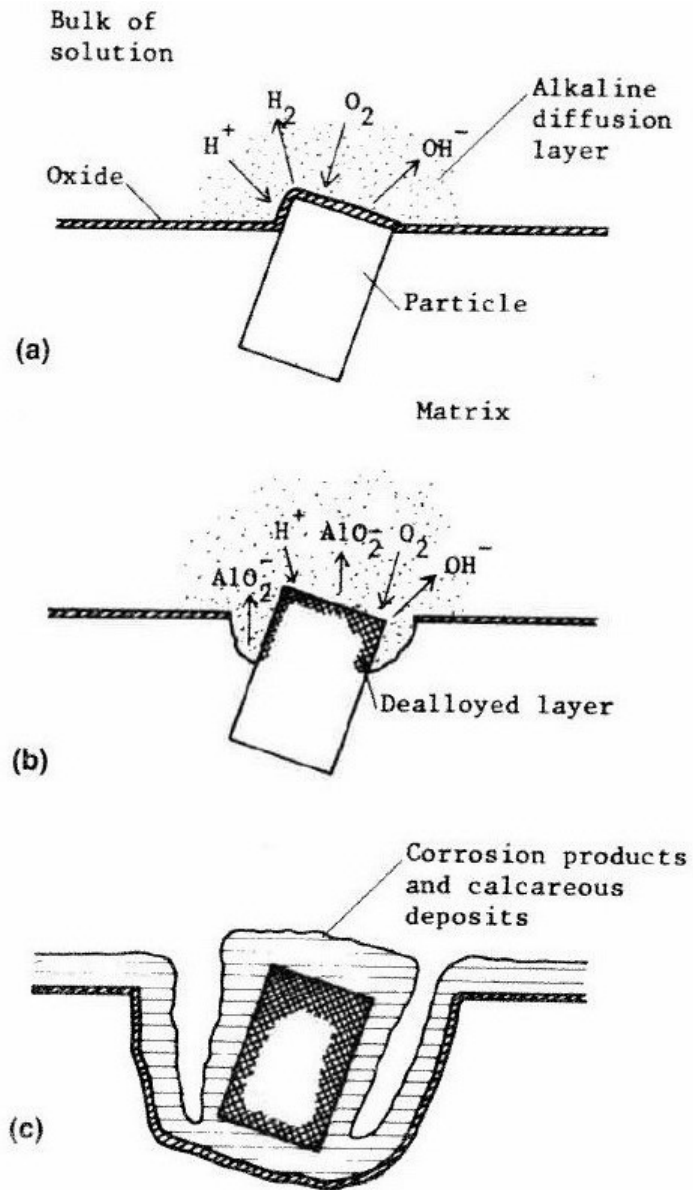
Figure 2.11: Cathodic protection mechanism for Aluminium [47].

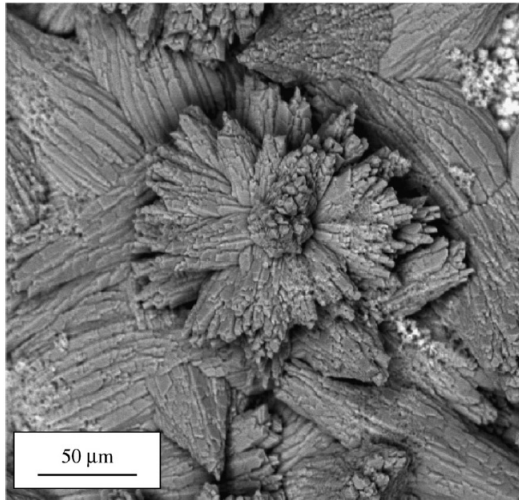
Figure 2.12: Photo of the Argonite structure for $CaCO_3$ formed on steel under CP [57].

The different types of calcareous deposits have different microstructures. $CaCO_3$ typically form as one of two microstructures when precipitating during CP, Argonite and Calcite. Figure 2.12 shows a SEM photo of the typical Argonite structure, while Figure 2.13 show the Calcite structure [57].

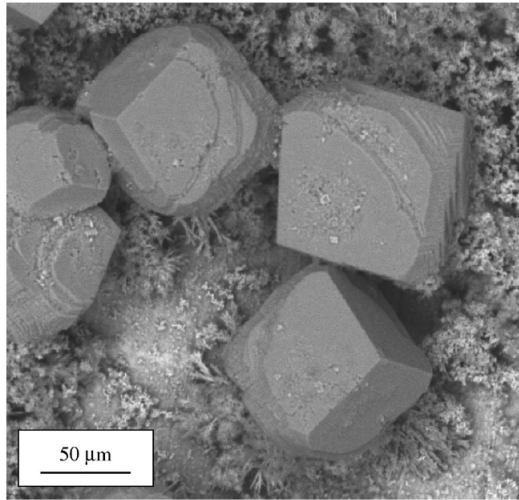
Figure 2.13: Photo of the Calcite structure for $CaCO_3$ formed on steel under CP [57].

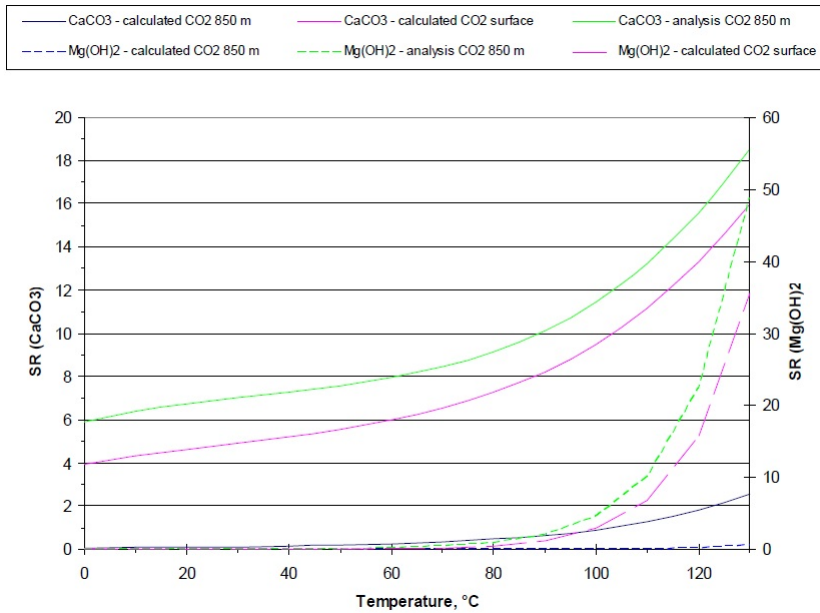
Figure 2.15: The effect of temperature on the saturation ratio for $Mg(OH)_2$ and $CaCO_3$ at surface conditions and at 850m sea depth [60].

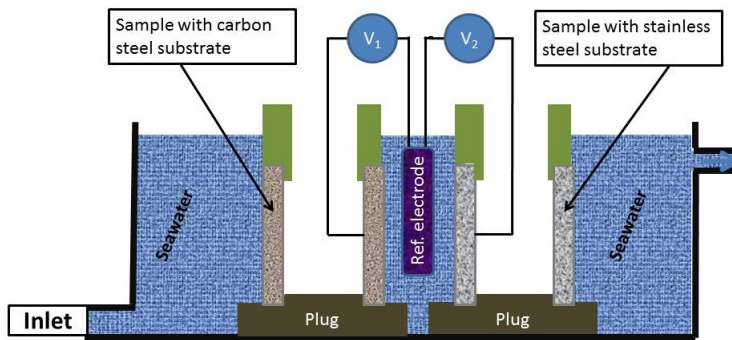
Figure 4.1: Experimental design for second experiment with no internal heating.

V1 measured the corrosion potential of the TSA on carbon steel substrate, while V2 measured the corrosion potential of the TSA on the 254 SMO stainless steel substrate. No heating was applied to this experiment, meaning that the seawater temperatures was approximately 8 °C.

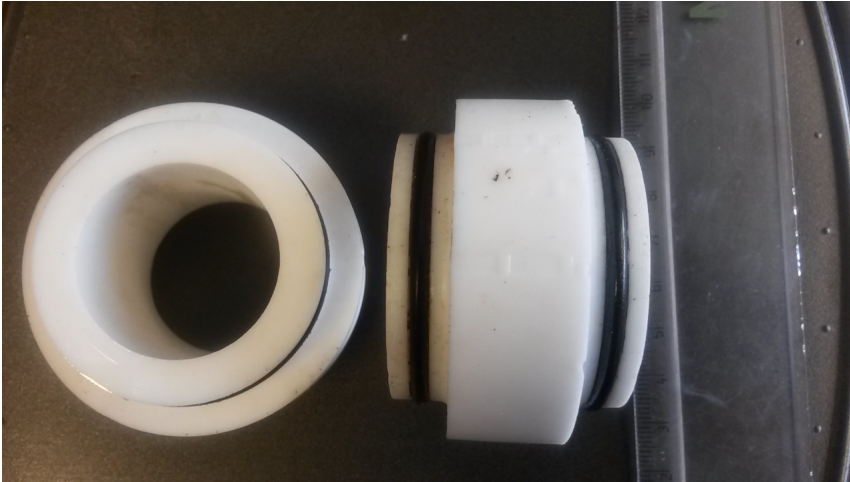
Figure 4.2: Isolation piece with O-ring gaskets.

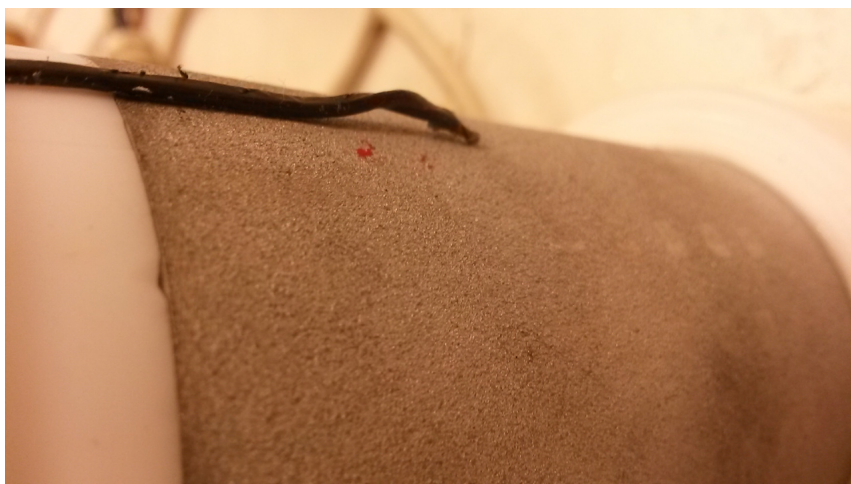
Figure 4.4: Mounting of Thermocouple on TSA surface before applying glue.

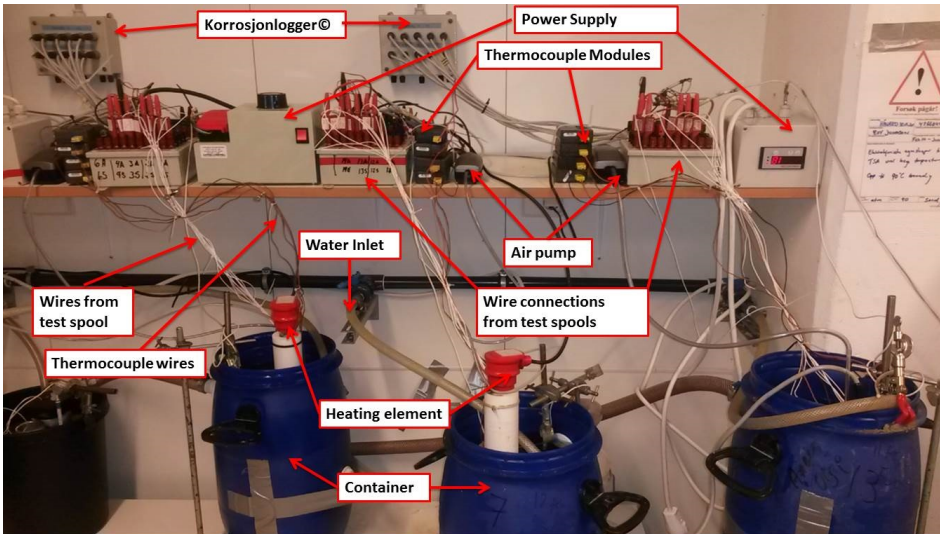
Figure 4.5: Photo taken of the experimental setup for the high temperature experiments at SINTEF Sealab Brattørkaia.

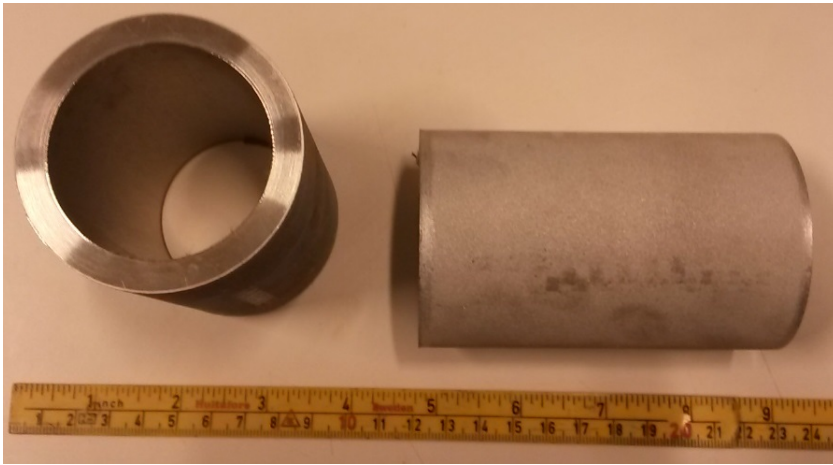
Figure 4.7: Picture of two typical test pieces used in this Thesis.

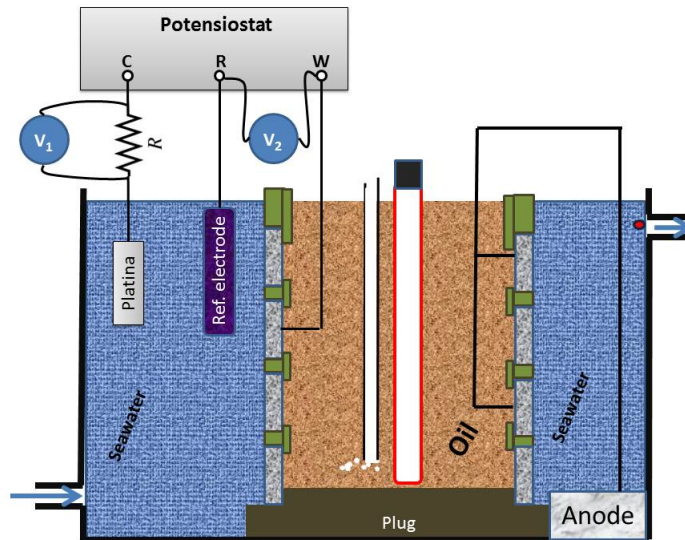
Figure 4.8: Schematic presentation of the test set-up for LPR and Polarization curves testing.

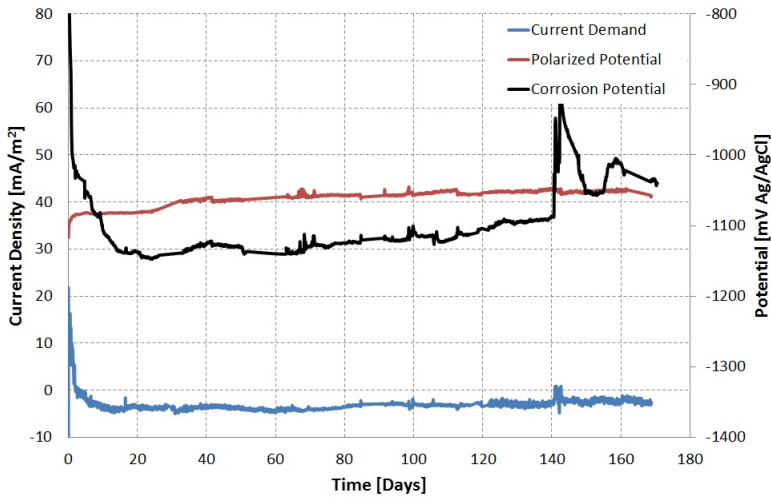
Figure 5.1: Current density, corrosion potential, and polarized potential development over time with no internal heating

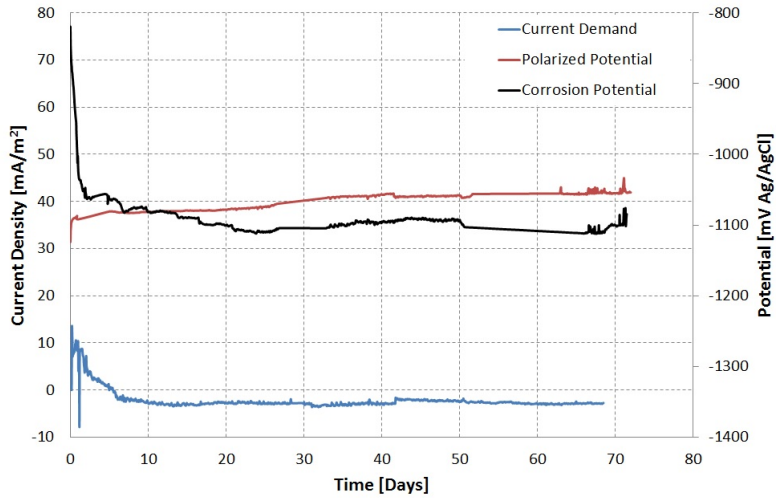
Figure 5.2: 30 °C Internal temperature. Current demand, polarized potential, and corrosion potential as a function of time.

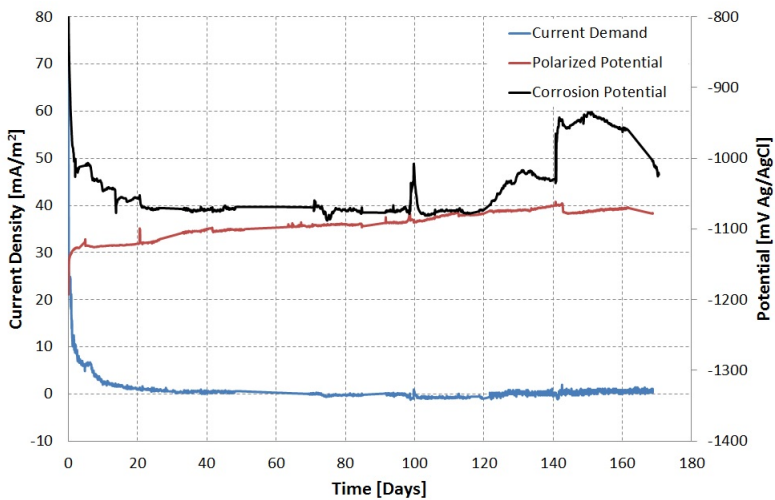
Figure 5.3: Current density and corrosion potential development over time with 40 °C Internal temperature

The spool with 40°C internal temperature had a more positive potential than the other spools with the lowest potential registered at -1078 mV vs Ag/AgCl. The corrosion potential was around -1070 mV Ag/AgCl from day 20 to day 120, which is the major part of the experiment.

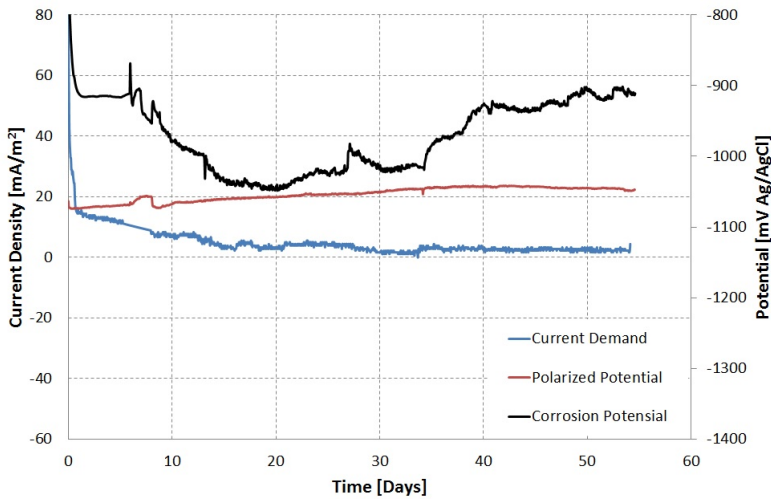
Figure 5.4: 50 °C Internal temperature. Current density, polarized potential and corrosion potential as a function of time.

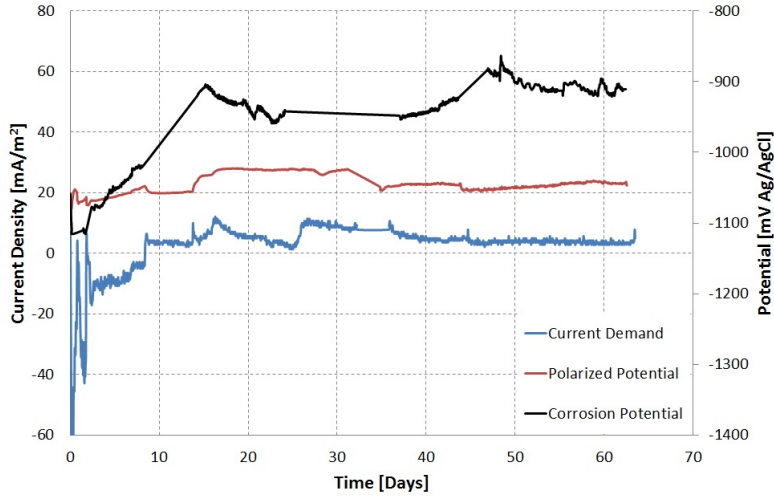
Figure 5.5: 70 °C Internal temperature. Current density, polarized potential and corrosion potential as a function of time.

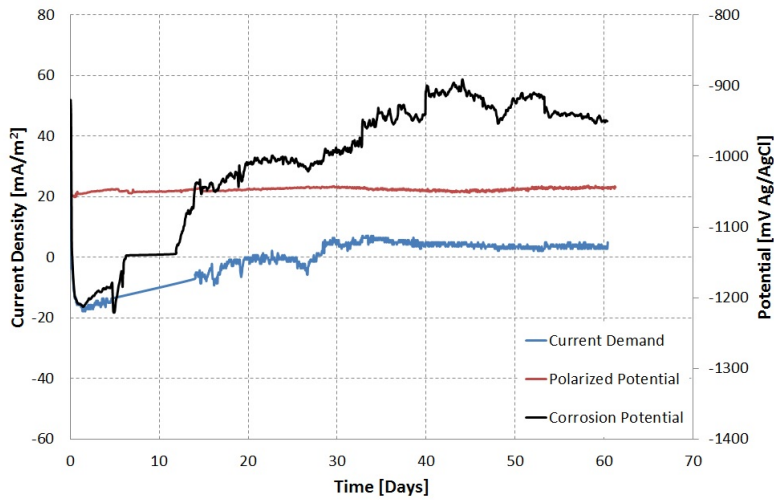
Figure 5.6: 90 °C Internal temperature. Current density, polarized potential and corrosion potential as a function of time.

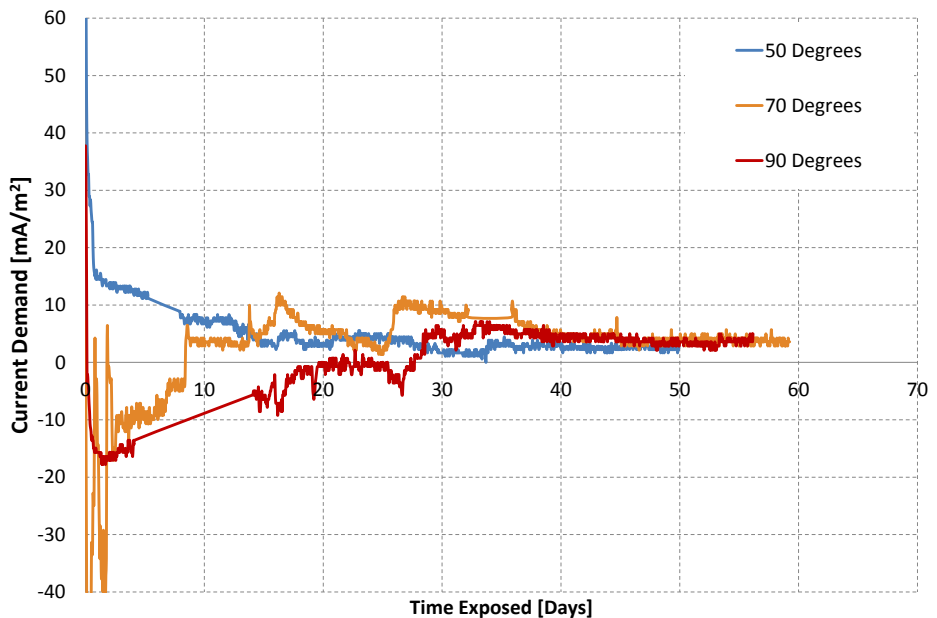
Figure 5.8: Current density demand development over time for TSA polarized connected to an anode with 50, 70 and 90 ° C internal temperature.

The current density for the spool with 90 ° C have a high negative current demand when the corrosion potential is lower than the polarized potential, and becomes higher than the 50 and 70 ° C when the corrosion potential stabilizes at a more positive potential than the polarized potential.

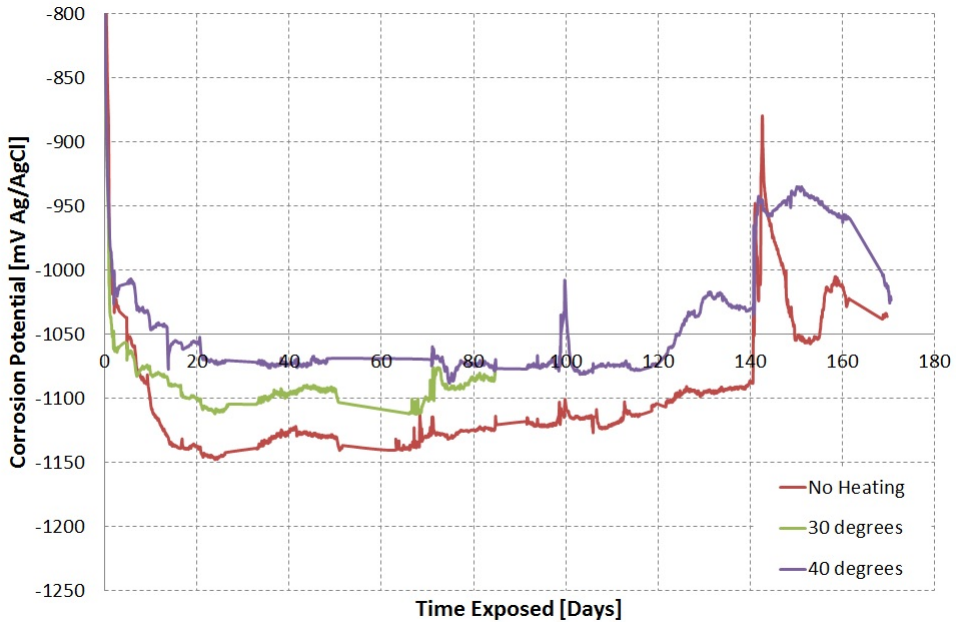
Figure 5.9: Development of corrosion potential of TSA exposed to seawater with no internal heating, and 30 and 40 ° C internal temperature.

Figure 5.9 shows the development of the corrosion potential for TSA at the three lowest temperature over time. The corrosion potential rapidly falls for all temperatures and stabilized between -1050 and -1150 mV Ag/AgCl. After 140 days the potential increases and is between -1020 and -1050 mV Ag/AgCl

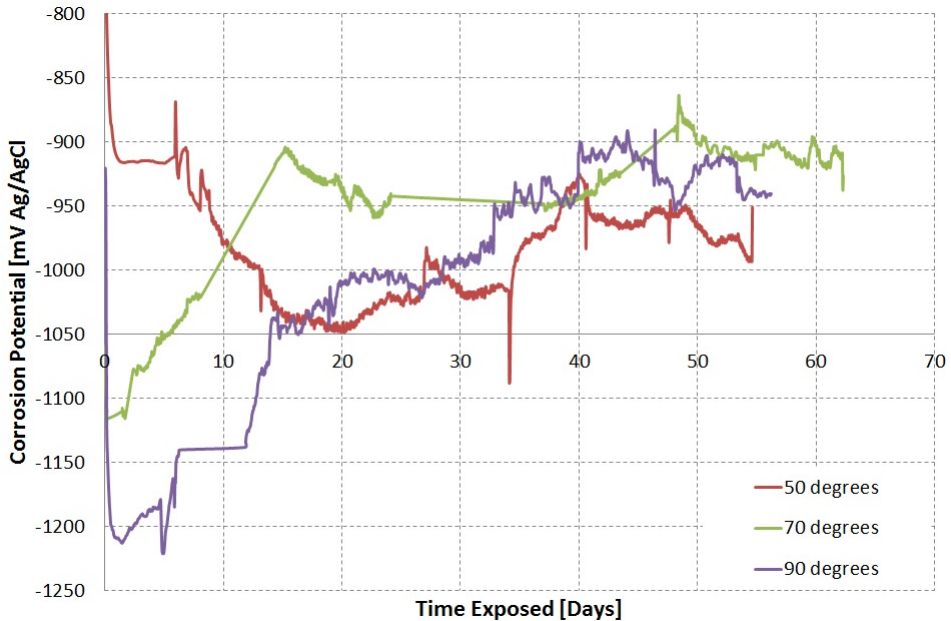
Figure 5.10: Development of corrosion potential of TSA exposed to seawater with 50, 70 and 90 °C internal temperature.

After approximately 40 days the corrosion potentials stabilizes at approximately -990, -910 and -940 mV Ag/AgCl for 50, 70 and 90 °C internal temperature respectively.

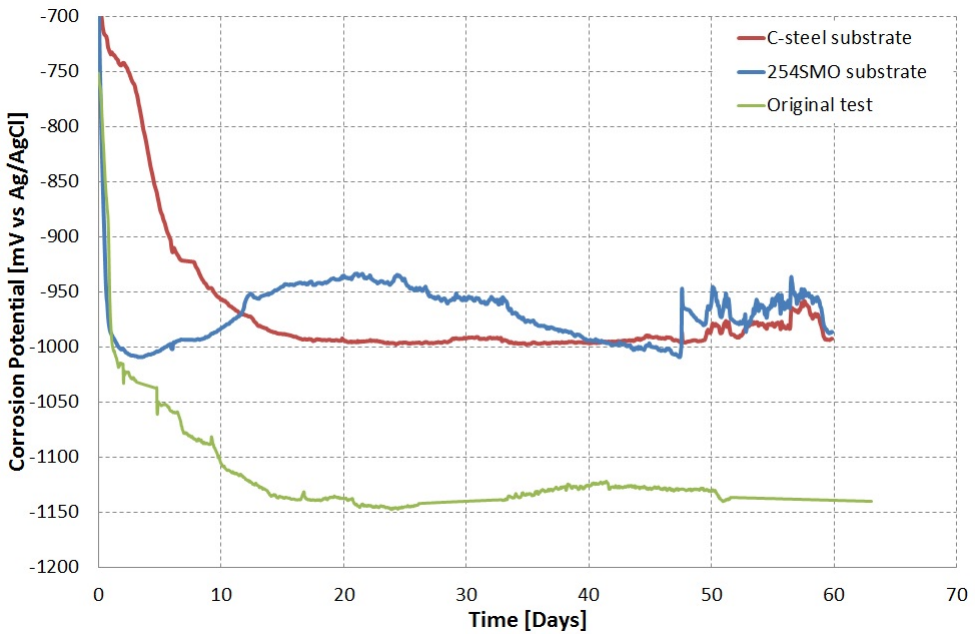
Figure 5.11: The development of corrosion potential over time for TSA on UNS S31245 stainless steel and X65 carbon steel without heating in seawater.

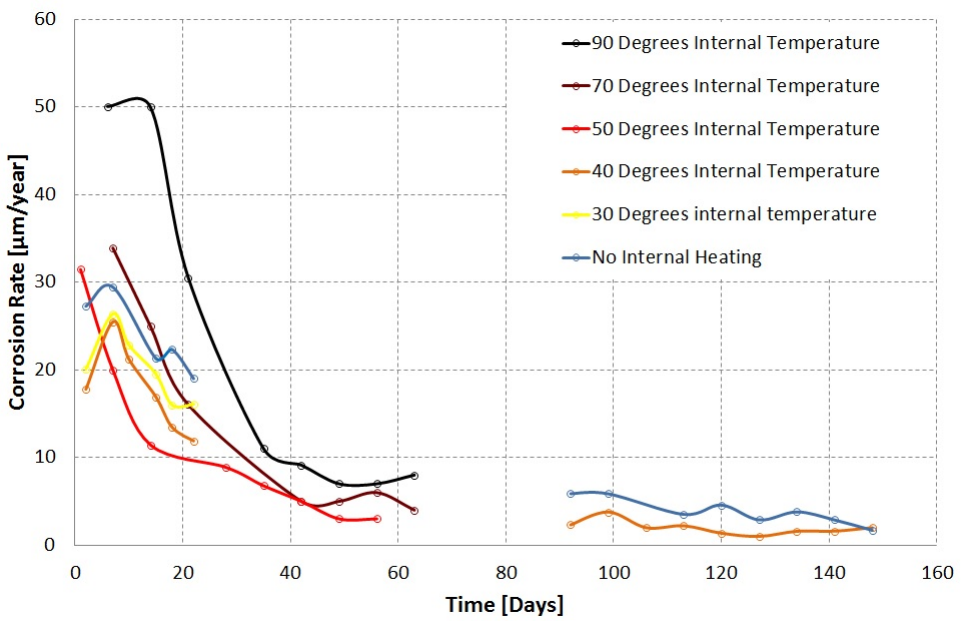
Figure 5.12: The development of corrosion rate as a function of exposure time.

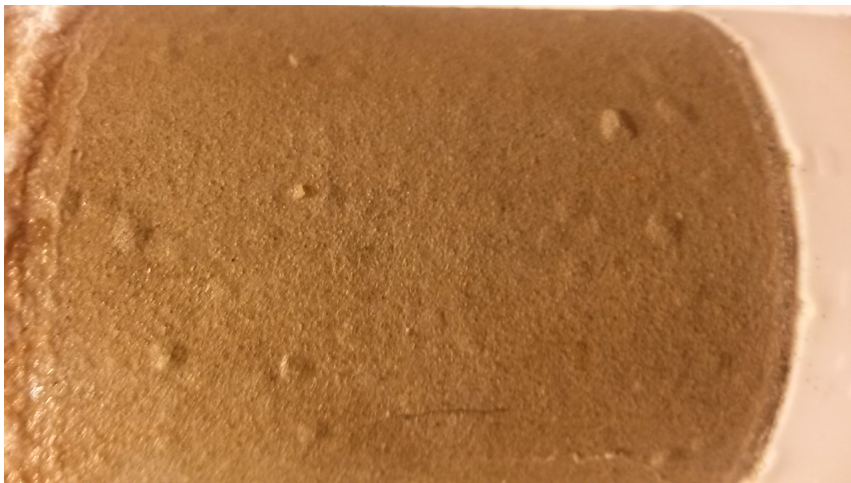
Figure 6.1: Photo of blisters in TSA exposed to seawater for 65 days with 90 ° C internal temperature.

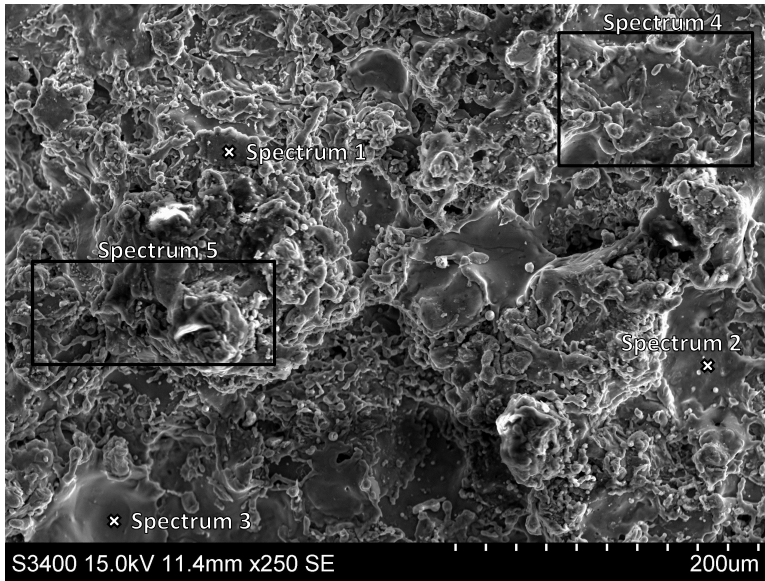
Figure 6.3: SEM photo of an unexposed TSA surface.

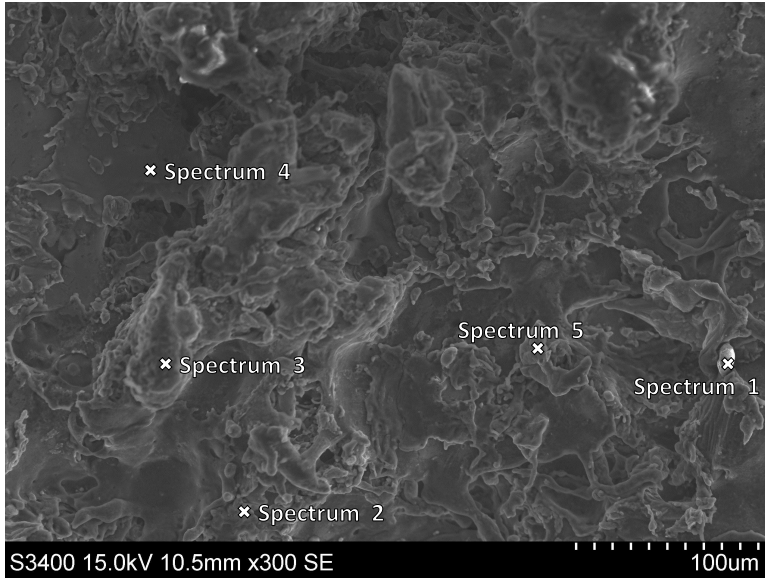
Figure 6.7: Sem photo of TSA surface freely corroding in seawater for 170 days with no internal heating.

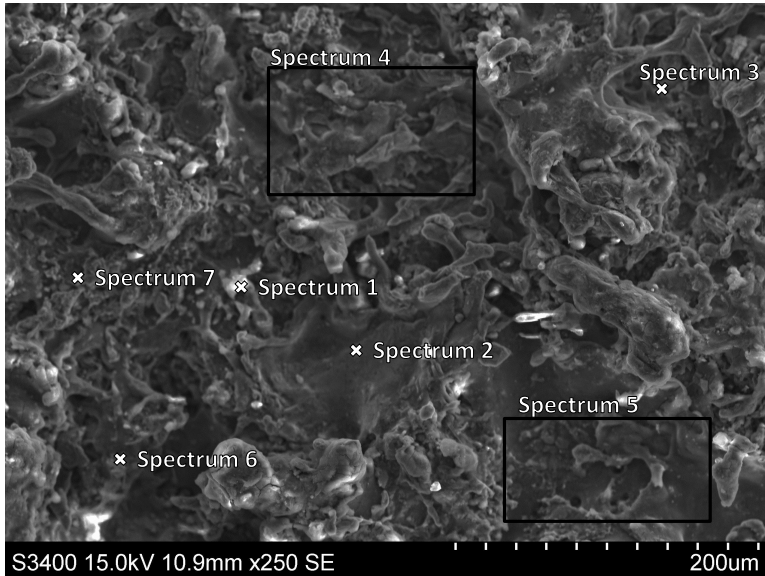
Figure 6.8: SEM photo TSA connected to an anode and exposed to seawater for 70 days with 30 °C internal temperature.

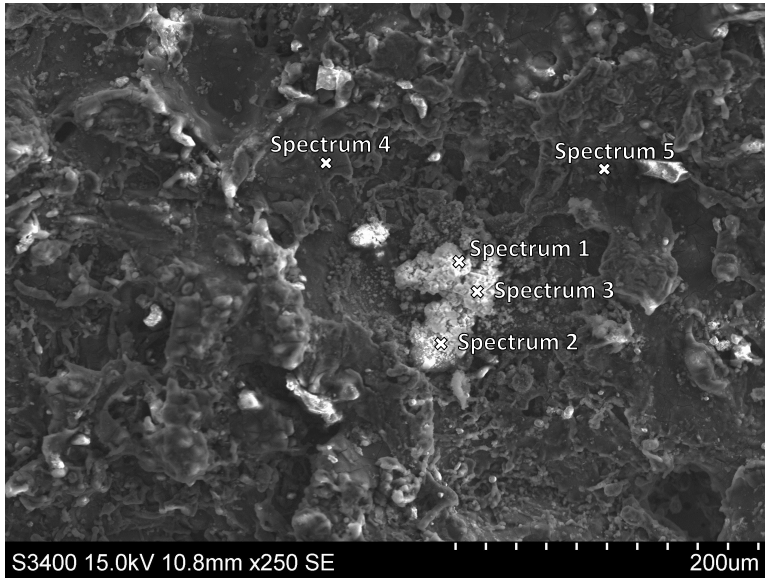
Figure 6.9: SEM photo over TSA freely corroding in seawater for 70 days with 30 ° internal temperature.

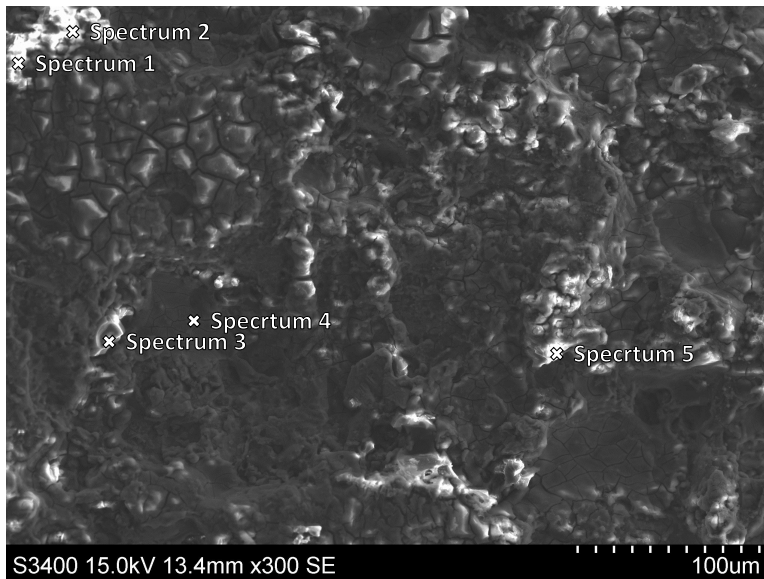
Figure 6.10: SEM photo of TSA freely corroding in seawater for 170 days with 40 °C internal temperature.

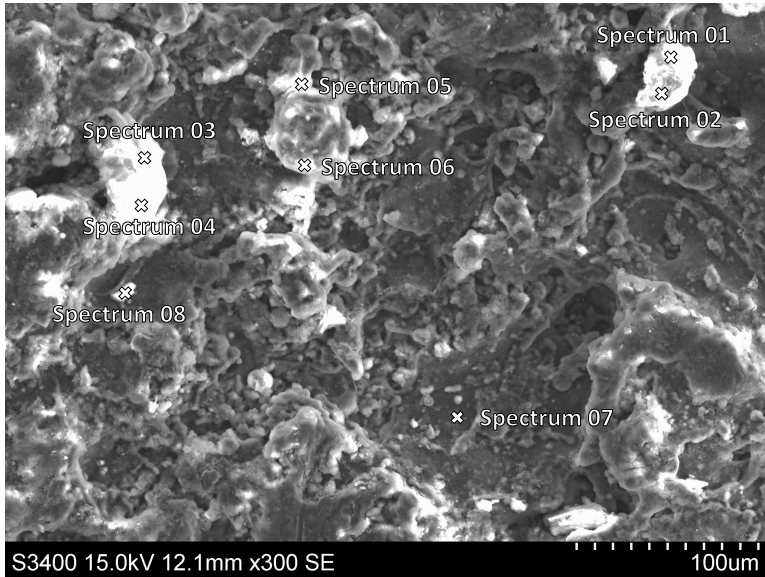
Figure 6.12: SEM photo of TSA surface freely corroding in seawater for 60 days with 50 °C internal temperature.

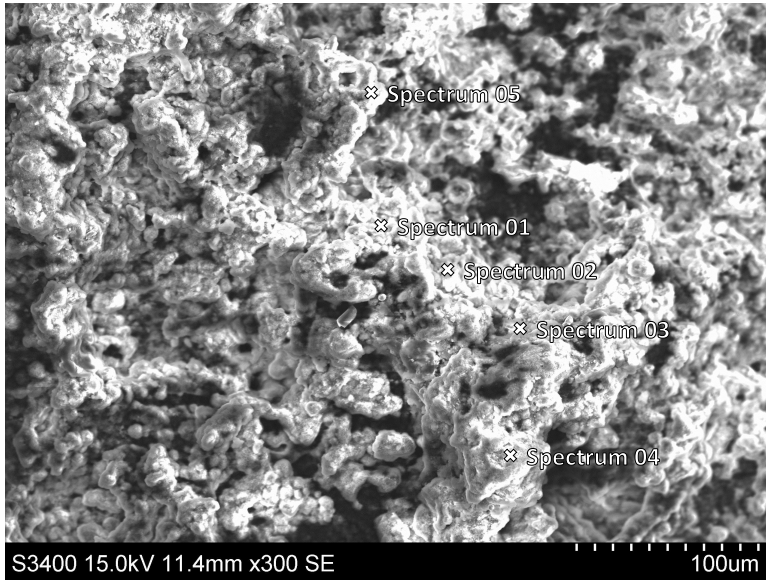
Figure 6.15: SEM photo of TSA freely corroding in seawater for 65 days with 70 °C internal temperature.

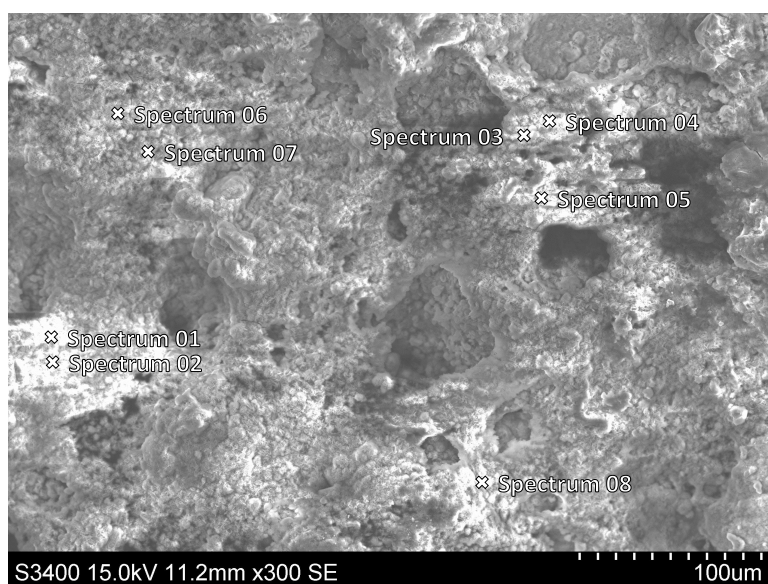
Figure 6.16: SEM photo of TSA that freely corroded in seawater for 65 days with 90 °C internal temperature.

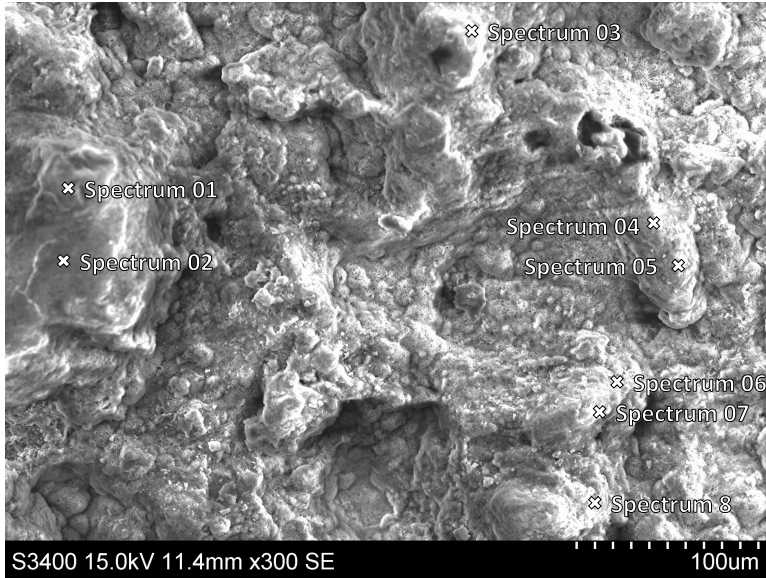
Figure 6.17: SEM photo of TSA connected to an anode and exposed to seawater for 65 days with 90 ° C internal temperature.

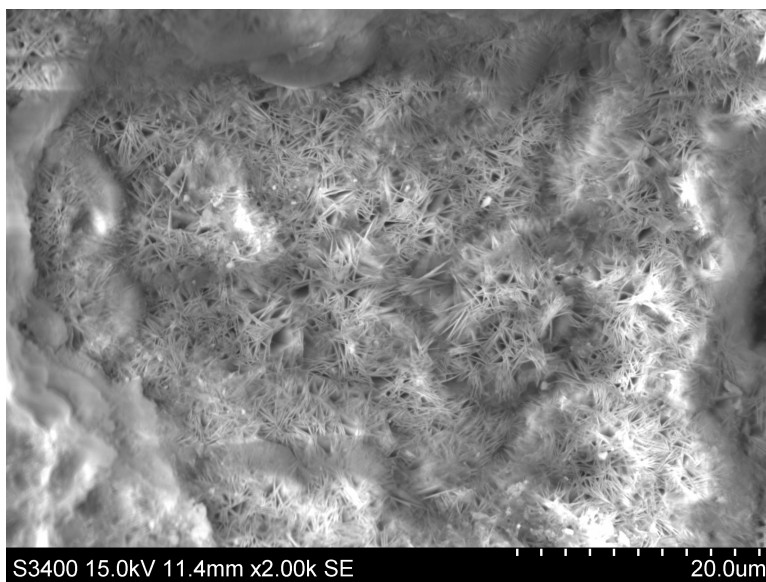
Figure 6.18: SEM photo of calcareous deposit microstructure of calcareous deposits on TSA connected to an anode and exposed to seawater for 65 days with 90 °C internal temperature.

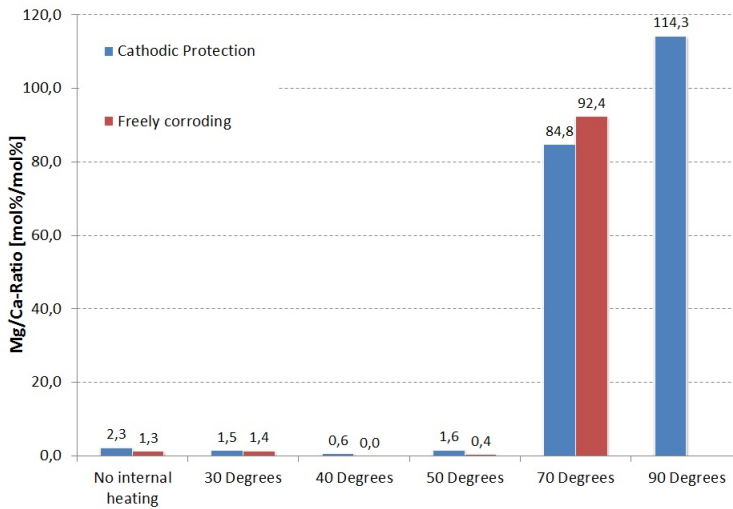
Figure 6.19: Graph presenting the ratio between Mg and Ca in the calcareous deposits on TSA exposed to seawater at different temperatures.
