# The Rock Slope Instability at Tytefjell in Vindafjord, Rogaland

Hazard Assessment for Different Failure  
Scenarios

**Øyvind Bertinussen Rem**

Submission date: May 2016

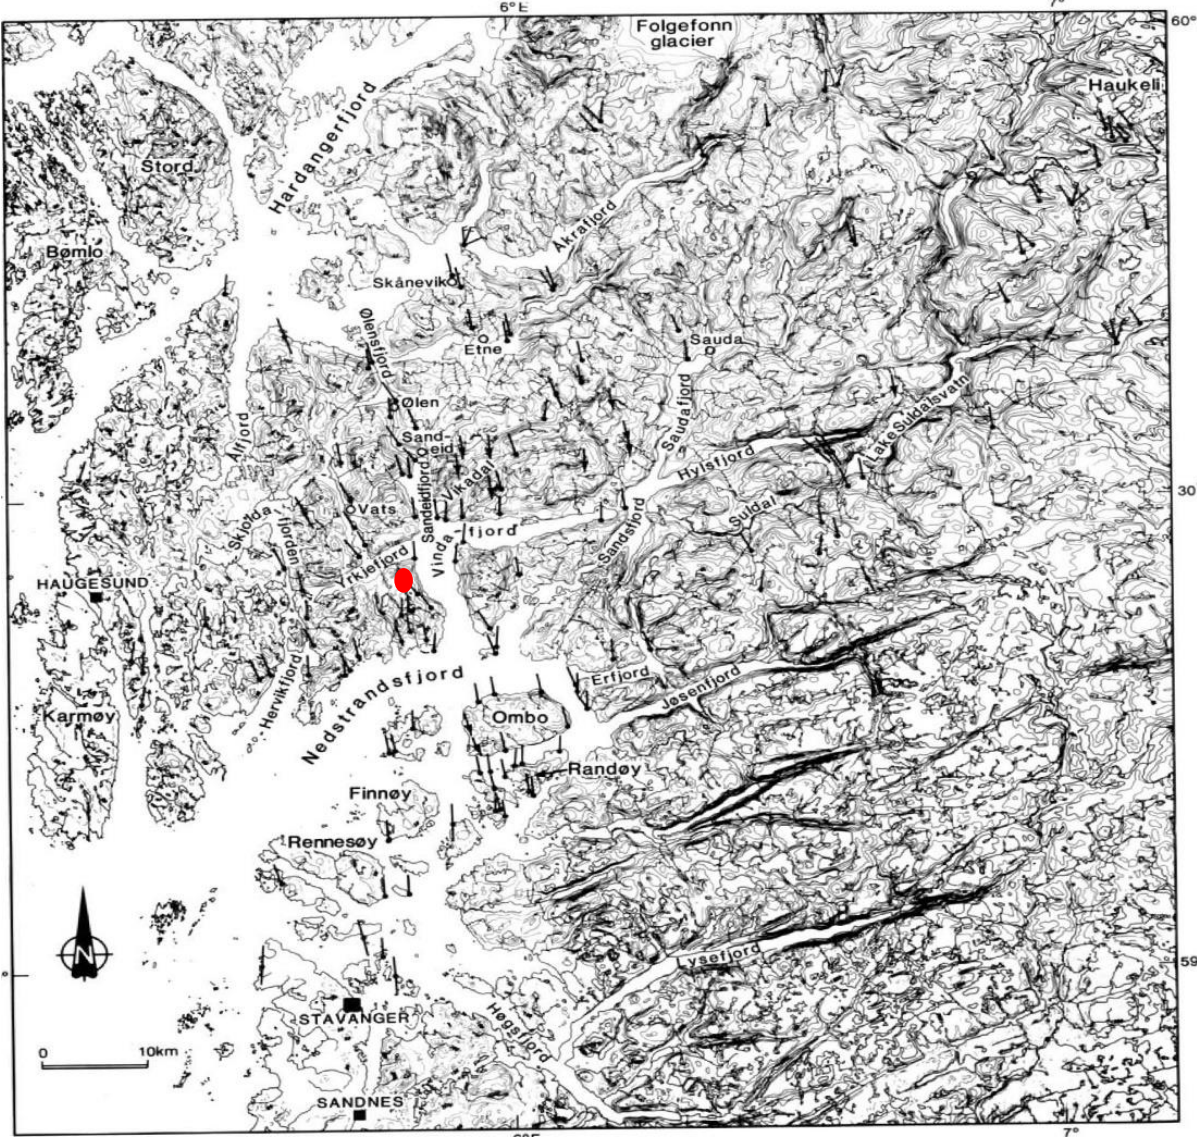
**Figure 1.3:** Glacial flow directions in the Vindafjord area. Black arrows indicate flow direction mainly towards the south. Red dot marks the study area. Modified from (Anundsen, 1990).

Series of weathered glacial striae along the Vindafjord reveals an old glacial movement towards the south (Anundsen, 1990). The same flow markers are found on the plateaus and in the valley sides (figure 1.3). In total, six different ice movements can be distinguished in this area.

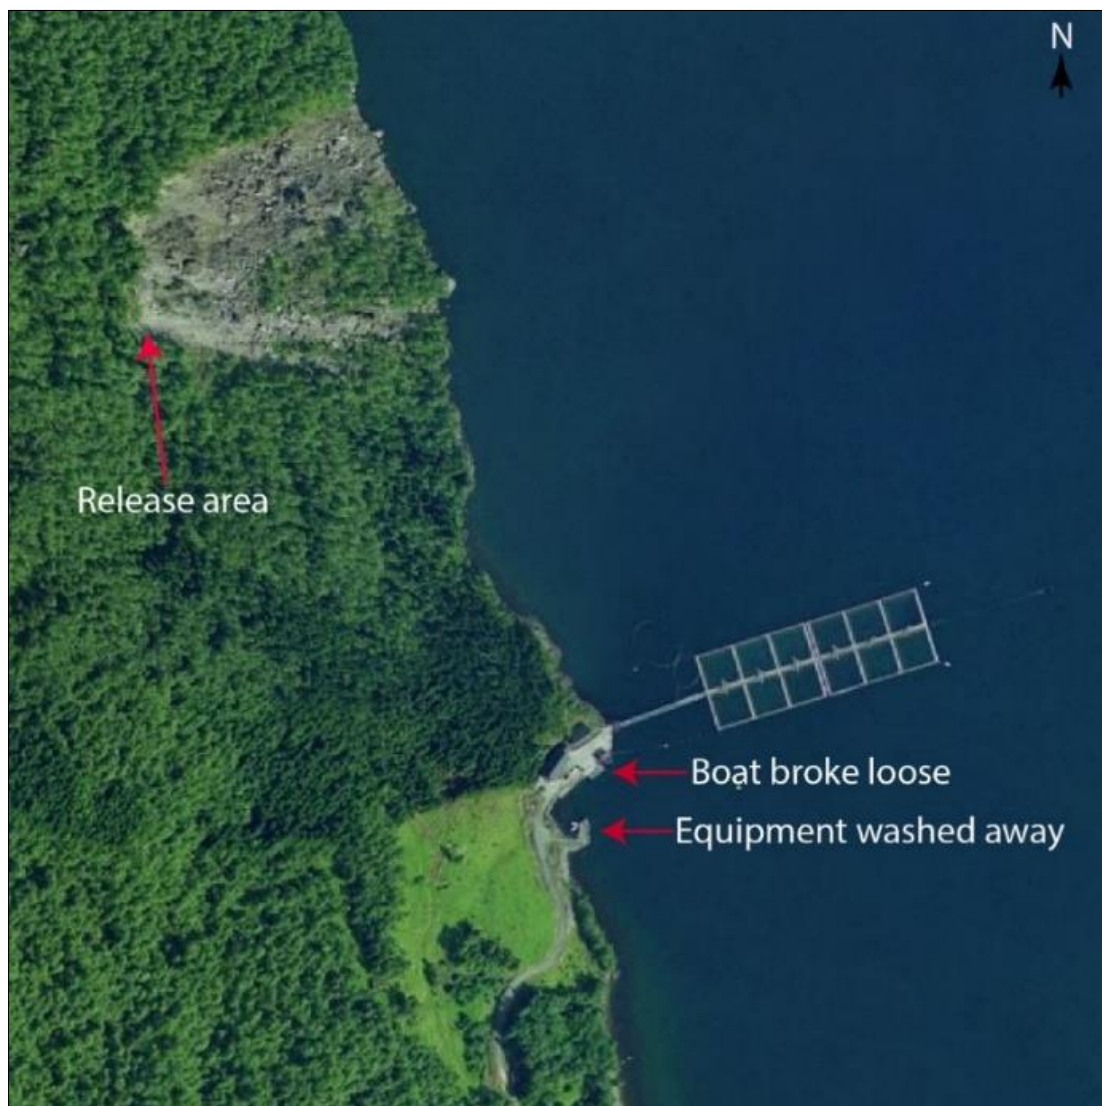
**Figure 1.5:** Orthophoto showing the northeast sector of the unstable area. The fish farm is located approximately 450 meters south of the impact area. Location of the boat that broke loose and the damaged equipment are indicated. Length of the fish farm is 240 meters. Modified from Kartverket (2015).

Based on interviews with locals in the town of Nedstrand, south of the mapped area, there has been one significant rockfall event documented from the frontal limit of the northern sector of the unstable slope. This occurred in November 1999 when a bigger rockfall event created a displacement wave in the fjord directly below the northern sector. A boat lying by a fish farm 450 meters south of the impact area broke loose from the dock, and equipment was washed out in the fjord from another dock lying two meters above water level (figure 1.5). The fish farm itself did not sustain any damage. The event resulted in large amounts of driftwood that caused problems for the fish farm in the following days. Employees at the fish farm who experienced the event, estimated the wave to be less than five meters high. A smaller event occurred from

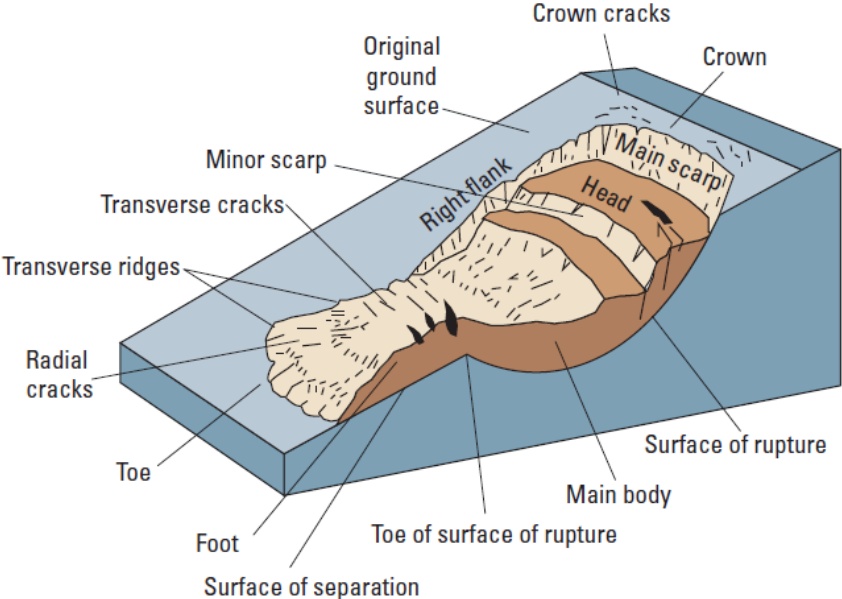
**Figure 2.1:** Landslide terminology (Varnes, 1978).

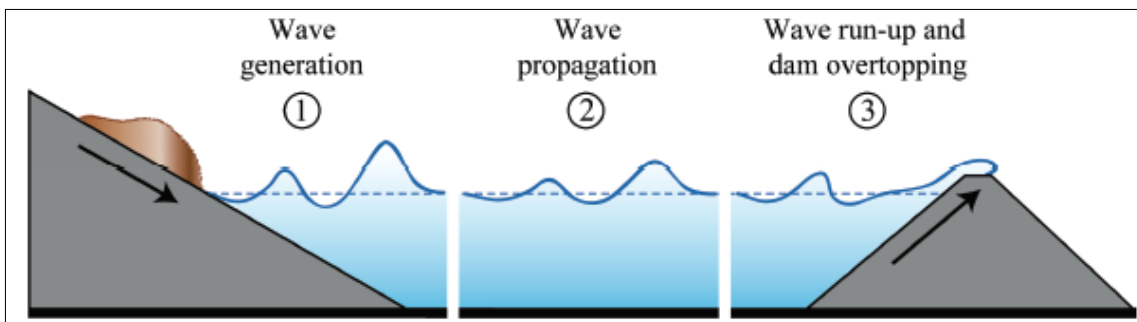
**Figure 2.2:** The three different phases of displacement waves (Heller et al., 2009). This example shows a landslide going into a reservoir with subsequent dam overtopping. The three faces are also applicable to waves generated in fjords.

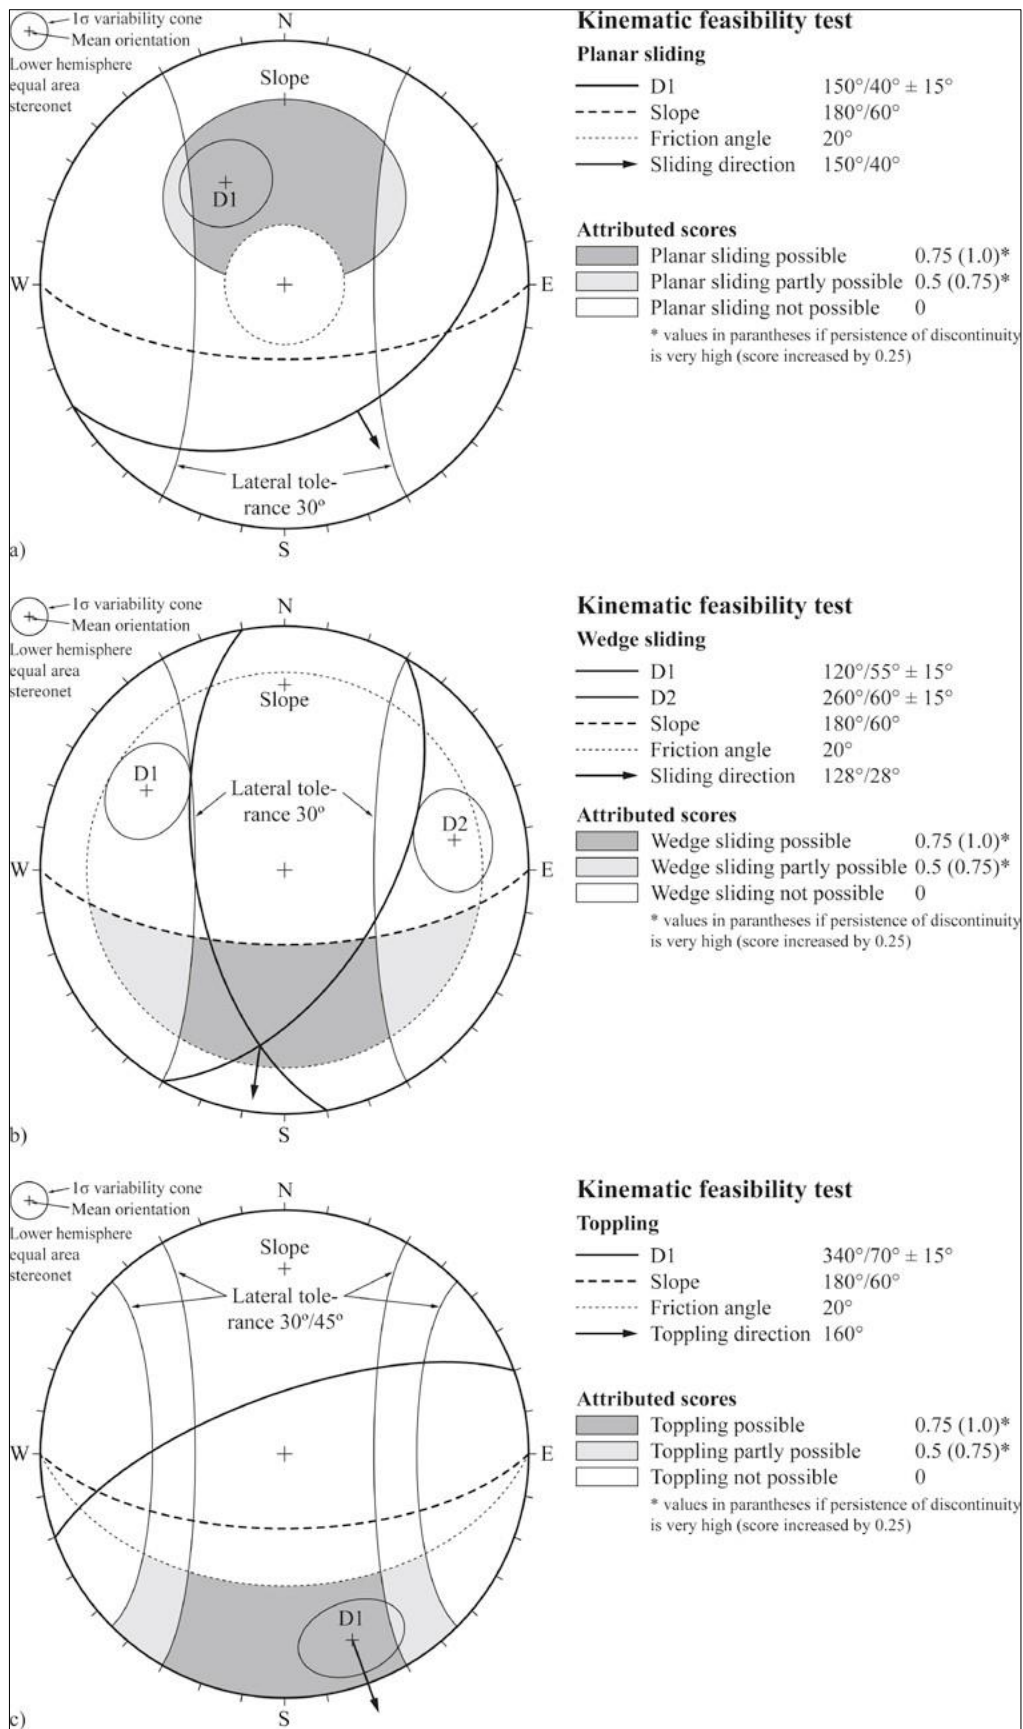
**Figure 3.4:** Kinematic feasibility test for a) planar sliding b) wedge sliding, and c) toppling failure. The scores given in brackets are used if the persistence of the discontinuity is very high (Hermanns, Oppikofer, et al., 2012).

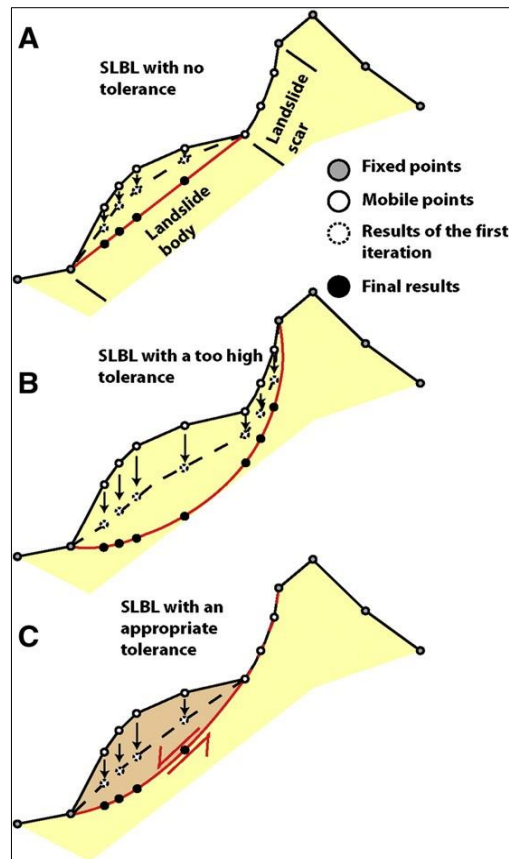
**Figure 3.6:** Estimating the depth of the failure surface using different tolerance levels. Figure C shows the geometry when the surface fits the scar curvature defined by the user (Travelletti, Demand, Jaboyedoff, & Marillier, 2010).

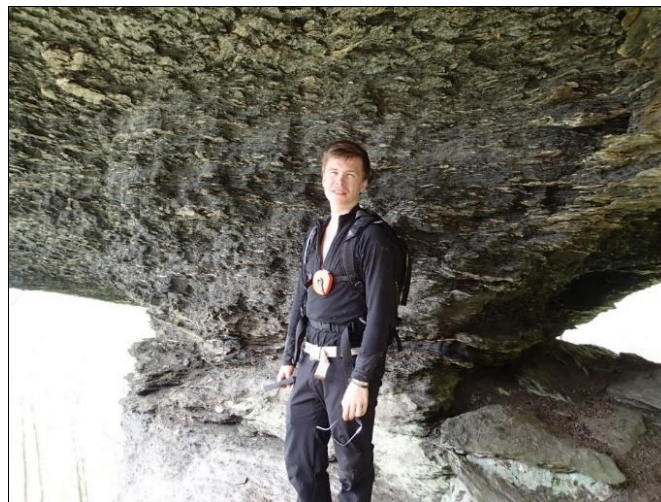
**Figure 4.1:** Intensively weathered graphitic phyllite resulting in a block resting on a thin residual pillar.

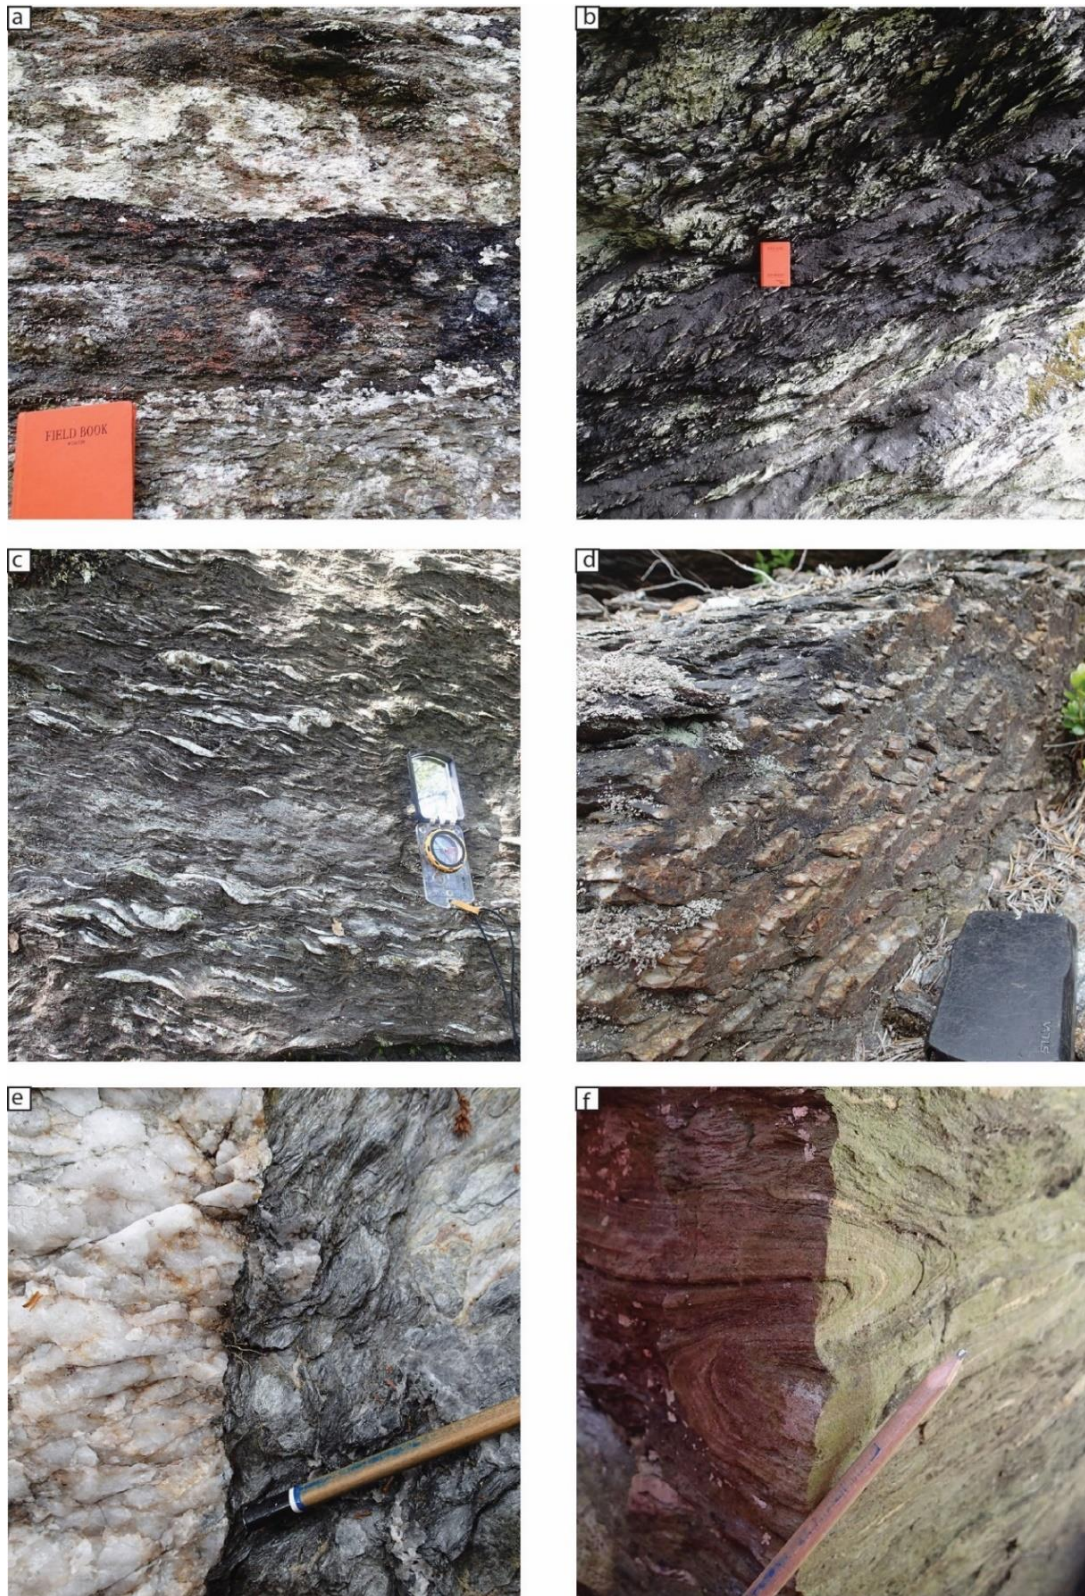
**Figure 4.2:** Photos of the rock mass within the unstable area at Tytefjell A: **A:** 20cm thick graphite rich layer easily recognizable by the darker colour. Marked strength contrast between the layers. **B:** Interlayering of graphite and quartz bands. The field book measures 19x12cm. **C:** Picture showing the intense small scale folding. Compass for scale. **D:** Folded quartz lenses sticking out of outcrop, compass for scale. This amount of quartz is not representative for the entire study area. **E:** Shiny grey phyllite to the right, quartzite to the left. **F:** Isoclinal small scale folding. Photo shows a corner, with shade on the left face.

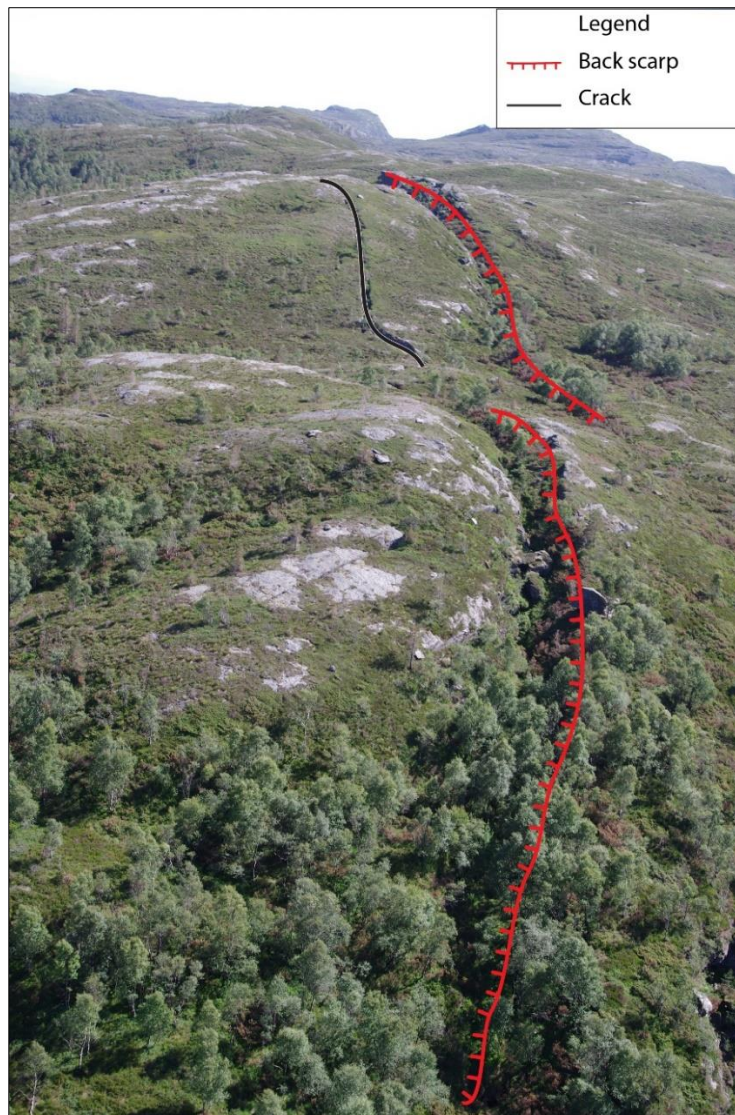
**Figure 4.4:** Photo of the back scarp taken from a helicopter looking SSW. The increasingly dense vegetation towards N is easily observable. The transverse crack is indicated in black. The two parts of the observable back scarp is separated by 25 meters.

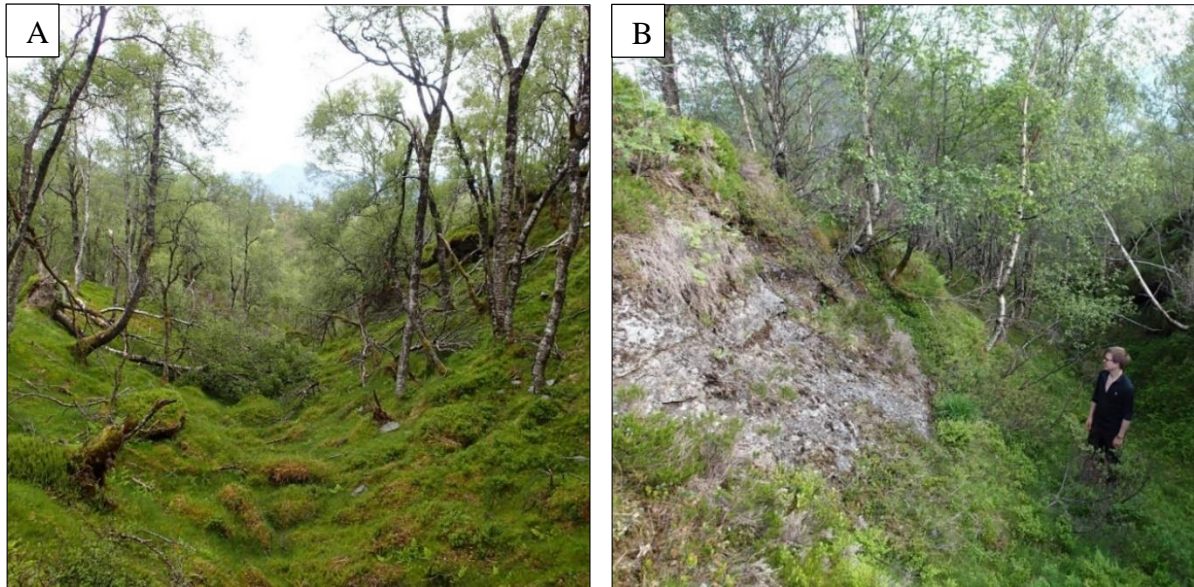
**Figure 4.5:** **A:** Picture taken north of location 6 showing how the back scarp has changed from an open scarp to a vegetated depression. The picture is taken looking north; the unstable part is on the right side of the picture. **B:** Picture taken looking north showing the back scarp at location 7. This is also the area where the back scarp becomes more vegetated towards the north. Person for scale.

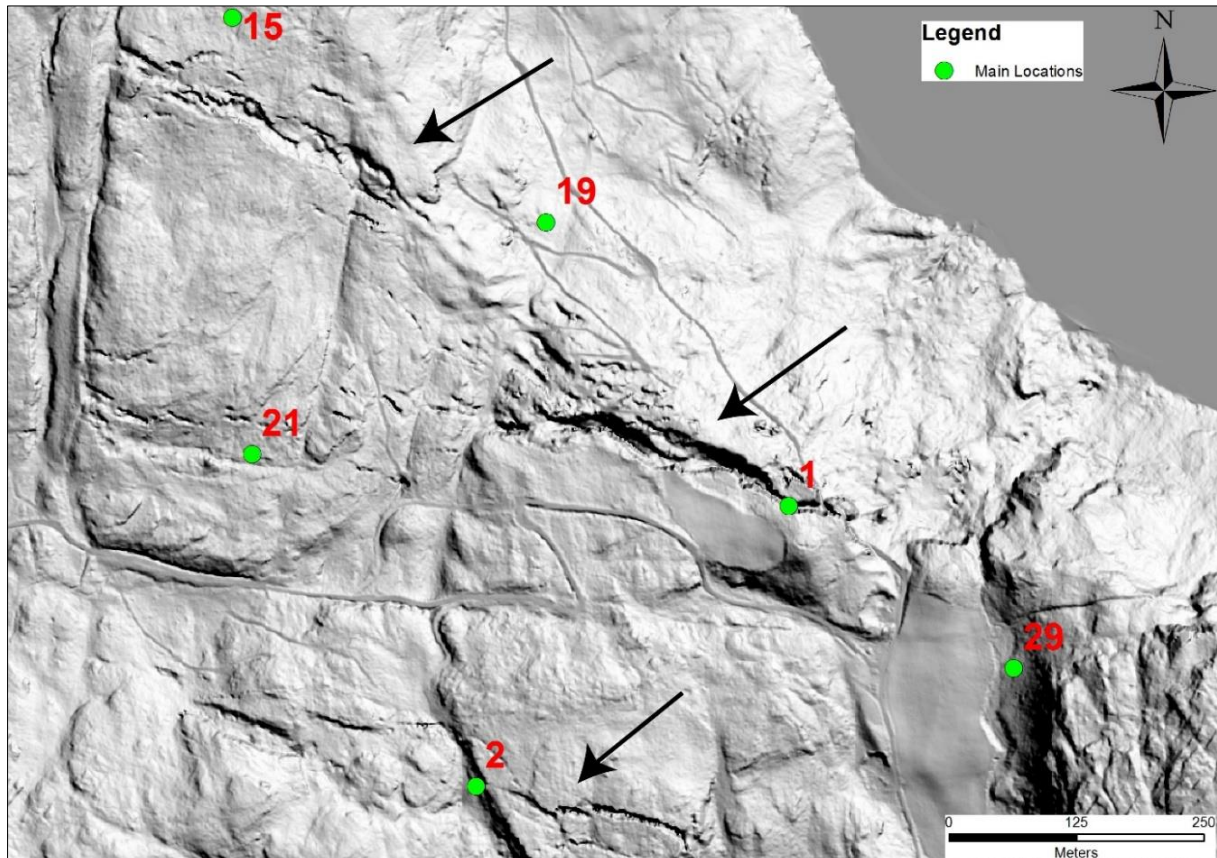
**Figure 4.7:** Figure showing a section of the southernmost area of the instability. The one close to location 1 is set as the southern lateral limit. Three prominent fracture systems are marked with black arrows.

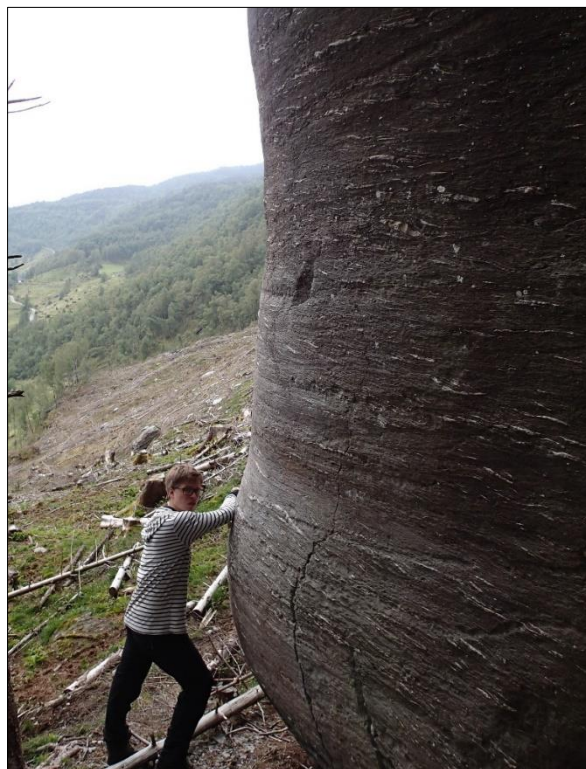
**Figure 4.8:** Completely rounded, 10-meter-high outcrop above the deforested section south of the rock fall area. Picture taken towards south. Person for scale.

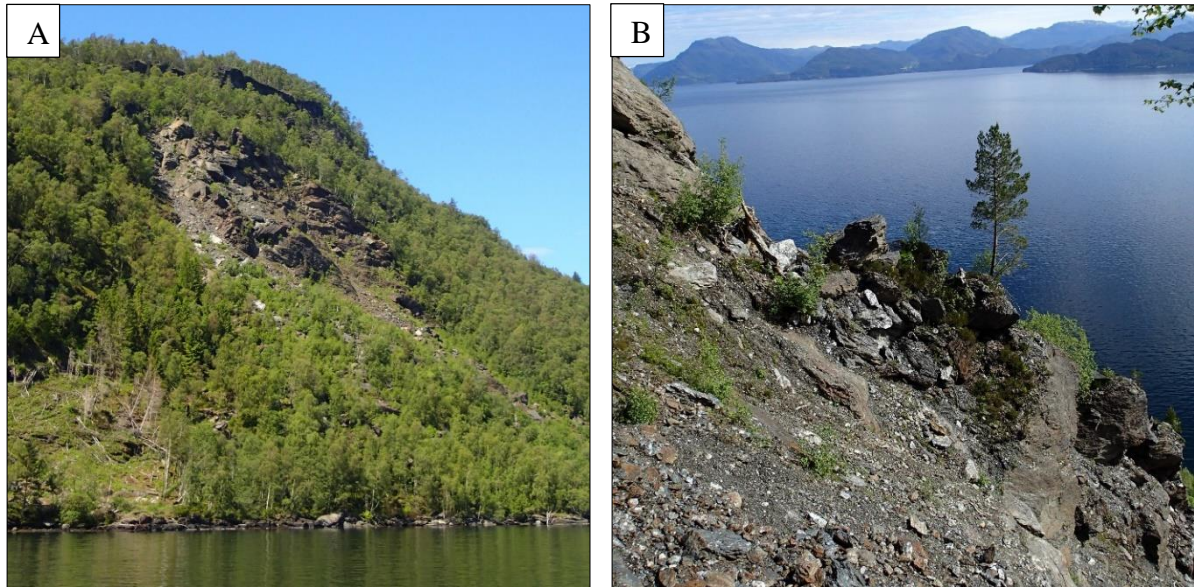
**Figure 4.9:** **A:** Picture taken from the fish farm looking NW showing the active rockfall release area indicated in figure 1.5. The areal extent is 150x200 meters. **B:** Picture taken within the rockfall area, looking north. Unstable blocks are still present on the slope.

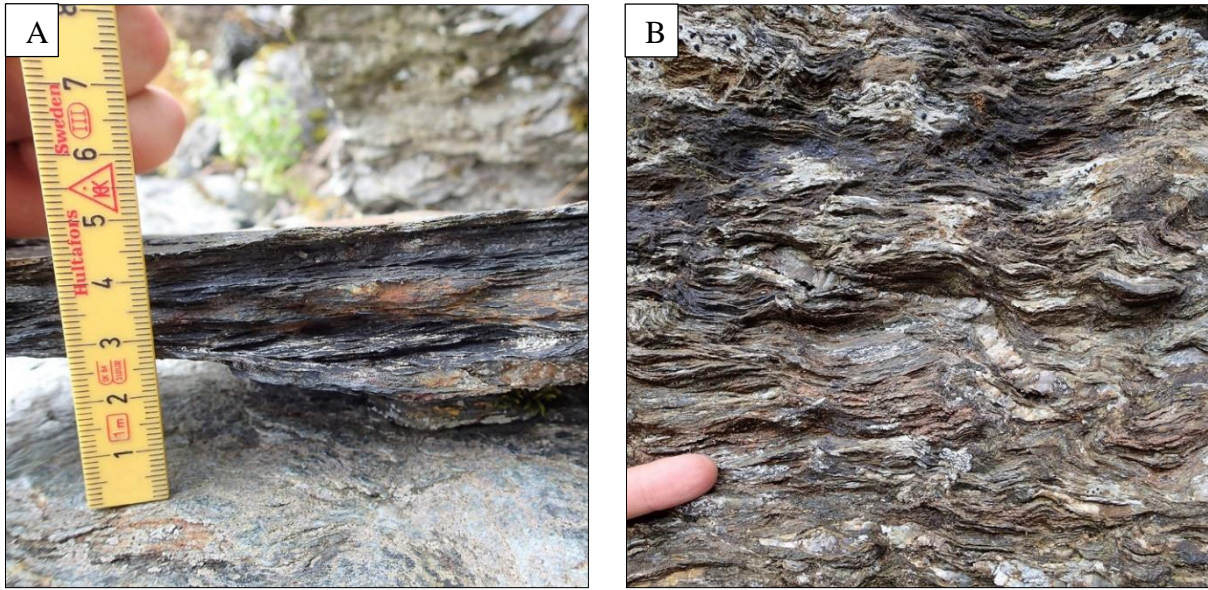
**Figure 4.10:** **A:** Picture showing the foliation in a sample found in the rockfall area at the front of the NE sector. **B:** Undulating foliation. Picture taken close to location 7. Finger for scale.

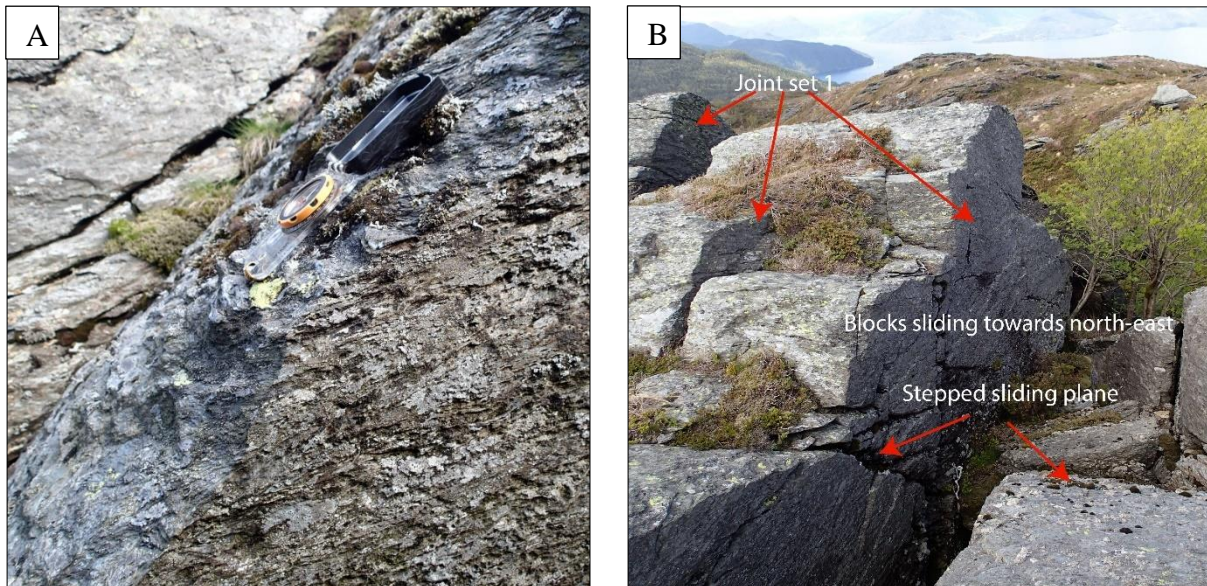
**Figure 4.11:** **A:** Plane composed of multiple daylighting foliation planes in a step-like fashion observed at location 8. The plane is clearly steeper than the sub-horizontal foliation visible in the picture. Compass for scale. Orientation of this plane:  $030^{\circ}/36^{\circ}$ . **B:** Overview over location 8 where multiple blocks is sliding towards NW along the stepped plane in figure A. The persistent joints seen on the picture belongs to joint set 1.

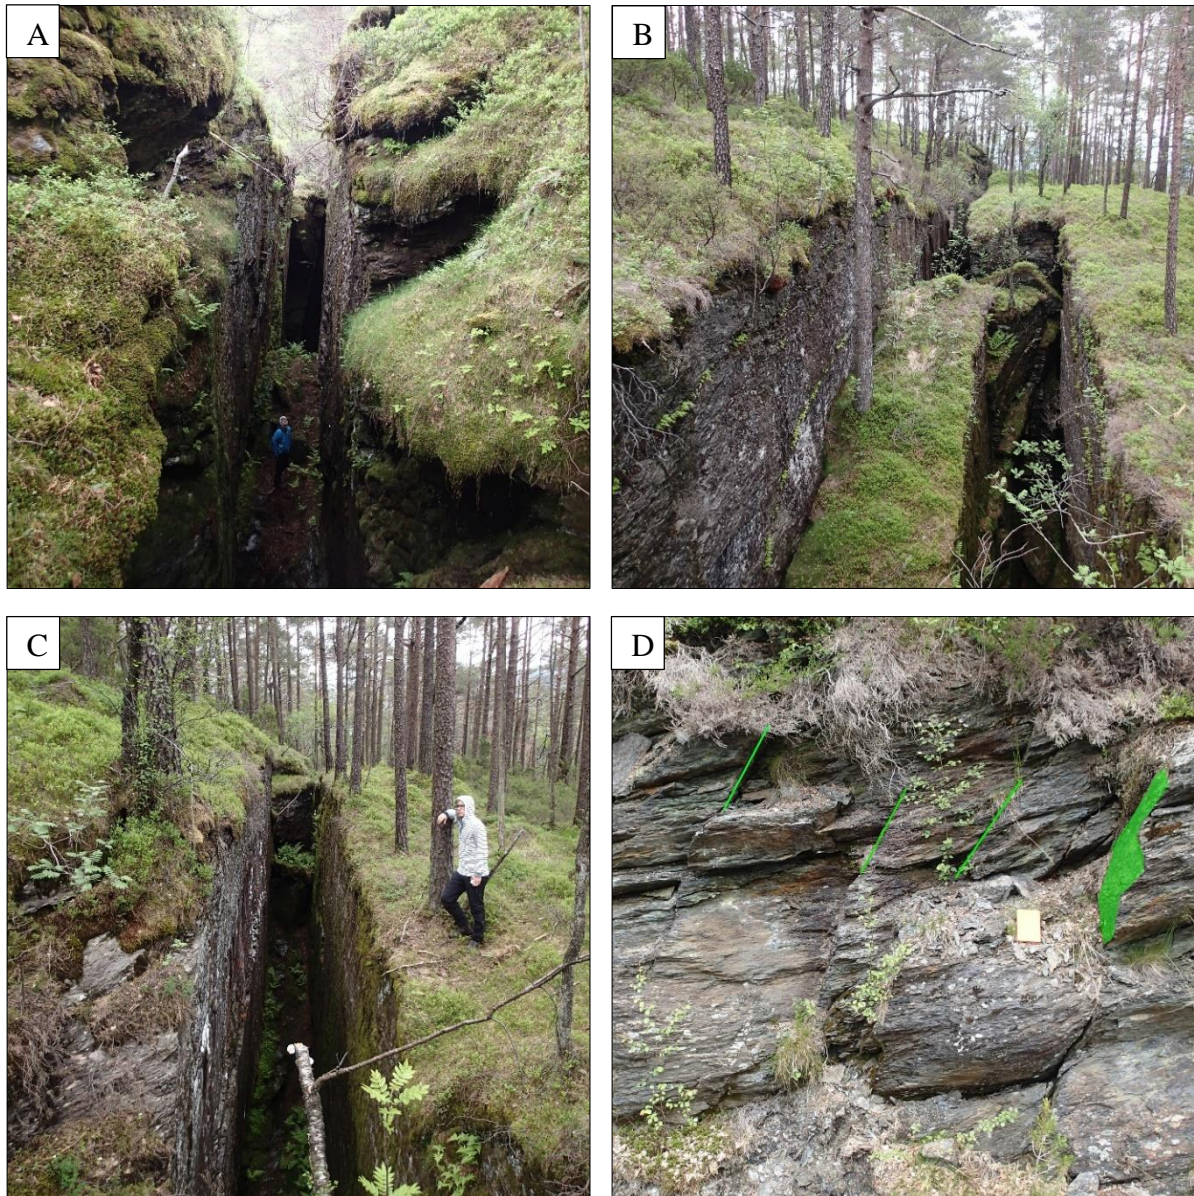
**Figure 4.12:** Pictures showing cracks following J1. **A:** Large crack following J1, where the smooth surface is clearly visible. Person in the crack for scale. Photo taken looking south. **B:** Persistent crack following J1. The left crack has persistence of >100 meters. Rectangular block fallen in between the two J1 discontinuities. Spacing 5m. Close to location 11. **C:** Persistent crack following J1 close to location 27. Smooth vertical surfaces on both sides. The crack is two meters wide and six meters deep. Vegetated bottom. Photo taken at location 11 looking NE. **D:** Picture showing the J1 spacing (green colour indicates J1), here found to be approximately 0.5 meters. Photo taken at location 21 looking SE, notebook for scale.

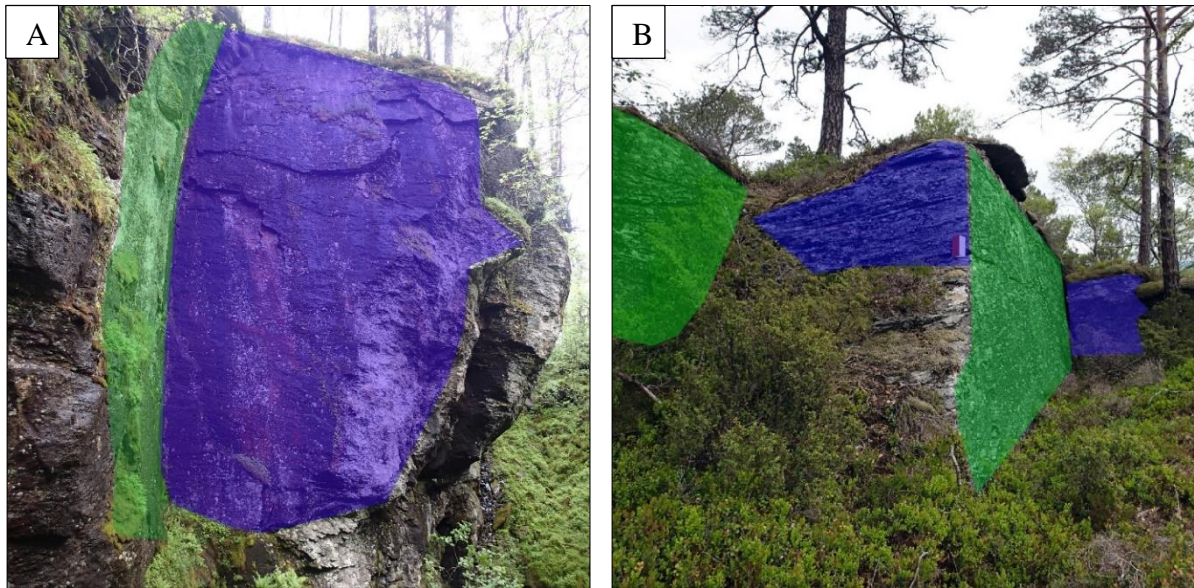
**Figure 4.13:** Steps between J1 (green) and J2 (blue) at two different locations. **A:** Photo taken towards WSW at location 1 inside the big canyon showing a 25-30-meter-high wall forming a standing wedge between J1 and J2. **B:** Looking north close to location 21. Clear steps between J1 and J2 vertical joint sets. Notebook for scale.

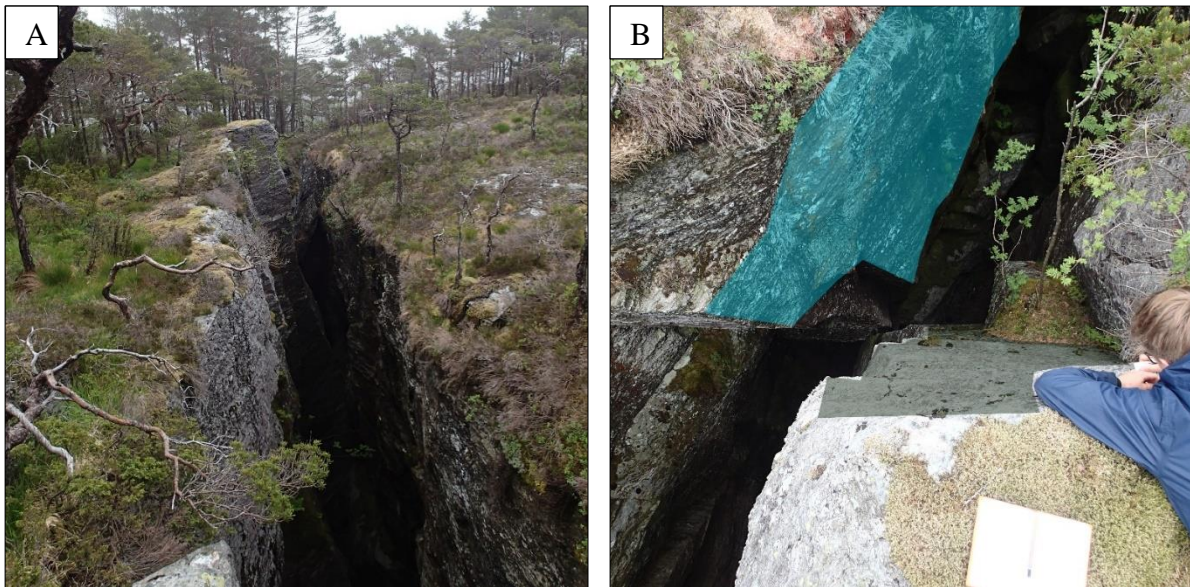
**Figure 4.14:** Pictures taken of a large crack east of location 2. **A:** Structure partly follows J3 striking E-W. The crack is up to 10-meters-wide and at least 40 meters deep. It gets deeper towards the east. This photo shows a vertical displacement of 2-3 meters. Picture taken towards ESE. **B:** Looking down into the same structure. This big crack follows J3 (turquoise) and is cut by J5 indicated in black.

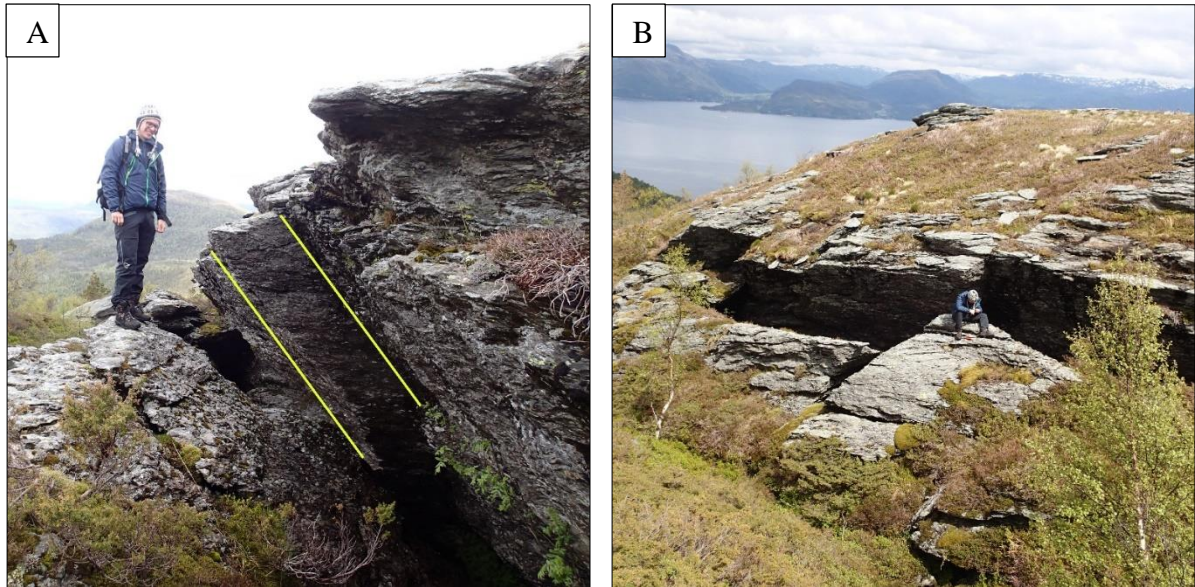
**Figure 4.15:** Pictures showing J4 along the back scarp close to location 7. **A:** Yellow lines mark J4 which dips towards the fjord. Spacing is around 0.5 meters. Blocks are toppling into the back scarp along this discontinuity. Photo taken looking north. **B:** J4 dipping towards the fjord along the back scarp. Blocks that have toppled along the discontinuity into the back scarp are visible. Photo taken towards NE. Sitting person for scale.

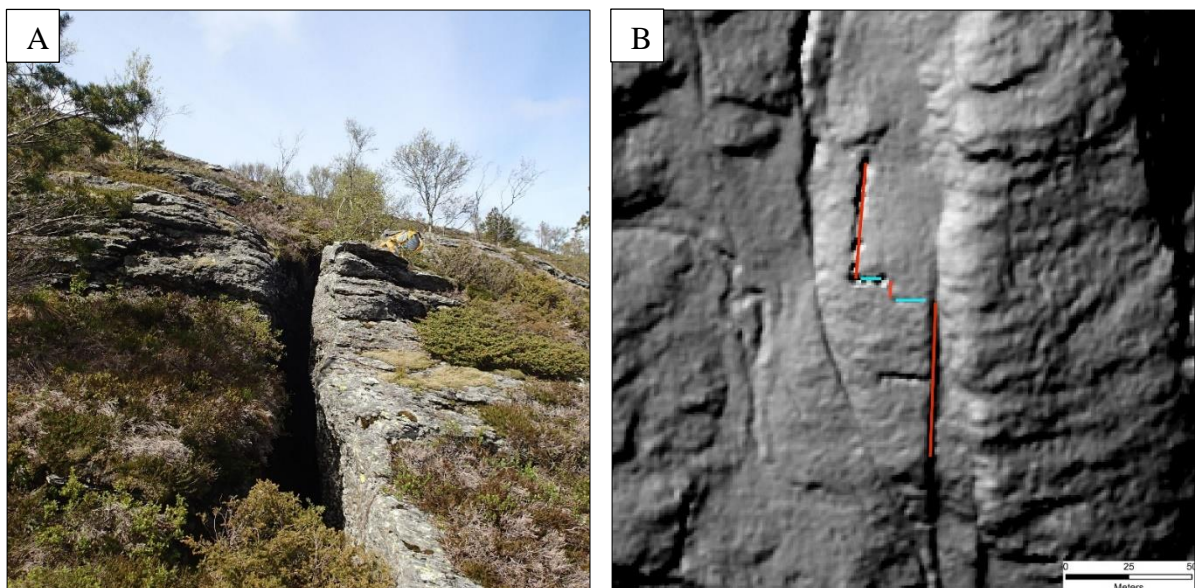
**Figure 4.16:** **A:** Photo taken towards NW that shows a NNW-SSE oriented crack following J5. Approximately 1-meter-wide and eight meter deep. Close to location 8. **B:** Map view over the area directly south of location 16. Red lines represent J5 and turquoise colour represent J3. This shows that the persistence of J5 can exceed 50 meter.

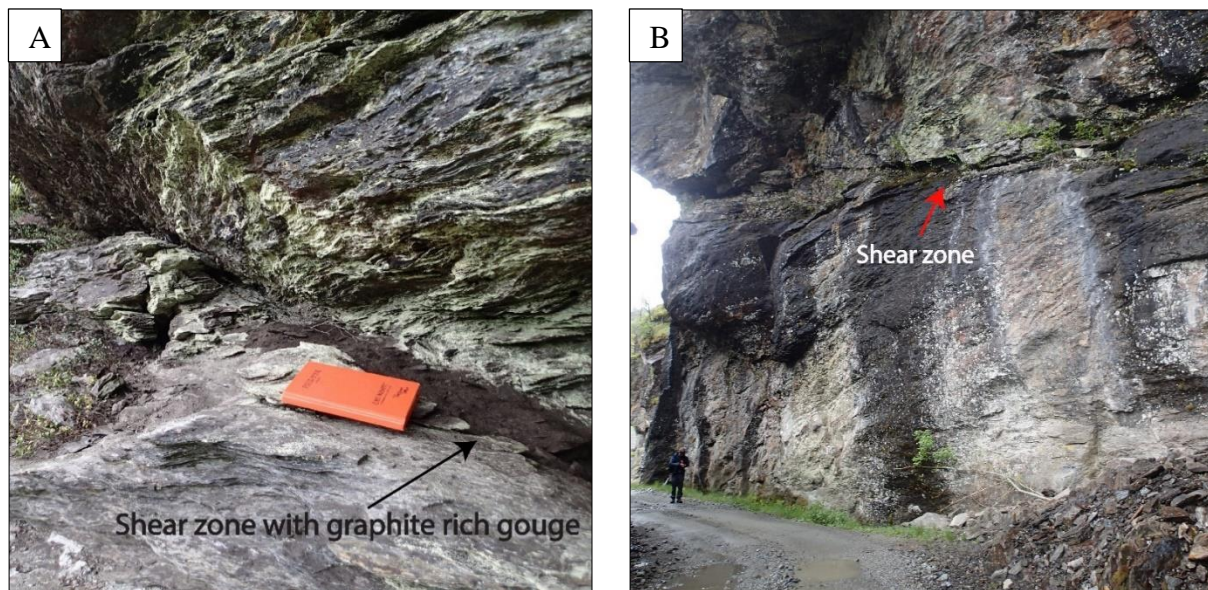
**Figure 4.17:** **A:** Evident shear zone close to location 6. Band of deformation is oriented  $082^{\circ}/36^{\circ}$  on average. Field book for scale. **B:** Big structure interpreted to be a shear zone at location 1. This structure was not possible to measure. Graphite dust was observed along this plane dipping towards NE. Person for scale.

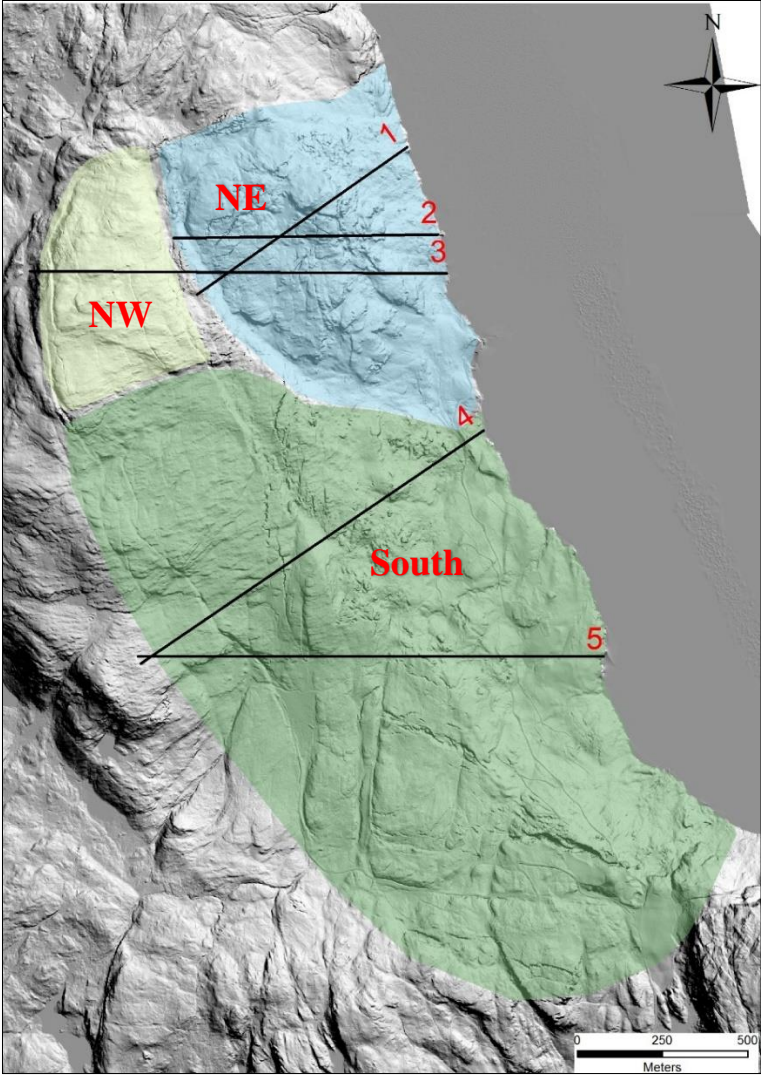
**Figure 4.18:** Hillshade showing the three structural domains. North-West domain in yellow, North-East domain in blue and the South domain in green. Profile lines 1-5 shown in black. These profile lines do extend into the fjord, but the low resolution of the bathymetry is not suitable to include in such a figure.

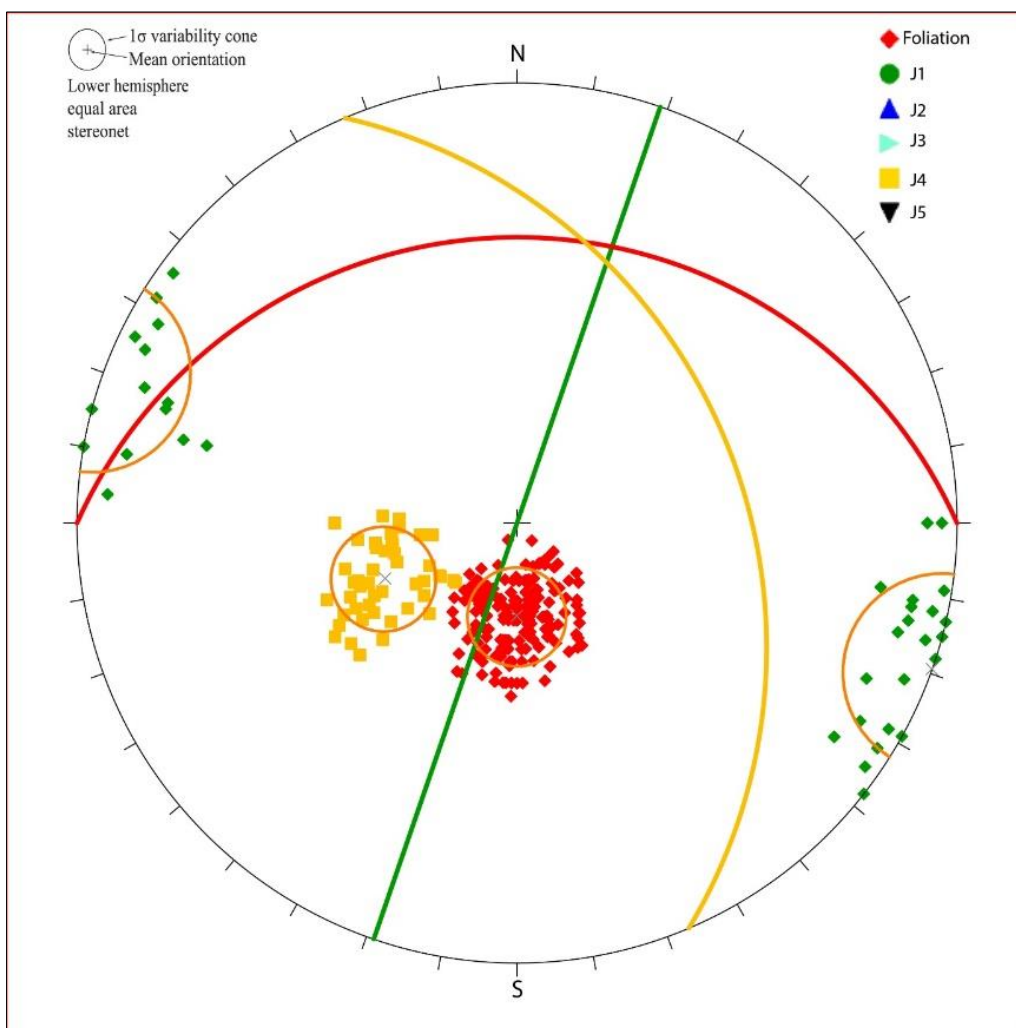
**Figure 4.19:** Stereoplot showing the mapped structures in the North-West domain.

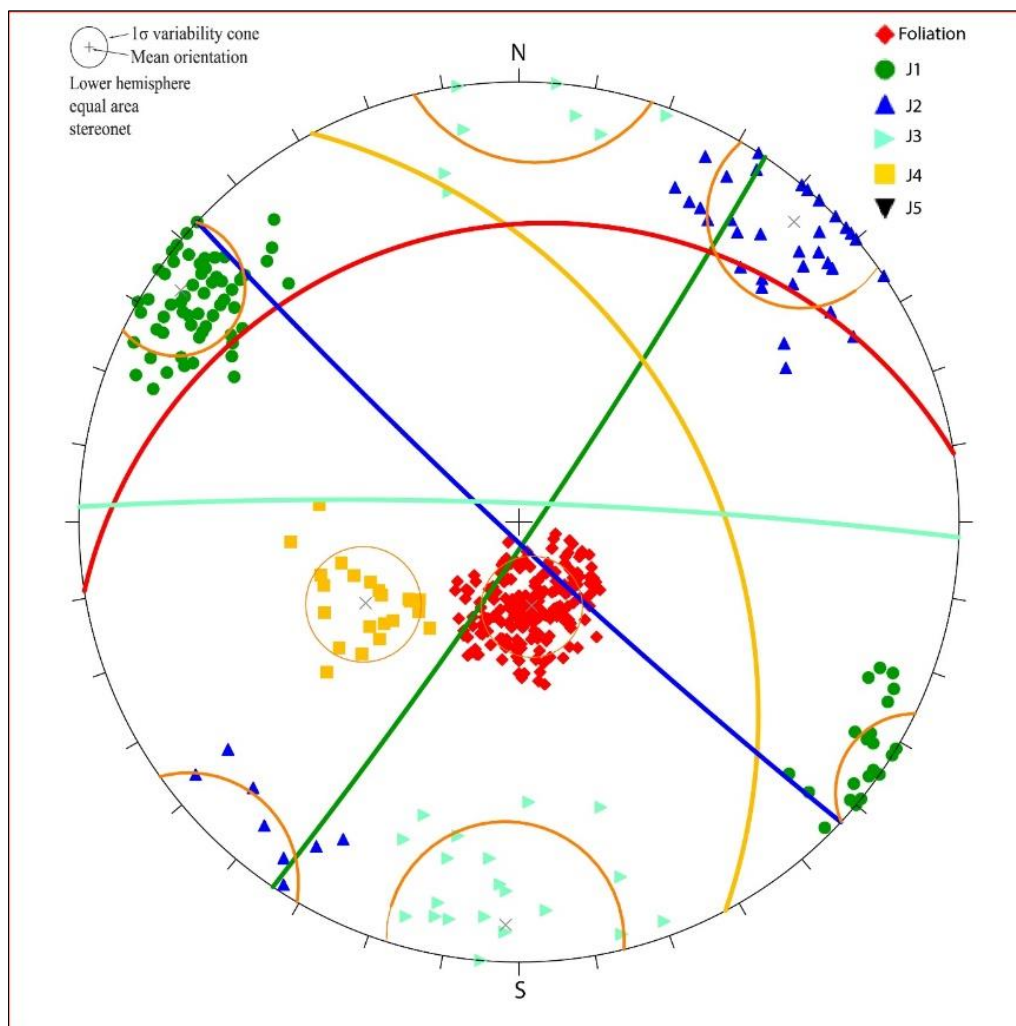
**Figure 4.20:** Stereoplot showing the mapped structures in the North-East domain.
