# The Rock Slope Instability at Tytefjell in Vindafjord, Rogaland

Hazard Assessment for Different Failure  
Scenarios

**Øyvind Bertinussen Rem**

Submission date: May 2016

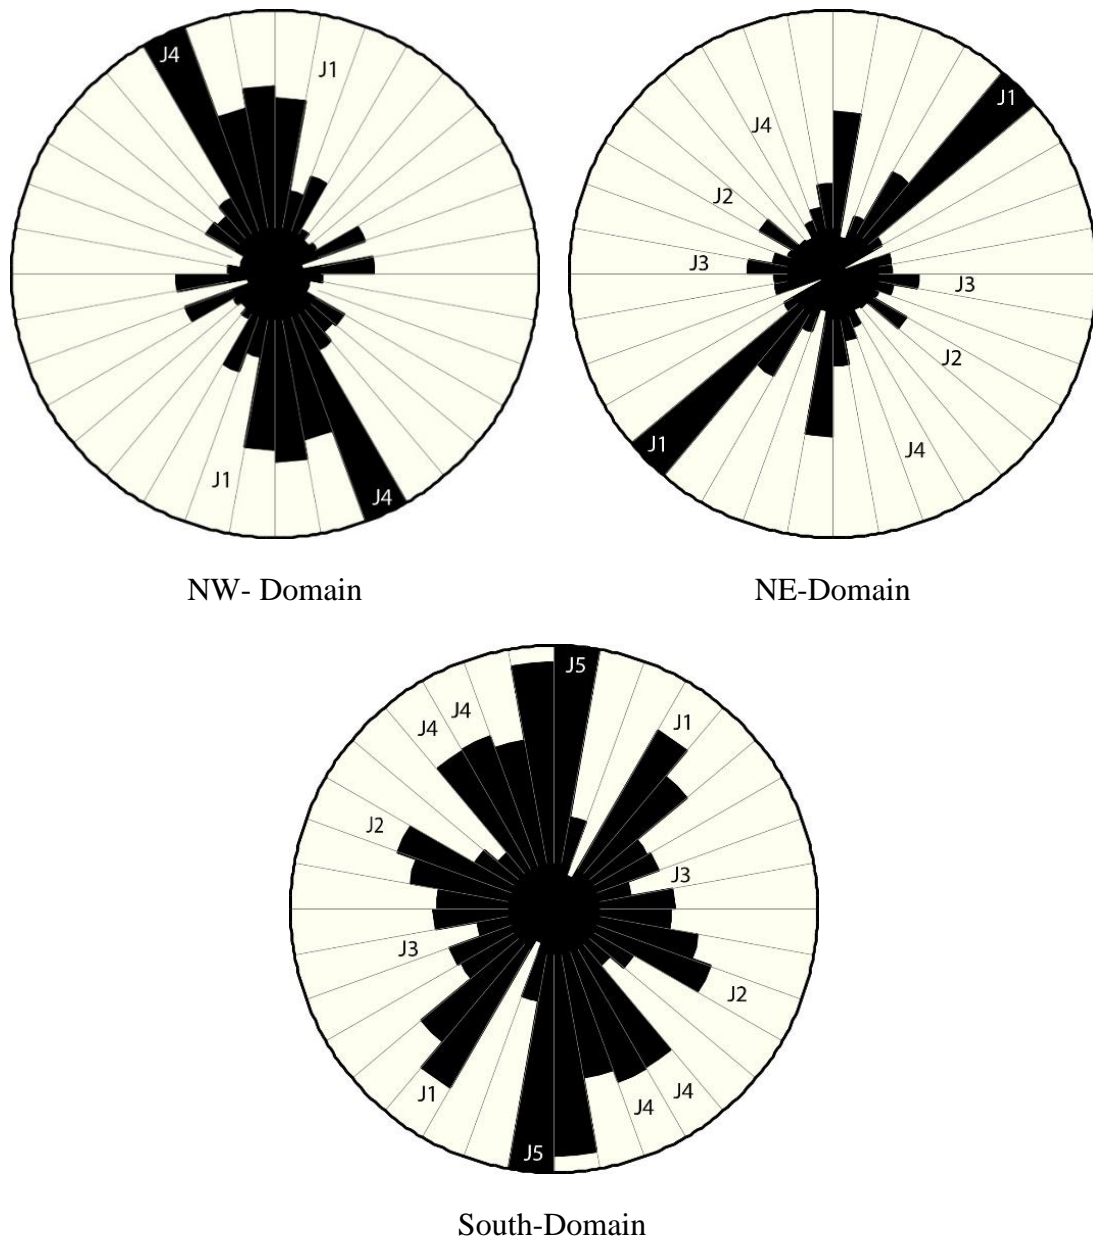
**Figure 4.22:** Rose diagrams for all three domains. Bin width is set to 10 degrees. A reasonable fit between the mapped joint sets and the digitized lineaments is visible in all three structural sub-domains.

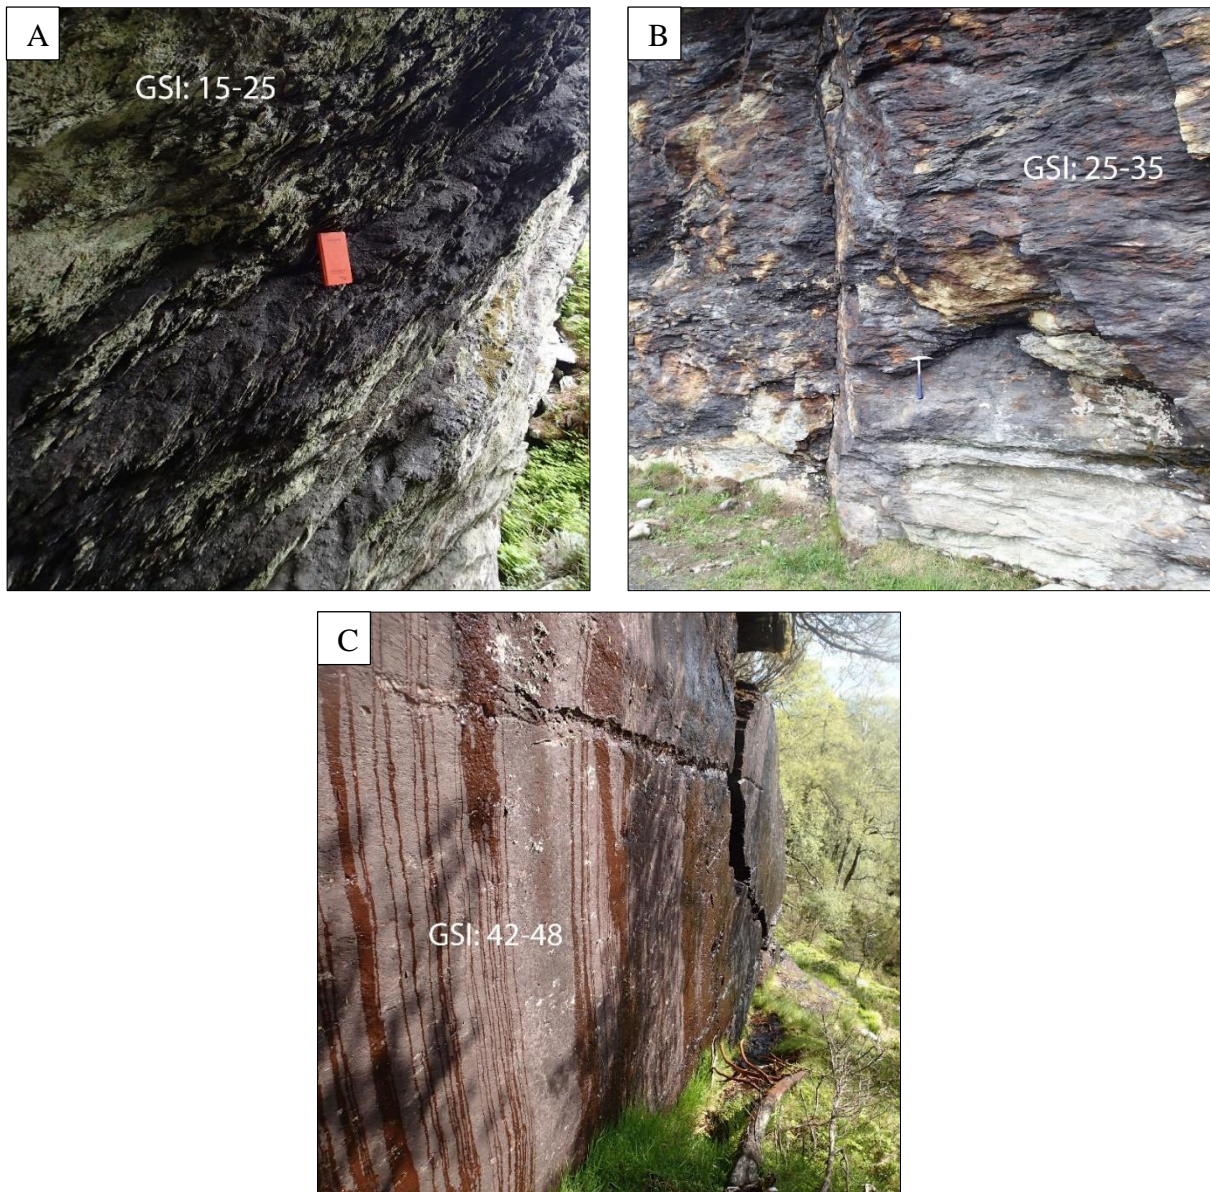
**Figure 4.23:** Examples of outcrops where GSI was estimated. **A:** Outcrop close to location 16 with graphite. GSI range: 15-25 **B:** Outcrop at location 1 showing weathered phyllites with a GSI range of 25-35 **C:** Outcrop south of location 30. GSI range: 42-48.

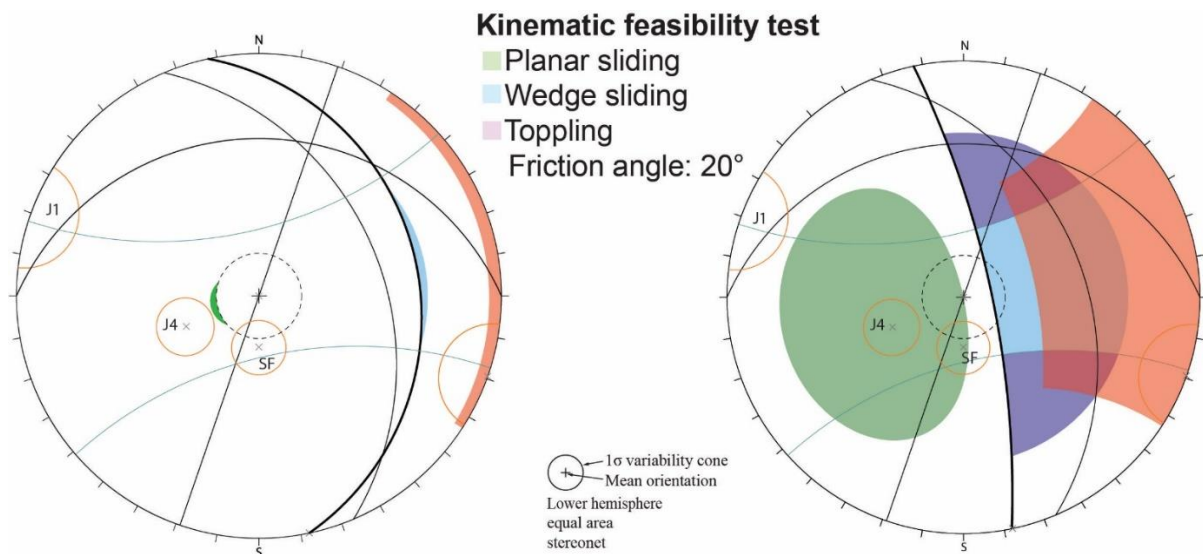
**Figure 4.24:** Kinematic analysis for the NW-Domain. Mean dip angle to the left, max to the right.

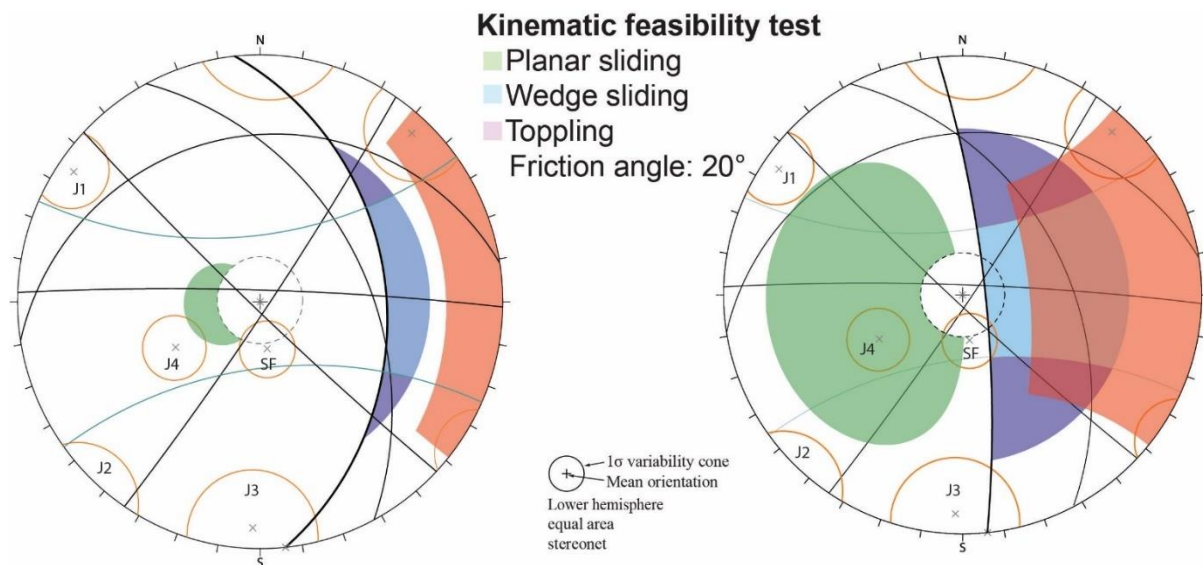
**Figure 4.25:** Kinematic analysis for the NE-domain. Mean dip angle to the left, max to the right.

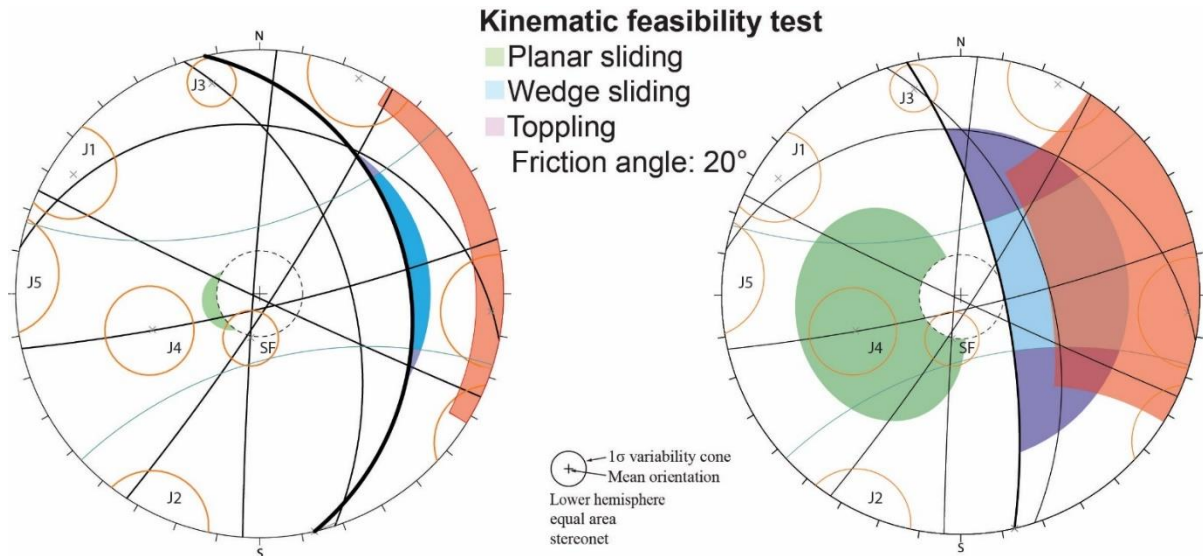
**Figure 4.26:** Kinematic analysis for the South-domain. Mean dip angle to the left, max to the right.

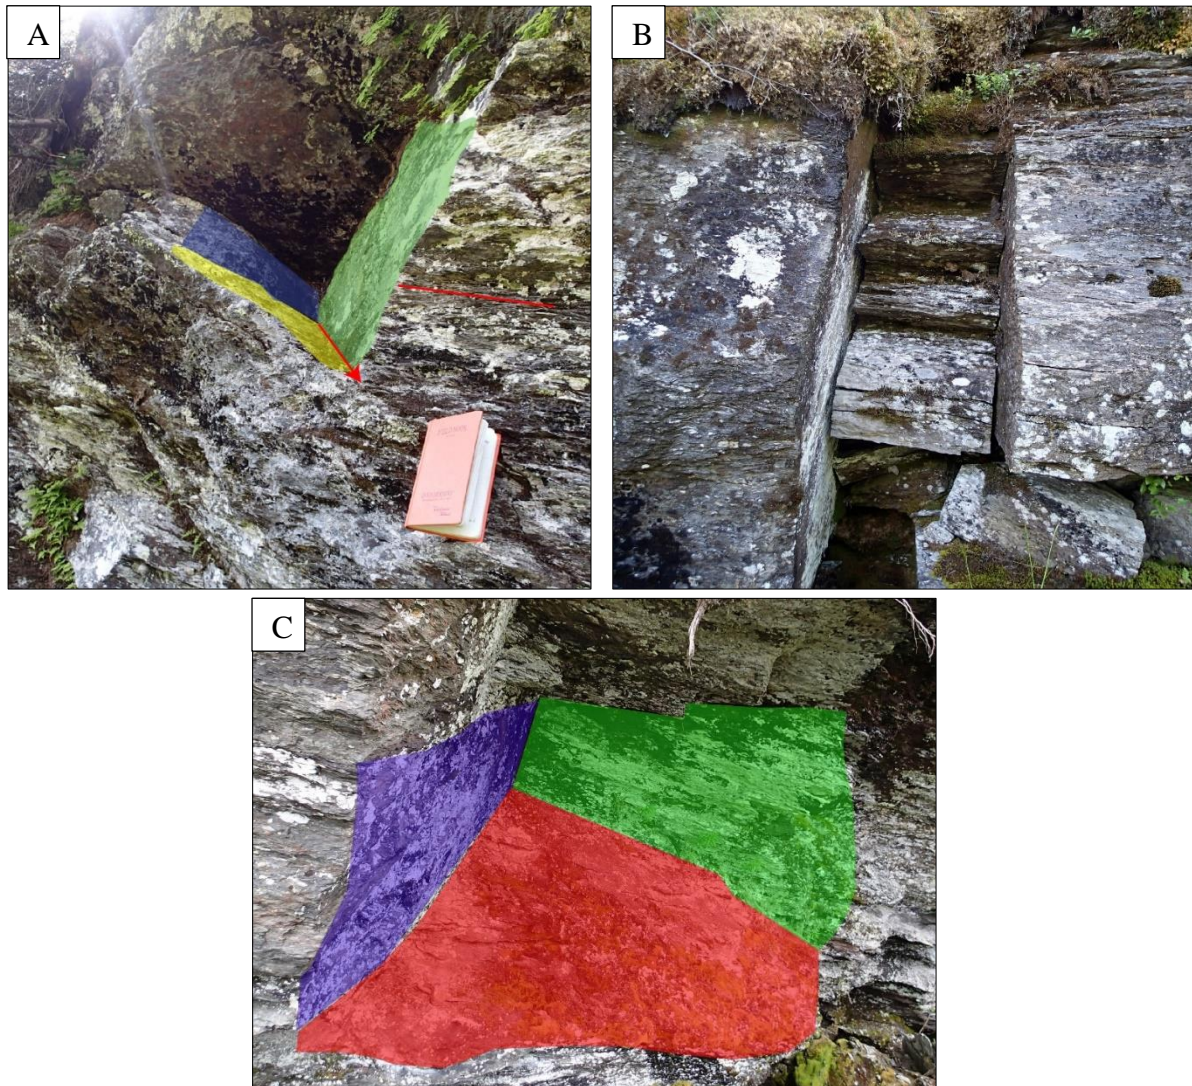
**Figure 4.27:** Pictures showing different examples of failure mechanisms found in the southern domain. **A:** Example showing a small wedge failure found in the field 130 meters north of location 21. This wedge is composed of three discontinuities, J1 marked in green, J2 marked in blue and an irregular plane cutting the foliation just as in Figure 4.11. marked in yellow. The intersection lineation marked by a red arrow plunges  $45^{\circ} \rightarrow 033^{\circ}$ . The red line above the field book marks the dip of the foliation, this is clearly shallower than the dip of the yellow plane. **B:** Photo taken 80 meters SE of location 19 looking SW, showing two vertical discontinuities belonging to J1. The gap between the joints are around 1 meter. Blocks have been sliding out of the wall along multiple foliation planes using J1 as lateral release surfaces on both sides. Average orientation for the plane dipping out of the outcrop is  $047/24$ . **C:** Picture taken towards NW showing a planar failure along the foliation with two joint sets as lateral release surfaces. These features were not possible to measure. North of location 16.

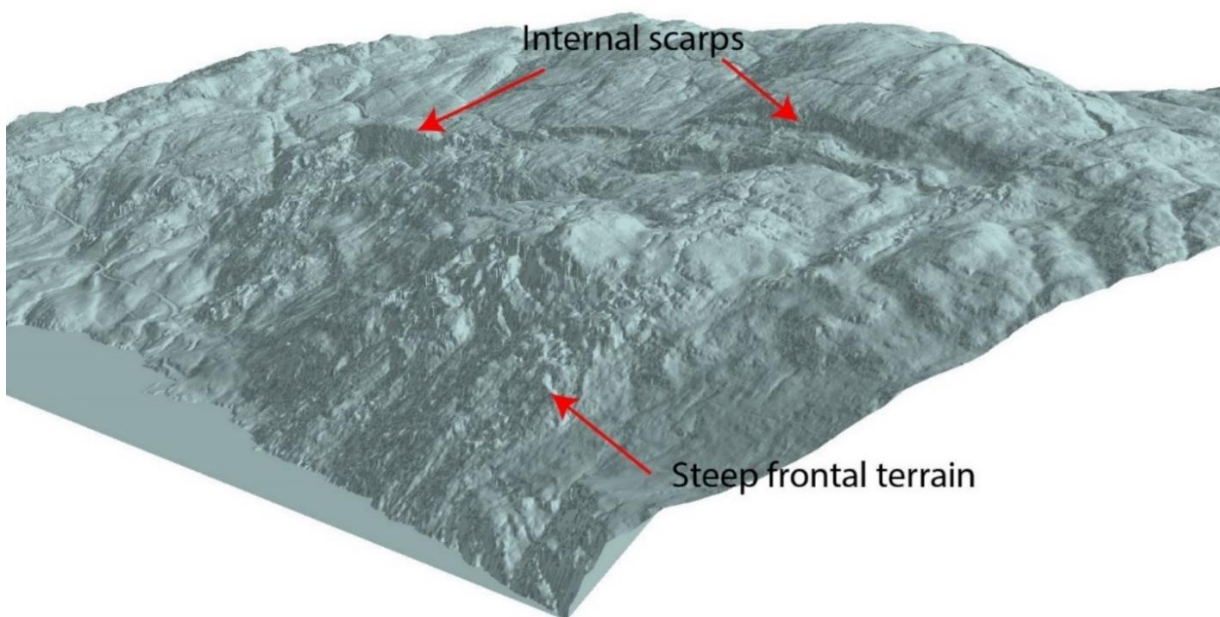
**Figure 4.28:** Screenshot of a 3D model created based on the 1x1m DEM showing the steep frontal terrain and the internal scarps in the NE sector of the slope. The steepness of the frontal areas made investigations of these areas difficult. View is towards SW.

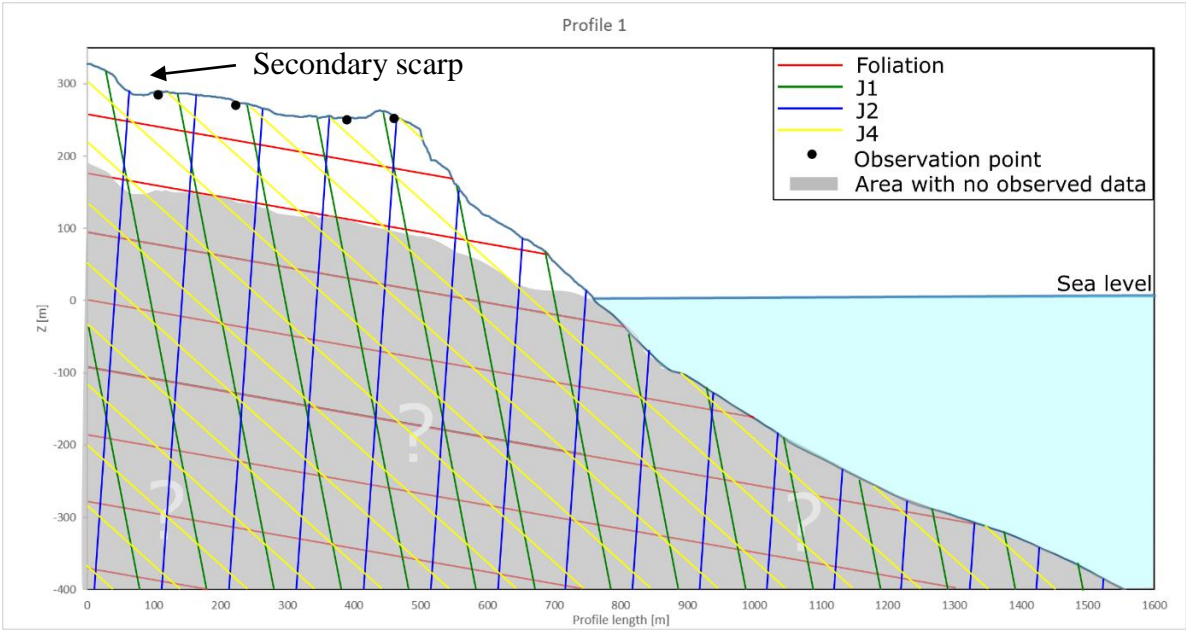
**Figure 4.29:** Profile 1 crossing the NE domain with the mean dip values of the discontinuities. Orientation of the structures in the grey area is estimated based on observations elsewhere. Profile strikes 55°.

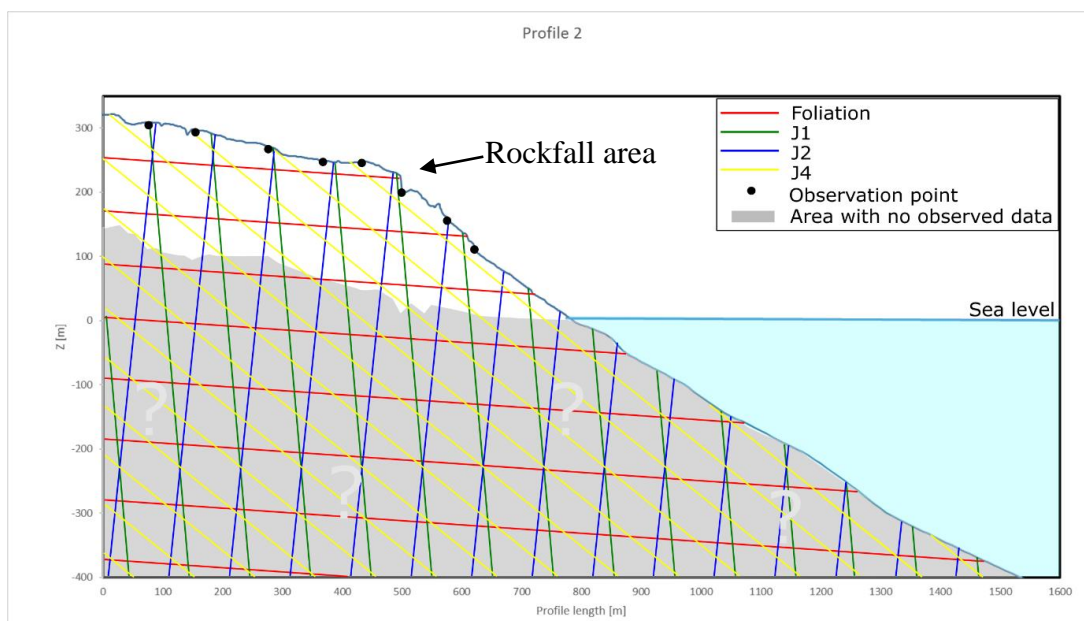
**Figure 4.31:** Profile 2 crossing the NE domain with the mean dip values. Profile strikes 90°.

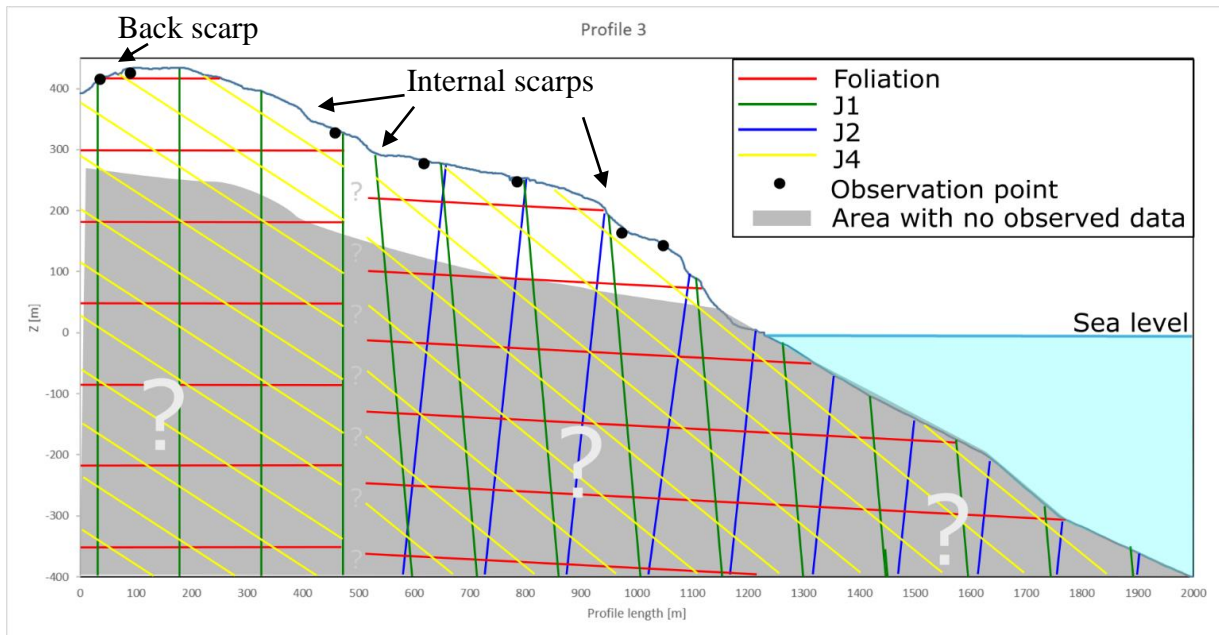
**Figure 4.33:** Profile 3 crossing the NW and NE domains with the mean dip values. Profile strikes 90°.

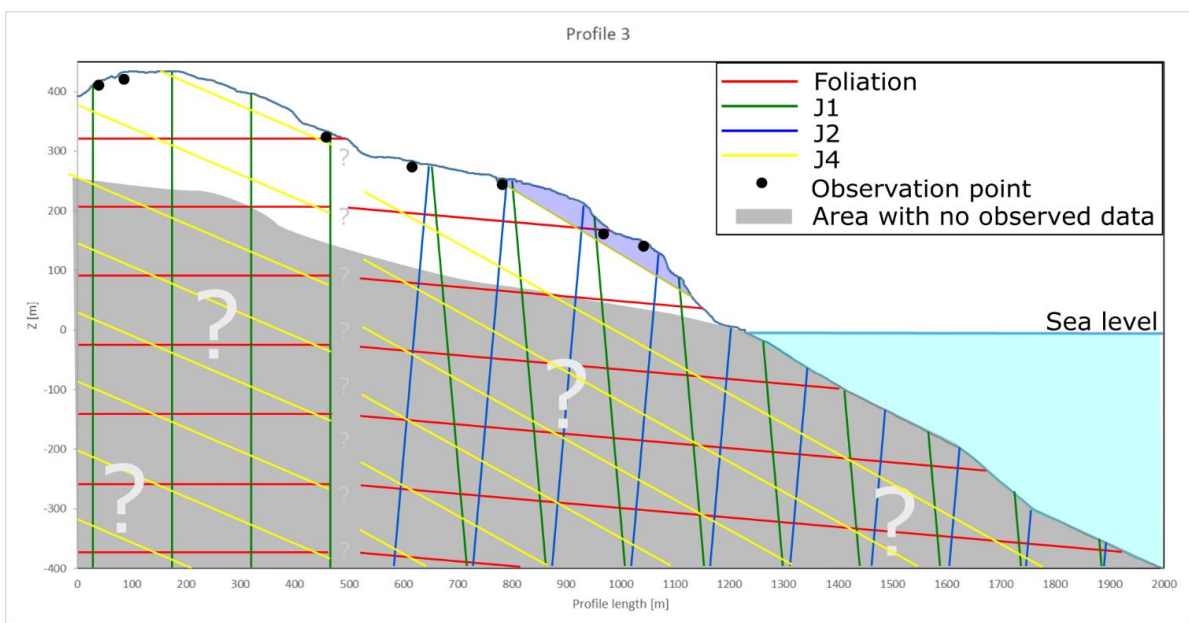
**Figure 4.34:** Profile 3 crossing the NW and NE domains with only the critical structures. Profile strikes 90°.

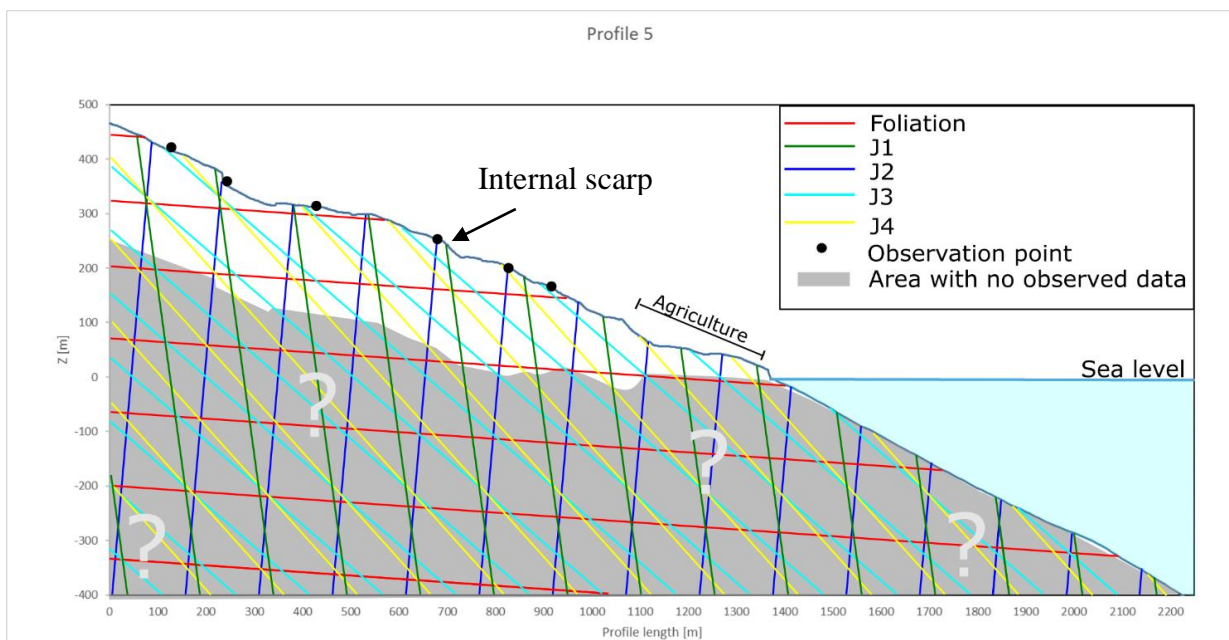
**Figure 4.37:** Profile 5 crossing the south domain showing the mean values. Profile strikes 90°.

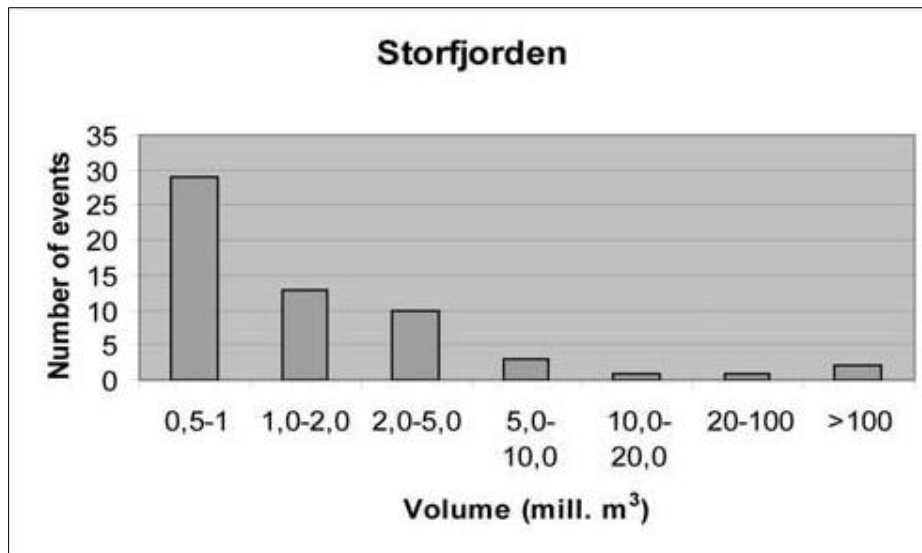
**Figure 4.38:** Diagram showing the number and volume of recorded rock-avalanche events in the entire Storfjord (Møre og Romsdal county). The distribution of events show that failures volumes rarely exceeds 10 million m<sup>3</sup>. This is one of the most active areas in terms of rock slope failures in Norway (Blikra et al., 2005).

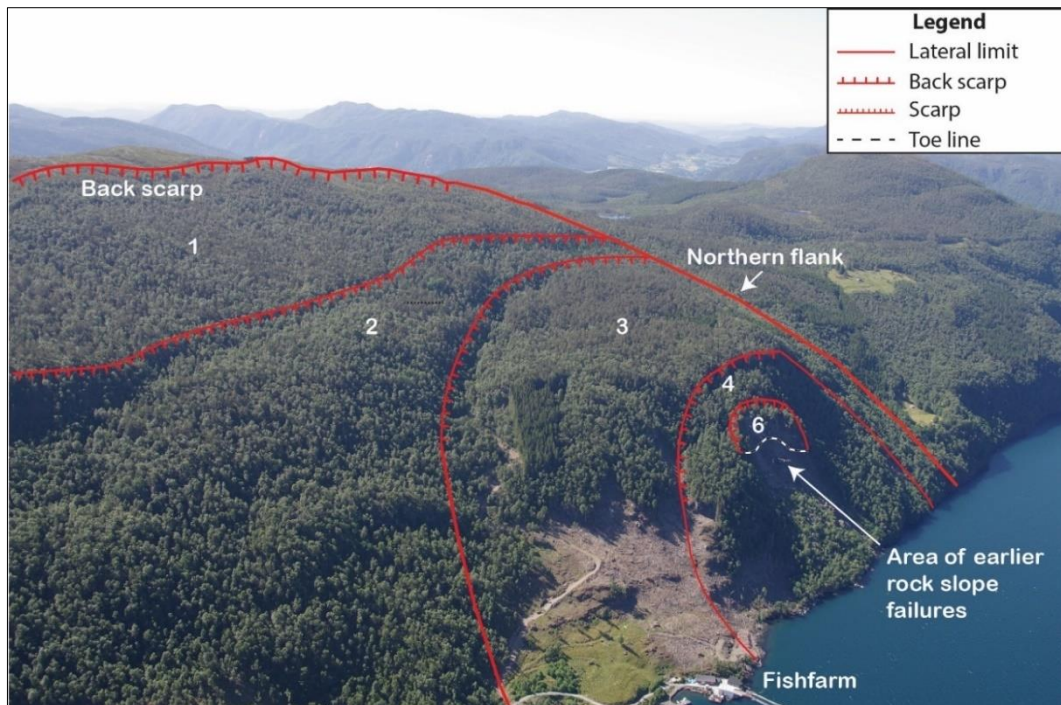
**Figure 4.39:** Aerial photograph taken towards NNW, showing the NE part of the unstable slope at Tytefjell with lineaments showing five of the six failure scenarios. Each smaller scenario is included within the bigger scenarios. The scenarios are marked with numbers.

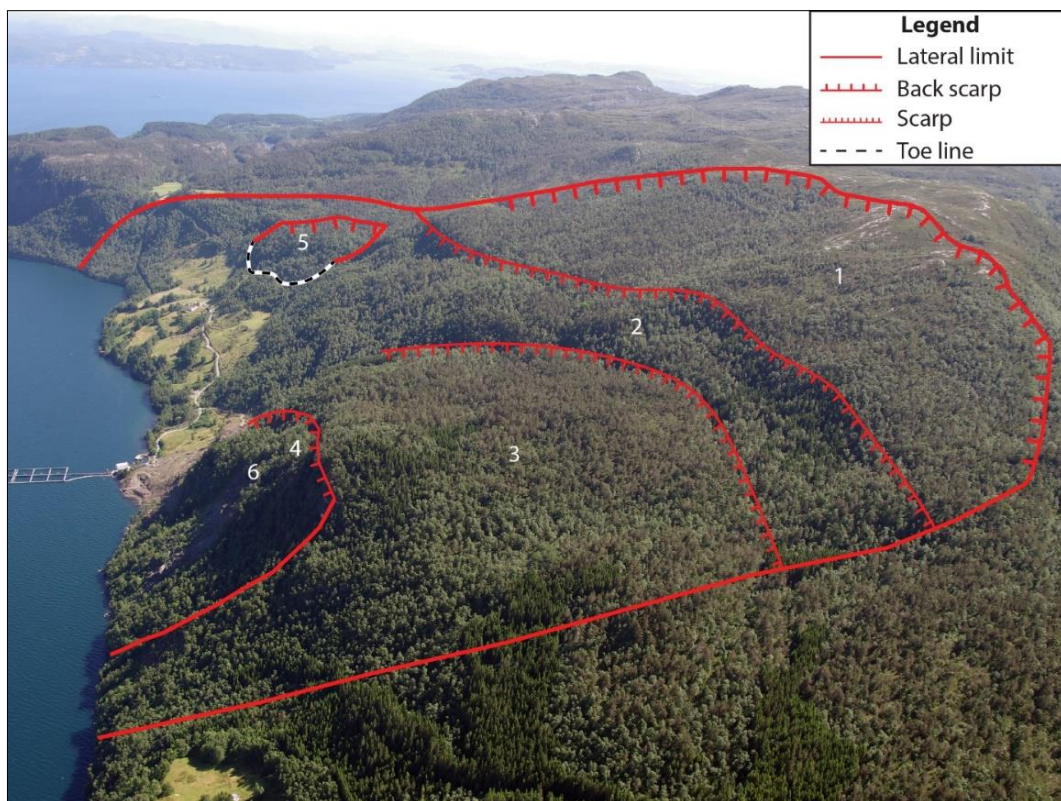
**Figure 4.40:** Aerial photograph taken towards SSW of the unstable slope at Tytefjell. Failure scenario 5 is marked at the southern end of the unstable area. Each smaller scenario is included in the bigger scenarios. The flat agriculture area below scenario 5 is visible.

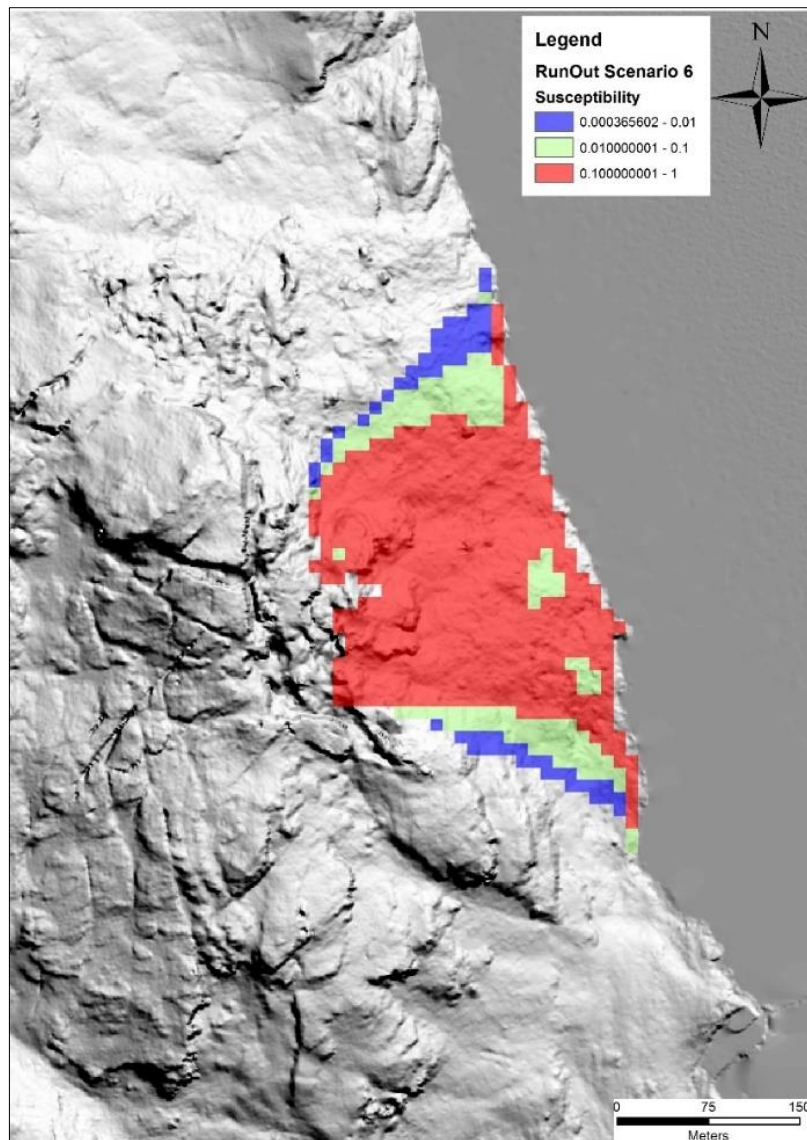
**Figure 4.42:** Computed runout area for scenario 6 (Flow-R). The computation shows a high probability for a failure reaching the fjord.

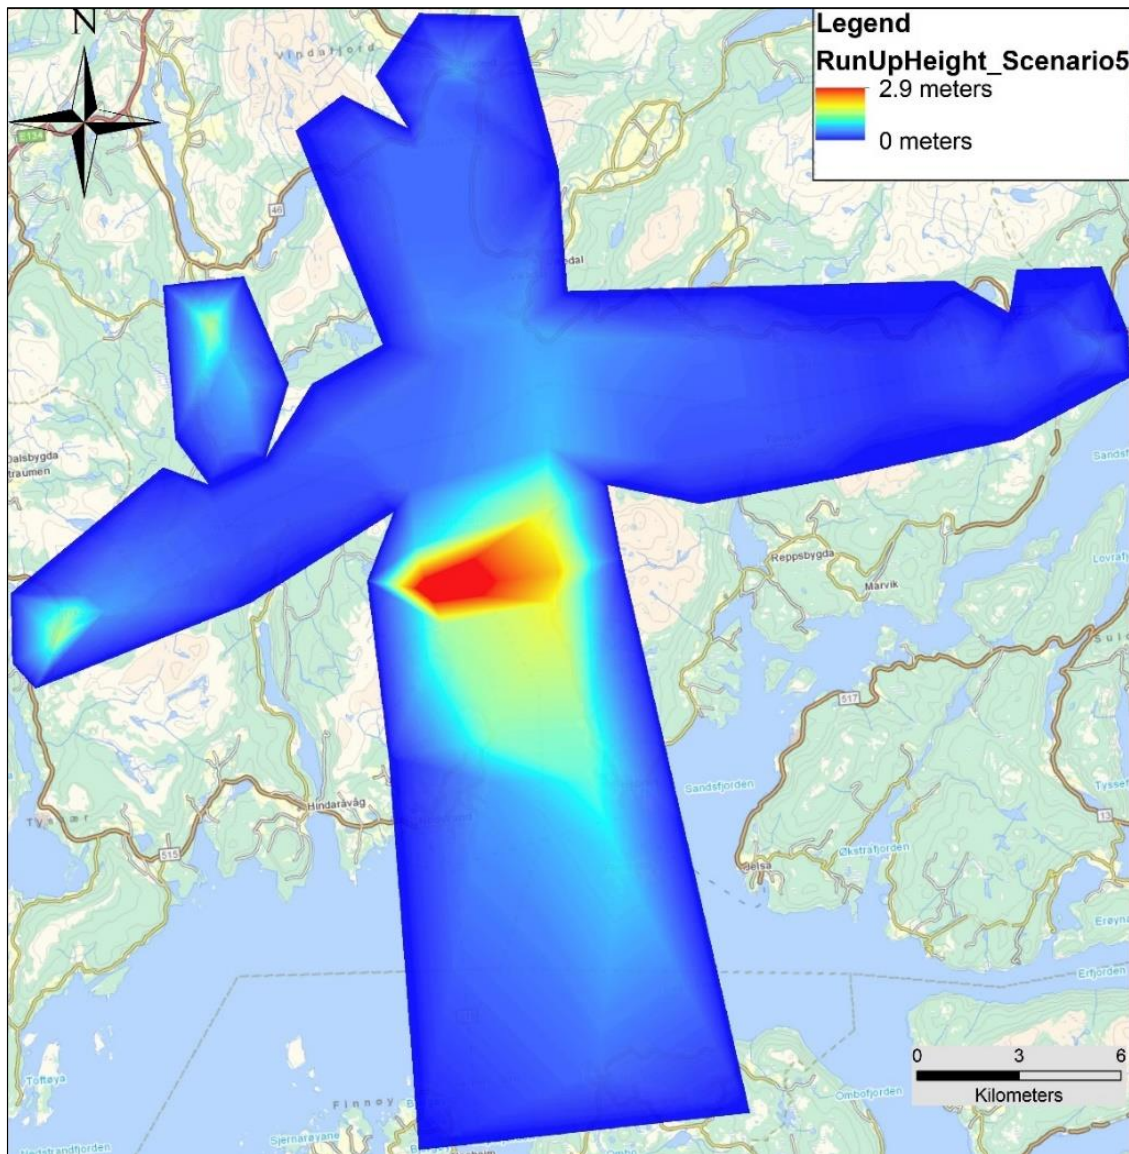
**Figure 4.43:** Results from the VAW analysis showing the run-up heights for scenario 5. Maximum run-up 2.9 meters.

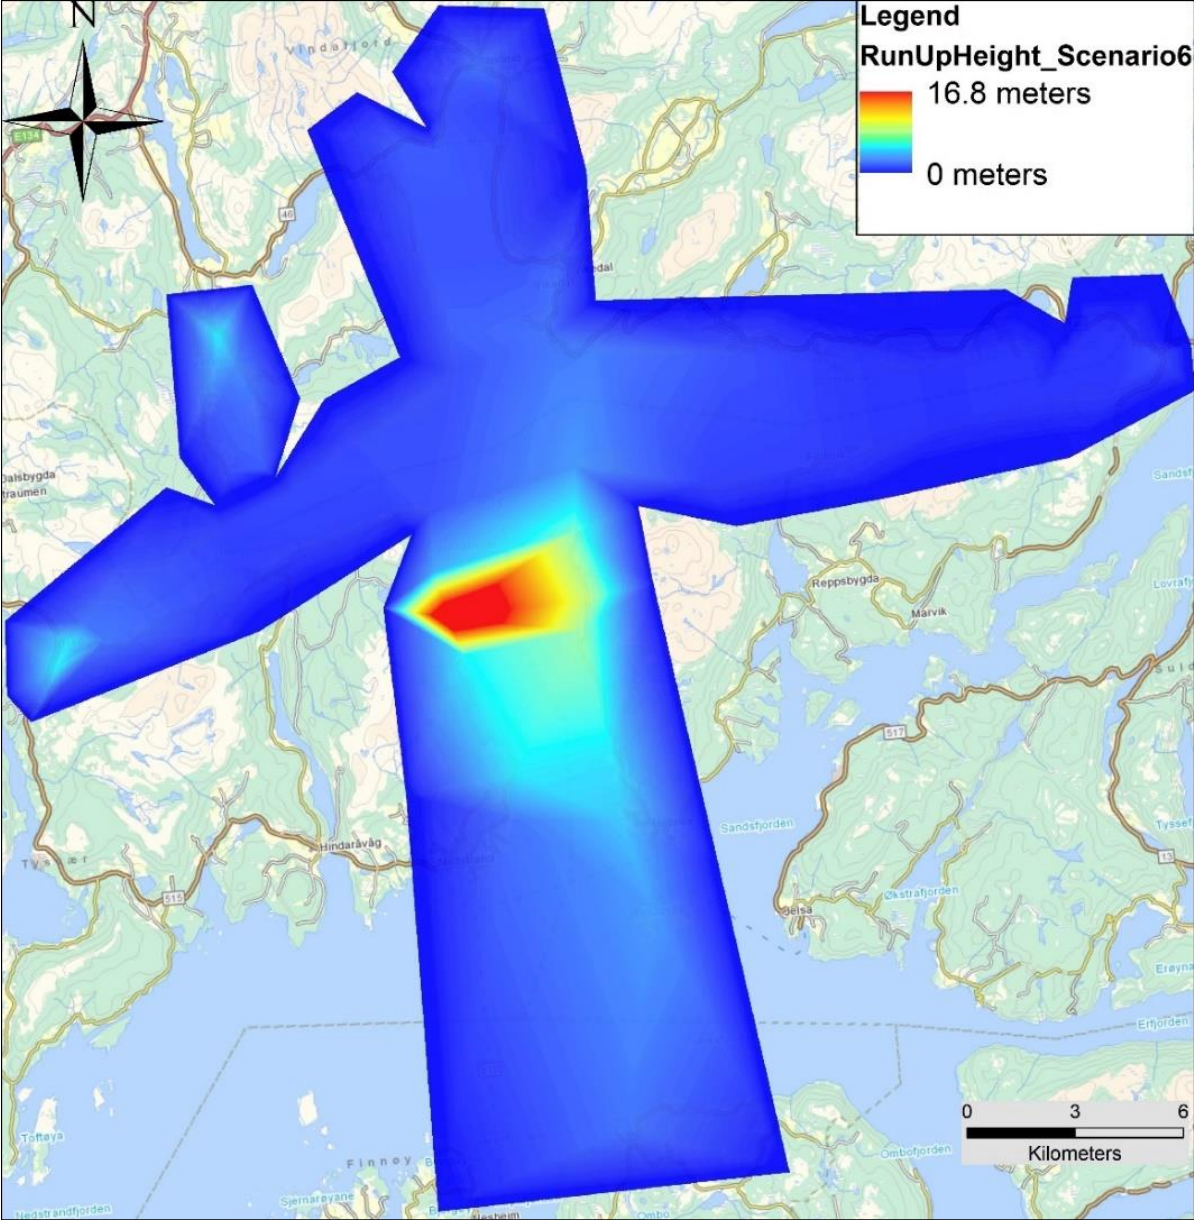
**Figure 4.44:** Results from the VAW analysis showing the run-up heights for scenario 6. Maximum run-up 16.8 meters.

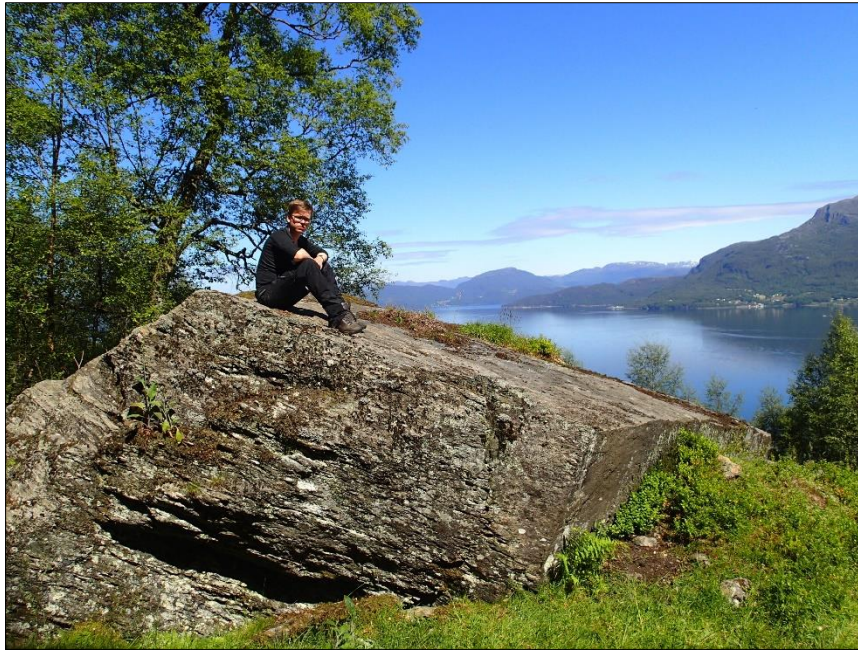
**Figure 5.2:** Picture taken towards north close to location 19 showing large boulder with planar smooth edges. Most likely released along joints.

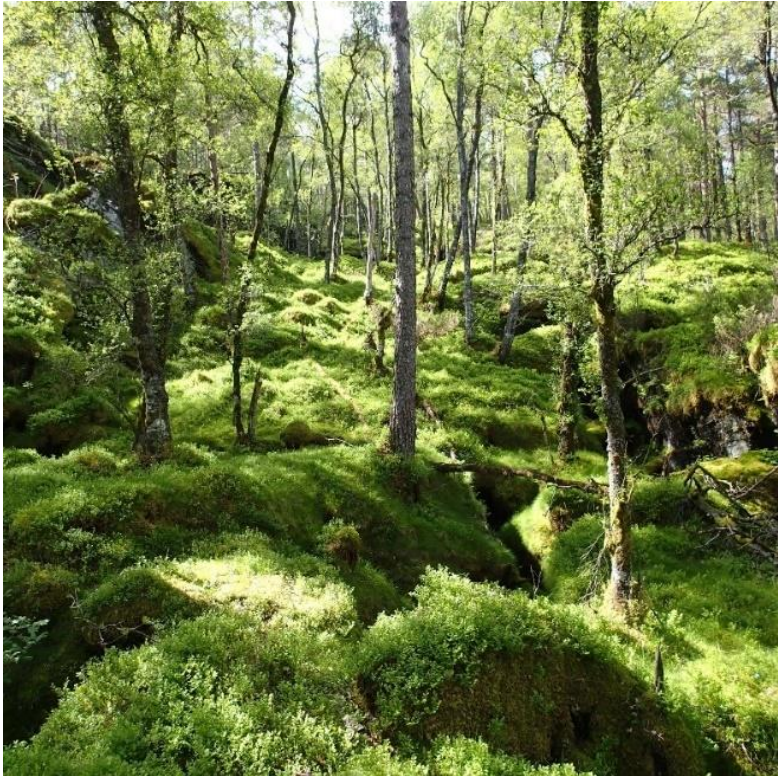
**Figure 7.1:** Photo illustrating the average amount of vegetation in the NE domain.

The most active parts of the slope have no suitable landing area for a helicopter, resulting in more workhours if the monitoring system involves several measuring points in the NE domain. The points closer to the back scarp will require less time for investigation, since suitable landings spots are available. It is important to have information on the displacement pattern before designing a monitoring network (Blikra & Kristensen, 2013). Better knowledge and a substantial reduction of the uncertainties for some of the scenarios are needed before any decision of implementing permanent monitoring can be made.

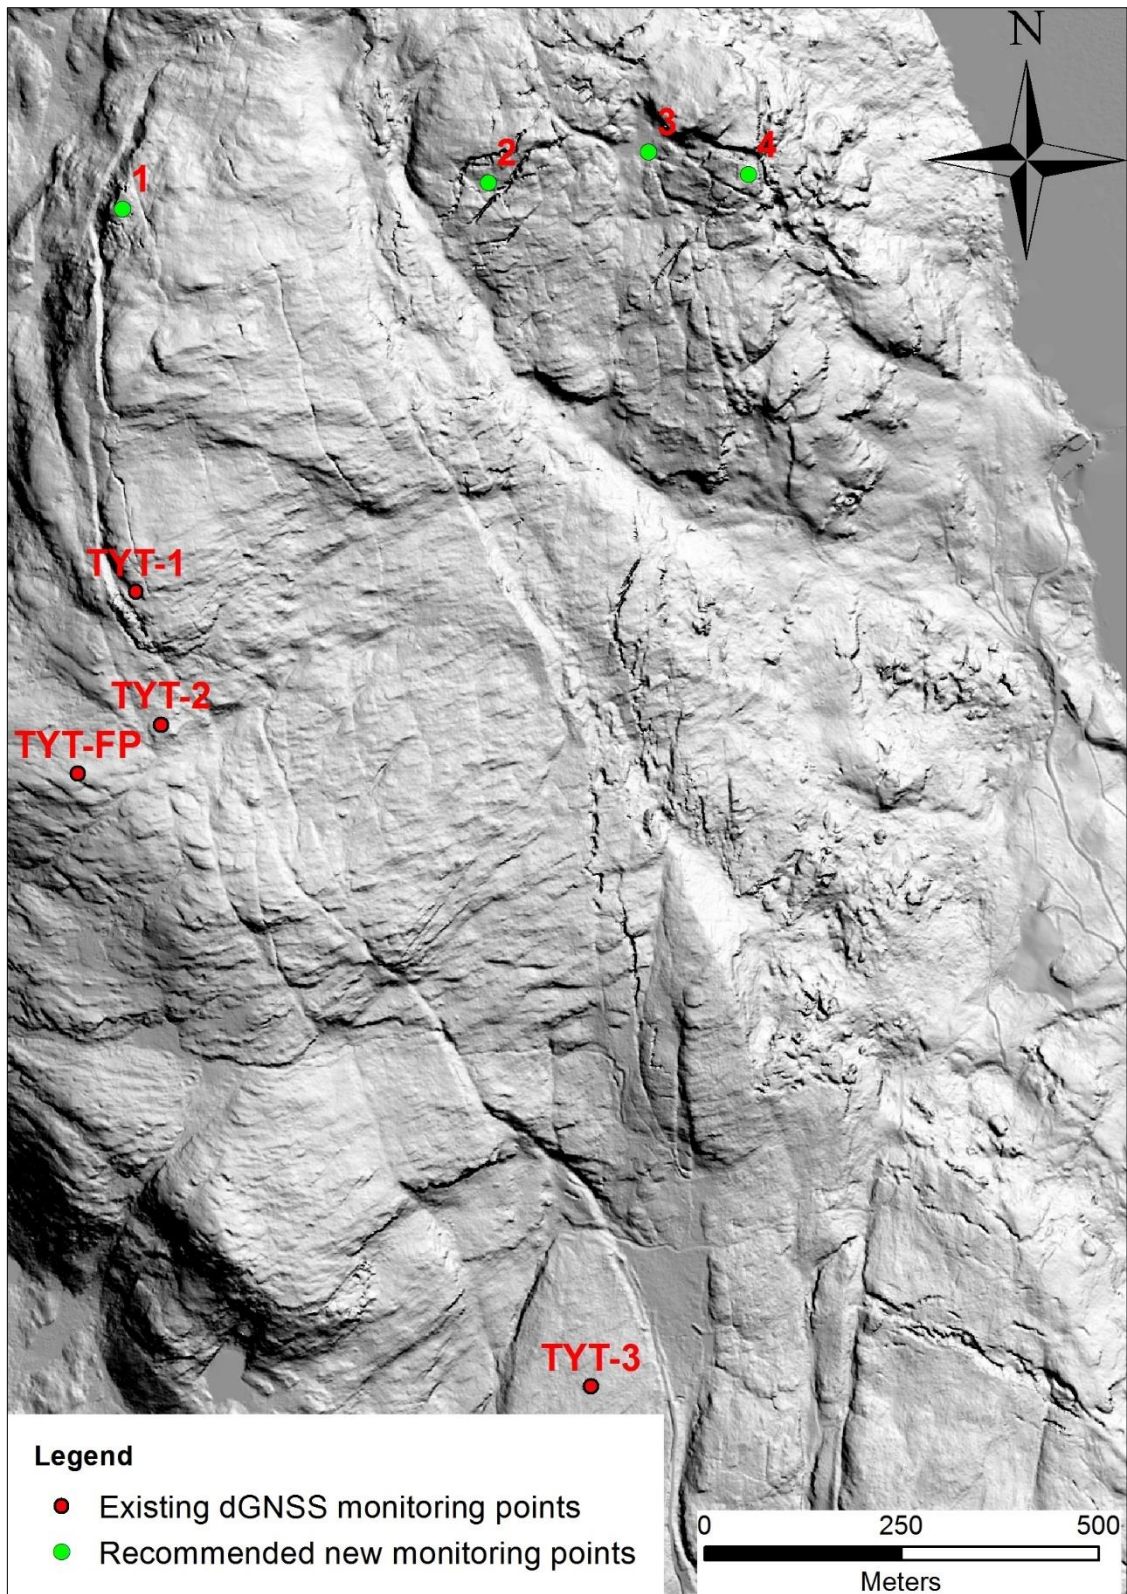
**Figure 7.2:** Location of the existing dGNSS monitoring network. Three rover points are installed in addition to one fixed point marked TYT-FP. In addition, 4 additional monitoring points are suggested to capture the deformation in the most deformed area and along the head-scarp. See text for details.

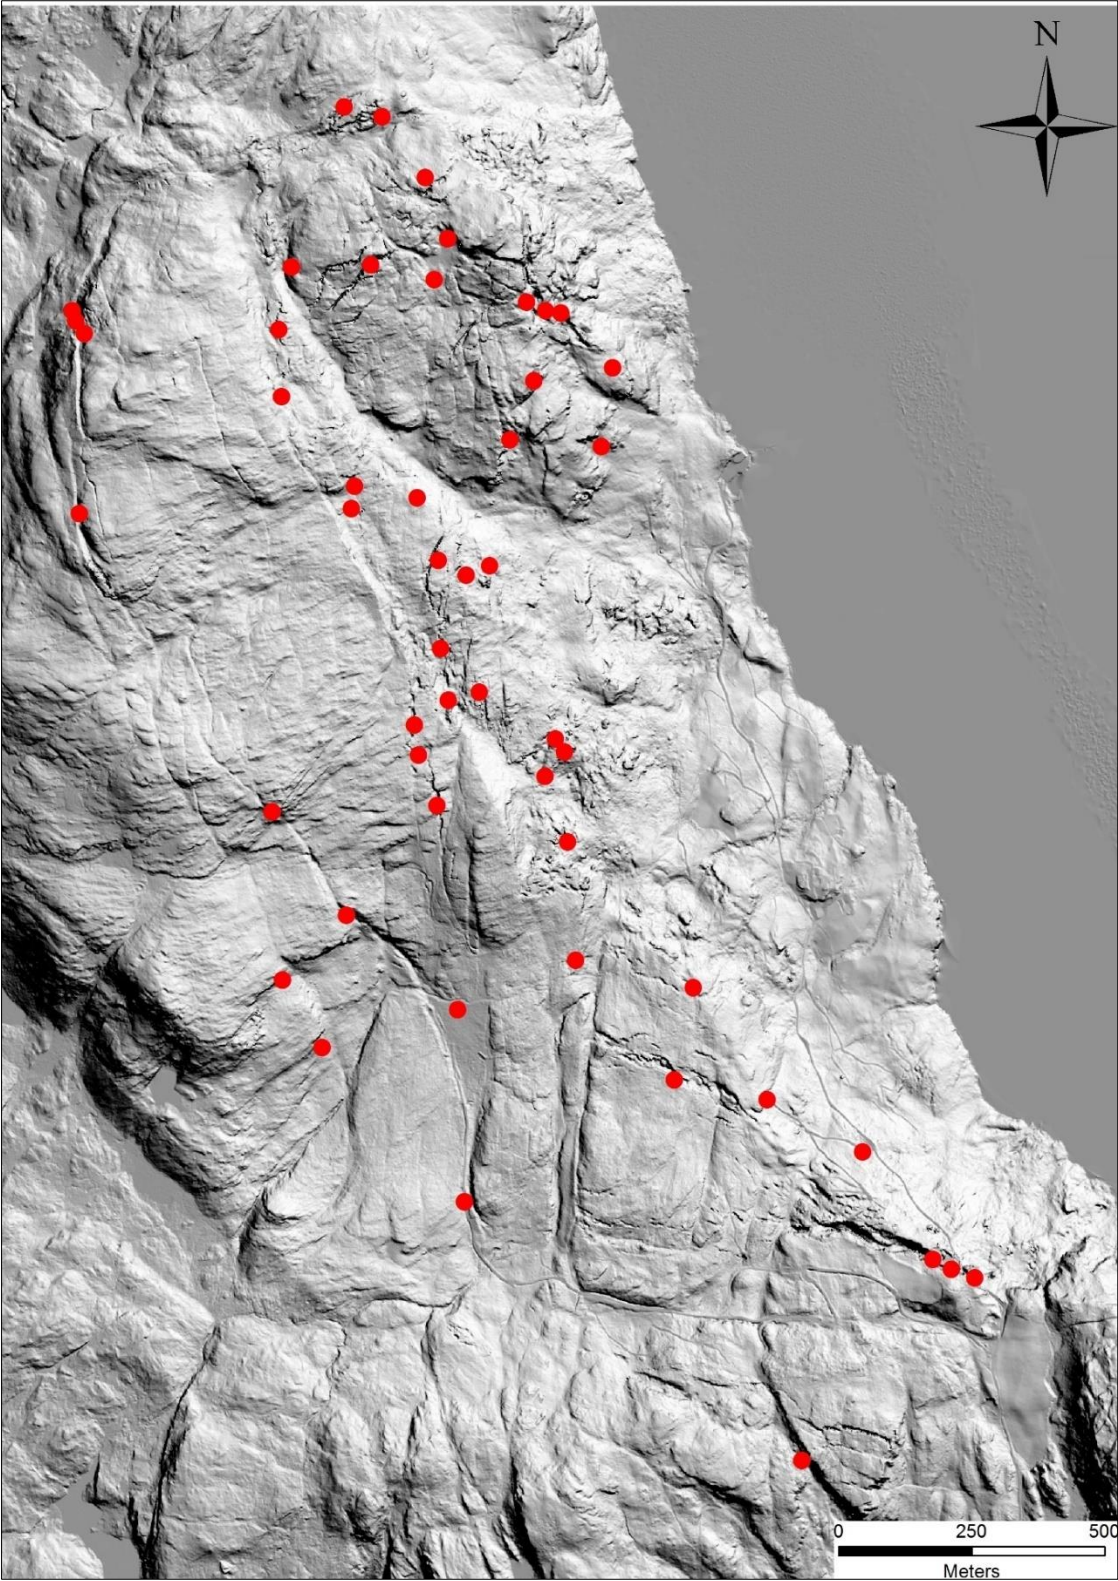
**Figure 8.1:** Outcrops with observed graphite.
