# The Rock Slope Instability at Tytefjell in Vindafjord, Rogaland

Hazard Assessment for Different Failure  
Scenarios

**Øyvind Bertinussen Rem**

Submission date: May 2016

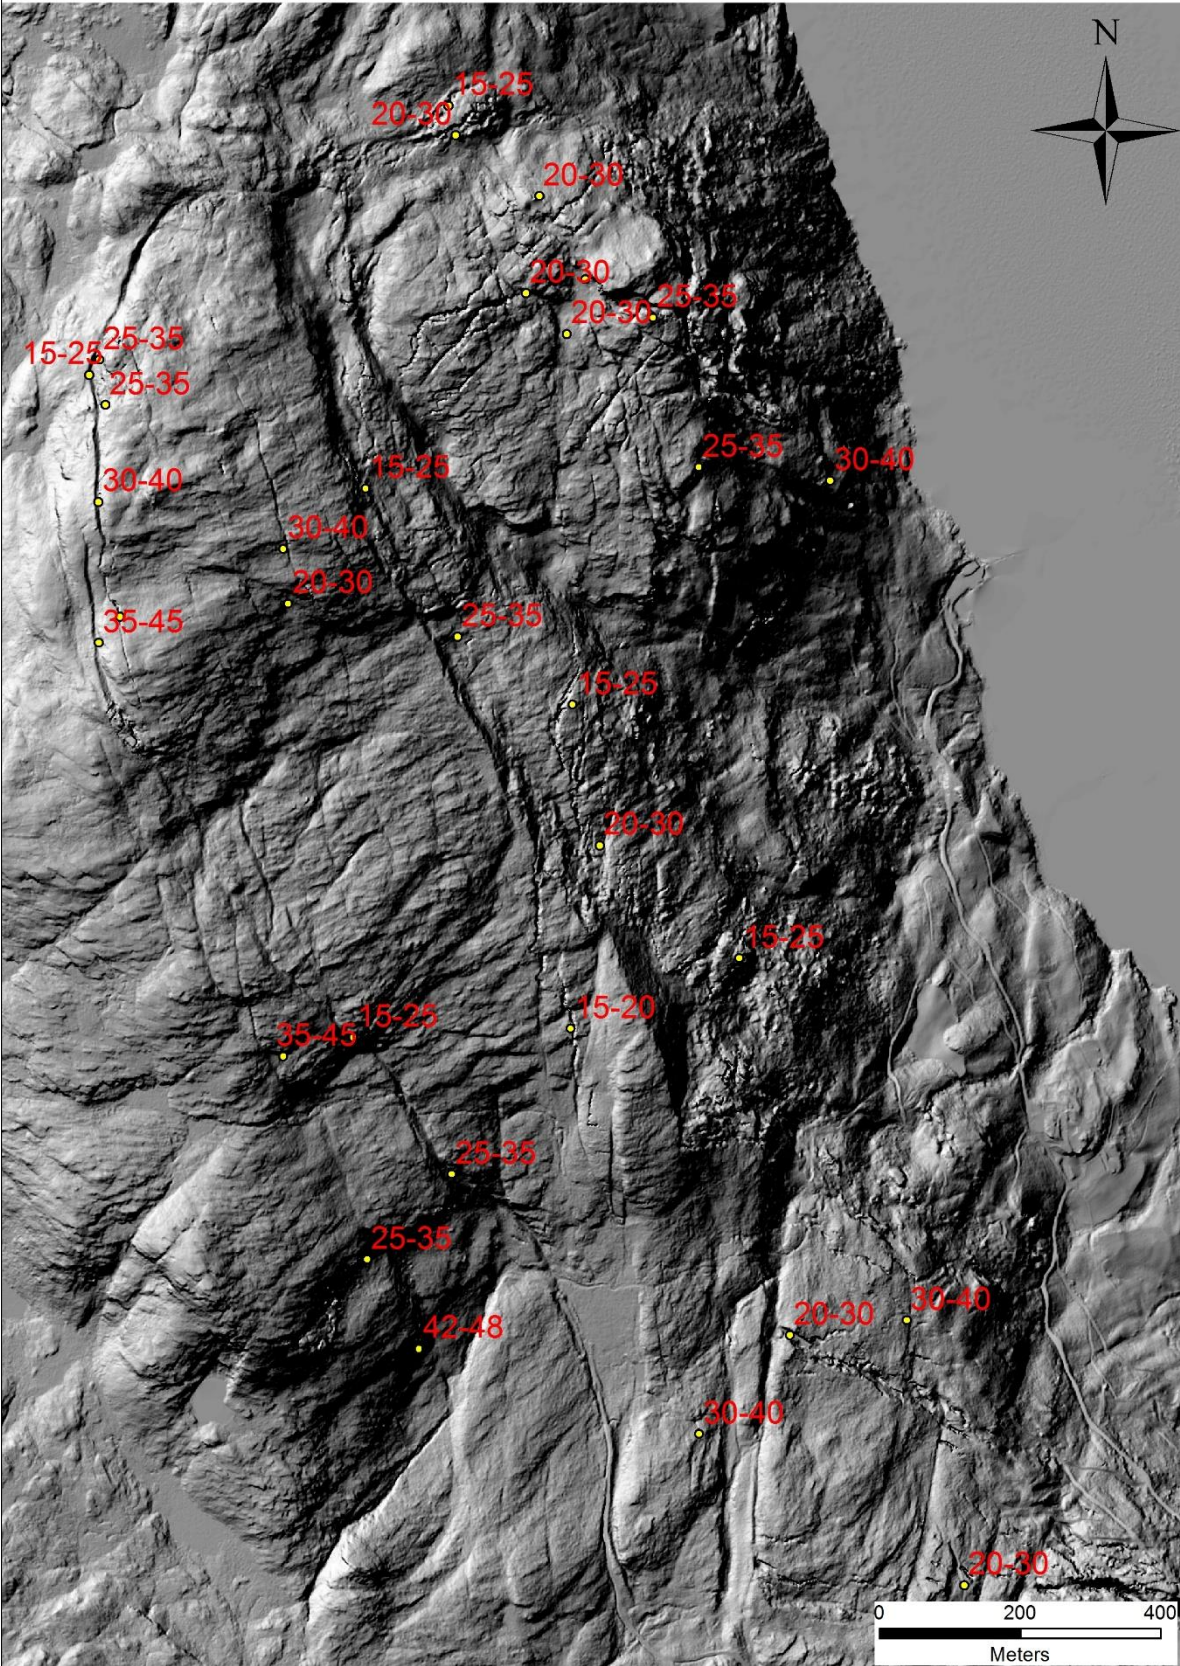
**Figure 8.2:** Overview showing all GSI estimates.

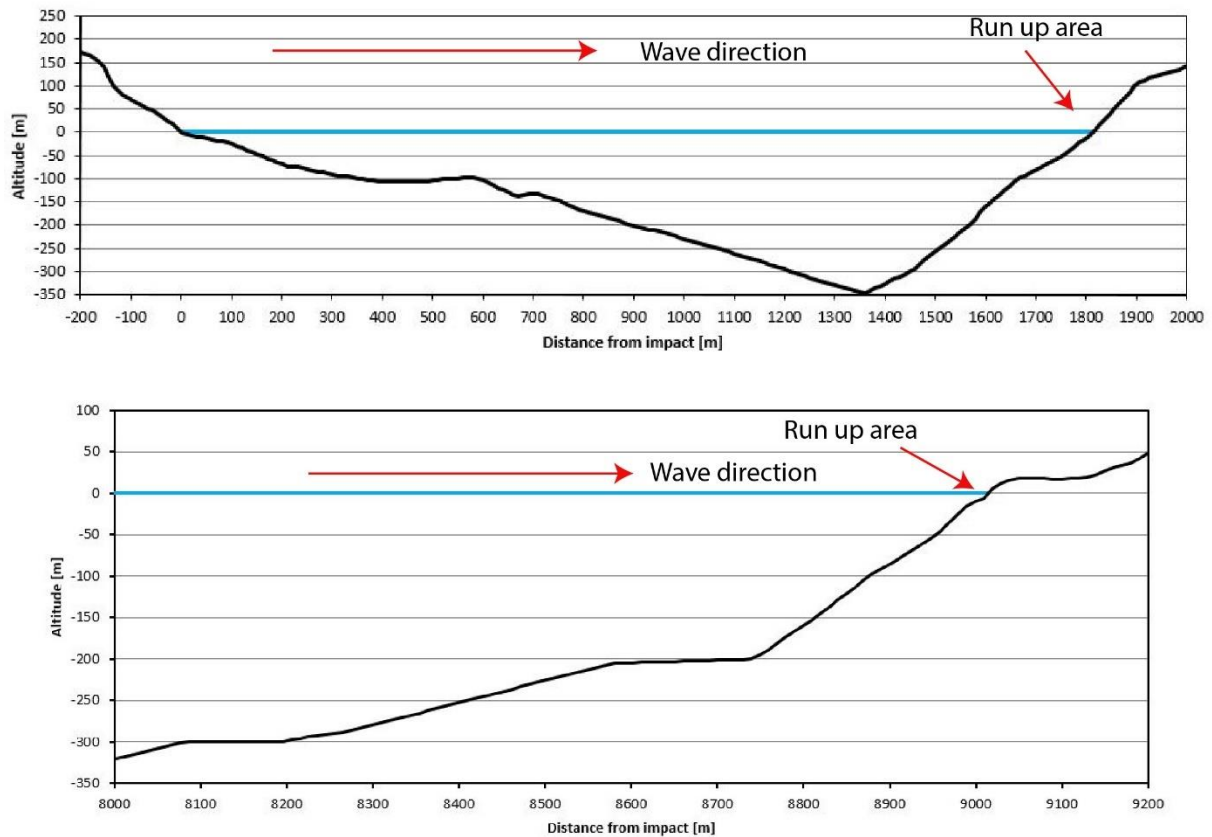
**Figure 8.4:** Figure showing how the run-up slope angles was defined both for the VAW analysis and the empirical analysis. All angles were measured perpendicular to the shoreline since this maximizes run-up. **Top:** If the run-up area consists of a smooth slope, the average angle was used as run-up angle. **Bottom:** If the run-up slope angle increased towards the shoreline, the inclination of the area closest to the run-up was chosen.
