# Wear and corrosion properties of steels used in Tunnel Boring Machines

**Christian Kreyberg Grødal**

Materials Technology

Submission date: June 2012

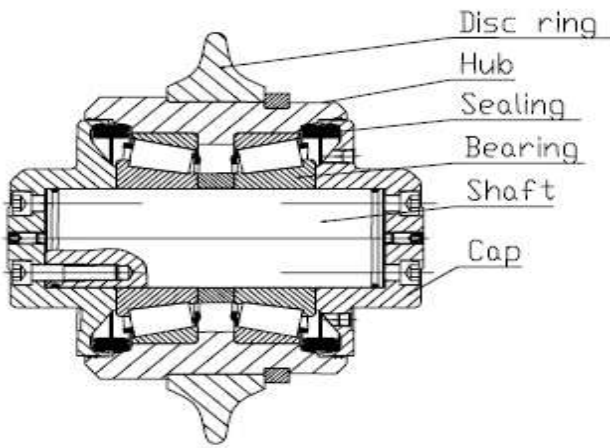
Figure 1 Typical disc cutter design [2].

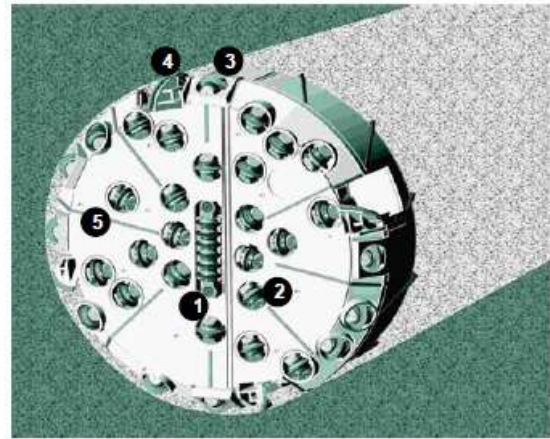
- 1 Centre Cutter
- 2 Face Cutter
- 3 Gauge Cutter
- 4 Scraper
- 5 Wear Plates

Figure 2 Cutter Head front view [2].

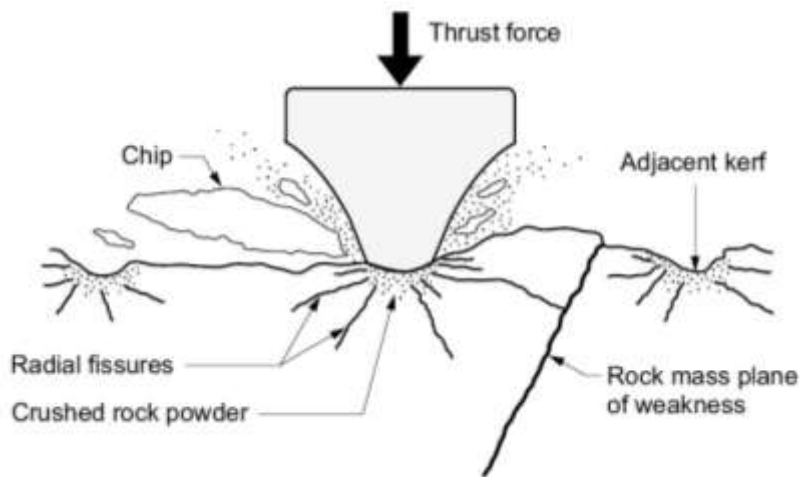
Figure 3 Failure mechanism under the cutter edge [3].

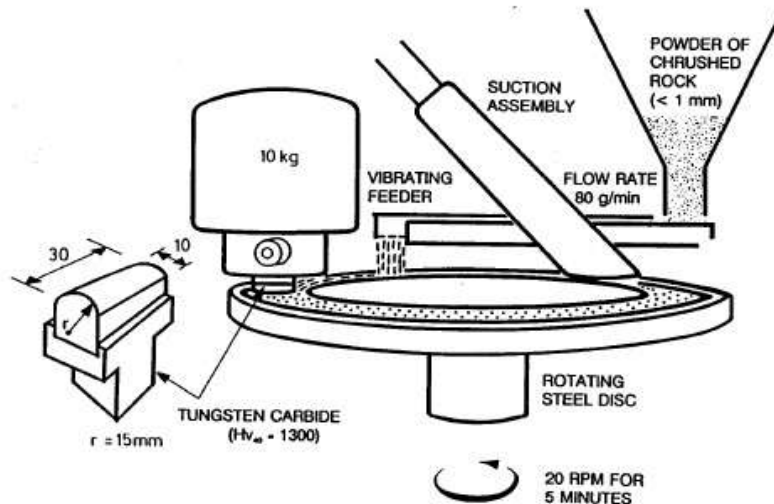
The intact rock surface, fragments of rock and crushed rock powder are causing abrasive wear on the cutters. The toughness, strength and hardness are all influencing the amount of rock and powder produced. While the hardness and the strength are parameters affecting the rock's abrasivity the most. For a rough indication of the abrasiveness of the abrasivity of a rock the Moh's hardness may be used. To obtain a more accurate value it is possible to use the Cerchar test or Abrasion Value test (AV/AVS). Figure 4 shows the Abrasion Value test rig [4].

Figure 4 The Abrasion Value test [4].

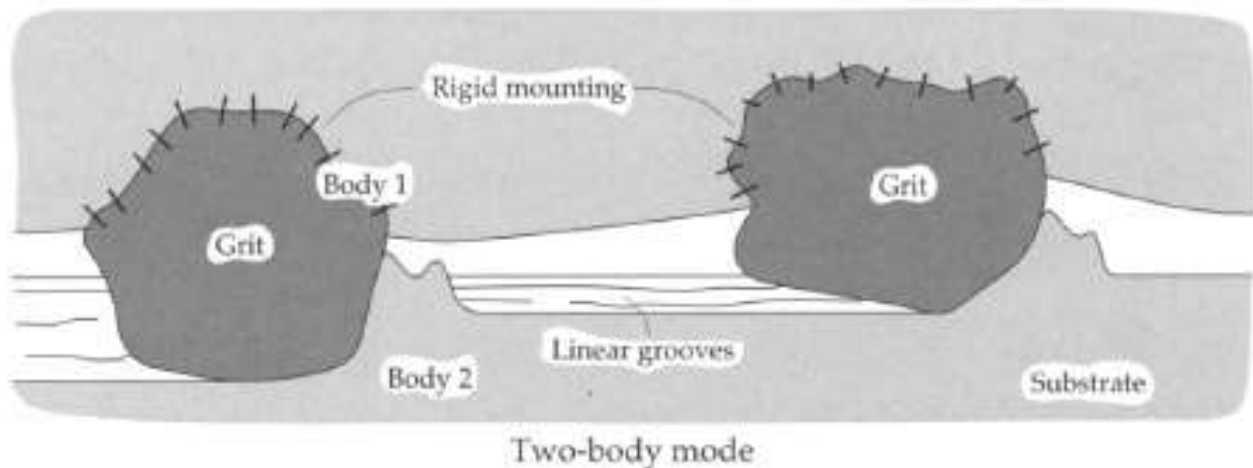
The most common wear mechanism for TBMs is abrasive wear. Abrasive wear occurs on the surface of a component due to relative motion to an adjacent surface with harder asperities or hard particles trapped at the interface [8]. The two modes of abrasive wear are referred to as Two-body and Three-body abrasive wear, as shown in Figure 10 and Figure 11, respectively [7]. The two-body abrasive wear occurs when the harder asperities or firmly held grits act like a cutting tool (Figure 10). Three-body abrasive wear occurs when particles are free to roll and slide over the surfaces of both components (Figure 11). The three-body abrasive wear is ten times lower than two-body wear, this is because three-body wear have to compete with other wear mechanisms. Both these two modes of abrasive wear can occur during tunnel boring. Three-body wear can occur due to chipped hard rock particles present between the rock and steel surfaces. Any particles stuck due to the surface roughness on the rock, are removed by the steel surface. In addition, an increase in the temperature can cause two-body wear to occur. The effect of temperature can be divided into two groups: influenced by the temperature of the surroundings and induced by plastic deformation. For this project the latter case is most relevant, because the temperature of the surroundings is not high enough to affect the steel properties. While there are sufficient plastic deformations present to obtain the temperature needed to soften the steel. The plastic deformations causing increased temperature are often induced by high speeds [7]. However, evidence of localised melting have been found in wear tests at sliding speeds as low as  $1 \text{ ms}^{-1}$  [8]. When the temperature increases because of plastic deformation due to three-body wear, the contact period would be relatively short. This causes only the deformed material to soften, leaving the grits hardness unaltered [7]. Consequently, rock particles that are stuck will not be removed, but rather cause two-body wear increasing the wear on the steel surface.

Figure 10 Two-body wear [7].

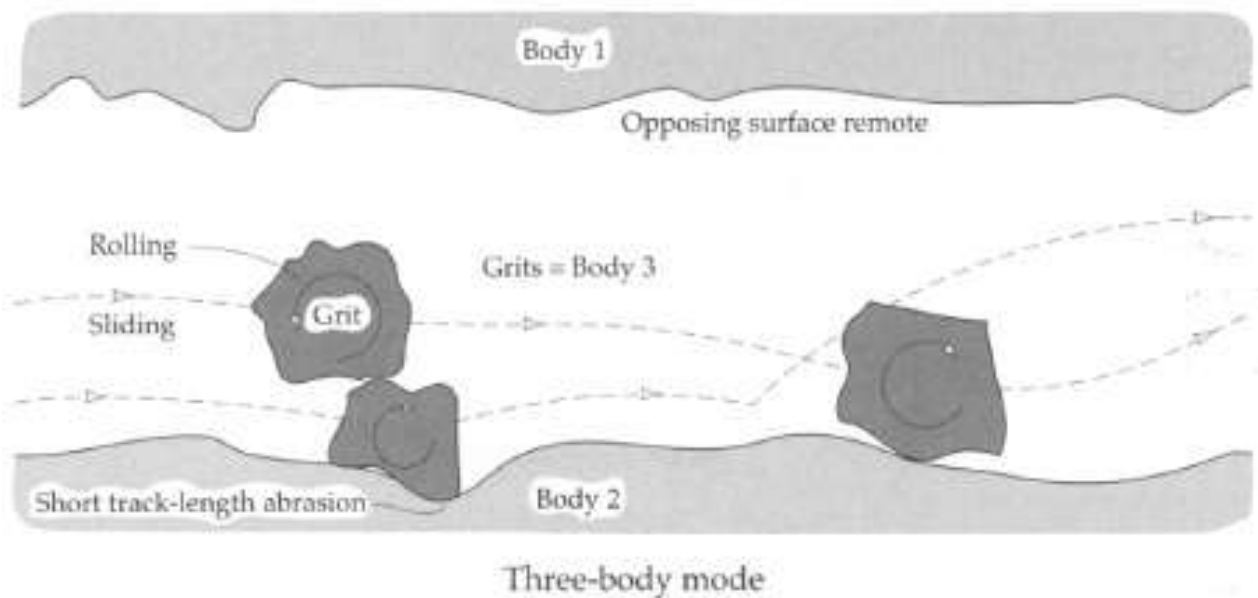
**Figure 11 Three-body wear [7]**

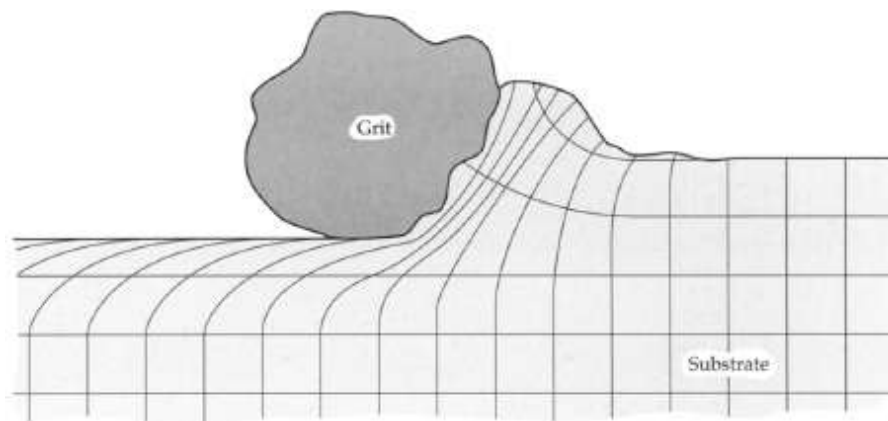
When the harder surfaces asperities are pressed into the softer material in combination with tangential motion, the result is cutting/ploughing removing the softer material [9]. The material underneath the surface exposed to abrasion is plastically deformed. This subsurface deformation causes the occurrence of strain hardening, which may reduce the abrasive wear. This is shown in Figure 12 [7].

**Figure 12 Subsurface deformation by ploughing [7].**

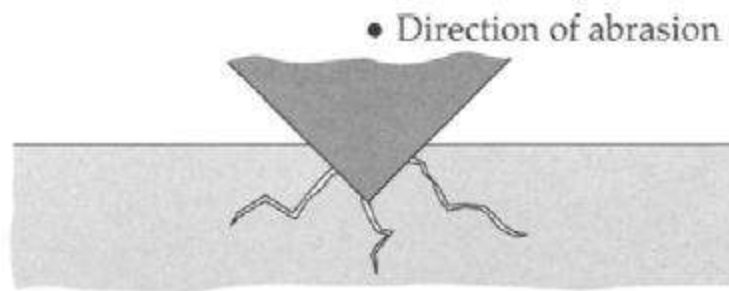
This mechanism is caused by the surface traction exerted by the harder asperities, causing plastic shear deformation of the softer material. As the loading is repeated, deformation is building up. Eventually cracks are formed in the vicinity of already existing voids or inclusions. Once a crack is formed, additional loading cause it to propagate. Consequently, the cracks reach the surface, causing chips to break off [8]. This is shown in Figure 13.

Figure 13 Fracture due to abrasive deformation [7].

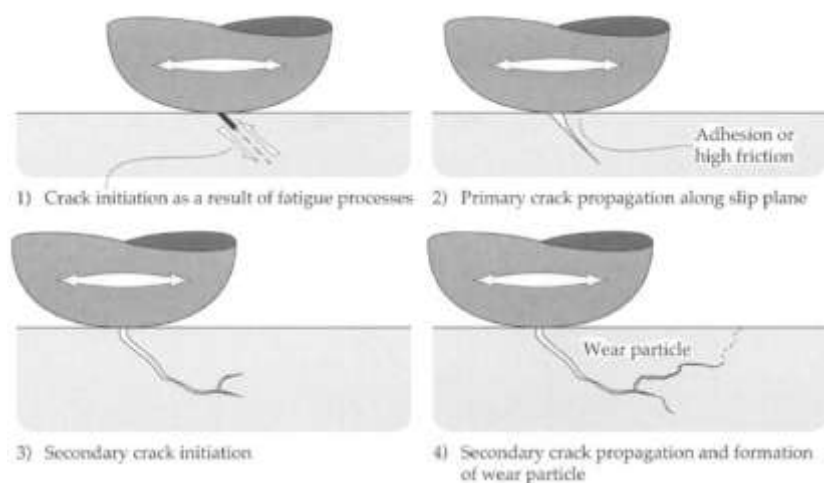
The mechanism of fatigue is similar to that of fracture. Fatigue is caused by repeated strain causing grits or asperities to deform the surface. This will cause cracks to nucleate from material defects. However, unlike fracture, fatigue may eventually occur after being operational for many hours and at a much lower load. Particles from fatigue wear are characteristically much larger than those from plain abrasive wear, and once a particle chip off from one of the surfaces, further deterioration usually follows rapidly [8]. This is shown in Figure 14.

Figure 14 Fatigue wear [7].

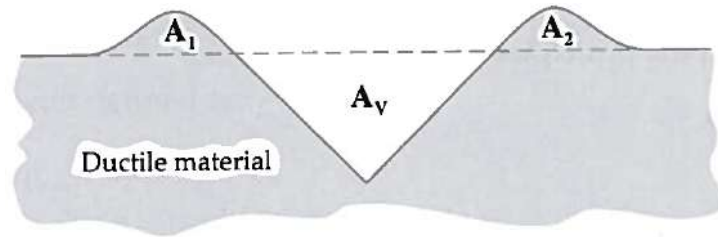
During two-body abrasive wear a large proportion of the abraded material is thought to be displaced to the sides of the grit path, instead of just disappearing. For a ductile material the displaced portion is observed as a pair of walls to the edges of the abrasion groove (Figure 15) [7].

Figure 15 Model of material removal and displacement in ductile abrasive wear [7].

- $A_v$  is the cross-sectional area of the wear groove [ $m^2$ ];
- $(A_1+A_2)$  is the cross-sectional area of the material displaced at the edges of the groove (Figure 15) [ $m^2$ ].

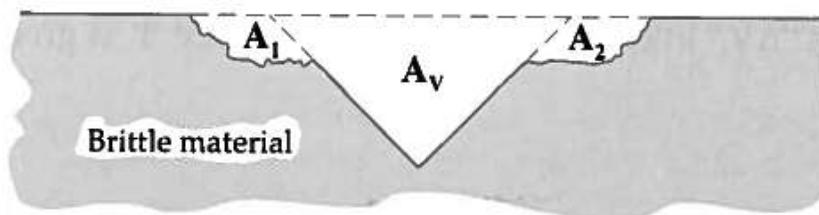
For abrasive wear of brittle materials there is no displaced material at the edges of groove, but rather a widening of the groove due to chipping at the side of the grooves as shown in Figure 16.

Figure 16 Model of material removal in brittle abrasive wear [7].

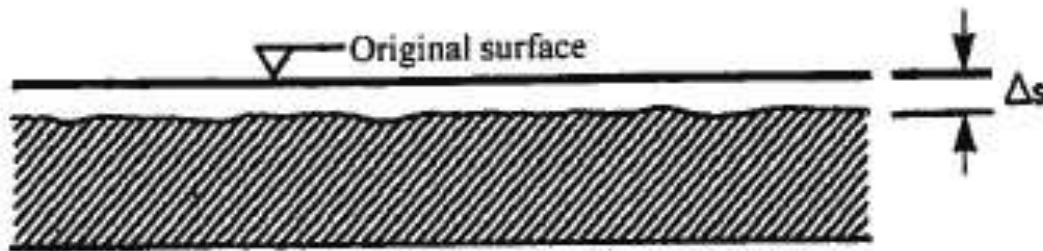
**Figure 18 Uniform corrosion, where  $\Delta s$  is the amount of corrosion occurred measured in millimetres from the original surface. [11].**

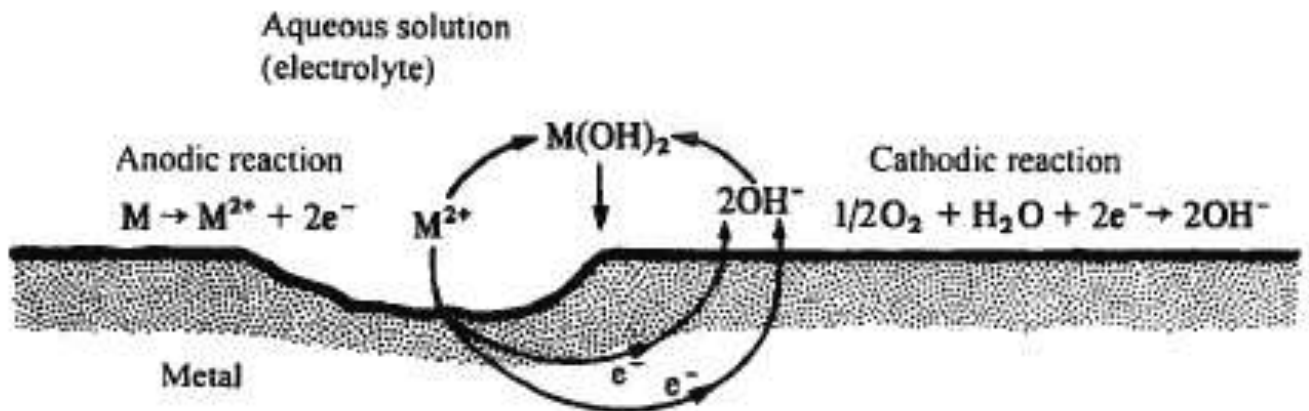
$Fe(OH)_2$  forms a layer/barrier that oxygen has to diffuse through in order to continue the corrosion process further. However,  $Fe(OH)_2$  is not stable and with access to oxygen and water it oxidizes to an iron hydroxide,  $Fe(OH)_3$ , which is the typical red/brown rust [11, 12]. The iron hydroxide film is causing a lowering of the corrosion rate because the diffusion rate of oxygen is also lowered as the film gets thicker [12]. Figure 19 shows the corrosion process present, for a hypothetical divalent metal M.

Figure 19 Corrosion of a divalent metal M in an electrolyte containing oxygen [11].

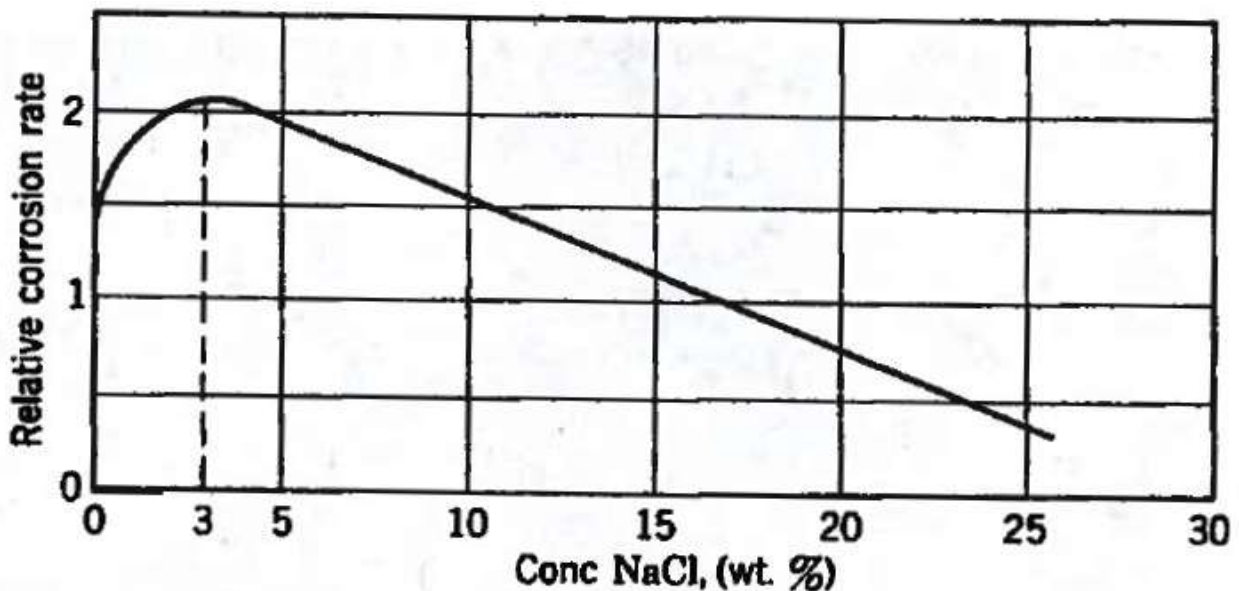
The tests conducted in this master thesis are performed in liquids obtained from real tunnel boring projects. At one of the projects the excavation was performed underneath the sea bed, causing the liquid to contain high concentrations of NaCl. The effect of NaCl concentration on corrosion of iron in air-saturated water at room temperature is shown in Figure 20. The corrosion rate first increases with salt content and then decreases, reaching a corrosion rate at NaCl-saturation (26 % NaCl) that is lower than for distilled water. The corrosion rate is controlled by the oxygen depolarisation (Equation 16) throughout the NaCl concentration range. The reason why the corrosion rate reaches a maximum at about 3 wt. % NaCl and then decreasing are because of this. An increase in the concentration of NaCl results in a decrease of the solubility of oxygen, explaining the lower corrosion rates at the higher NaCl concentrations. The initial rise in corrosion rate can be related to a change in the protective nature the diffusion-barrier rust film that forms on corroding iron. Because of the distilled water's low conductivity, anodes and cathodes must be located relatively near to each other. This causes the formation of  $\text{OH}^-$  ions at the cathode sites in accordance to Equation 18. They are always in the proximity of  $\text{Fe}^{2+}$  ions forming at nearby anodes, resulting in a film of  $\text{Fe}(\text{OH})_2$  adjacent to and adherent to the metal surface. This film provides an effective diffusion-barrier film. However, NaCl solutions have a greater conductivity, thus, additional anodes and cathodes can operate much further apart from each other. At such cathodes,  $\text{OH}^-$  does not react immediately with  $\text{FeCl}_2$  formed at the anodes. Instead, they diffuse into the solution, reacting to form  $\text{Fe}(\text{OH})_2$  away from the surface. Because of this a protective barrier layer does not form at the metal surface. Consequently, more dissolved oxygen can reach the cathodic areas. Above 3 wt. % NaCl the decrease in dissolved oxygen becomes more important than the change in diffusion-barrier layer. Consequently, the corrosion rate decreases [12].

Figure 20 Effect of NaCl concentration on corrosion of iron in aerated solutions, room temperature [12].

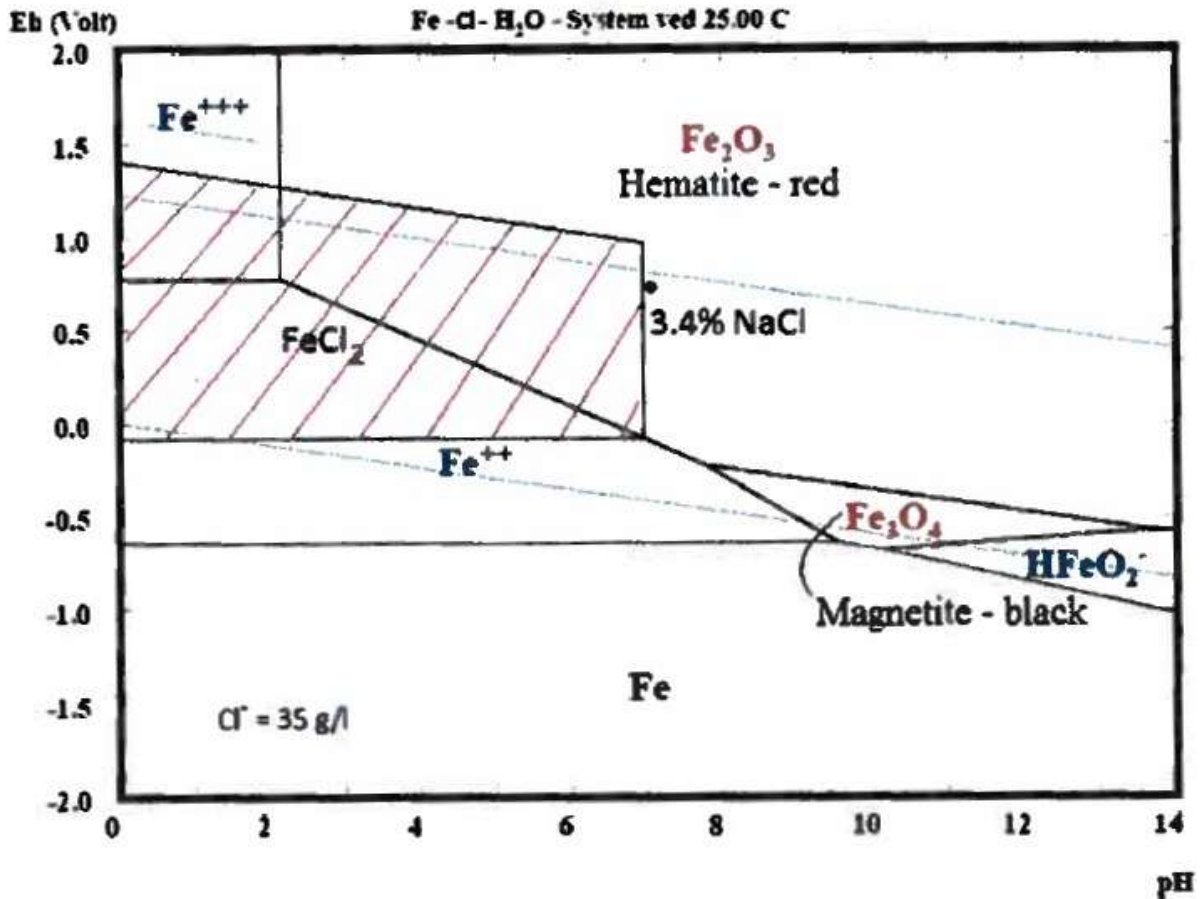
Figure 22 Pourbaix diagram for iron in 3.5 wt. % NaCl at 25° C [13].

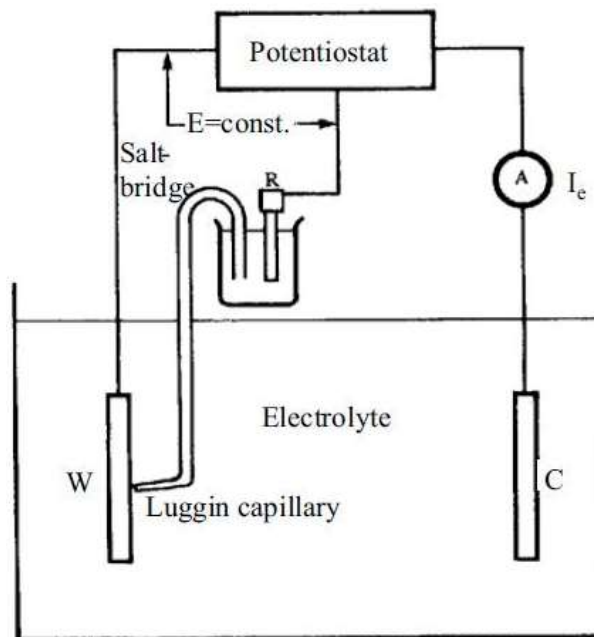
It is possible to determine the corrosion rate of a metal by utilizing polarisation curves. This can be done with a potentiostat, see Figure 24. A potentiostat is an apparatus that holds a set electrode potential over the working electrode-reference electrode cell, and delivers the current demanded to keep it [11].

Figure 24 Wiring diagram for potentiostatic experiments [11].

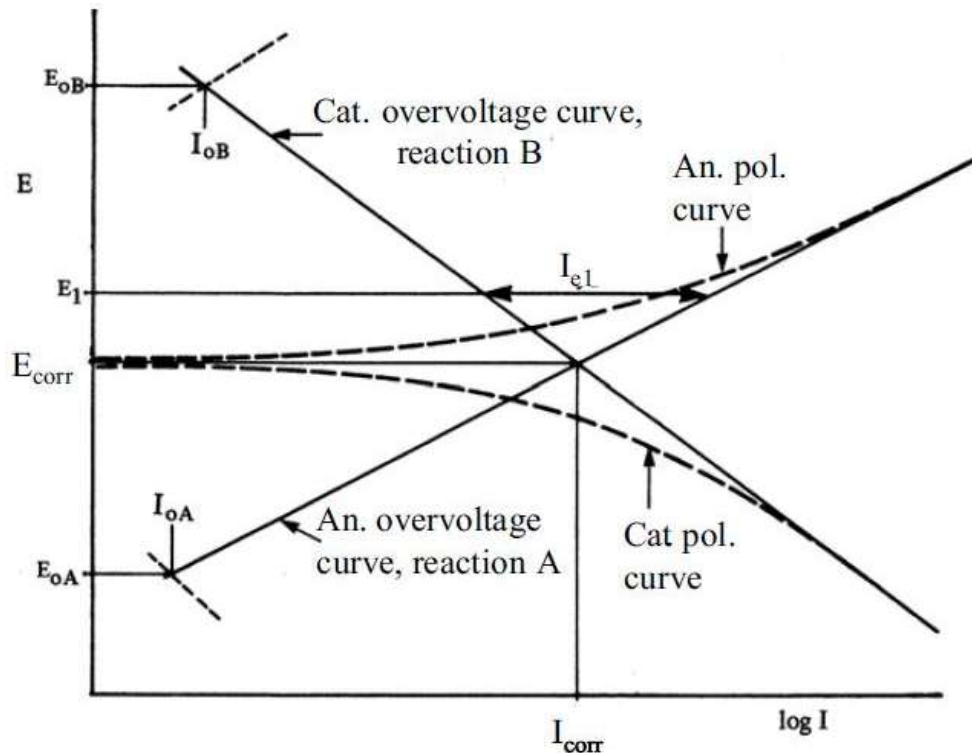
It is assumed that only two reactions can occur on the working electrode, in accordance with the over potential curves and corrosion potential ( $E_{corr}$ ) shown in Figure 25.

**Figure 25 Overvoltage curves and corresponding polarization curves [11].**

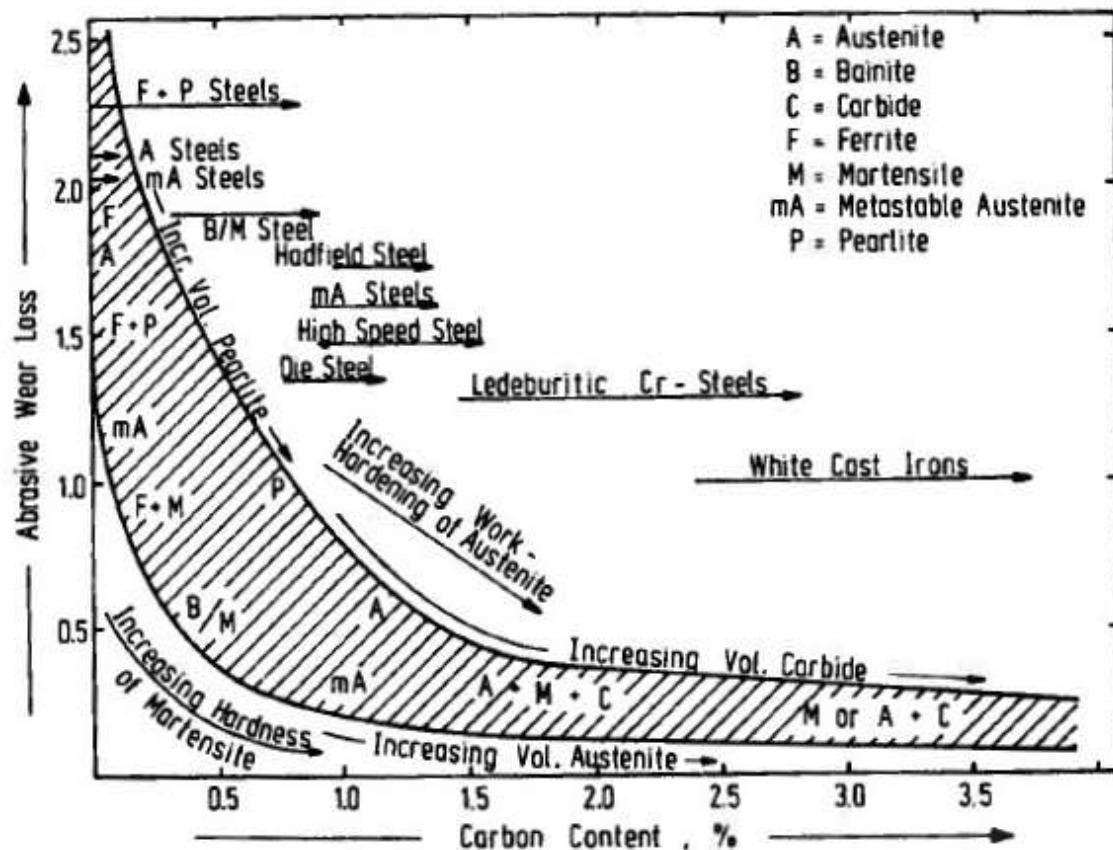
Earlier studies have shown that the abrasive wear resistance of iron alloys increase with increasing carbon content. This may, among other, be due to the increasing work hardening capability of austenite or increasing hardness of martensite. Figure 28 shows the abrasive wear loss of iron alloys as a function of carbon content. However, it is important to remember that the wear loss at a given carbon content can differ considerable due to the microstructure of the alloy [16].

Figure 28 Abrasive wear loss of iron alloys measured by using a pin abrasion test versus carbon content of different Fe-alloys [16].

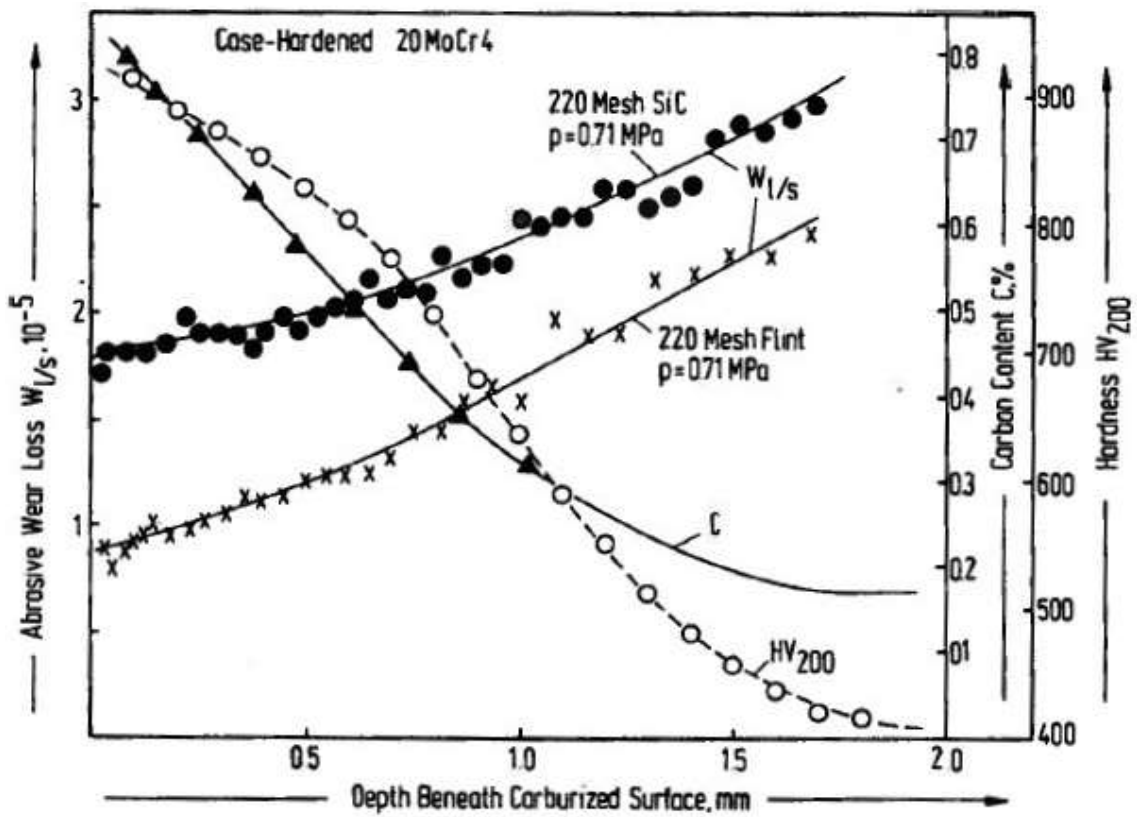
Figure 29 Abrasive wear loss measured by a pin abrasion test, carbon content and hardness of a carburized steel, as a function of depth below the carburized surface [16].

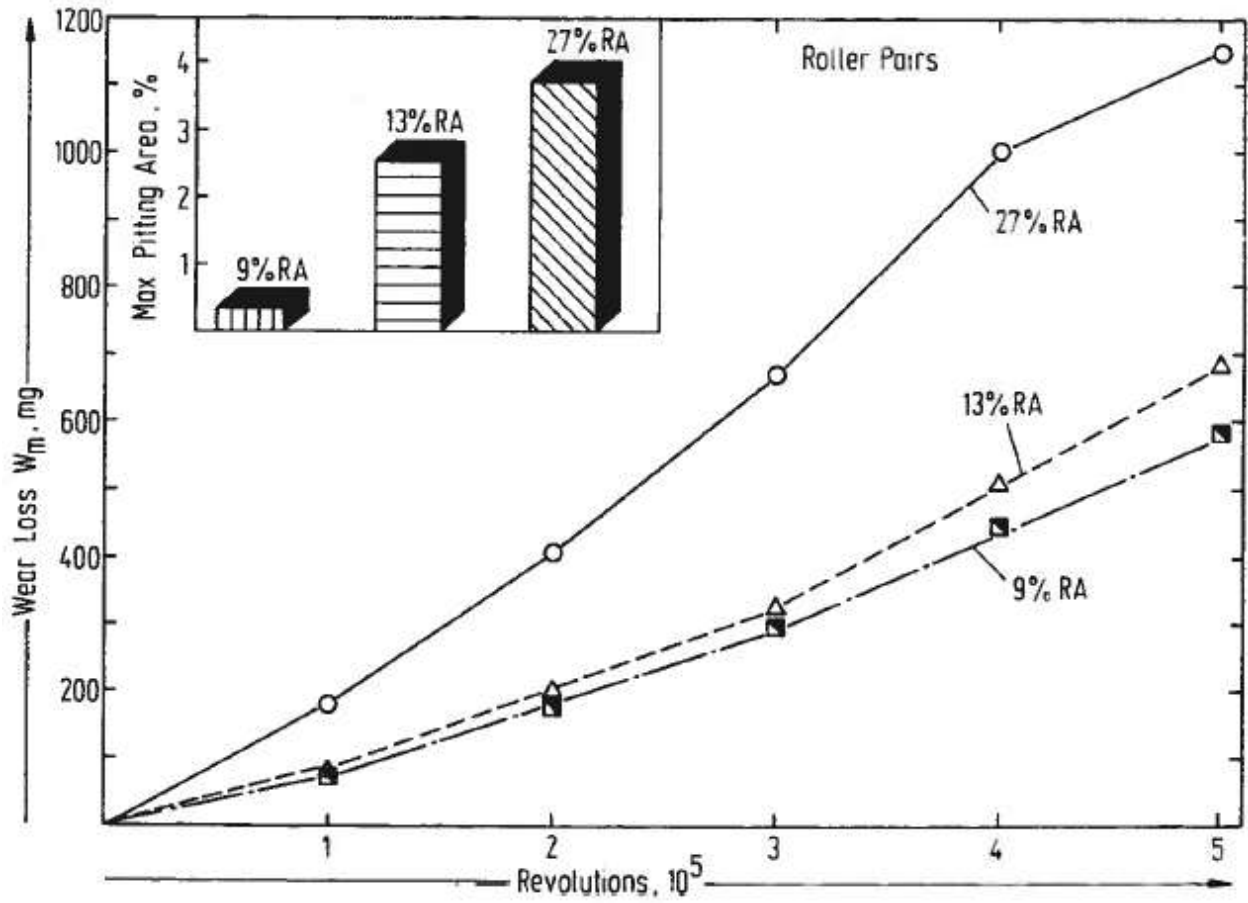
Figure 30 Mass loss and maximum area of pitting of steel containing different amounts of retained austenite, as a function of revolutions [16].

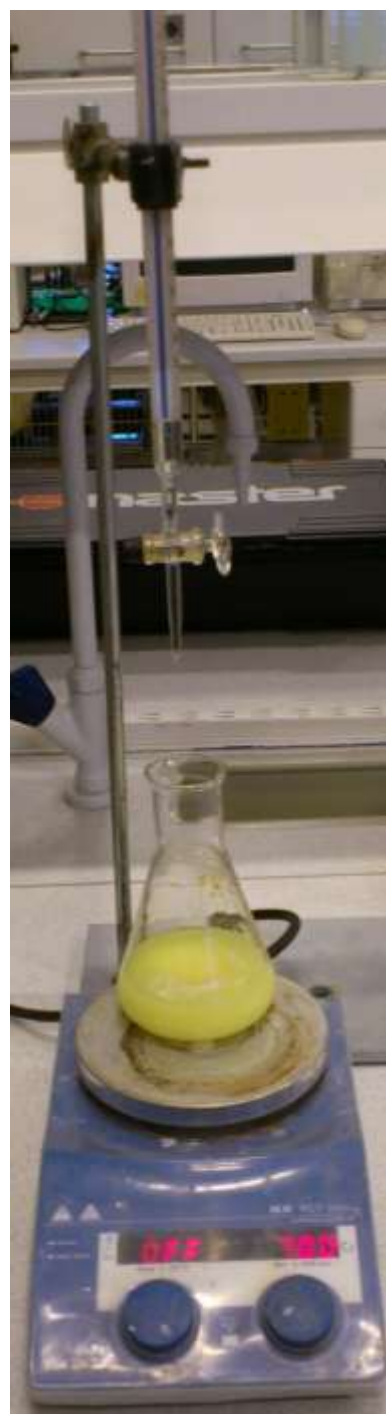
Figure 31 Titration setup.

To determine the amount of chloride in the water samples obtained from the field trips, precipitation titration was carried out. The test setup is shown in Figure 31.

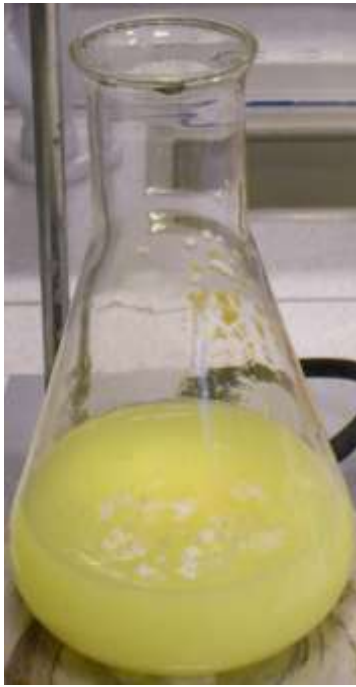
Figure 32 Solution with white  $\text{AgCl}$  precipitate.

The titration method used determines the amount of chloride ions by adding a  $\text{AgNO}_3$  (silver nitrate) solution. The  $\text{AgNO}_3$  solution is slowly added to the samples, forming a white silver chloride precipitate (Figure 32) according to Equation 27.

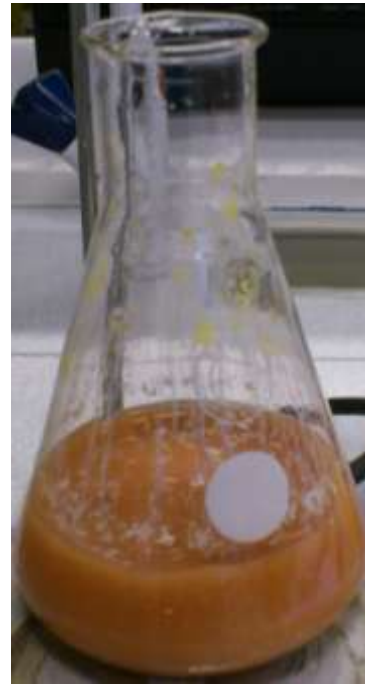
Figure 33 Solution with red  $\text{Ag}_2\text{CrO}_4$  precipitate.

To determine when all the chloride ions have reacted to silver chloride, a  $\text{K}_2\text{CrO}_4$  (potassium chromate) solution was added to the sample. This caused any excess  $\text{AgNO}_3$  added to react with the  $\text{K}_2\text{CrO}_4$ , forming a red  $\text{Ag}_2\text{CrO}_4$  precipitate (Figure 33) according to Equation 28.

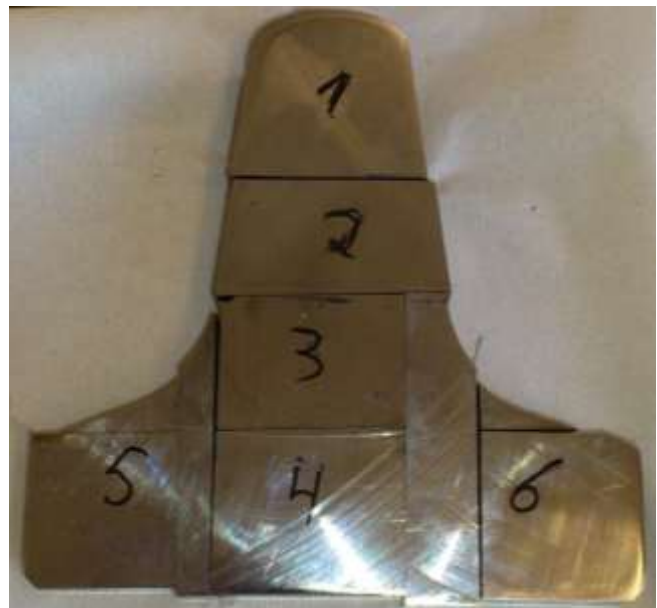
Figure 34 Cross-section of cutter tool with the hardness measurement areas.

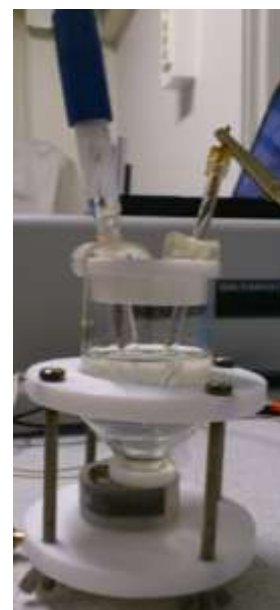
Figure 36 The cell setup used in this master thesis.

In order to determine the polarisation curves of the steel used in this master thesis, a potentiostat was used (Figure 35 and Figure 36). The polarisation curves were obtained by applying voltage  $\pm 700$  mV from the  $E_{\text{corr}}$  and with a speed of 5 mV each second, both in the anodic and cathodic areas. The potentiostat and software used in this test were AUTOLAB and Nova version 1.5, respectively.

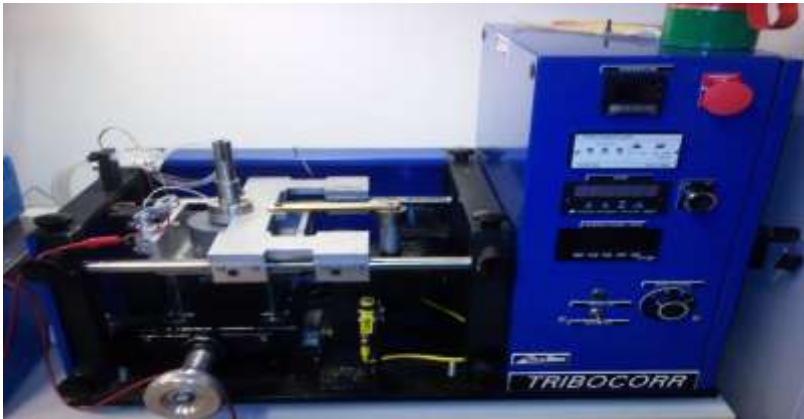
Figure 37 ResMat Tribocorr.

The test rig used to determine the abrasion-corrosion properties of the cutter steel was a ResMat Tribocorr, Figure 37. The test was performed by sliding a steel ball back and forth with a stroke length of 10 mm, see Figure 38. During the tests rocks obtained from a tunnel boring site at the Faroe Islands were exposed to dry conditions, liquid solutions obtained from the same site as the rock samples and a mixture of 50 vol.% of the liquid solution and 50 vol.% foam additive. The foam used was MEYCO ABR 5 [18]. This foam is used in rock tunnelling. The water used had a pH value of 7.7.

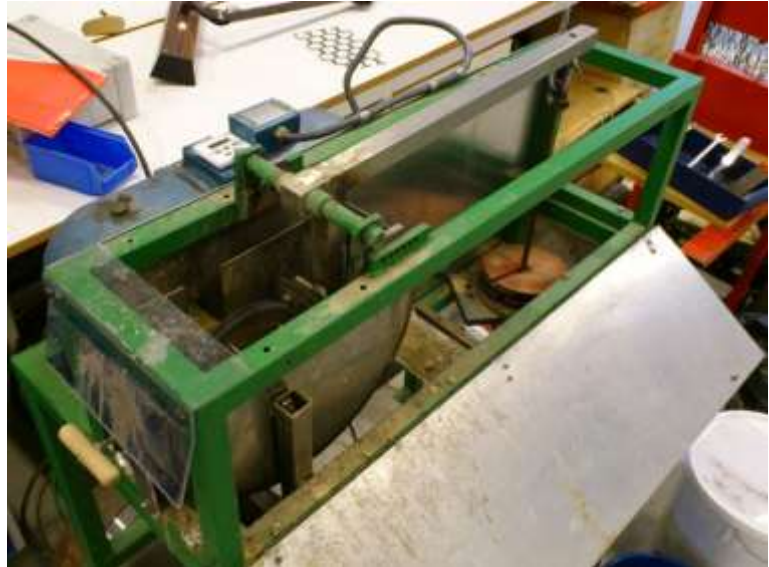
Figure 39 Picture of the Rubber Wheel test setup used.

To test the abrasivity of the soils, a Rubber Wheel test rig was used (Figure 39 and Figure 40). The tests are performed by applying a force of 220N between the rubber wheel and the specimen, and rotating the rubber wheel. The rubber wheel has a durometer hardness of 70 and rotating at about 200 revolutions per minute (rpm). The rubber wheel diameter is 7 inches, consequently, a rotating speed of 200 rpm is equivalent to about  $2 \text{ m/s}$ , which is within the range of what a cutter disc may be exposed to during boring.

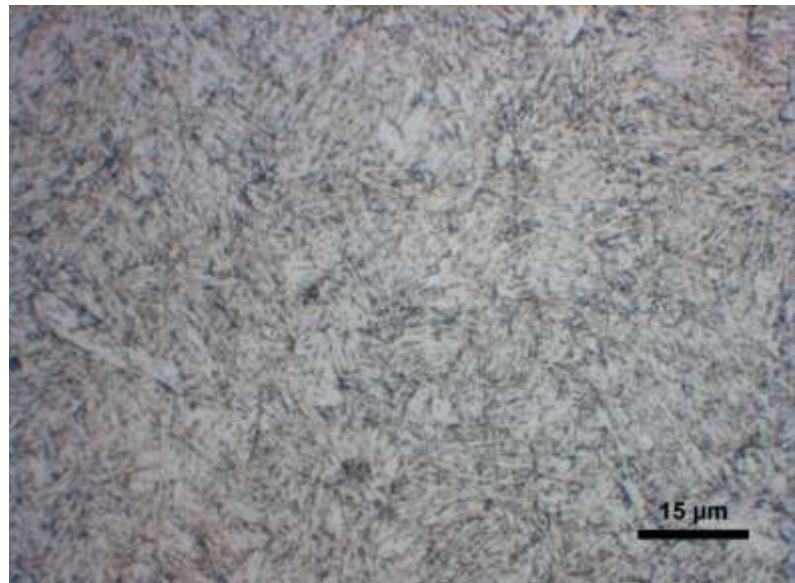
**Figure 42 Picture of the microstructure taken in an optical microscope.**

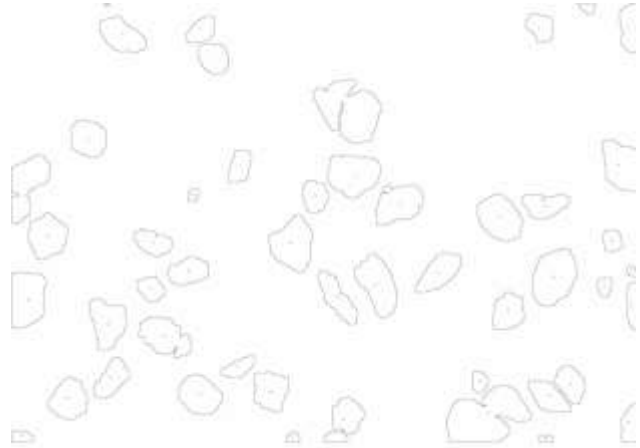
Figure 44 Outlines of the particles from a SEM picture, used for calculating shape descriptors in ImageJ.

Figure 43 shows the SEM picture of the sand from Israel used to determine the shape of the particles by use of ImageJ. ImageJ marked the outlines of the particles (Figure 44) and calculated several shape descriptors. Figure 45, Figure 46 and Figure 47 shows that the Aspect Ratio, roundness and form factor, respectively, are spread over a wide range.

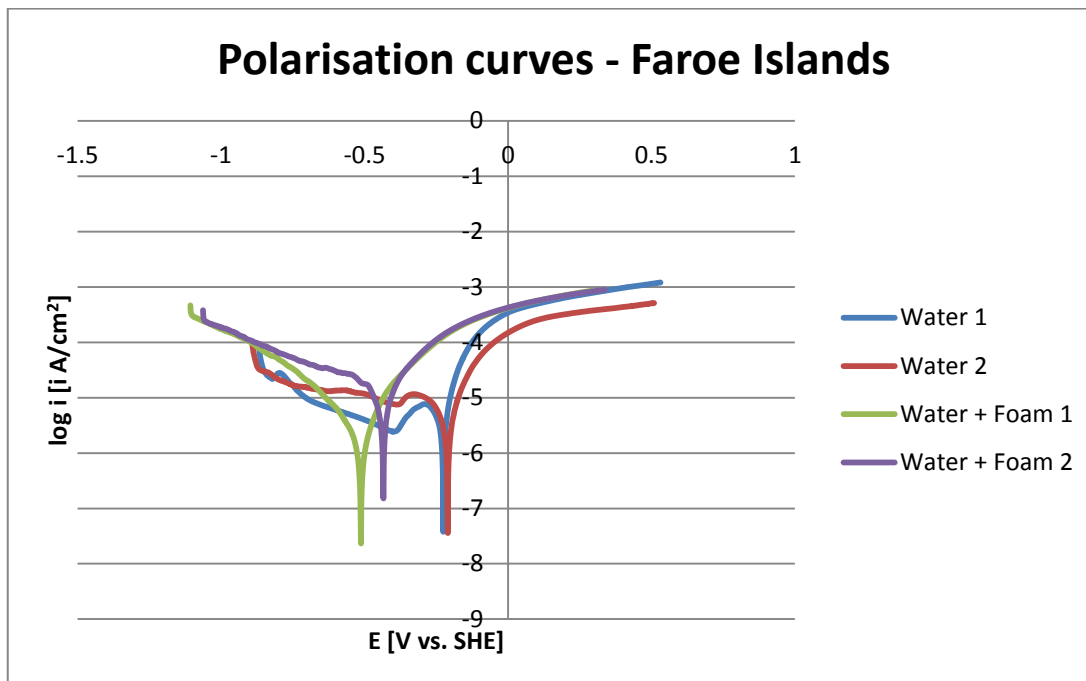
Figure 48 Polarisation curves for the water from the Faroe Islands.

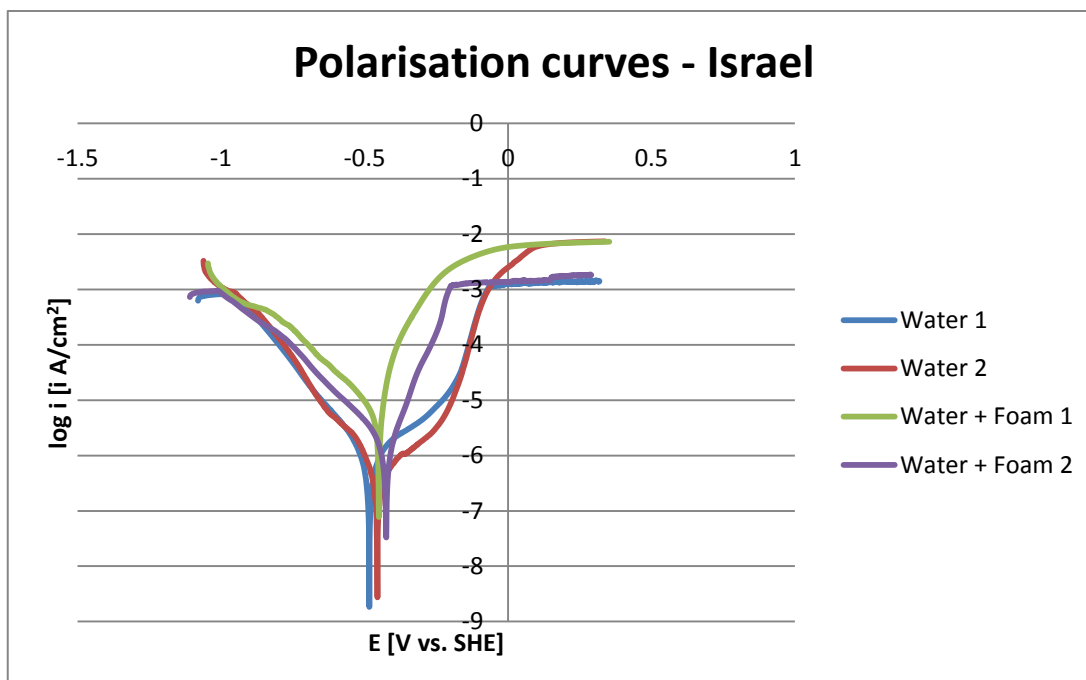
Figure 49 Polarisation curves for the water from Israel.

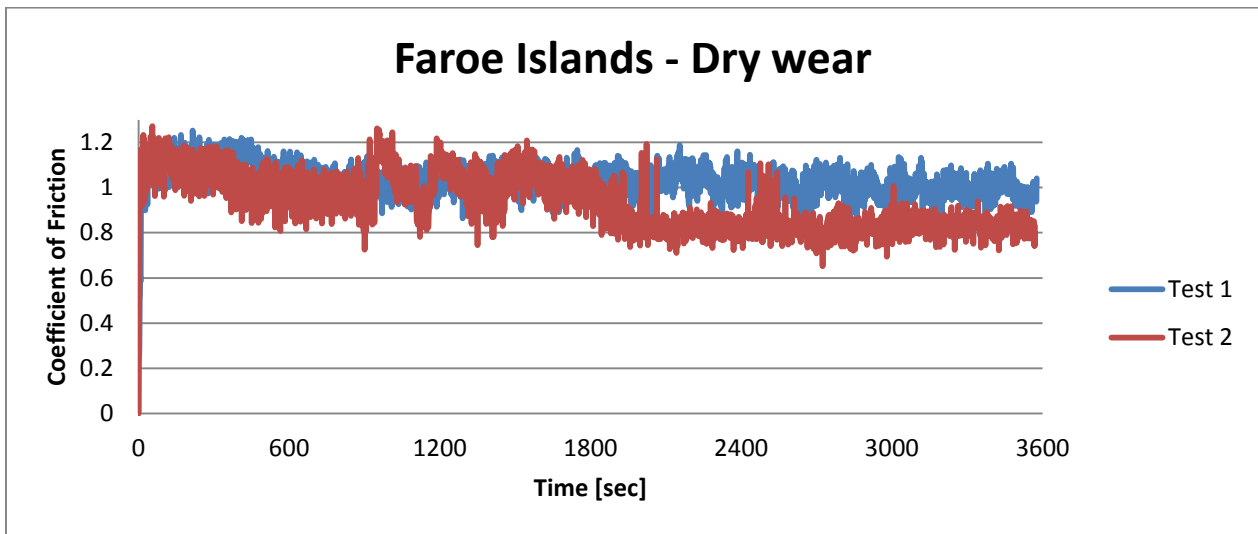
**Figure 50 Friction coefficient graphs for dry rubbing steel ball on rock.**

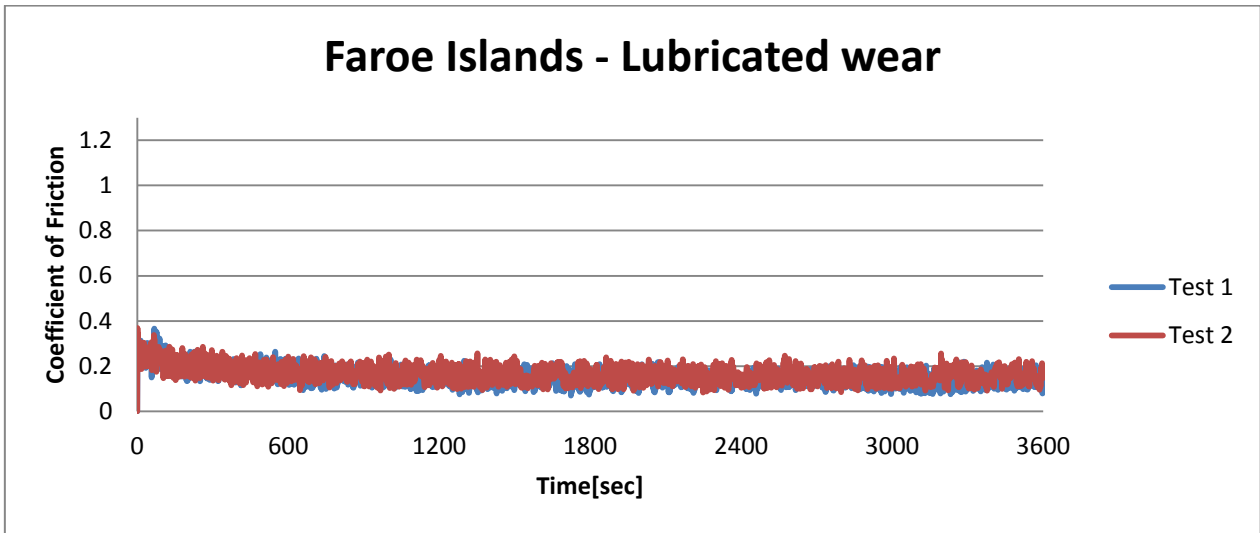
Figure 52 Friction coefficient graphs for lubricated rubbing steel ball on rock.

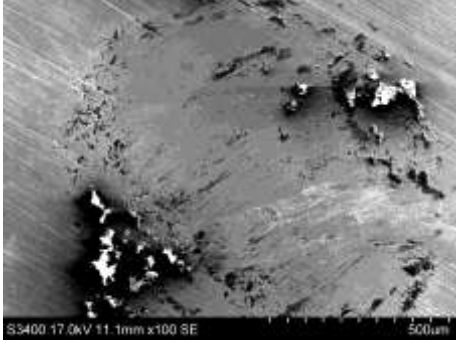
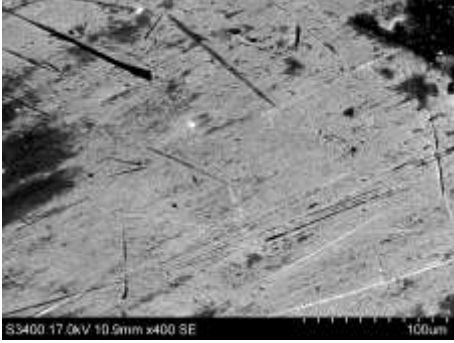
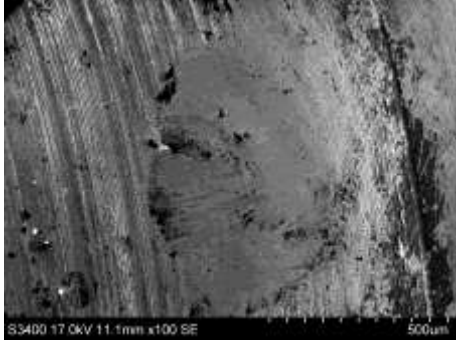
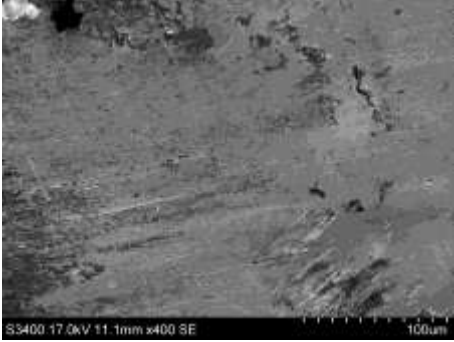
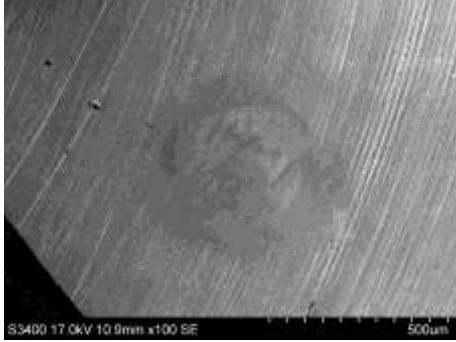
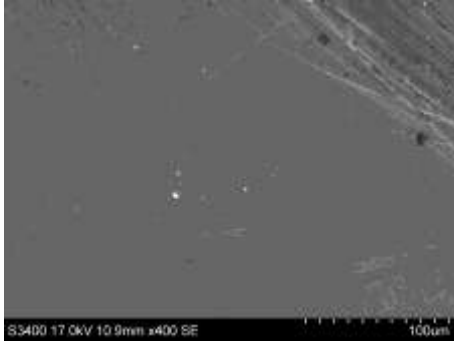
<p><b>Figure 53</b> Wear track on the steel ball from dry wear at 100X magnification.</p>

<p><b>Figure 54</b> Wear track on the steel ball from dry wear at 400X magnification.</p>
Wet wear (water)

<p><b>Figure 55</b> Wear track on the steel ball from wet wear, lubricated with water, at 100X magnification.</p>

<p><b>Figure 56</b> Wear track on the steel ball from wet wear, lubricated with water, at 400X magnification.</p>
Lubricated wear (foam)

<p><b>Figure 57</b> Wear track on the steel ball from lubricated wear at 100X magnification.</p>

<p><b>Figure 58</b> Wear track on the steel ball from lubricated wear at 400X magnification.</p>

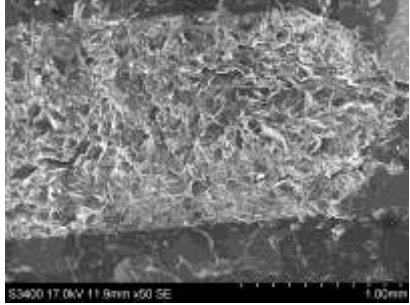
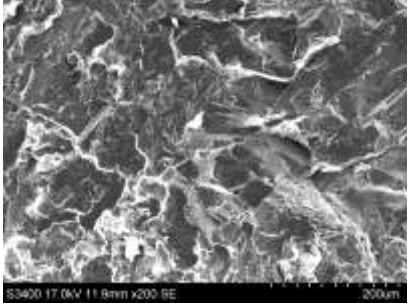
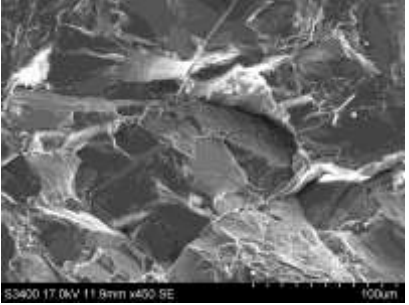
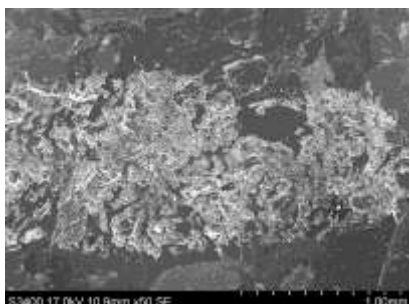
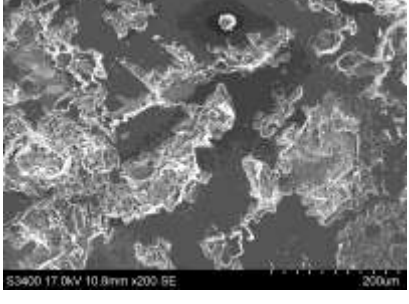
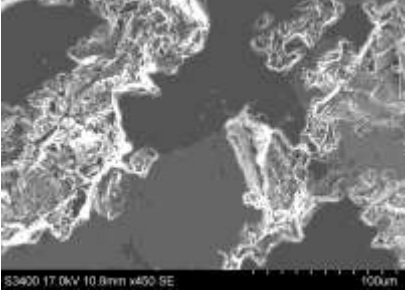
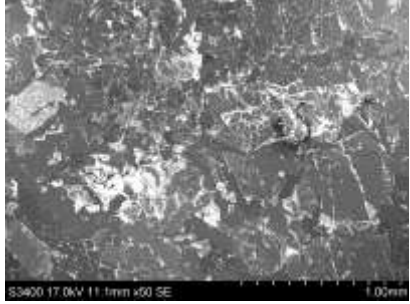
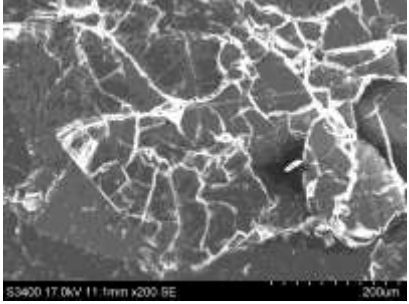
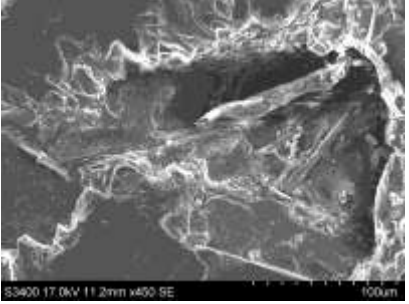
<p>Figure 59 Wear track on the rock from dry wear at 50X magnification.</p>

<p>Figure 60 Wear track on the rock from dry wear at 200X magnification.</p>

<p>Figure 61 Wear track on the rock from dry wear at 450X magnification.</p>
Wet wear (water)

<p>Figure 62 Wear track on the rock from wet wear, water lubricated, at 50X magnification.</p>

<p>Figure 63 Wear track on the rock from wet wear, water lubricated, at 200X magnification.</p>

<p>Figure 64 Wear track on the rock from wet wear, water lubricated, at 450X magnification.</p>
Lubricated wear (foam)

<p>Figure 65 Wear track on the rock from lubricated wear at 50X magnification.</p>

<p>Figure 66 Wear track on the rock from lubricated wear at 200X magnification.</p>

<p>Figure 67 Wear track on the rock from lubricated wear at 450X magnification.</p>
