# Wear and corrosion properties of steels used in Tunnel Boring Machines

**Christian Kreyberg Grødal**

Materials Technology

Submission date: June 2012

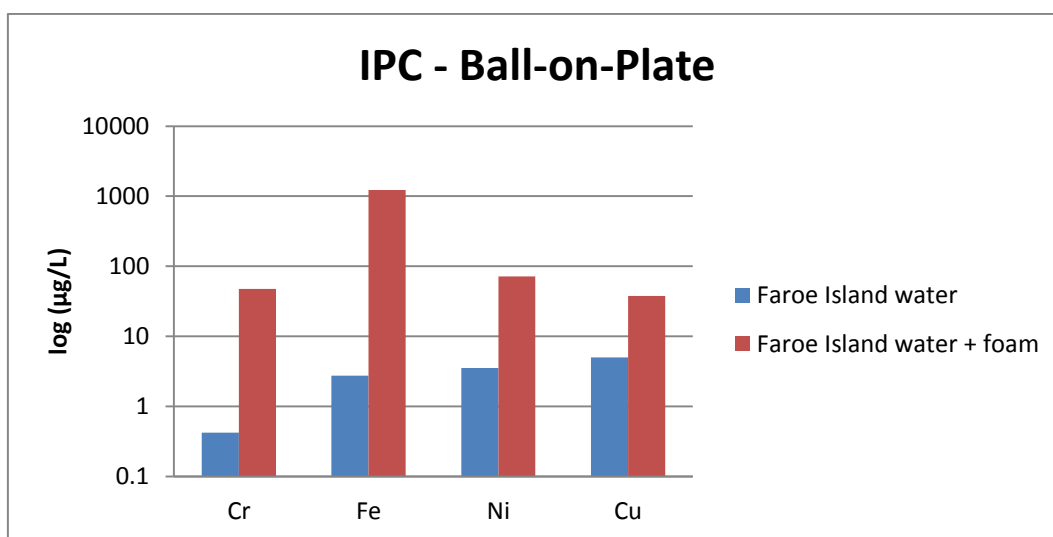
**Figure 68 Graphical presentation of the results from the IPC analysis of the Ball-on-Plate test.**

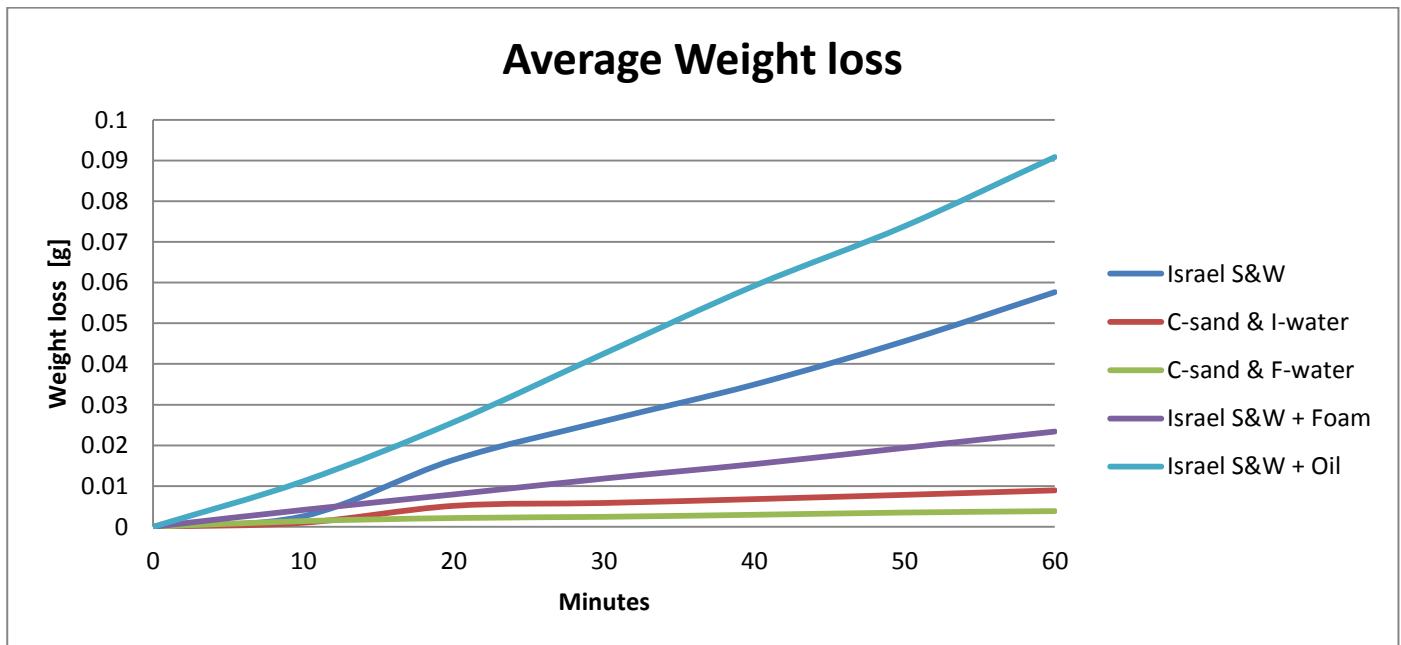
**Figure 69 Average weight loss during the Rubber Wheel test.**

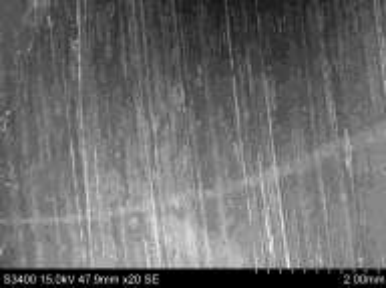
<p><b>Figure 70</b> Wear track on the steel surface for Rubber Wheel test with sand and water from Israel at 20X magnification.</p>

The test with sand and water from Israel (Israel S&W) gave the second highest weight loss of the tests. Figure 70 shows that in addition to the abrasive wear, some corrosion have occurred as well. The occurrence of corrosion is not strange since the water contains 1.43 wt. % chloride ions. From Figure 72 it is possible to see that the corrosion occurs along the abrasive stripes caused by the sand particles. This may be because these grooves act as a crevice, causing crevice corrosion to occur. The IPC analysis shows that the concentration of Cr and Fe are the second highest. This supports the weight loss measurements. However, as for the casting sand and Israel water test, the concentrations of Ni and Cu are the second lowest and the lowest, respectively. This may be because these elements are only present in small quantities (0.04 % Cu and 0.14% Ni) in the steel.

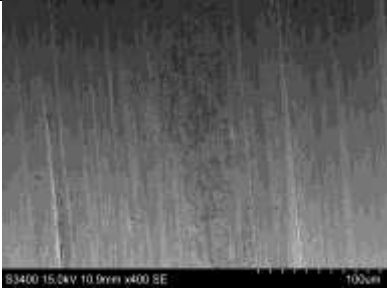
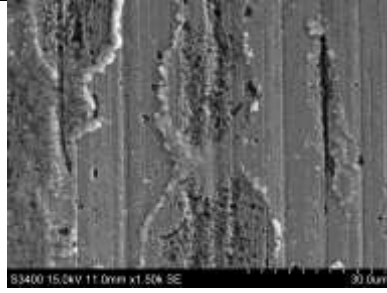
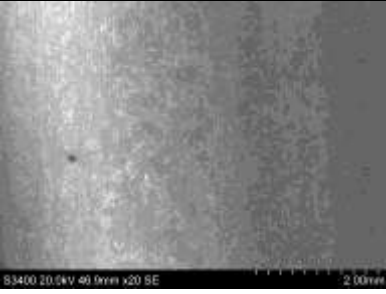
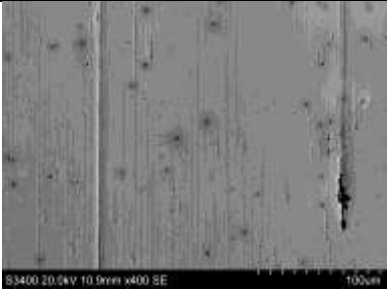
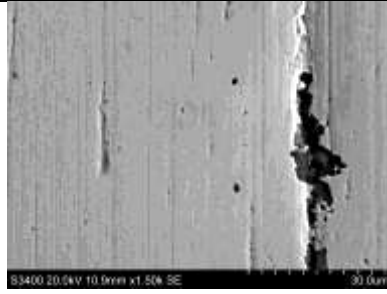
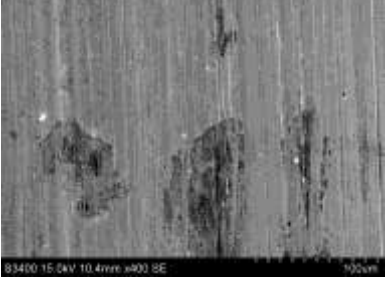
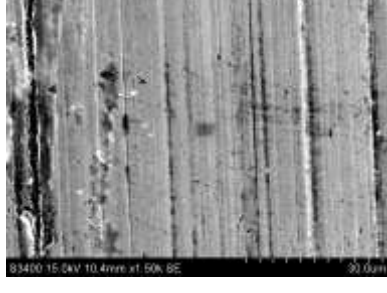
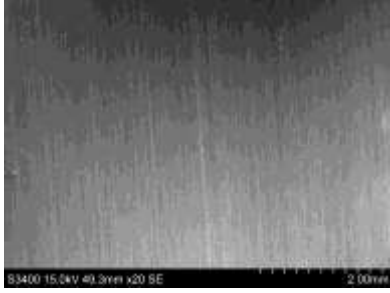
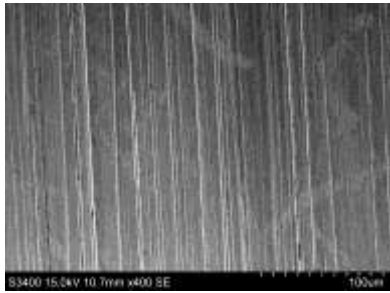
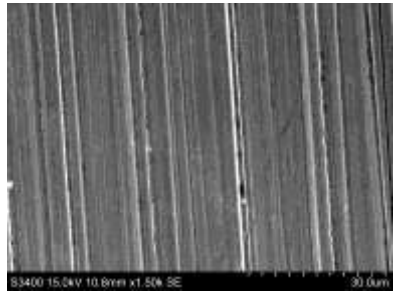
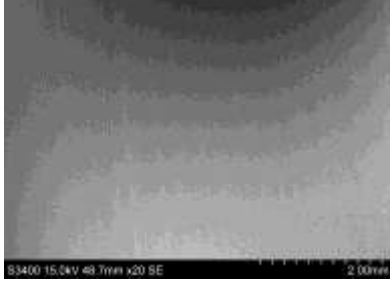
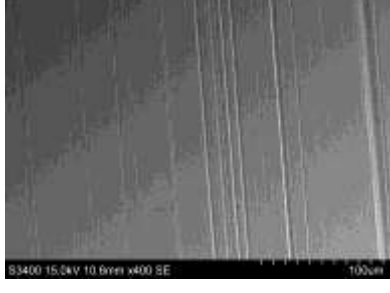
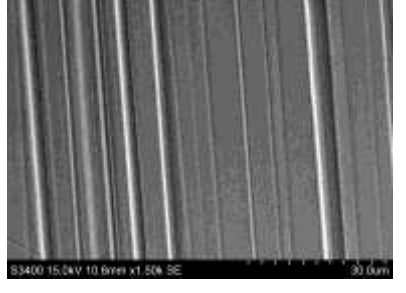
<p><b>Figure 71</b> Wear track on the steel surface for Rubber Wheel test with sand and water from Israel at 400X magnification.</p>

<p><b>Figure 72</b> Wear track on the steel surface for Rubber Wheel test with sand and water from Israel at 1500X magnification.</p>
Israel sand & water + Foam

<p><b>Figure 73</b> Wear track on the steel surface for Rubber Wheel test with sand and water from Israel + foam additive at 20X magnification.</p>

<p><b>Figure 74</b> Wear track on the steel surface for Rubber Wheel test with sand and water from Israel + foam additive at 400X magnification.</p>

<p><b>Figure 75</b> Wear track on the steel surface for Rubber Wheel test with sand and water from Israel + foam additive at 1500X magnification.</p>

<p><b>Figure 77</b> Wear track on the steel surface for Rubber Wheel test with sand and water from Israel + oil at 400X magnification.</p>

<p><b>Figure 78</b> Wear track on the steel surface for Rubber Wheel test with sand and water from Israel + oil at 1500X magnification.</p>

<p>Figure 79 Wear track on the steel surface for Rubber Wheel test with casting sand and water from Israel at 20X magnification.</p>

<p>Figure 80 Wear track on the steel surface for Rubber Wheel test with casting sand and water from Israel at 400X magnification.</p>

<p>Figure 81 Wear track on the steel surface for Rubber Wheel test with casting sand and water from Israel at 1500X magnification.</p>
Casting sand & Faroe Islands water

<p>Figure 82 Wear track on the steel surface for Rubber Wheel test with casting sand and water from the Faroe Islands at 20X magnification.</p>

<p>Figure 83 Wear track on the steel surface for Rubber Wheel test with casting sand and water from Israel at 400X magnification.</p>

<p>Figure 84 Wear track on the steel surface for Rubber Wheel test with casting sand and water from Israel at 1500X magnification.</p>

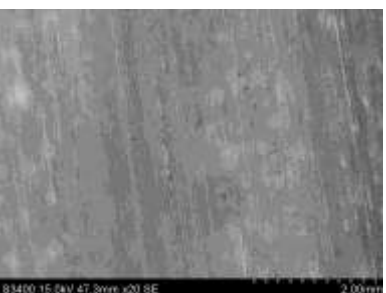
<p><b>Figure 76</b> Wear track on the steel surface for Rubber Wheel test with sand and water from Israel + oil at 20X magnification.</p>

Adding oil instead of foam caused the highest weight loss of all the tests. The SEM pictures (Figure 76 to Figure 78) show that the amount of abrasive wear on the steel surface increased compared to the test with foam. This shows that in this setting the oil acts as a poor lubricant. In addition to the increased abrasive wear, a significant amount of corrosion pits occurred in this test as well. These pits may have effects equivalent to those in the foam test described above. The IPC results show that the concentration of Cr, Fe and Cu are the highest ones measured, supporting the weight loss measurements. However, as for the previous tests, the Ni content is only the second highest. This may be because of the amount of Ni present in the steel compared to the others, as described previously.

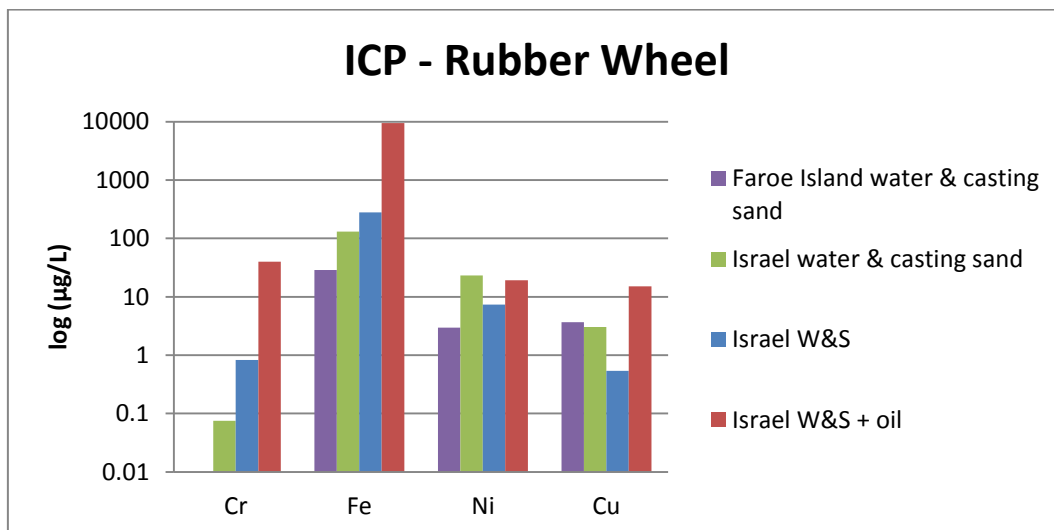
Figure 85 Graphical presentation of the results from the IPC analysis of the Rubber Wheel test on a logartimic scale.

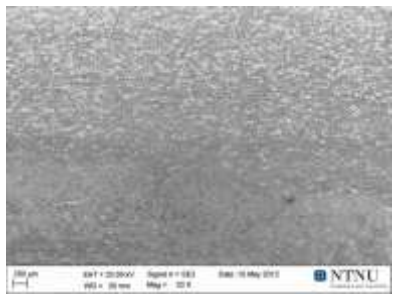
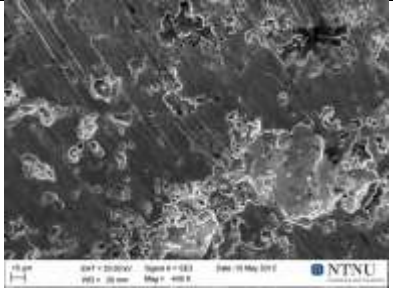
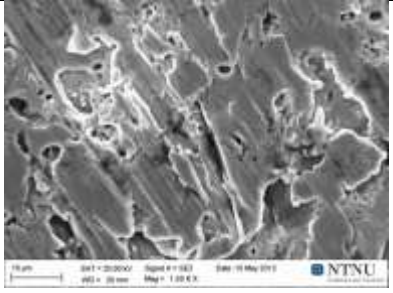
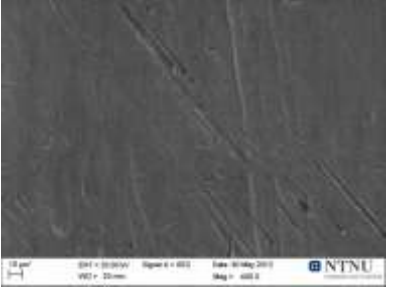
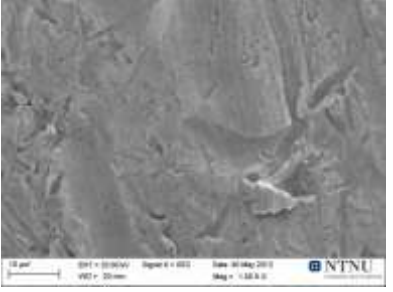
<p><b>Figure 87</b> Wear track on the steel surface after Hyperbaric Soil Abrasion test, saturated with water, at 20X magnification.</p>

<p><b>Figure 88</b> Wear track on the steel surface after Hyperbaric Soil Abrasion test, saturated with water, at 400X magnification.</p>

<p><b>Figure 89</b> Wear track on the steel surface after Hyperbaric Soil Abrasion test, saturated with water, at 1500X magnification.</p>
Dry soil

<p><b>Figure 90</b> Wear track on the steel surface after Hyperbaric Soil Abrasion test, dry, at 20X magnification.</p>

<p><b>Figure 91</b> Wear track on the steel surface after Hyperbaric Soil Abrasion test, dry, at 400X magnification.</p>

<p><b>Figure 92</b> Wear track on the steel surface after Hyperbaric Soil Abrasion test, dry, at 1500X magnification.</p>

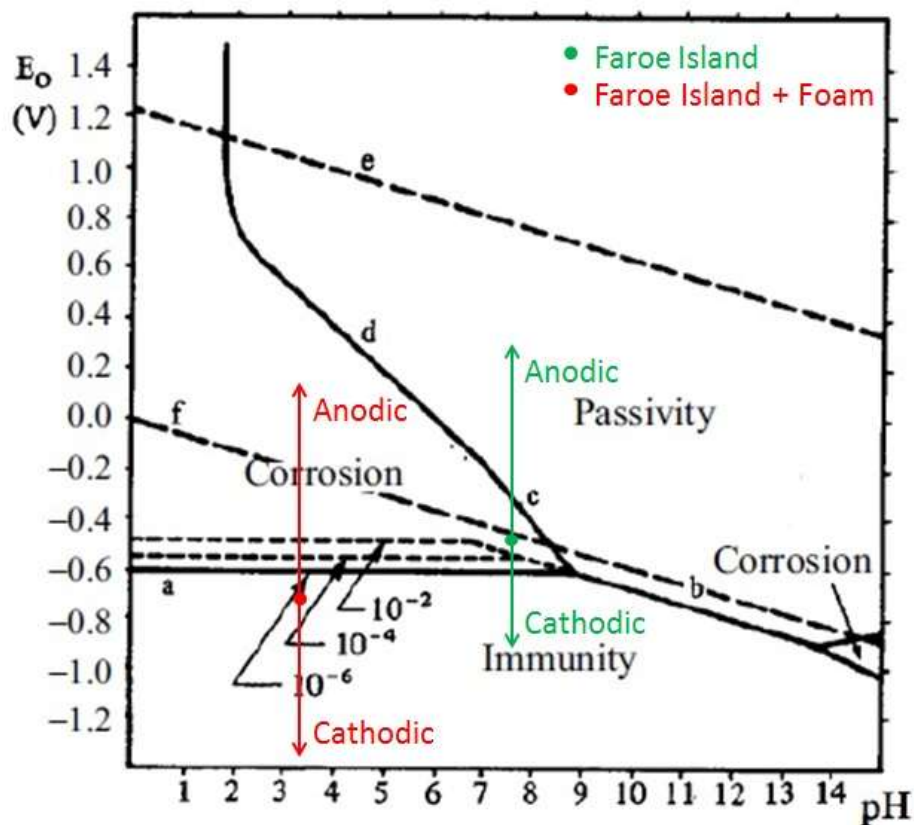
Figure 93 The Pourbaix diagram for iron in water showing the anodic and cathodic potentials from the potentiostat [11].

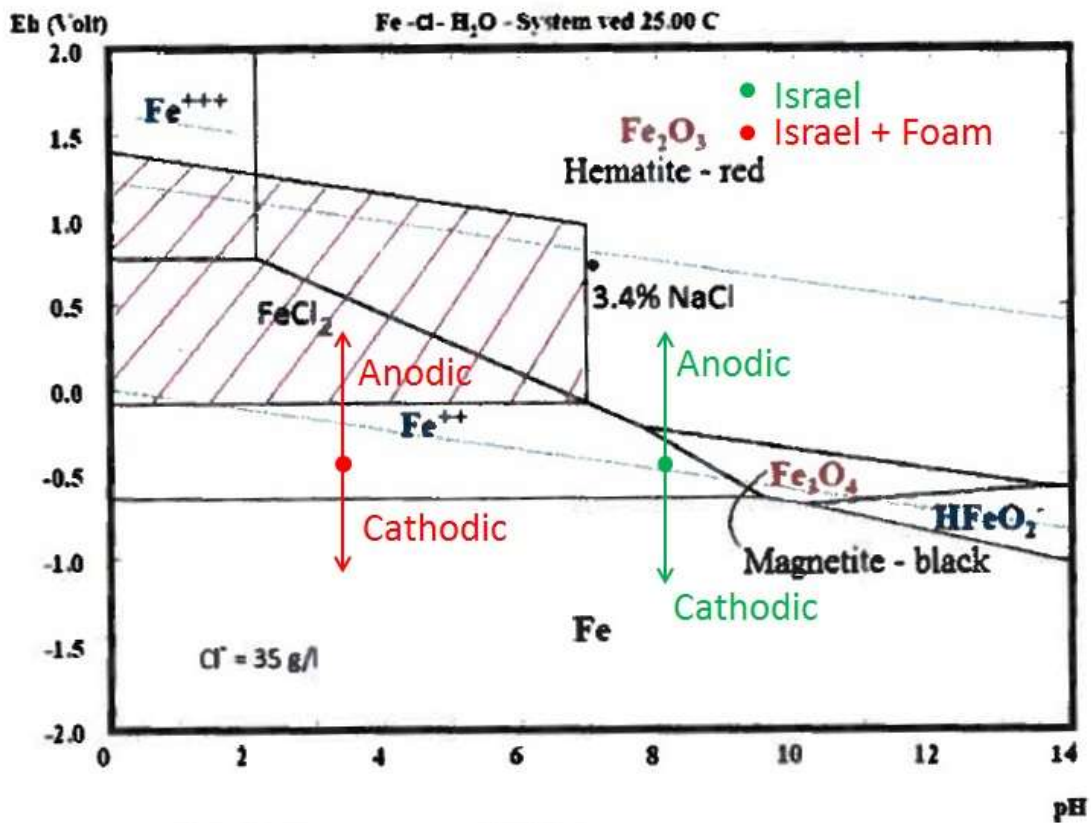
Figure 94 The Pourbaix diagram for iron in 3.5 % NaCl showing the anodic and cathodic potentials from the potentiostat [13].
