Change of strain field due to damage development in adhesive joints

Master of Science in Mechanical Engineering

Submission date: December 2013

In this thesis six metal I-beams with a crack repaired by a composite patch been tested in four point bending. The patches used to repair the beams had three different patch thicknesses. The different thicknesses were manufactured to see how the thickness affects the stress field inside the laminates. To attach the patch to the steel beam, adhesive joints were used. However, the long-term performances of such joints are still not well understood. Monitoring the damage development in joints like this can provide a better understanding of how the damage propagates to investigate the long-term performance of the joint.

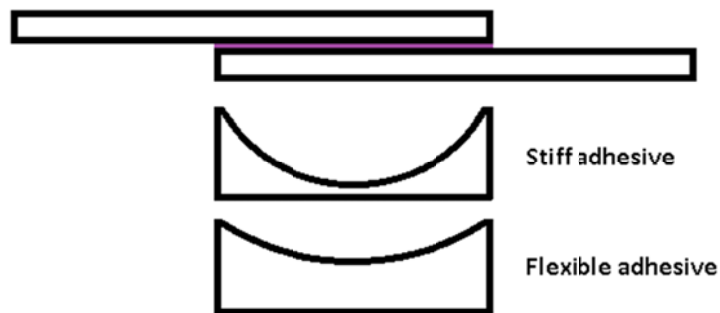
By repairing a structure with a composite patch, it is possible for the patch to either fail in the adhesive, or inside the patch. When the interlaminar shear strength of the laminate is smaller than the shear strength of the adhesive interface, the patch repair is expected to fail within the laminate [7]. The strength of an adhesive joint does not only depend on the ultimate strength of the adhesive. Flexibility of the adhesive is just as important. All adhesive joints gain their strength from the surface area where the two adherends are joined together. By using a less flexible adhesive, one would get stress concentrations at the end of the adhesive as show in schematic form in Figure 1. A more flexible adhesive would distribute the stresses across the length [8].

Figure 1 – Schematic illustration of the stress distribution in overlap with a stiff or flexible adhesive

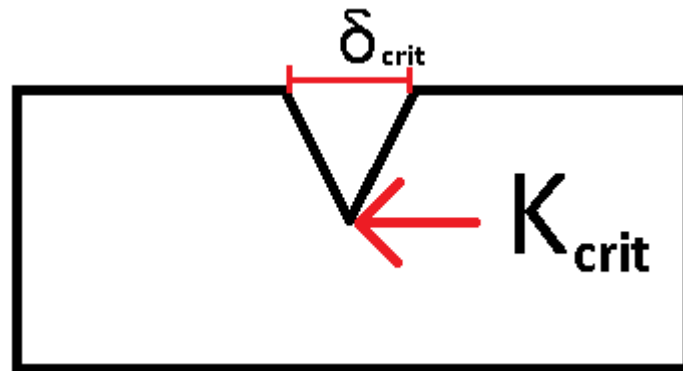
The stress intensity factor, K , is a parameter that describes the stresses and displacements near the crack-tip, in a linear elastic material. With the assumption that a material will fail locally at some critical combination of strain and stress, one can say that the fracture occurs at critical stress intensity K_{crit} . For a K_{crit} there will be a critical crack tip opening displacement (CTOD), δ_{crit} , see Figure 2. Applying a patch over a crack in a beam will result in $\delta < \delta_{crit}$. Hence $K < K_{crit}$ means that the crack will not propagate.

Figure 2 – Schematic illustration of K_{IC} and CTOD

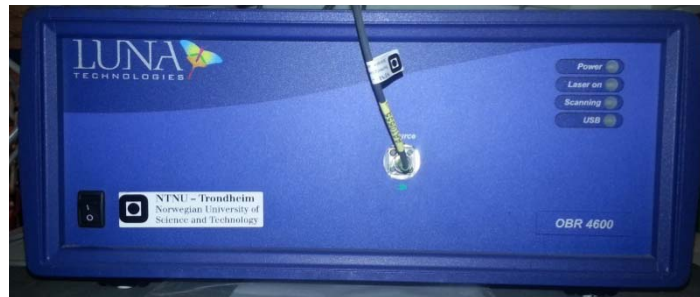
Figure 3 – OBR 4600

Luna OBR 4600 see Figure 3, sends an optical signal through the fibers and allows the data be saved at the computer it is plugged into. The machine can only output one signal at the time, which makes it impossible to sample more than one fiber at a time. To enable use of multiple fibers, one must use an optical switch.

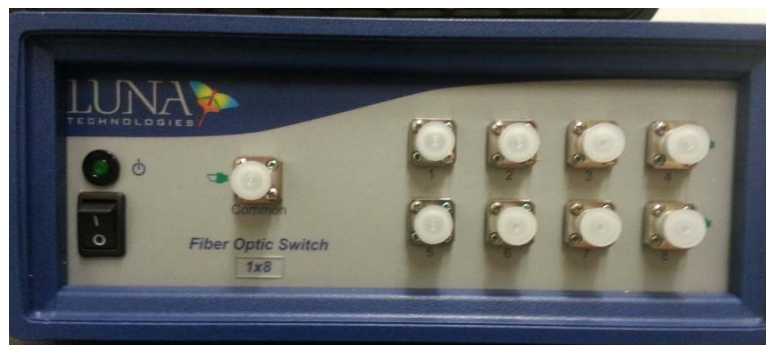
Figure 4 - Luna FOS

Luna FOS see Figure 4, makes it possible to output one of eight different channels. It is important to use one specific channel for a specific fiber. This is because of the internal wiring inside the FOS. Switching one fiber to another channel may result in useless data because of the different distance from the OBR. Connecting the FOS to a computer by USB, make it possible to change channel.

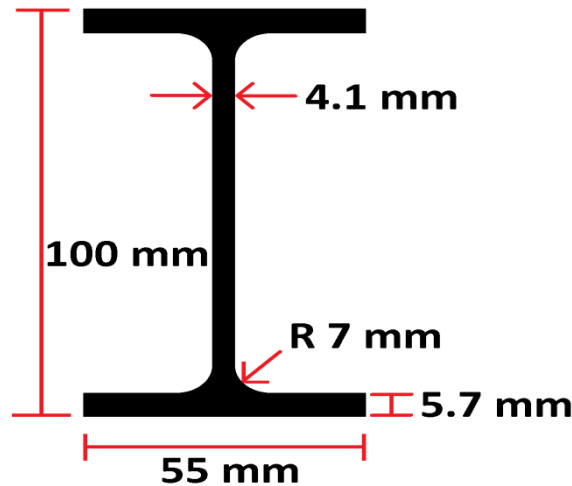
In this thesis there were used 1000 mm long IPE100 beams with a crack sawn down at the middle of the beams. A schematic illustration of the I-beams dimensions can be seen in Figure 17. All the beams were made after DNV's recommended practice for composite patch repairs [12]. At the bottom of the crack a hole was drilled and broached for crack arrest.

Figure 17 – Schematic geometry of IPE100

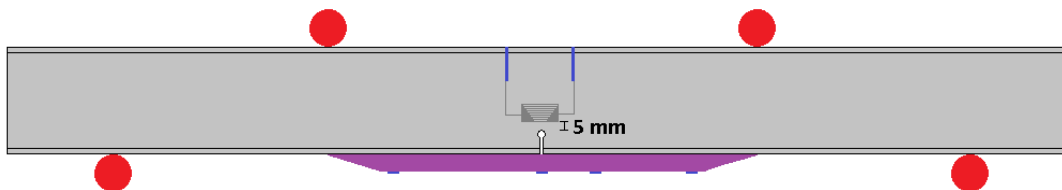
Figure 20 – Schematic illustration of a with crack gauge

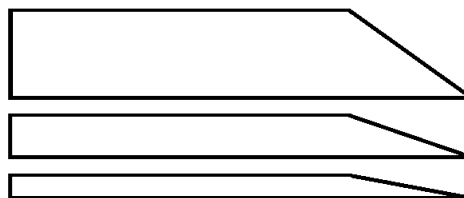
Figure 21 – Schematic illustration of the tapering geometries, starting from top: thick, medium and thin.

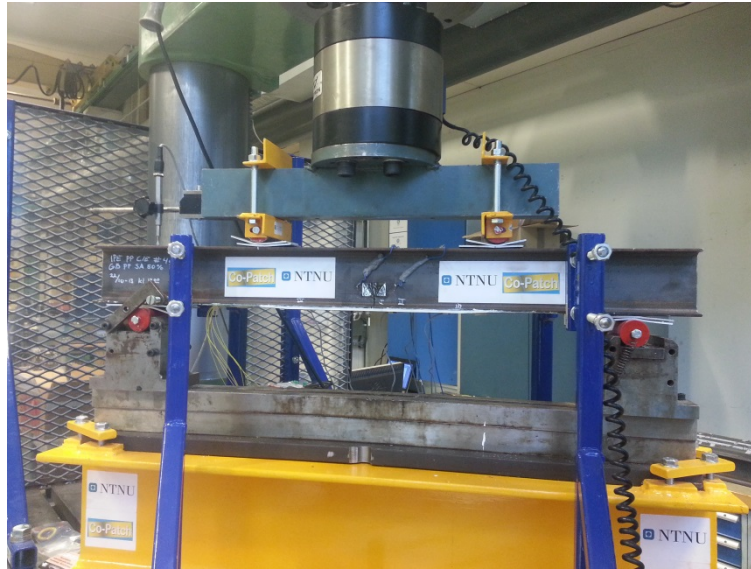
All the testing was done in the fatigue lab at IPM NTNU. The setup of the test can be seen in Figure 22. The test machine was controlled by an Instron controller and had a load capacity of 250 kN.

Figure 22 – Setup of four point bending test

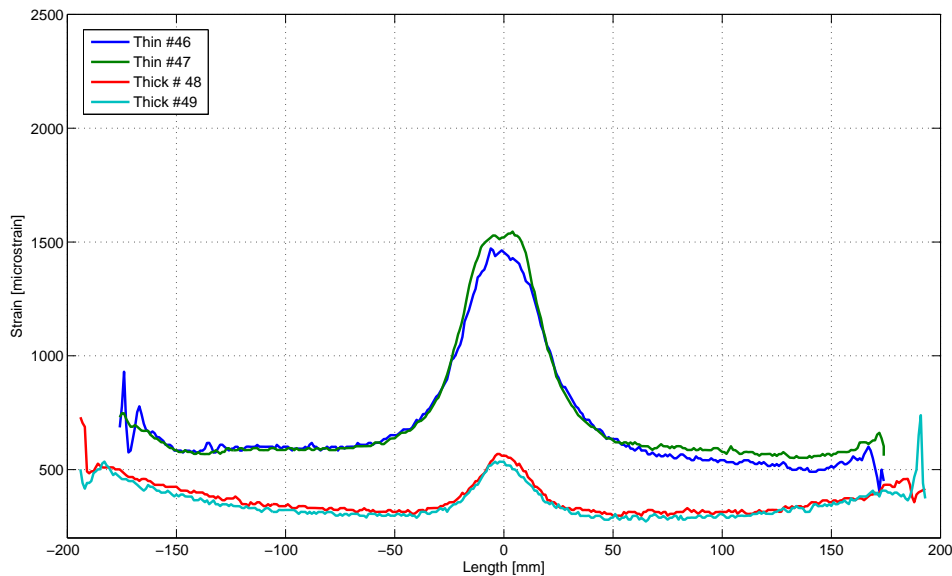
Comparing graphs and trying to find similarities, is easier to do when there is none or little damage done to the laminate. Even under first loading, there will always be some damage.

Figure 25 – Layer 4, 0 cycles at 55kN, beam #46, #47, #48 and #49

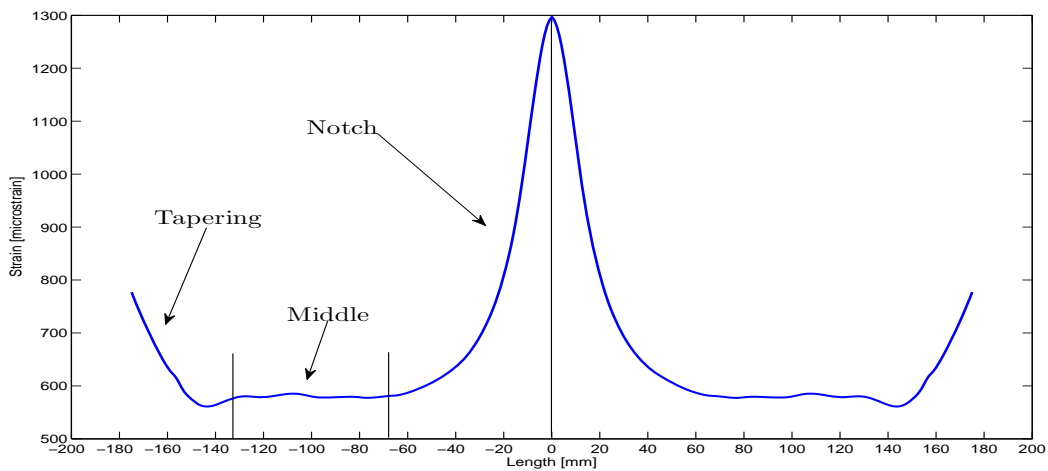
Starting with the tapering section it is easy to see that the strains get higher near the end of the beam. Depending on how steep the tapering is the longer the tapering section will be. The tapering section will show the ratio between the thicknesses of the laminate versus length of tapering.

Figure 26 – Indication of sections in the strain field

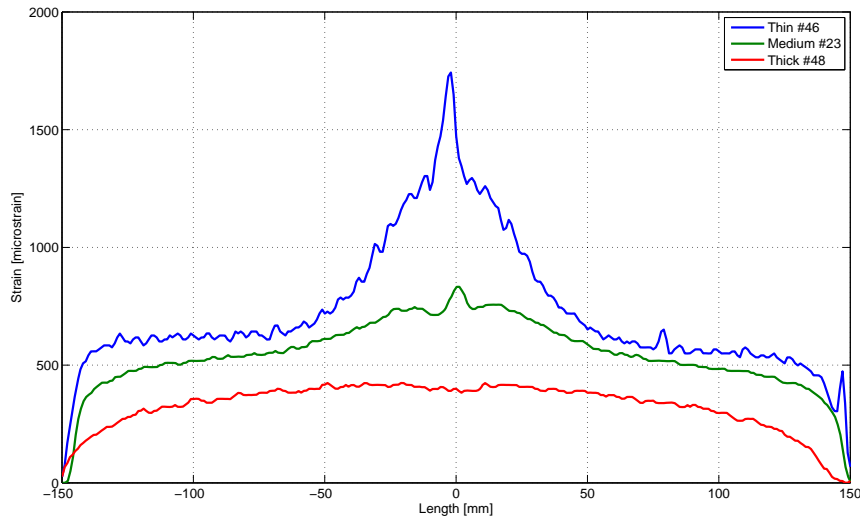
Figure 27 show the strain field for the thin, medium and the thick beams top layer after 10 cycles at 55 kN. They had almost the same shape around the middle part of the plot.

Figure 27 – Top layer, 10 cycles at 55 kN, beam #46, #23 and #48

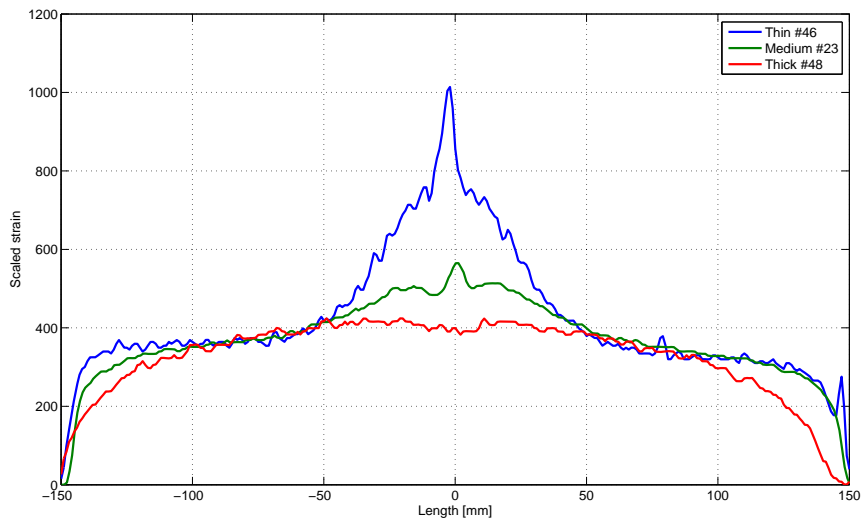
Beam #46 (thin)	Beam #23 (medium)	Beam #48 (thick)
Length	2.0	2.23	2.1
Strain	782.58	553.73	382.65
Ratio	2.05	1.45	1

Figure 28 – Scaled version of beam #48 from Figure 27

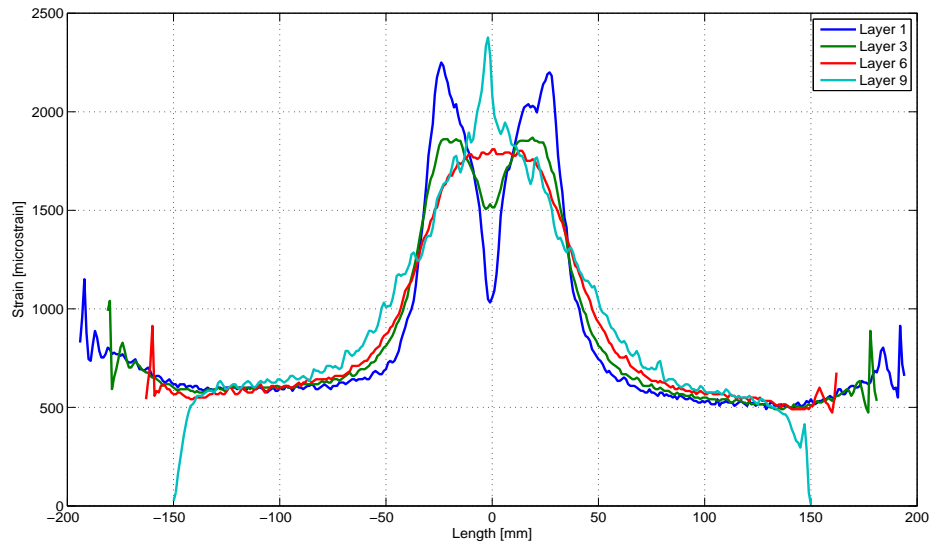
This section will show the strains around the notch. To be able to say anything about the actual differences through the thickness they will be analyzed after all the initial damage was done to the laminate. One will look at the strains after 10 000 cycles where there was not done too much damage.

Figure 29 – Strain field, 10 000 cycles at 55kN, thin beam #46

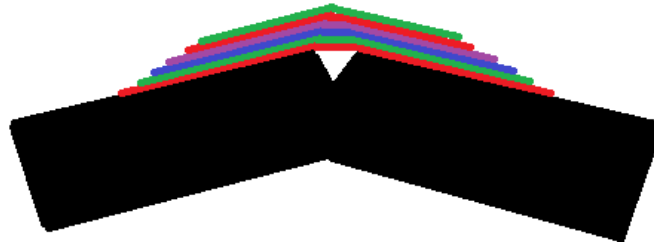
Figure 30 – Representation of layers

In order to explain why the strain at the top of the beam went down, it is appropriate to look at each layer in the laminate as simply supported. A combination of Figure 30 and Figure 31 represent possible deformation of the layers that can explain how it was possible to get drop in strain.

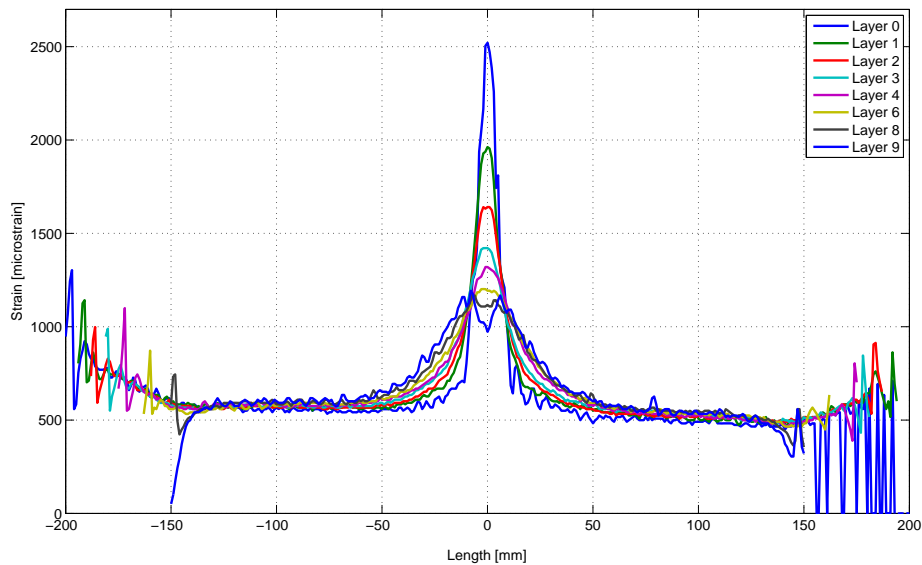
There is reason to believe that the angle of the tapering has an influence on the strains at the end of a composite patch. In Figure 33 and Figure 34 it is possible to see that the strain was rising at the end of the patch. Figure 33 shows that from around 150 mm from the center of the beam the strains started to go up. All the strains around the notch were higher than the strains at the end of the patch for the thin beam.

Figure 33 – Strain field, 0 cycles at 55 kN, thin beam #46

From the observations above it is tempting to say that the strains from the end of the patch in Figure 34 had a higher impact towards center of the patch, than the strains going out from the notch. On the other hand it looks like the strains from the crack in Figure 33 spread out more towards the sides, which made them more dominant than the strains from the sides. This is consistent with the two thick beams starting to delaminate from the end of the patch towards the crack, and the two thin beams the other way around.

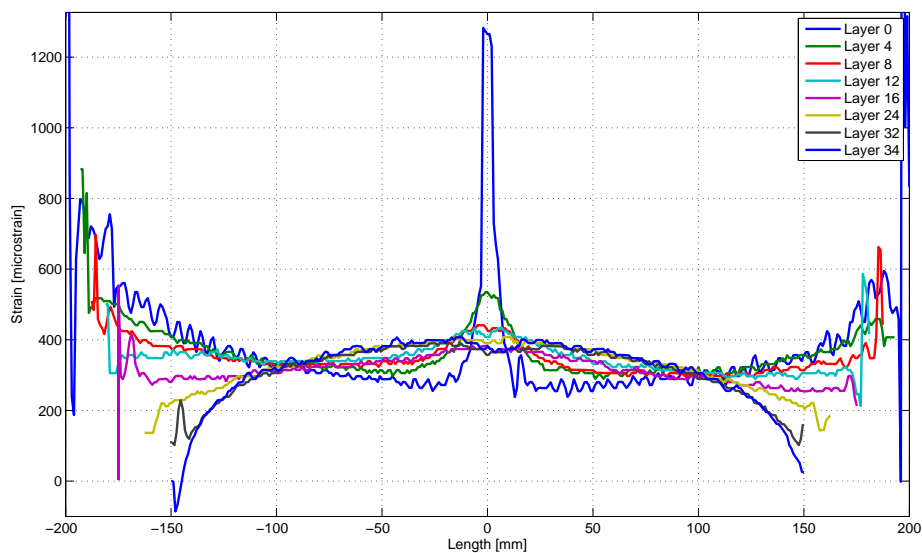
Figure 34 – Strain field, 0 cycles at 55 kN, thick beam #48

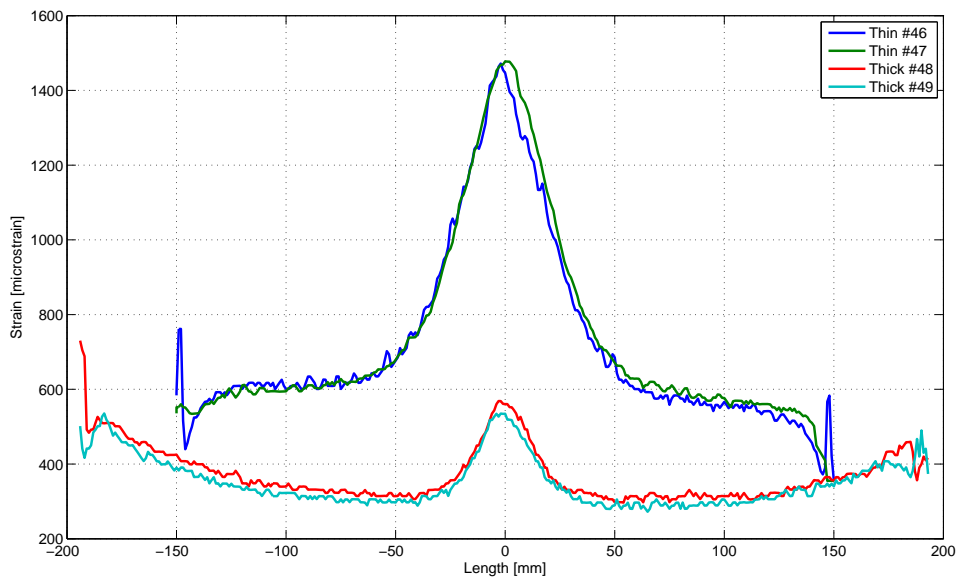
Figure 35 – Layer 8, 10 cycles at 55kN, beam #46, #47, #48 and #49

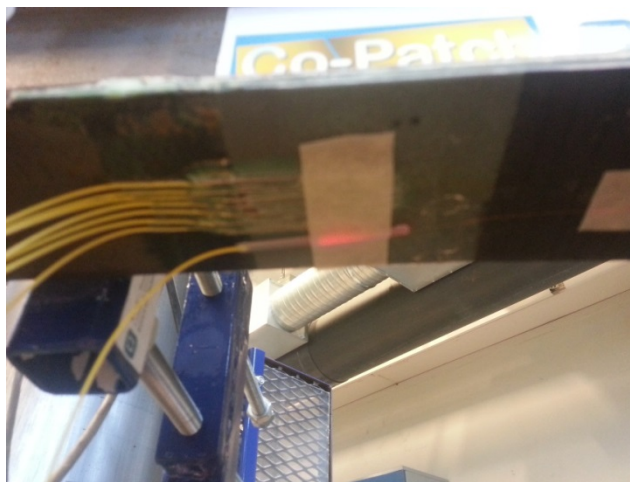
Figure 37 shows how it was possible to check if the fiber was broken. The picture also shows how the different fibers were lining up outside the patch. All the fibers embedded into the laminate were aligned at the center of the beams. If the fiber was broken the laser would stop at the point where it was broken. When the fiber was not broken the laser would be reflected through the fiber to the end and look like the red dot in Figure 38.

Figure 37 – Testing with laser to check if the fiber is broken

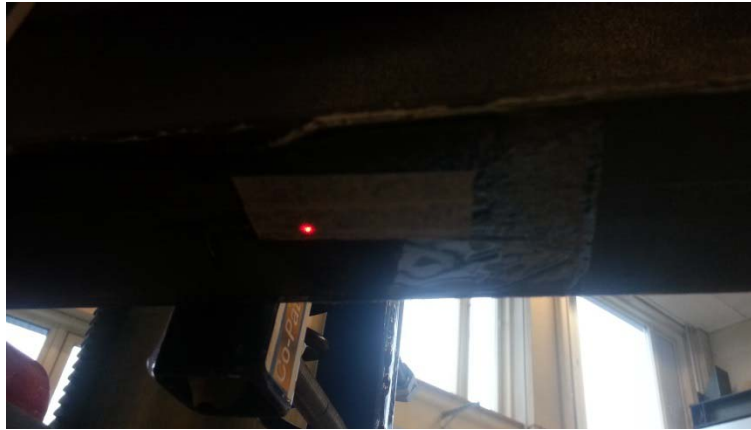
Figure 38 - Indication that the fiber is not broken

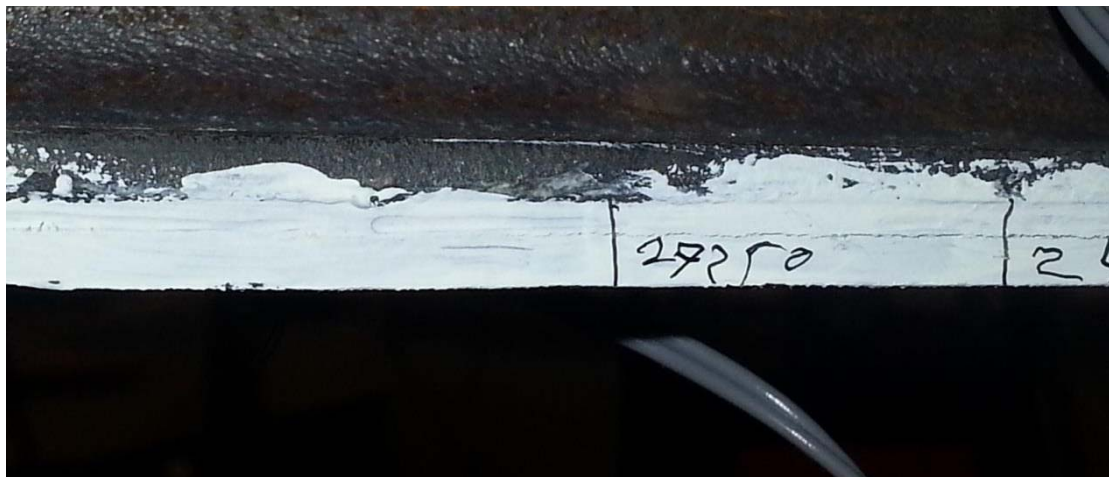
Already at 8000 cycles it was possible to see delamination going out from the crack. Figure 39 shows the delamination after 27 250 cycles. At this point the delamination had gone 119 mm from the middle of the beam. That was only 30 mm from where the tapering starts to go down from the top of the lami-

Figure 39 - Delamination at 27 250 cycles

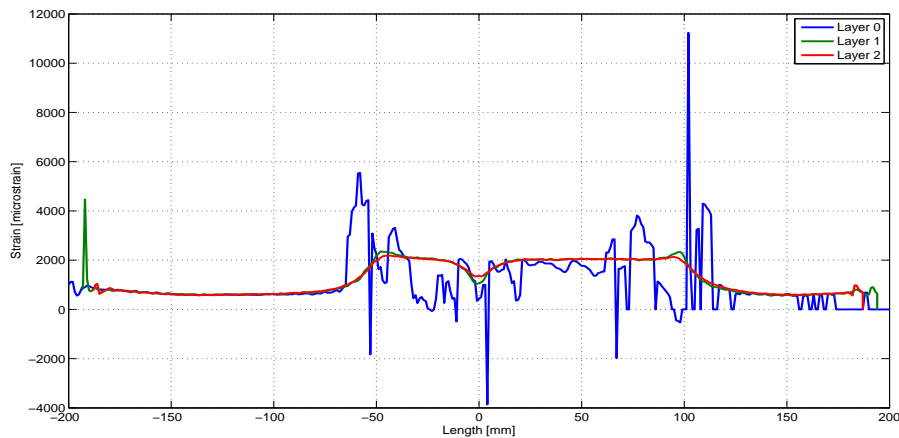
nate. Figure 40 and Figure 41, obtained by the OBR clearly points out that there was delamination in the laminate. When the delamination first started it went to both side of the notch. After approximately 19 500 the delamination stopped and only propagated towards one side. Figure 40 indicates an extreme value for layer 0 around 100 mm from the crack, where one can see the delamination for layer 2 and 3. Since layer 0 was in the adhesive between the laminate and the GFRP it is difficult to know if the value actually indi-

Figure 40 – Strain field, 25 000 cycles at 55 kN, beam #46

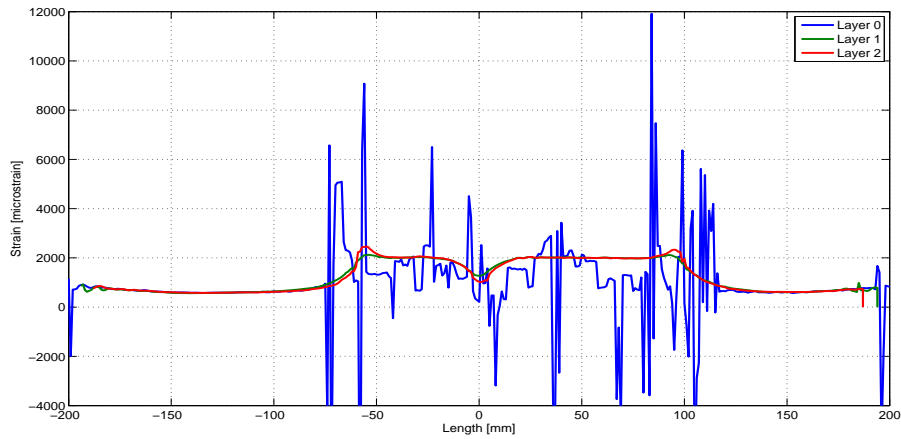
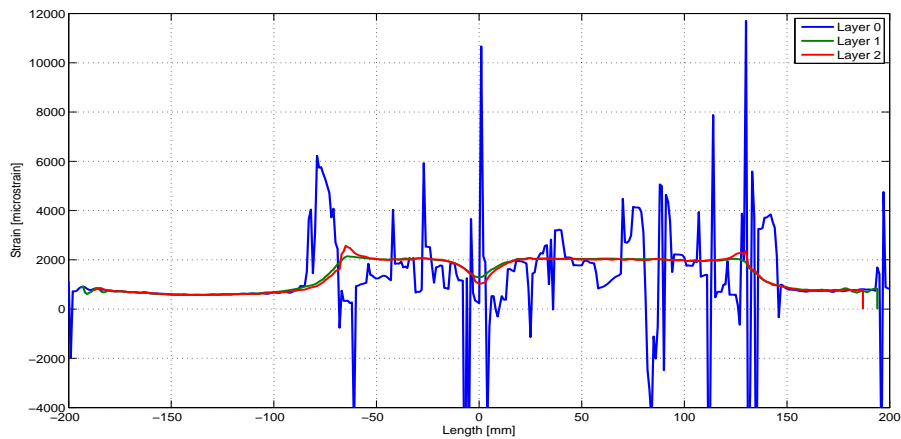
Since there were the same damage development on both beam #46 and #47, it would be interesting to compare the different layers at bottom of the laminate. Figure 43 and Figure 44 show the same trend as seen for beam #46, although there was more noise in layer 0 for beam #47.

Figure 43 – Strain field, 25 000 cycles at 55 kN, beam #47

Figure 44 – Strain field, 28 000 cycles at 55 kN, beam #47

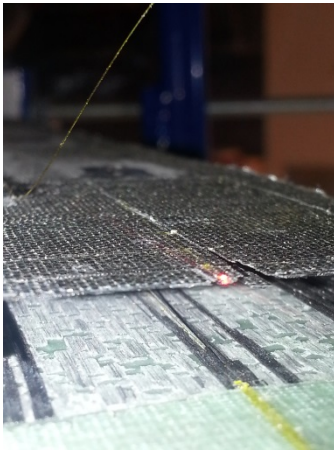
This beam broke on the right side. Figure 45 shows that it broke between the GFRP and the laminate. There were also some fibers from the laminate sitting on the GFRP, which makes this FRP and adhesive interface debonding. In Figure 46 there is no doubt that the beam was broken. Because of the relative low stiffness of the beam, the crack propagated relatively fast. Table 10 shows failure information of beam #47.

Figure 45 - Failure of beam #47

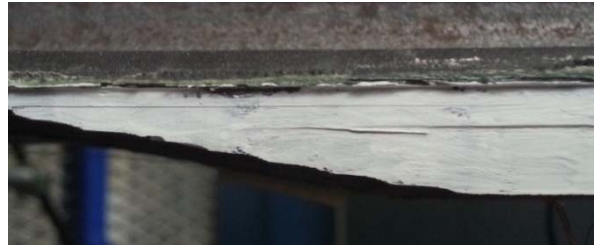
Figure 48 – Delamination started at the tapering on beam #48

For this beam the delamination started at the start of the tapering around where group 1 ends. This delamination can be seen in Figure 48. Unfortunately, all the fibers except for the fiber on top of the beam stopped working due to this delamination.

There were no changes in the strain field inside the laminate from around 5 000 cycles until they broke. By visually comparing the deformations from the thin beams and the thick is was clearly a much stiffer beam. The displacement logged by CatmanEasy tells us that the total displacement from 100 kN to 10 kN was only 20 % of the displacement for the thin beam.

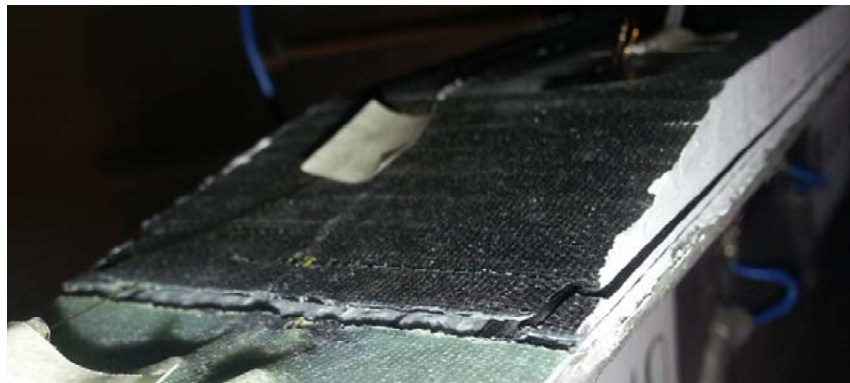
Figure 49 – Failure of beam #48

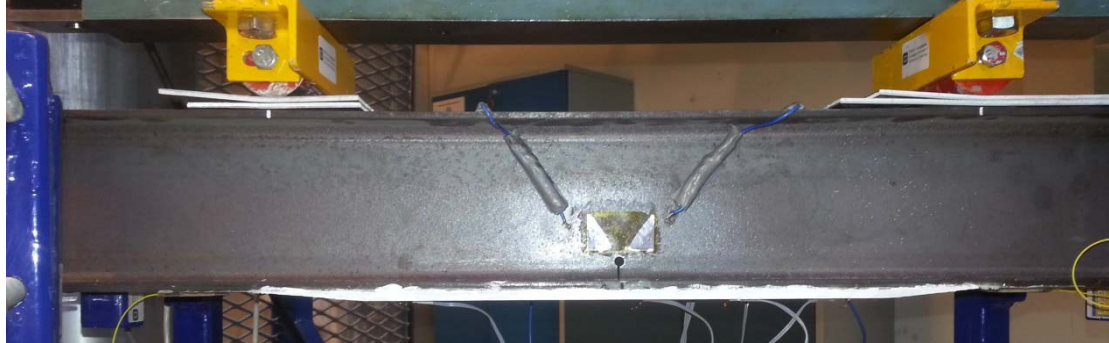
Figure 53 – Beam #23 ready to start testing

The two medium beams were different from the other beams. During fracture many failure mechanisms occurred. A picture taken with beam #23 inside the four point bending test can be seen in Figure 53.

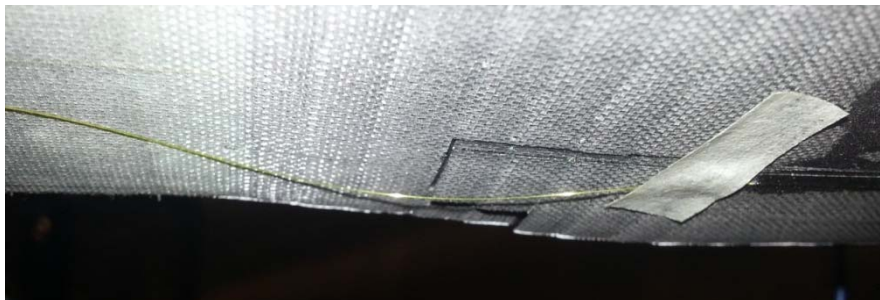
After 184 636 cycles of fatigue testing a part of the patch delaminated. The delamination occurred at the back left side of the beam, the picture in Figure 54 was taken right after this delamination. The side where the delamination started was also the side that the laminate failed.

Figure 54 – Part of the patch delaminated on beam #23

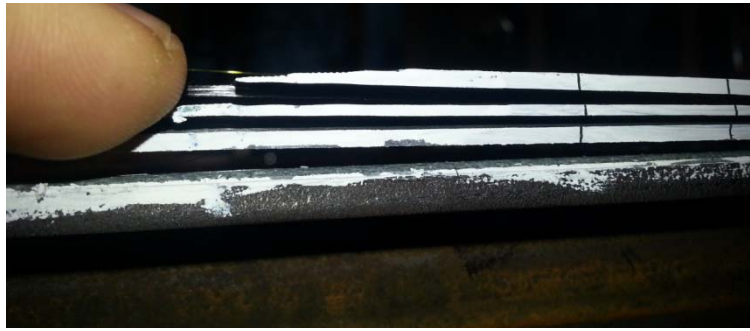
Figure 55 – Delamination in different layers, beam #23

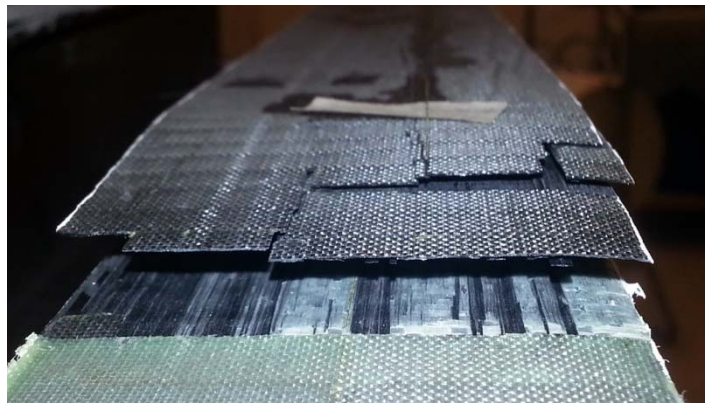
Figure 56 – Delamination in different layers, beam #23

Figure 55, Figure 56 and Figure 57 shows different angles of how damaged the laminate was after failure. The figures illustrate that the failure modes upon failure were FRP delamination in combination with FRP and adhesive interface debonding. Table 13 shows failure information of beam #23.

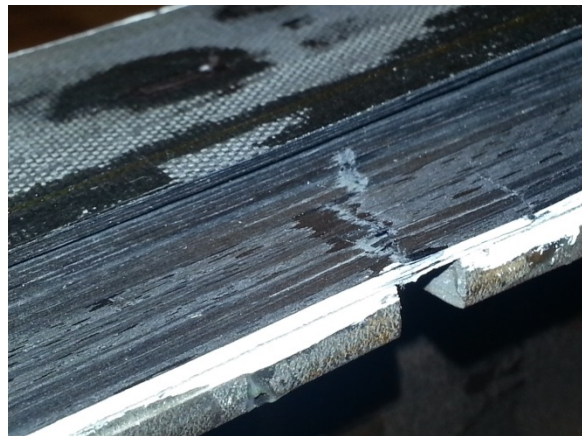
Figure 59 – Fiber rupture, beam #24

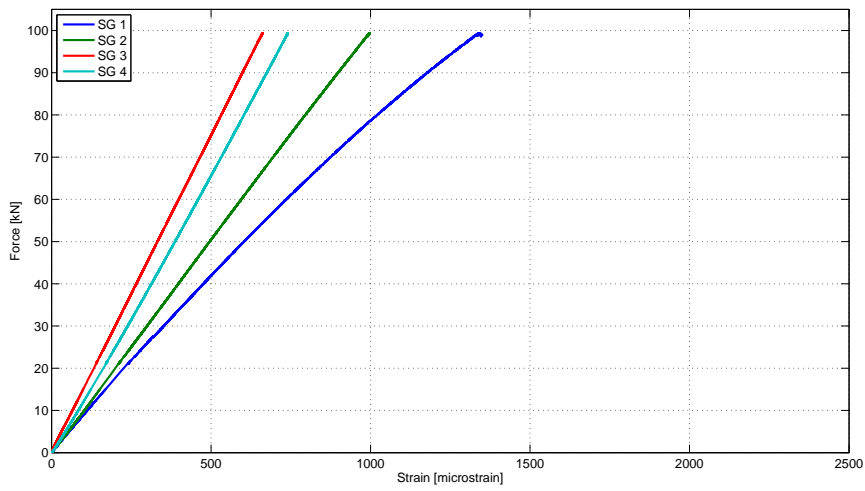
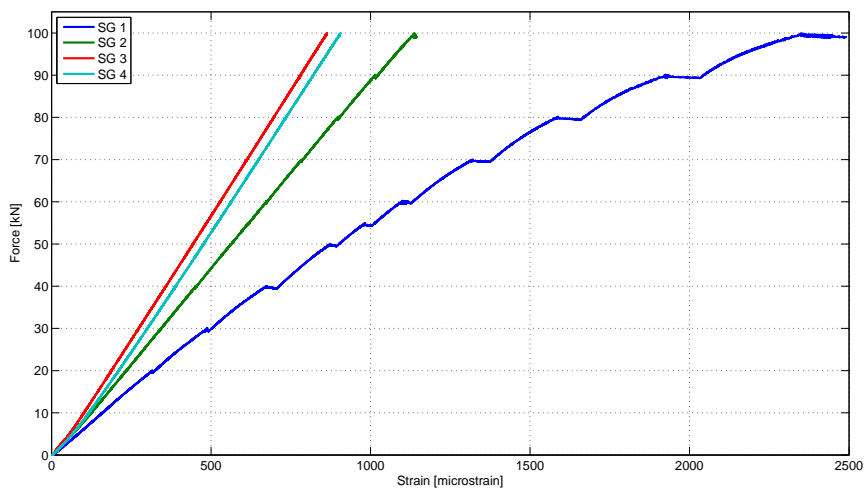
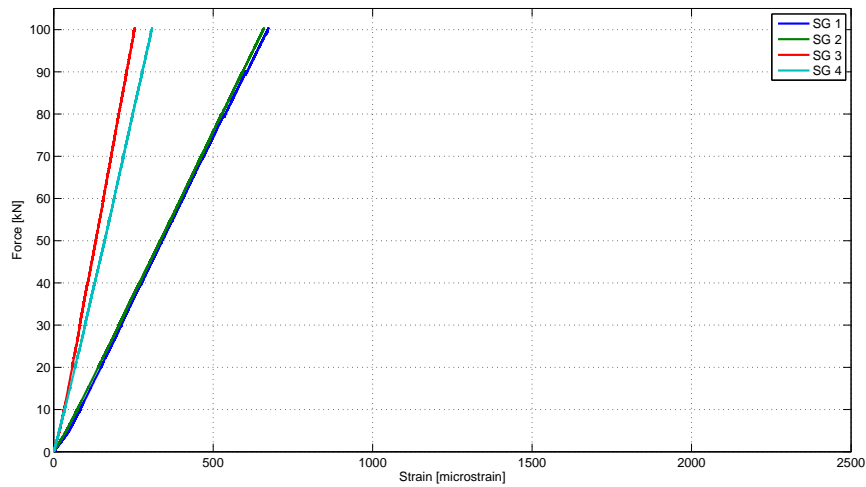
By looking at only SG 1 and 2 of the different beams, it is possible to say something about their stiffness. The physical distance between SG 1 and 2 was only 50 mm, though on beam #47 there was a huge difference in strains. On the stiffer beam #49 there was almost no difference in strain. For beam #48 the strains in SG 1 and 2 had switched places compared to beam #49. This graph can be found in Appendix A.

Figure 60 – Strain Gauge 1 – 4 static test, beam #24

Figure 61 – Strain Gauge 1 – 4 static test, beam #47

Figure 62 – Strain Gauge 1 – 4 static test, beam #49

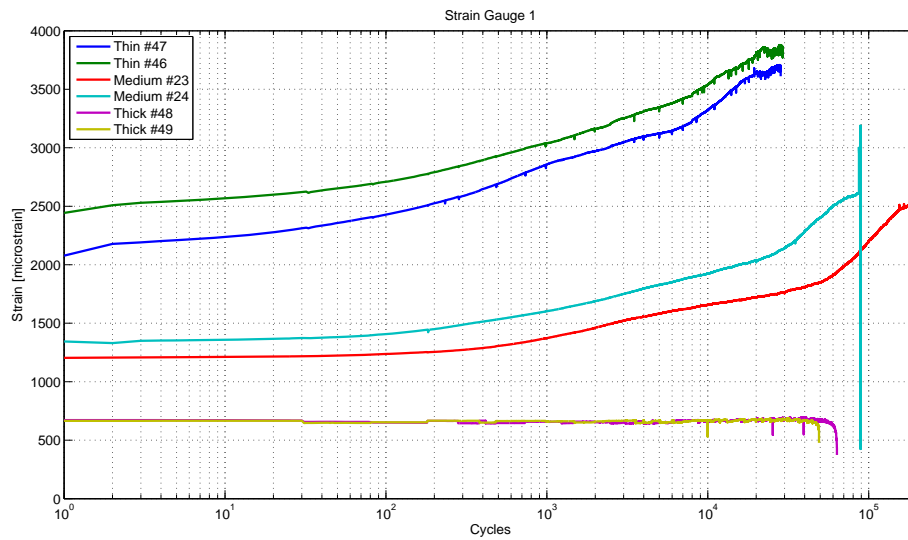
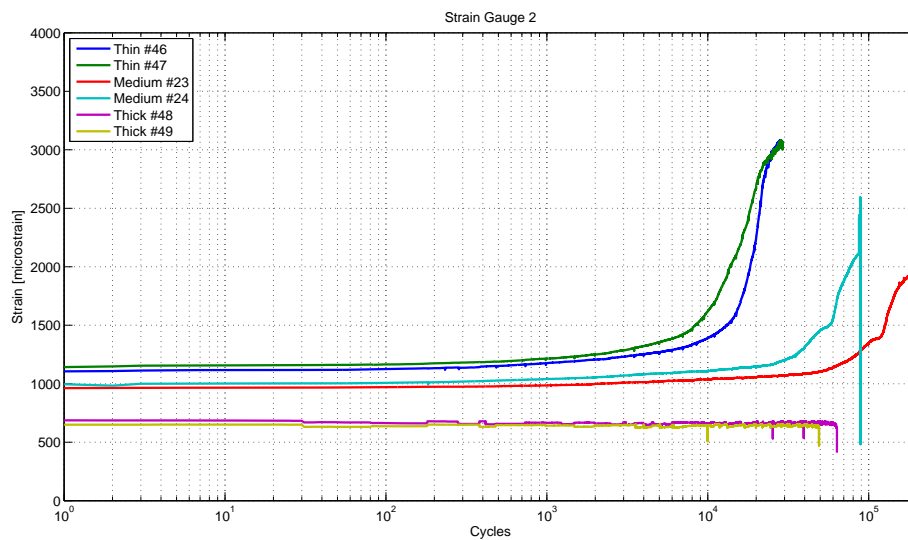
More interesting is the fact that the medium beams had almost exactly the same graphs. Taken into consideration that beam #23 failed at over the double number of cycles than #24.

Figure 63 – Strain gauge 1 until failure, all beams

Figure 64 – Strain gauge 2 until failure, all beams

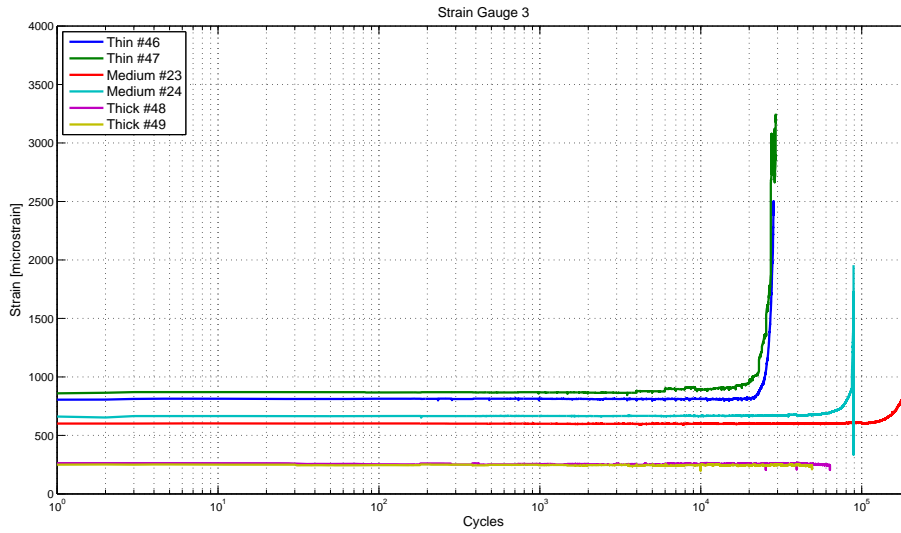
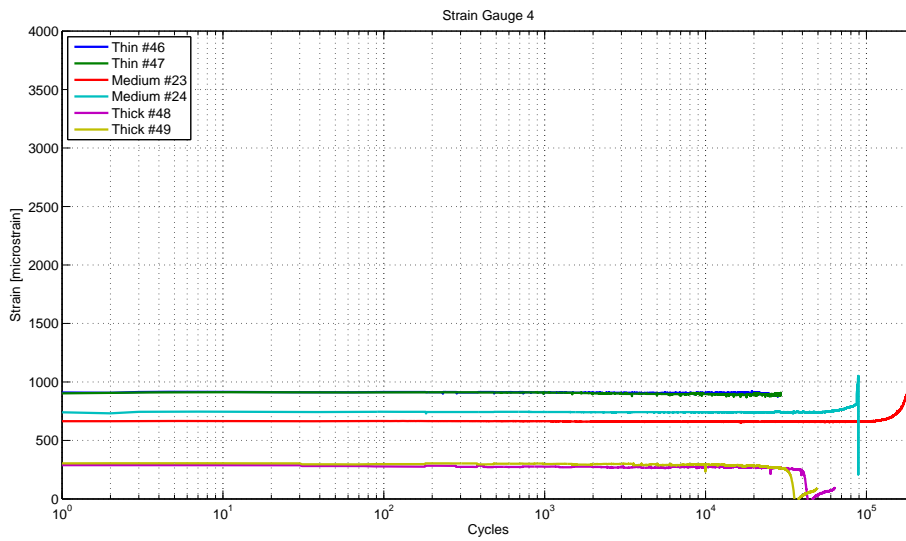
in Figure 66 relates to the delamination that started from the left side towards the crack.

Figure 65 – Strain gauge 3 until failure, all beams

Figure 66 – Strain gauge 4 until failure, all beams

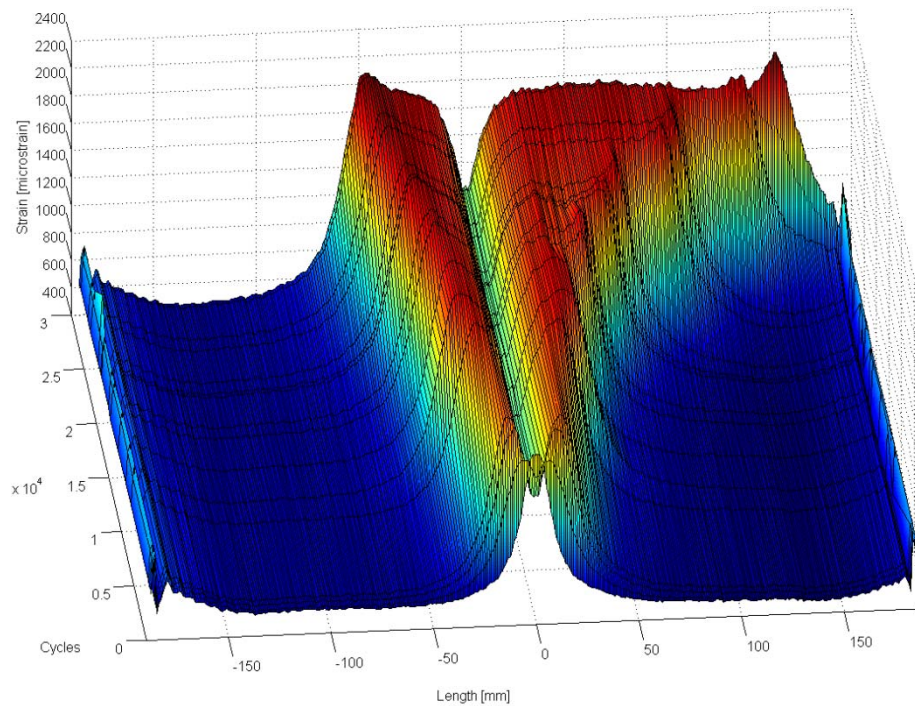
During fatigue testing of the beams, visual inspection of the beams was used to reveal crack propagation in the laminate. The measurements were done by measuring the visual propagation on the side of the laminate. These measurements may differ from the real crack inside the laminate. For the reader to easier understand how the strain field changed due to damage development there has been made a 3-D plot of the strain field in layer 2 for the thin beam #46. Figure 67 illustrates the strain field of layer 2 were the depth of the figure is cycles with an increment of 5 000 cycles. This was the development of the strain field due to the cyclic loading.

Figure 67 – 3D plot of strain fields in layer 2, beam #46

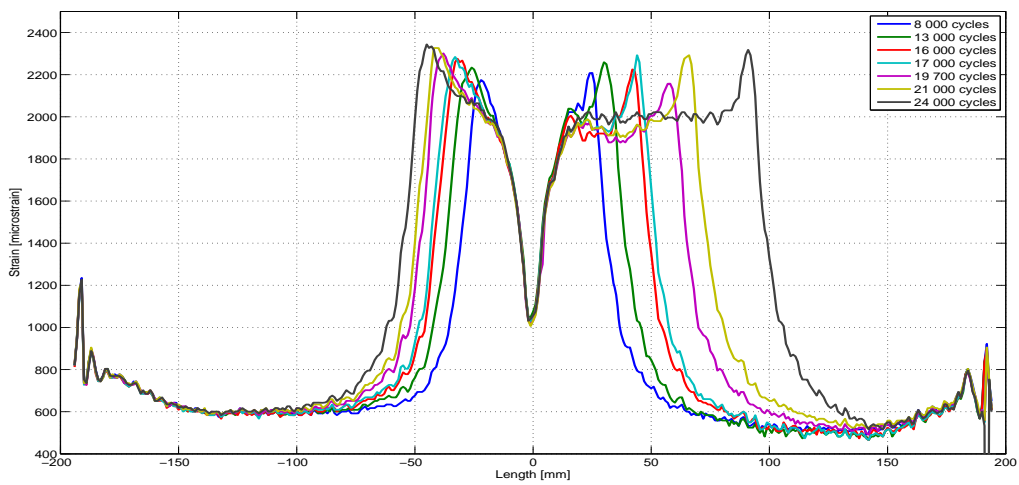
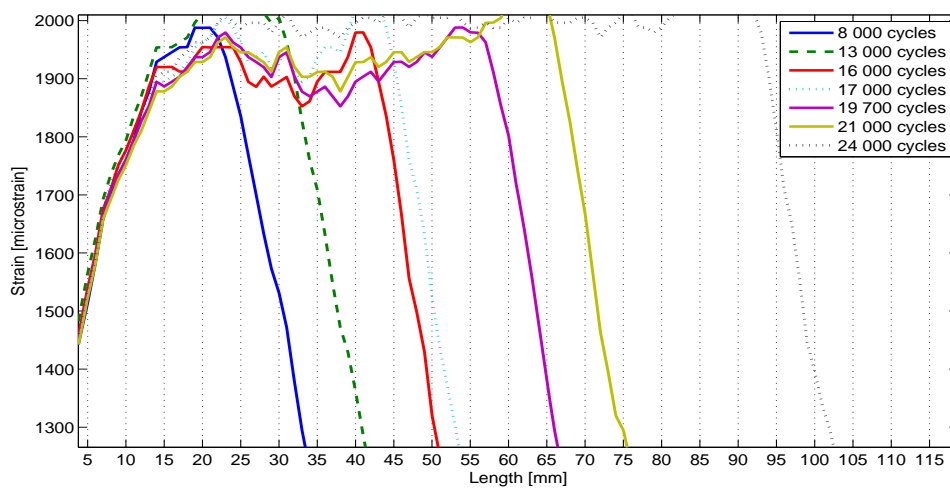
Thin beam #46	
Cycles	Crack propagation
8 000	34 mm
13 000	46 mm
16 000	51.5 mm
17 000	59 mm
19 700	64 mm
21 000	74.5 mm
24 000	95 mm

Figure 68 – Strain field in layer 2 at different cycles, beam #46

Figure 69 – Section of Figure 68

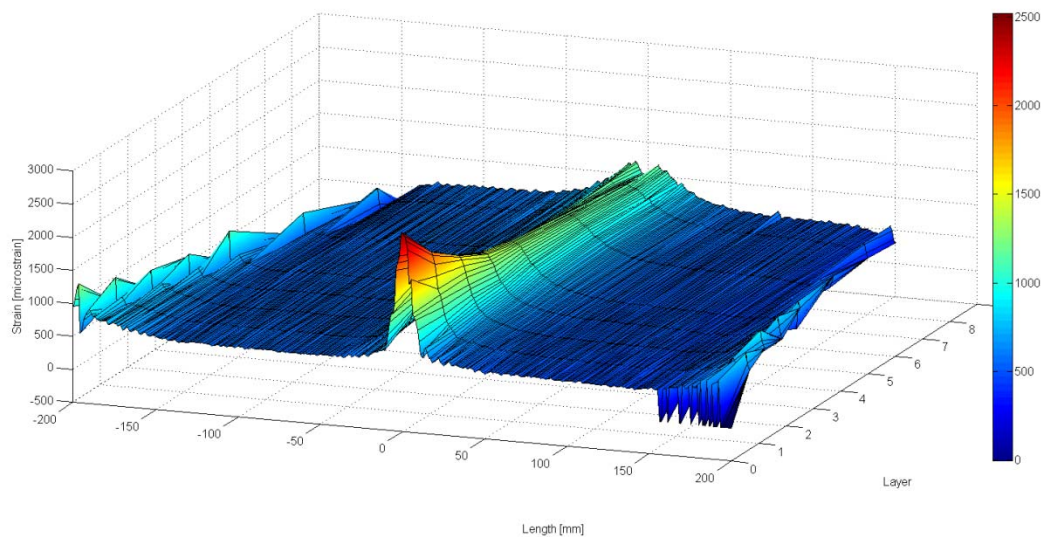
In this part it will be shown how the strains from the optical fibers can be used to show how the strain field changes through the thickness of the laminate. Figure 70 shows the strains from the different layers in the thin beam #46. From Table 5 one can see that there were not sampled any strains from layer 5 and 7. This gave the plot a bit lower resolution. Unfortunately, there was too much noise in the adhesive layer after some cycles, so this layer was only represented in the first plot at 55 kN.

Figure 70 – 3D-plot of the strain field through the thickness of the laminate,
