# Improving Thermal Insulation of Timber Frame Walls by Retrofitting with Vacuum Insulation Panels – Experimental and Theoretical Investigations

Many of the Norwegian buildings from the 1960s-1980s with timber frame walls are ready for retrofitting. Retrofitting of these buildings with vacuum insulation panels (VIPs) may be performed without significant changes to the buildings, e.g. extension of the roof protruding and fitting of windows. Effectively, U-values low enough to fulfil passive house or zero energy requirements may be achieved, thus contributing to a reduction of the energy use and CO<sub>2</sub> emissions within the building sector. Retrofitting with VIPs on the exterior side is normally considered as a better solution; however, it may cause condensation in the wall. To investigate this and the interior option, four different wall fields were tested. One of them was a reference wall field built according to Norwegian building regulations from the 1970s, and three other fields represent different ways of increasing the thermal insulation level. In addition to the experiments, numerical simulations were performed where temperature, relative humidity (RH), and surface we

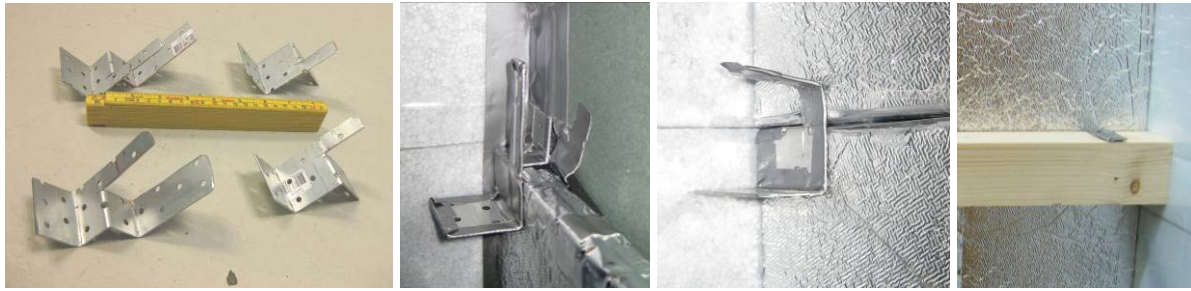
**Figure 5. Principle of the fastening bracket. The left photo shows the fastening brackets used in the middle of the wall (between two VIPs, fastened on a wooden stud), and fastening brackets used at the top plate. The three other photos show different stages in the installation of the fastening bracket between two VIPs.**

Figure 5 shows the application of the VIP fastening brackets in practise, where different steps during the implementation of the brackets are shown. Note that the fastening brackets were

taped around before installation in order to reduce the probability of VIP puncture due to sharp edges in the brackets.

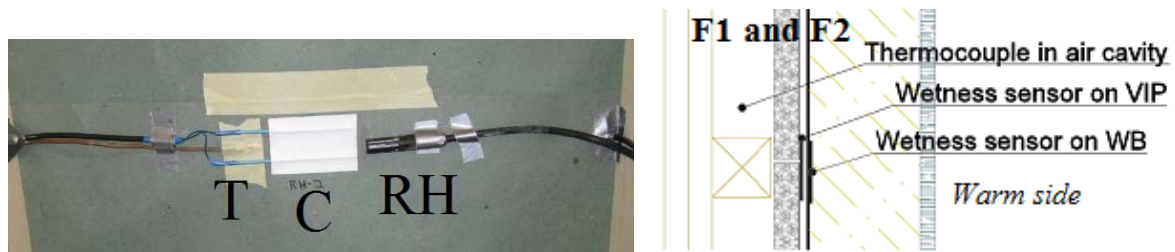
**Figure 7.** Left photo depicts the thermocouple (T), wetness sensor (C), and RH air sensor (RH) as installed on the wind barrier before the mineral wool was added. Right drawing shows a cross-section of F1 and F2 with a wetness sensor both on the wind barrier and on the joint between two VIPs at the middle of the fields. The thermocouple in the air cavity is also shown, while other sensors on the wind barrier (WB) are not depicted.

Altogether, 36 sensors of three different types were used in experiment, i.e. thermocouples (T), air humidity sensors including thermocouples (RH) and wetness sensors (C) as depicted in Fig.7. The thermocouples are familiar and consist of a cable with two separate conductors, i.e. copper and constantan. The cables are twined and soldered together at the tip where the measurements based on varying electrical potentials take place. The air humidity sensors were of the type Vaisala humidity and temperature transmitter Type HMP233, abbreviated as RH air sensors.

The most critical location for condensation was considered to be on the warm side of the VIPs in Field 1 and Field 2 (Fig.7), and at the warm side of the wind barrier (WB) at the reference field (F3). The thermal resistance of the wind barrier is marginal and the type of wind barrier used has a small water vapour resistance, i.e. condensation was expected to occur on the wind barrier as well as on the VIP surface. Hence, for practical reasons and the desire of having the sensors at the same locations for all four fields, most of the sensors were located at the warm side of the wind barrier. The sensors at the top and the bottom were located 100 mm from the sills where the natural convection in the mineral wool was considered to have the largest influence. The sensors at the middle were located directly within the joints of the VIPs, i.e. 1200 mm above the bottom sill. Furthermore, there were also sensors at other locations in the wall module. A wetness sensor were glued directly over the horizontal joint between two VIPs in F1 and F2 as shown in Fig.7, i.e. F1 and F2 had wetness sensors on both sides of the

wind barrier in the middle of the field. There were also thermocouples in all four ventilated air cavities as depicted in Fig.7. In addition, air temperature and RH were measured in both climate rooms.

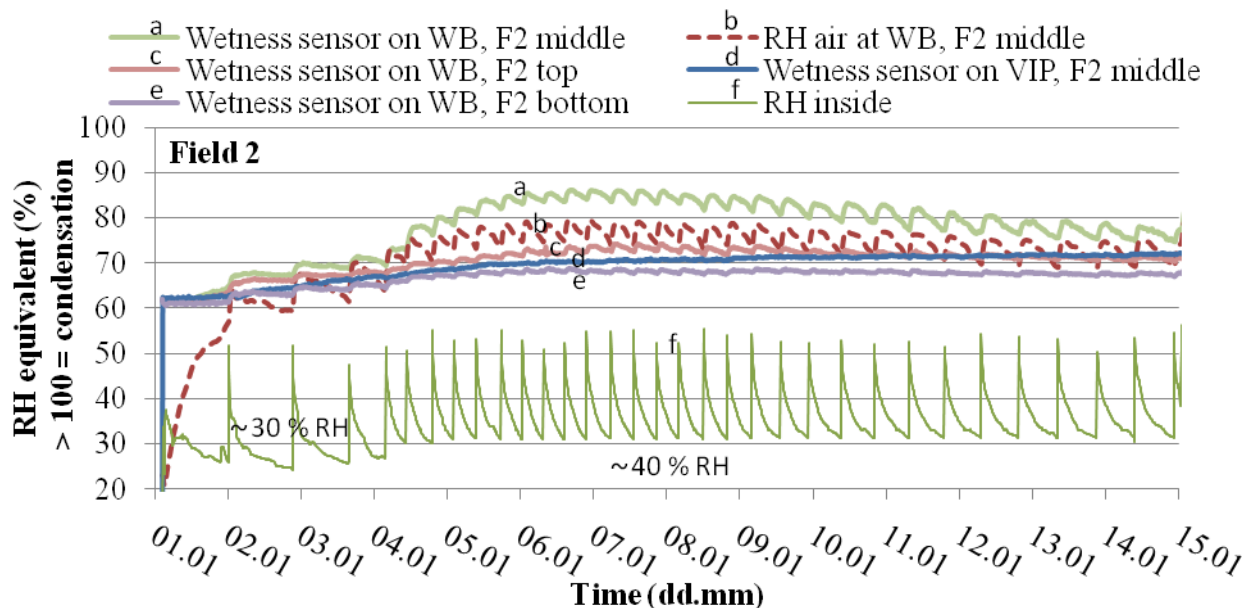
**Figure 8. Moisture sensors in F2 during climate step 1 and 2. The RH equivalent values of the four wetness sensors, as well as the RH air sensor, are shown. The climate room RH was ~ 30 % from day 1 to 4, and ~ 40 % from day 4 to 15 (graph f).**

None of the fields experienced condensation during climate step 1 or 2, with a RH of ~ 30 % and ~ 40 %, respectively. Hence, day 1 to day 15 of the experiment are only plotted for F2, thus depicting a case with no condensation as seen in Fig.8. The large alternation of RH in the climate room, up to 25 percentage points from the lowest to the highest value, can be seen in Fig.8. However, this problem was reduced after test day 15, when a different humidifier was installed.

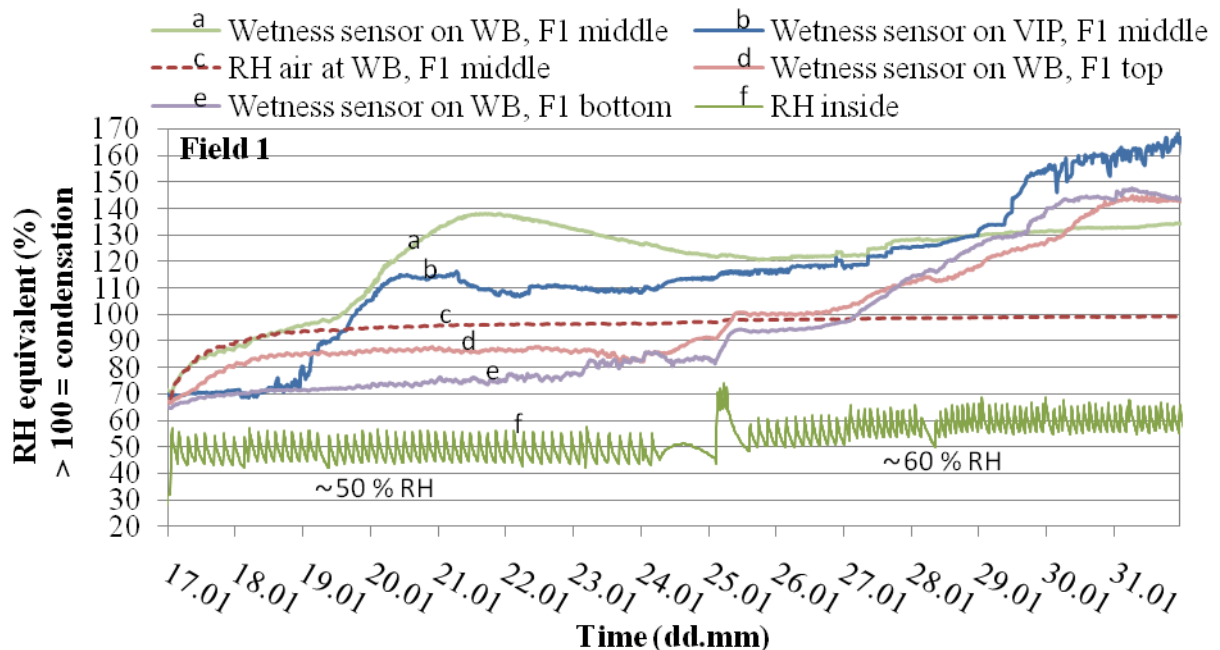
Figure 9. Moisture sensors in F1 during climate step 3 and 4. The RH equivalent values of the four wetness sensors, as well as the RH air sensor are shown. The climate room RH was  $\sim$  50 % from day 17 to 24, and  $\sim$  60 % from day 26 to 32 (graph f).

Figure 9 shows F1, during the two climate steps with RH  $\sim$  50 % and  $\sim$  60 %. F1 experienced condensation at RH  $\sim$  50 %, which was not expected for this climate step compared to numerical simulations, at least not after that short period of exposure. This might be caused by the relatively large alternations in RH at the inside climate room, seen in the lower graph (graph f) in Fig.9. The moisturising at the RH peak is possibly larger than the drying-out at the RH bottom. Small air leakages in the structure might also contribute to the measured condensation. The wetness sensor shows condensation (value above 100 %) when the RH air sensor shows about 95 % RH. A possible explanation is that the RH air sensor is located about 5 mm from the wind barrier. Moreover, the wetness sensor is more influenced by condensed water on the vapour barrier than the RH air sensor. The wetness sensor located on the joint between two VIPs shows lower values than the wetness sensor on the wind barrier. Assuming that both sensors have the same temperature, condensation may be caused by the small vapour resistance of the wind barrier. The wetness sensor on the VIP (behind the wind barrier) then becomes moisturised by the wet wind barrier, which causes the sudden increase at the wetness sensor on the VIP. Another influencing factor is convection over the joint between two VIPs (about 2 mm opening) that might dry the sensor somewhat. A third aspect may be time delay due to the small vapour resistance of the wind barrier, but this should not result in such a sudden increase. The wetness sensors at the top and the bottom have different development at the end of climate step 3. A possible explanation might be that the wetness sensor at the top experienced a lower RH caused by an (erroneous) increase in the outdoor temperature during the experiment (Fig.12). The increase at the wetness sensor at the bottom may be condensed water that runs down from the middle of the vapour barrier and moisturises the sensor.

Both Fig.9 and Fig.10 show a peak at the wetness sensors during condensation. The cause of these peaks might be the different sorption curves for spruce and paper, i.e. that the measured electrical resistance is in a sensitive area of the curve that describes the electrical resistance as a function of moisture content for spruce (as the moisture meter is calibrated with respect to spruce). A small decrease in RH might then give a large effect on the output value of the moisture meter. The graphical plots from F1 and F2 show a lower RH at the top and the bottom than in the middle of the fields. The high RH at the middle is due to the thermal bridge of the joint between two VIPs. The temperature at the structures laying above and below the module influences the temperature, and hence the RH at the top and the bottom. However, the surrounding structures cool down the module, therefore this only have a conservative effect, i.e. lower temperatures increase the RH. It is therefore clear that the thermal bridge at the joint between two VIPs is a critical point for condensation in the wall, together with the surfaces of the fastening brackets.

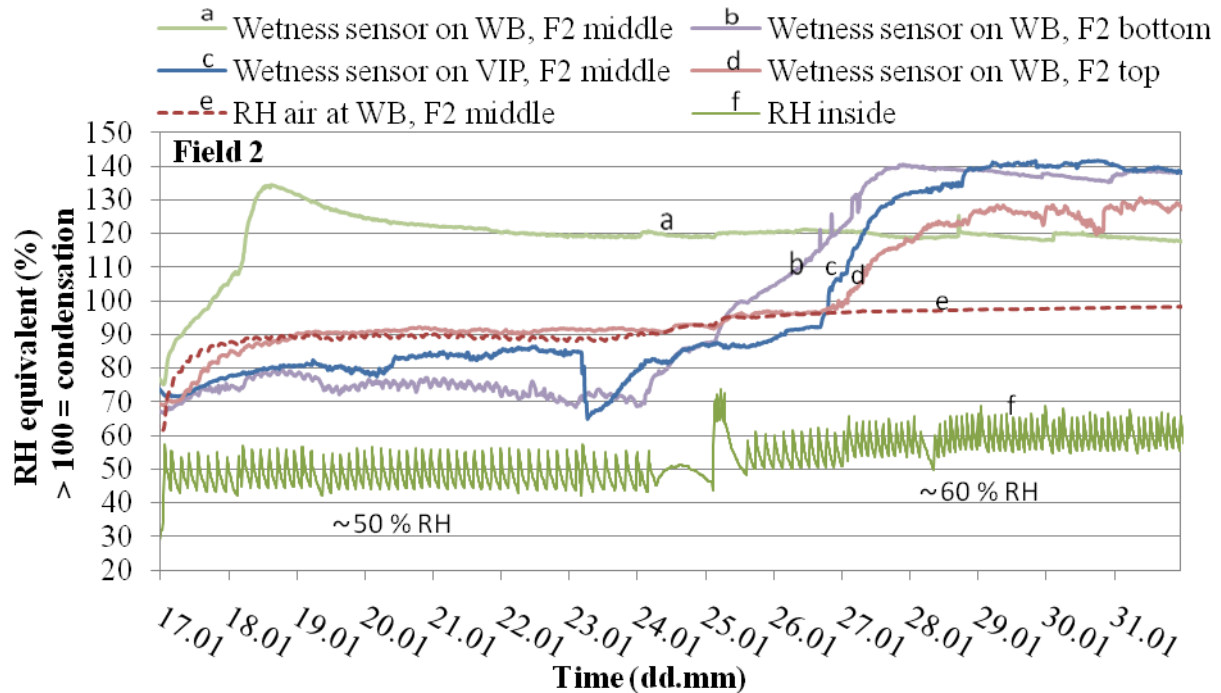
Figure 10. Moisture sensors in F2 during climate step 3 and 4. The RH equivalent values of the four wetness sensors, as well as the RH air sensor, are shown. The climate room RH was ~ 50 % from day 17 to 24, and ~ 60 % from day 26 to 32 (graph f).

Figure 10 shows F2, during the two climate steps with RH  $\sim$  50 % and  $\sim$  60 %. In accordance with numerical simulations, the field experienced condensation during both climate step 3 and climate step 4. However, an interesting difference between F1 and F2 is the wetness sensors located on the VIPs. In F1 this sensor measured condensation at both climate steps, whereas in F2 this sensor measured condensation only for climate step 4 even if this field is less insulated (only 20 mm VIP). The temperatures measured at the warm side of the wind barrier

(Fig.12) depict that the wetness sensor at F1 had a higher temperature than the wetness sensor in F2, i.e. as expected, thus the reason why the wetness sensor at the joint between two VIPs in F2 did not show condensation is unclear. It might be caused by difference in workmanship of the wall or installation of the sensor. The somewhat rigid wind barrier was hard to fit properly and this might have caused air cavities between the VIP and the wind barrier that was different from F1 to F2. Another unexpected occurrence was the sudden drop at the wetness sensor at the joint between two VIPs (graph c) in Fig.10, which might be caused by a loosening of the sensor from the surface of the VIPs (however, this is not known).

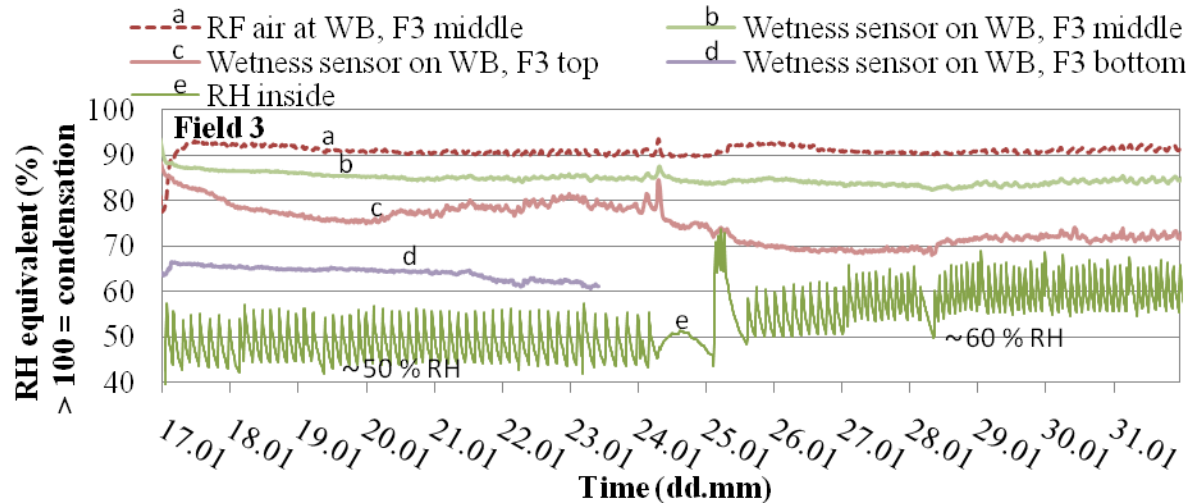
Figure 11. Moisture sensors in F3 during climate step 3 and 4. The RH equivalent values of the three wetness sensors, as well as the RH air sensor, are shown. The wetness sensor at the bottom (graph d) stopped giving reliable outputs. The climate room RH was ~ 50 % from day 17 to 24, and ~ 60 % from day 26 to 32 (graph e).

Figure 11 shows the reference field (F3) during climate step 3 and climate step 4. None of the sensors show condensation. The wetness sensors are not calibrated for temperatures below

0°C and are thus less trustworthy in F3. It is reasonable that the electrical resistance increases when the temperature drops below 0°C and the water freezes. Therefore, the values from the wetness sensors in F3 are lower than the RH air sensor. Condensation might be present in F3 without being measured. The time frame of the test is not necessarily long enough to give condensation, as F3 will experience a certain exsiccation to the outside climate room. The outside temperature was in addition increasing somewhat from the start of the climate step to the end as the cooling unit was manually de-iced for each climate step (Fig.12). This contributed to hold the RH air sensor on the wind barrier stable, as seen in Fig.11.

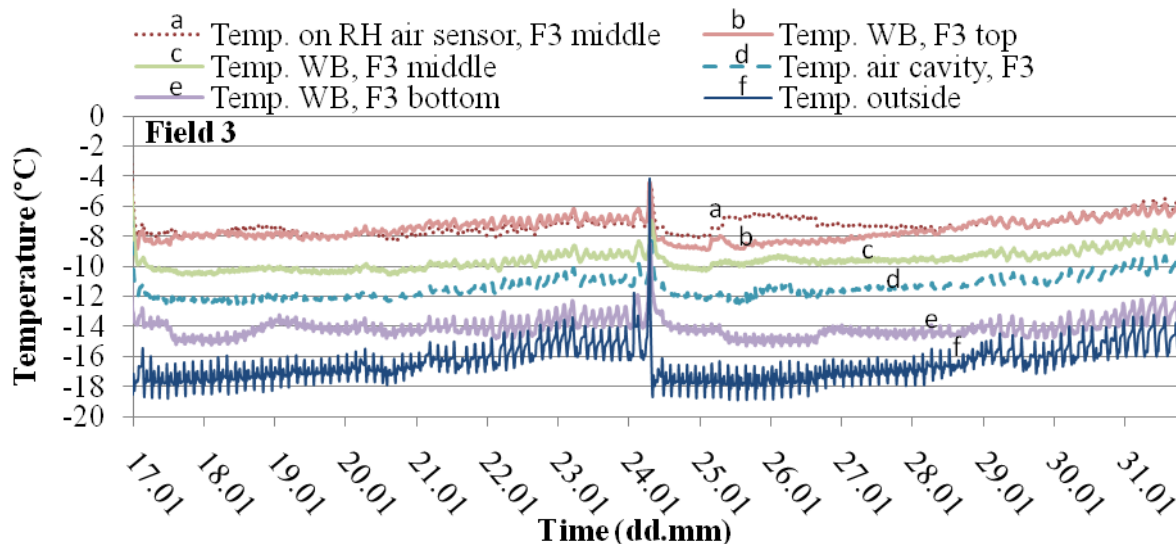
Figure 12. Temperatures in F3 (reference) measured at the warm side of the wind barrier (WB) over the same time span and at the same locations as the wetness sensors shown in Fig.11. In addition, the temperature on the RH air sensor, the temperature in the air cavity on the inside of the wooden cladding, and the outside temperature in the climate room, are given.

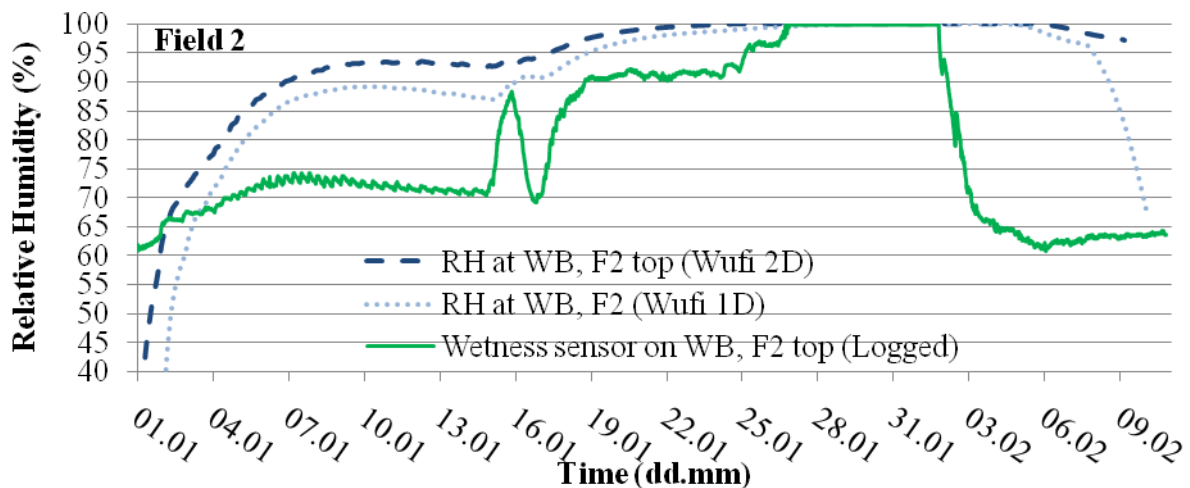
Figure 13. Relative humidity simulated in WUFI 1D and WUFI 2D, and measured RH at top of F2.

Figure 13 shows the WUFI and the wetness sensors results at the top of F2. The difference in RH values between the 1D and 2D simulation seems to be systematic and is probably caused by a lower temperature in the 2D simulation as depicted in Fig.14, which may be caused by the thermal bridge in the 2D simulation. The difference in wetness sensor measurements and simulated RH values seems mainly to be caused by the temperature difference as well. In Fig.14 the logged temperature graph is about 2.5°C warmer than the simulated values, which corresponds to a decrease in RH of about 20 percentage points at this temperature level. The low temperatures in the simulations may be caused by the application of the VIP upper limit declared thermal conductivity of 0.005 W/(mK) (Porextherm 2009), as the real thermal conductivity may be as low as 0.004 W/(mK) (Binz et al. 2005). Measurements have shown that both the conductivity and the thickness of different VIPs may vary, e.g. Grynning et al. (2010) measured conductivities somewhat higher than the declared ones and panel thicknesses that were less than stated.

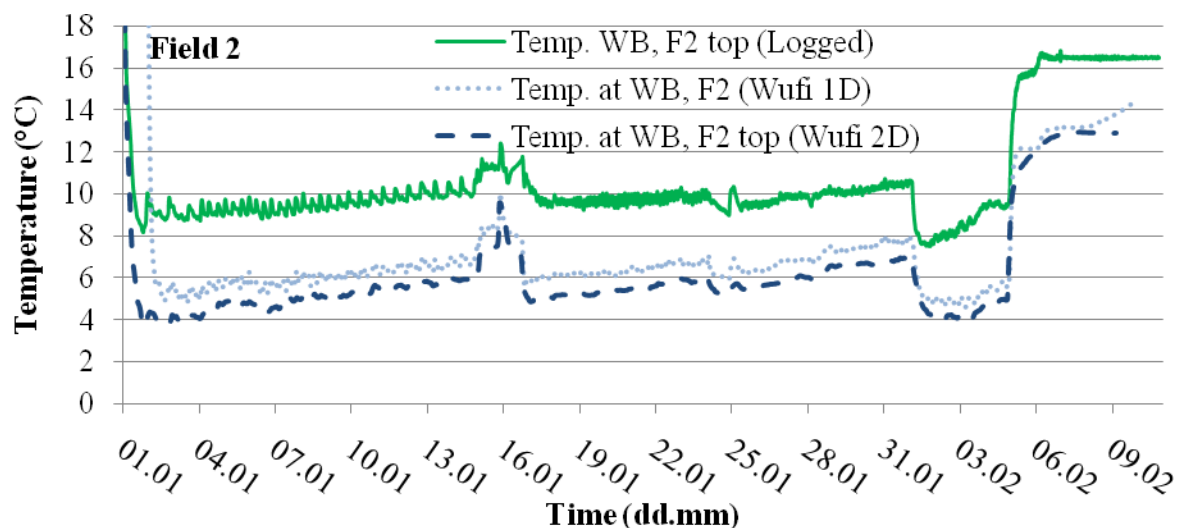
Figure 14. Temperature simulated in WUFI 1D and WUFI 2D, and measured temperature at top of F2.

Analogous plots (not presented here) as Fig.13 and Fig.14 were also made for F1, i.e. simulated and measured values of RH and temperature at the top of F1. The WUFI 1D and WUFI 2D simulation results compared well. However, the graph of the wetness sensor at the top showed also in this plot about 10 percentage points lower RH, except for the case of condensation. The difference seemed also here to be caused by a warmer temperature in the experimental results.

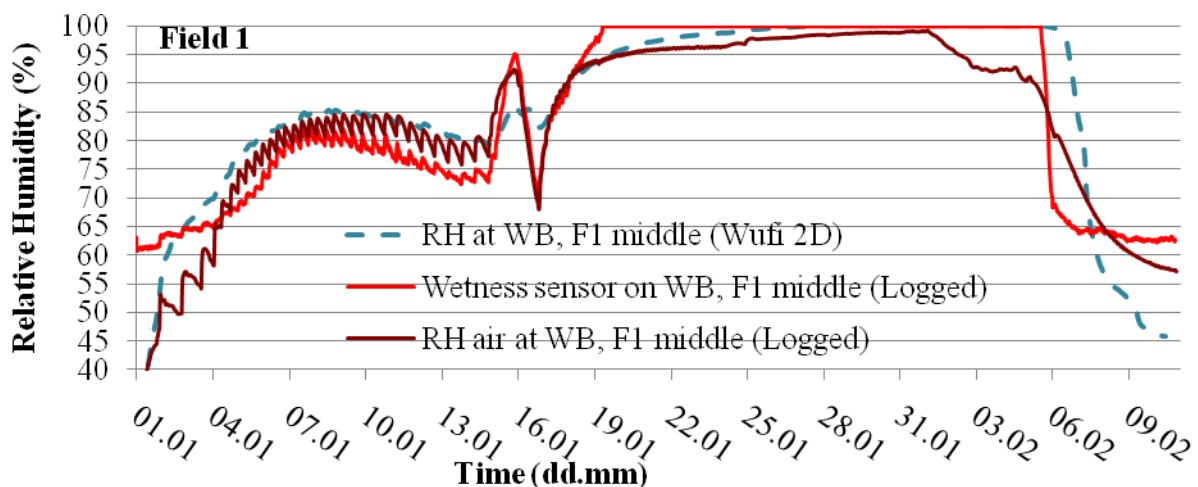
Figure 15. RH simulated in WUFI 2D, and measured RH in the middle of F1.

Figure 15 shows measured and simulated RH values at the middle of F1, where both the simulated and measured values compared quite well. The wetness sensor showed condensation when the two other graphs showed a RH of about 95 %, indicating that the wetness sensor represents a better condensation sensor than the regular RH air sensor due to the ability to register wetness on a surface. The small differences might be due to the eccentric location of the two other measurements, i.e. they are placed on a slightly warmer isotherm.

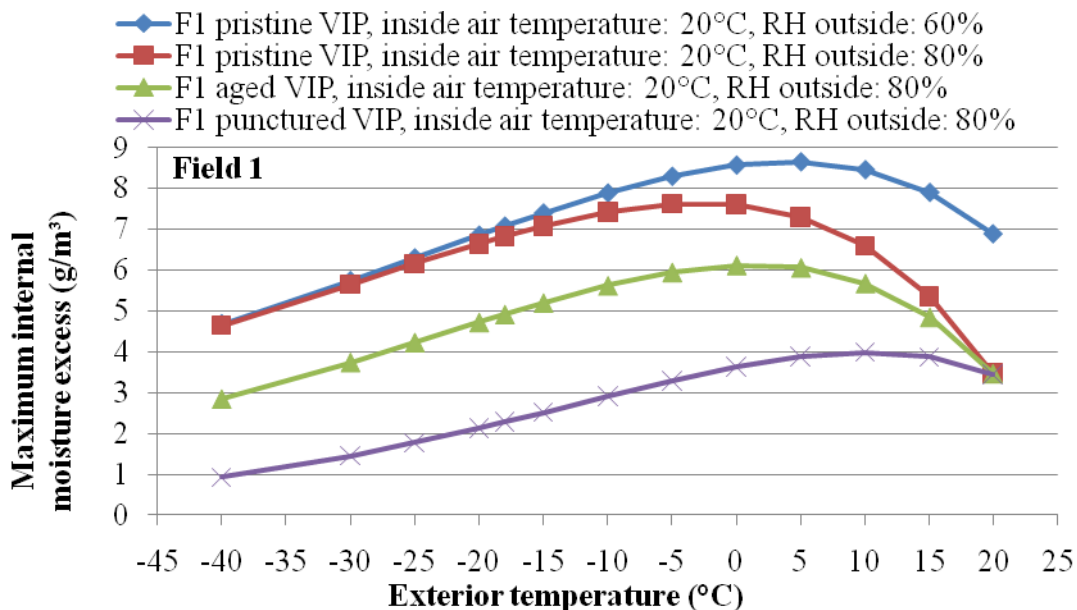
Figure 16. Maximum moisture excess before condensation on VIP in F1.

The calculations of condensation-start-limits are shown in Fig.16, illustrating what external temperature and internal moisture excess may cause condensation on the VIP surface for different conditions (thermal conductivities) of the VIPs. The calculations are based on an interior temperature of 20°C and an exterior RH of 80 % (except the upper graph with an exterior RH of 60 %). As for the U-value calculations, the thermal conductivities applied for pristine, aged and punctured VIPs are employed. It is important to emphasize that the tested constructions do not have a vapour barrier on the inside, and is hence considered as a worst-case wall compared to a more typical wall with a vapour barrier. The water vapour diffusion resistance of the materials at the interior of the VIPs is neglected, which represents a conservative simplification. It should also be noted that the risk of mould growth on wood in structures normally is assumed to start at a RH of 80 %.

Figure 16 shows that for an exterior RH level of 60 % and an exterior temperature of  $-18^{\circ}\text{C}$ , the moisture excess must be  $7.1 \text{ g/m}^3$  for condensation to occur at the VIPs in F1. This is equivalent with an indoor RH of 46 % at these conditions. During the experiment, condensation was not observed on the top or bottom of the fields before the inside RH was 60 %. Neglecting the water vapour diffusion resistance of the materials on the interior side of the VIPs may explain this difference. The material thermal conductivity might also deviate from the real value and cause an incorrect temperature factor. Lower thermal resistance at the surface due to air circulation in the climate rooms may also contribute to this difference. Furthermore, the calculations assume steady-state conditions, whereas the experiment was not run for a sufficient long time to reach complete steady-state.
