Integrated analysis of past, and potential future rock slope failures of various size from Rombakstøtta, Nordland

Odd André Morken

Geology

Submission date: May 2017

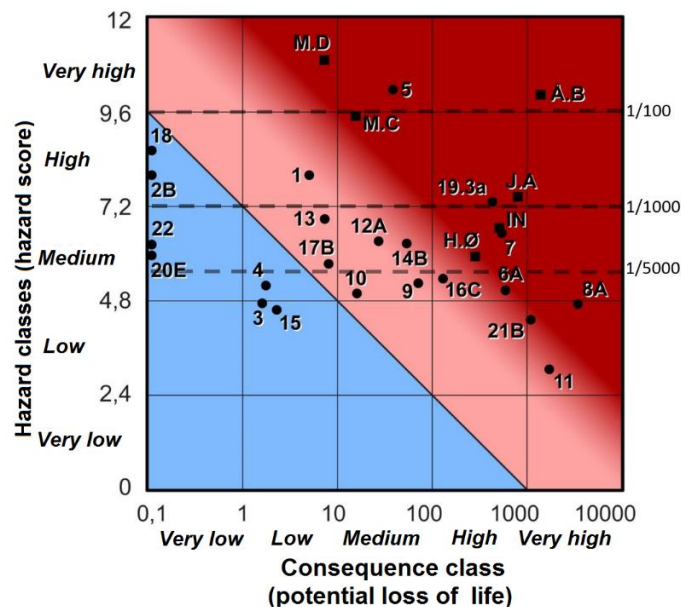
Figure 2.5 Risk matrix, with a few already classified unstable slopes. Blue = low risk; bright red = moderate risk; red = high risk. Note the transition zone between moderate and high risk, as well as the annual probabilities for failure on the right side, following TEK 10. Edited from Blikra et al. (2016).

The hazard score and the potential life losses are combined into a risk matrix (Figure 2.5). The purpose of the risk matrix is to aid the decision of whether a rock slope should be periodically or continuously monitored. Most of the unstable rock slopes in Norway fall within the blue category. At such sites, further actions are not economically viable due to low consequences, or the geological conditions needs to change dramatically for the slope to fail (Hermanns et al., 2012b).

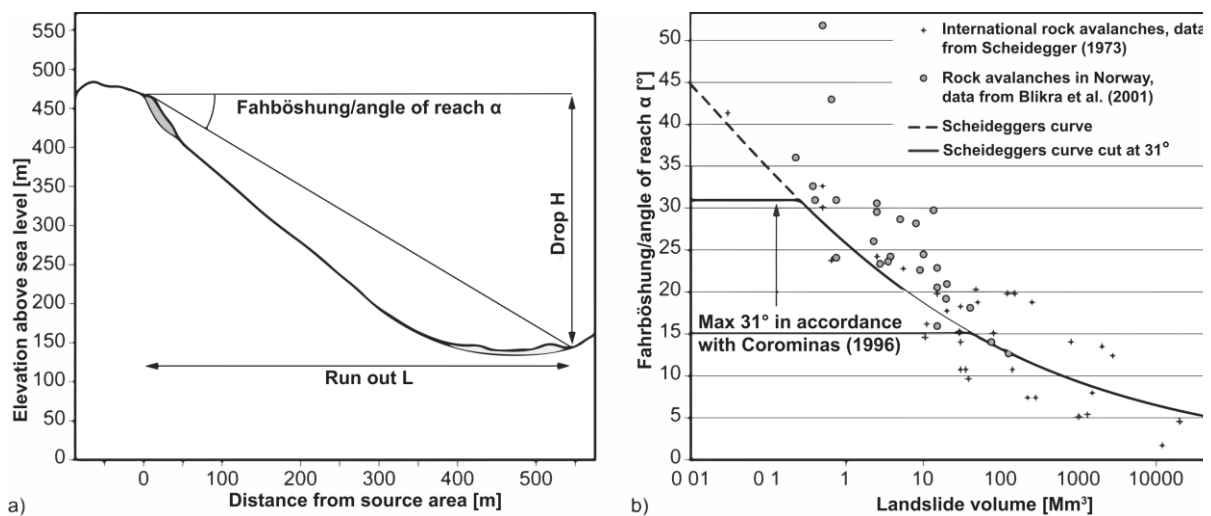
Figure 2.7 Empirical assessment of a landslide's reach: a) schematic profile of a landslide; b) empirical relation between fahrböschung/angle of reach and volume, based on Scheidegger (1973). Norwegian rock avalanches (Blikra et al., 2001) in general have a higher angle of reach (i.e. a shorter run out) than Scheidegger's best fit curve. Figure edited from Oppikofer et al. (2016).

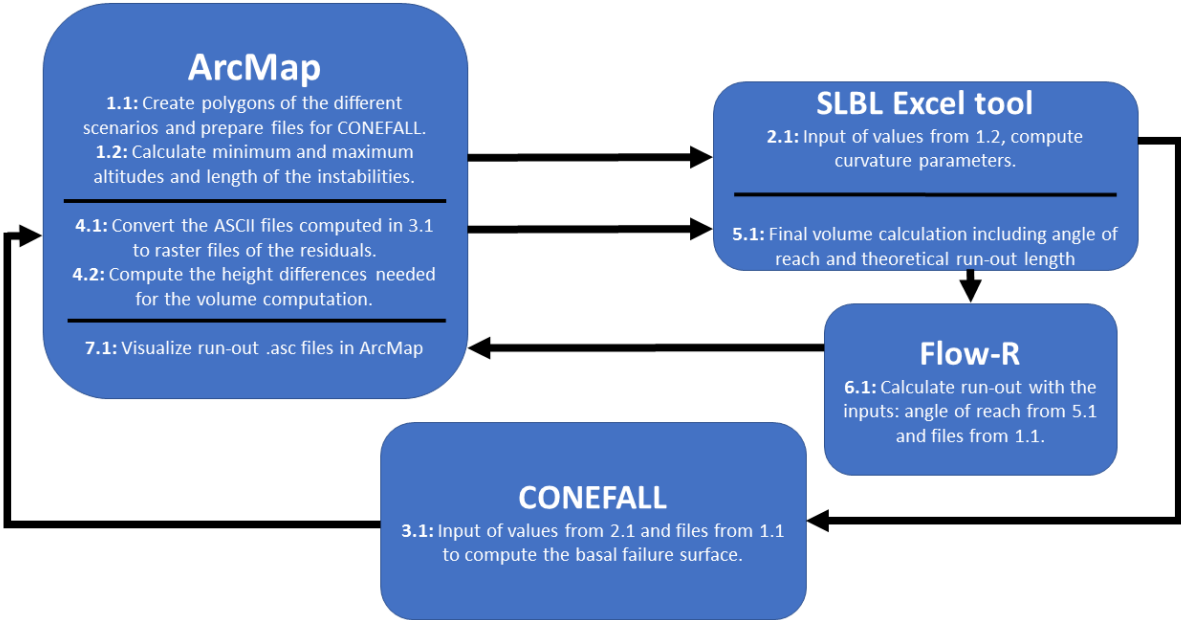
Figure 3.1 Conceptual workflow for the calculation of SLBL surfaces, volume and run-out analysis based on the procedure developed by NGU (Oppikofer et al., 2016). The procedure start in ArcMap.

The 1-meter resolution DEM was downscaled to 5-meter resolution for the steps shown in Figure 3.1. This reduces the calculation time, while it has minor effects on the final output (i.e. volumes and run-out) (Oppikofer et al., 2016). The initial input files in this process includes a DEM and polygons enveloping the different failure scenarios (Figure 3.1) (Oppikofer et al., 2016). An Excel-based tool, developed at NGU, was used to calculate the curvature parameters inputted to CONEFALL (Jaboyedoff and Labieuse, 2003). CONEFALL calculated the SLBL-surface, which were fed to the Excel-tool for the final volume calculation. Three SLBL-surfaces giving three different volumes are calculated (V_{minimum} , $V_{\text{intermediate}}$, V_{maximum}). Potential fall height and minimum altitude of the valley bottom, lake, or fjord are fed into the SLBL Excel tool, which estimates the reach based on the calculated volume (applying the theory mentioned in section 2.4.8).

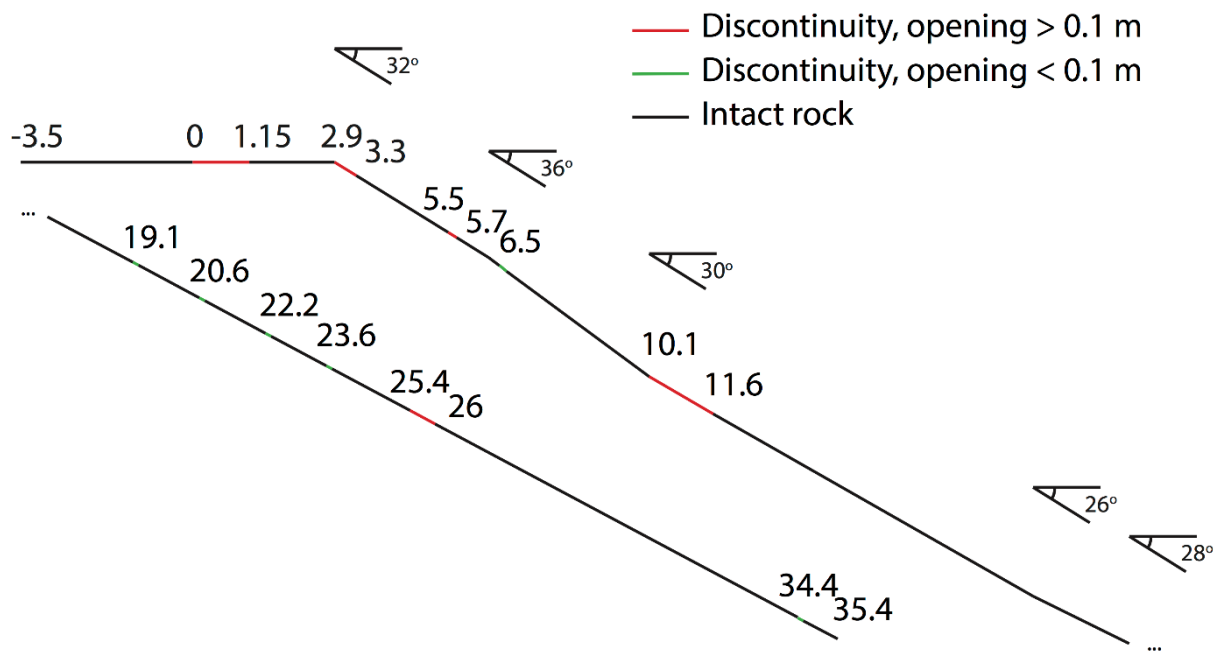
Figure 3.3 Example of a digitized scanline in profile. The numbers represent the distance from 0 in meters, and are measured to both sides of the joints. Dip of the slope was recorded as well, but have not been used in the calculation of block volumes. -3.5 m is at the edge of the slope, but 0 m in the scanline is at the edge of the first joint because the outermost block was completely detached from the rock mass, thus walking here was avoided because of safety reasons.

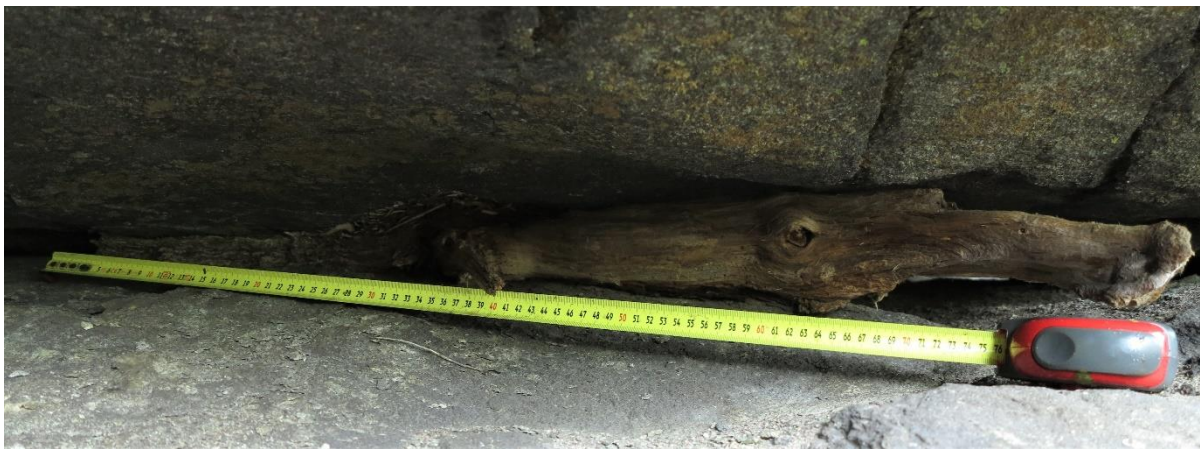
Figure 3.4 The piece of wood from which the C-14 sample was retrieved, in its initial position.

A piece of wood was found squeezed between two large moss-covered blocks. The block on top provided shelter from the elements, so the wood was well conserved (Figure 3.4). From the bark, it was possible to tell that it was a pine tree. A hypothesis of the rock falling onto the tree, squeezing it and killing it, seemed feasible from the surroundings. So, a sample for C-14 dating was collected in plastic bags, and later wrapped in aluminum foil. The sample was brought to Trondheim for dating. The exact laboratory method for dating is not known.

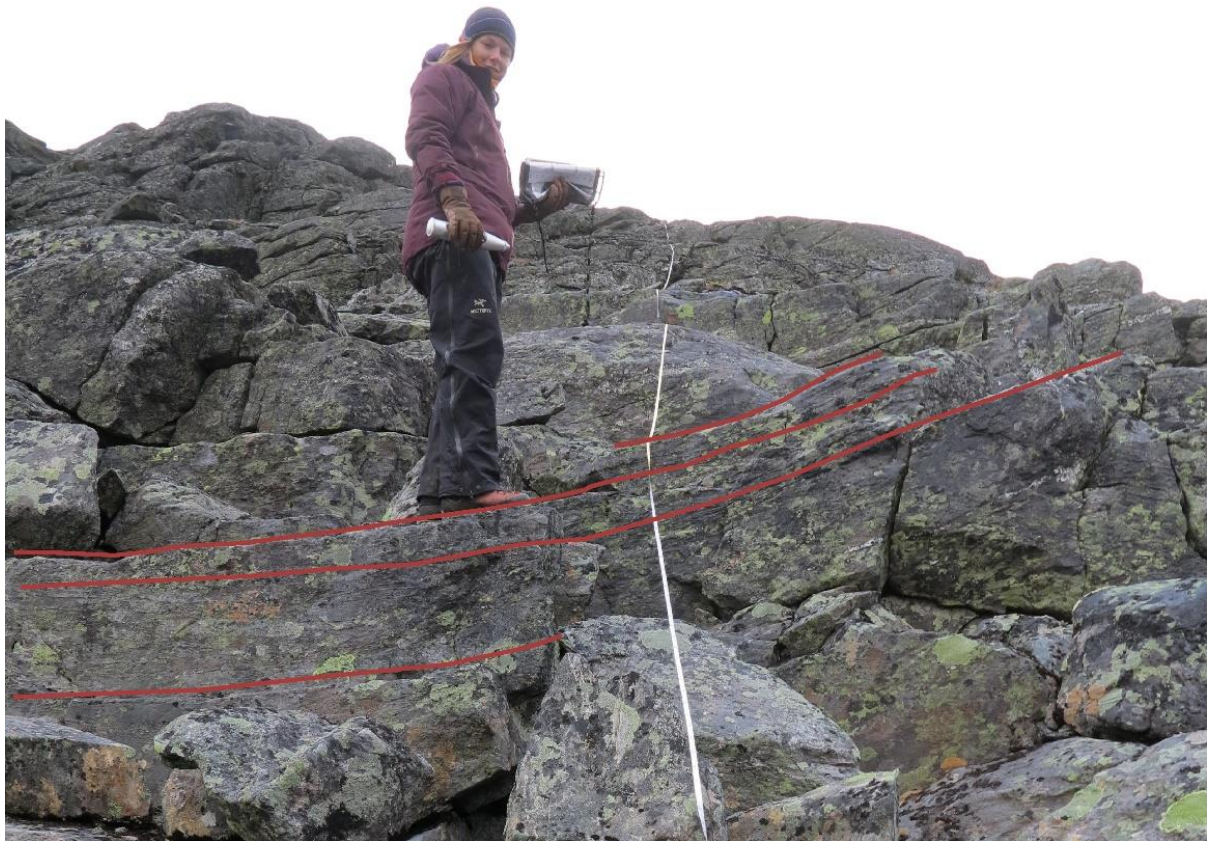
Figure 4.2 Lines drawn along the foliation, which is slightly folded. The folding varies within the study area.

There is a gentle folding in the rock. The folding undulates slightly and was discovered by studying the variation in the foliation (Figure 4.2).

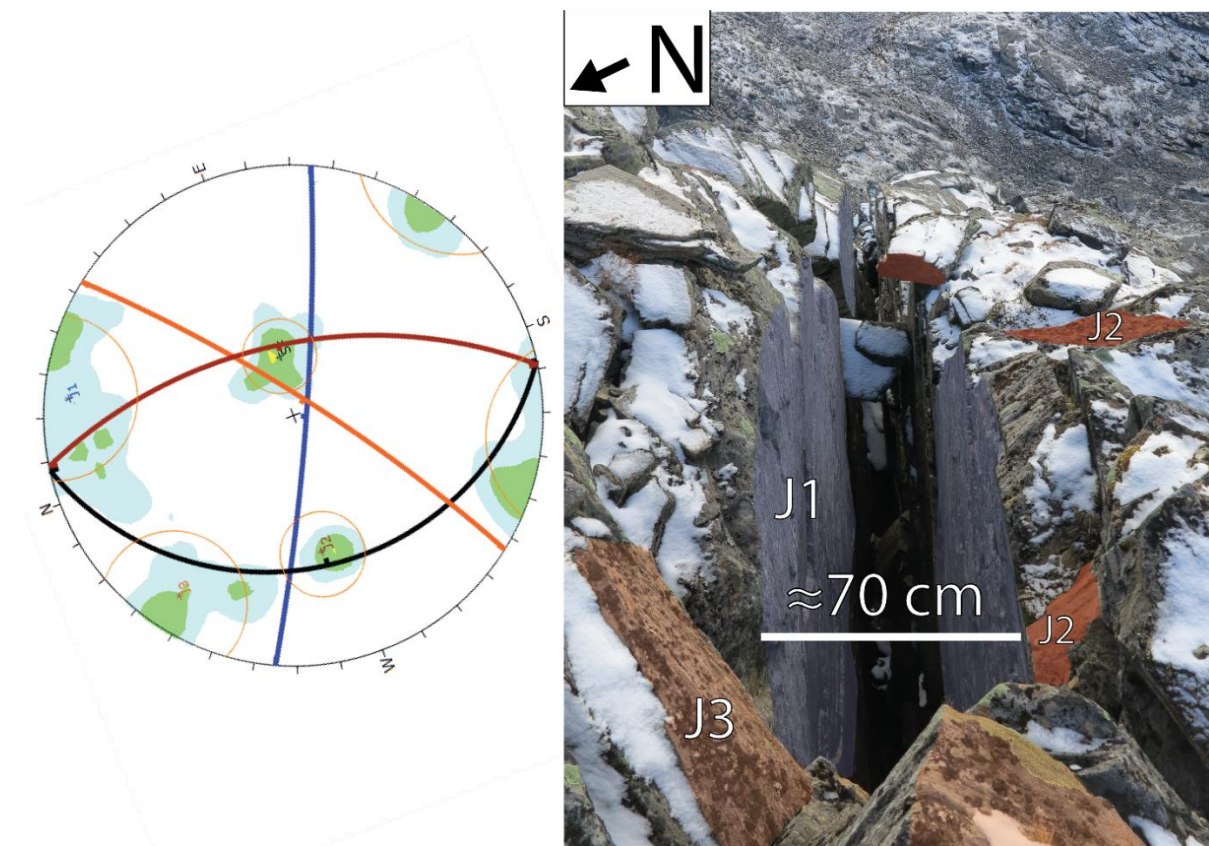
Figure 4.5 Stereographic plot from east domain oriented relative to the photo. Photo is edited to display planes better, the colors for planes in the photo is the same as in the plot.

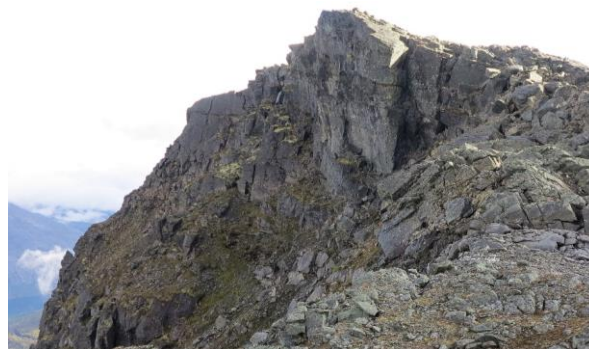
Figure 4.7 The most striking instability (4.D) in the eastern domain, clearly look as a possible toppling failure.

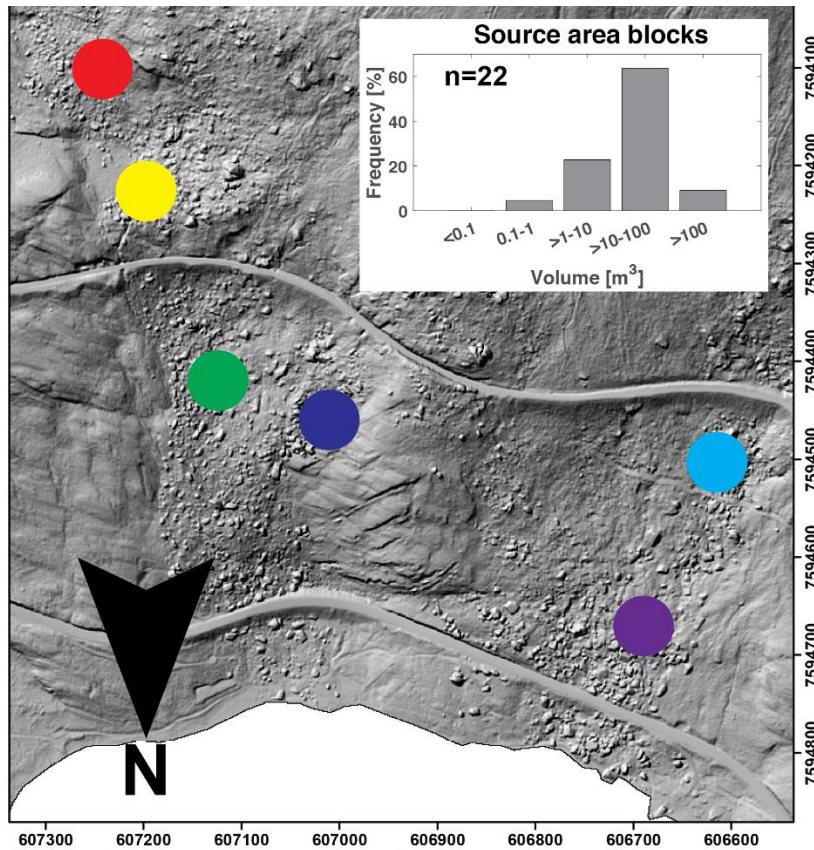
Figure 4.17 Histograms for the relative frequency (%) of rock volumes in the deposits, and one of the source areas at the top. Note that the histograms contain 100 observations, while the one in the map only contains 22 observations. The source area is to the south (upwards) outside of the map, while the fjord is the white to the north (downwards) in the map.

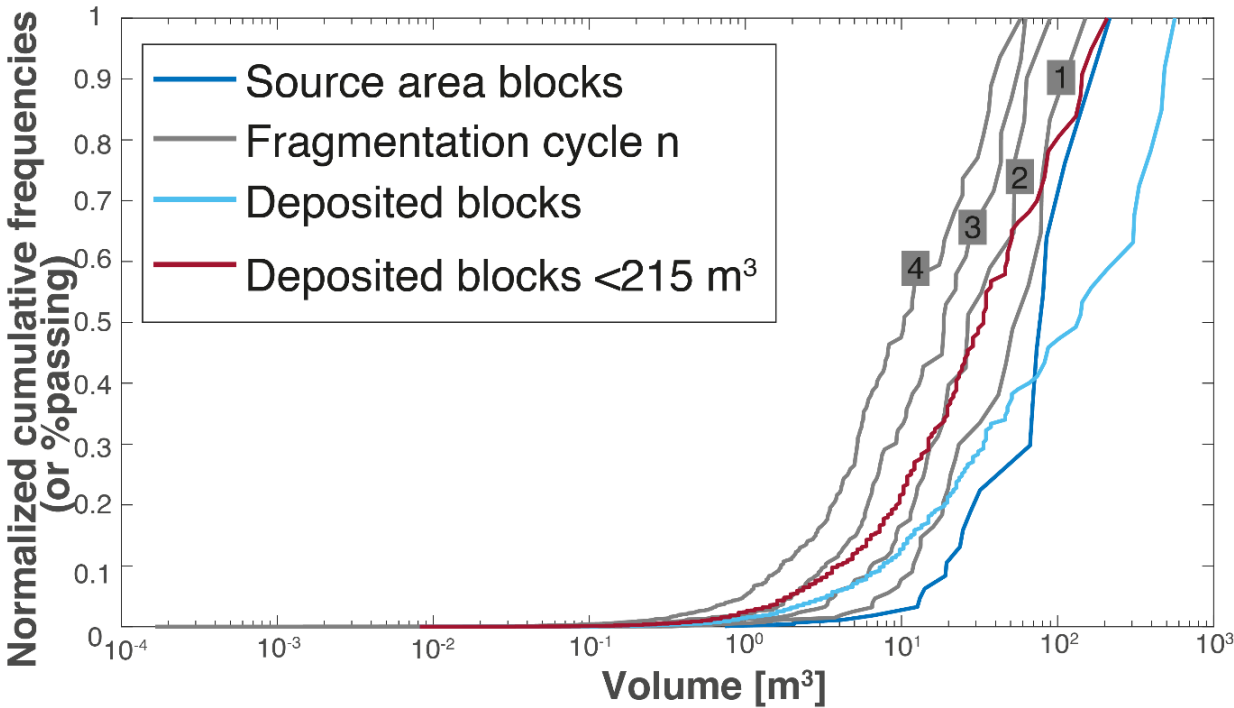
Figure 4.18 A semi logarithmic grain size distribution plot of the modelled and actual deposits at Rombakstøtta. Each line represents either the source area blocks, calculated fragmented blocks or the deposited blocks. Each plot does not represent the same sampling range.

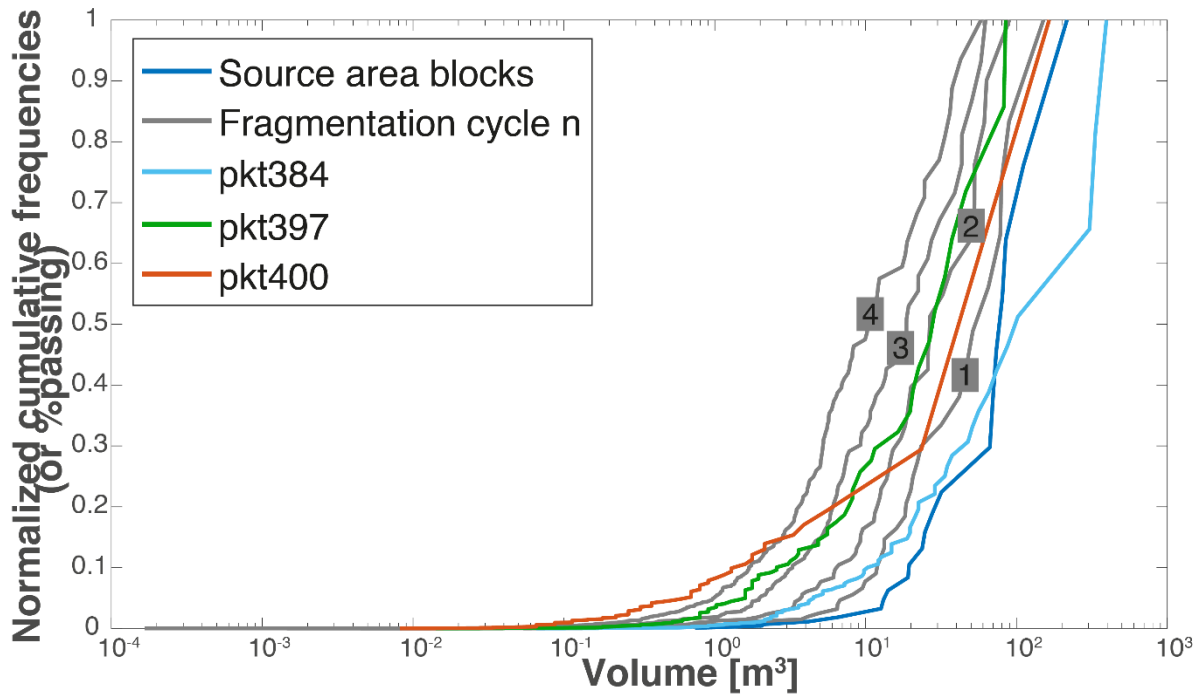
Figure 4.19 Grain size distribution for stations pkt384, pkt397 and pkt400.

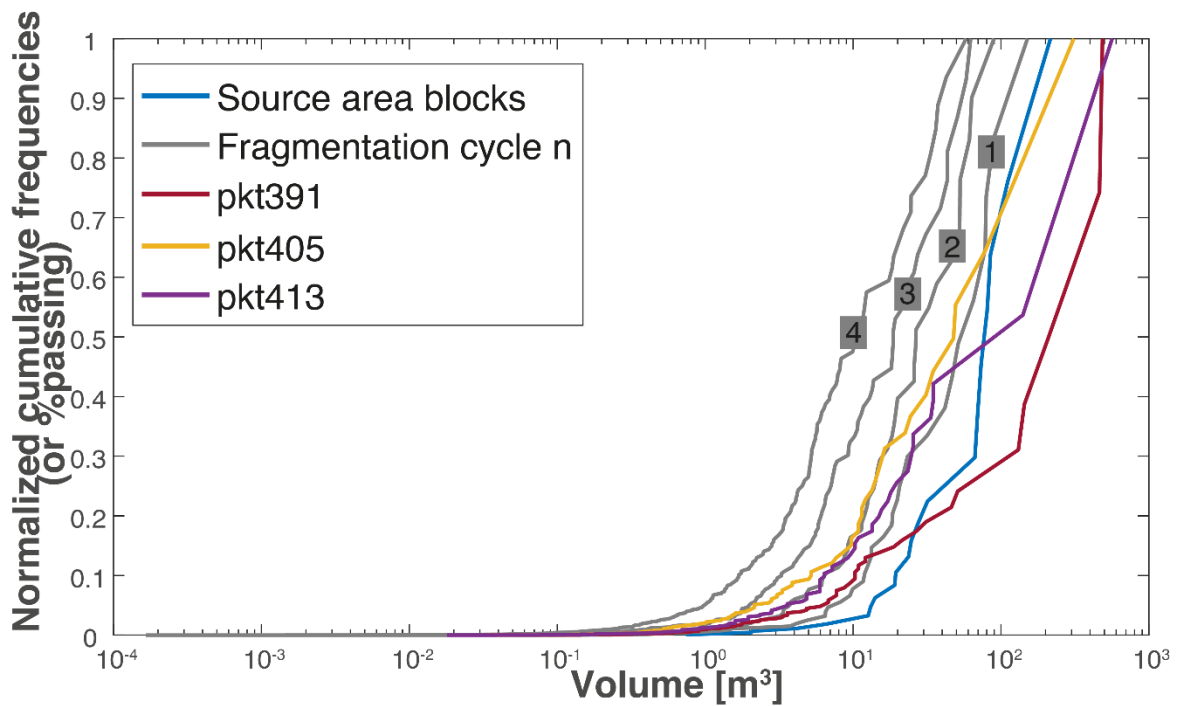
Figure 4.20 Grain size distribution for stations pkt391, pkt405 and pkt413.

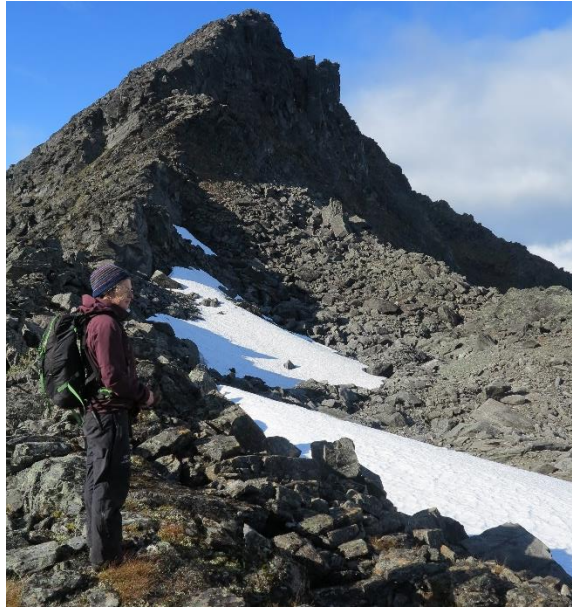
Figure 5.1 View towards west along the back scarp of scenario 3.A. Note the drop along the back scarp, and that the material that has dropped down is sloping towards the back scarp.

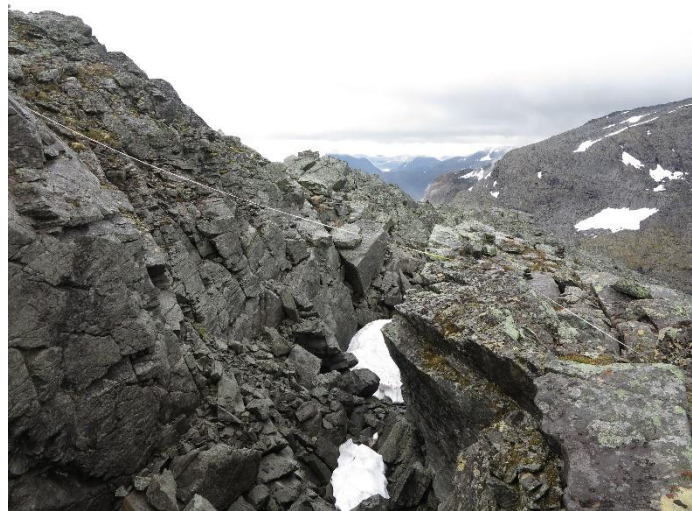
Figure 5.2 Photo showing the thickness vs. shortest axis ratio of the blocks along the main scanline in the source area. Unfortunately, the photo does not have any scale, but the open crack is measured to be 4.5 m wide.

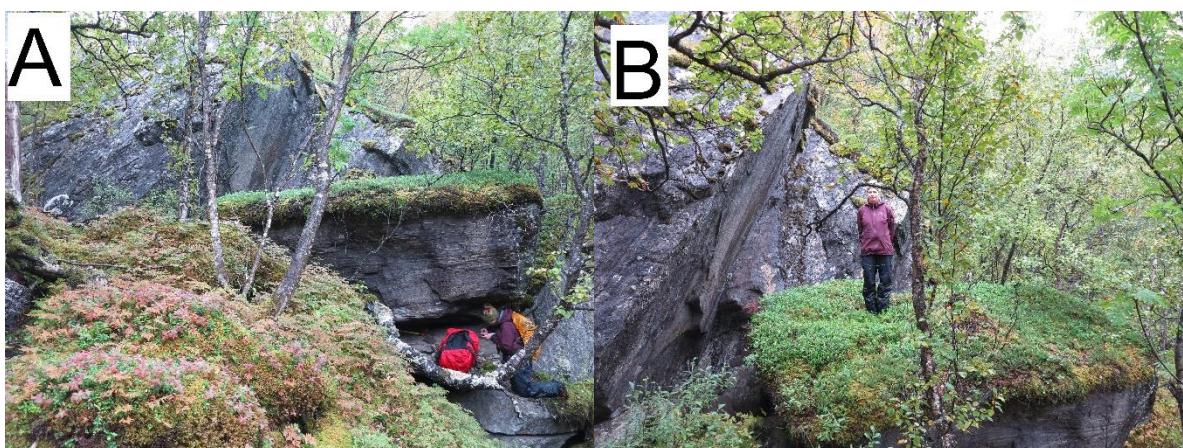
Figure 5.3 A) The wooden sample was found beneath the block under which the field assistant is sitting. There is a larger block partly hidden behind the small trees in the foreground (A), or to the left of the field assistant (B). B) In the right picture the field assistant is standing on the block which squeezed the tree.

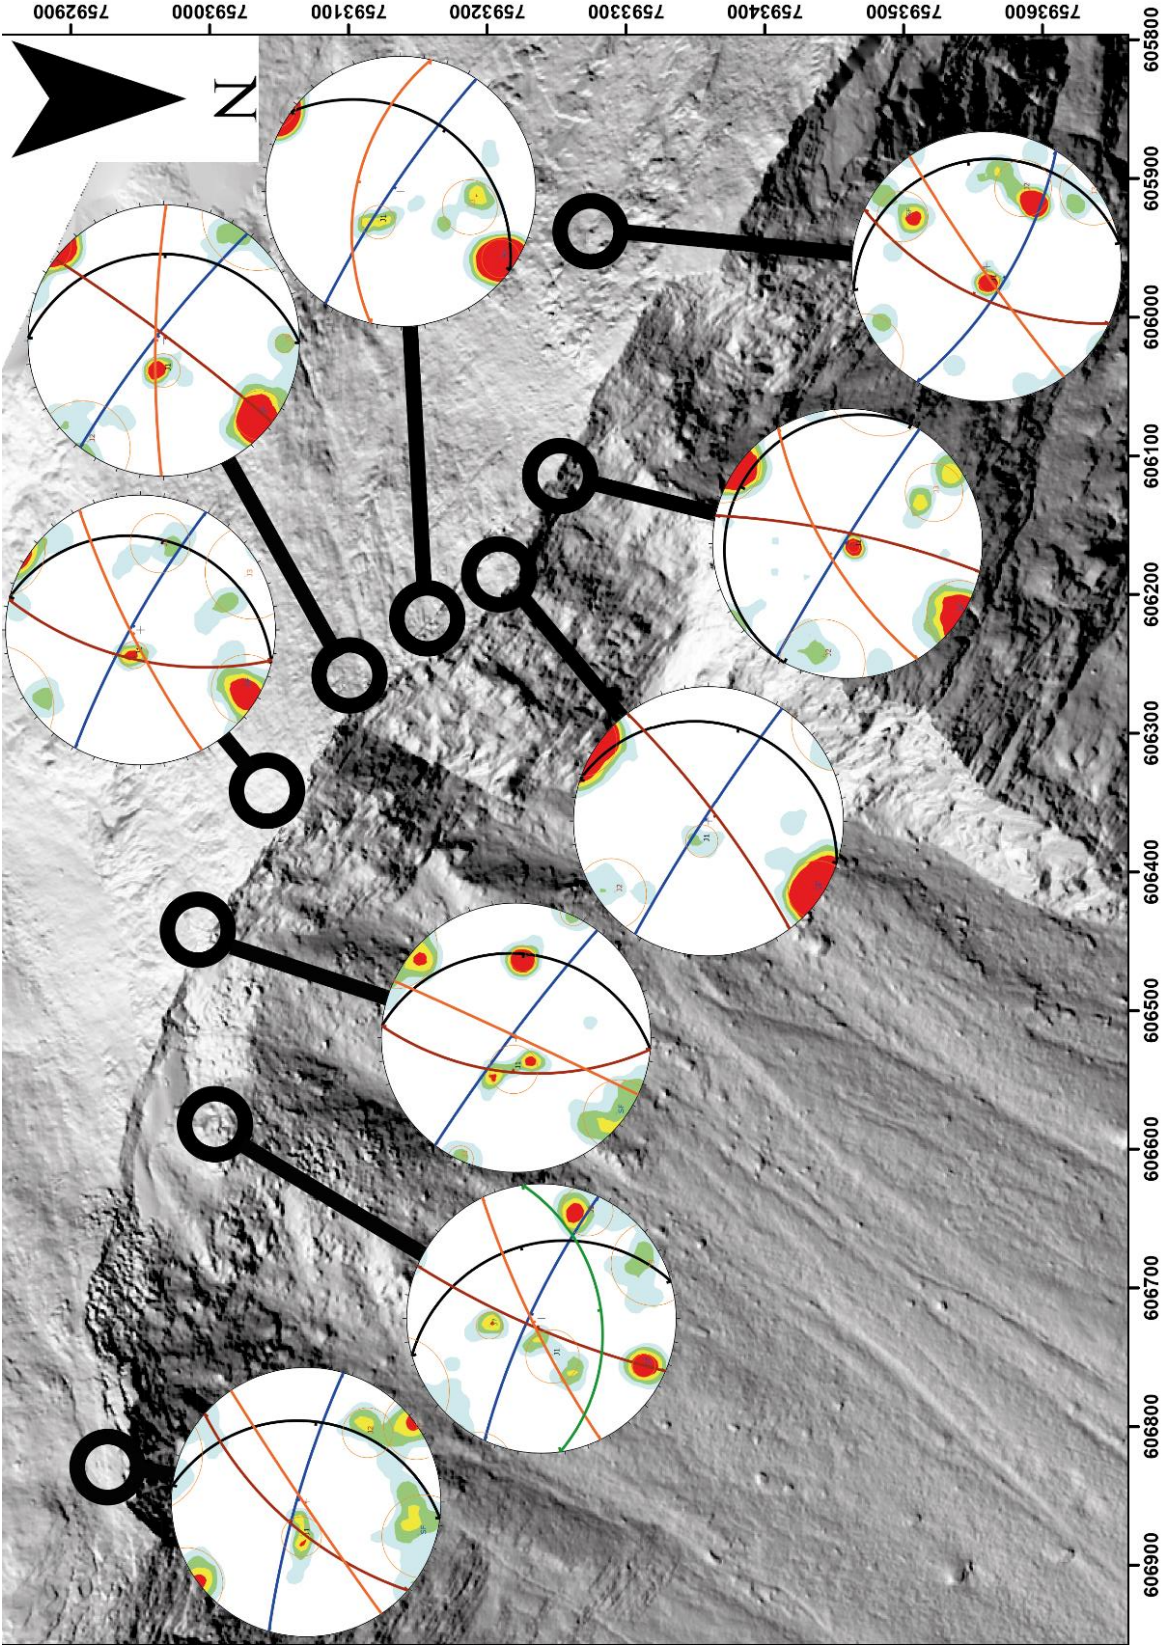
Figure 8.2 All the structural measurements divided into stations based on their spatial relationship and plotted in Dips 7.0. Foliations and joint sets defined based on field observations and contour density concentrations. Displayed on the LiDAR/DEM.
