Corrosion Fatigue of Extruded AA6082 Aluminium Alloy

The effects of Surface Roughness: Machined,
Punched, and Counter Trimmed Surfaces

Materials Science and Engineering

Submission date: June 2017

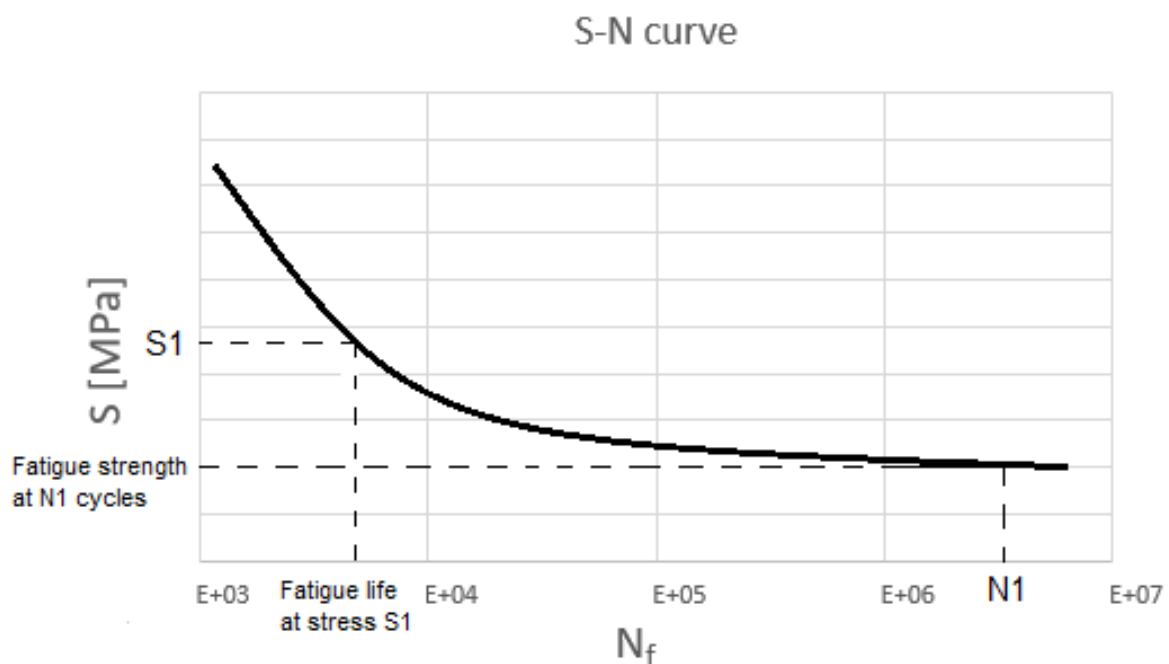
Figure 8: Shows a S-N curve for a non-specific material. S and N_f are stress amplitude and fatigue life, respectively. $S1$ signifies the stress amplitude or fatigue strength and the connected dashed line leads to the corresponding fatigue life. $N1$ shows a fatigue life and the connected dashed line leads to the fatigue strength. Made by the author.

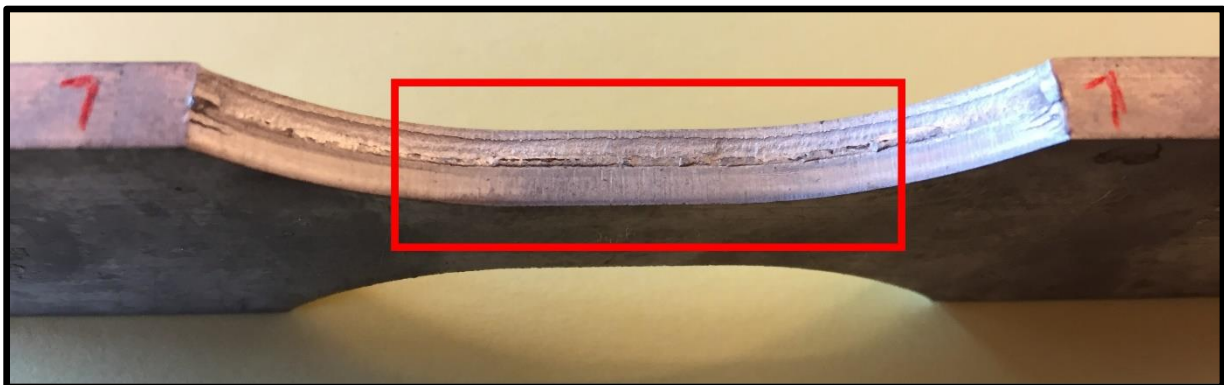
The area of the samples which were scanned is shown in Figure 24. This is the so called “test area”. This is where the samples have the smallest cross-section area. It is also the area which was measured to calculate the force for fatigue testing. This area (with a good margin) was submerged in saltwater during testing. Every scanned sample caught a little of the curvature, to make sure it got the whole test area.

Figure 24: Photo showing the area which was scanned.

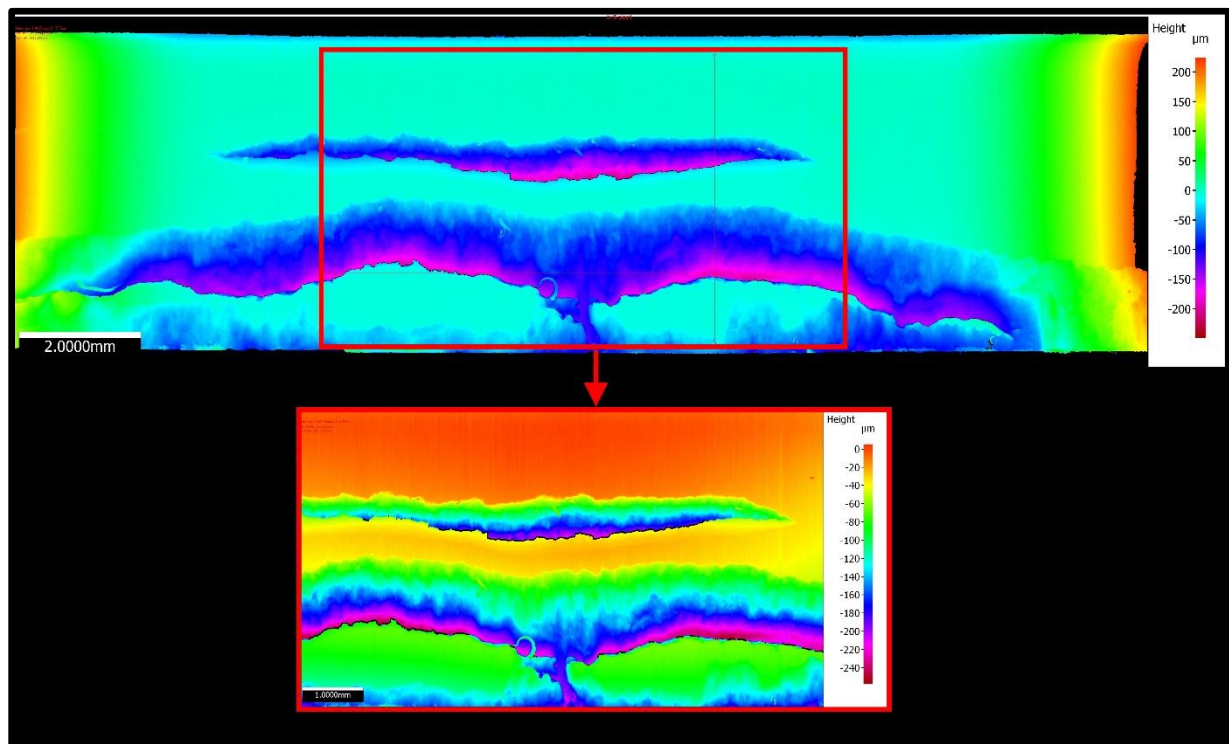
Figure 26: Showing how the areal roughness was chosen.

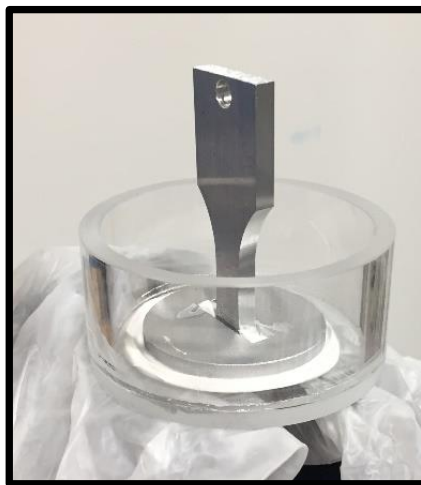
Figure 29: Sample with disc mounted to the first chamber.

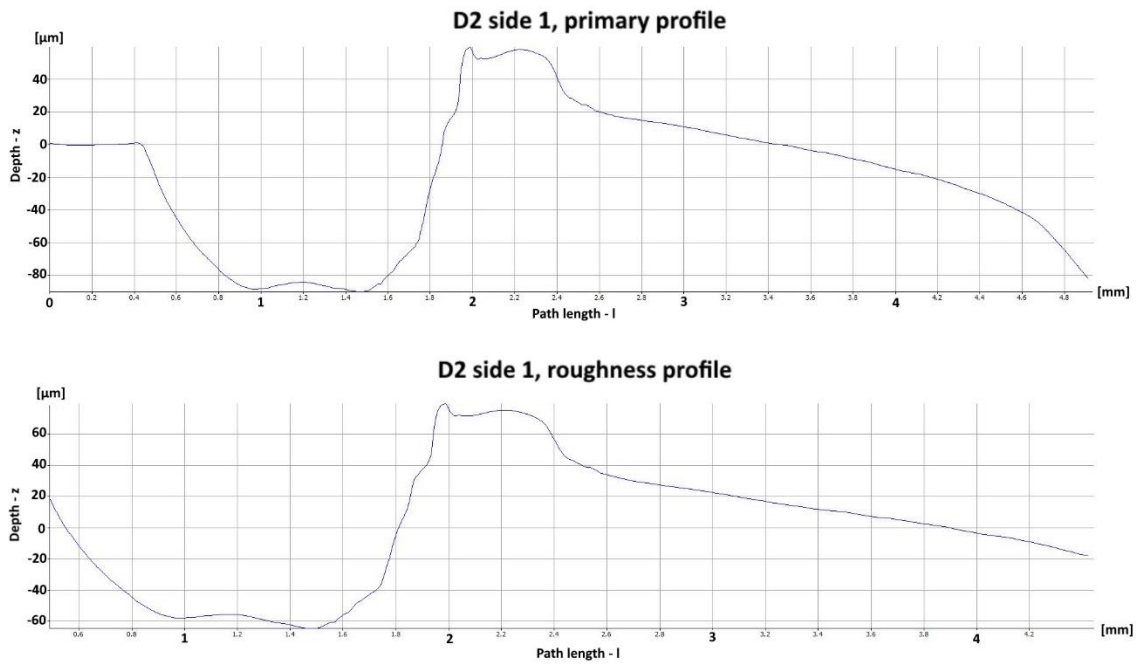
Figure 47: The corresponding profiles for D2 side 1, representing the D-series.

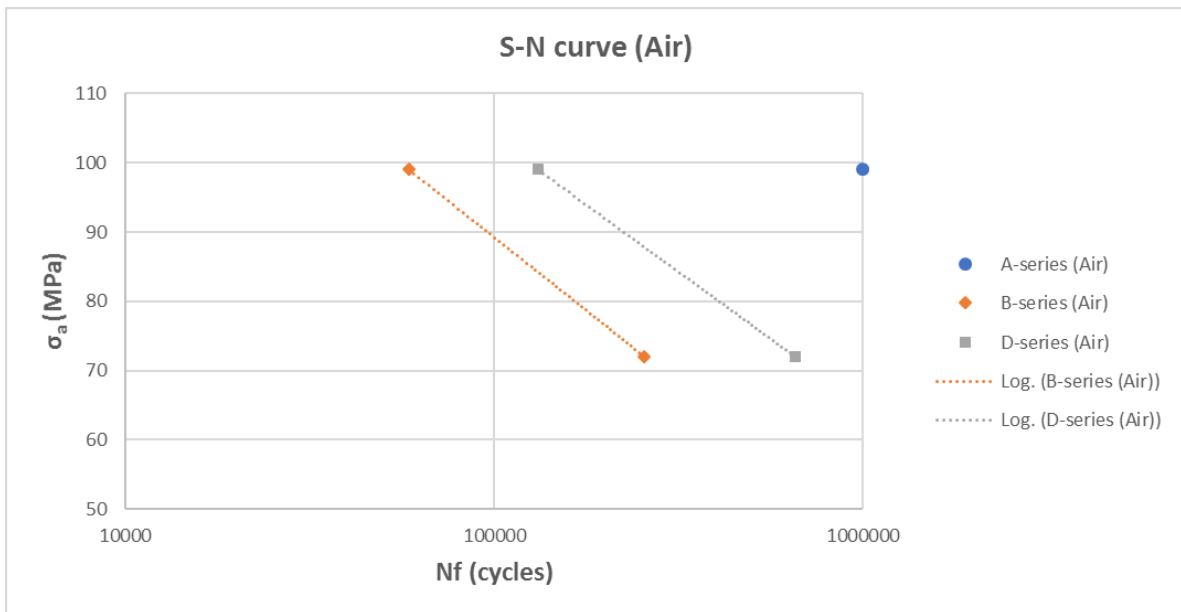
Figure 52: S-N curve for samples from each series tested in air with a logarithmic trendline.

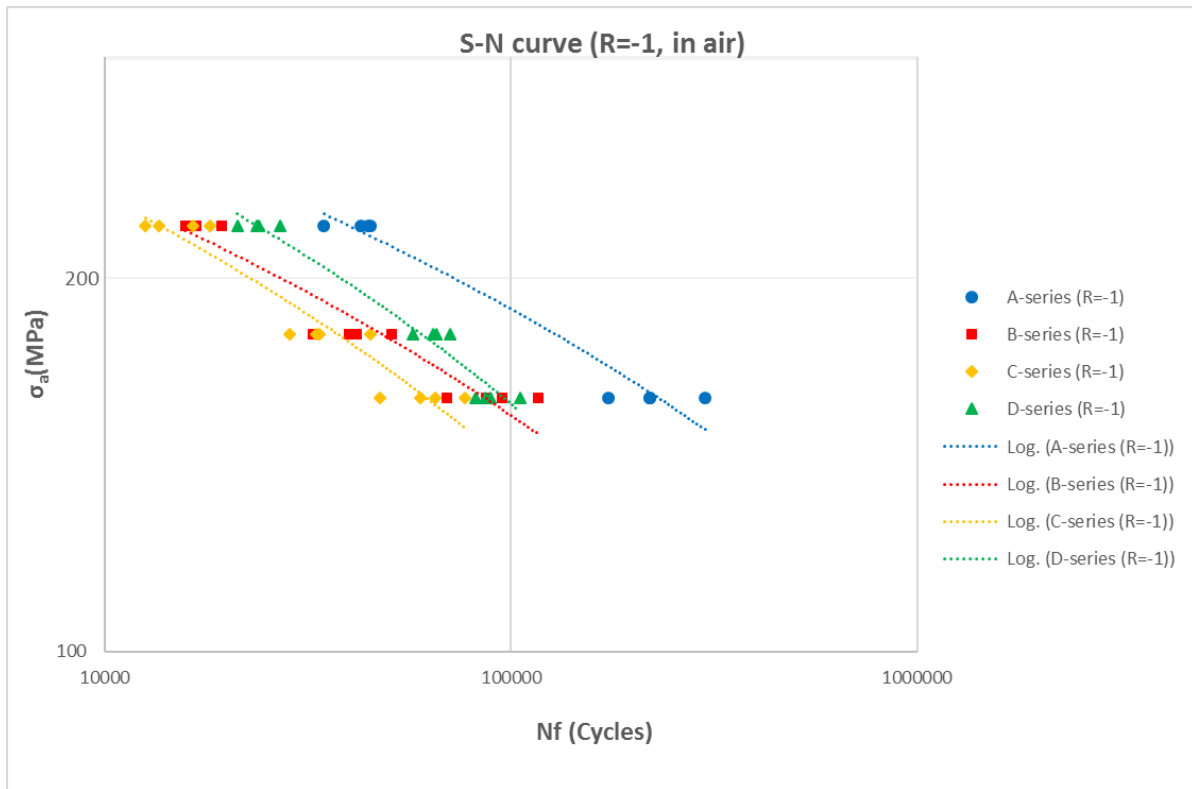
Figure 54: Results from specialization project conducted by the author. All the series are tested in air, with $R = -1$ and at 10hz. This graph is a log-log plot to show its linearity.

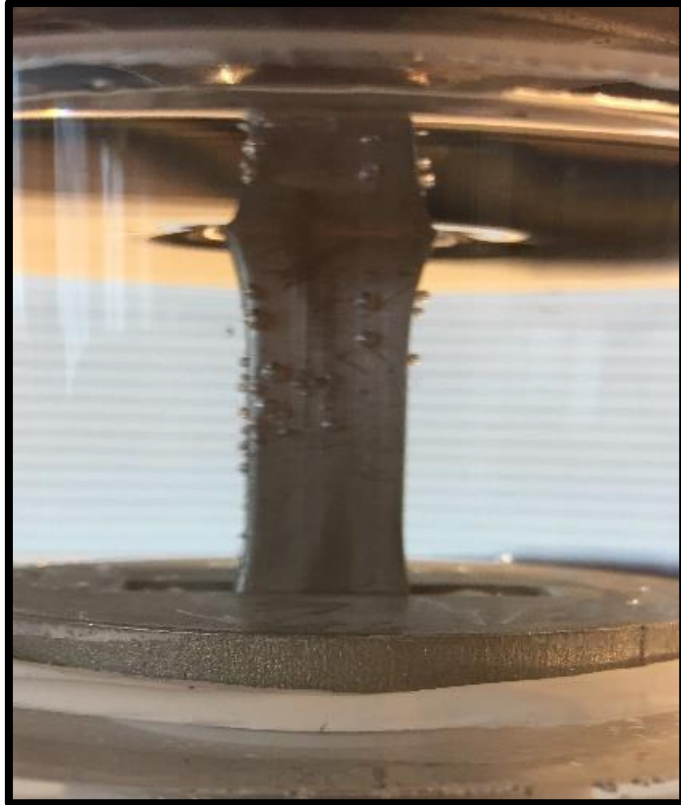
Figure 59: Air bubbles on surface due to how the saltwater was poured in.
