# Viability study of Acoustic Emission for condition monitoring of coiled tubing

**Christoffer Torkildsen  
Stenerud**

Subsea Technology

Submission date: June 2017

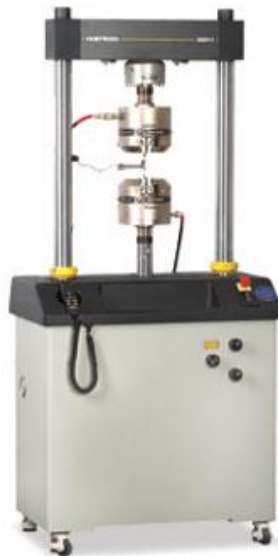
**FIGURE 1- INSTRON 8801 SERVOHYDRAULIC TEST RIG USED FOR TENSILE AND FATIGUE TESTS [2]**

For all tensile and fatigue tests, an Instron 8801 servo hydraulic testing system, shown in Figure 1, was used. The rig is capable of applying 100kN of axial force via a hydraulic cylinder and is powered by a hydraulic power unit (HPU) [2]. The wide range different grips and fixtures allowed for proper connection to both the flat tensile test specimens and the K1c fatigue test specimens.

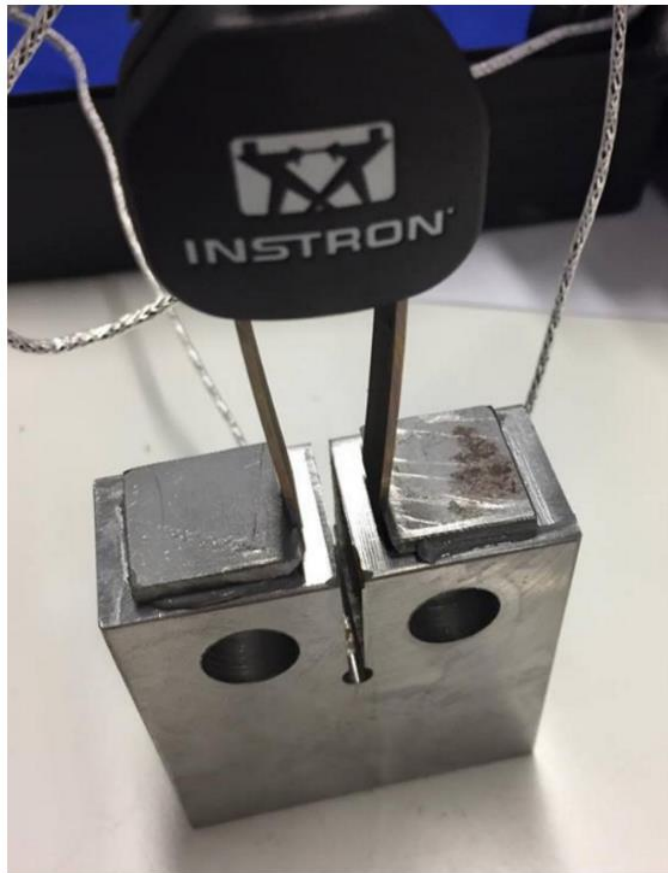
**FIGURE 2 - INSTRON CRACK OPENING DISPLACEMENT GAUGE MOUNTED ON FATIGUE CRACKING SAMPLE**

For the fatigue tests, an Instron crack opening displacement gauge was used to measure the crack growth in real time. The gauge provides a precise measure of the increase in relative displacement between two knife-edges, which is converted to actual crack length. The gauge is positioned between two knife-edges that are glued on to the fatigue crack specimen, as shown in Figure 2. For the sake of perspective, it can be noted that the size of the specimen in Figure 2 is approximately 60mm wide, 54mm high and 23mm thick.

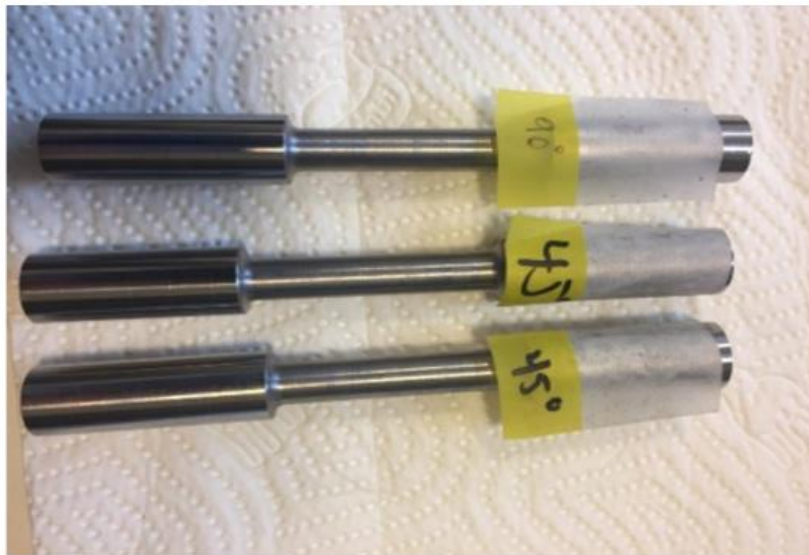
FIGURE 5 - CIRCULAR TENSILE TEST SPECIMENS

The tests were done using three circular tensile test specimens machined, shown in Figure 5, from the same steel block as the rest of the test specimens. The specimens were machined in compliance with the NS-EN 10002-1 standard. In order to obtain information regarding processing and rolling of the steel, one of the specimens was machined at a 90-degree angle and two specimens at 45-degree angle relative to the steel block.

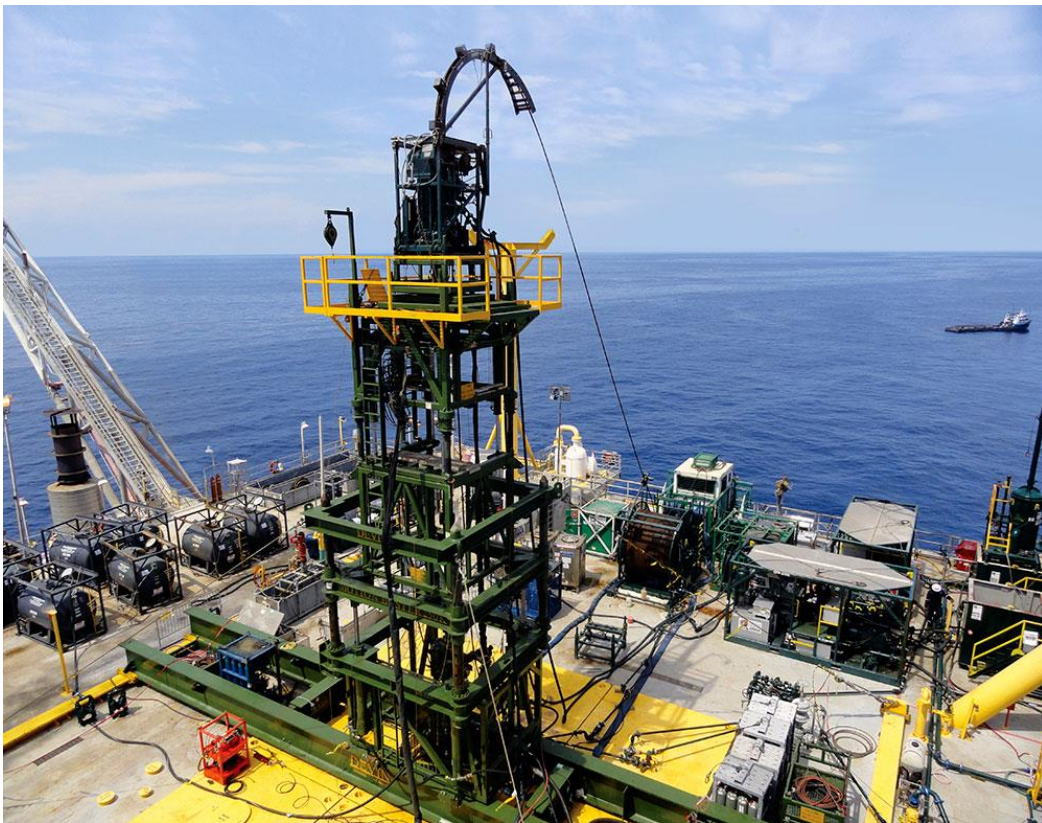
FIGURE 10 - OFFSHORE COILED TUBING CONFIGURATION [7]

- Reel – used for storage and transportation of CT string
- Gooseneck – guides and aligns the CT string vertically with the injector head
- Injector head – provides the necessary drive to run and retrieve the CT string
- Power supply – provides the necessary power to operate all CT components

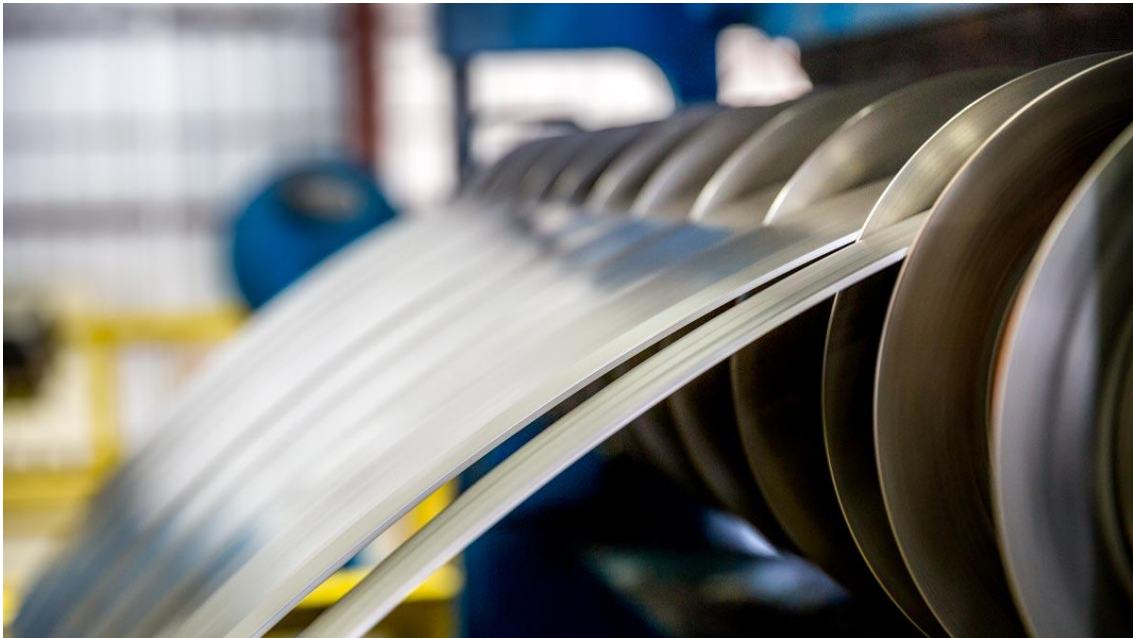
FIGURE 12 - SLITTING STEEL SHEETS FOR CT [10]

The manufacturing process of CT initiates by acquiring wide steel sheets (40-48 inches) and wrapping them on a large coil, often referred to as the “master coil” [10]. These sheets are then put in a strip and are slit to a width corresponding to the desired circumference of the final tubing. From there the skelp ends are welded together forming a continuous steel length and inspected for defects. A series of rollers gradually work the steel sheets mechanically into a tubular shape and leave the tube edges close together. High frequency induction welding (HFI) join the two edges together by generating heat from resisting the flow of electrical current and pressing them together using forming rollers [10].

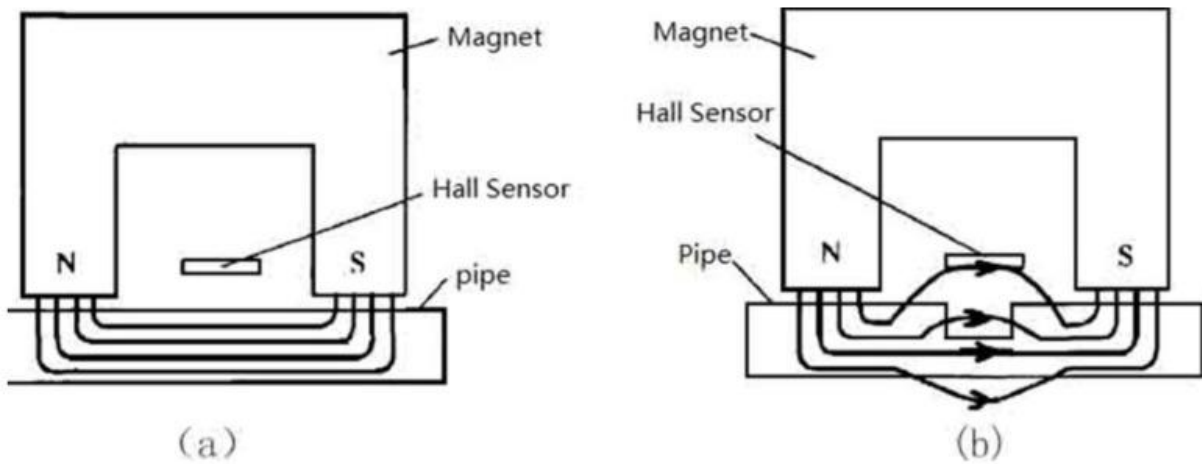
FIGURE 15 - MAGNETIC FLUX LEAKAGE PRINCIPLES [14]

A proven and widely popular NDT technique for CT strings is the Magnetic Flux Leakage (MFL) method. The method can operate without requiring surface preparation or coupling between sensor and monitoring surface [14]. Consequently, the method has no issue monitoring a muddy or wet surface, thus making it suitable for use in an offshore environment. Furthermore, it is able to detect both interior and exterior surface defects. The working principle in MFL inspection relies on magnetizing the ferromagnetic pipe material to approximately saturation values. This is achieved by applying a magnetic field using a permanent magnet as an excitation source. Magnetic flux lines will travel through the ferromagnetic pipe material, flowing from the south pole of the magnet to the north pole [14].

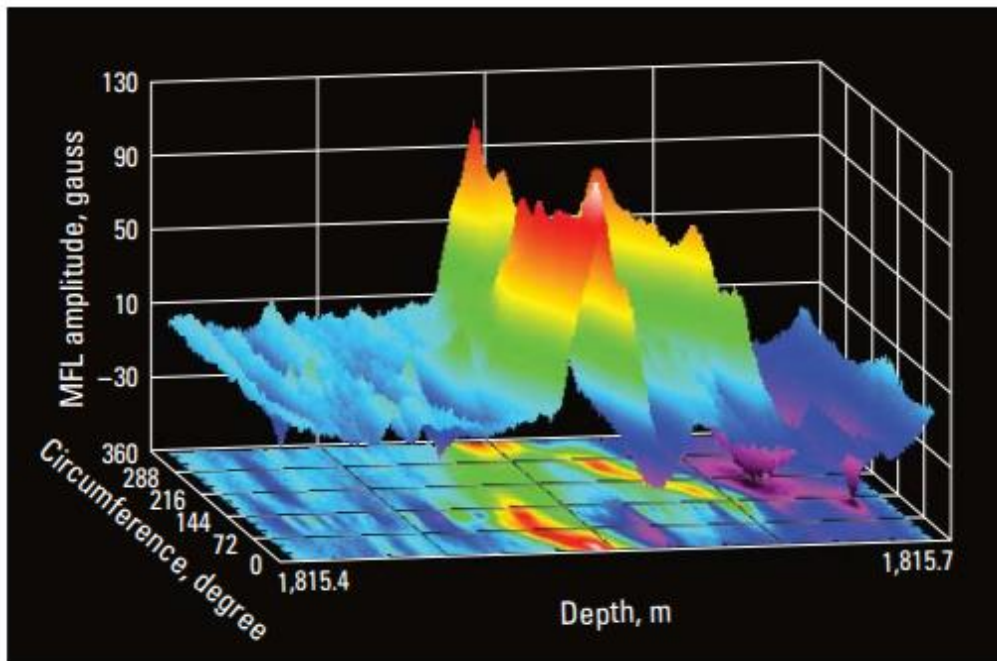
FIGURE 17 - 3D MFL PLOT FOR BIAS WELD ANOMALY [14]

However, more advanced representations are available in 3D signature plots of the leakage field surrounding the defect. Such representations may simplify the qualitative analysis the operator has to perform in order to characterize defects. Figure 17 shows a 3D representation of a CT string bias weld anomaly with respect to MFL amplitude, circumference and depth.

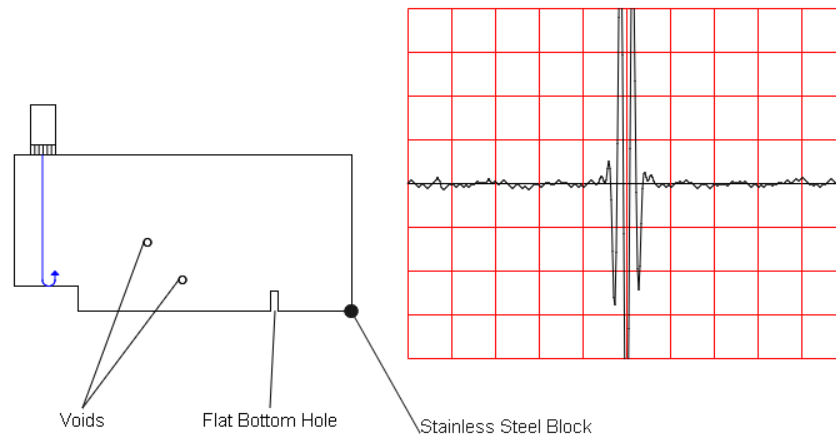
**FIGURE 20 - OSCILLOSCOPE READING OF REFLECTED SIGNALS [18]**

Figure 20 shows an oscilloscope reading of an UT-signal propagating and reflecting through a stainless-steel block. The x-axis of the oscilloscope reading shows time while the y-axis shows signal amplitude. The reading illustrates one distinct signal originating from the reflection of the end of the steel block. This indicates that there are no detectable defects at this location.

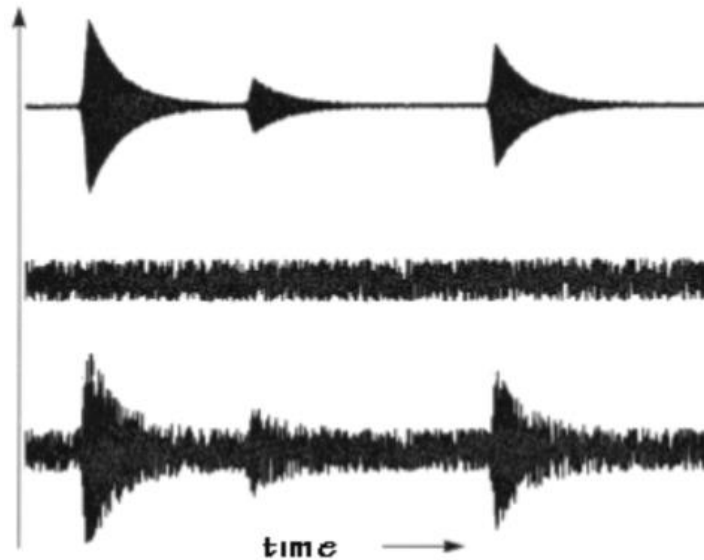
FIGURE 24- BURST, CONTINUOUS AND MIXED MODE SIGNALS [23]

The AE signals themselves are divided into the three main categories; burst, continuous and mixed mode. Burst type emissions are sudden discrete signals with a near instant rise time and a slightly longer decay time. These signals are generally generated from damage formation in the form of fiber cracking, delamination etc. [23]. Continuous emission signals are often the result of electrical interference or friction acting on the material. The signals appear as multiple bursts overlapping to a degree where they cannot be distinguished or analyzed as individual events. Lastly, mixed mode emission is a combination of bursts and continuous emission. This includes a number of bursts with amplitudes exceeding that of the continuous emission and is the most commonly encountered type of signals. Figure 24 shows the waveform of burst, continuous and mixed mode signals respectively.

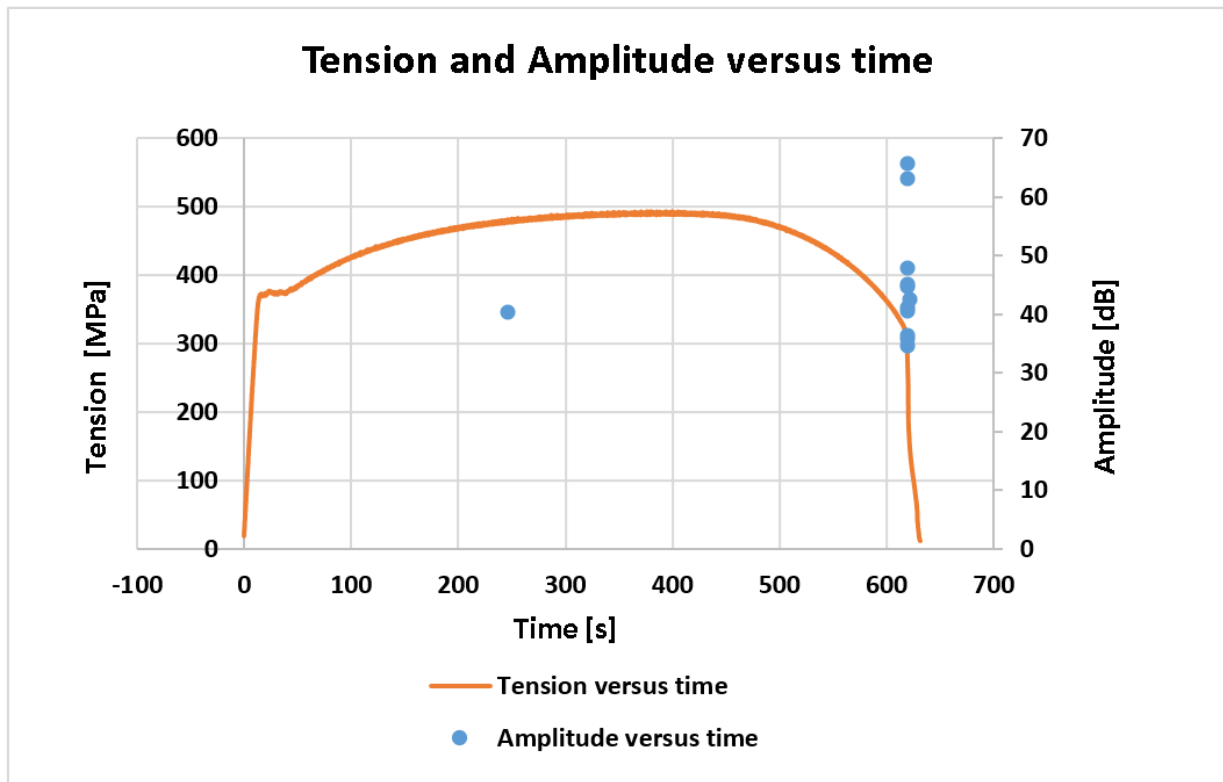
FIGURE 29 - RECORDED AE ACTIVITY DURING TENSILE TEST

The result for the linear deformation tensile test is presented in this section. As explained in the previous section, the noise generated from the hydraulic test rig completely contaminated the AE recordings in the range from 18 - 30dB. This means that any AE within this range would be impossible to extract without filtering tools, as they would effectively be buried within the noise. Consequently, a threshold value of 30dB was implemented in order to only record hits exceeding 30dB. Figure 29 illustrates the recorded AE activity through the duration of the tensile test. From this test, it was expected to observe AE activity centered around the yield strength, the peak load and the final fracture. However, as can be seen in the figure, there is no activity prior to the final cracking except for one hit which was the result of a pencil break test done to verify that the transducer was working. During the final cracking of the specimen, several hits with amplitudes ranging from 30dB – 65dB can be observed.

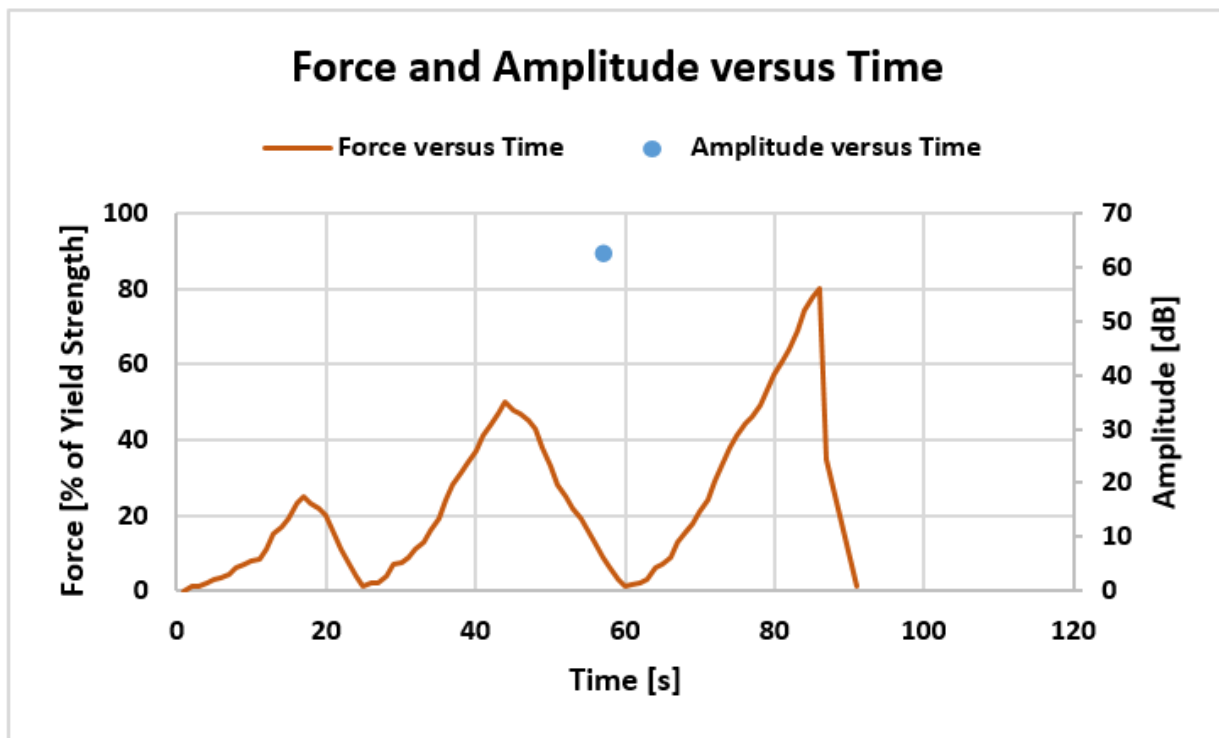
FIGURE 30 - FORCE TIME CURVE FROM STEPWISE TENSILE TEST WITH AE

These results indicate that the AE activity, occurring prior to the final breaking of the specimen, has amplitudes not exceeding the threshold value thus effectively being buried within the hydraulic noise. Absent tools for frequency filtering this test was unsuccessful in verifying the Kaiser-effect.

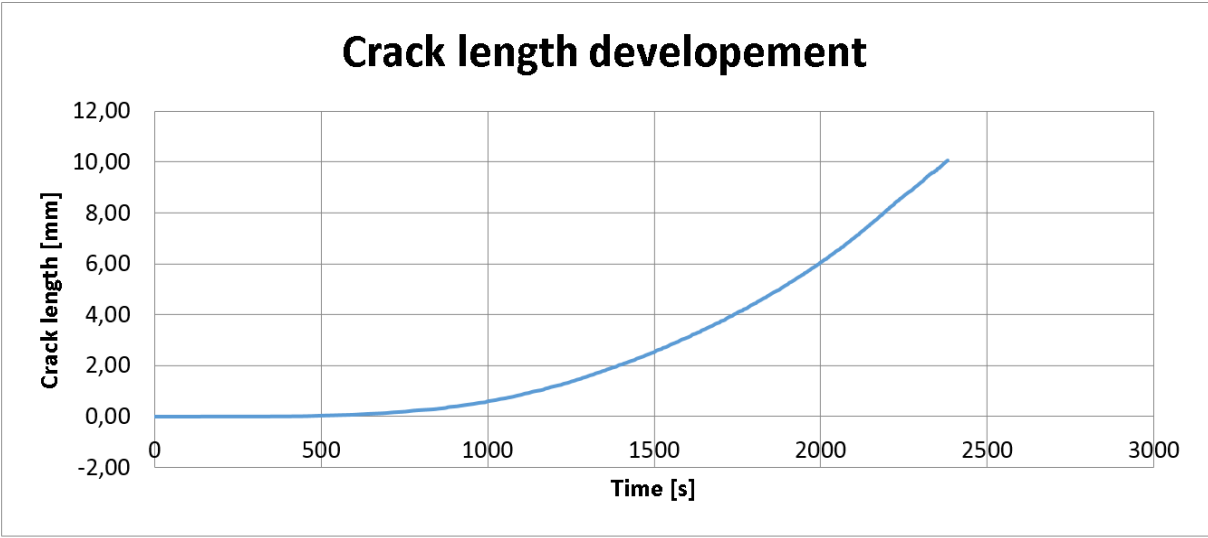
FIGURE 32 - CRACK LENGTH DEVELOPMENT OF LOW CYCLE FATIGUE TEST (50kN)

In Figure 32, the incremental crack length development of the first fatigue test is plotted versus time giving a visual representation of the crack propagation within the material. From the figure, an exponentially increasing crack length initiating at 500 seconds can be observed. It was decided to plot the crack length versus time as opposed to number of cycles in order to later on study its correlation with data from the AE software, which did not record cycles. However, with a frequency of 5Hz the cycle number can easily be calculated from the time in seconds.

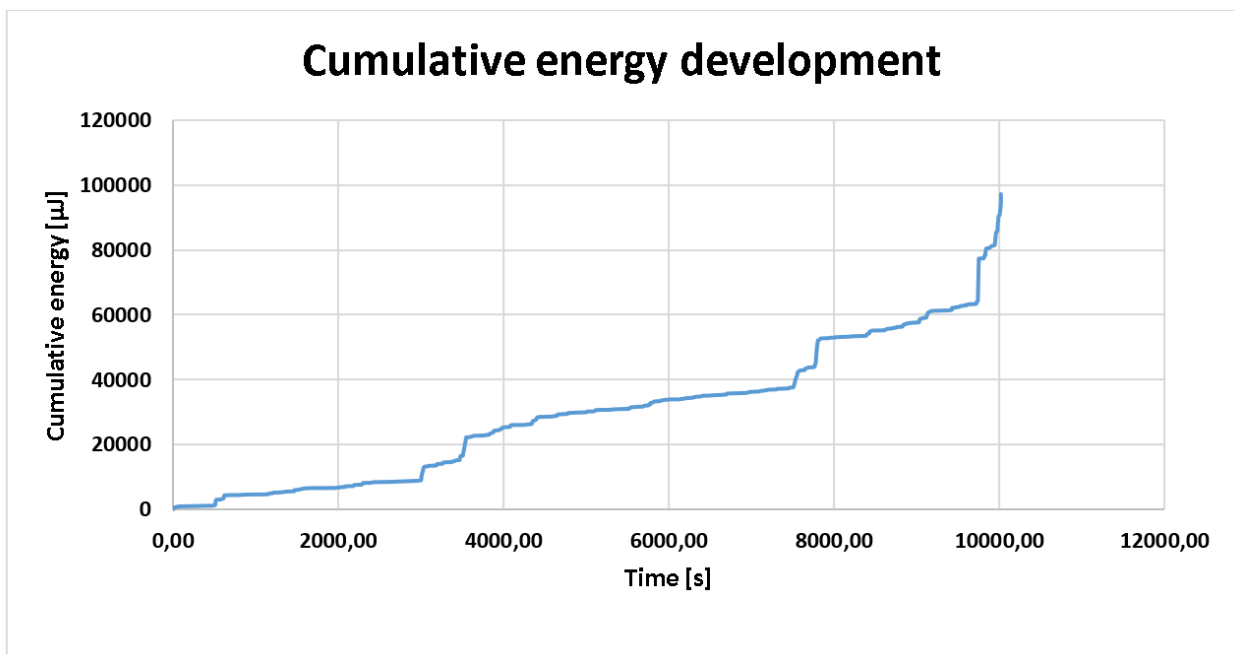
FIGURE 34 - CUMULATIVE ENERGY DEVELOPMENT OF HIGH CYCLE FATIGUE TEST (35kN)

The second fatigue test was conducted at 35kN and a frequency of 5Hz, resulting in a significantly increased test time. Furthermore, a test specimen without an induced crack was used in order to determine whether the early emissions prior to crack initiation of the previous test were caused by the stress concentrations of the machined crack or from hydraulic startup noise. Figure 34 shows the cumulative energy development of the second fatigue test at 35kN. Similar to the previous test, the cumulative energy is increasing with some areas of steeper increase. Again, emission is initiating prior to crack initiation ultimately indicating that the source of this AE activity is the startup of the hydraulic rig.

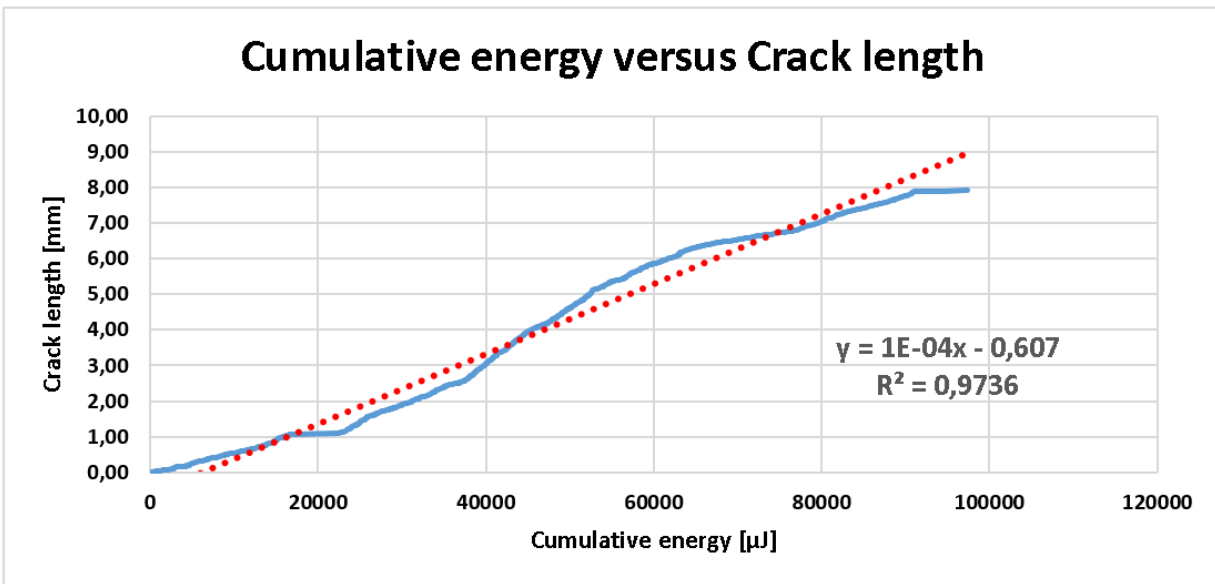
FIGURE 36 - CUMULATIVE ENERGY VERSUS CRACK LENGTH OF HIGH CYCLE FATIGUE TEST (35kN)

Finally, the recorded cumulative energy is again plotted versus the developing crack length in order to study the correlation between the two parameters, as shown in Figure 36. Using a trend line to visualize the linear relationship between the two parameters, a definite correlation can be observed. Furthermore, an  $R^2$  value of 0,9736 indicates a strong fit between the regression line and the recorded data. However, it is recognized that the value is lower than for the previous test. This is believed to be a result of the longer test time allowing for more interference from sources other than genuine AE.
