# Influence of sigma phase precipitation on the impact behaviour of duplex stainless steel pipe fittings

In this study, the effect of sigma phase precipitation in duplex stainless steel (grade 2205) pipe fittings collected from top-side process systems offshore was investigated under realistic loading conditions. This was done by conducting quasi-static and dynamic impact tests on 3" fittings with nominal outside diameter of 88.9 mm, nominal wall thickness of 3.05 mm and D/t-ratio of nearly 30. The fittings had a sigma phase level between 0 and 15 vol.%, and were loaded by a massive steel indenter with a hemispherical nose of 25 mm radius. In the quasi-static tests, the loading rate was 2 mm/min, while in the dynamic tests the impact velocity was varied between 5 and 10 m/s. A few dynamic impact tests on 2" fittings with an increased wall thickness and low sigma phase levels were carried out for comparison, while some 3" fittings were pre-charged with hydrogen before dynamic testing to examine the effect of sigma phase on cathodic protected subsea components. When the sigma phase level was low (i.e.,  $\sigma \leq 5$  vol.%), no evidence of fracture was found in any of the pipe fi

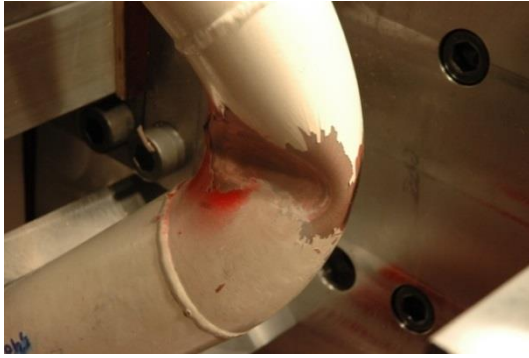
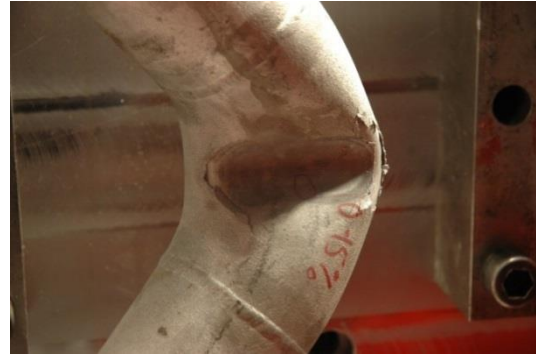
Fig. 9. Final deformed shape of fittings after dynamic testing: a) Test D1 ( $\sigma \approx 0$  vol% ); b) Test D2 ( $\sigma \approx 2-5$  vol% ).

visual inspection (see Fig. 9), but the coating peeled off. The superimposed oscillations on the measured force-displacement curves in Fig. 8 are due to elastic vibrations of the test component during impact. The same holds for the force-displacement curves presented below. Assuming clamped supports of the specimen, it can be shown by a simple calculation that the fundamental frequency of the system corresponds to a period of approximately 1 ms, which is similar to the measured oscillations. Thus, these oscillations are not due to reflected stress waves in the load cell or multiple impacts.

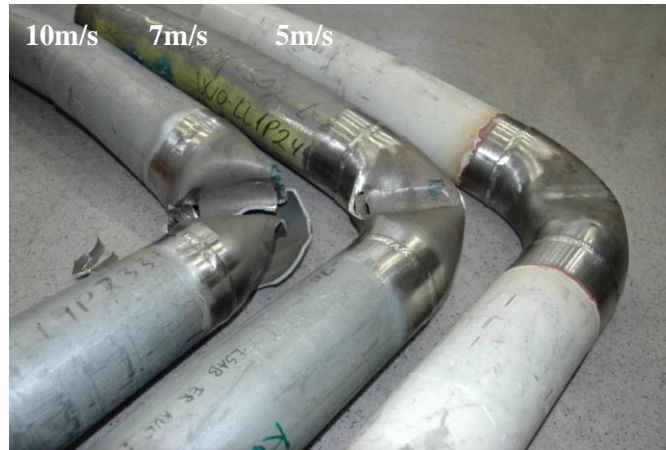
Fig. 12. Test samples with  $\sigma \approx 8$  vol% after dynamic testing at various impact velocities (tests D3, D4 and D5).

When the sigma phase level was increased to  $\sigma \approx 8$  vol.% (i.e., test D3-D5 in Table 2), fracture occurred in the test sample. Fig. 10 shows a comparison of the force-displacement and energy-displacement curves from these tests, where the impact velocity was varied. It transpires that the force-displacement curves are similar and practically independent of impact velocity until unloading. It should be noted here that the trolley impacted the crash boxes after about 100 mm displacement when the impact velocity was 10 m/s. For lower impact velocities, the trolley rebounded before reaching the crash boxes. Fig. 11 shows the final deformed shape of the fittings after testing at impact velocities between 5 m/s and 10 m/s, while Fig. 12 compares the final shape of the test samples. The fitting was nearly split in two at an impact velocity of 10 m/s, exhibiting quasi-brittle behaviour with fragmentation and extensive crack propagation at low displacements. The crack was arrested at the weld, which was free of sigma phase in these tests. At an impact velocity of 7 m/s, less fracture was seen, but it was still rather severe with a clearly visible hole in the fitting after impact. Only a small crack was seen in the fitting at an impact velocity was 5 m/s, similar to the one observed for quasi-static loading.

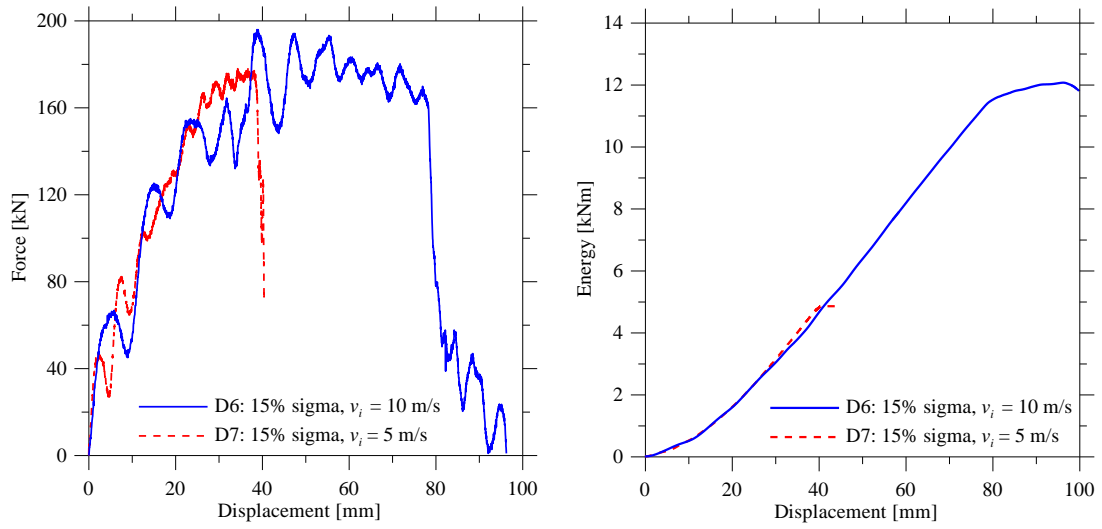
Fig. 13. Force-displacement and energy-displacement curves from test D6 and D7 at impact velocities of 10 m/s and 5 m/s.

treated to obtain the desired level of sigma phase, which is the reason why the weld was not capable of arresting the running crack. Fig. 13 shows a comparison of the force-displacement and energy-displacement curves from these tests, where the impact velocity was varied. As before, the force-displacement curves are similar and independent of impact velocity until unloading. High-speed camera images of the impact process in test D6 at an impact velocity of 10 m/s are shown in Fig. 14, while the final shapes of the fittings are presented in Fig. 15. These pictures illustrate the extensive amount of fracture in these fittings.

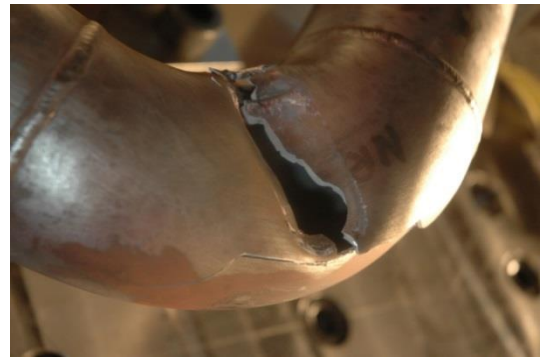
Fig. 15. Final deformed shape of fittings after dynamic testing: a) Test D6 ( $\sigma \approx 15 \text{ vol\%}$ ,  $v_i = 10 \text{ m/s}$ ); b) Test D7 ( $\sigma \approx 15 \text{ vol\%}$ ,  $v_i = 5 \text{ m/s}$ ).

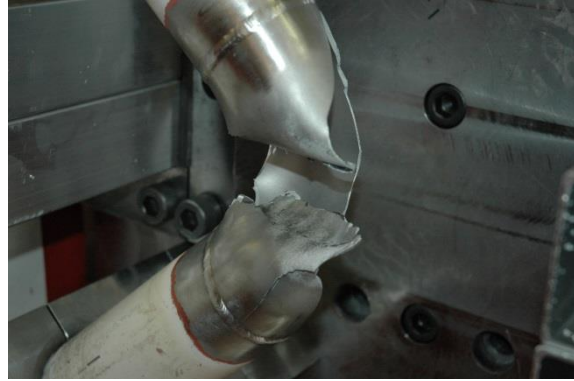
Fig. 16. Dynamic tests D11-D13 on hydrogen-charged fittings: a) Force-displacement curves; b) Fracture in test D12 ( $\sigma \approx 8$  vol% ,  $v_i = 7$  m/s).

Finally, Fig. 16a) gives a comparison of measured force-displacement curves for the hydrogen-charged fittings, i.e., test D11-D13 in Table 2. As already indicated the amount of hydrogen in these fittings was somewhat low, and the effect on the behaviour at low impact velocities was found to be minor (if compared to corresponding curves in Fig. 10). In the hydrogen-charged fitting with 8% sigma, i.e., test D11, a surface crack similar to that observed in test D5 was seen. At an impact velocity of 7 m/s, i.e., test D12, significant fracture occurred in the hydrogen-charged fitting with 8% sigma phase, and the component was quasi-brittle with fragmentation and severe crack propagation (see Fig. 16b)). The crack propagation was arrested at the welds. The fracture appeared more severe than in a similar test on a fitting not charged with hydrogen (Fig. 11b)). In the hydrogen-charged fitting with 0% sigma, i.e., test D13, no fracture was seen at an impact velocity of 5 m/s.

The force-displacement curves from impact tests at 5 m/s on hydrogen-charged fittings with or without sigma are similar. These curves are also similar to the curves from corresponding tests on fittings without hydrogen. The results indicate that neither moderate sigma phase levels nor low hydrogen contents have any important influence on the impact resistance of the DSS fittings. These results are somewhat unexpected, taking the large effect of sigma and hydrogen on the ductility of the DSS at material level into account (Børvik et al. 2010). When increasing the impact velocity to 7 m/s (i.e., doubling the impact kinetic energy), the force level is slightly increased, but now the fitting showed significant fracture upon impact.
