AC corrosion on cathodically protected steel

Materials Science and Engineering

Submission date: June 2012

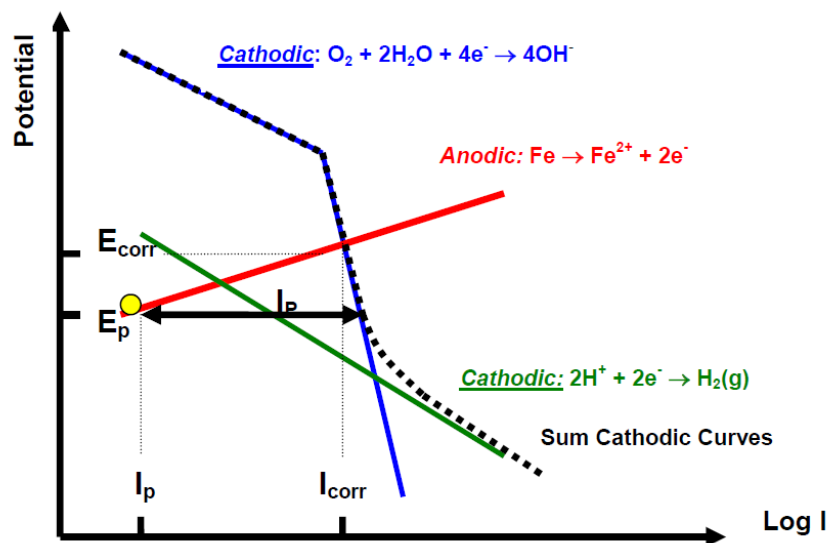
Figure 2.1: Sketch of a potential-current diagram showing how the steel is polarized by the protection current [1].

Cathodic protection (CP), often combined with a coating system, is the most usual way to protect carbon steel from corrosion in offshore environment. The principle of CP is that an external current is supplied to the steel which polarizes the steel to a potential more negative than its protection potential as can be seen from Figure 2.1. This is done either by sacrificial anodes or an impressed current system. CP from sacrificial anodes is based on the principle of galvanic corrosion where a less noble metal is connected to the structure to be protected. To achieve protection, a potential E_p -850 mV_{SCE} is needed for carbon steel in seawater [1].

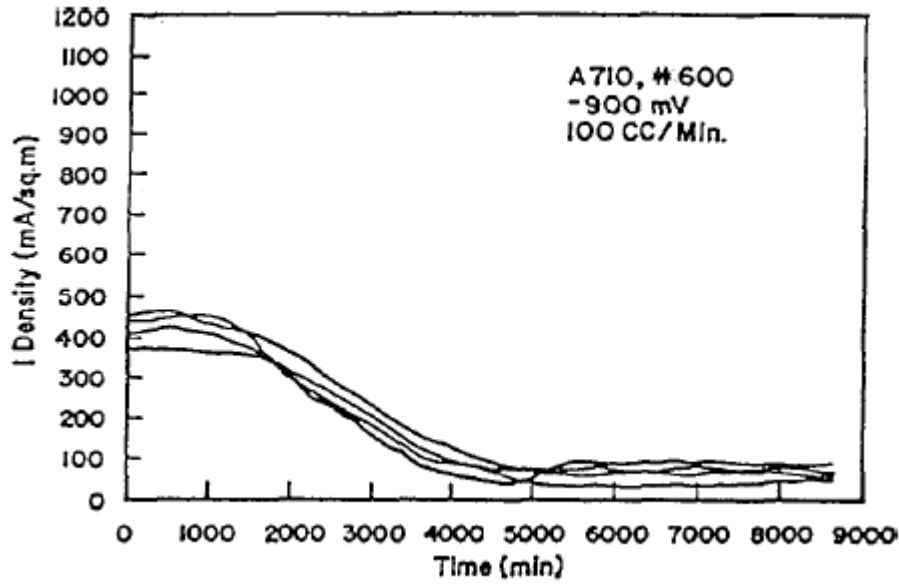
Figure 2.2: Current density vs time curve for a A710 steel polarized to -900 mV_{SCE} . The different curves represent different surface treatment [6]

Previous studies shows that current demand plotted versus time for cathodic protection in seawater is characterized by a sigmoidal curve involving an upper plateau of approximately constant current density to about 50 hours. A transition regime of current density drop is then observed at 50 to 100 hours, followed by a lower plateau of constant current density [6]. Figure 2.2 shows how current density decreases with time for carbon steel.

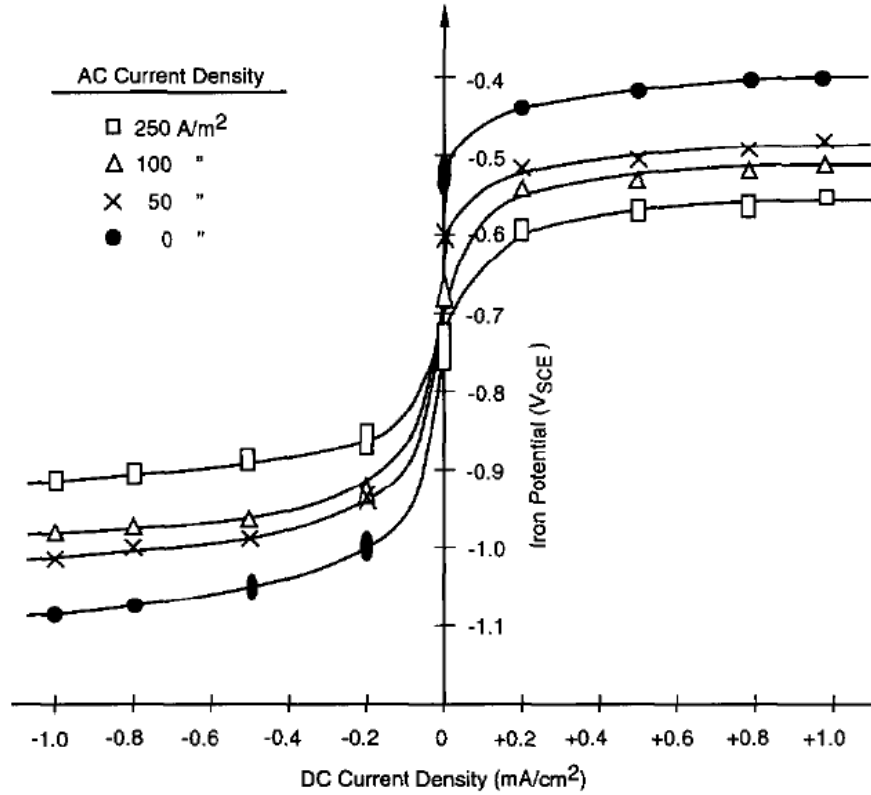
Figure 2.4: The effect of AC in polarization of steel [14]

AC corrosion with CP was first investigated in the early 60's. A lot of scientists, including Bruckner, Hewes and Hamlin, reported that AC corrosion can be reduced to negligible values in the presence of cathodic protection. Tests have shown that the potential of the steel electrodes became more electropositive with increasing AC current density and the protection current density increased. The view that AC corrosion was insignificant when cathodic protection was applied was not supported by Devay. He performed tests where the corrosion rates were measured when an iron couple was subjected to AC current densities from 0 to 250 A/m^2 and DC current densities from 0 to 10 A/m^2 . The results showed that although increased DC current densities reduced the corrosion, the corrosion rate was still significant. He also showed the depolarizing effects of AC on the anodic and cathodic polarization characteristics. Figure 2.4 shows that the potential will become more electropositive with increasing AC when carbon steel is polarized in cathodic direction [14].

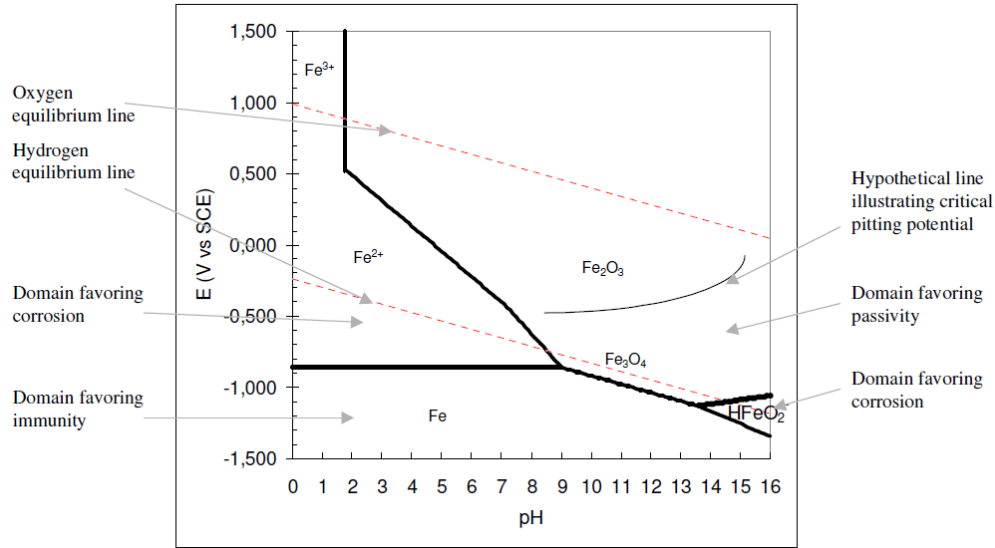
Figure 2.5: Pourbaix diagram for carbon steel in sea water [17].

Galsgaard and Nielsen [17] reported that the alkalization mechanism on the steel surface is one of the most important factors which have an impact on AC corrosion. Figure 2.5 shows the Pourbaix diagram for steel in water. When the pH at the steel surface increases, the steel might move into the active region to the right in the diagram. Such a high pH does not exist in any natural environment and must be created locally in a coating damage with cathodic protection. In this region, steel will corrode due to the reaction:

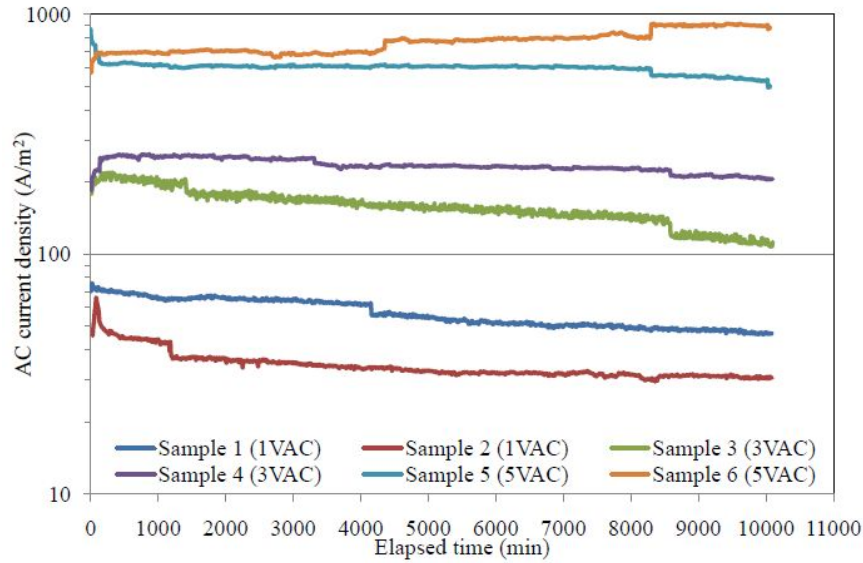
Figure 2.6: AC current vs time for cathodically protected steel with applied AC voltage

Lilleby's studies [2] have shown that the AC current decreases with time for carbon steel under cathodic protection with a constant value of applied AC voltage (Fig. 2.6). She suggests that this is related to increased precipitation of calcareous deposits, which is supported by macroscopic observations of the film. In this work, the samples were polarized and the potential was held at a constant value of -1100 mV_{SCE} .

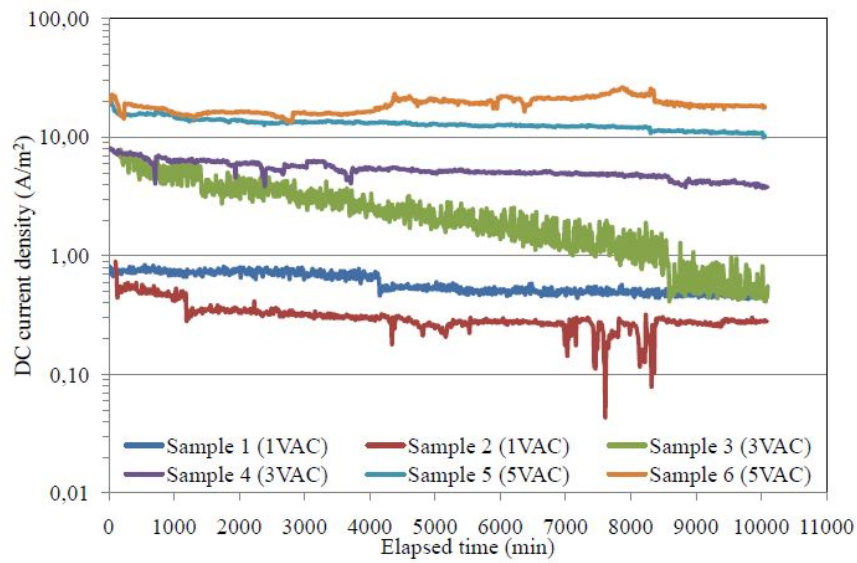
Figure 2.7: DC current vs time for cathodically protected steel with applied AC voltage

The changes in protection current density (Fig 2.7) in Lilleby's work were closely related to the AC current density. This indicates that the calcareous deposits formed during the exposure to AC voltage affected the DC current and AC current in a similar way. It can also be seen from the figure that the DC current density decreases for all samples which shows the protection properties of calcareous deposits.

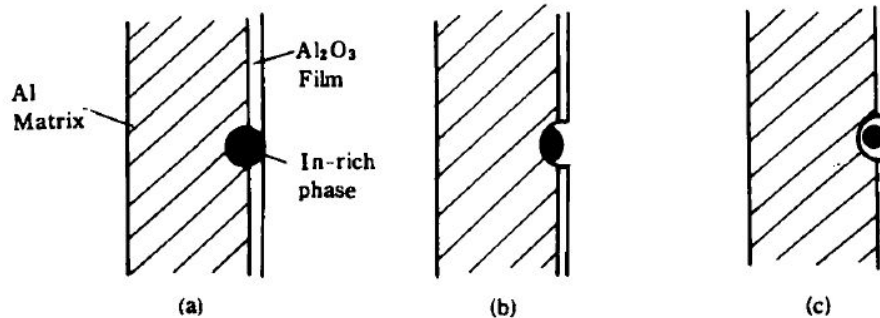
Figure 2.8: The activation process of Indium in AlZnIn sacrificial anode [20].

There has been reported that the formation of $ZnAl_2O_4$ results in a higher instability of the Al oxide layer which can explain the role of Zn in the activation process. A small amount of Zn has an effect mainly on propagation and repassivation of metastable pits and not on their nucleation frequency[19]. In do also play a significant role in the activation of the AlZnIn anode due to segregation of In. The process can be classified in three steps (Fig. 2.8). (a) The In rich segregated phase, as a small anode, forms a galvanic cell with the Al_2O_3 film as a large cathode. The In rich segregated phase dissolves until the Al matrix is exposed to the electrolyte. (b) The Al matrix then forms a new high potential galvanic cell with the Al_2O_3 film. This results in active dissolution of the Al matrix and the In rich segregated phase becomes cathode and stops dissolving. (c) After the dissolution of the surrounding Aluminum, the In rich particles separate from the matrix and dissolve in the electrolyte [20].

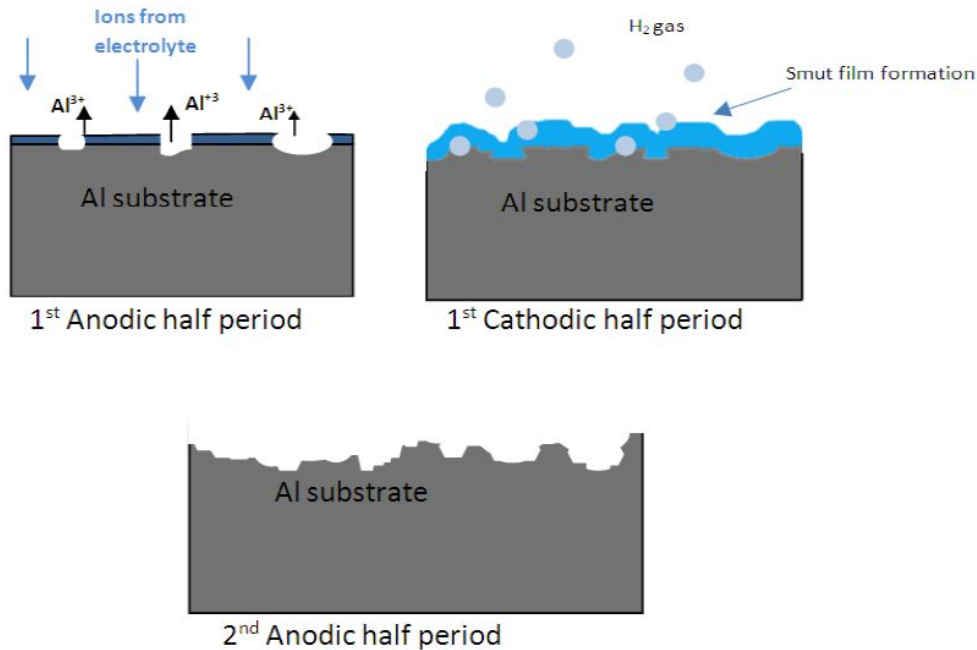
Figure 2.9: Pitting morphology on Aluminum exposed to AC [21]

Due to reaction (2.15), the pH at the surface will increase and Aluminum hydroxide will precipitate at the surface as a white gel. This will form a protective film and increase the potential. The cathodic half cycle involves a repassivation of the surface resulting in a re-distribution of pits during the anodic half cycle. A schematic representation of this can be seen from Figure 2.9. Depending on the electrolyte and AC current density, the pitting morphology can vary between uniform, non-uniform and etch-like morphology.

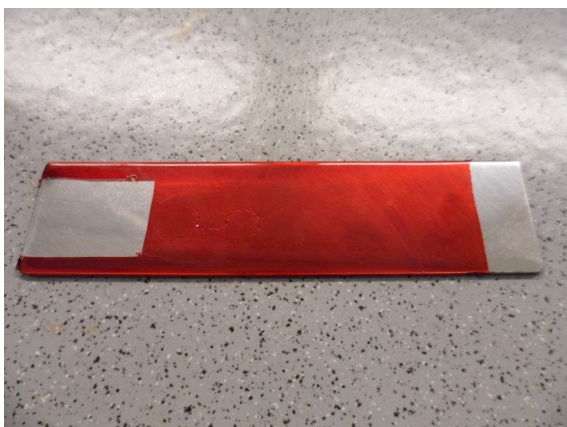
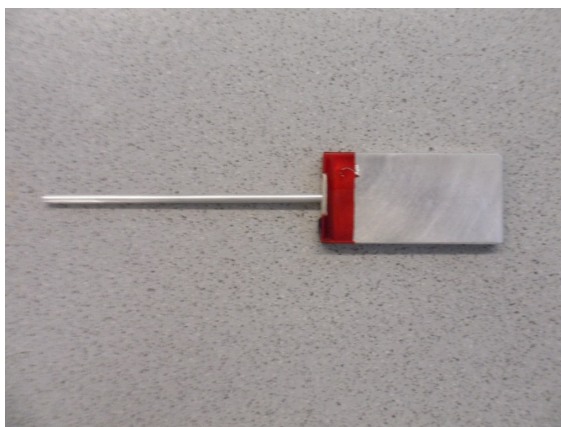
(a) Carbon steel

(b) AlZnIn sacrificial anode

Figure 3.1: Painted samples for the experiments

The AlZnIn samples were machined to 2 different shapes. One set of samples was machined to rectangular shape with dimensions of $80\text{mm} \times 20\text{mm} \times 3\text{mm}$. These samples were painted with Microshield which gave an exposure area of 8 cm^2 . The other set were sacrificial anodes and these samples had also a rectangular shape with dimensions of $60\text{mm} \times 30\text{mm} \times 5\text{mm}$. To obtain an area ratio of 1:10 between anode and cathode, these samples were painted with Microshield which gave an exposure area of 35 cm^2 (Fig 3.1 (b)). Each sample was weighted before painting.

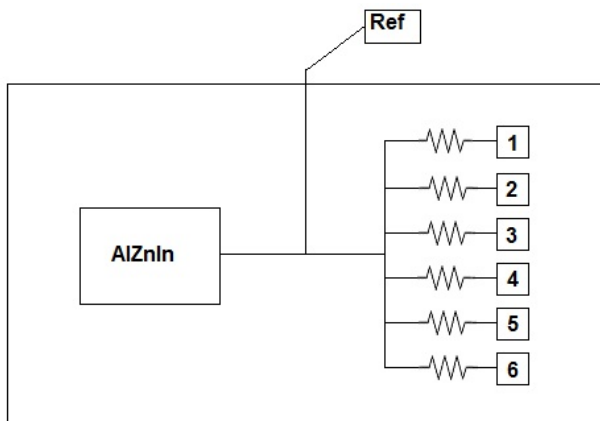
Figure 3.2: Electrical circuit diagram of the formation of calcareous deposits experiment

Six samples were placed in a vessel filled with synthetic seawater and an AlZnIn sacrificial anode. The anode was connected to the samples through a 1Ω -resistor. An Agilent 34970A data logger was used to measure the potential of the steel samples, the resistance and the potential drop through the resistor for each sample every hour. Figure 3.2 shows a drawing of the circuit while the test setup can be seen from Figure 3.3.

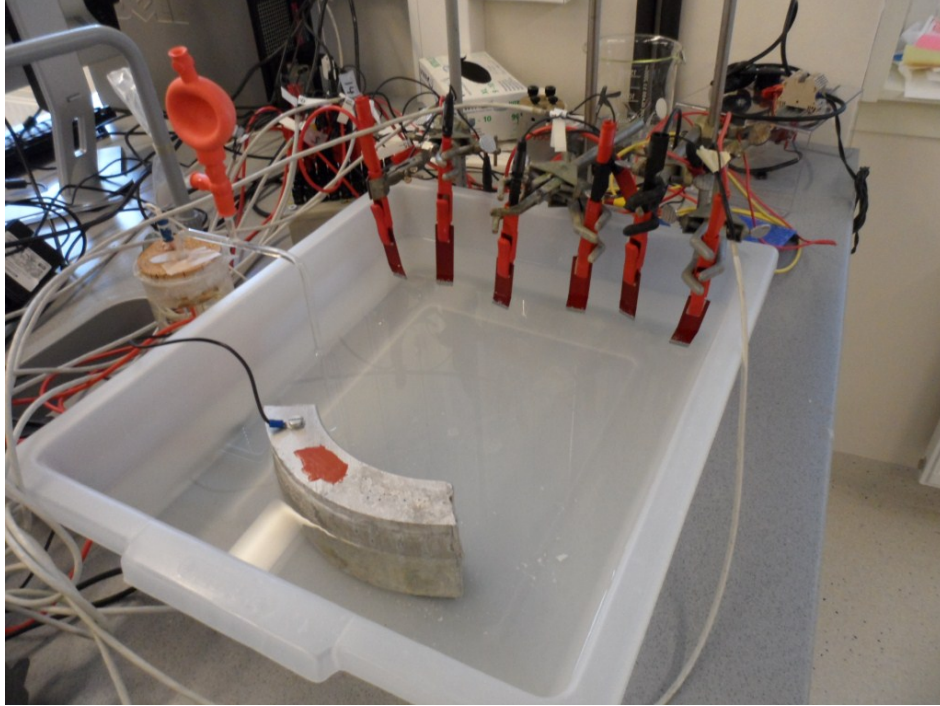
Figure 3.3: Test setup for the formation of calcareous deposits experiment

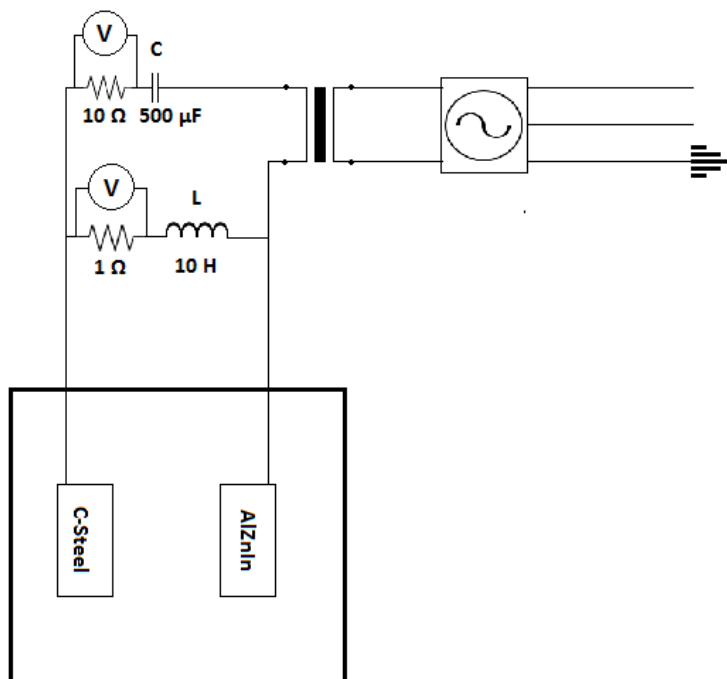
Figure 3.4: Electric circuit for the CP with superimposed AC experiment.

After the pre exposure, each steel sample was placed one by one in a vessel filled with synthetic seawater and a sacrificial anode as described in section 3.2.2. The sacrificial anode was connected to a 10 H inductor and a 1Ω -resistor to measure the DC current density. A VariAC and a 500 μ F Capacitor was connected in parallel to superimpose AC current and to prevent DC current to flow into the AC circuit. The Agilent 34970A data logger was used to measure the DC current density, AC current density and DC potential every 30 minutes during the exposure time. Fig 3.4 shows the circuit diagram and Fig 3.5 shows a picture of the setup.

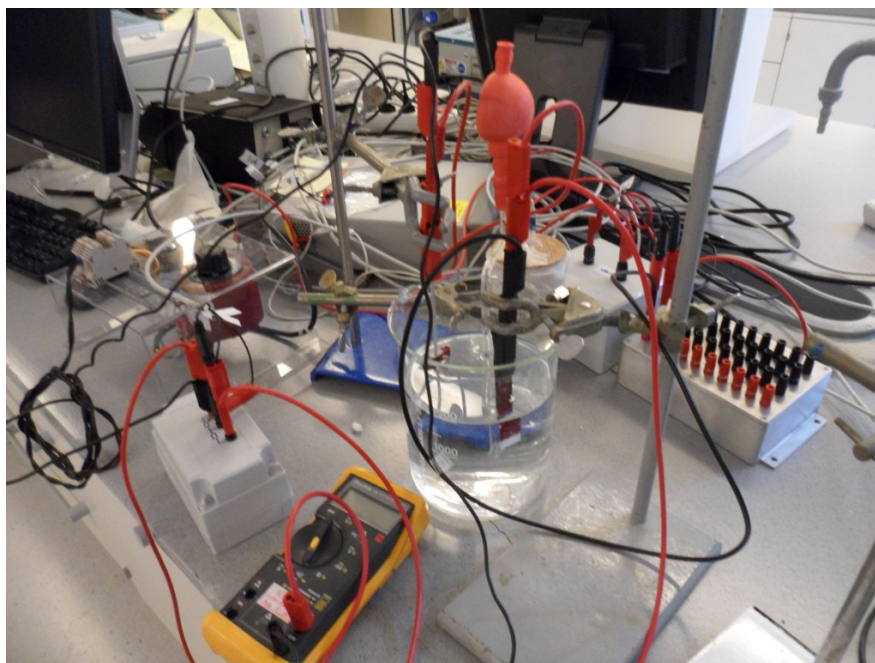
Figure 3.5: Setup for the CP with AC experiment.

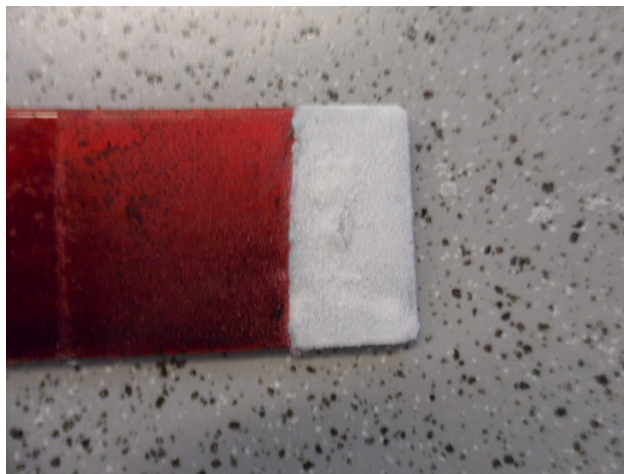
Figure 4.1 shows a macroscopic picture of one of the samples pre exposed to cathodic protection. It can be seen from the picture that the painting is still intact and calcareous deposits have formed uniformly at the surface, despite a small crack that can be seen at the center of the exposure area.

Figure 4.1: Calcareous deposits on carbon steel

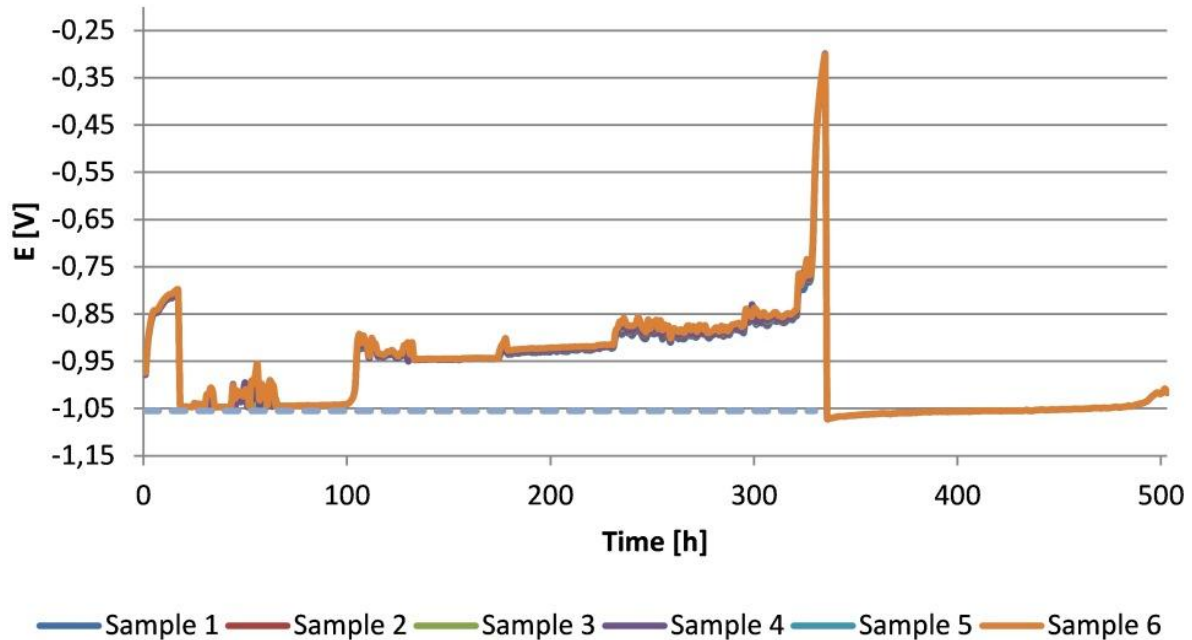
Figure 4.2 shows the potentials and Figure 4.3 shows the current densities of the steel samples during the exposure time of 504 hours. The potential is quite unstable during the first 300 hours. After 300 hours, the potential increases significantly to $-0,30$ V. At this stage, the reference electrode was replaced by a new reference electrode and the potential dropped to $-1,05$ V. This was also the potential for the remaining exposure time. It is believed that the first reference electrode did not operating well and the dotted line represent the probable potential during the whole experiment. The potential during the first 300 hours should therefore be ignored. Each sample showed identical potential during the whole exposure time.

Figure 4.2: Potentials on the samples during the pre exposure

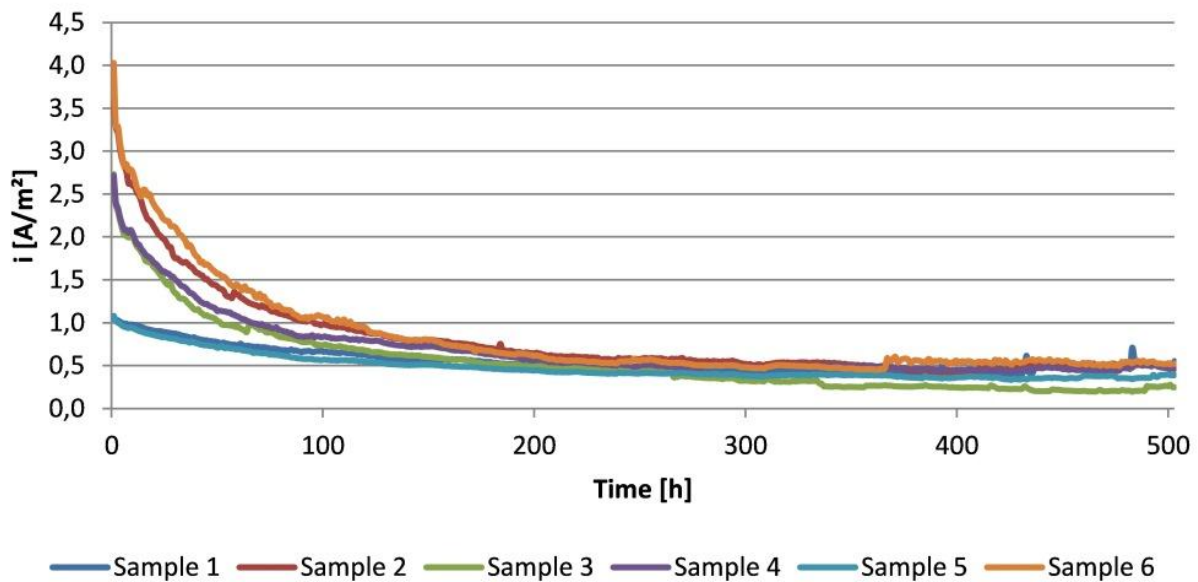
The current density decreased for all the samples during the pre exposure. The reduction rate was highest during the first 100 hours for all the samples followed by a relatively constant value for the last 400 hours. The reduction rate and current density were lower at the early stages of the experiment for sample 1 and 5 compared to the other samples.

Figure 4.3: Current densities on the samples during the pre exposure

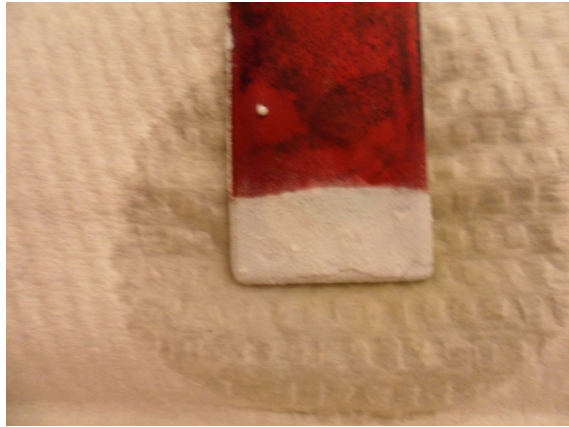
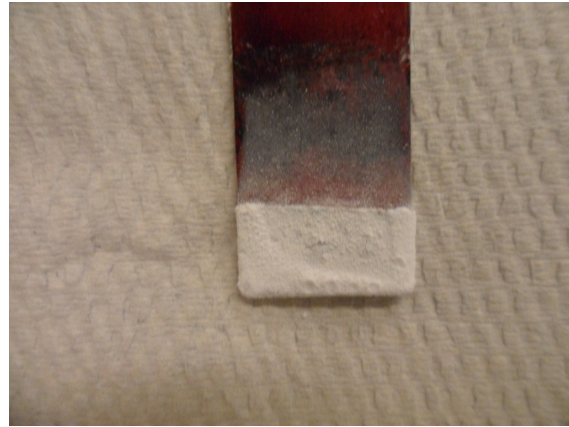
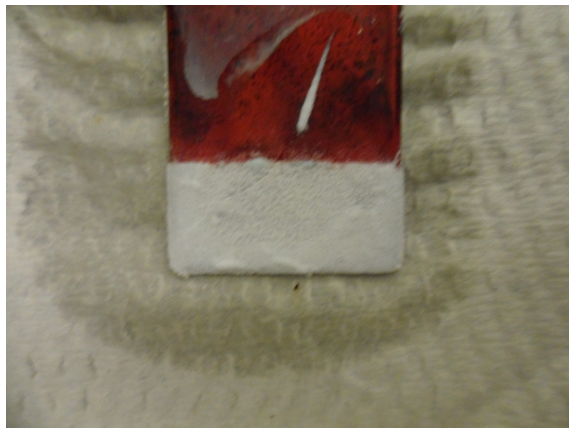
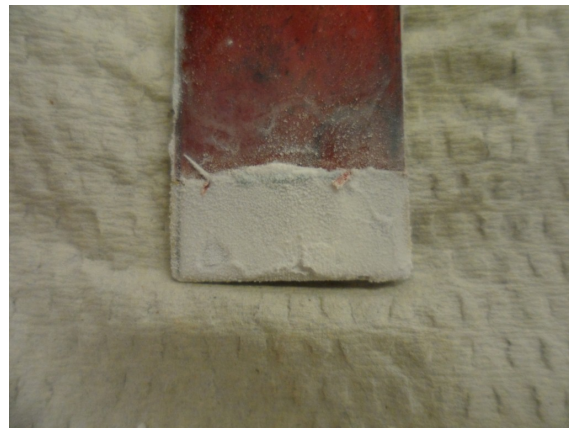
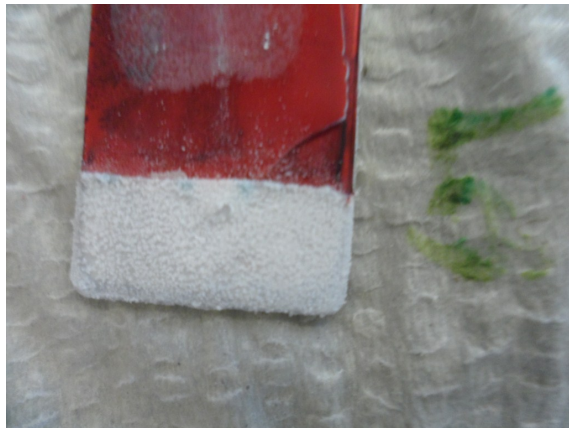
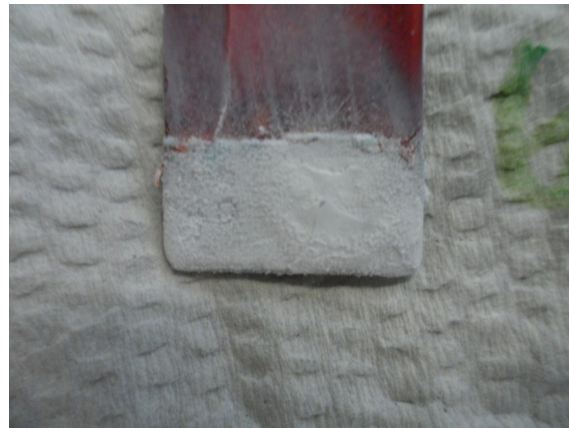
Macroscopic pictures of the steel samples after the CP experiment with superimposed AC can be seen in Figure 4.4. The AlZnIn samples that have undergone the removal of corrosion products procedure in the same experiment can be seen in Figure 4.6. The calcareous deposits were still intact for all steel samples after the experiment. A non-uniform morphology in the layer can be seen at sample 2, 4 and 6 while the surface morphology is smoother for the other samples. Calcareous deposits can also be seen at the painting above the exposure area, following the bubble direction. The painting was still intact after the experiment.

Figure 4.4: Pictures of steel samples under cathodic protection immediately after the experiment.

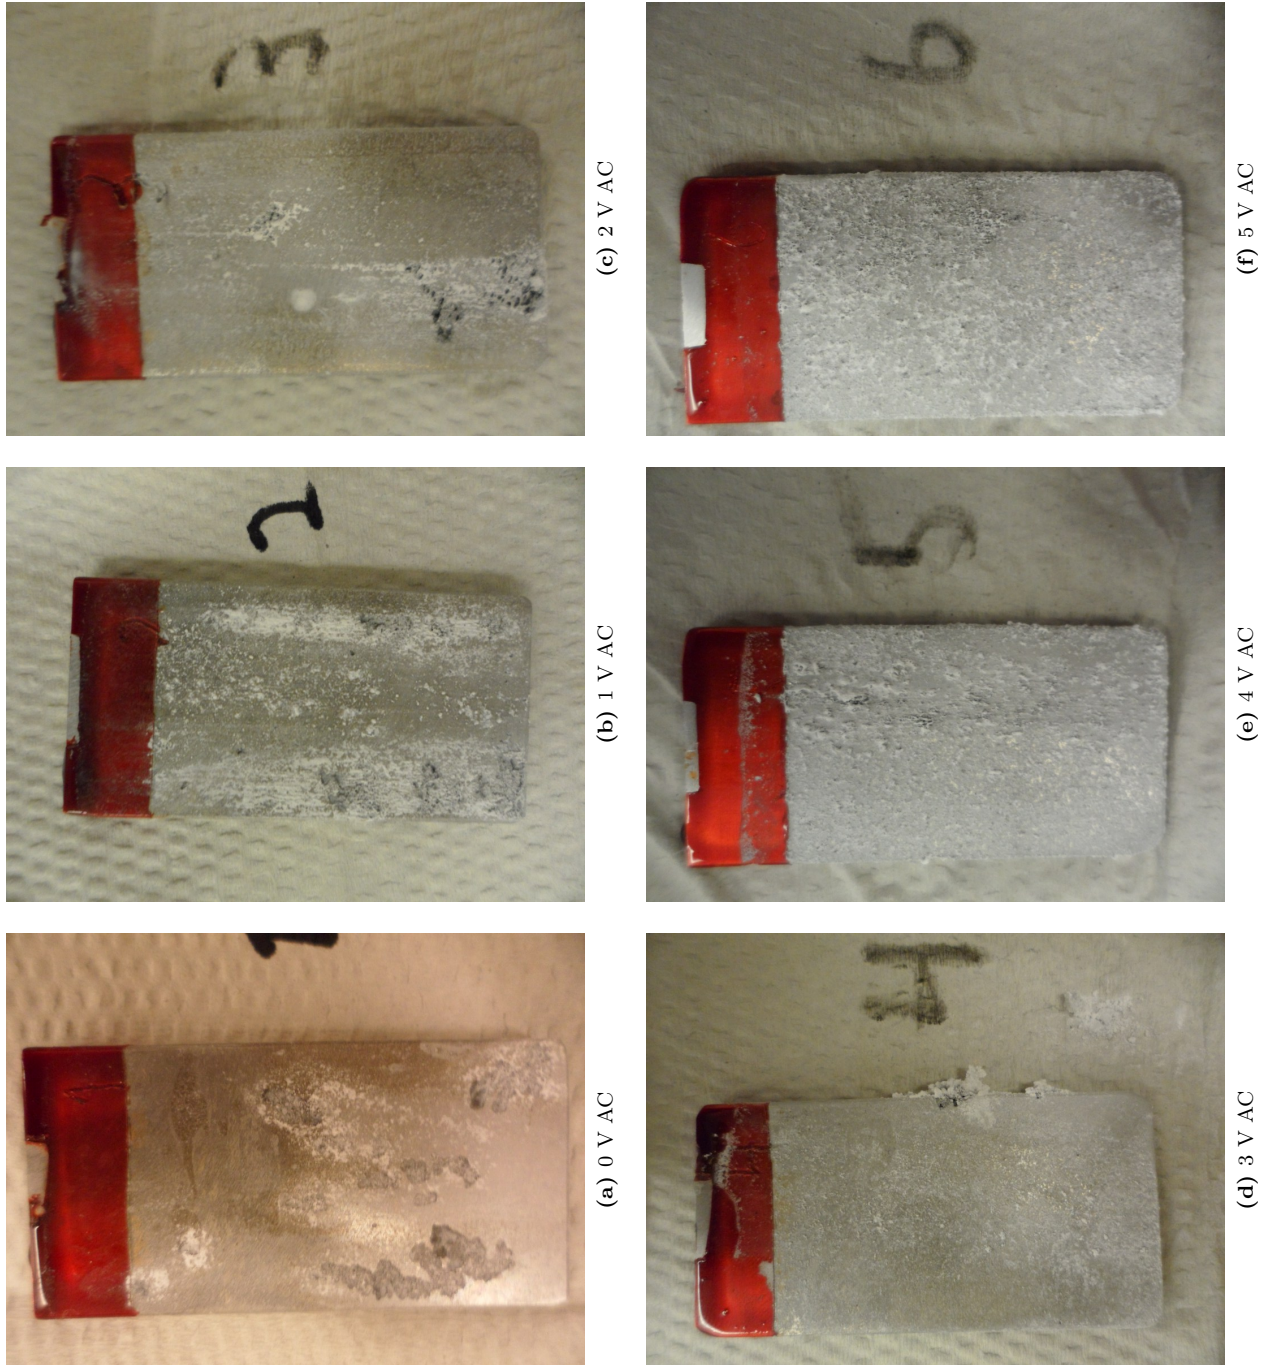
The sacrificial anodes immediately after the experiments are shown in Figure 4.5. A white layer can be seen on all samples. For the samples exposed to 0, 1 and 2 V AC, this layer is in general presented in the corroded areas and it follows the direction of the hydrogen bubbles upward the sample. For the sample exposed to 3 V AC, the layer is presented at almost the entire surface and a large amount at the corroded area at the edge of the sample. The samples exposed to 4 and 5 V AC are both fully covered by this layer and it is thicker than for the other samples.

Figure 4.5: Pictures of AlZnIn samples under cathodic protection immediately after the experiment.

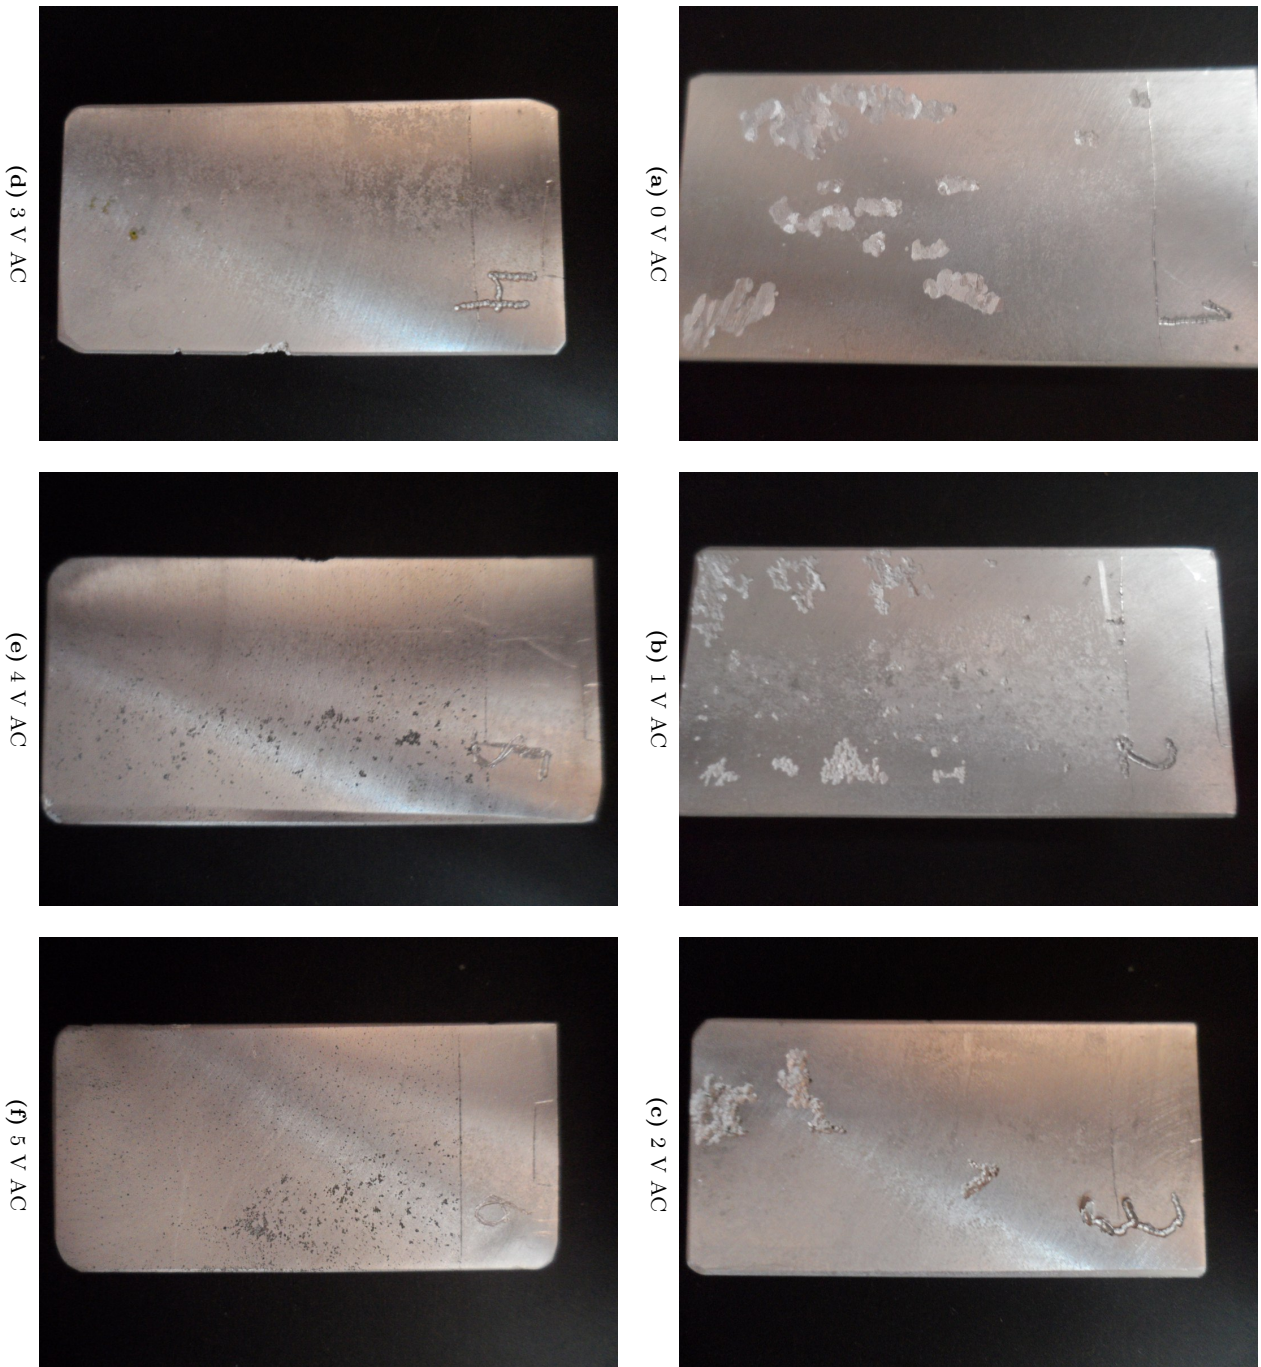
Macroscopic pictures of the AlZnIn samples after removal of corrosion products can be seen from Figure 4.6. The surface of the three samples with lowest AC value are characterized by large corroded areas surrounded by smooth surface. On sample 2 there is a band in longitudinal direction in the middle of the sample with small pits. Outside this areas, close to the edges of the sample on each side, the morphology is almost the same as for sample 1 and 3. That means large corroded areas surrounded by a smooth surface. Sample 4 had a large corroded area at one of the edges of the sample while there were small pits on the rest of the surface. The samples exposed to 4 V and 5 V AC had no such large corroded areas that could be seen at the other samples. On these two samples there were a uniform distribution of pits at the entire surface.

Figure 4.6: Pictures of AlZnIn samples under cathodic protection with different AC values after removal of corrosion products

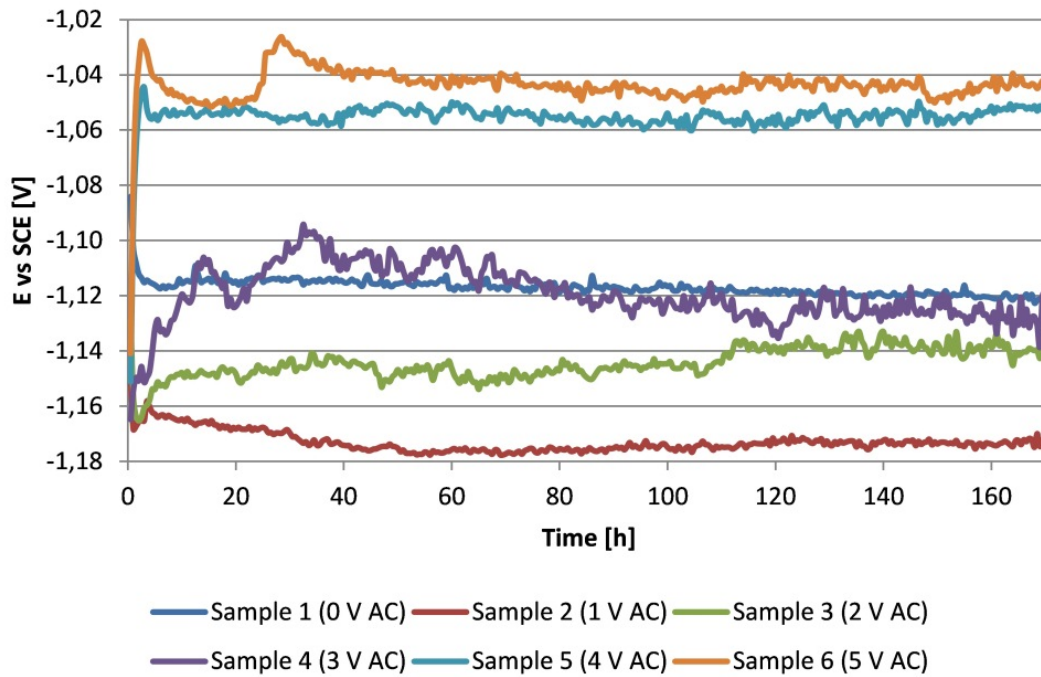
Figure 4.7 shows the potentials of the different samples during the exposure time. Sample 6 showed a rapid increase in potential during the first couple of hours to about $-1,03$ V and had the highest potential during the experiment. The potential of sample 5 varied between $-1,04$ and $-1,06$ V. An increase in potential from $-1,16$ V to $-1,10$ V can be seen for sample 4 during the first 40 hours. After this, the potential decreased slightly to about $-1,13$ V during the rest of the experiment. The potential of sample 1 decreased from $-1,10$ V to $-1,12$ V in the early stages of the experiment and flattened out at $-1,12$ V during the rest of the exposure time. Sample 3 had a potential of about $-1,15$ V the first 110 hours followed by a decrease to $-1,14$ V which lasted for the remaining exposure time. The lowest potential in this experiment was the potential of sample 2 which decreased from $-1,15$ V to $-1,18$ V during the first 50 hours followed by a slightly increase to $-1,17$ V during the remaining exposure time. The potentials of the samples exposed to AC increased with increasing AC voltage.

Figure 4.7: Potential vs time curve for the samples exposed to CP with applied AC voltage

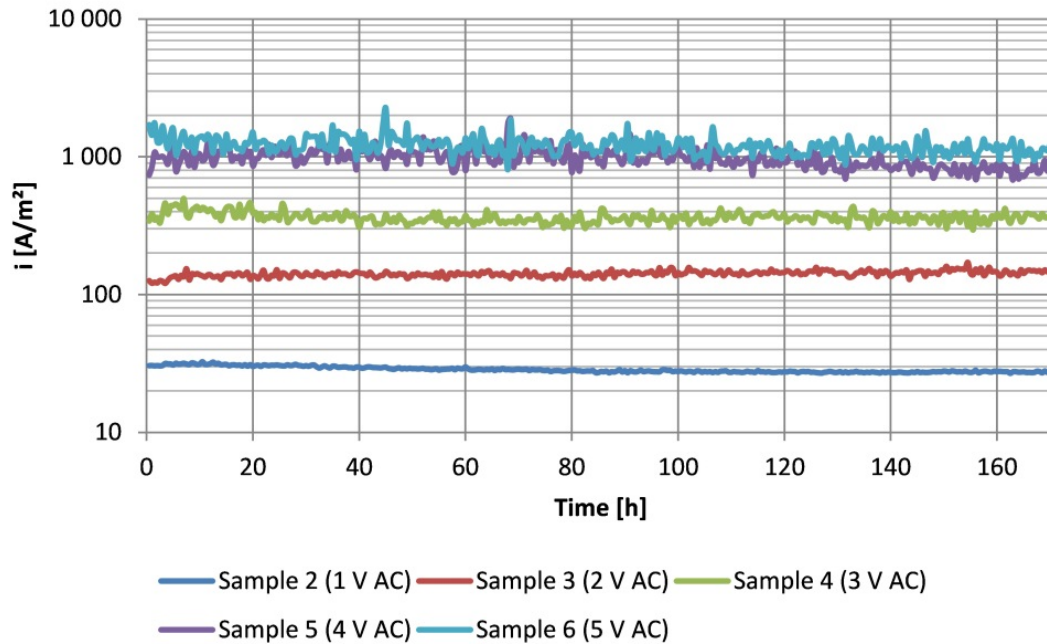
The AC current density for the steel samples can be seen from Figure 4.8. For all samples, the AC current density increased with increasing AC voltage. Sample 2 and sample 3 had quite stable alternating current densities, respectively 30 A/m² and 150 A/m² during the whole exposure time. The AC current density of sample 4 varied between 300 A/m² and 500 A/m² while sample 5 had an AC current density varying between 700 A/m² and 2000 A/m². The sample with highest alternating current density in this experiment was sample 6 which had a current density varying between 800 A/m² and 2500 A/m². Figure 4.9 shows the AC current density values for the AlZnIn samples which is one tenth of the steel values due to the area ratio of 1:10.

Figure 4.8: AC current density vs time for the steel samples exposed to CP with applied AC.

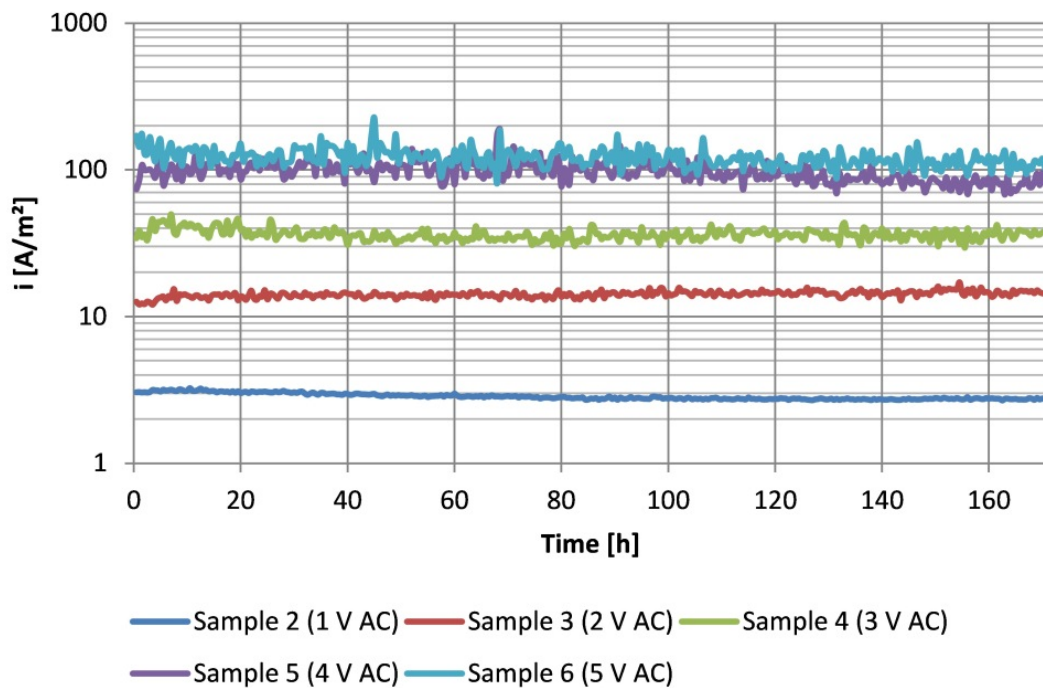
Figure 4.9: AC current density vs time for the AlZnIn samples exposed to CP with applied AC.

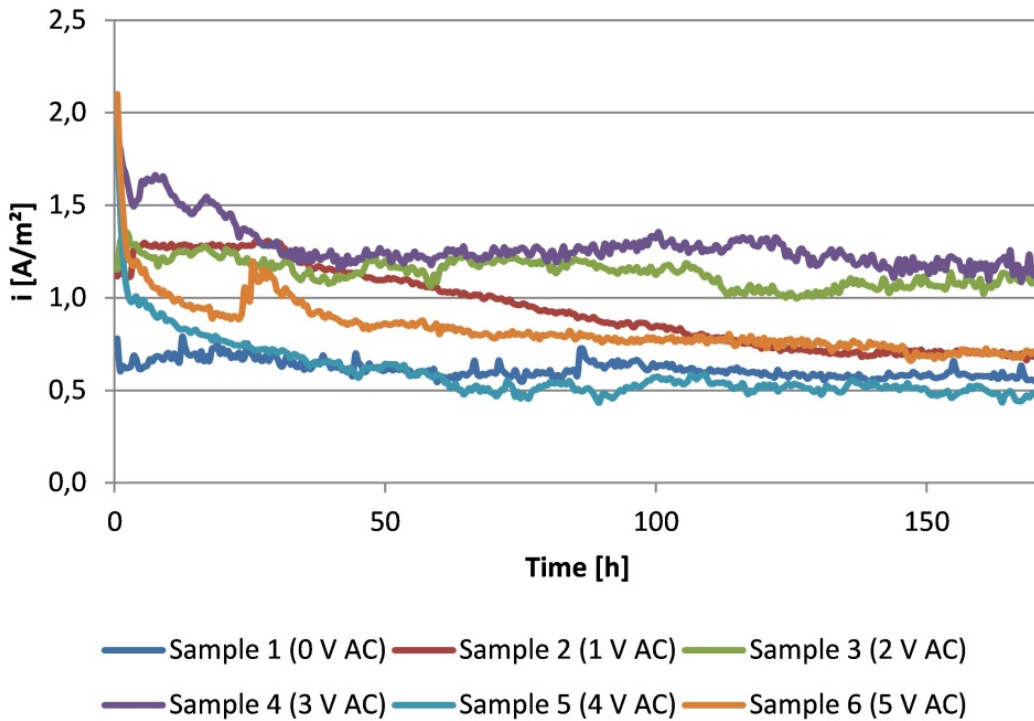
Figure 4.10: DC current density vs time for the steel samples exposed to CP with applied AC

varied between 1 A/m^2 and $1,4 \text{ A/m}^2$. Sample 4 had the highest average DC value of all samples in this experiment, starting at $1,9 \text{ A/m}^2$ followed by a decrease to about $1,3 \text{ A/m}^2$ after 40 hours. This DC value lasted for the remaining exposure time for sample 4. Both sample 5 and sample 6 showed a rapid decrease in DC current during the first couple of hours, from respectively $1,9 \text{ A/m}^2$ to $1,0 \text{ A/m}^2$ and $2,1 \text{ A/m}^2$ to $1,2 \text{ A/m}^2$. For sample 5, this was followed by a slightly decrease in DC current the next 60 hours to about $0,5 \text{ A/m}^2$ which was the value for the remaining exposure time. The DC value of sample 6 decreased to about $0,8 \text{ A/m}^2$ during the first 20 hours. This was followed by a rapid decrease to $1,25 \text{ A/m}^2$ before the curve decreased slightly to $0,7 \text{ A/m}^2$ during the last period of the experiment. Also in this case, the DC values of the AlZnIn samples was one tenth of the steel values because of the area ratio as can be seen in Figure 4.11.

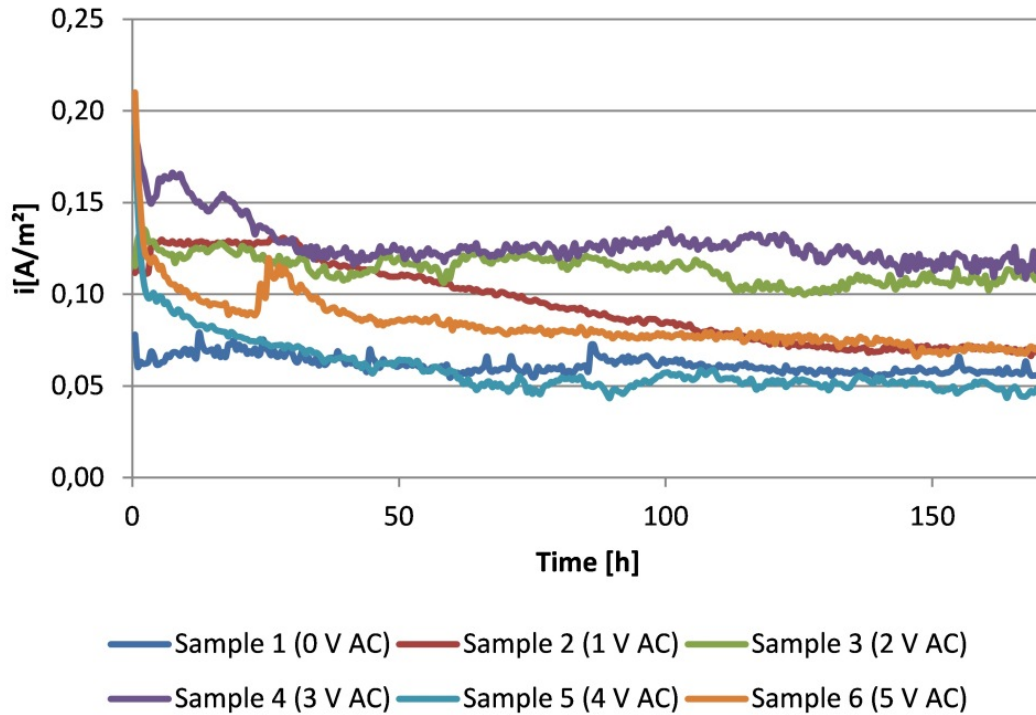
Figure 4.11: DC current density vs time for the AlZnIn samples exposed to CP with applied AC

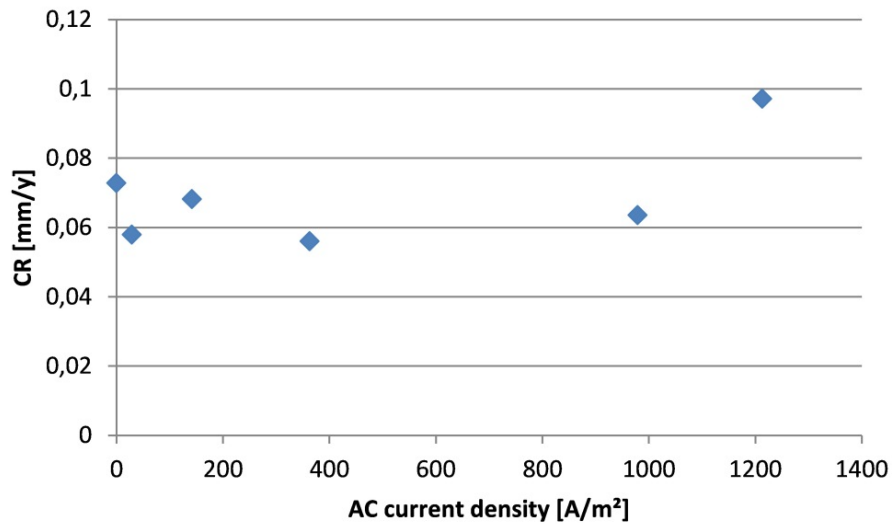
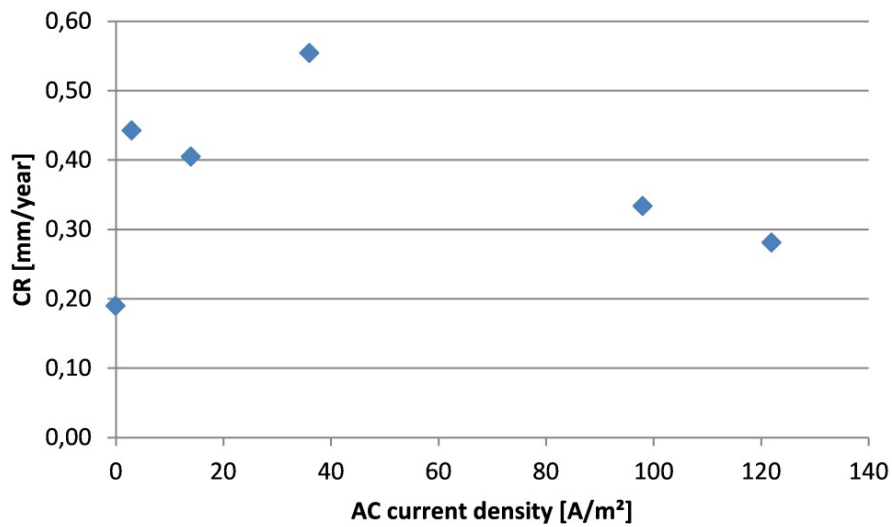
The corrosion rates as a function of AC current density can be seen from Figure 4.12. For the steel samples, the corrosion rates are relatively constant for AC current density below 1000 A/m^2 . Above this value, the corrosion rate increases to $0,097 \text{ mm/year}$ at an AC current density of 1200 A/m^2 . A rapid increase in corrosion rate for AlZnIn occurs when AC is present. This is followed by a more slightly increase, reaching a peak at $0,55 \text{ mm/year}$ at 400 A/m^2 . The corrosion rate decreases with a constant rate for AC current densities above 400 A/m^2 .

Figure 4.12: Corrosion rate vs AC current density for the CP experiment
