AC corrosion on cathodically protected steel

Materials Science and Engineering

Submission date: June 2012

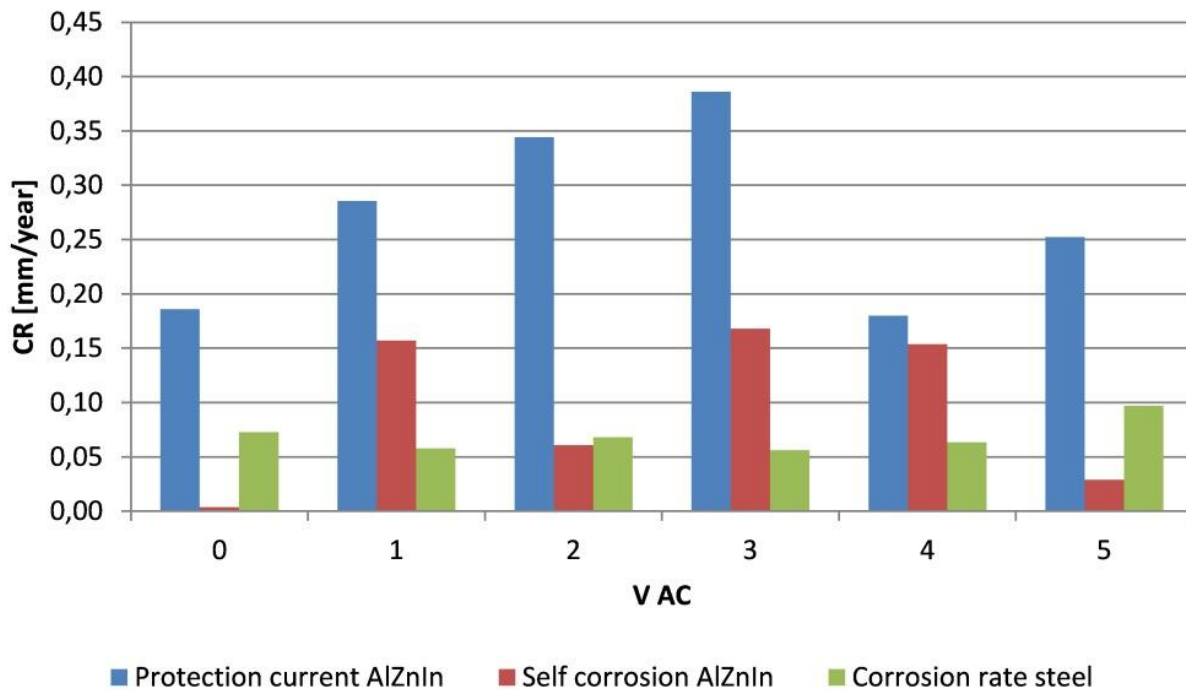
**Figure 4.13:** Corrosion rates of steel and AlZnIn by self corrosion and protection of steel.

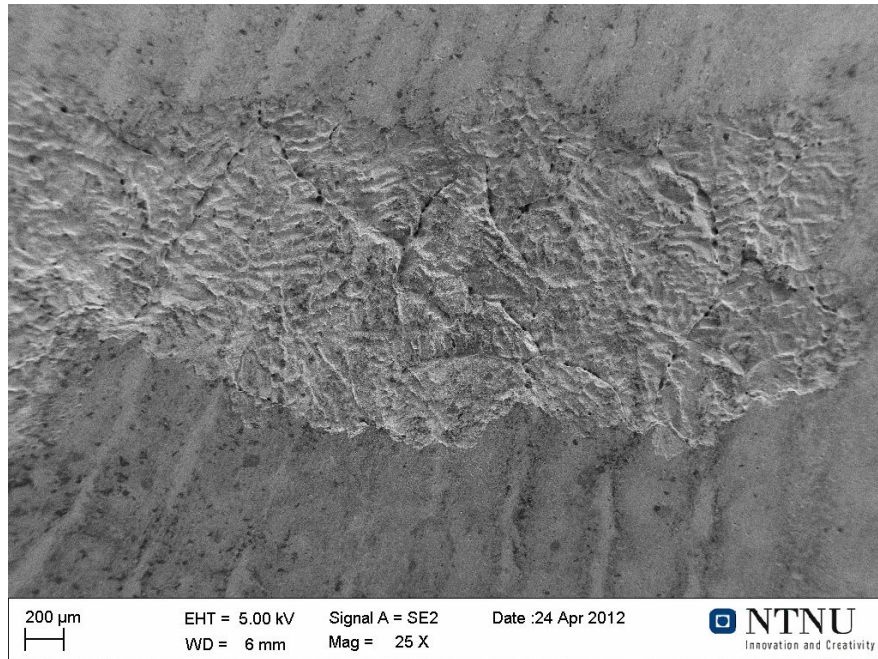
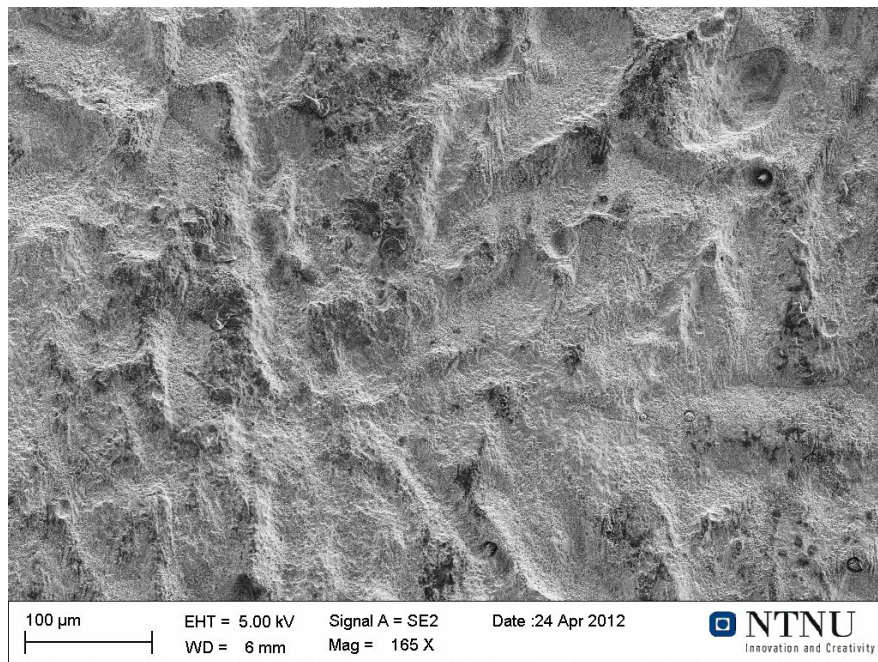
Microscopic pictures of the sample without AC voltage can be seen from Figure 4.14. Figure 4.14 (a) shows a large corroded area on the surface while Figure 4.14 (b) shows an enlarged picture inside this area. The area is characterized by peaks and valleys

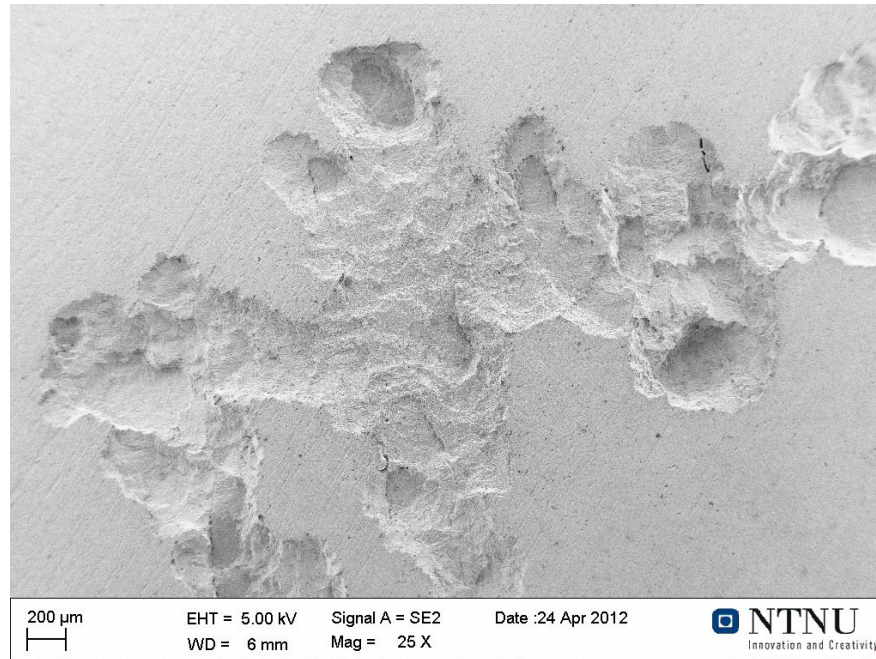
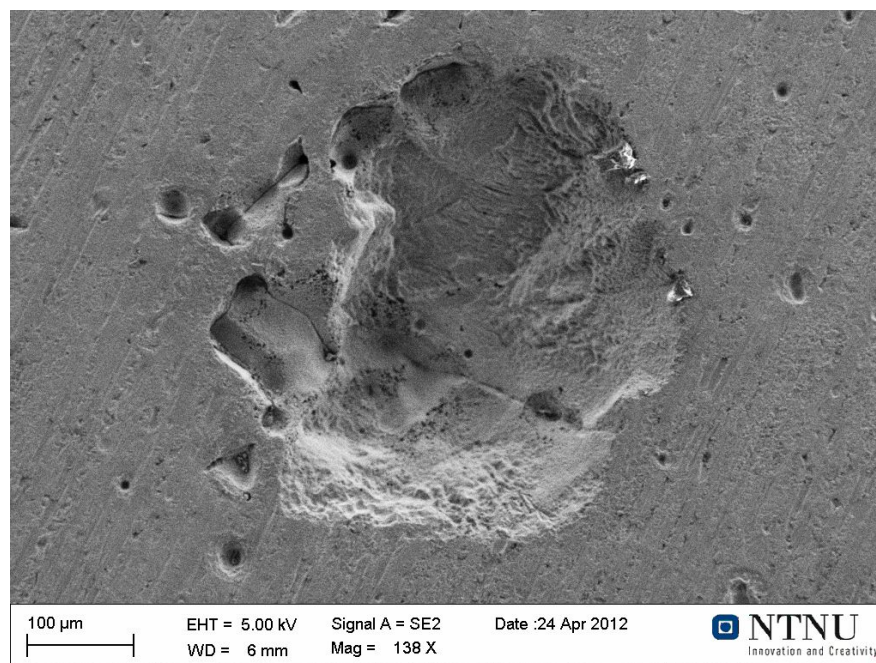
Figure 4.15 shows two microscopic pictures of the sample exposed to 1 V AC. A large corroded area is shown in Figure 4.15 (a). The surface inside this area is rough compared to the surroundings. The area is characterized by a number of hemispherical pits that have merged to form a large corroded area. The picture is taken close to the edge of the sample. Figure 4.15 (b), which is a picture taken in the middle of the sample, shows a small pit on the surface. This pit has a smooth surface and is surrounded by small newly nucleated pits.

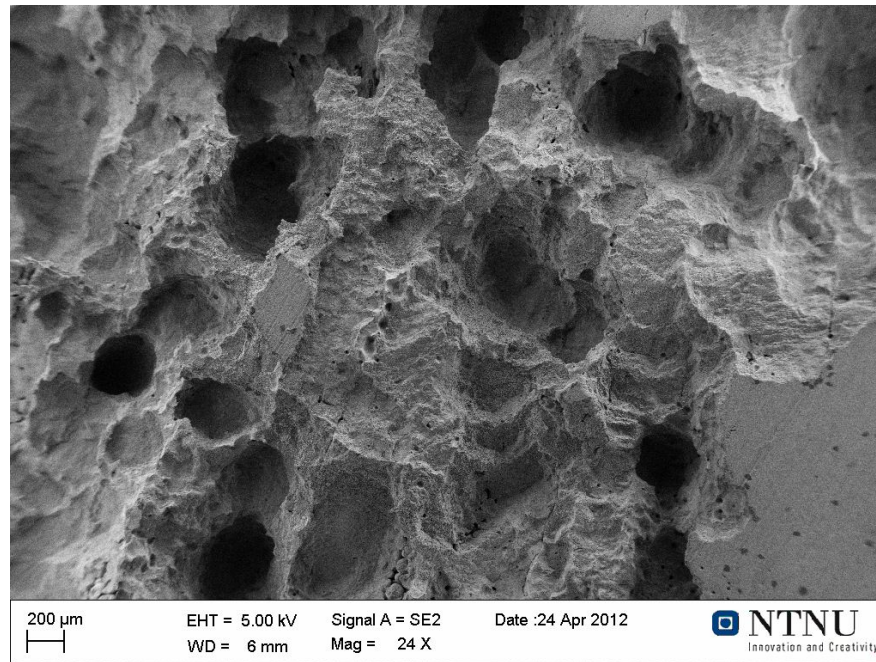
A large corroded area can be seen on the sample exposed to 2 V AC (Figure 4.16). The morphology inside the corroded area is very rough compared to the smooth surroundings that can be seen in the bottom right corner. The corroded area is characterized by deep thin holes.

Figure 4.16: SEM picture of the AlZnIn sample exposed to 2 V AC

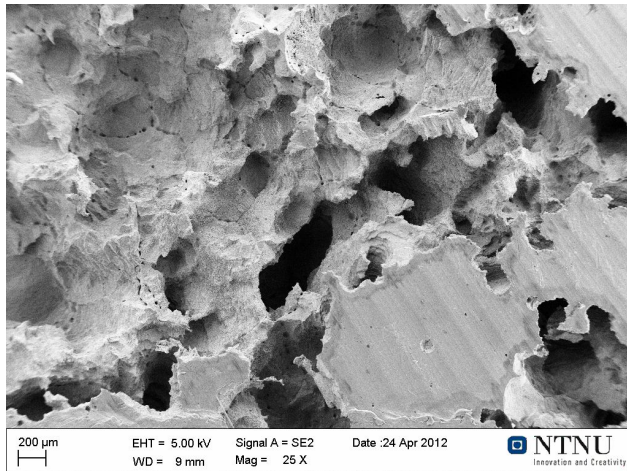
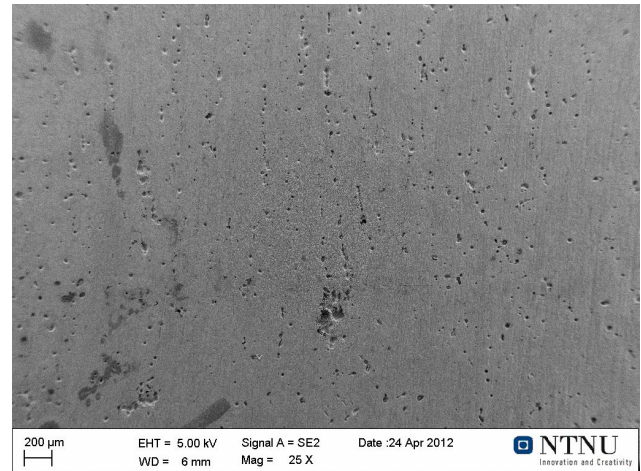
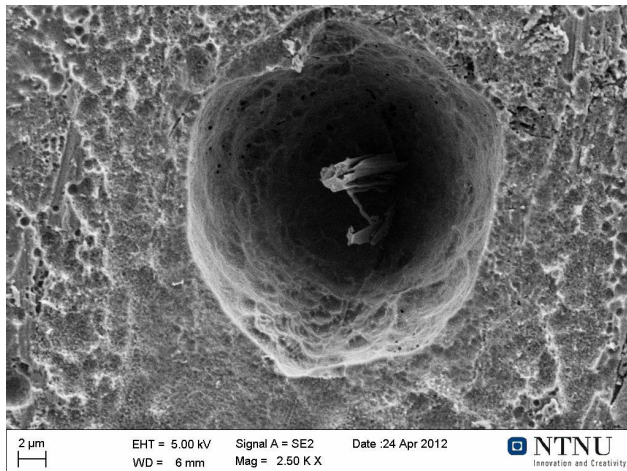
Three pictures were taken of the sample exposed to 3 V AC (Figure 4.17). Figure 4.17 (a) shows a picture that is taken of the large corroded area on the edge of the sample (Figure 4.6 (d)). This area is characterized by a rough morphology and deep corroded holes. As can be seen from Figure 4.17 (b), the entire surface was covered by small pits. Figure 4.17 (c) shows an enlarged picture of one of these pits. The pit is half spherical and it is characterized by a smooth surface inside.

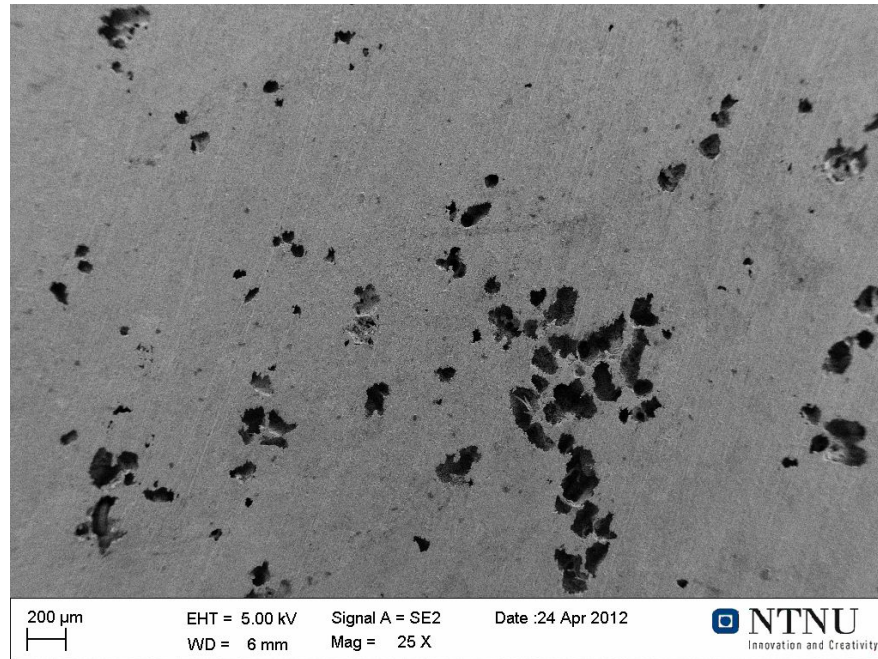
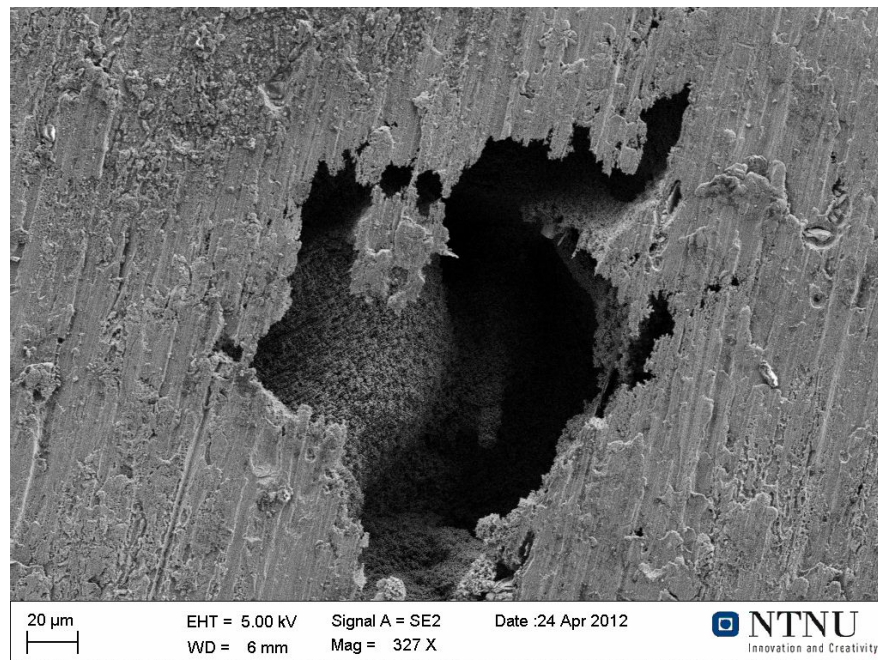
Pictures of the sample exposed to 4 V AC can be seen from Figure 4.18. Figure 4.18 (a) shows that deep pits were formed on the entire surface. One of these pits is shown in Figure 4.18 (b). The pit has sharp edges and a rough surface inside the pit. The grinding strips from the sample preparation can be seen on the surface outside the pit.

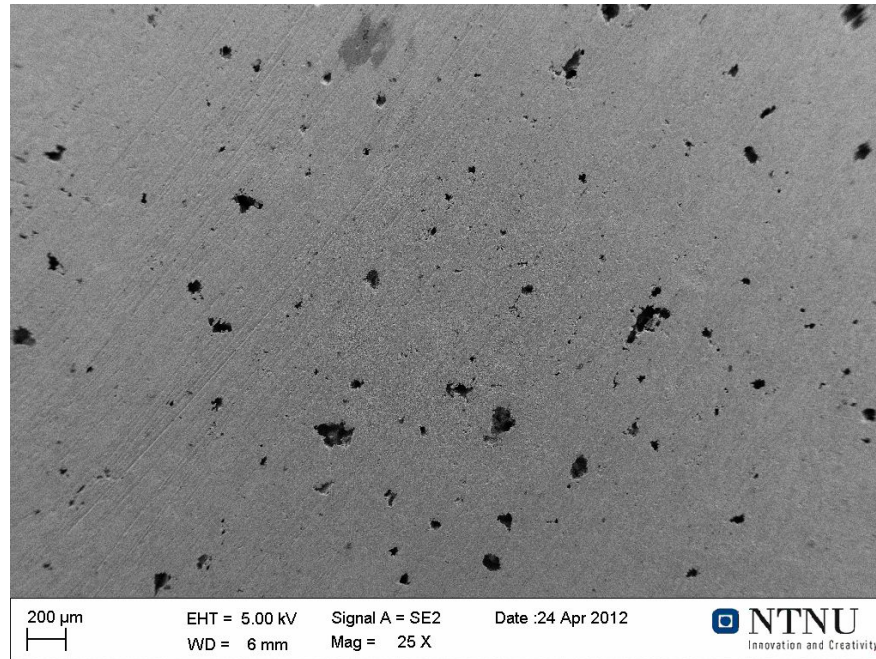
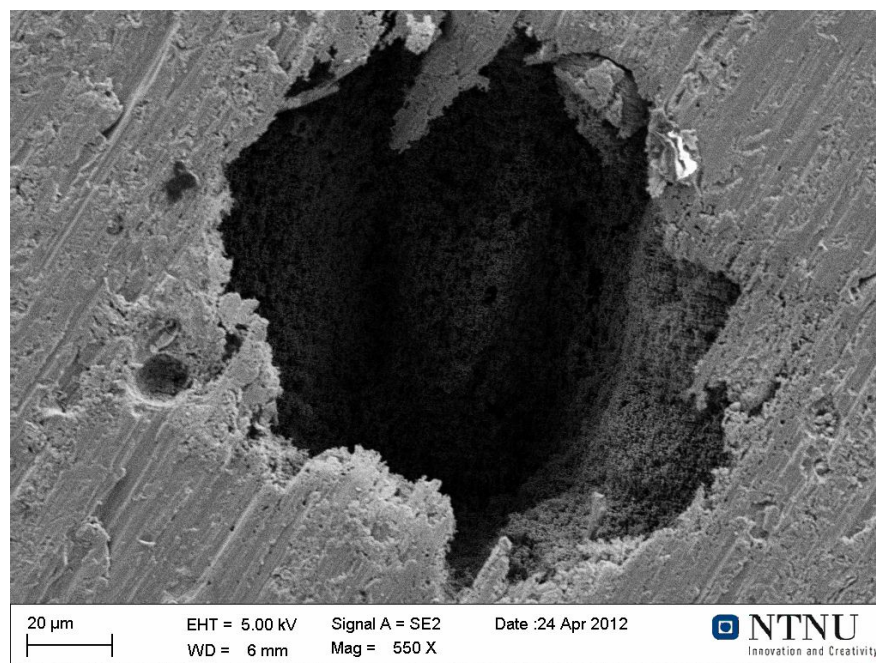
The last sample is shown in Figure 4.19. Also in this case, the entire surface was covered by small pits (Figure 4.19 (a)). As can be seen from Figure 4.19 (b), the pits were deep and had a smooth surface. Also for this sample, the grinding strips from the sample preparation is still intact.

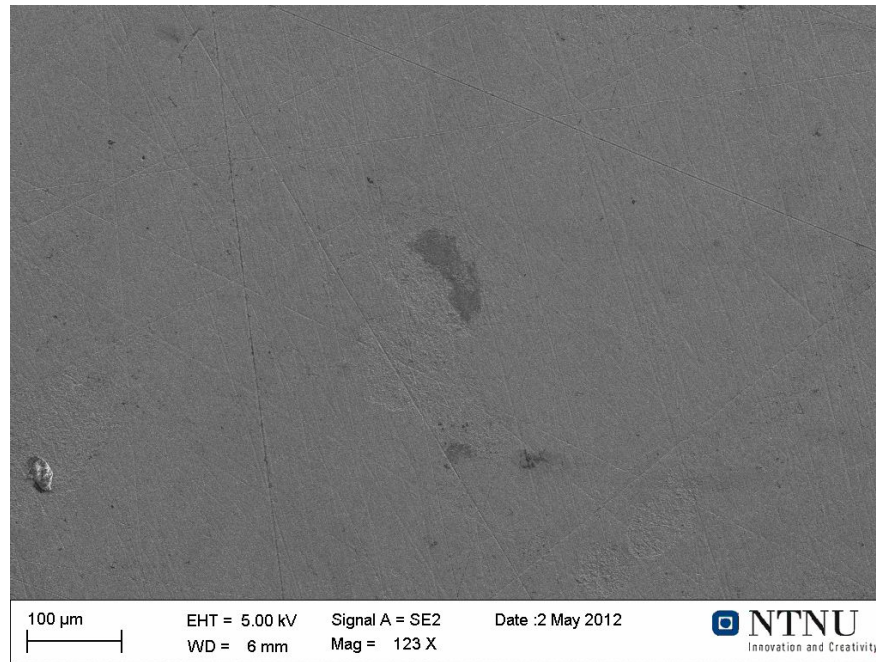
Microscopic picture of the steel sample exposed to 3 V AC can be seen in Figure 4.20. The picture shows a smooth surface and this was also the case for all the other steel samples. No pits could be seen on any of the samples.

Figure 4.20: SEM picture of the steel sample exposed to 3 V AC

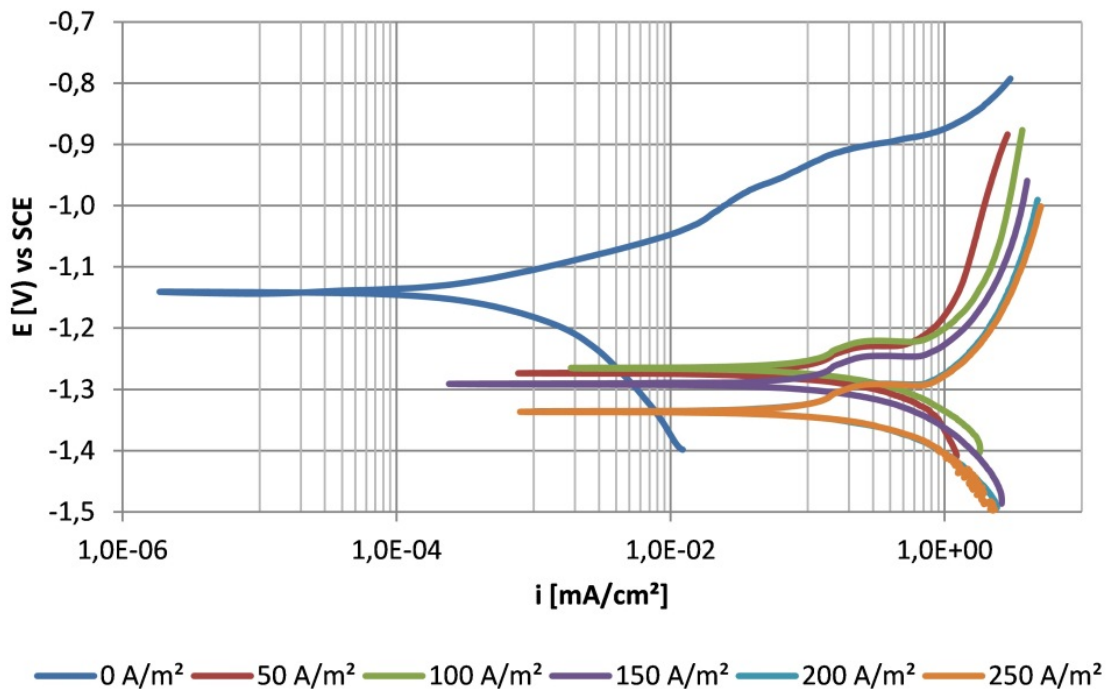
Figure 4.21 shows the polarization curves for the AlZnIn samples.

Figure 4.21: Polarization curves for AlZnIn with different values of AC current density

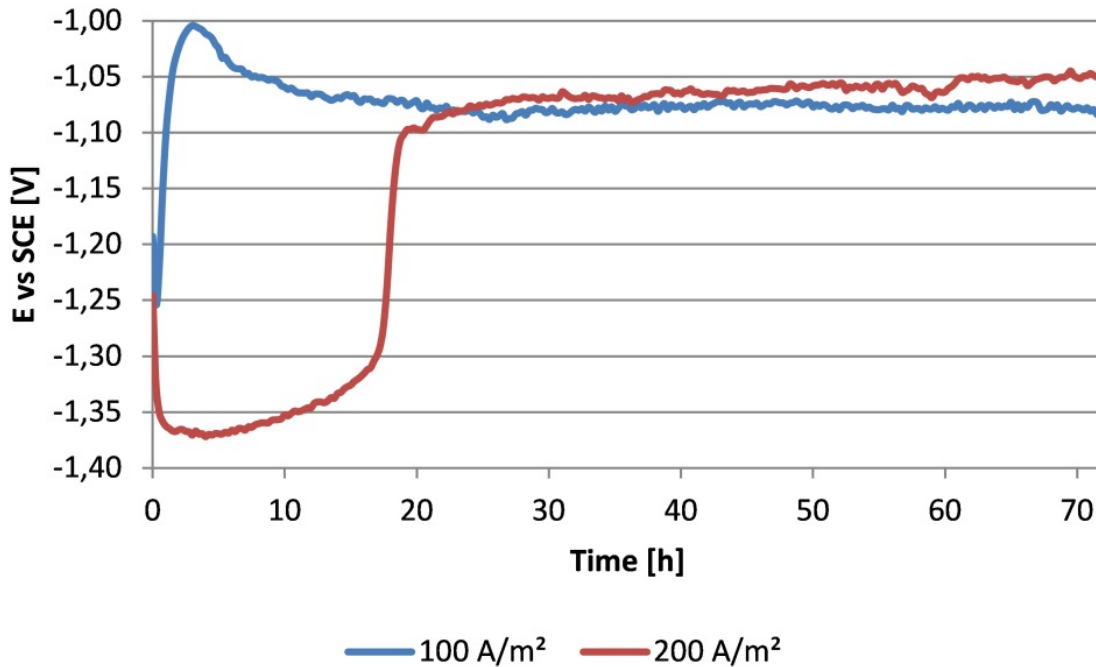
The potential vs time curves can be seen from Figure 4.22.

Figure 4.22: Potential vs time for AlZnIn samples with superimposed AC current.
