Effect of Sulfide Inclusions in Austenitic Stainless Steel on the Initiation of Pitting in Base Metal and Heat Affected Zone after Welding

Materials Technology

Master Thesis, Spring 2012

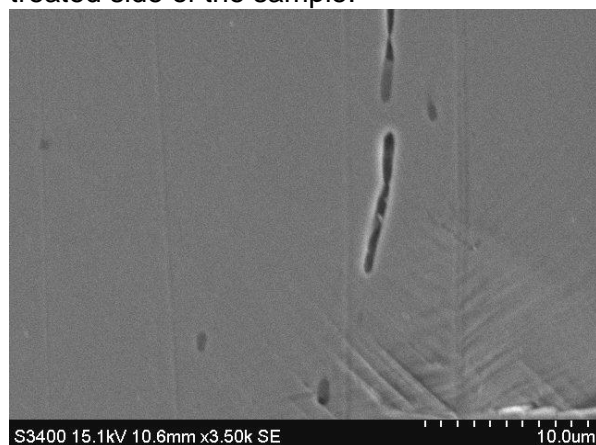
Two samples for welding were also treated with acid. This was done by immersing the half length of the samples in 25 wt% nitric acid for one hour. The treatment was performed in this way in order to later be able to compare the corrosion properties on both sides of the weld, where both sides thus have experienced the same welding conditions, but where MnS inclusions has been removed on one of the sides before welding. After the acid treatment, the samples were welded. Figure 10 - Figure 13 show examples of areas and inclusions in the surface of both the treated and untreated half length of the weld samples, before and then again after the welding. For the different areas, the distance from the fusion line is used to indicate the location of the areas.

Figure 10 Area at 8 mm from the future fusion line before acid treatment and welding.

Figure 11 Area at 8 mm from the fusion line after acid treatment and welding, on the acid-treated side of the sample.

Figure 12 Inclusions located 16 mm from the future fusion line before welding.

Figure 13 Inclusions at 16 mm from the fusion line after welding, on the side of the weld sample not treated with acid.

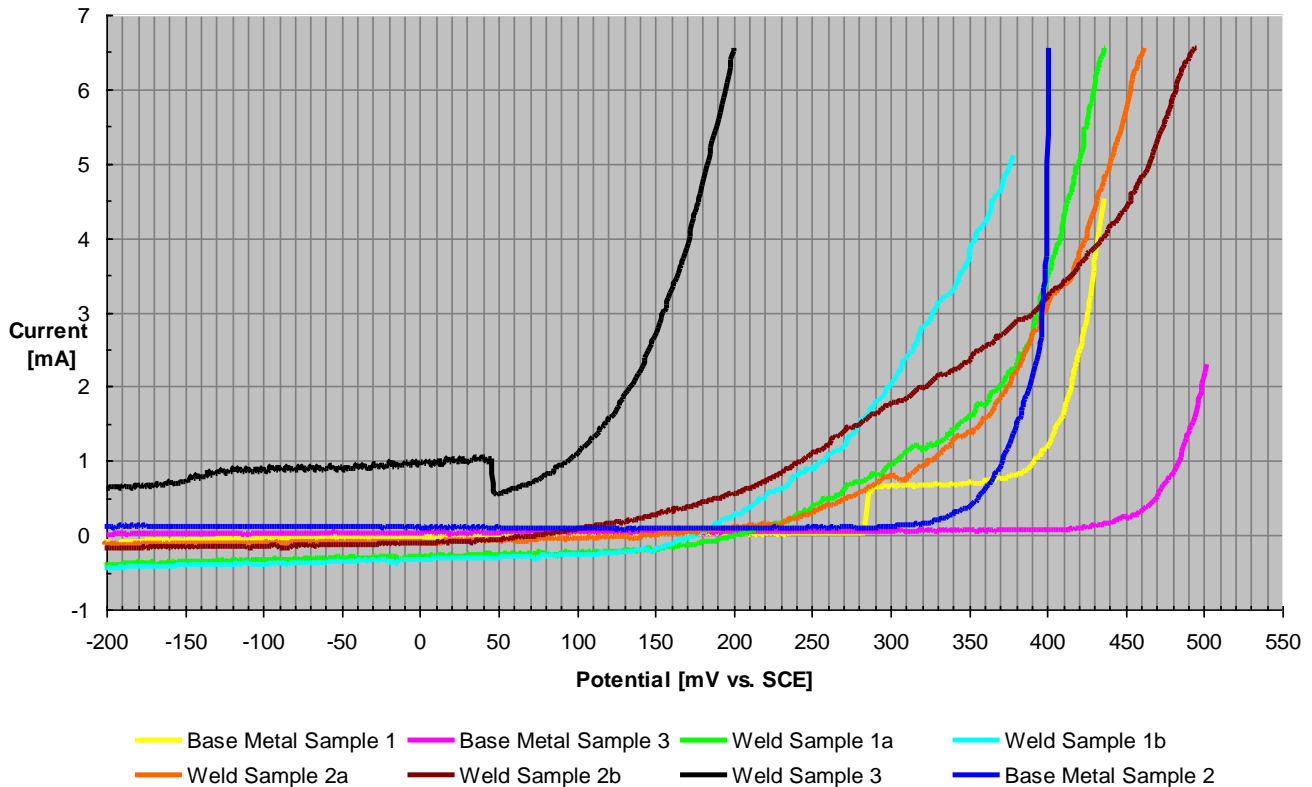
The polarization curves for all samples are included in Figure 19. The polarization was started at -250 mV vs. SCE, polarized cathodically to -500 mV vs. SCE and then polarized anodically until the current started to increase rapidly. The polarization was then stopped. Only the part of the polarization curve in the anodic direction above -200 mV vs. SCE is shown in the plot.

Figure 19 Polarization curves for welded and non-welded 316L samples in synthetic seawater at room temperature and pH 7.5.

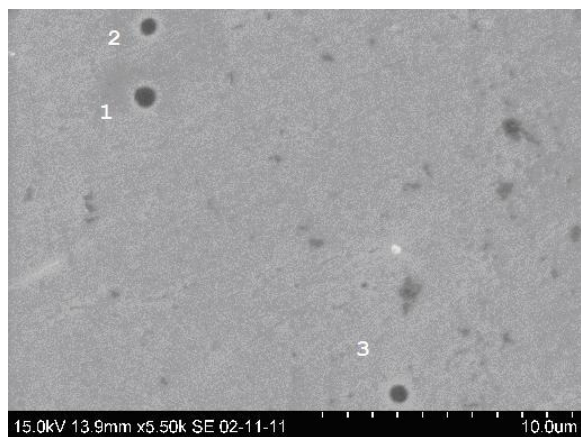
inclusions. A similar area can vaguely be observed in the lower right corner of Figure 20 and Figure 21. The area became darker after the electron beam had been focused on this area for some time during the examination of an inclusion. It can be seen that the inclusion located in this area did not initiate pitting. This behaviour has also been observed for several other inclusions. In order to indicate whether any changes had occurred in the inclusions in Figure 25 during the electrochemical polarization, EDS measurements before and after the polarization were obtained. The measurements are included in Table 11 and Table 12.

Figure 24 Inclusions in Base Metal Sample 2 before electrochemical polarization.

Figure 25 Inclusions in Base Metal Sample 2 after electrochemical polarization.

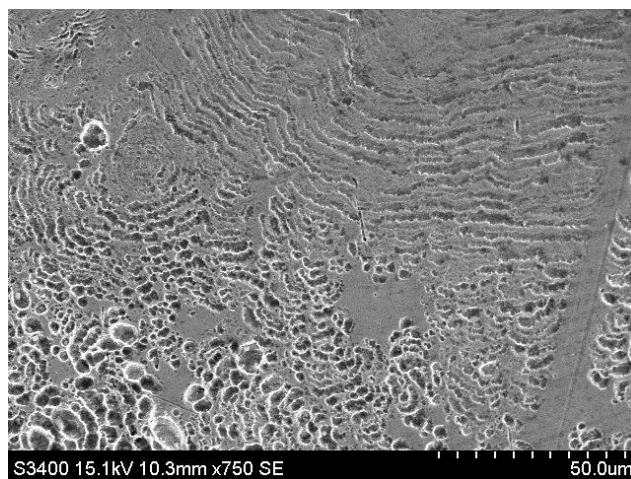
The structure seen in Figure 32 was limited to a distance of 1.0 – 2.5 mm from the fusion line and was seen on both sides of the weld, in the approximate same distance. Figure 34 show an overview of the structure on the other side of the weld, i.e. in Weld Sample 1a, and in more detail in Figure 35 and Figure 36.

Figure 34 Area at 1.0 mm – 2.5 mm from the fusion line in Weld Sample 1a.

Figure 35 Close view of corroded area in Weld Sample 1a.

Figure 36 Another close view of corroded area in Weld Sample 1a.

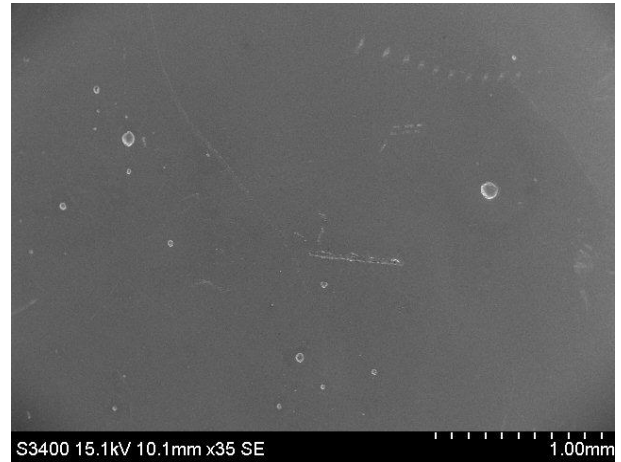
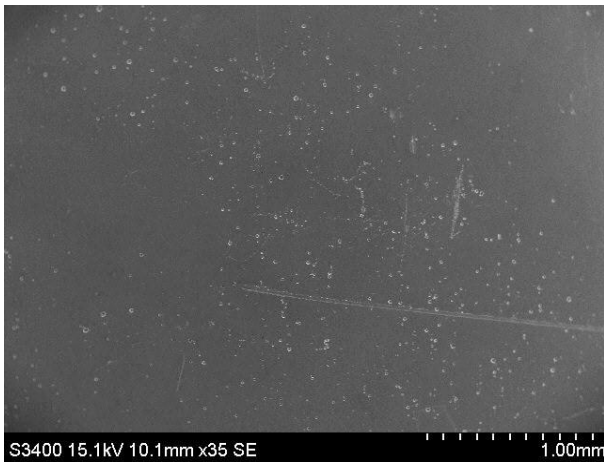
Initiated pitting attacks were observed further away from the weld and the fusion line in Weld Sample 1a. The amount of attacks seemed to increase with increasing distance from the fusion line. Figure 38 - Figure 41 show the surface at different distances from the fusion line. Some markings for the SEM examination have been done in the surface.

Figure 38 Area at 5 mm from the fusion line.

Figure 39 Area at 7 mm from the fusion line.

Figure 40 Area at 16 mm from the fusion line.

Figure 41 Area at 20 mm from the fusion line.

It is seen that the initiated pitting attacks are more frequent in the areas located 16 mm and 20 mm from the fusion line than at 5 mm and 7 mm. The pitting attacks had been initiated at inclusions. One example is included in Figure 42.

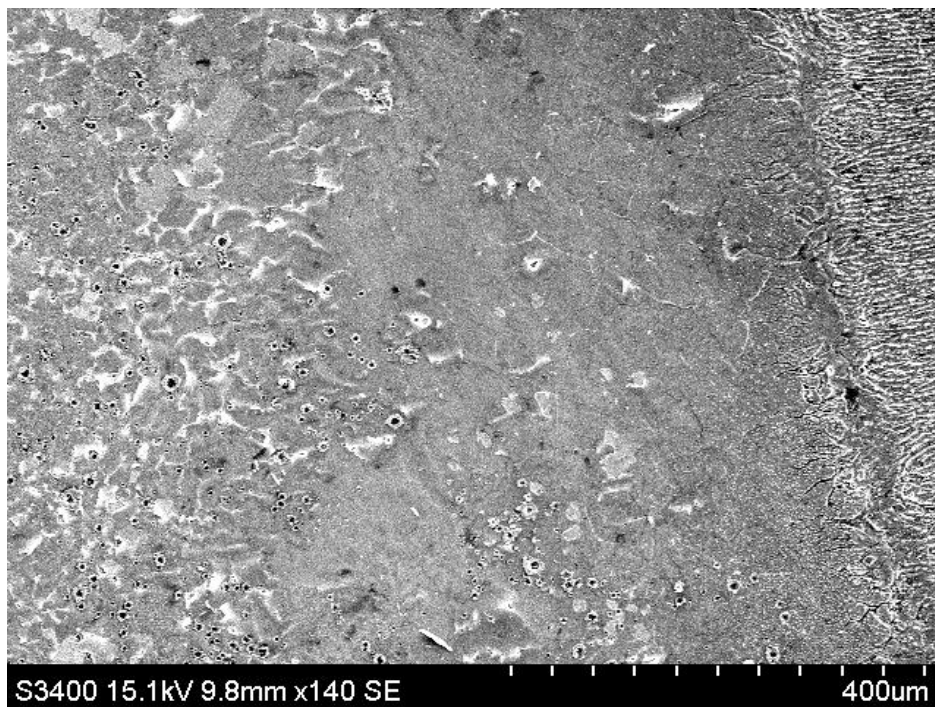
In the SEM, a visible grain structure was detected out to about 1.5 mm from the fusion line. Beyond this distance, no evident change of the surface was observed. The part of the HAZ between 0 mm and 0.8 mm from the fusion line is shown after electrochemical polarization in Figure 47.

Figure 47 HAZ between 0 mm (to the right) and 0.8 mm from the fusion line in Weld Sample 3.

Also seen in Figure 47, further away from the weld, at about 0.3 mm and beyond, inclusion-like formations are present. This is showed in detail in Figure 51. EDS measurements to identify elements present in these formations were performed. The measurements are included in Table 13. These inclusions were observed in a distance between 0.1 mm and 1 mm from the fusion line, along the weld, in the rest of the sample surface.

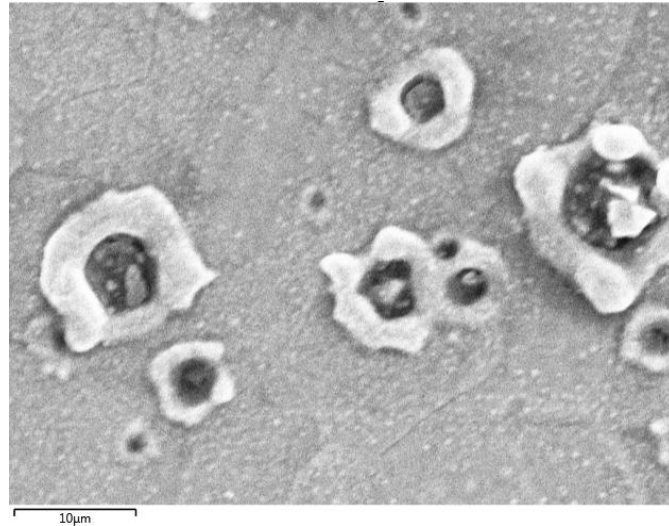
Figure 51 Inclusion-like formations in Weld Sample 3.
