# The Susceptibility to Hydrogen Induced Stress Cracking for Alloy 718 and Alloy 725

**Gaute Stenerud**

Materials Science and Engineering

Submission date: June 2014

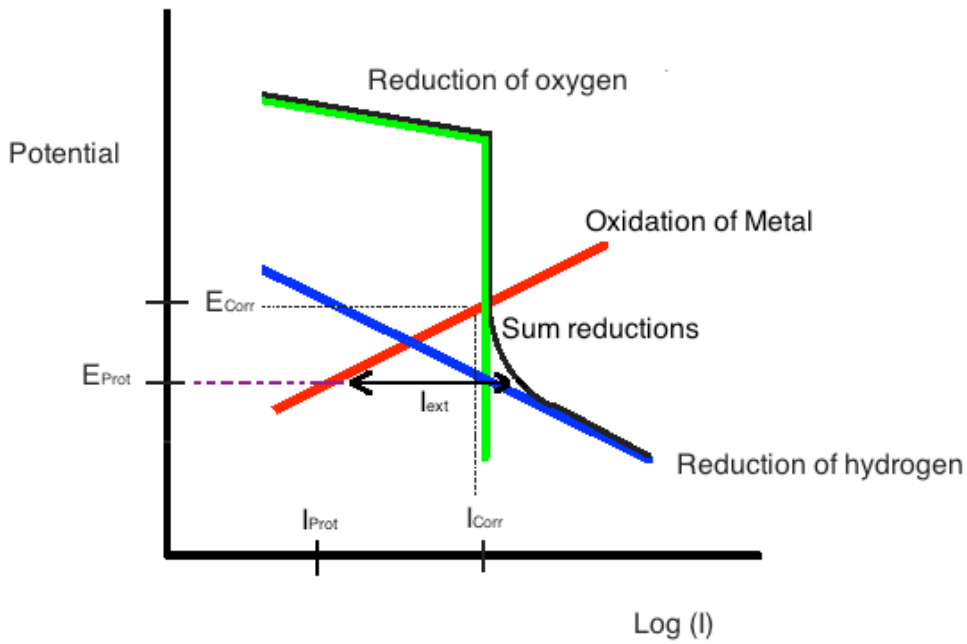
Figure 10: An Evans diagram for a hypothetical metal.

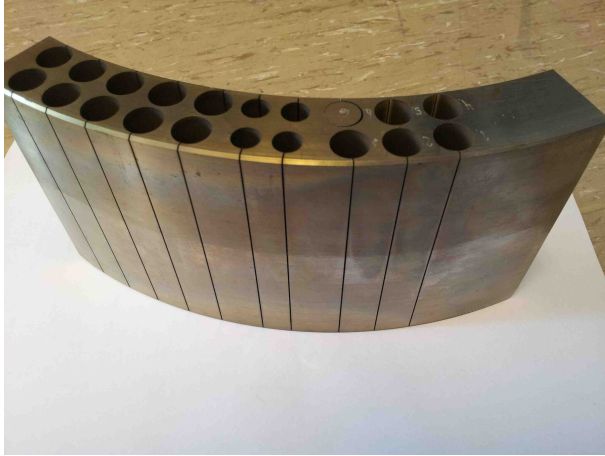
**Figure 12:** A picture of how the Alloy 725 samples were extracted from the material.

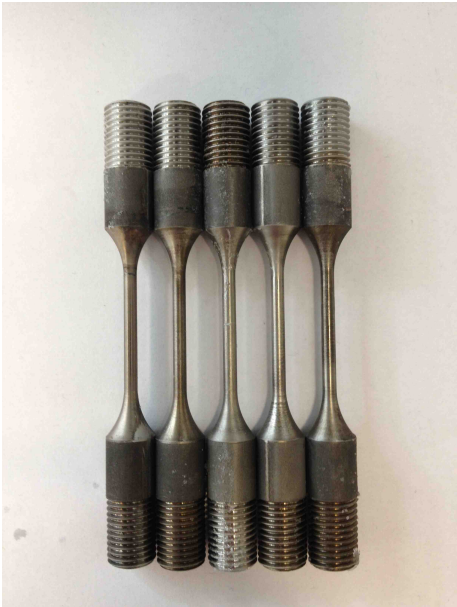
Figure 16: A picture of the HISC bars after pre-charging.

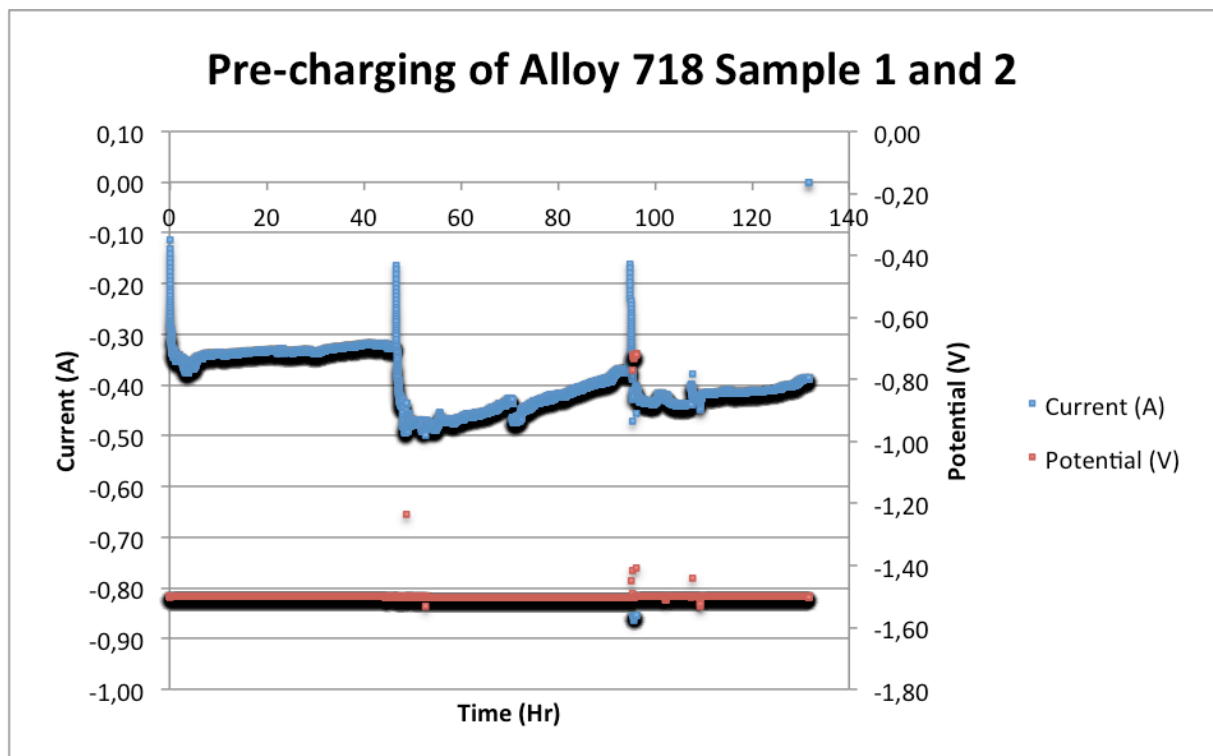
Figure 21: A current and potential plot for HISC sample 1 and 2 of the Alloy 718 material. The potential is measured against a Hg/HgSO<sub>4</sub> reference electrode.

The potentiostat used for the pre-charging logged the current and the potential during the time of the charging. These values were imported to Excel and used to make graphs as show in Figure 21 and Figure 22. Large fluctuations in the current were observed. The three peaks in the graphs occurred due to the change of electrolyte and the following temperature drop. The counter electrodes were removed and washed before they were reinserted into the pre-charge chamber. In this way, the distance between the anode and the cathode was altered, which did also affect the current. It also seems as the resistance in the electrolyte gradually increased during the pre-charging. The pre-charge graphs for the rest of the samples are included in Appendix A.

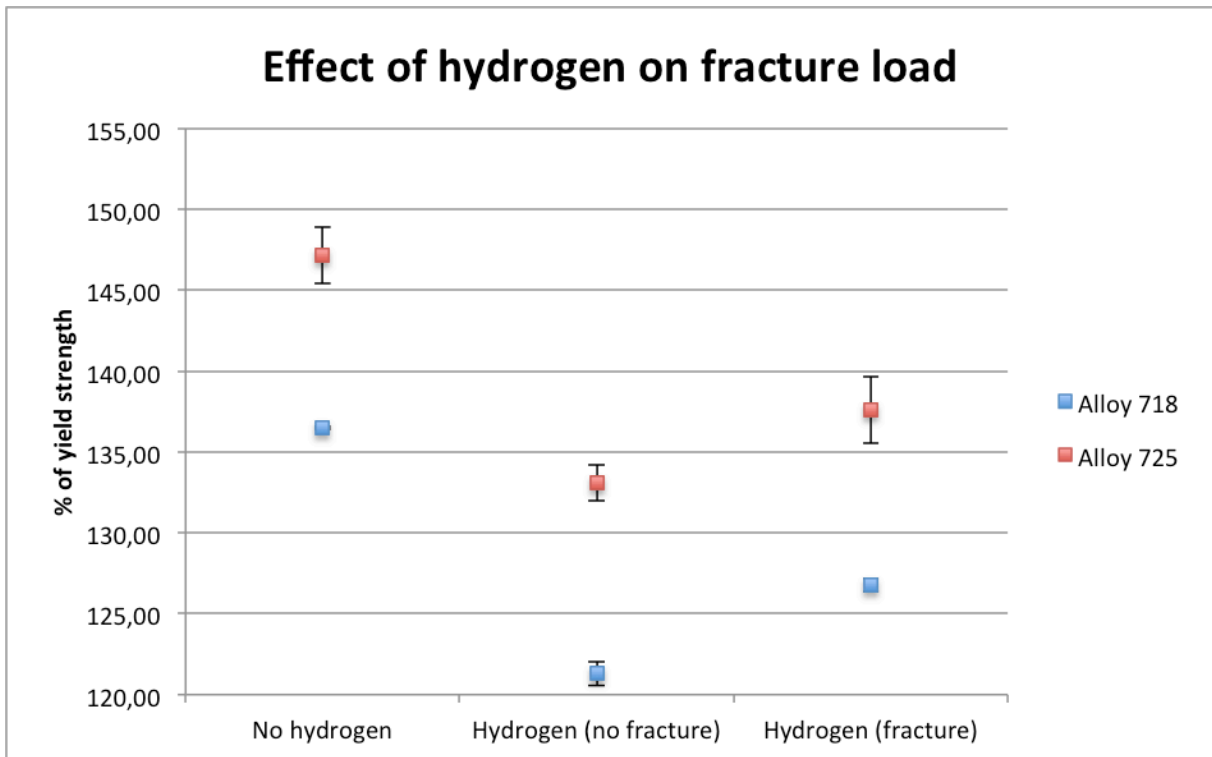
**Figure 27: The same figure as Figure 26, only without Alloy 718 samples 1 and 3. This is the reason for the reduced standard deviation.**

The results in Table 7 and Table 8 are presented in Figure 26. The “No hydrogen” values are the results obtained from the tensile testing, while the “Hydrogen” values are those obtained from the HISC testing. The high standard deviation for Alloy 718 is mainly due to the sample 1 and sample 3. If these two are excluded from the calculations, the deviation is greatly reduced. This is shown in Figure 27.

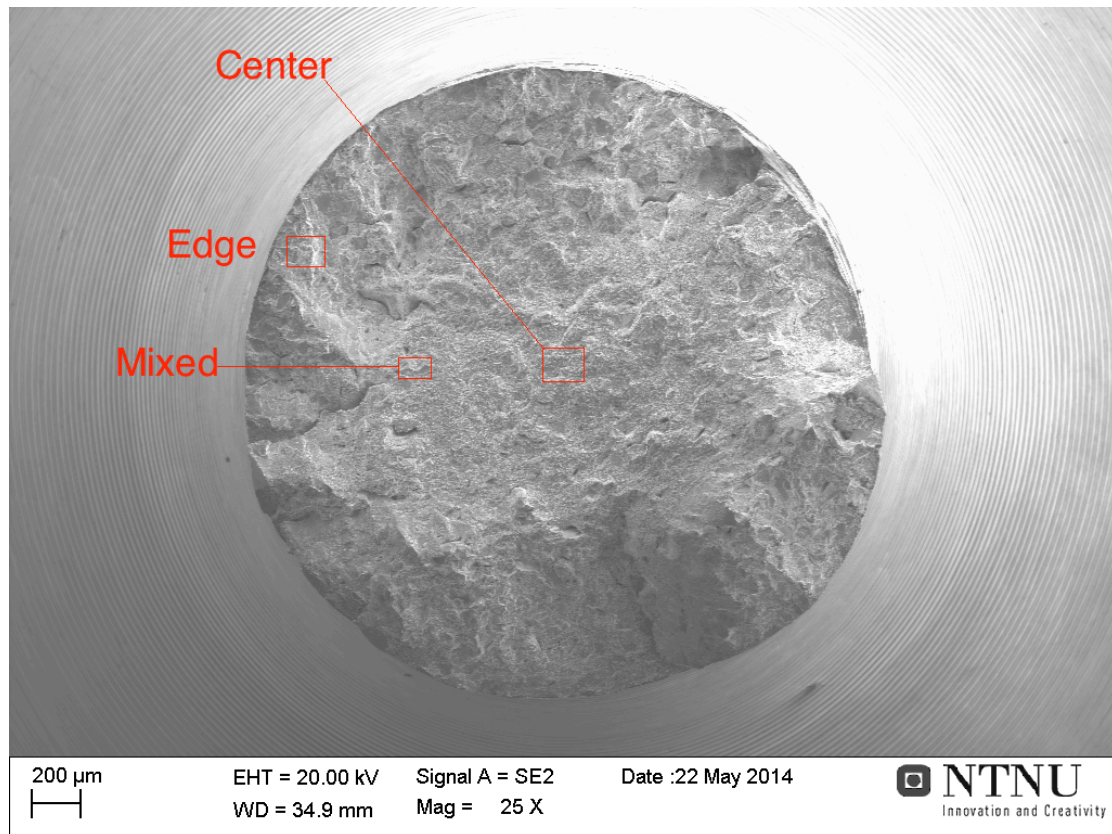
**Figure 30: The fracture surface from HISC test of Alloy 718. The marked squares are areas where the next photos are taken.**

Both the fracture surfaces from the standard tensile test and the HISC test were examined. Already on a macroscopic scale, one could observe a loss of ductility (no necking) in the HISC test. The loss of ductility was also observed on the fracture surfaces. The fracture surface from the standard tensile test is presented in Figure 29 while the fracture surface from one of the HISC tests is presented in Figure 30.

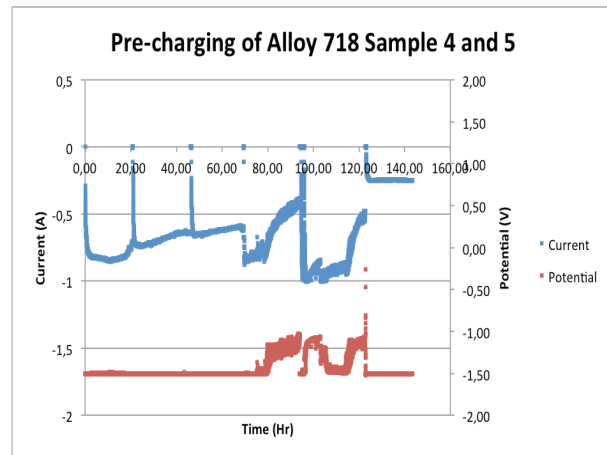
Figure 54 Pre-charging of Alloy 718 sample 4 and 5.

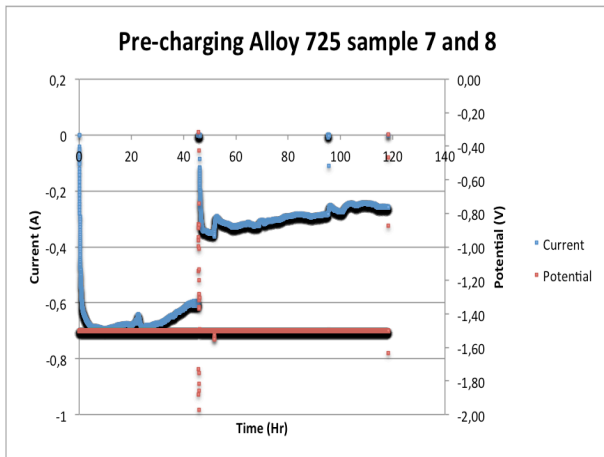
**Figure 59 Pre-charging of Alloy 735 sample 7 and 8.**
