# Hydrogen induced stress cracking of alloy 718

Effects of chemical composition and  
microstructure

Materials Science and Engineering  
Submission date: June 2014  
Supervisor: Roy Johnsen, IPM

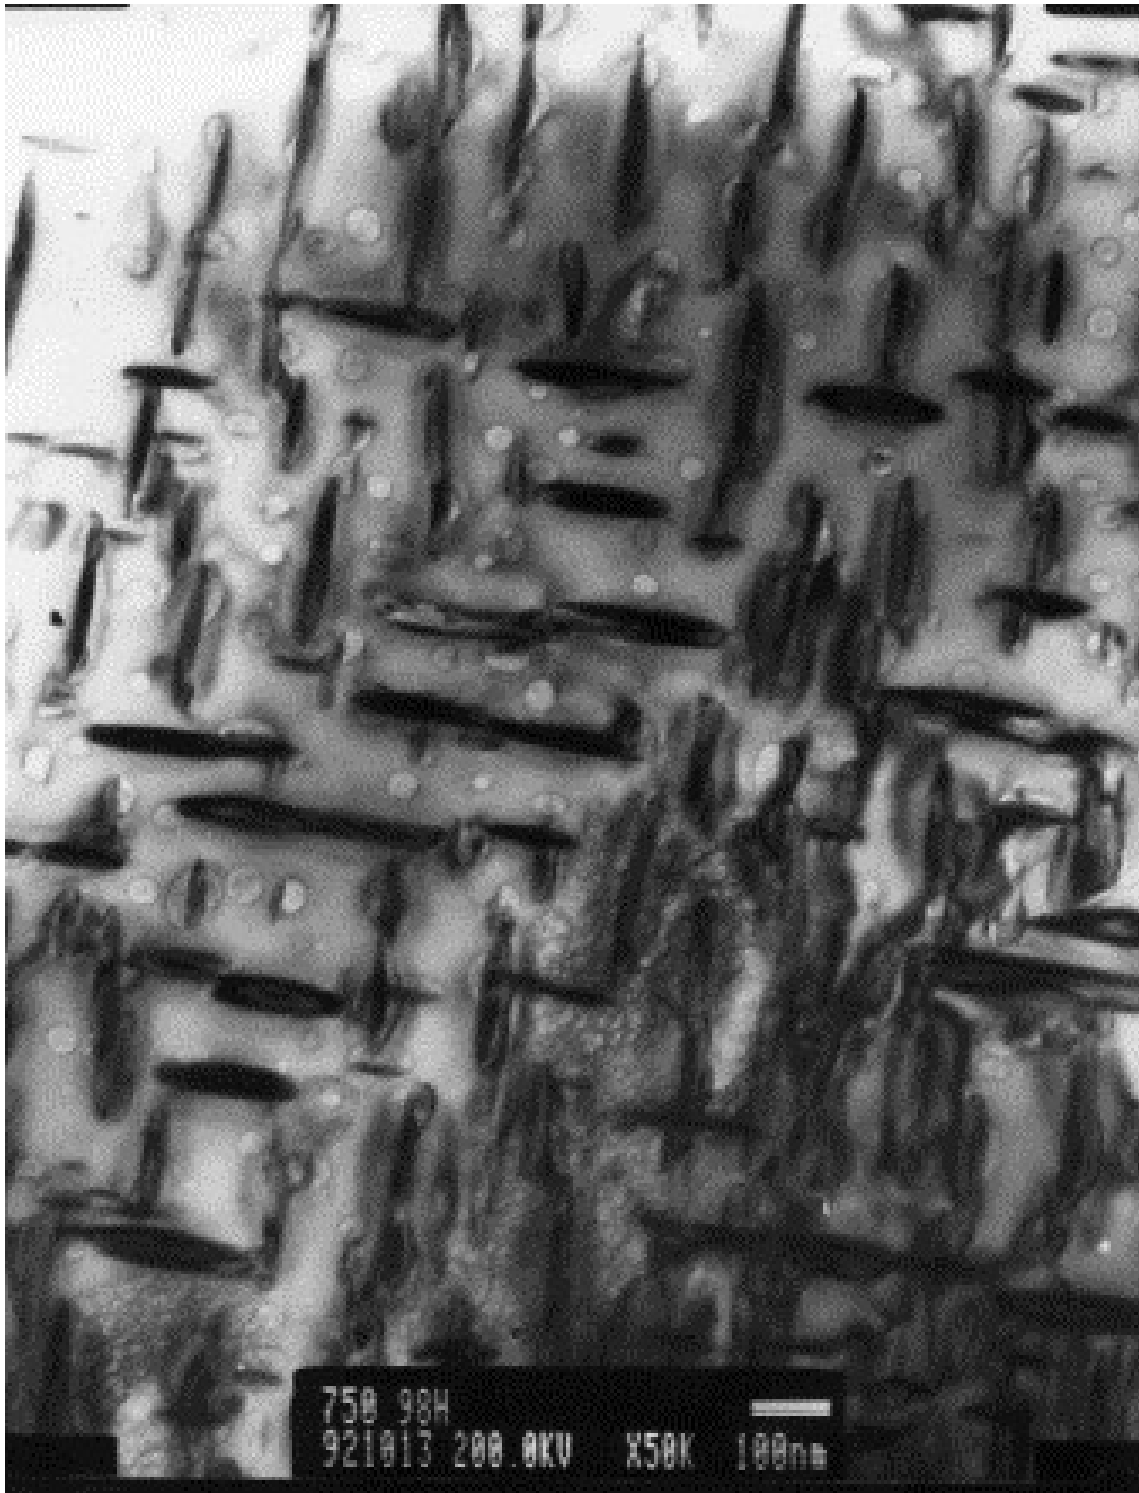
Figure 2: A TEM image from the article: "Structural characterization of aged inconel 718" by C. Slama [51]. The image shows the different precipitates formed in Inconel-718 during aging:  $\gamma'$  (White),  $\gamma''$  (Black) and the  $\gamma$ -matrix (Grey background). The  $\gamma''$  phase tends to nucleate at previous  $\gamma'$  particles.

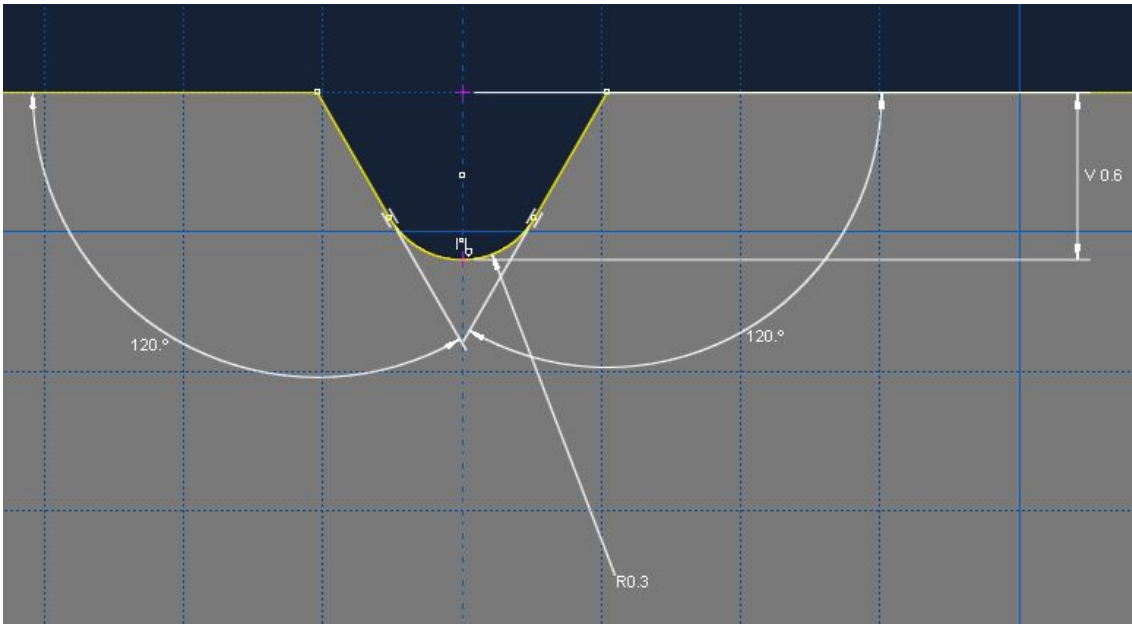
Figure 8: A sketch showing the notch geometry and tip radius. The notch has a depth of 0.6mm and a tip radius of 0.3mm

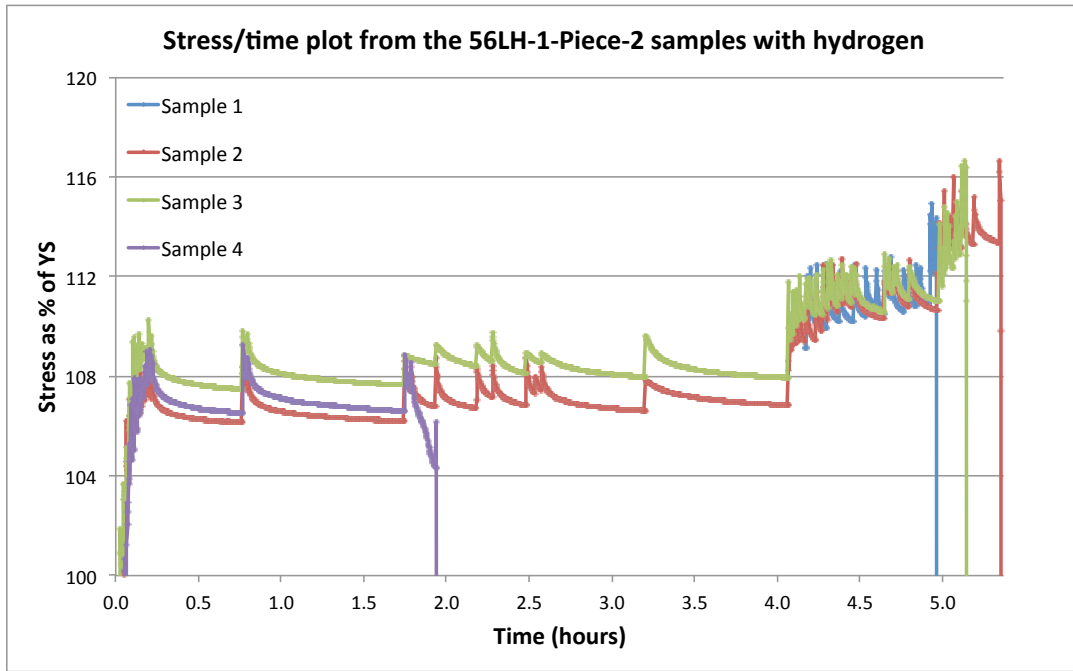
Figure 26: Stress - time plot from the 56LH-1-Piece-2 samples pre-charged with hydrogen. The premature fracture observed in sample 4 was particularly strange, given the consistency seen in sample 1-3. The hypothesis is that some sort of internal defect have been present in sample 4.

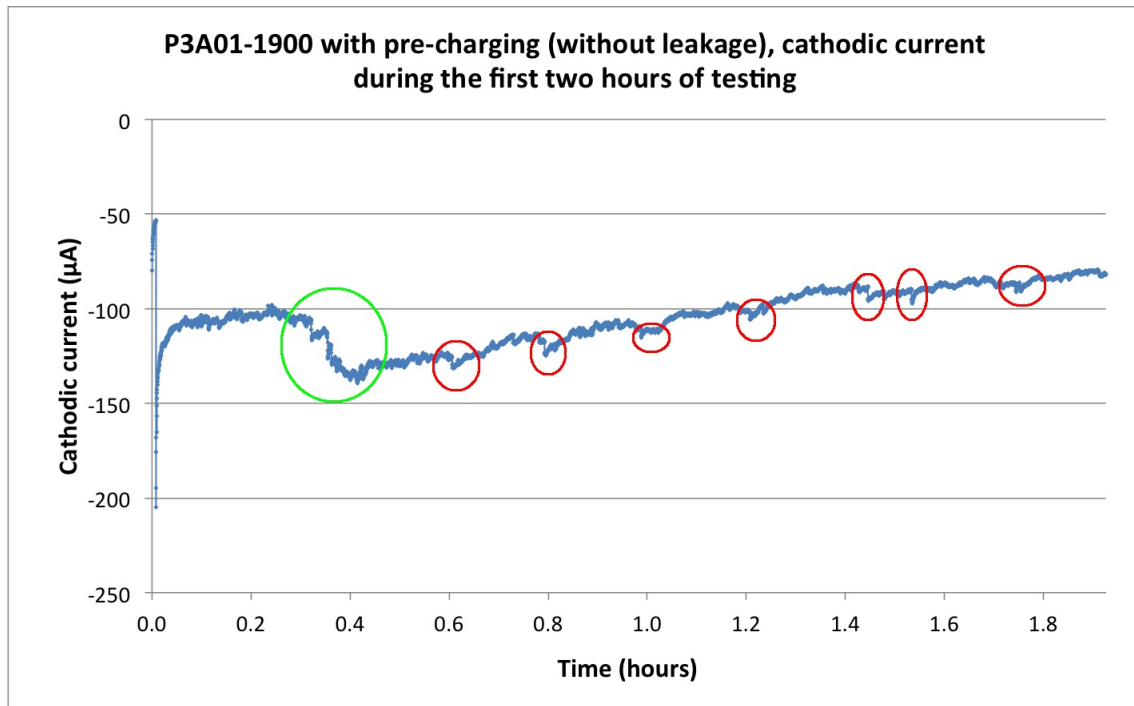
Figure 42: A plot showing the cathodic current recorded during the two initial hours of tensile testing of P3A01-1900 with pre-charging (Sample-1). No leakage occurred. Large bubble releases are marked with red.
