# TBM Tunneling in Hard Rock Conditions

Verification of the NTNU and the  $Q_{\text{tbm}}$   
estimation models and assessment of TBM  
performance at the Upper Kontum  
Hydroelectric Powerplant

**Egil Zahl Johansen**

Submission date: June 2018

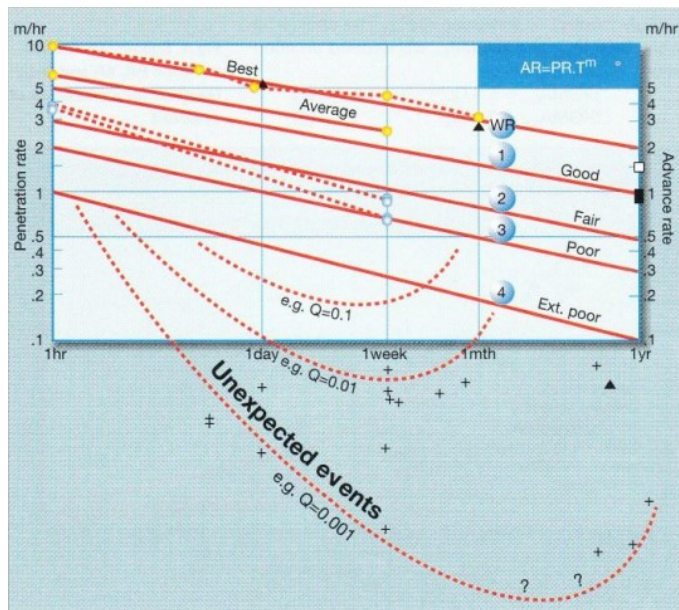
Figure 2.6: Connection between PR and AR over time (Barton, 1999)

The  $m_1$  will be a negative number decided by the Q-value, thus having the same mathematical function as for calculating PR, with a decreasing impact on AR at a higher number of work-hours. The TBM diameter D is included as a factor in the long term-performance, indicating that an increase in diameter will have a negative impact on the advance rate. A lower CLI and a higher quartz content both also contribute to larger decrease in AR. Porosity of the rock is also included as a factor, where an increase in porosity decreases the AR. The relationship between the AR and the PR over time will be as illustrated in figure 2.6.

As we can see from the plot, the AR after one full year of work-hours is expected to range between one tenth to one fifth of the PR in terms of m/h bored, with the exception of boring through extremely challenging conditions with low Q-value. Looking at the PR and AR as a function of the Q-value, we get the following relationship as shown in figure 2.7.

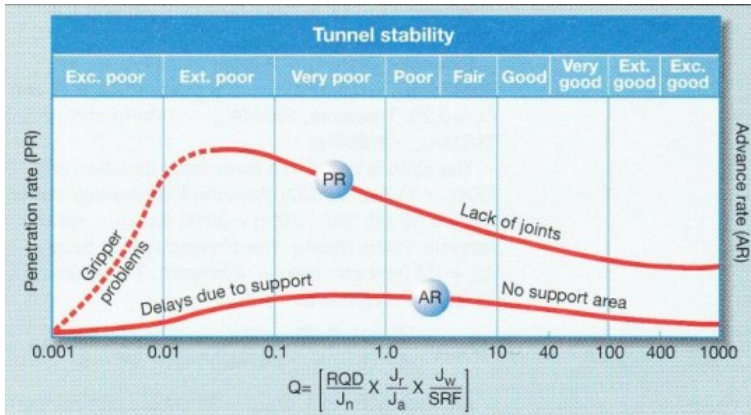
Figure 2.7: Connection between Q-Value and AR/PR (Barton, 1999)

Favorable rock mass conditions are expected at Q-values between 0,1 and 10, as the rock will neither require too much work with support measures or having too low penetration rate due to intact rock mass(Barton, 1999).

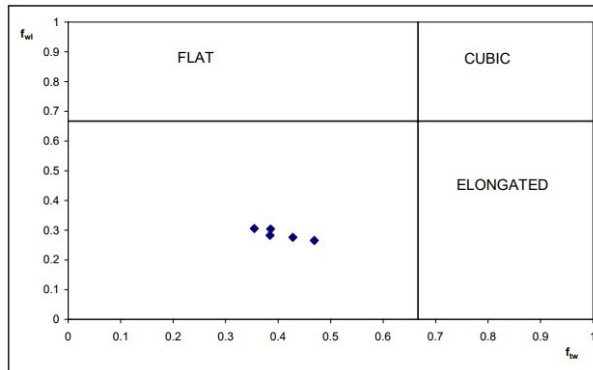
Figure 3.2: Sample Table for Chip Analysis (Bruland, 1998)

The shape factor of the chips can also provide information regarding the breaking process. The chip is described by the relationship  $f_{hw} = \frac{h_{cb}}{w_{ch}}$  and is shown in figure 3.2.

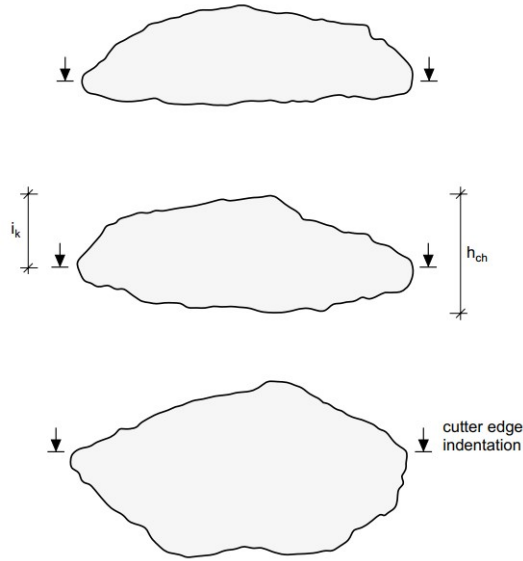
Figure 3.3: Example of chipping under different cutter loads (Bruland, 1998)

In addition to the volume of the chips broken off, the ration between depth of the kerf from passing measured from the thickest part of the chip and the thickness of the chip give valuable information regarding the chip breaking process(Bruland, 1998).

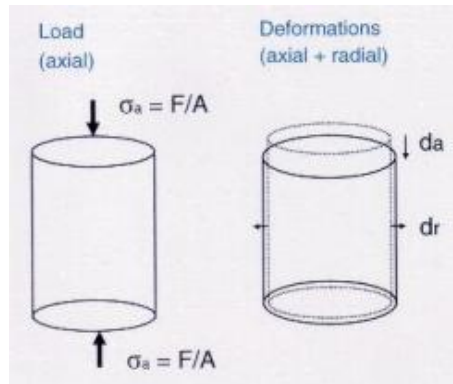
Figure 3.5: Test procedure for determining compressive strength (Jacobssen, 2004)

The UCS test is a common test procedure for deciding the strength of a certain material. A cylindrical sample with the length of 2-3 times the diameter is compressed along the length axis, and the strength is given by the peak tension before the sample fails. The procedure can be seen in figure 3.5.

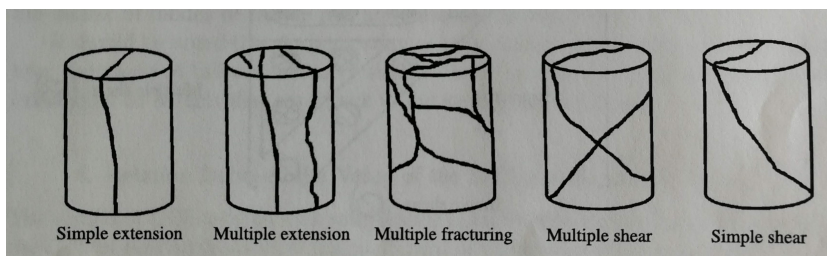
Figure 3.6: Modes of Failure (Szwedzicki, 2007)

The test is conducted at SINTEF in accordance with the ISRM standard (Bieniawski & Bernede, 1979). Five samples were tested and the failure documented. Different modes of failure are typically connected to different peak tensions. Low peak tensions are connected to simple shear failures while higher peak tensions are connected to multiple shear and multiple fracturing. Shear and fracturing failures are typically connected to that failures happen along discontinuities in the sample, while failure along the axis are connected to the intact rock (Szwedzicki, 2007). Illustration can be seen in figure 3.6.

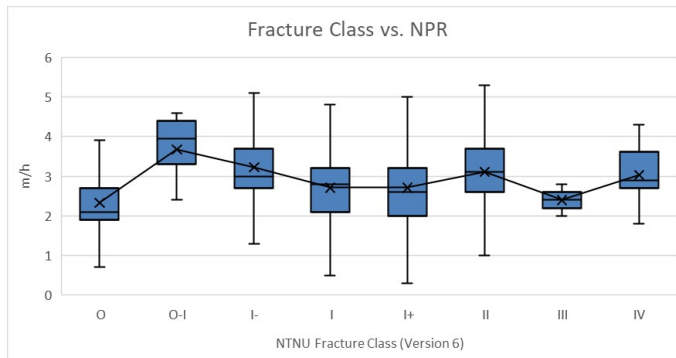
The project registered the NTNU fracture class continuously as the TBM was advancing. The classification definitions used was in accordance with version 6, as this was the current version when the project commenced. The plot of all actual net penetration rates to their respective fracture class can be seen in figure 4.1.

Figure 4.1: Relationship between fracture class given by Robbins and actual NPR for the given areas. Box contains 50% of observations, line inside box shows median value, “x” shows average value, whiskers shows total spread in data.

Looking at all the data combined, there appear to be no correlation between registered fracture class and estimated NPR. There was however a large spread in the length observed per class, which may cause some uncertainty in the averages given.

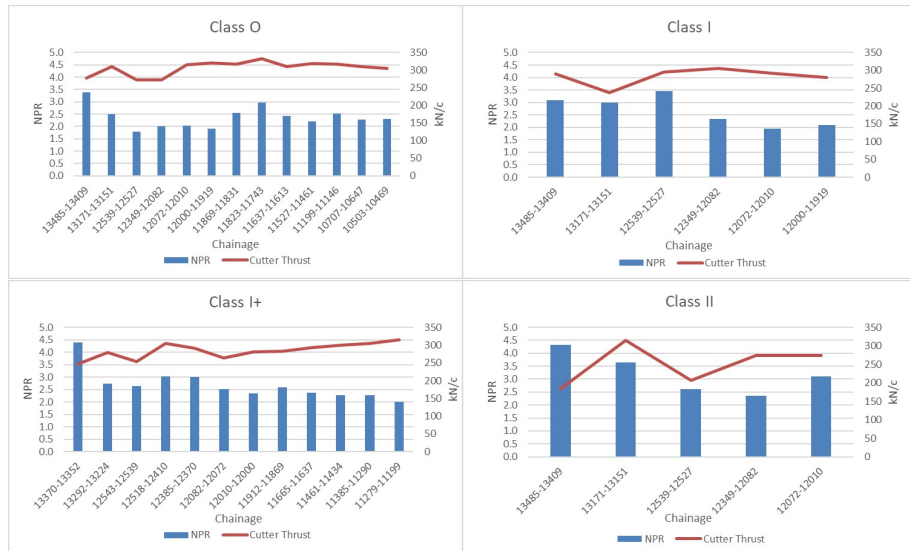
connection between the way the NTNU fracture class has been estimated and actual tunneling performance. Looking at sections internally per fracture class, one gets a better understanding of the spread of the data.

Figure 4.3: Resulting NPR and cutter thrust for different sections per fracture class.

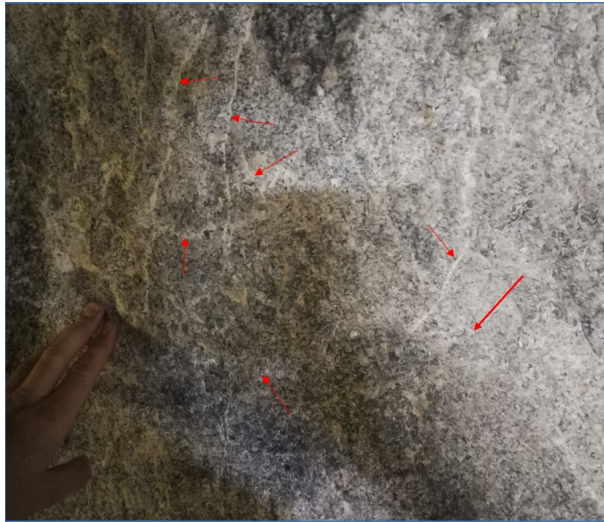
The mapping itself, and indirectly the classification given, was not done in accordance with the procedure described in version 6. The fracture class had been assessed by all fractures regardless of direction, as one would when estimating the joint volume for RQD, and given an average distance based on this. An example of fractures included can be seen in figure 4.4.

Figure 4.4: Picture showing all fractures included when evaluating the fracture class by Robbins.

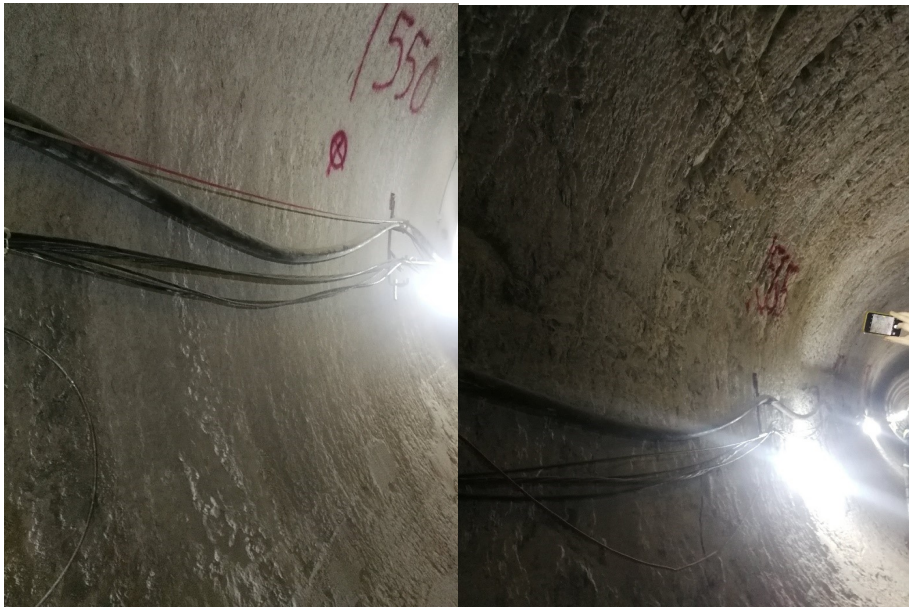
Solely based on comparing the NPR and the observed cutter thrust levels with the estimations given by the NTNU-model, all observations of NPR lower than 2.0 m/h and the majority of all observations lower than 2.5 m/h appears to actually be class O. The remaining observations, with a few exceptions, does not appear to belong to the class listed to. According to site personnel, the intention behind registering the NTNU-fracture class was not to obtain data for penetration rate estimations for later projects, but rather as a tool to describe how the rock-mass appeared after it has been passed. The surface left behind after the TBM has passed by does show a significant difference despite belonging to the same fracture class (when fracture class is estimated correctly). As can be seen in figure 4.5, there is a clear difference in how fractured the rock-mass appear to be despite both being class O, thus the need for a system to describe this. No samples from this area was taken to investigate if the intact rock parameters were any different.

Figure 4.5: Difference in tunnel surface under equal rock-mass conditions

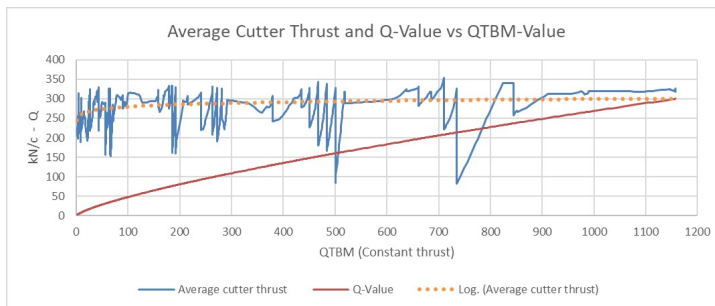
Figure 4.10: Cutter thrust and Q-value as a function of the  $Q_{TBM}$ -value.

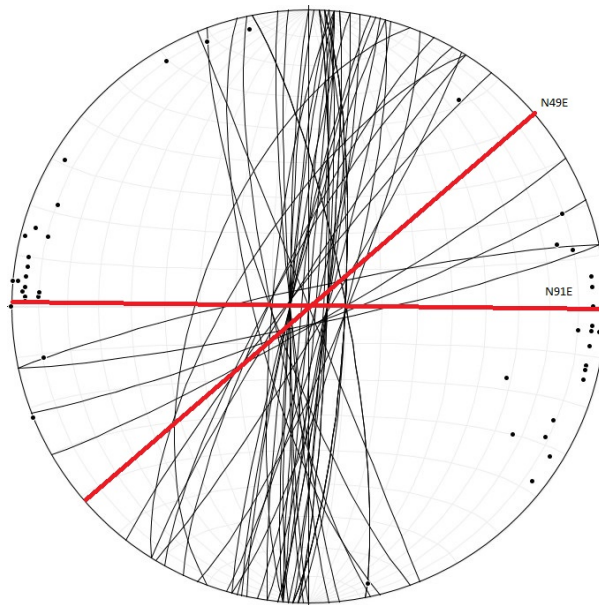
As the fracture class registration by The Robbins Company could not be used, only mapping from the field study at the site could be used for the NTNU-model. Based on strike and dip measurements taken over the entire length of the mapped area, there was identified two distinctive sets that were used as input to the model. The predominant set J1 was identified with a strike of  $N190^{\circ}E$  and a dip of  $85^{\circ}$ , and minor set J2 was identified to  $N65^{\circ}E$  and a dip of  $85^{\circ}$  (nomenclature for strike and dip in accordance with project standard). The sets respectively gave an angle towards the tunnel axis of  $49^{\circ}$  and  $6^{\circ}$ , seen in figure 4.14.

Figure 4.14: Stereonet Plot from Measurements of Strike and Dip, with Tunneling Directions shown in red

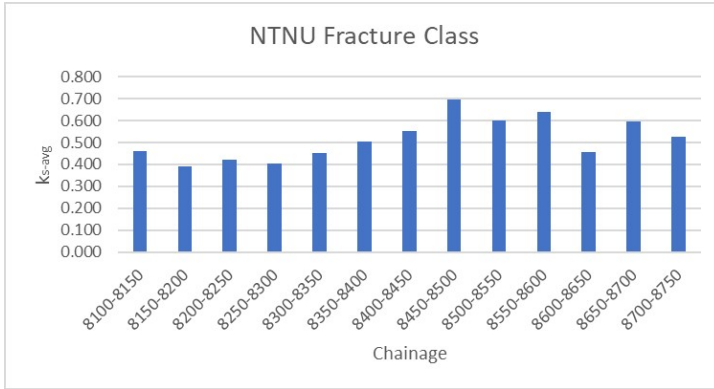
spacing was estimated using the “n+1” approach. This is an alternative approach to achieve a more accurate description of the spacing in these conditions (Seo et al., 2015). The resulting  $k_{s-avg}$  can be seen in figure 4.15.

Figure 4.15: Results from Mapping In Accordance With NTNU-Model Fracture Class

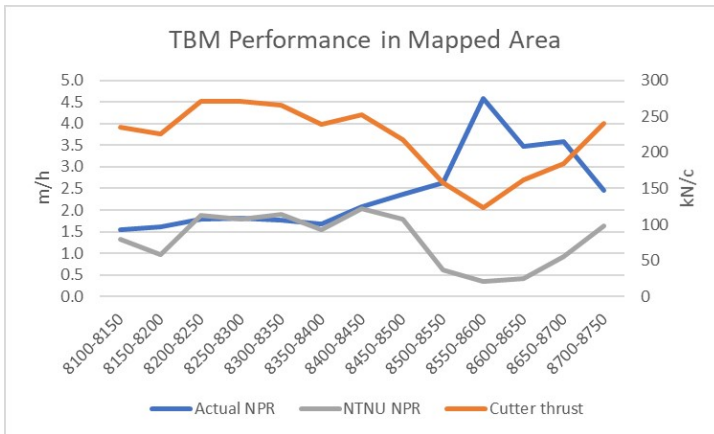
Verifying the mapping can only be done by assessing the TBM performance in terms of cutter thrust and NPR. This can be seen in figure 4.16.

Figure 4.16: NPR performance and estimation compared to the actual cutter thrust utilized.

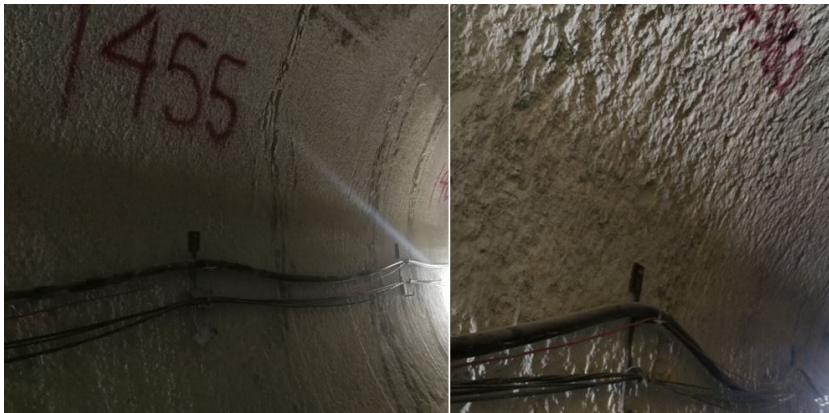
the rock-mass and the TBM. The surface left behind after the TBM had passed were in and close to chainages 8500-8700 was uneven and the fracturing induced by the TBM appeared to have spread outside the cross-section of the tunnel. This can be seen in figure 4.17. Pieces of rock could easily be loosened by hand in these areas. The opposite was the case outside this area, where the TBM left a smooth and completely intact surface except for around the fracture sets, as seen in figure 4.17.

Figure 4.17: NPR performance and estimation compared to the actual cutter thrust utilized.

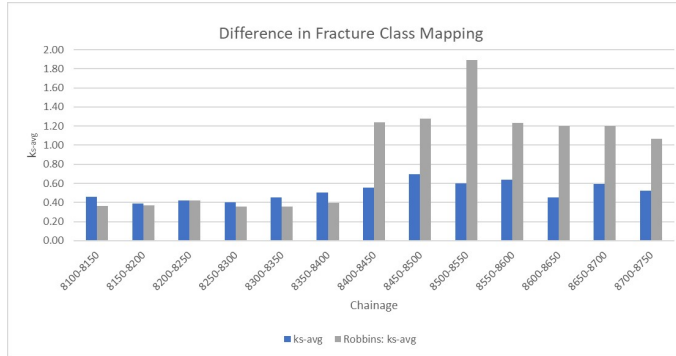
Figure 4.20: Resulting fracture class from Robbins mapping versus independent mapping

Figure 4.20 shows the results from the mapping done during the visit at site versus the mapping done by Robbins. The assessment is approximately equal in chainage 8100-8400, while it deviates significantly in chainage 8400-8750.

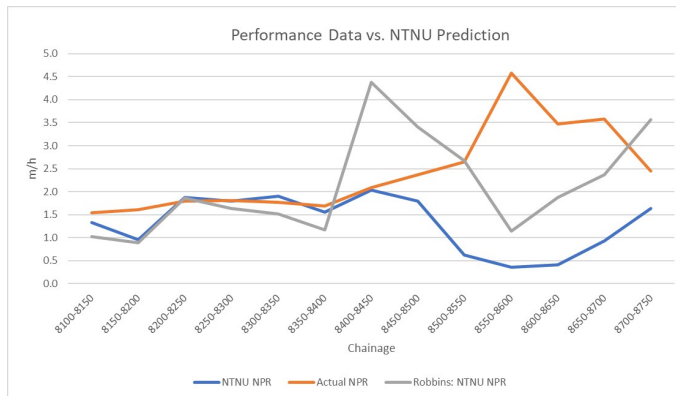
Figure 4.21: NTNU-model NPR estimations for Robbins and independent fracture class mapping

estimation in chainage 8100-8400. The Robbins mapping indicate a highly fractured rock-mass for chainage 8400-8500, which does not lie in the weakness zone. The corresponding estimated NPR for this area is thereby significantly higher than the actual NPR.

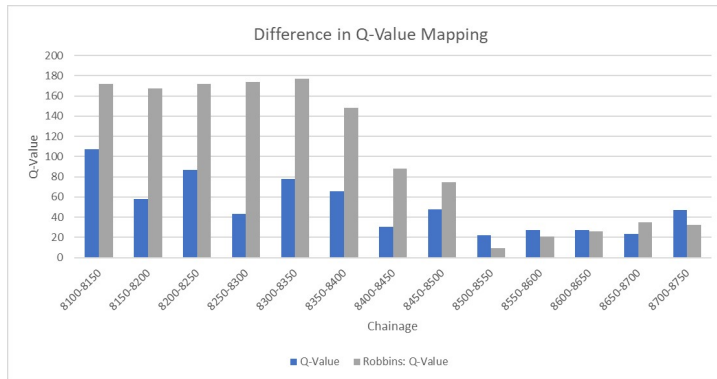
Figure 4.22: Resulting Q-system value from Robbins mapping versus independent mapping

The results from mapping with the Q-system can be seen in figure X. The mapping conducted by Robbins shows a higher value given in areas with good rock-mass conditions compared to the student mapping, while the value is more equal for the other areas.

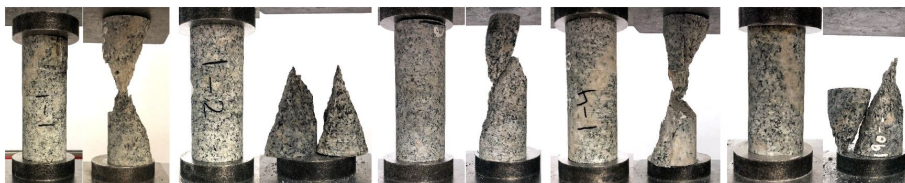
Figure 4.24: Pictures before and after testing showing failure mode

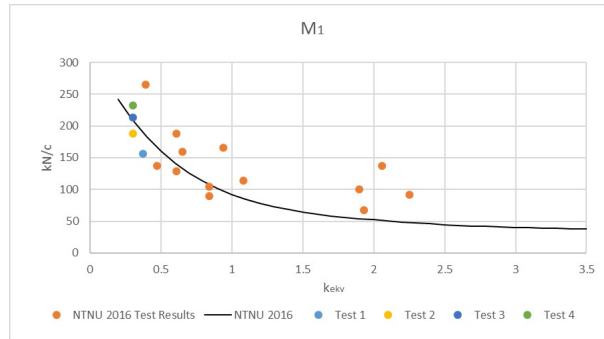
Figure 4.29: Results from Kontum tests plotted with  $M_1$  results used in version 7 of the NTNU model

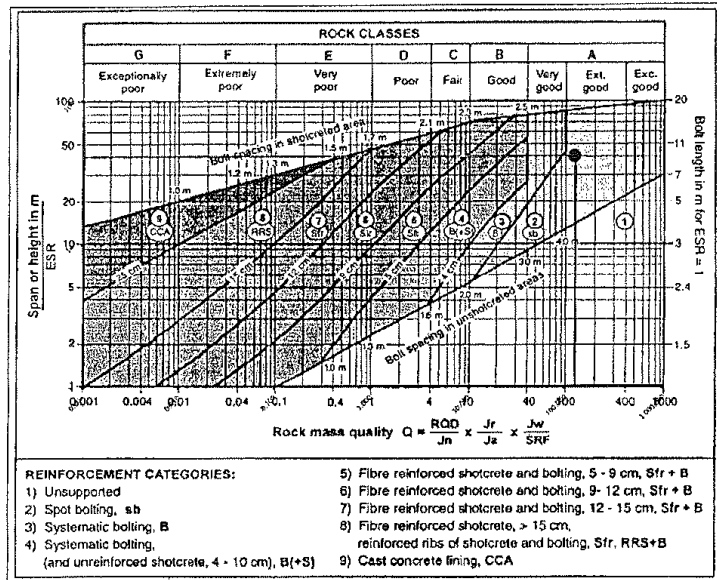
Figure 4: Recommended rock support for the powerhouse, according to the Q-system.

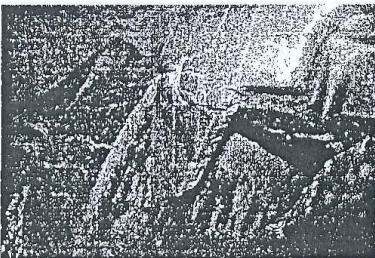
Bended wearing plate can damage cutters

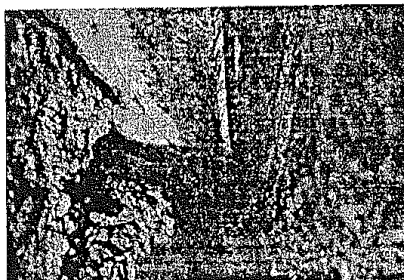
Leak oil on outer seal

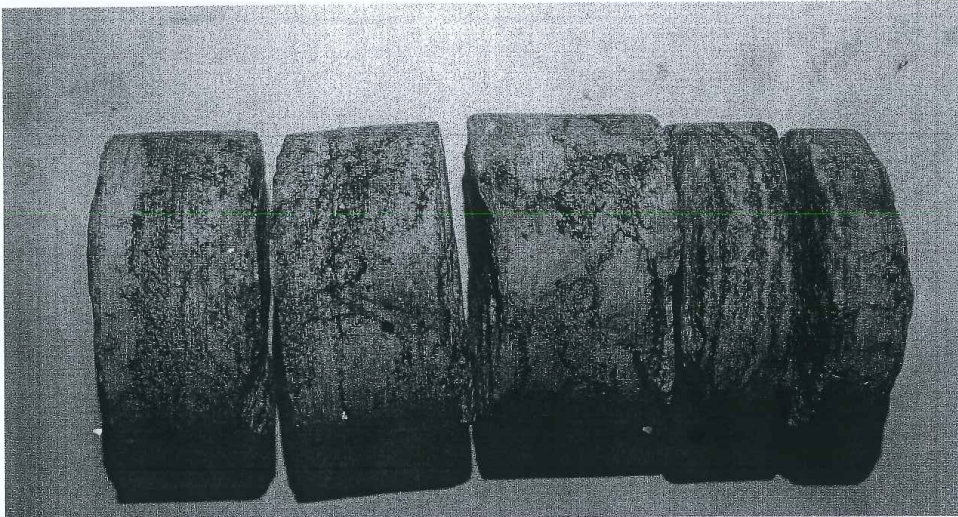
Figure 5: Core diskings under high stress condition.

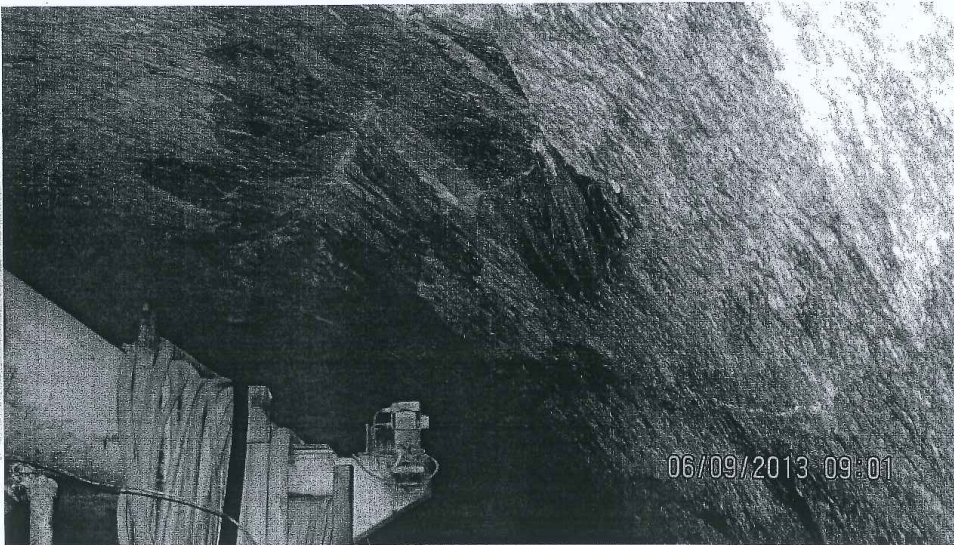
Figure 6: Rock slabbing/bursting around K16+545 under high stress condition.

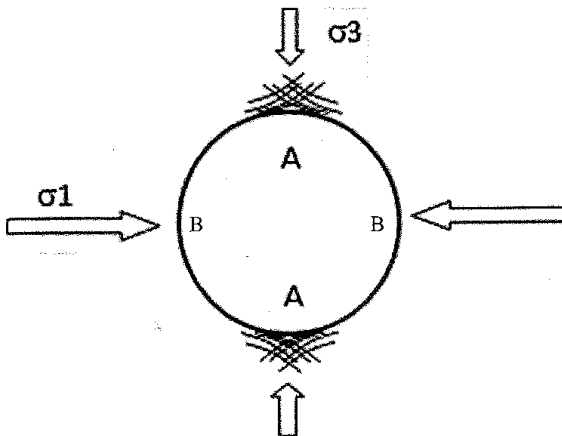
Figure 7: A circular tunnel and the stress concentration.

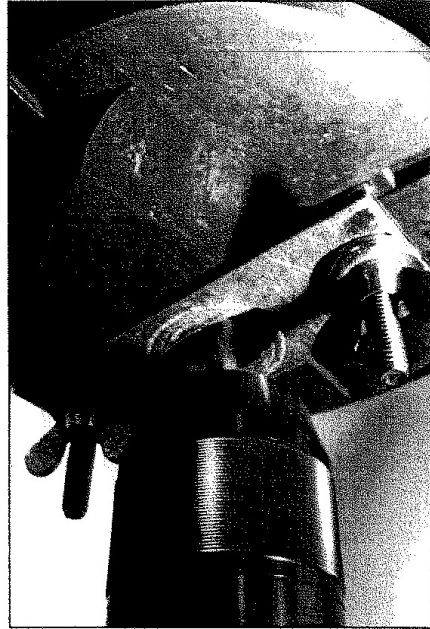
*Close up of drill and Sievers' J piece.*
