Load measurements at riprap toe.

# Load Measurements at Riprap Toe

Master's Thesis in Hydropower Development

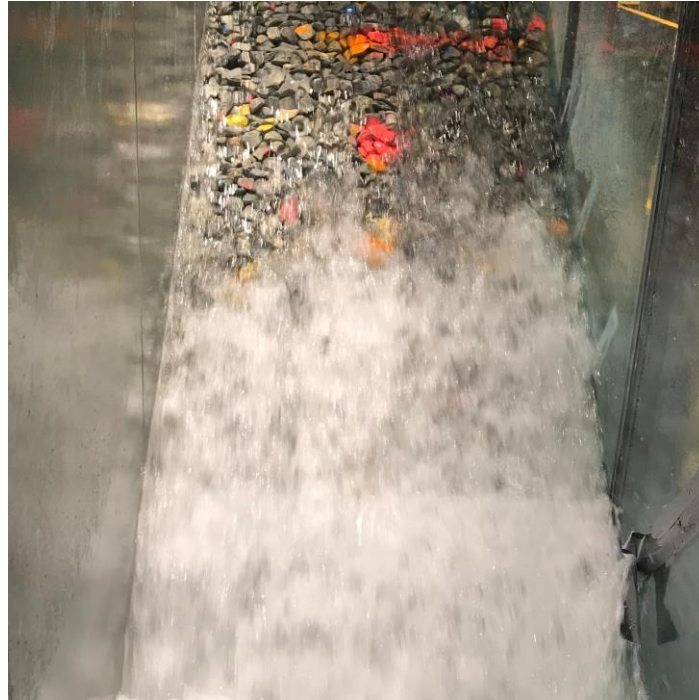
*Figure 2 Laboratory model test which shows highly turbulent flow condition at the riprap toe on the downstream slope of an embankment dam. Photo by K.N. Opore*

Due to the very turbulent flow conditions that give rise to these dynamic loads at the dam toe, quantification of these loads are very challenging. The dam toe has to deal with these dynamic forces that are transferred from the riprap unto it. This process can result in loosening of the riprap stones at the embankment toe which can result in removal of these stones which will in turn lead to a progressive collapse of the entire riprap structure. This situation is exacerbated if the downstream slope is steep ( $S > 0.5$ ). Hence arriving at a qualitative and quantitative descriptions of the dynamic load generation mechanisms and finding ways to measure and quantify such loads at the toe of ripraps under overtopping conditions is of great importance as this can be of relevance for design of embankment dam toe structures.

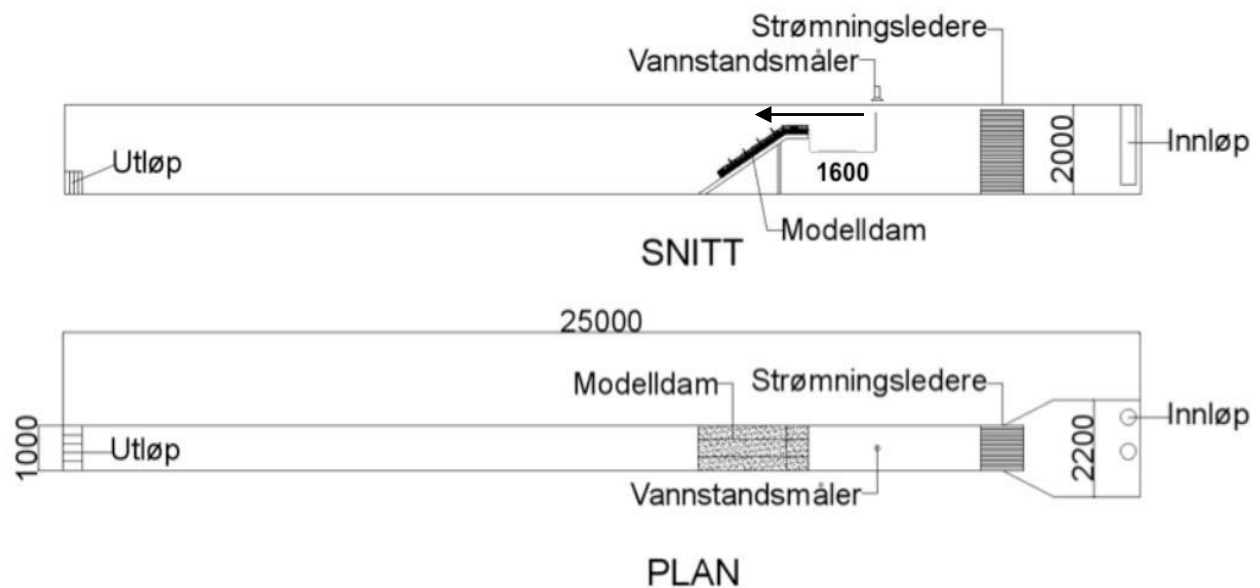
Figure 5 General plan and section of the test flume in the hydraulics laboratory at NTNU as illustrated by (Pattersen,2015).

The model riprap constructed in the 25m long, 1m wide and 2m high flume in the hydraulic laboratory at NTNU is used in this experiment. Slight modifications are effected to the model compared to the one used by Hiller et al. (2017) to make way for the installation of load measurement devices at the toe of the riprap. Hiller et al. (2017) gives a detailed description of the experimental instrumentation and procedure. For ease of referencing, an overview of the instrumentation and the procedure with specific emphasis on the modifications that have been done to the model for this experiment are presented here.

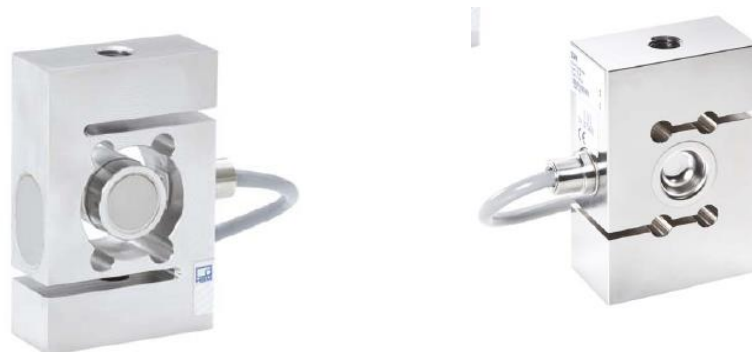
*Figure 8 The S9M load cells used for the experiments.*

The S9M/500N force transducer is a device manufactured by HBM. The S-shaped S9M load cells measures tensile and compressive forces and can be used for various kinds of static and dynamic applications. The S9M is tailor made to suit difficult applications in that the measuring body is made of stainless steel and is well welded which makes it an ideal option for this kind of test. Installed at the riprap toe during overtopping tests meant that the device was soaked in water during testing and hence its ability to work in such conditions without affecting the outcome of the results was very good. The S9M has nominal (rated) forces ranging from  $500\text{N}$  to  $50\text{kN}$ . Six (6) of the  $500\text{N}$  load cells were used for this experiment giving it a combined capacity of  $3\text{kN}$ .

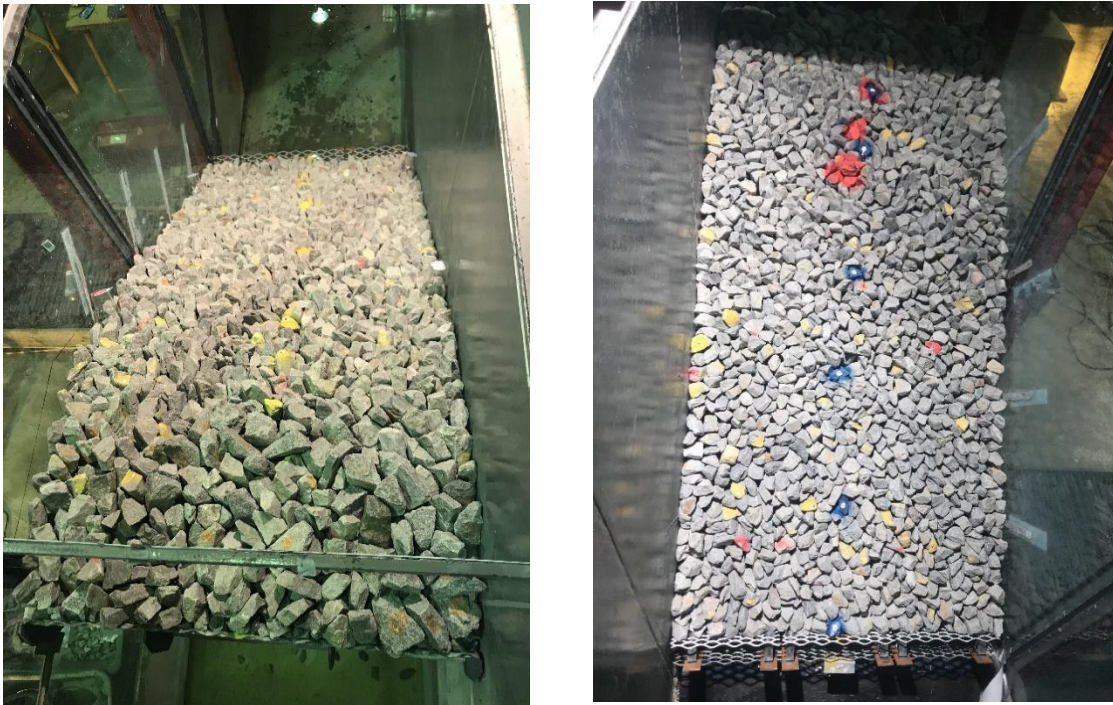
*Figure 11 Constructed riprap ready for overtopping test with marked stones at specified distance from the toe for observing displacements. View from both upstream and downstream. View from downstream also shows installed load cells. Photos by K.N. Opere.*

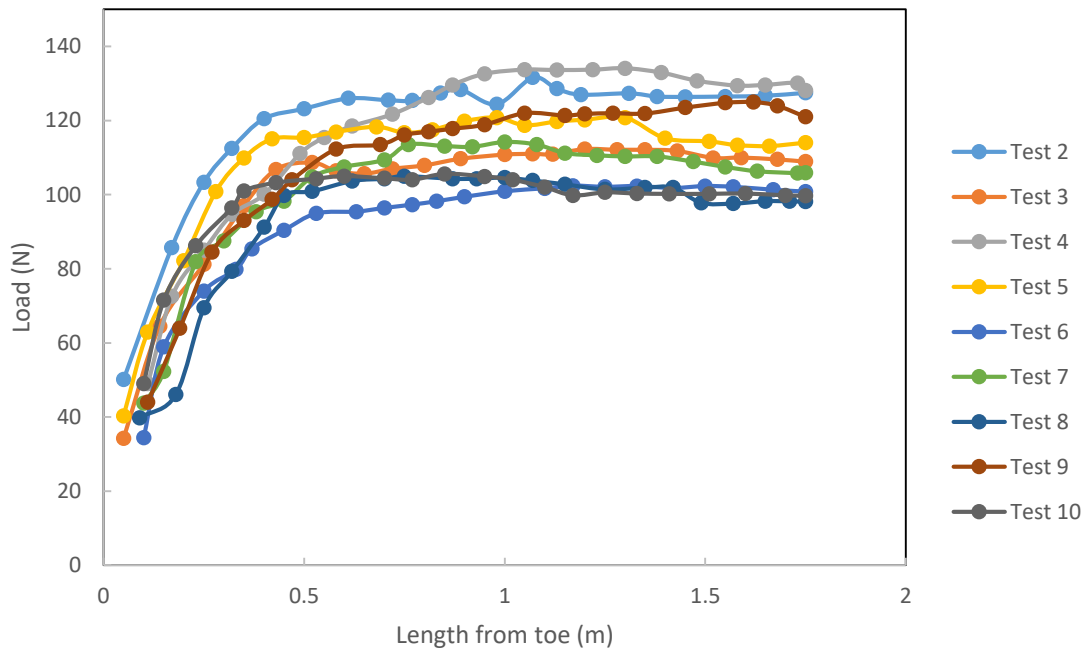
*Figure 12 Progress of riprap stone self-weight on the dam toe as recorded during riprap construction for all tests. It is seen how the load stabilizes after a threshold distance from the toe.*

Figure 12 shows the variations of the loads recorded at the riprap toe during construction for all the tests. It is observed that the load for lower third of the chute length, the load increases rapidly then gradually reduces through the middle third until it finally sort of stabilizes. From this point onwards, addition of more riprap stones cause no change in the load cell reading. Meaning the weight of the stones above a certain threshold length has no significant influence at the toe of the riprap. Beyond this threshold point, the weight of added riprap stones is carried by the underlying layer and the friction resistance from the underlying filter layer.

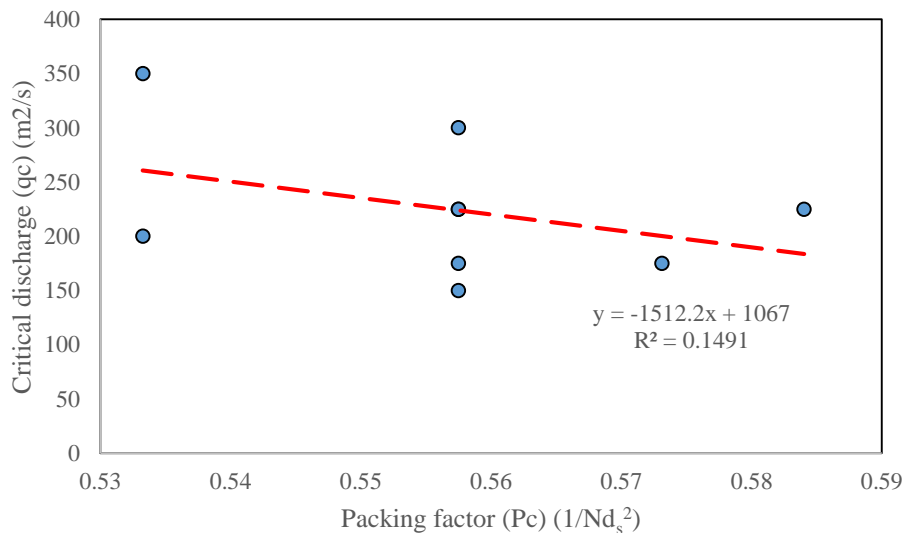
Figure 15 Graph of critical discharges against packing factors for all overtopping tests which shows no linear relation.

Hiller et al. (2017) suggested the packing factor to be a factor that determines the critical discharge of placed riprap, this study has found no clear relation between the packing factor and the critical discharge as shown in Figure 15.

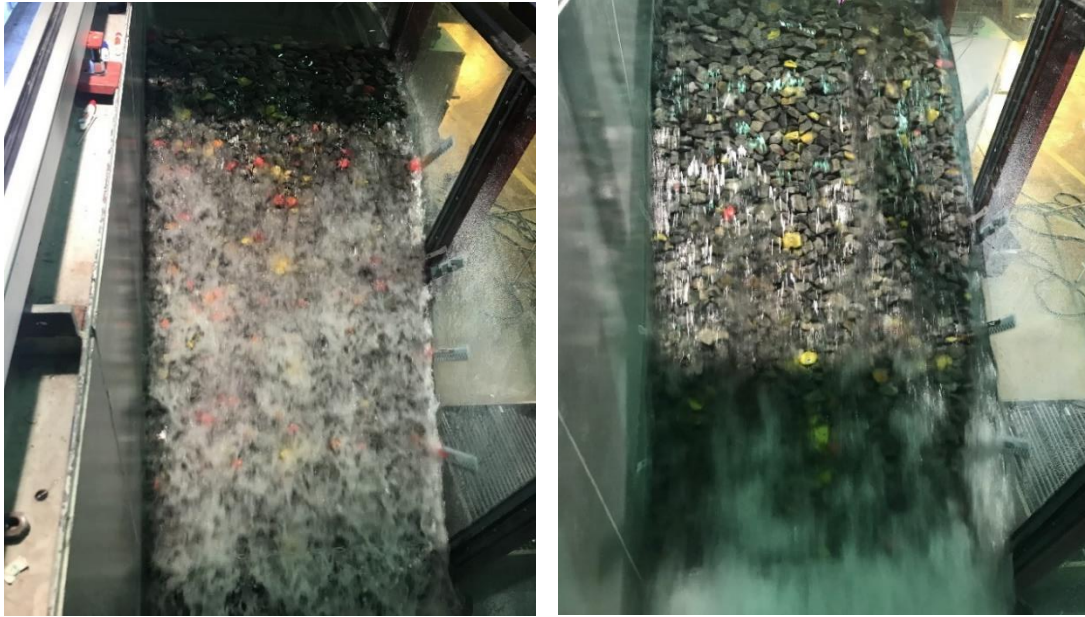
*Figure 178 Two different overtopping scenarios during tests. Low discharge resulting in highly aerated flow over the entire riprap on the left and high discharge resulting in a complete clearly defined depth of water over the riprap layer on the right.*

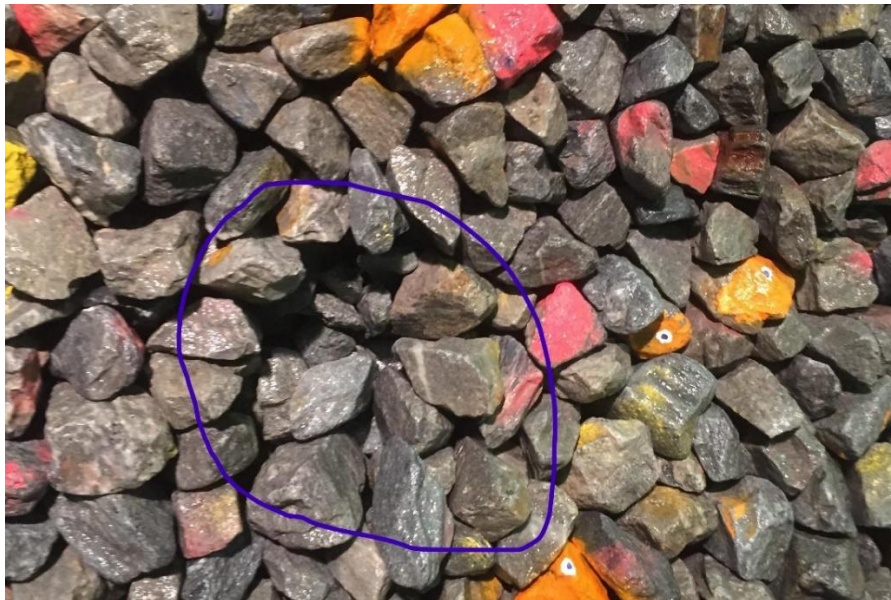
*Figure 18 Removal of a single stone after one of the overtopping tests. Entire riprap structure worked perfectly even with that stone removed.*

During the overflow tests, riprap failure was considered when there was total collapse of the riprap or when there have been a considerable washing away of many riprap stones that it could clearly be seen that the integrity of the riprap had been compromised even though the structure was still standing. It was observed that during the tests, there were instances where loosely placed lone stones detached from the entire structure but the riprap structure worked perfectly.

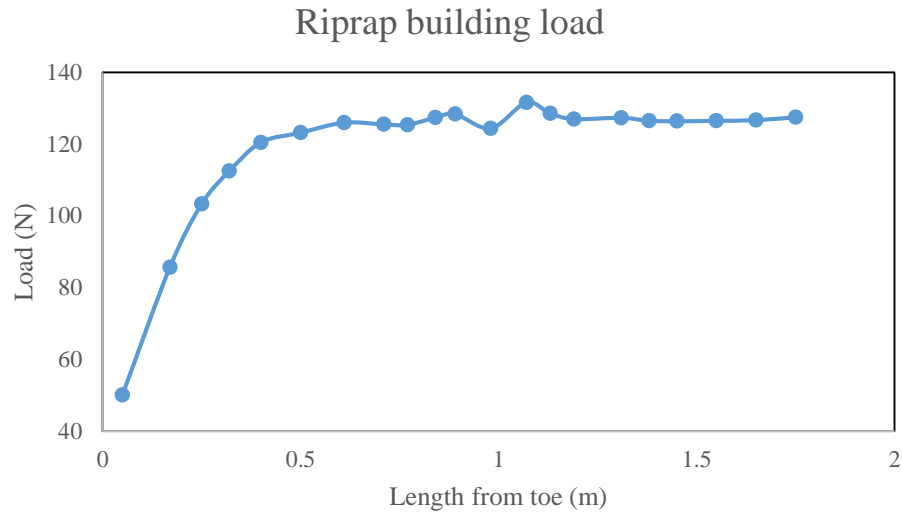
*Effect of riprap stone self-weight felt at the toe of the riprap during riprap construction.*

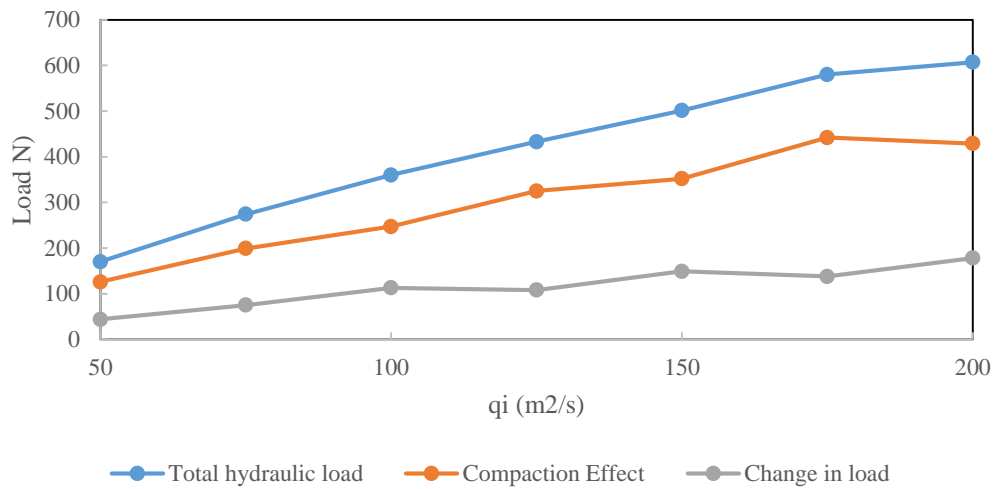
Changes in the different load types with change in the incremental discharges

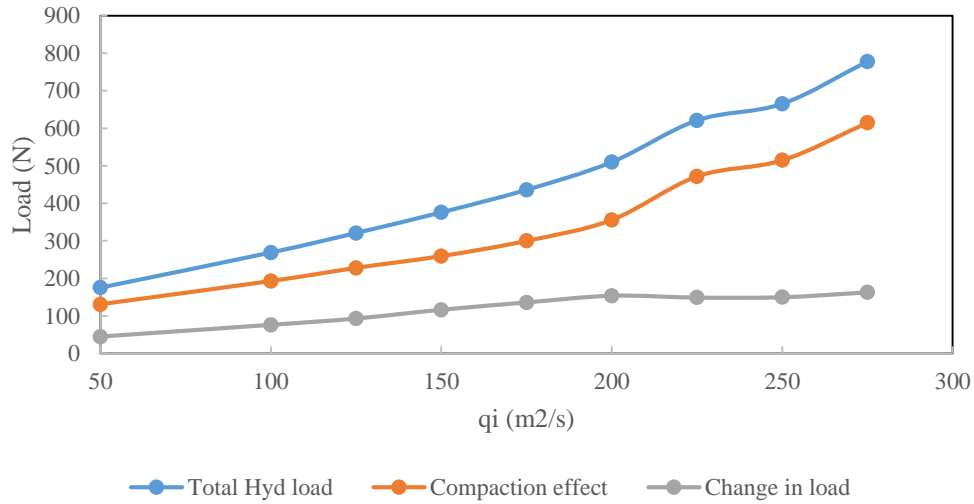
Change in the different loads with increasing incremental discharge for test 3.

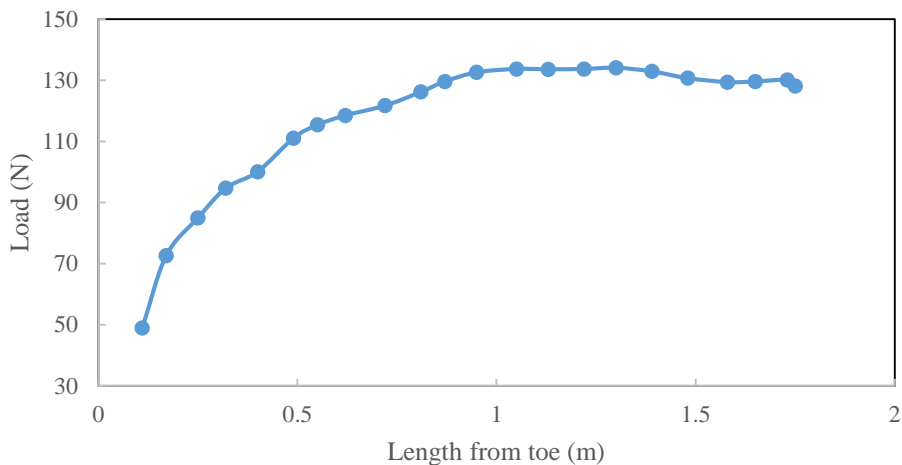
Effect of riprap self-weight at the toe of the riprap during riprap construction.
